**2014 2.5k
Cypress, TX**

PROPERTY INSPECTION REPORT

Prepared For: Sample Report
(Name of Client)

By: David Gibbs, Lic #7406 TREC Professional Inspector 01/20/2021
(Name and License Number of Inspector) (Date)

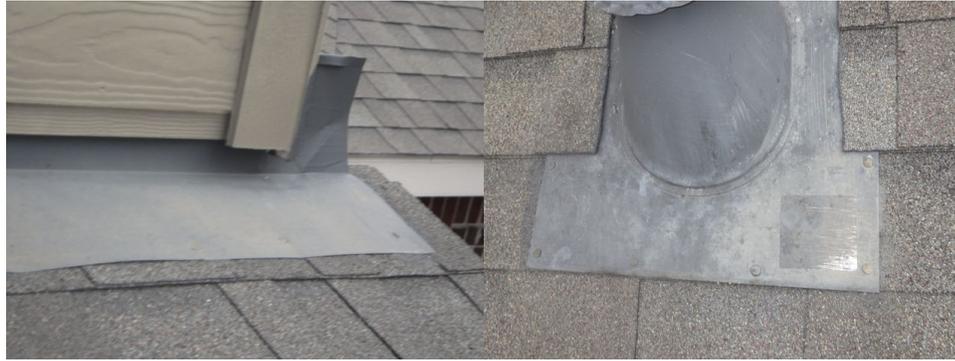
VISIBLE FLASHING / ROOF PENETRATIONS:

The kitchen plumbing drain waste vent flashing was improperly altered for patio cover addition. There was evidence of leakage at this location (water damage kitchen ceiling). We recommend further inspection by a specialist contractor and repair or replace as necessary.

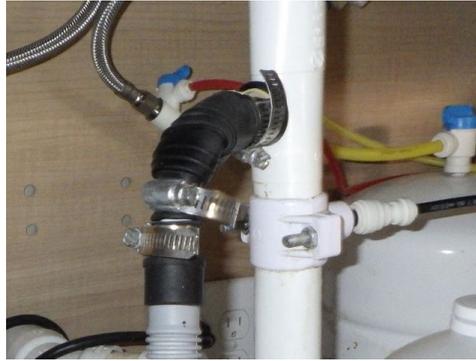
The dishwasher drain line lacked a visible backflow preventer (air-gap or high loop) as required by present standards and necessary to prevent mixture of supply and waste water from disposal. We recommend a high loop or an approved backflow preventer be installed.
