Solid Home Inspections

PROPERTY INSPECTION REPORT

Concerning: 2021 build - 4232 sf, Cypress, TX 77433
(Address or Other Identification of Inspected Property)

By: David Gibbs, Lic #7406 TREC Professional Inspector 01/28/2021
(Name and License Number of Inspector) (Date)

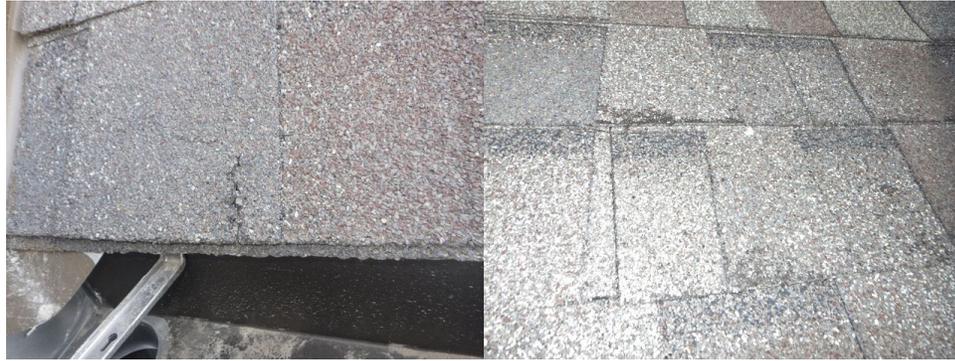
Observed multiple nail holes in shingles. These are likely from use of toe boards (lumber improperly nailed to roof surface to create walkway during construction). We recommend repair or replace as necessary to prevent water penetration.

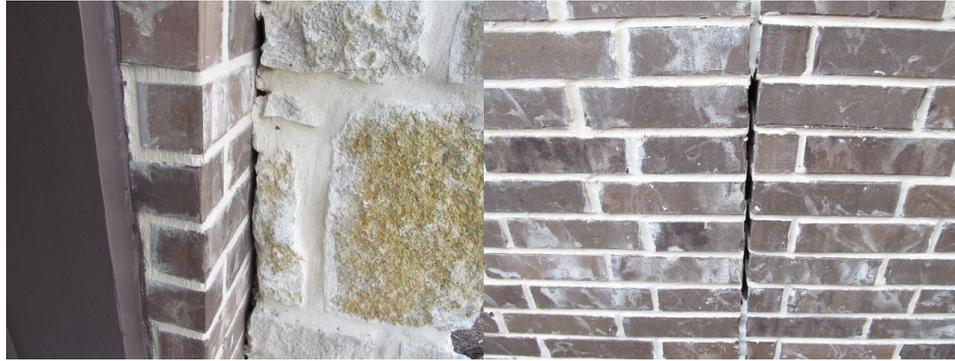
Observed caulking was missing or deficient around wall penetrations in some areas. We recommend all wall gaps for joints between cladding materials / vents / plumbing / electrical etc, be caulked to prevent water penetration.

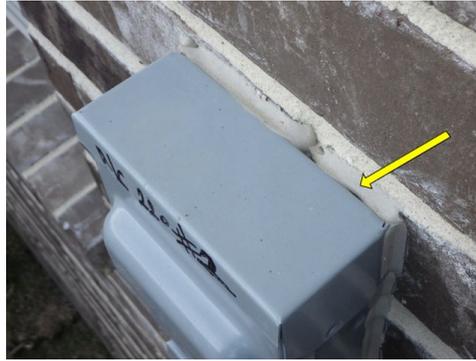
Observed gap in wall below flashing where air conditioner refrigerant / electric supply lines pass through exterior wall. We recommend install foam sealant and/or metal mesh to prevent rodent entry.
