Home Inspection Report

Prepared For Joe and Jane Homeowner
11/21/2021

123 Main St
Anywhere, OR

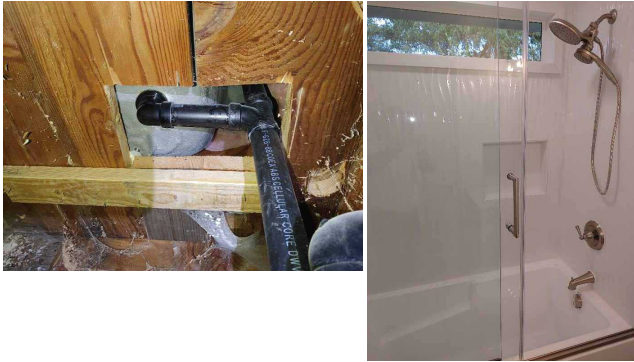
8. 1st floor main Bathroom Tub/Surround: Fiberglass tub and fiberglass surround

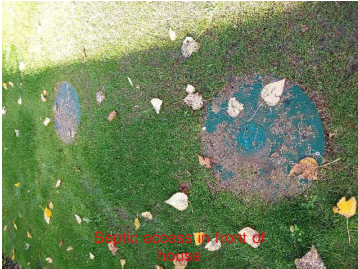
Sewage Disposal: Septic How Verified: Multiple Listing Service

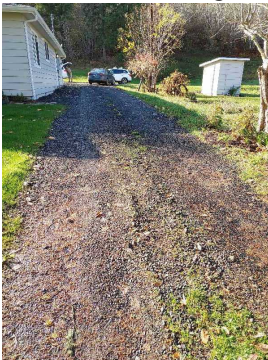
Acceptable Driveway: Gravel - Initial section of driveway (from highway) is in what appears to be a swale area, and therefore flooding may become an issue at times

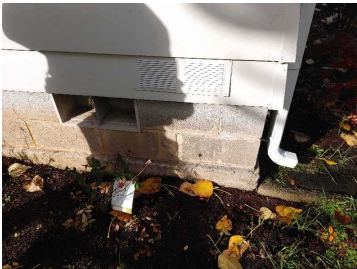
Foundation: Block - No obvious or significant foundation cracking or settling noted at time of inspection.

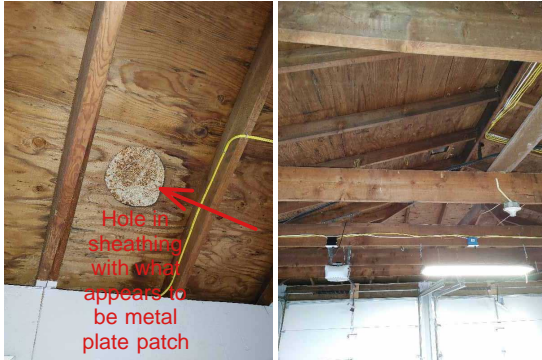
Acceptable Ceiling: Exposed framing

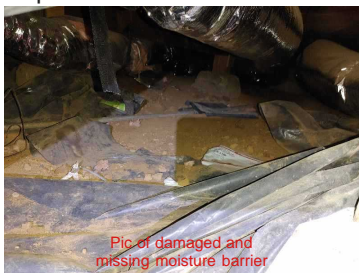
5. Next to front steps Crawl Space Moisture Barrier: Plastic moisture or vapor barrier torn, No moisture or vapor barrier present in multiple locations. This can allow ground moisture to enter the crawl space and then damage the wood members of the house, including mold growth and insect infestation. A qualified contractor is recommended to evaluate and estimate repairs

Not Present Vapor Barrier:

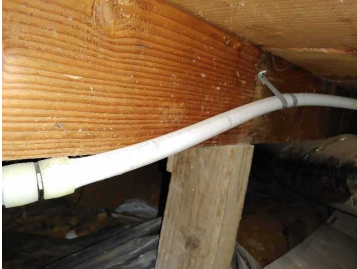
Acceptable Service Line: PEX - Plumbing supply and drain lines appear to be recently replaced with PEX supply and ABS drain.

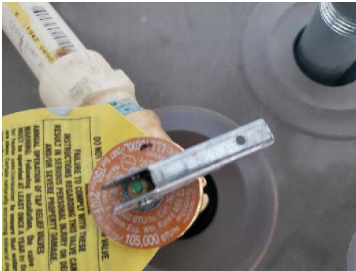
Acceptable TPRV and Drain Tube: PVC - TPR drains to garage floor

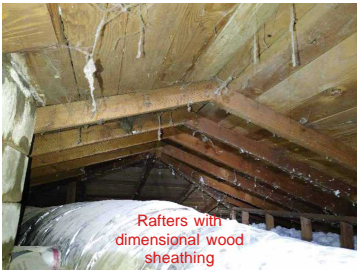
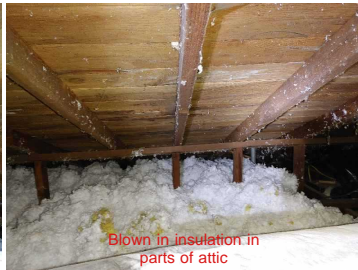
Acceptable Roof Framing: Rafter

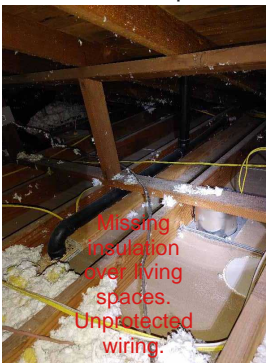
Acceptable Insulation Depth: 6 - Insufficient insulation present as some areas of attic had no insulation at all.

5. Pantry Attic Insulation: Blown in - Insufficient insulation present, Recommend additional insulation be installed. In addition, most of the wiring is unprotected and running over the tops of joists. This subjects them to damage which could cause electrical shorts and/or a fire. Recommend qualified electrician to route wires properly.

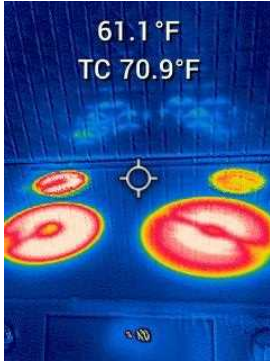
Acceptable Cooking Appliances: Samsung - Range is brand new. Cooktop operated properly at time of inspection. Further inspection deferred as unit still had instruction manuals attached to inside of oven.

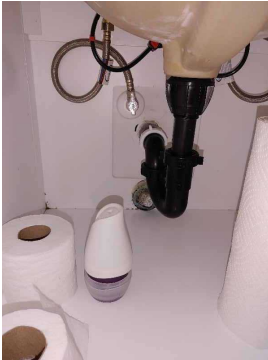
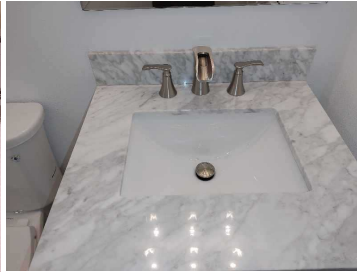
Acceptable Faucets/Traps: Low pressure or flow rate at faucet, further review and/or repair is indicated
Acceptable, Defective Tub/Surround: Fiberglass tub and fiberglass surround

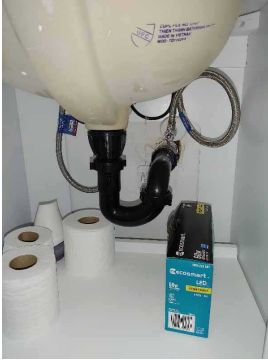
Acceptable Faucets/Traps: Low pressure or flow rate at faucet, further review and/or repair is indicated
Not Present Tub/Surround:
