# Lead Cable Investigation

June 30, 2023

**Prepared for:**

Marine Taxonomic Services, Ltd.  
Below the Blue 501(c)3

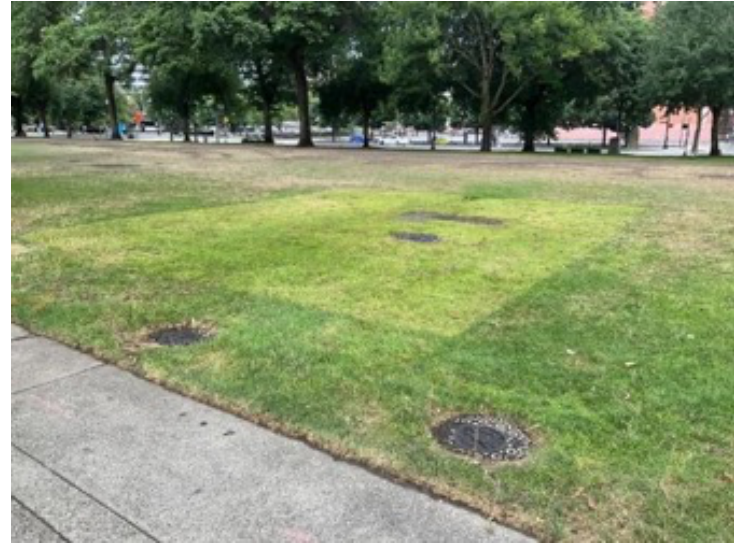
(C) Five Bell Systems manholes with vault. WR 2.2. August 2022, Portland, Oregon.

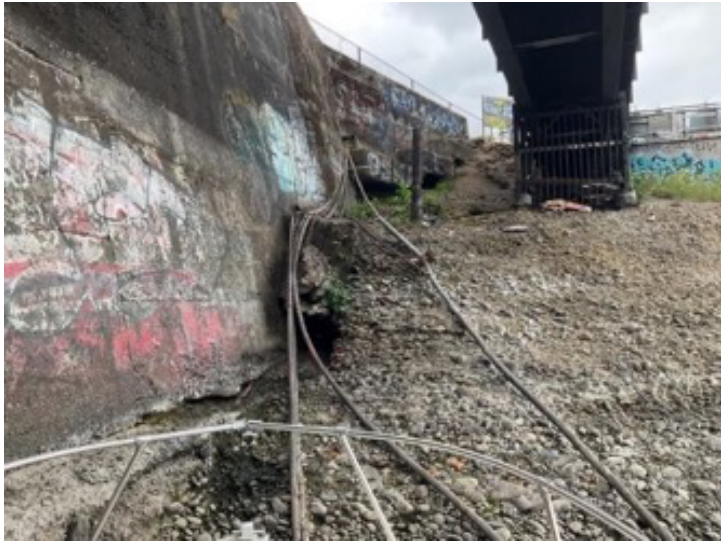
(E) North Steel Bridge cables. WR 6. August 2022, Portland, Oregon.

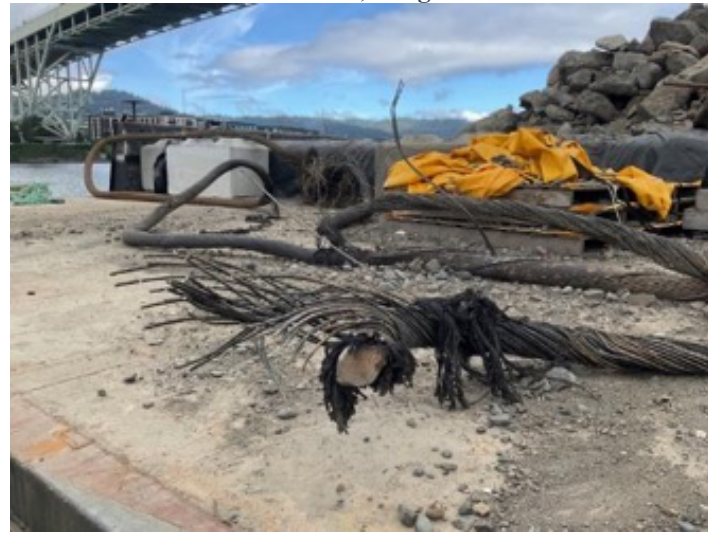
by, passing boats, or floating debris in the river (Figure 14(F)). The final screened location WR 8, was an active construction site along the waterfront. There was limited access to the point of interest provided by the WSJ, however, the team observed a coiled-up, lead sheathed cable on the barge. After a brief discussion with the foreman, it was learned that this cable may have been pulled from the Abernathy Bridge south of Ross Island. This was not a location the team had time to investigate during this trip (Figure 14(G-H)).

(H) Possible Abernathy Bridge cable. WR 8. August 2022, Portland, Oregon.

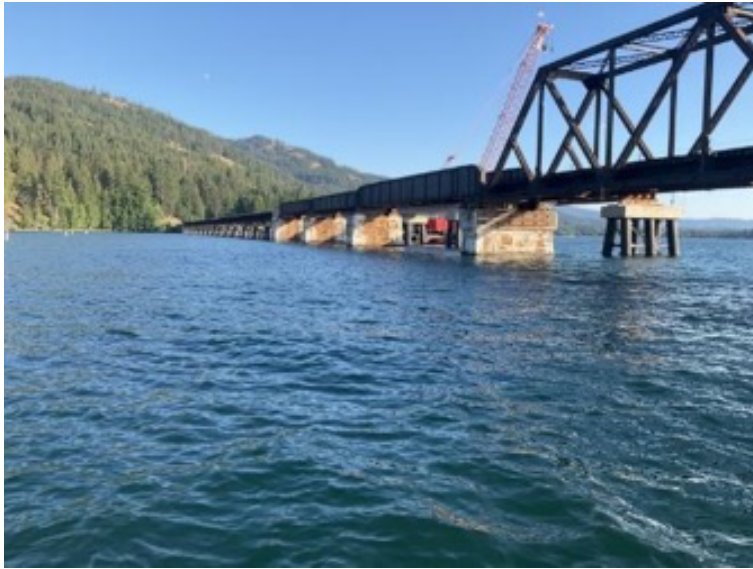
(A) Lake Pend Oreille, ID Railroad Bridge. August 2022.

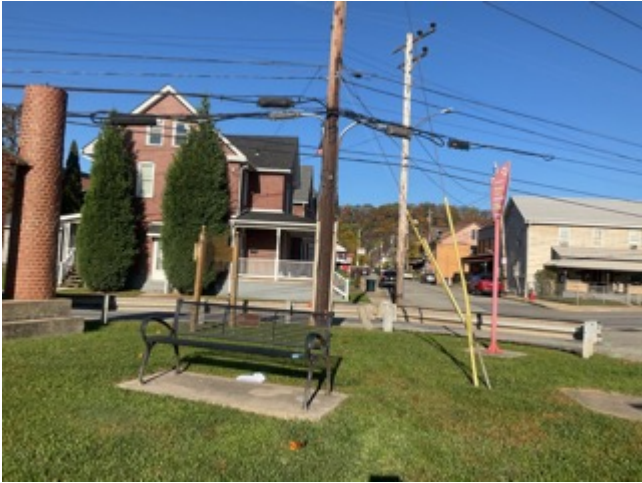
Aside from the overhead cable found within California Township (Coal Center), there were only two points along the Allegheny River where visible lead sheathed cable was recorded. AR 1 also, has a small portion of lead sheathed cable running up an old telephone pole near a personal watercraft boat launch, with a sitting bench (Figure 17(A-C)).

**(A) Park bench near exposed lead sheathed cables and splice boxes. October 2022. Natrona, Pennsylvania.**

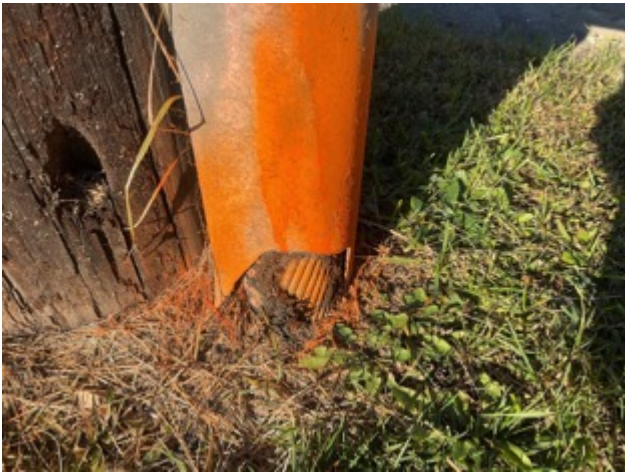
**(B) Base of telephone pole in (A) and (C) showing marked cable going into the ground. October 2022. Natrona, Pennsylvania.**

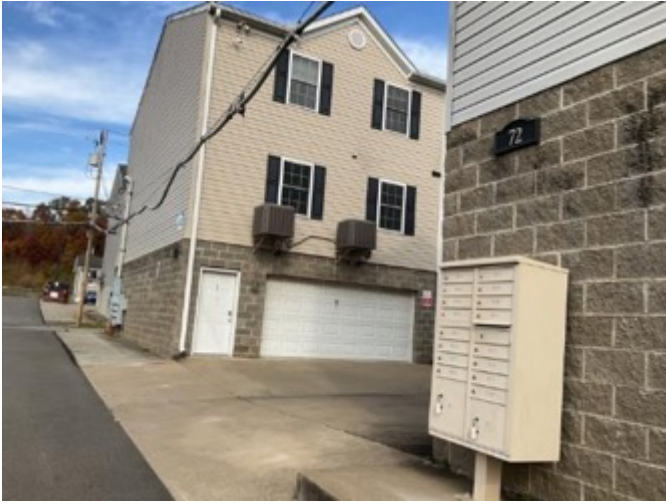
(D) CT6. Overhead lead sheathed cable running across the entrance into apartments and over access to mailboxes. February 2023. Coal Center, Pennsylvania.

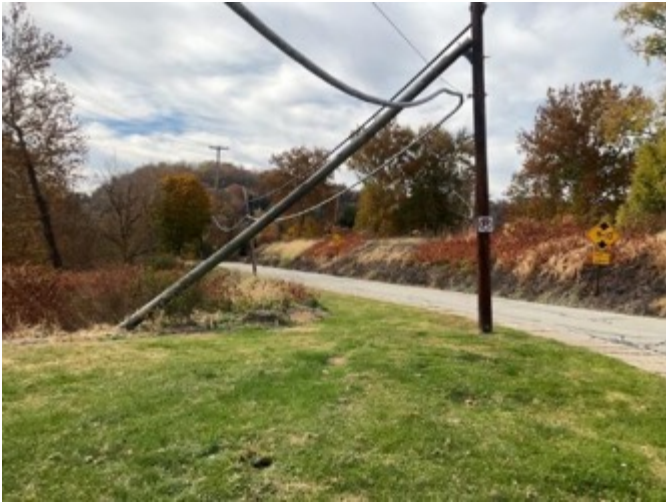
(E) CT8. Overhead lead sheathed cable running across a greenway and sidewalk. February 2023. Coal Center, Pennsylvania.

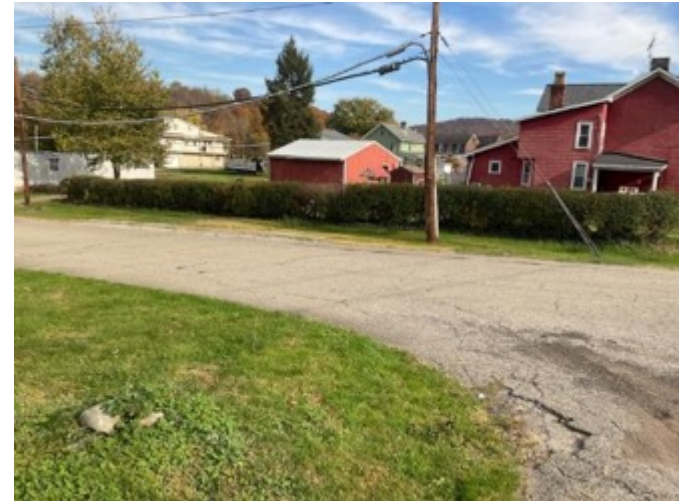
(G) CT12. Overhead lead sheathed cable running across the road next to homes. October 2022. Coal Center, Pennsylvania.

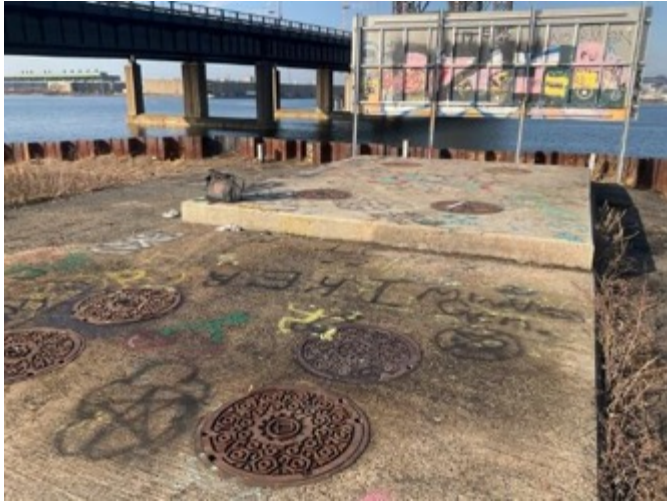
(A) Large vault with eight Bell Systems manholes on the Hackensack River. Looking towards South Kearny. January 2023, West Side, New Jersey.

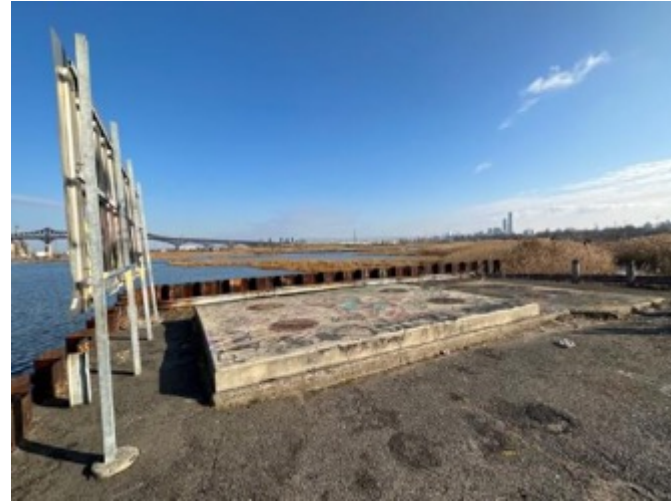
(C) Vault area looking towards Lincoln Park Wetlands & Nature Trail. January 2023, West Side, New Jersey.

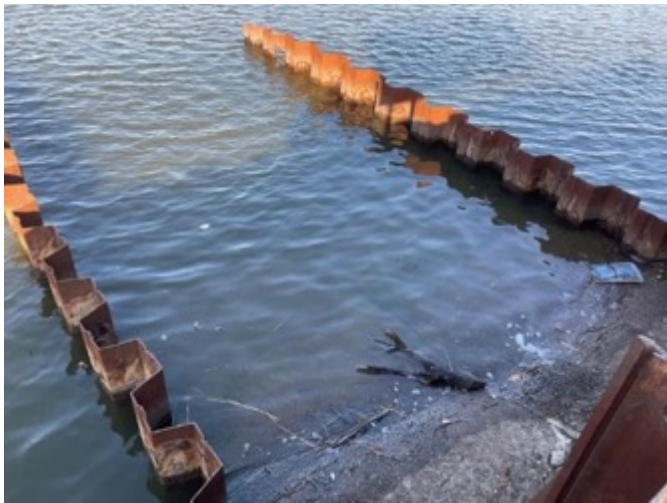
(B) Cable landing area covered with concrete. Area is below the sign in (D). January 2023, West Side, New Jersey.

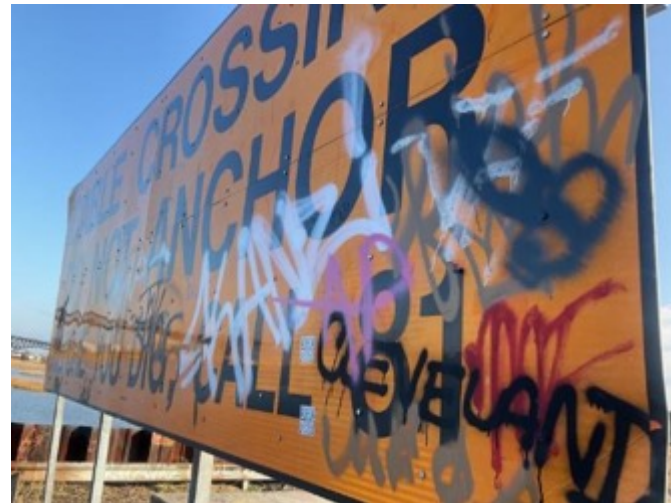
(D) Cable Crossing Sign. January 2023, West Side, New Jersey.

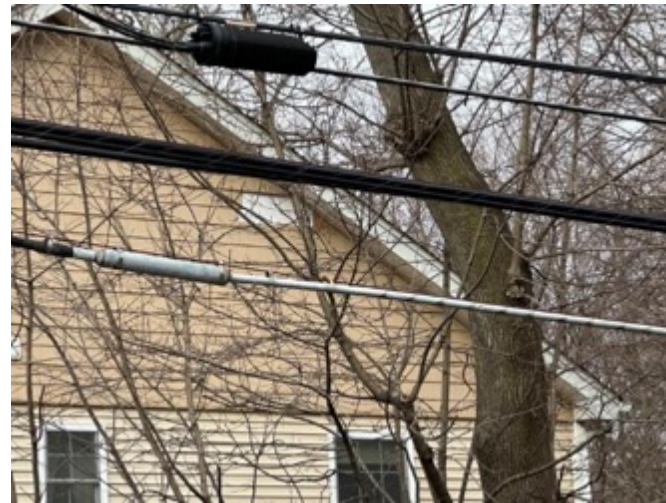
Four generalized data points were recorded for Highland Falls Township. Lead sheathed cable appears to run throughout the town and is occasionally covered with a protective sheathing that encompasses parts of the cable. Visible bare leaded splice boxes were observed at nearly every telephone pole. (Figure 25(A-C)). This site required more time than was available for detailed observations and further investigation is recommended.

(C) Exposed bare lead splice box and lead cable. January 2023. Highland Falls, New York.

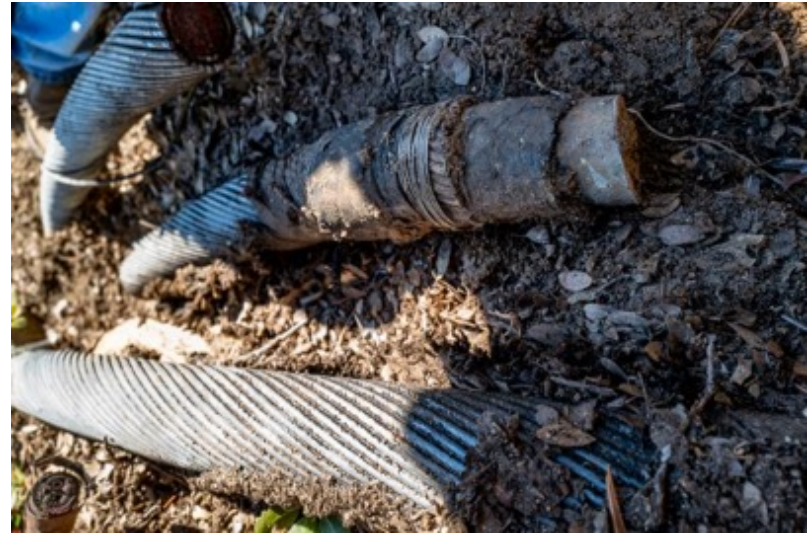
The main Lake Tahoe cable is approximately seven miles long and runs along the western shoreline from Baldwin Beach to Four-Ring Road. It was installed in 1955 in efforts to extend and improve telecommunications to the west shore. This is a 3.5-inch lead sheathed cable with five leaded splice boxes on land. This cable is not severed in water, however, there are numerous damaged locations. This cable is severed on land. The cable can be observed above water to roughly 100-ft deep in Lake Tahoe. The Rubicon area is a wall of granite, and the cable is draped along the granite wall and boulders. All steel rock anchors and associated cables that would have held the cable in place, are broken (Figure 30(A-C) and Figure 31(D-F)).

(B) Another splice location from land during the same site visit with AT&T in January 2021.

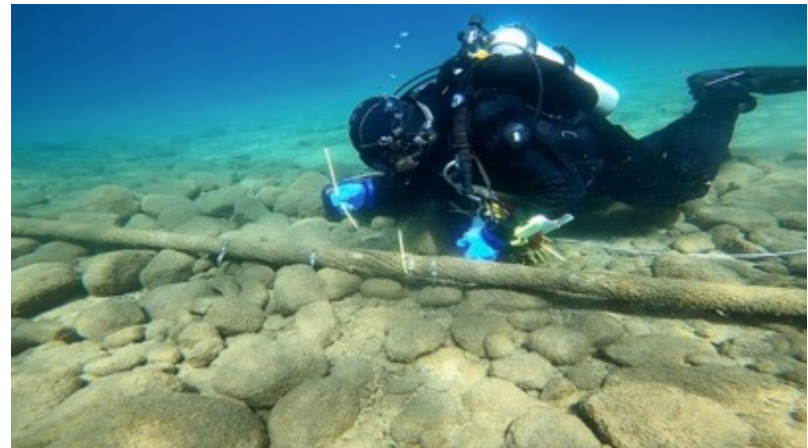
(C) Diver marking locations of damage during a survey in April/March 2022, Lake Tahoe, California.
