## Background

## Key point 1 – Continuity of the insulated plane (thermal bridge risk)

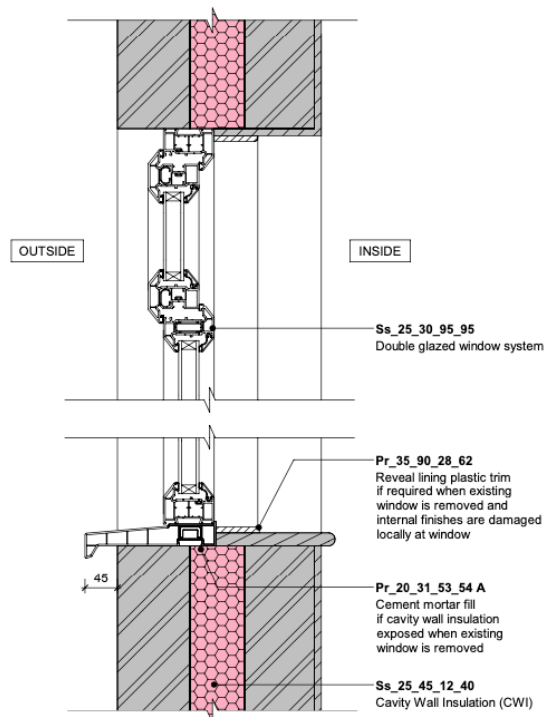
The appropriate placement within the reveal is specified in section 4.15d of Part L of the building regulations: 'window or door units should be located with an overlap between the inner face of the unit and the inner face of the external leaf – for windows an overlap between 30mm and 50mm, and for doors 50mm – so that the window or door unit is contiguous with the insulation layer of the external wall.' The below design gives a good illustration of how this detail should look when installing a window to a cavity wall.

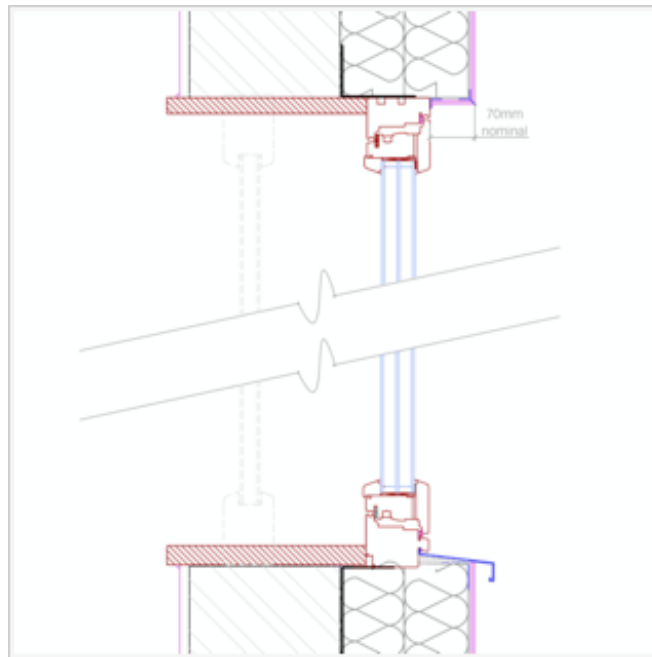
Where windows and doors are installed in conjunction with EWI, the same principles apply; they should be installed in a way that ensures continuity with the insulated layer. The below detail from the Retrofit Pattern Book illustrates the requirement nicely.

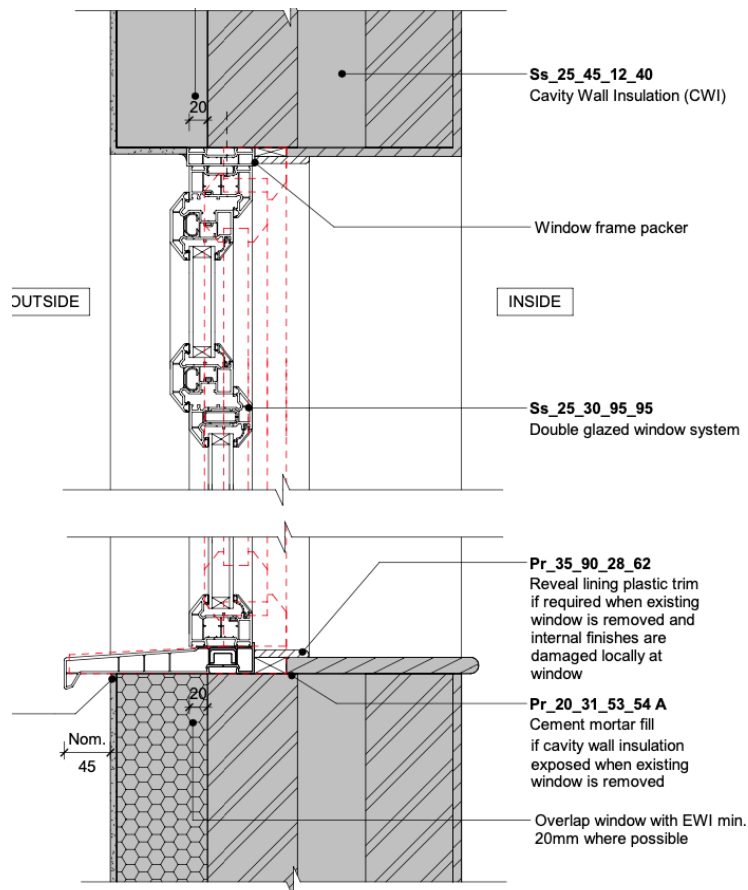
Different properties and designs will require different alignments so always consult with the Retrofit Design and Retrofit Designer if required. The detail could look more like the below with a minimum of 20mm overlap specified:

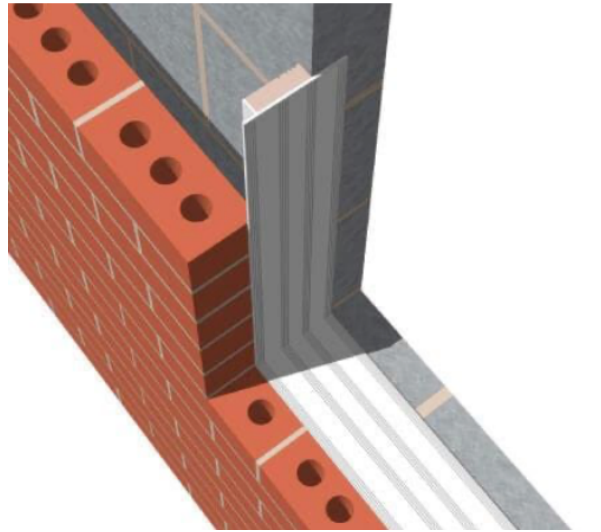
Use of insulated cavity closers on retrofit projects will not always be possible due to the risk of damaging the walls around the window opening however, where possible, this should be considered in order to provide a continuous insulated layer right up to the window frame. Please consult the design for specific project requirements.
