# LEVEL 2 REPLACEMENT RESERVE REPORT FY 2022 CHARLESTOWNE VILLAGE

## CHARLESTOWNE VILLAGE

GREENBELT, MARYLAND

December 28, 2021

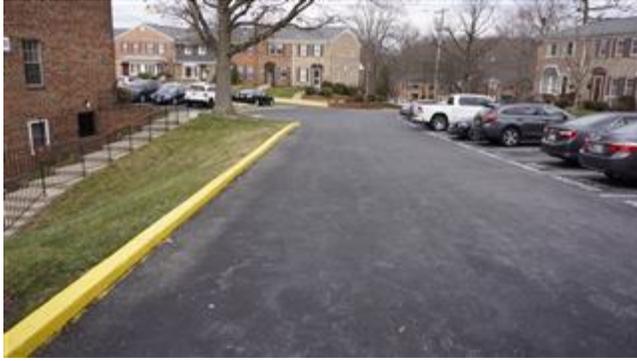
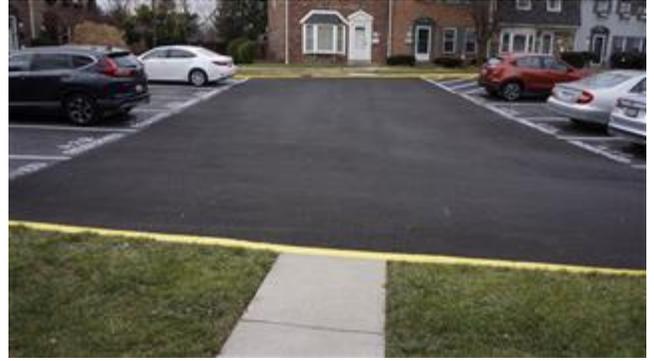
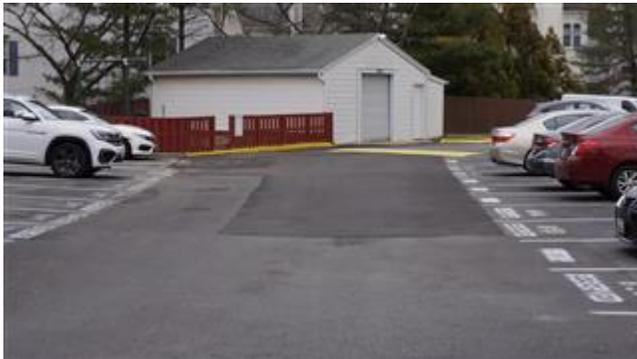
**Asphalt Pavement.** The Association is responsible for the roadways and parking areas within the community. Other roadways are maintained by the City, County, or other municipality. In general, the Association's asphalt pavements are in fair condition. Asphalt overlay and sealing work completed in 2020 indicate that the Association is working to keep all asphalt surfaces in serviceable condition.

The report segregates asphalt mill and overlay at areas re-worked in 2020 from the remainder of the asphalt areas not recently re-worked, with appropriate remaining economic life factors assigned to each.

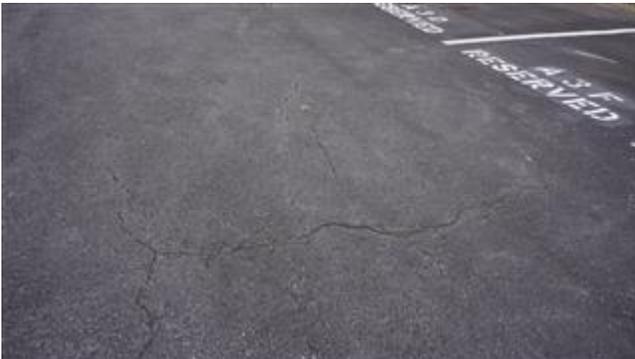
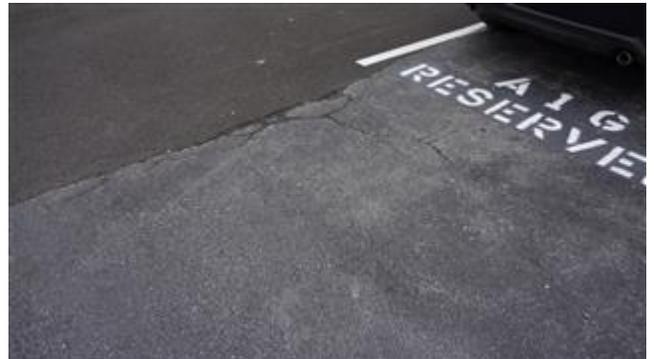
- **Open Cracks.** There are multiple locations where open cracks are allowing water to penetrate to the asphalt base and the bearing soils beneath. Over time, water will erode the base and accelerate the deterioration of the asphalt pavement. If cracks extend to the base and bearing materials, remove the damaged areas, and replace defective materials. As a part of normal maintenance, clean and fill all other cracks.

- **Reflective Cracking.** The asphalt pavement has a significant number of reflective cracks. Reflective cracks occur when placing a new asphalt overlay over and existing cracked pavement. With time and movement, existing cracks will migrate through the new asphalt. Installing a bridging membrane or fabric at the time of overlay can control reflective cracking.

As a rule of thumb, asphalt should be overlaid when approximately 5% of the surface area is cracked or otherwise deteriorated. The normal service life of asphalt pavement is typically 18 to 20 years.

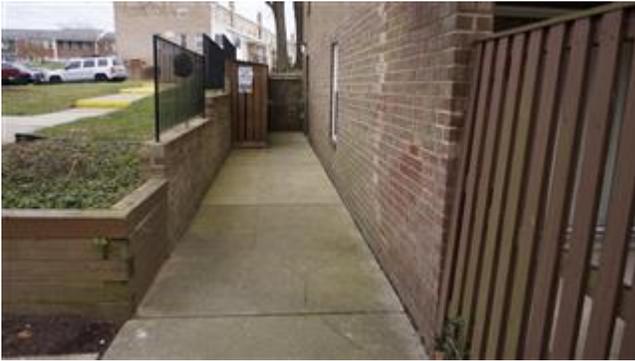
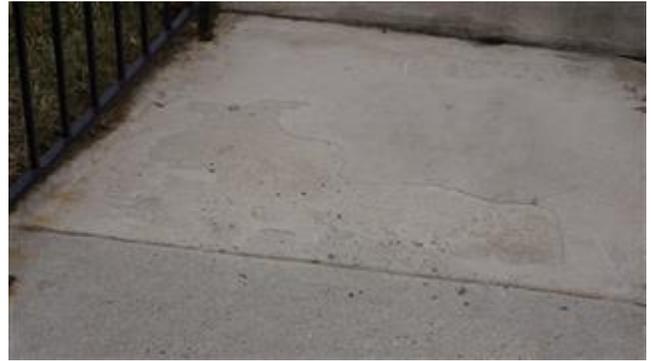
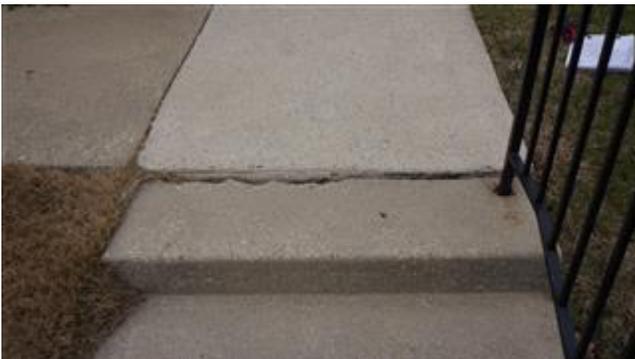
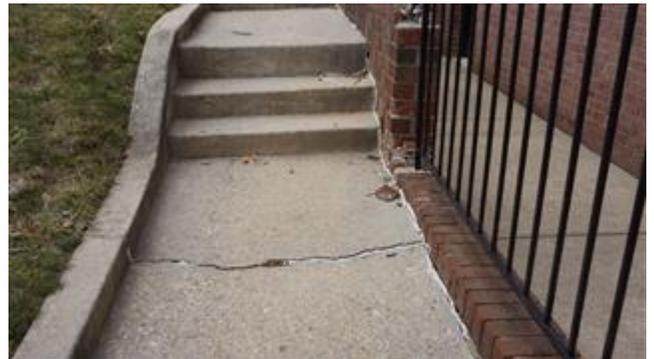
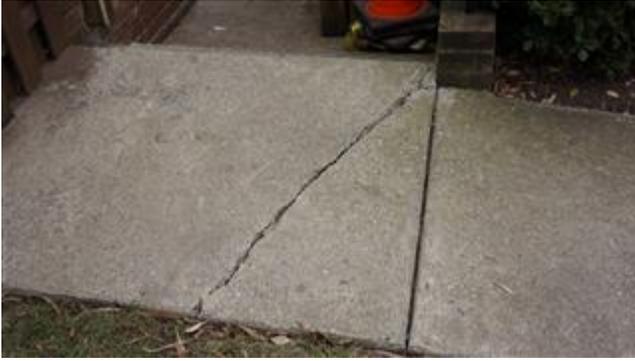
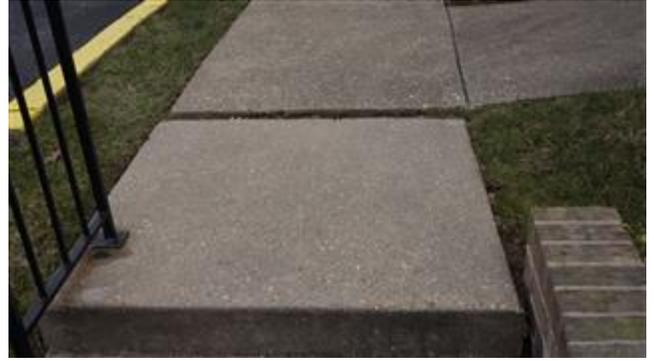
**Concrete Work.** The concrete work includes the community sidewalks, lead walks, stairs, stoops, patios, curbs, and gutter as well as other miscellaneous flat-work. We have modeled for curb replacement when the asphalt pavement is overlaid. The overall condition of the concrete work varies from recently replaced to concrete work which has cracked, settled, and spalled. Many instances of tripping hazards have been noted and it is recommended that these areas be promptly replaced. Another potentially hazardous condition is the undermining of concrete stairs and walks due to erosion by stormwater and improperly installed drain leaders. The recent replacement of concrete slabs and stairs indicates the Association is continually working to correct deficiencies such as those noted.

Because it is highly unlikely that all of the concrete components will fail and require replacement in the period of the study, we have programmed funds for the replacement of these inventories and spread the funds over an extended timeframe to reflect the incremental nature of this work.

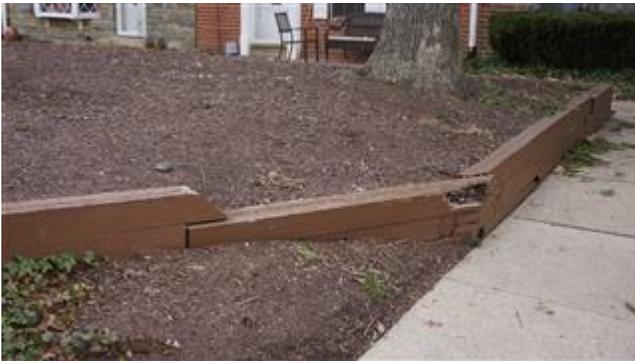
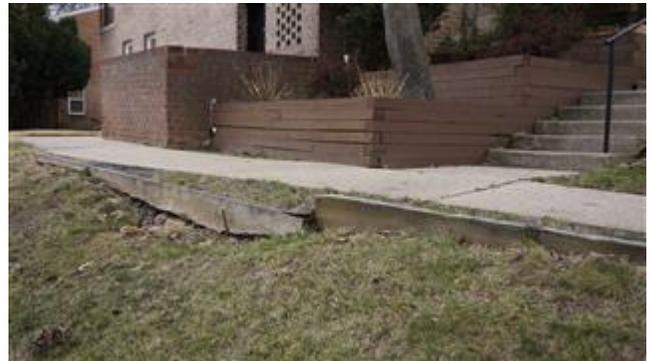
The treated wood retaining walls located throughout the property are mostly in poor condition with numerous instances of rotting and loose connections noted.

Retaining wall replacement can be costly, and early planning on the part of the Association can help to reduce the impact of this work on the community's budget in the future. We, therefore, recommend having a Professional Engineer inspect the walls and develop preliminary replacement alternatives and recommendations based on the site conditions, replacement costs, and recommended replacement wall types. This information can then be incorporated into future updates to the Reserve Study.

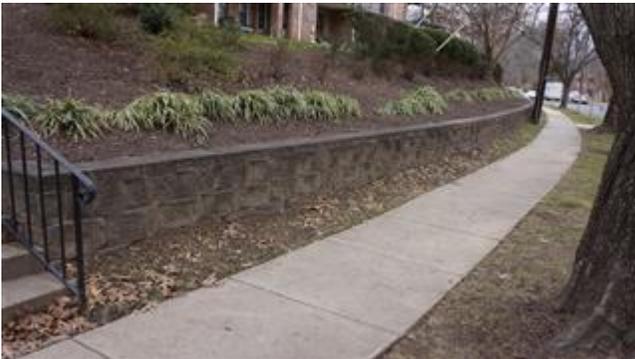
The segmental block walls, at two locations along the property line adjacent to Lakecrest Drive, are in good general condition with minor maintenance required to extend their economic life.

The poured concrete retaining walls, located along concrete stairways and adjacent to certain sidewalk areas, are in good general condition with minor cracking noted.

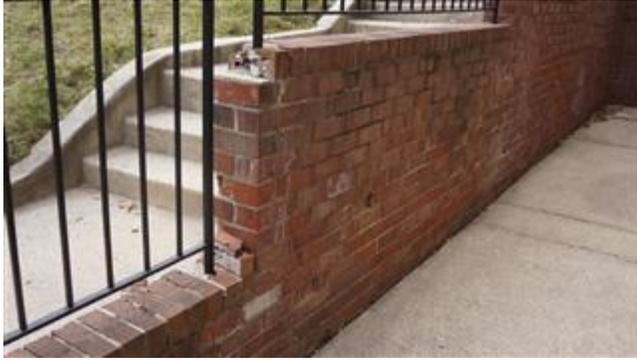
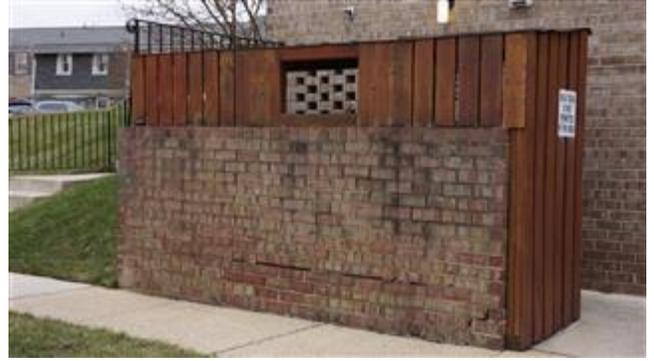
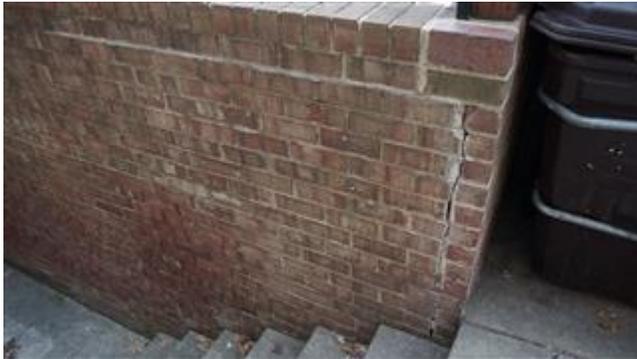
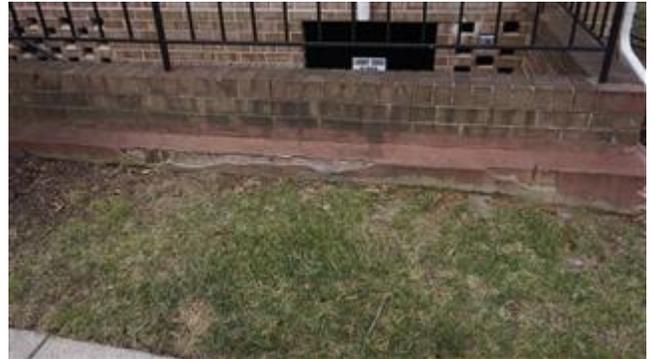
The brick retaining walls are primarily located at the below-grade access ways to the laundry rooms and storage rooms at either end of each of 12 buildings and at one end of three buildings. The condition of these walls varies from good to poor, with the primary deficiencies being loose and missing mortar, loose and missing brickwork, loose and deteriorating brickwork at metal railing bases, through-wall cracking, and deterioration of surface parging.

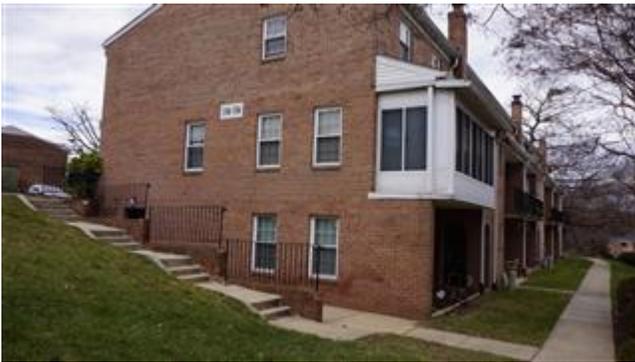
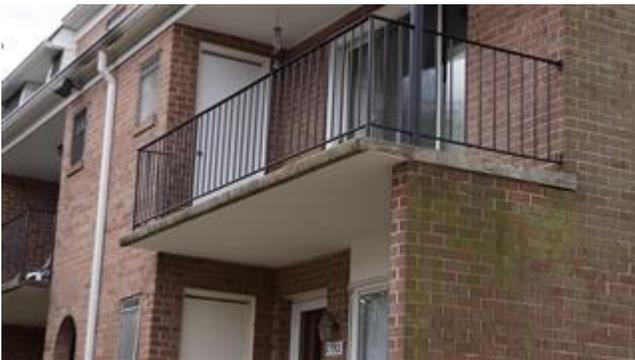
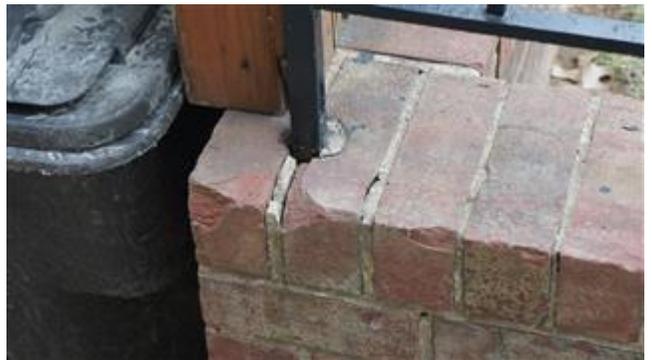
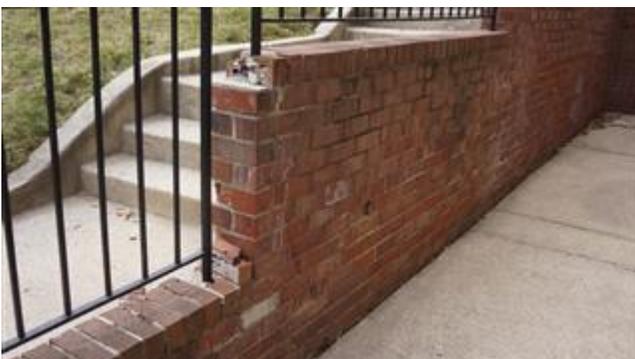
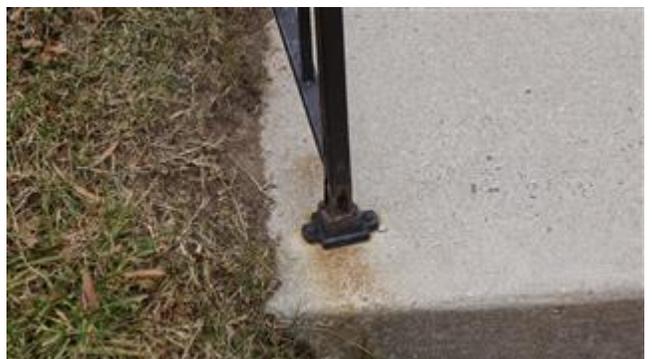
**Metal Hand Railing and Guardrails.** The Association maintains metal handrails, guardrails, and railing posts that are embedded in concrete or masonry, throughout the community. These handrails include free-standing rail systems, railings mounted to walls along stairways, guardrails at the top perimeter of retaining walls, and guard rails at the edges of the elevated balcony structures. These railings are generally in good condition and appear to be well-maintained by the Association although a number of deficiencies are noted. Most deficiencies are associated with the stability of the post bases mounted in the brick masonry retaining walls due to either rust corrosion or loose and broken brick. These conditions could compromise the stability of the associated railing system thereby creating a potential hazard.

It is noted that as the condition of the railings at the elevated balconies was assessed by inspection from the ground level only, the actual condition of these railings has not been determined. As noted for the concrete balcony structures, it is recommended that the Association retain the services of a structural engineer to perform a comprehensive inspection of the elevated deck structures, including the guardrails. and their support systems in order to establish their structural integrity.

Railings can have an extended useful life if these simple maintenance activities are performed regularly. If left unattended, the pressure from expansive post rust can crack and damage the supporting materials.

As part of normal maintenance, we recommend the following:

- Lift or remove ornamental base covers, if applicable.
- Remove existing caulk completely.
- Fully clean, prime, and paint all posts, rails, and pickets.
- Apply an appropriate caulk around each post base.
- Tool and shape caulking to shed water from the post.
- Reinstall base covers, and seal and paint all joints.

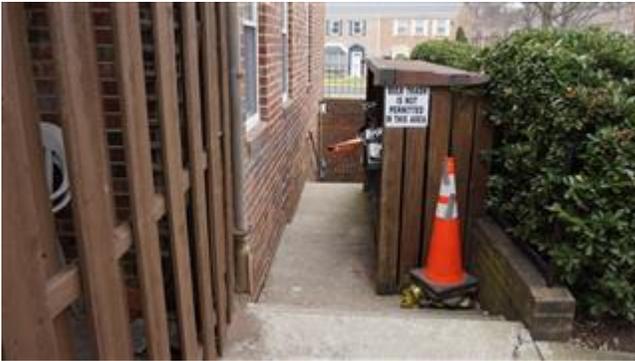
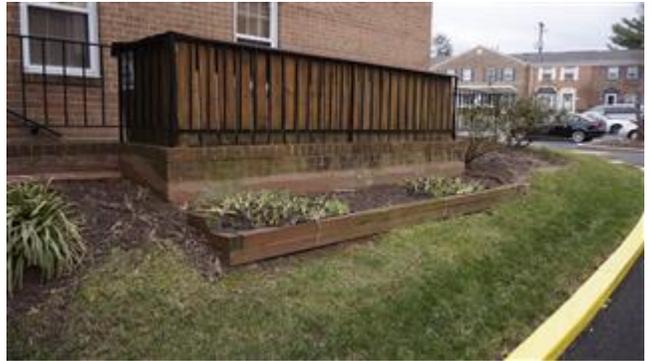
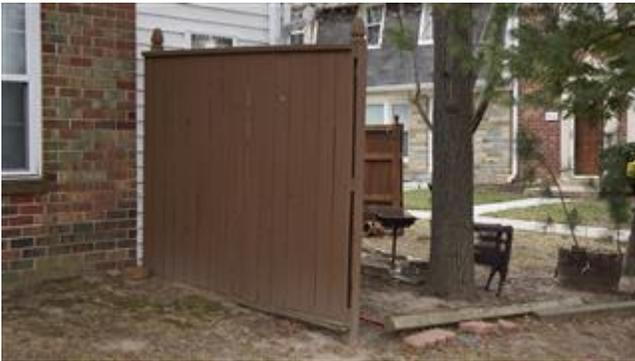
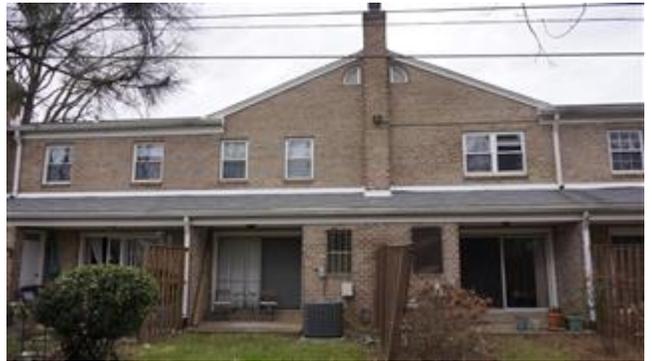
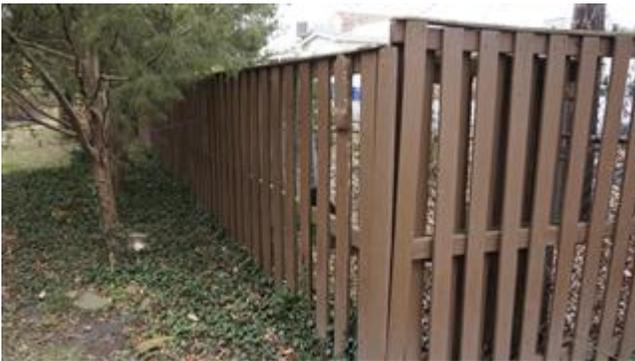
The wood board-on-board fencing is located along portions of the southwest property line, around the play area, at the trash enclosures at each of the 15 buildings, and at privacy fences at certain individual townhouse units. The condition of these various fences varies from good to poor, with rotten components, loose fence posts, and out of plumb sections of fencing noted

Fencing systems have a large number of configurations and finishes that can usually be repaired as a maintenance activity by replacing individual components as they become damaged or weathered.

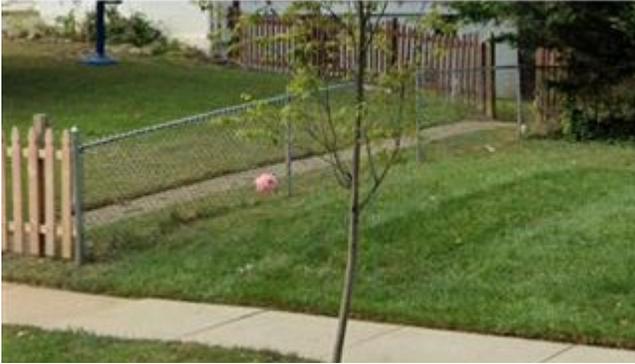
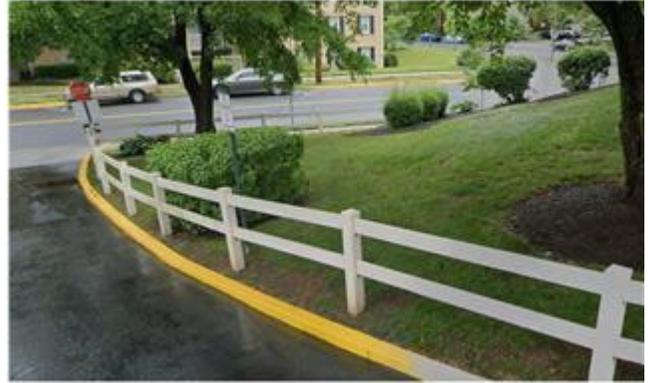
The chain-link fence is located at the south property line of the community adjacent to Lakecrest Drive. This fence appears to be in good condition.

The vinyl 2-rail and post fence is located along Lakecrest Drive and runs up the drive to the parking area at units 7748-7938. This fence appears to be in generally good condition.

Protection from string machine damage during lawn maintenance can extend the useful life of some fence types. Protection from this type of damage is typically provided by applying herbicides around post bases or installing protective sheathing.

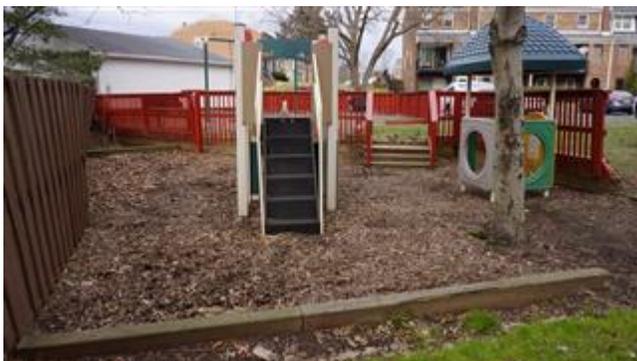
The play structures are in generally good condition with minor wear and a few loose connections noted. The play surface and wood border, including the steps, have reached the end of their economic life and need to be replaced.

Although the wood rail and batten fence and stair rail are in fair condition any repair or replacement of these items would need to be coordinated with the replacement of the wood border to which they are attached.

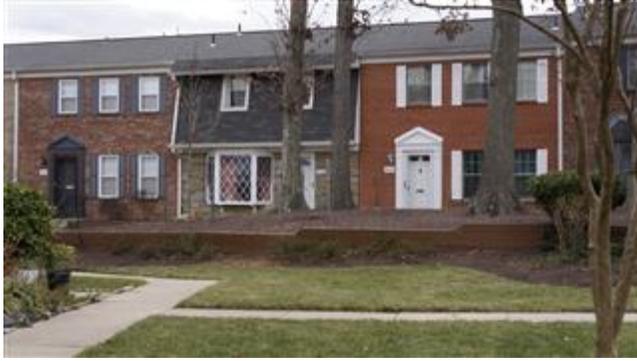
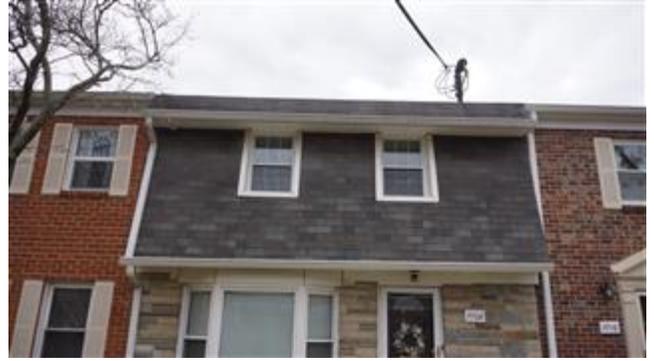
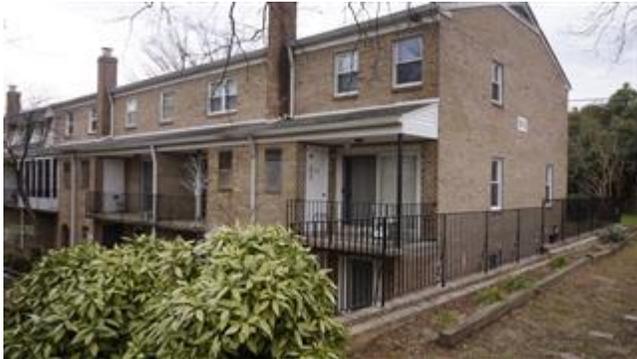
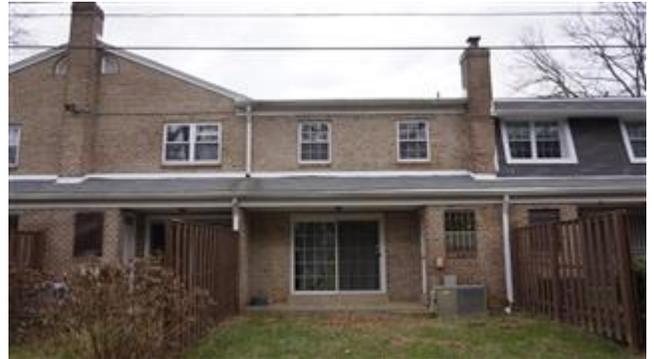
**Building Roofing.** The roofs at all 15 townhouse buildings, the storage/maintenance building, and at each trash enclosure are covered with shingles. According to the Association, these roofs have been replaced with 25-year fiberglass shingles within the last 8 years, with the latest of this replacement completed last year. According to Association documentation, the re-roofing included replacement of ridge vents, vent pipe flashing, aluminum flashing (as necessary), and drip edge flashing. Based upon an inspection of the roof surfaces from ground level, it appears that all roof surfaces and flashings are in good condition, with exceptions noted.

There are roof areas that have become discolored where downspouts from upper roof surfaces discharge onto lower roof surfaces. Although this is unsightly, the performance of the roof surface itself does not appear to be compromised. Organic growth noted on some lower roof surface areas, if not checked, may result in accelerated degradation of these surfaces. Finally, areas are noted where sheet metal counter flashing is excessively deflected from the adjacent roof surface which may allow for the intrusion of water into the roof surface and adjacent wall area.

The 19-year remaining economic life of the roofing is based upon the estimated 25-year warranty minus the eight years which have elapsed since the installation of the initial re-roofing. The future re-roofing of three buildings each is modeled over a five-year period.

Annual inspections are recommended, with cleaning, repair, and mitigation of vegetation performed as needed. Access, inspection, and repair work should be performed by contractors and personnel with the appropriate access equipment who are experienced in the types of roofing used for the facility.

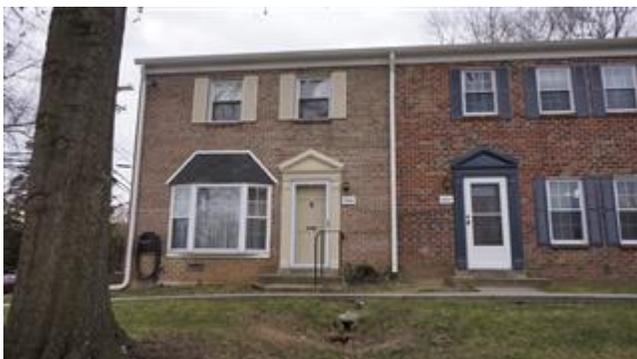
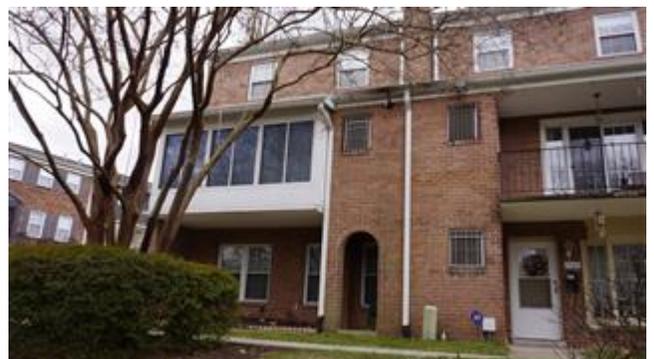
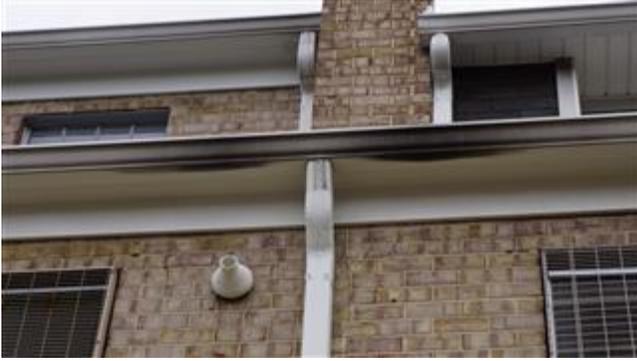
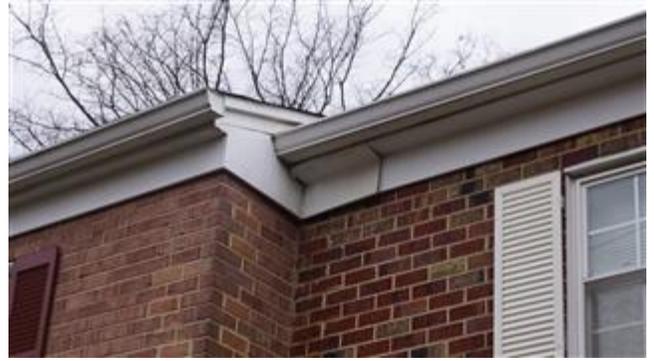
In general, the gutter and downspout systems appear to be functioning in an acceptable manner, although instances of loose connections, bent downspouts, loose flashing, and deterioration of joint sealant are noted. In addition, at locations where splash blocks are not present or where the connection of downspouts to the below-grade drainage piping is loose, erosion is noted. This erosion, if left unchecked, could cause damage to building foundations over time. Finally, there are locations where the water discharge from downspouts at upper roof areas appears to discharge over lower roof areas with such force as to overflow the lower gutter. This overflow could have undesirable effects on the wall and ground surfaces below.

It is recommended that all gutters be cleaned at least twice each year. If there are a large number of trees located close to a building, consider installing a gutter debris shield that will let water into the gutters but will filter out leaves, twigs, and other debris.

It is also recommended that the discharge from the downspouts be extended at least ten feet away from the foundations.

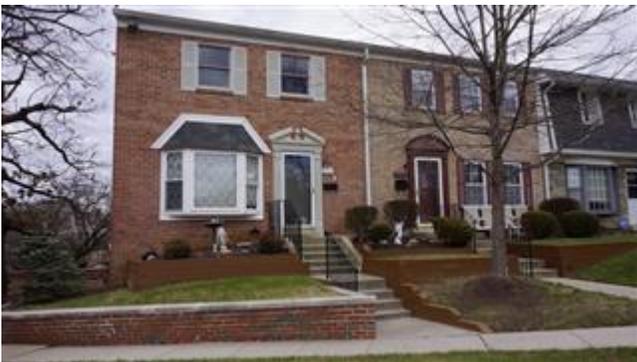
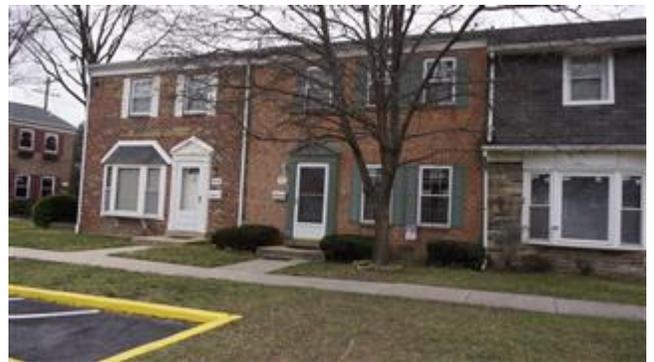
The bay windows appear to be in good serviceable condition. Most of the metal doors to the laundry and storage areas exhibit deterioration in the form of rust, particularly at the lower parts of the metal frames in contact with the concrete slab. In some cases, this deterioration has advanced to the degree that the integrity of the door and frame system is compromised. The remaining economic life of these doors and frames has been adjusted to accommodate this condition.

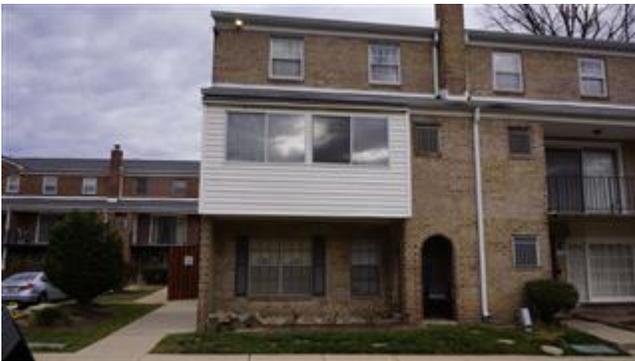
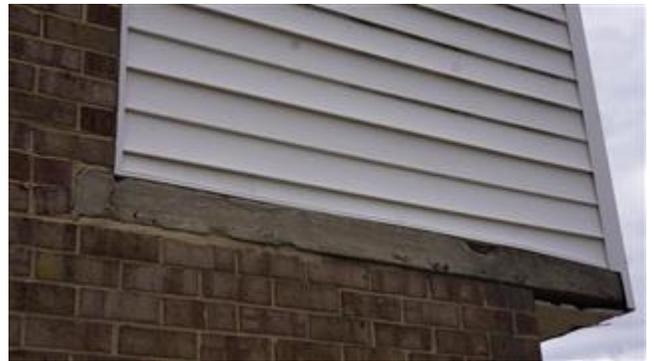
**Siding and Trim.** The Association maintains the exterior siding and trim at both the townhouse buildings and the storage/maintenance building. In general the siding and trim are in fair condition, with loose sections and discoloration due to organic growth noted.

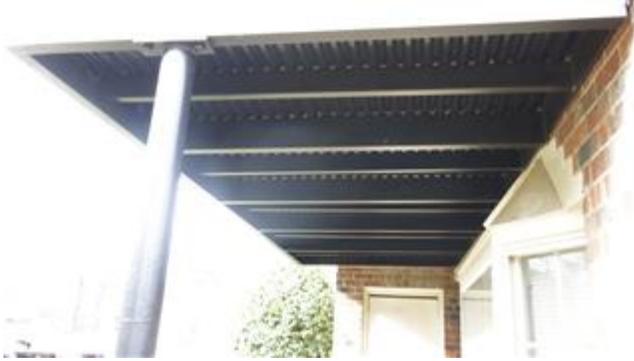
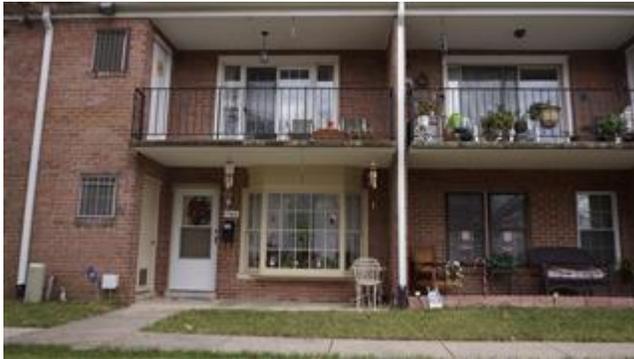
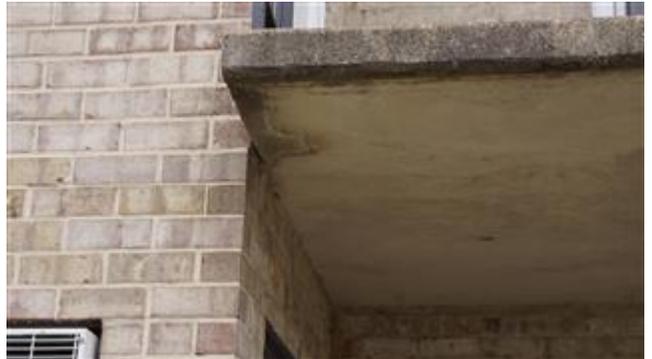
**Concrete Balconies.** The Association maintains the concrete balconies at each of the 15 townhouse buildings. Two types of balcony structures were observed, self-supporting slabs and slabs supported by a metal deck and steel beam and column system. The condition of these balconies, as assessed from the ground level, appears to be generally good, this includes the concrete slabs (visible areas of the bottom surfaces and at the edges), supporting steel column structures, and the wrought iron guard rails. The condition of the balcony surfaces has not been verified.

Based upon casual observation of the visible parts of the decks from the ground it appears that these deck structures exhibit a normal aging process, with some cracking and initial concrete degradation, as well as areas of previous repair noted. However, a detailed observation of the deck structures, guardrails, connections, and other appurtenances has not been made. As it is not the intent of this report to assess the structural integrity of these deck structures, it is recommended that the Association retain the services of a structural engineer to perform a comprehensive inspection of the elevated deck structures and their support systems in order to establish their structural integrity.

MillerDodson strongly recommends that the Association retain the services of a Structural Engineer to conduct thorough and periodic evaluations of the building structure, the balconies, and any other structural features of the community.

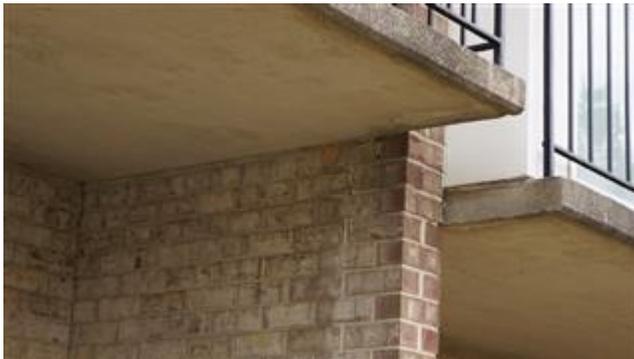
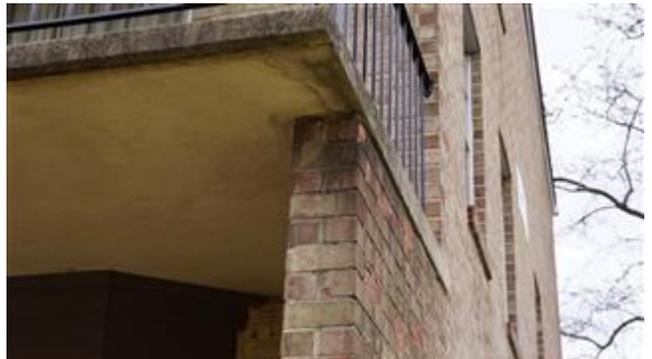
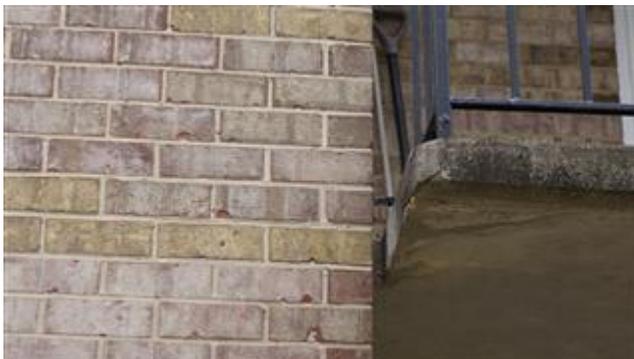
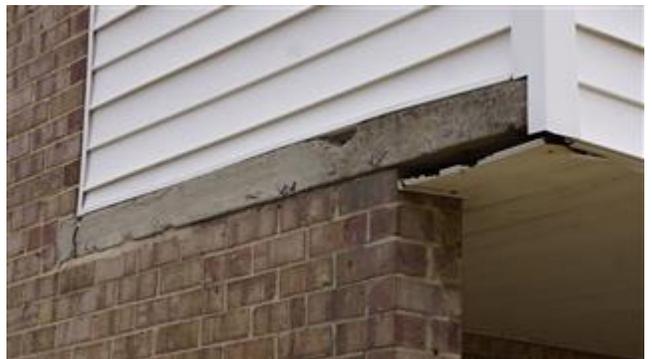
We noted no major defects which appear to be significant, although cracking in the concrete decks near support structures, cracks in supporting brick masonry, and spalling of brick at balcony bearing locations is noted. These defects should be closely monitored to determine if any of these conditions worsen over time.

We recommend for the Association implement an annual inspection and power-washing program. Installation of carpet or other water trapping coverings should be prohibited, and potted plants should be placed on raised feet to allow for proper air circulation and drying.

Additionally, we recommend the application of appropriate sealants or coatings to the top surface and exposed edges of the concrete deck, as well as re-caulking all railing post mounted into the deck slab. The underside of the concrete deck should be left untreated or treated with a breathable finish to allow entrapped moisture to escape.

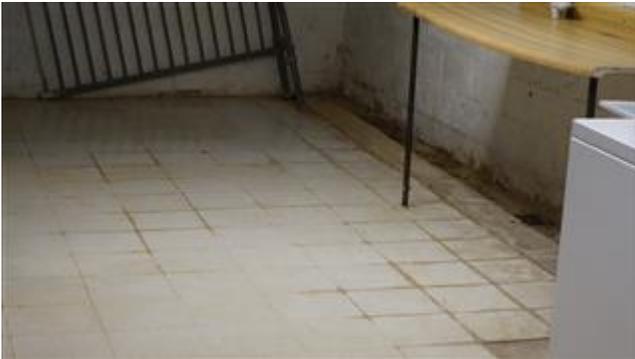
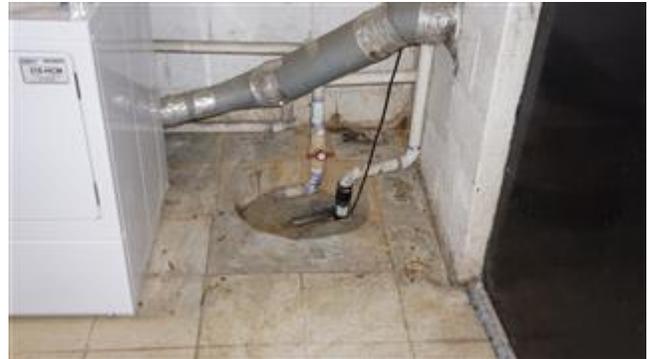
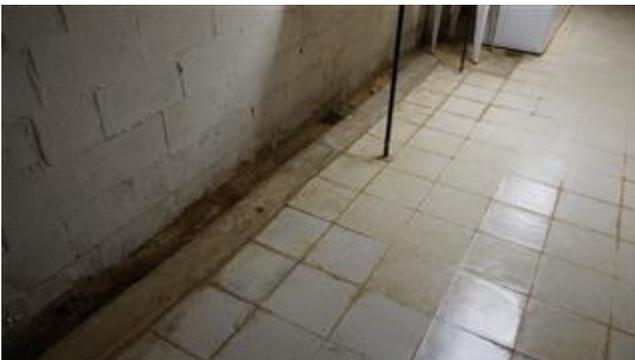
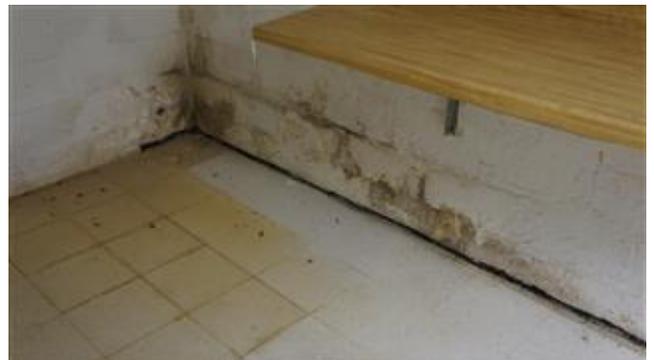
The vinyl flooring tile condition varies from good to rather poor. The latter being the result of the intrusion of water into a few of these rooms, which is causing these tiles to buckle and discolor. Tiles that have become loose have the potential to become tripping hazards. It appears that some type of drainage system has been installed in a few of these spaces in order to divert surface water to sump pits. In some cases, the covers to the sump pit are incorrectly installed which may present a hazard.

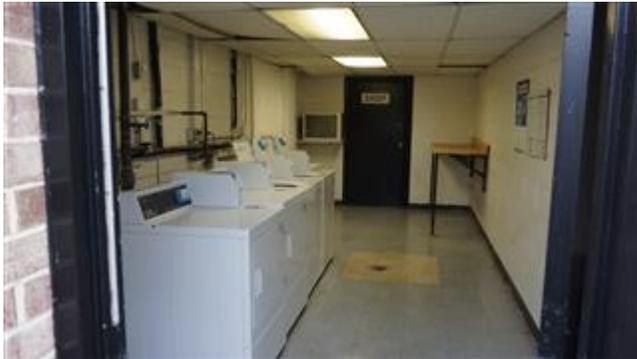
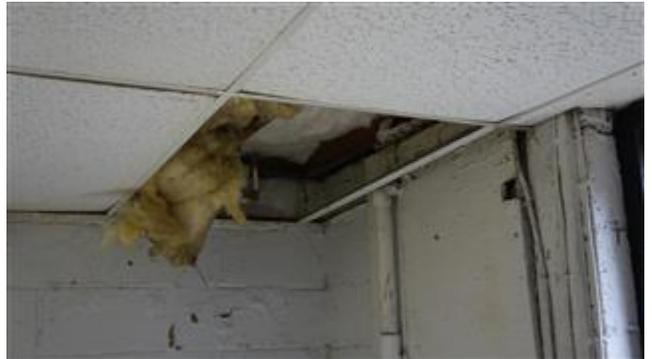
The condition of these ceilings ranges from fair to poor, as numerous instances of loose, missing, stained, and damaged ceiling panels is noted.

It is important that the integrity of these ceilings tile be maintained as it helps to insulate the above spaces to protect piping installed above the tile. Any gaps or missing tile will allow cold air to penetrate the space above the tile, increasing heat loss from the conditioned space increasing the chances of freezing the piping above the tile. We recommend that the tile be inspected in the fall and after any work is completed in the space above the tile.

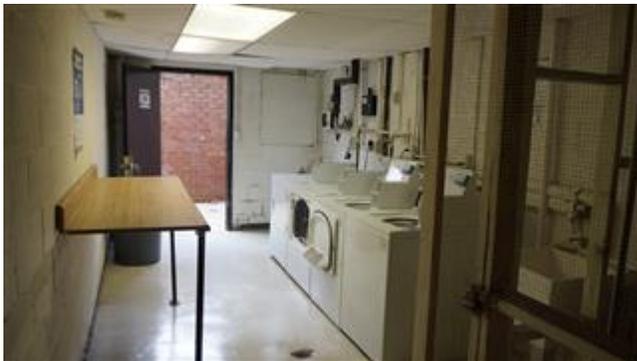
**Interior Lighting:** The Association maintains the interior lighting at the laundry rooms and storage rooms. At the individual laundry rooms, this lighting consists of 2x4 lay-in fluorescent fixtures. At those areas where the laundry rooms and the storage rooms are located in the same space and at the separate storage rooms, the lighting consists of various types, including surface-mounted 2x4 fluorescent lights, incandescent lights, and LED lights.

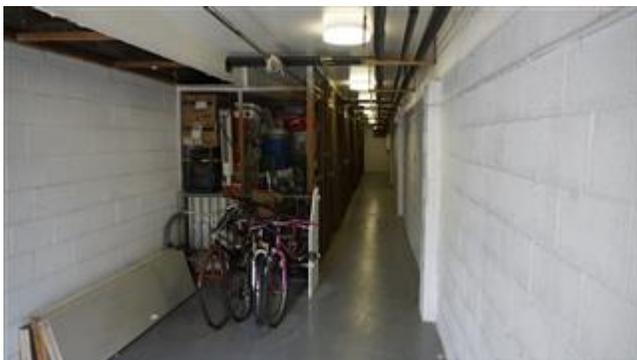
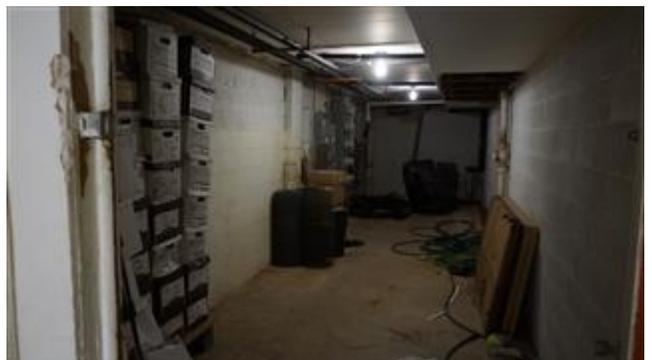
The condition of these light fixtures ranges from good to poor, as some fixtures appear to be newer or have been retrofitted with LED luminaries while others are in poor condition with inoperative luminaries and stained diffusers noted.

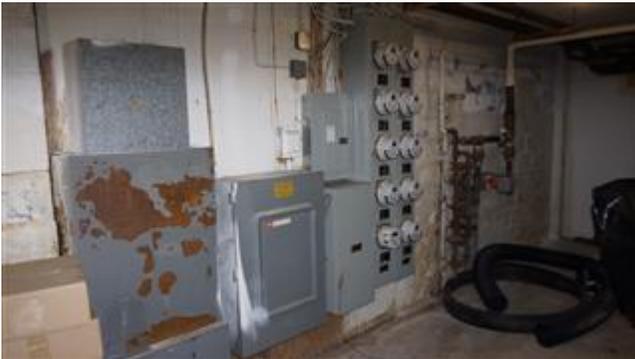
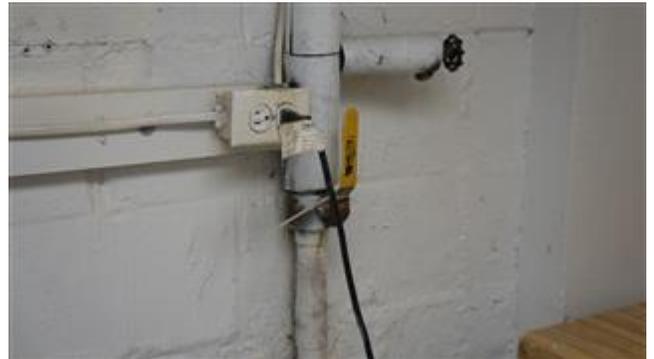
**Building Electrical Service.** The Association maintains the main switchgear at each of the 15 townhouse buildings, as well as the individual distribution panels at each of the 165 units. According to the Association, all electrical panels within all units and in the common areas were replaced in 2019. As a result, it is assumed that all of these replaced systems are in good condition. Stickers visible on some of these panels indicate that they have passed inspection by the authority having jurisdiction.

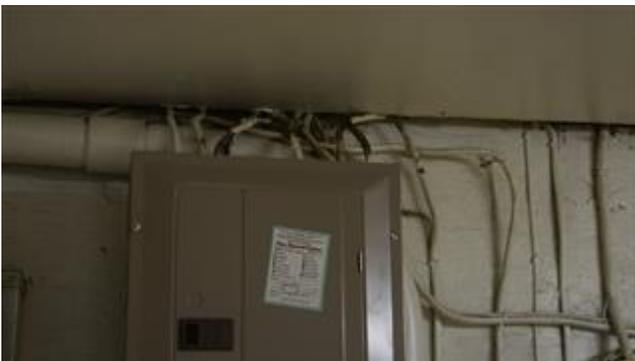
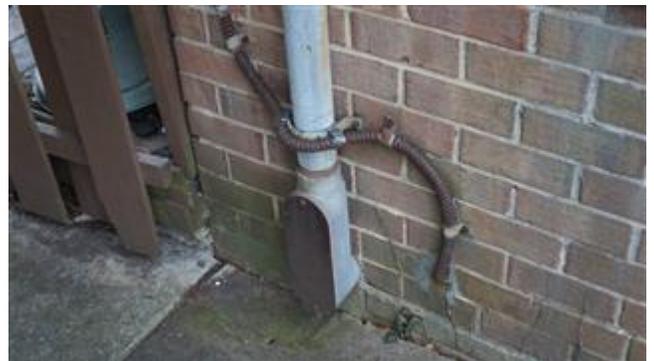
Other components of the overall electrical systems at the buildings appear to be in rather a poor condition. Conditions such as rusting box covers, rusting conduit (some at the exterior), exposed wiring with what appears to be damaged insulation, and improper wiring methods such as cords to sump pumps plugged into what appears to be non-GFI receptacles, were observed. It is recommended that these items be inspected by a licensed electrician to determine if there are any life safety issues associated with these conditions.

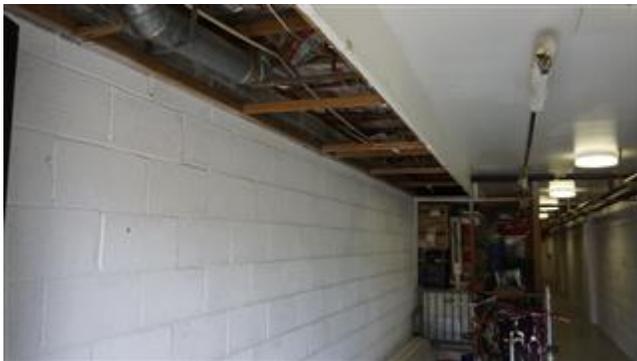
The most notable condition is the many instances where the gypsum board ceilings in various storage rooms have been removed (for what appears to be the installation of piping and/or mechanical venting systems) and not replaced. This has left the above-ceiling space open to the storage room thereby exposing the floor structure of the residential units above. If, as is likely, these ceilings form part of a fire-rated floor-ceiling assembly between the storage areas and the residential units above, the lack of integrity of these systems (due to the missing gypsum board finish) could present a life-safety concern in the event of a fire. It is recommended that the Association have a qualified building inspector render an expert opinion regarding this condition.

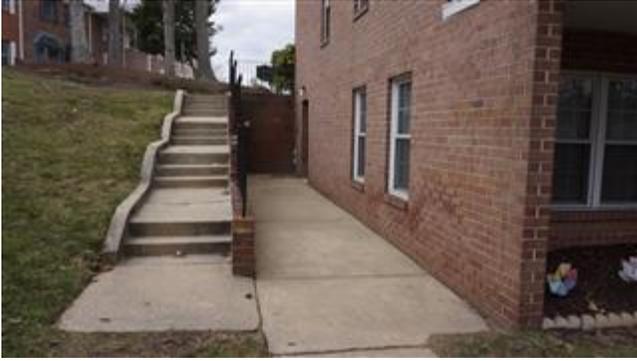
Another item of concern is the lack of handrails at certain stair structures at the site, including steps to concrete stoops at individual units. It is recommended that the Association consider the installation of handrails at these locations, particularly when these stairs are replaced as a part of on-going maintenance activities.

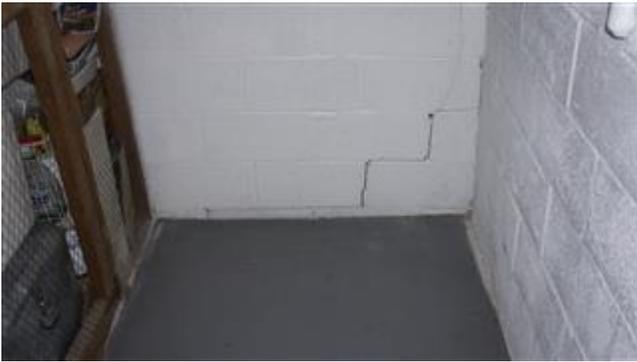
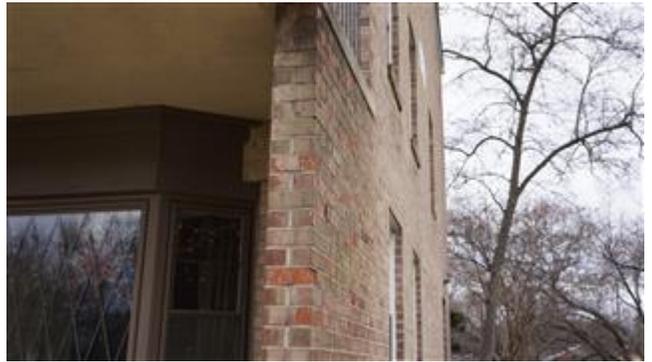
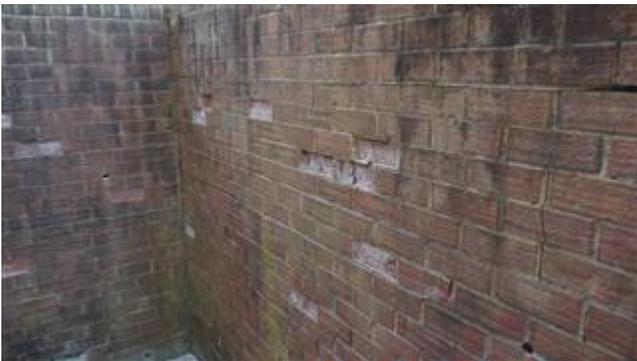
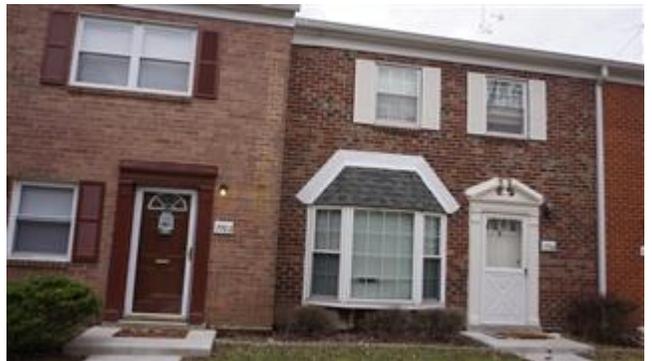
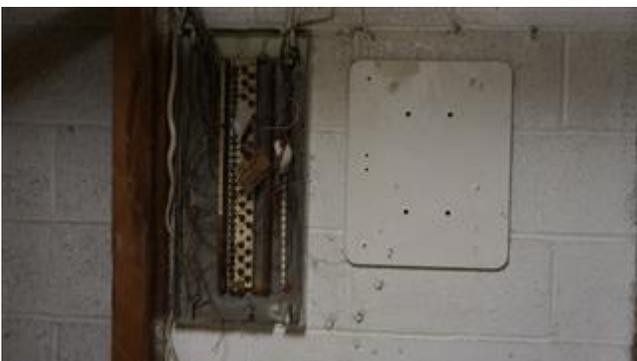
Also noted is the presence of spalling of the brick face at exterior building walls indicating water intrusion into the brick surface and freezing. Other evidence of deterioration in these building walls is loose and missing mortar at brick joints and the discoloration of the brick due to organic growth. Wall areas where brick has been replaced and re-pointed suggest that this is an ongoing issue. Settlement cracking noted at certain interior concrete masonry walls at laundry/storage rooms combined with settlement cracking at concrete slabs exterior to these rooms suggest settlement issues perhaps related to stormwater management problems. It is recommended that these issues be further examined by a qualified building inspector.

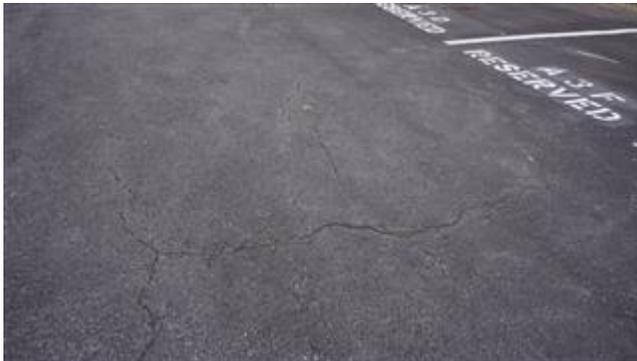
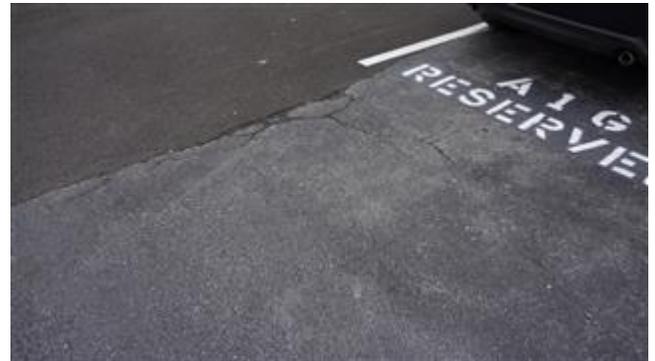
- **Reflective Cracking.** The asphalt pavement has a significant number of reflective cracks. Reflective cracks occur when placing a new asphalt overlay over and existing cracked pavement. With time and movement, existing cracks will migrate through the new asphalt. Installing a bridging membrane or fabric at the time of overlay can control reflective cracking.

As a rule of thumb, asphalt should be overlaid when approximately 5% of the surface area is cracked or otherwise deteriorated. The normal service life of asphalt pavement is typically 18 to 20 years.

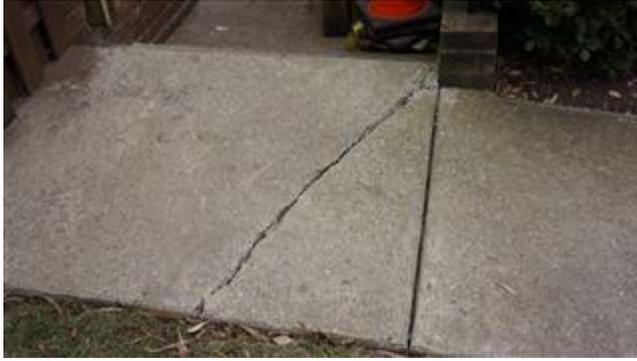
- Trip hazard, ½ inch height difference.
- Severe cracking.
- Severe spalling and scale.
- Uneven riser heights on steps.
- Steps with risers in excess of 8¼ inches.

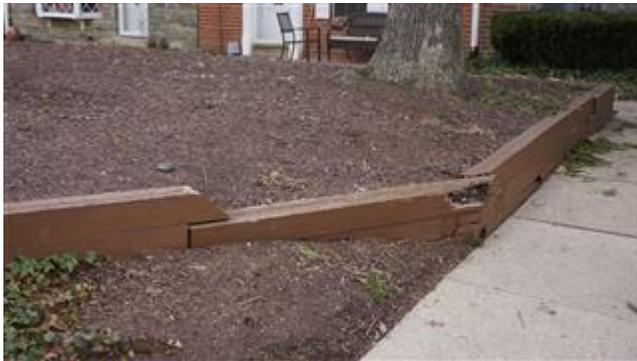
The treated wood retaining walls located throughout the property are mostly in poor condition with numerous instances of rotting and loose connections noted.
