# LEVEL 2 REPLACEMENT RESERVE REPORT FY 2022 CHARLESTOWNE VILLAGE

## CHARLESTOWNE VILLAGE

GREENBELT, MARYLAND

December 28, 2021

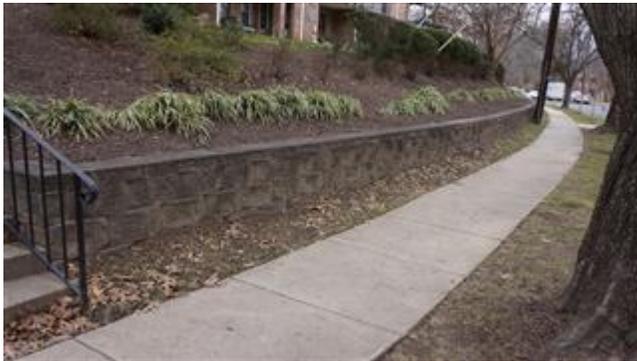
The poured concrete retaining walls, located along concrete stairways and adjacent to certain sidewalk areas, are in good general condition with minor cracking noted.

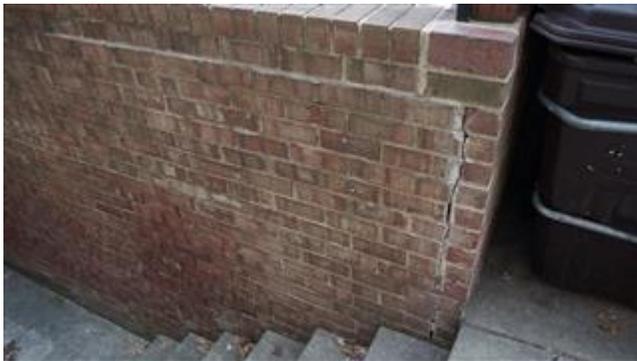
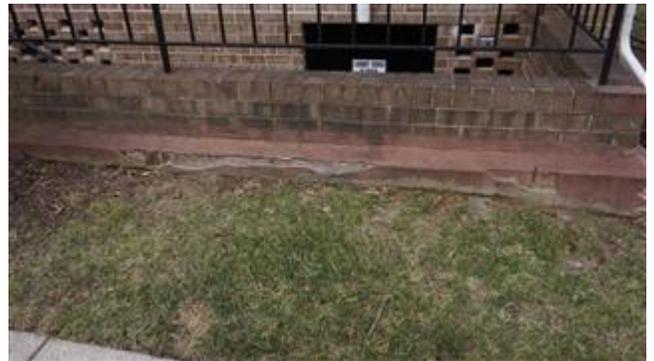
The brick retaining walls are primarily located at the below-grade accessways to the laundry rooms and storage rooms at either end of each of 12 buildings and at one end of three buildings. The condition of these walls varies from good to poor, with the primary deficiencies being loose and missing mortar, loose and missing brickwork, loose and deteriorating brickwork at metal railing bases, through-wall cracking, and deterioration of surface parging.

Retaining wall replacement can be costly, and early planning on the part of the Association can help to reduce the impact of this work on the community's budget in the future. We, therefore, recommend having a Professional Engineer inspect the walls and develop preliminary replacement alternatives and recommendations based on the site conditions, replacement costs, and recommended replacement wall types. This information can then be incorporated into future updates to the Reserve Study.

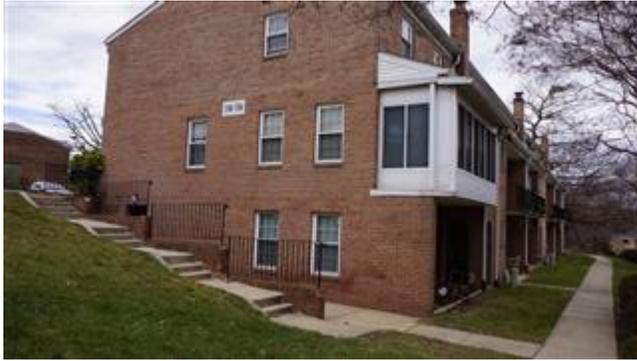
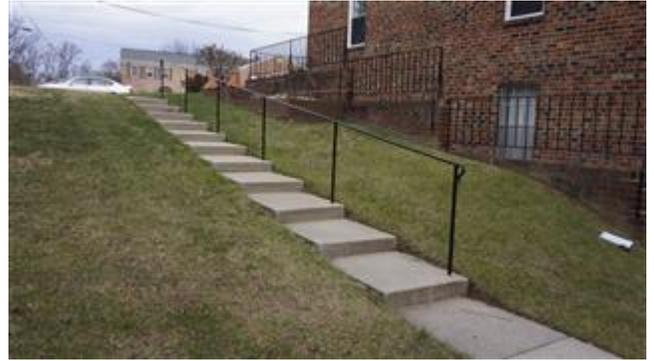
**Metal Hand Railing and Guardrails.** The Association maintains metal handrails, guardrails, and railing posts that are embedded in concrete or masonry, throughout the community. These handrails include free-standing rail systems, railings mounted to walls along stairways, guardrails at the top perimeter of retaining walls, and guard rails at the edges of the elevated balcony structures. These railings are generally in good condition and appear to be well-maintained by the Association although a number of deficiencies are noted. Most deficiencies are associated with the stability of the post bases mounted in the brick masonry retaining walls due to either rust corrosion or loose and broken brick. These conditions could compromise the stability of the associated railing system thereby creating a potential hazard.

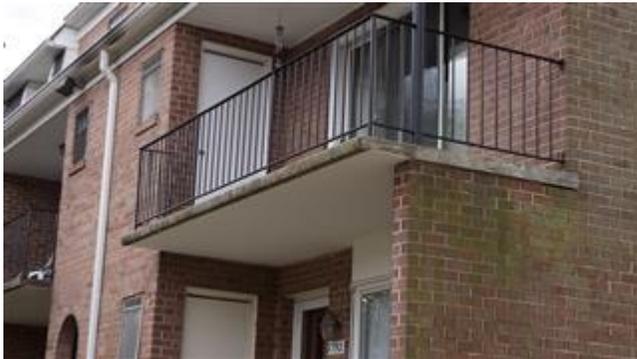
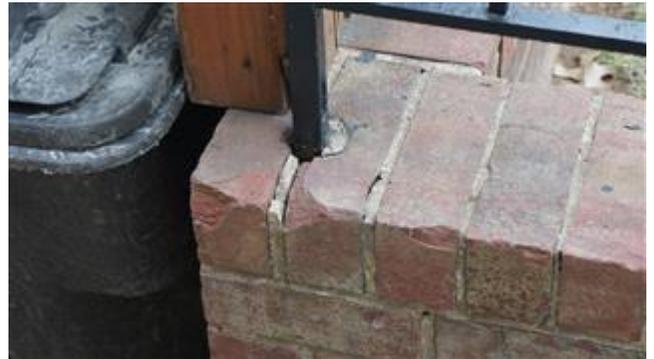
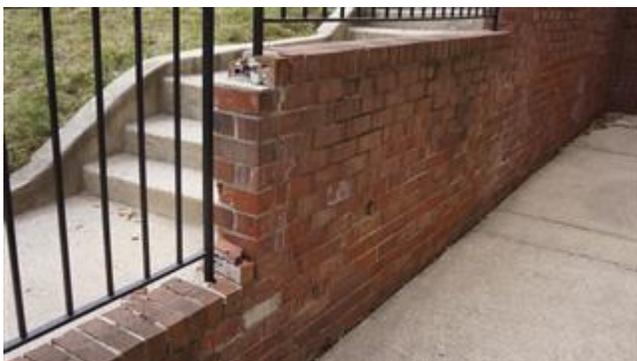
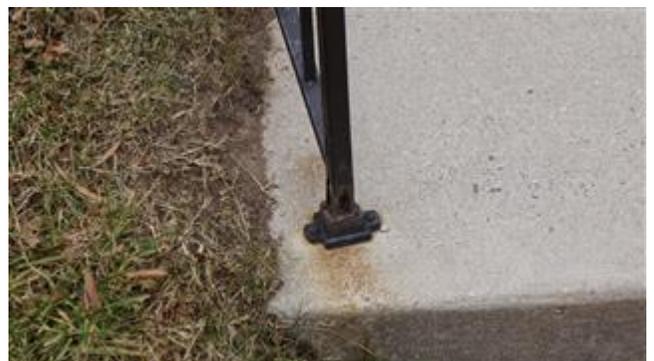
It is noted that as the condition of the railings at the elevated balconies was assessed by inspection from the ground level only, the actual condition of these railings has not been determined. As noted for the concrete balcony structures, it is recommended that the Association retain the services of a structural engineer to perform a comprehensive inspection of the elevated deck structures, including the guardrails. and their support systems in order to establish their structural integrity.

- Lift or remove ornamental base covers, if applicable.
- Remove existing caulk completely.
- Fully clean, prime, and paint all posts, rails, and pickets.
- Apply an appropriate caulk around each post base.
- Tool and shape caulking to shed water from the post.
- Reinstall base covers, and seal and paint all joints.

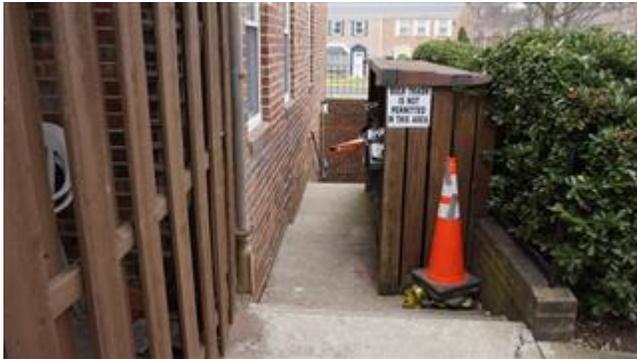
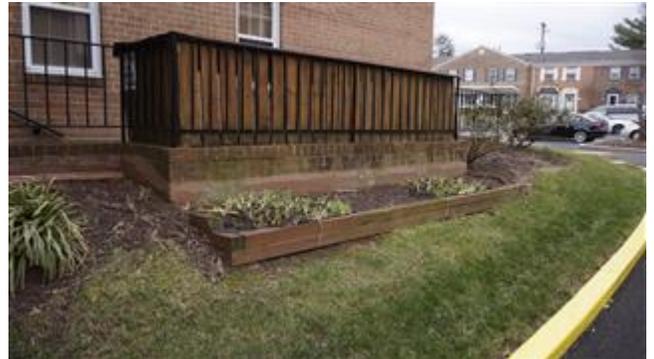
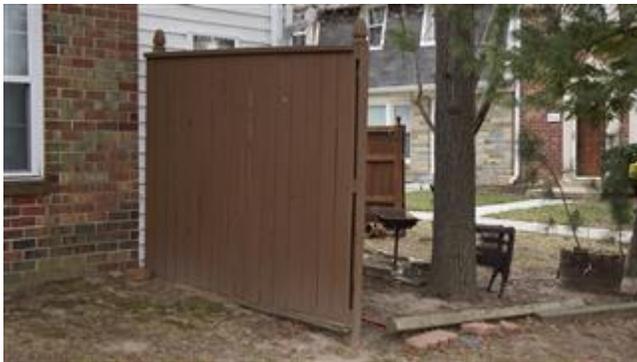
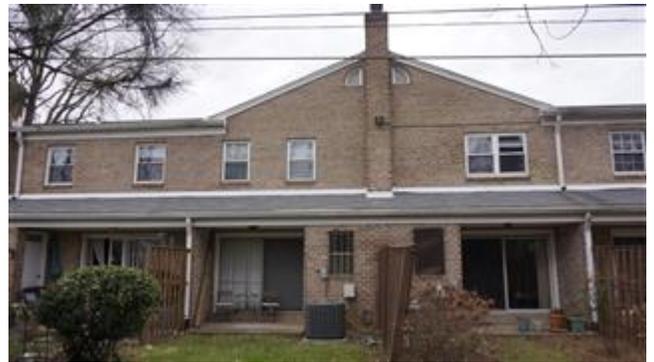
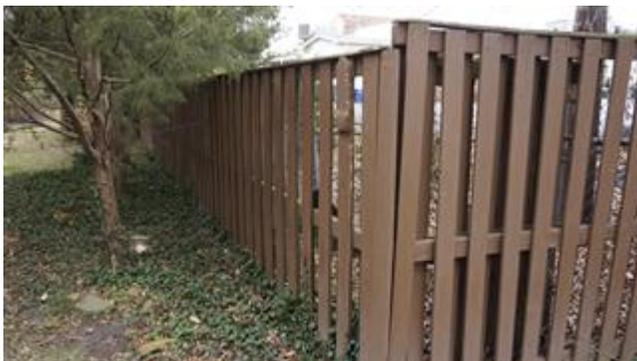
The wood board-on-board fencing is located along portions of the southwest property line, around the play area, at the trash enclosures at each of the 15 buildings, and at privacy fences at certain individual townhouse units. The condition of these various fences varies from good to poor, with rotten components, loose fence posts, and out of plumb sections of fencing noted.

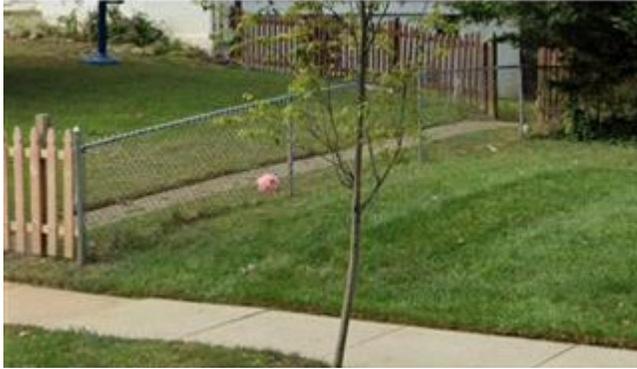
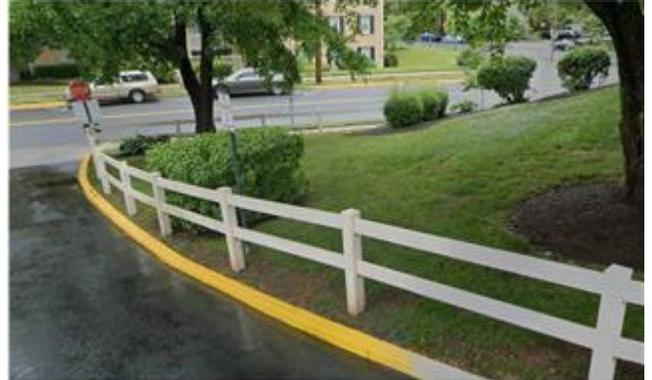
The vinyl 2-rail and post fence is located along Lakecrest Drive and runs up the drive to the parking area at units 7748-7938. This fence appears to be in generally good condition.

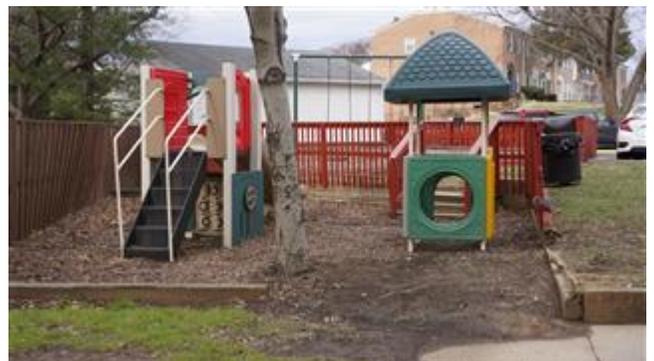
The play structures are in generally good condition with minor wear and a few loose connections noted. The play surface and wood border, including the steps, have reached the end of their economic life and need to be replaced.

Although the wood rail and batten fence and stair rail are in fair condition any repair or replacement of these items would need to be coordinated with the replacement of the wood border to which they are attached.

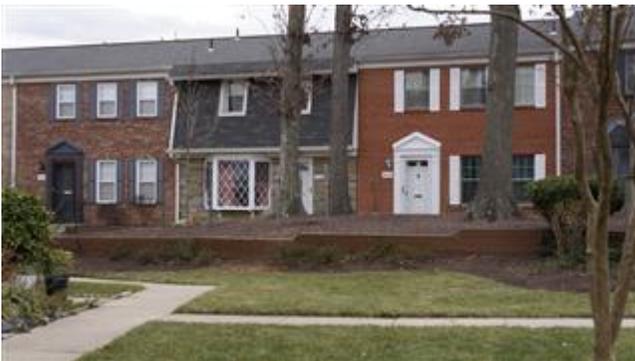
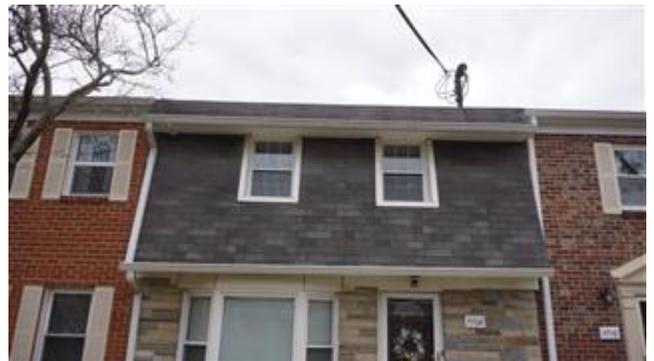
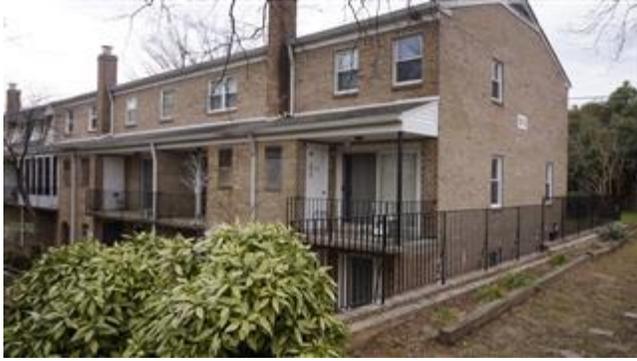
**Building Roofing.** The roofs at all 15 townhouse buildings, the storage/maintenance building, and at each trash enclosure are covered with shingles. According to the Association, these roofs have been replaced with 25-year fiberglass shingles within the last 8 years, with the latest of this replacement completed last year. According to Association documentation, the re-roofing included replacement of ridge vents, vent pipe flashing, aluminum flashing (as necessary), and drip edge flashing. Based upon an inspection of the roof surfaces from ground level, it appears that all roof surfaces and flashings are in good condition, with exceptions noted.

There are roof areas that have become discolored where downspouts from upper roof surfaces discharge onto lower roof surfaces. Although this is unsightly, the performance of the roof surface itself does not appear to be compromised. Organic growth noted on some lower roof surface areas, if not checked, may result in accelerated degradation of these surfaces. Finally, areas are noted where sheet metal counter flashing is excessively deflected from the adjacent roof surface which may allow for the intrusion of water into the roof surface and adjacent wall area.

Annual inspections are recommended, with cleaning, repair, and mitigation of vegetation performed as needed. Access, inspection, and repair work should be performed by contractors and personnel with the appropriate access equipment who are experienced in the types of roofing used for the facility.

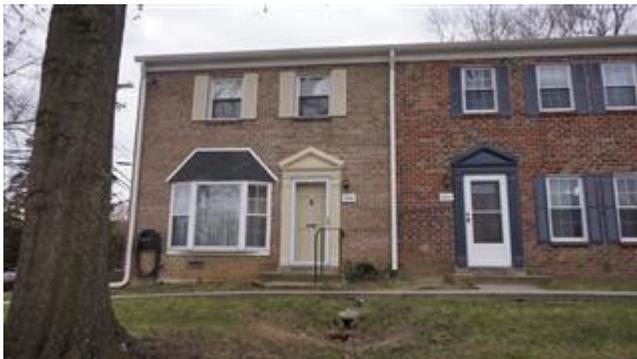
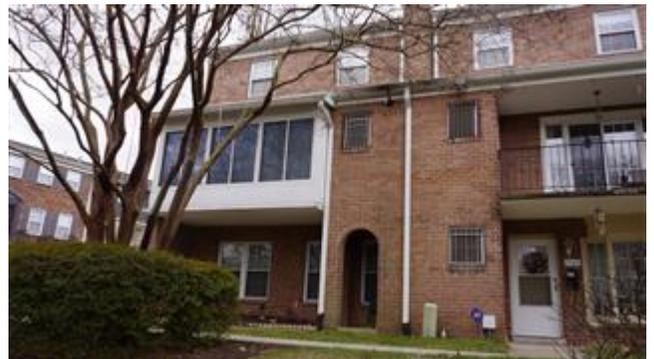
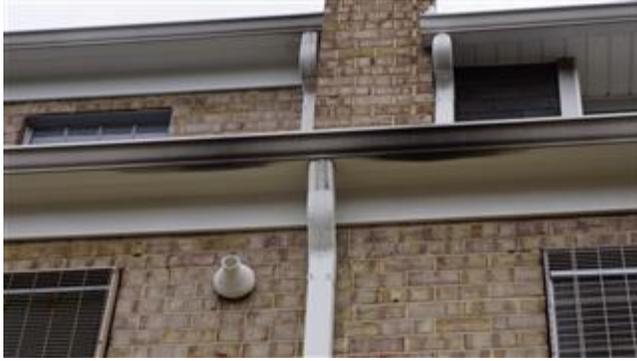
In general, the gutter and downspout systems appear to be functioning in an acceptable manner, although instances of loose connections, bent downspouts, loose flashing, and deterioration of joint sealant are noted. In addition, at locations where splash blocks are not present or where the connection of downspouts to the below-grade drainage piping is loose, erosion is noted. This erosion, if left unchecked, could cause damage to building foundations over time. Finally, there are locations where the water discharge from downspouts at upper roof areas appears to discharge over lower roof areas with such force as to overflow the lower gutter. This overflow could have undesirable effects on the wall and ground surfaces below.

It is recommended that all gutters be cleaned at least twice each year. If there are a large number of trees located close to a building, consider installing a gutter debris shield that will let water into the gutters but will filter out leaves, twigs, and other debris.

It is also recommended that the discharge from the downspouts be extended at least ten feet away from the foundations.

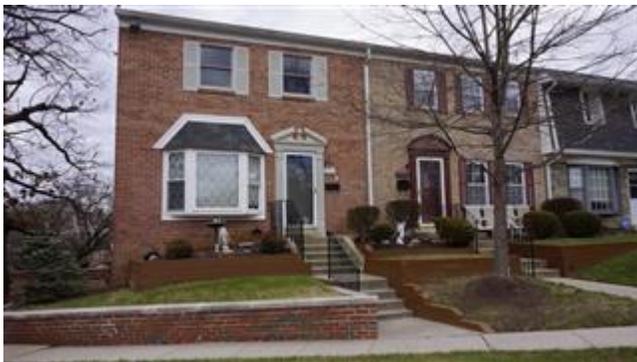
The bay windows appear to be in good serviceable condition. Most of the metal doors to the laundry and storage areas exhibit deterioration in the form of rust, particularly at the lower parts of the metal frames in contact with the concrete slab. In some cases, this deterioration has advanced to the degree that the integrity of the door and frame system is compromised. The remaining economic life of these doors and frames has been adjusted to accommodate this condition.

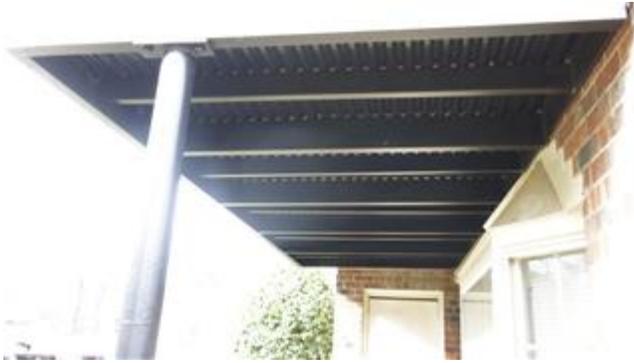
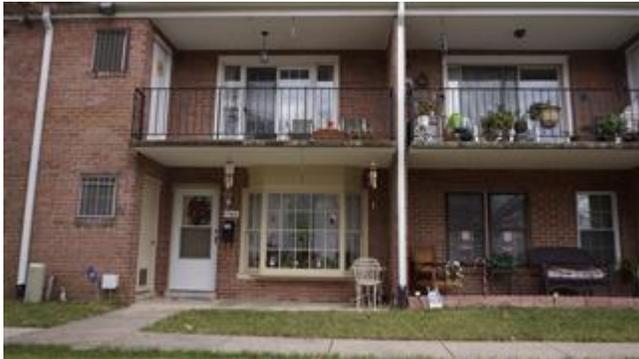
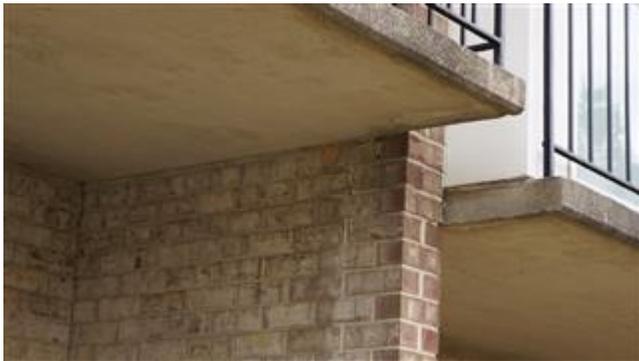
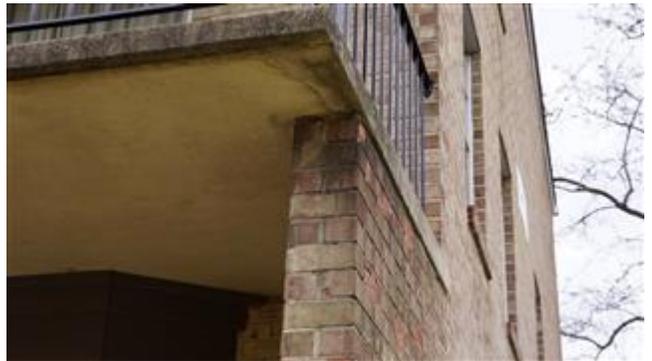
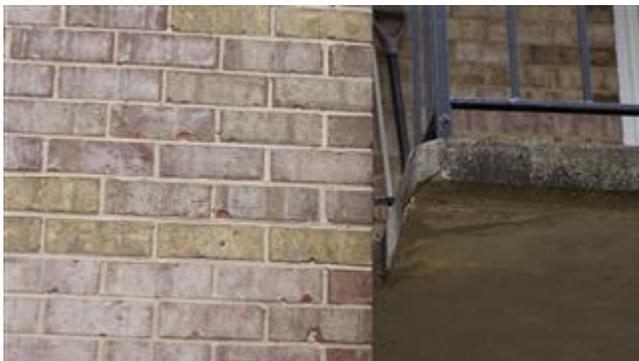
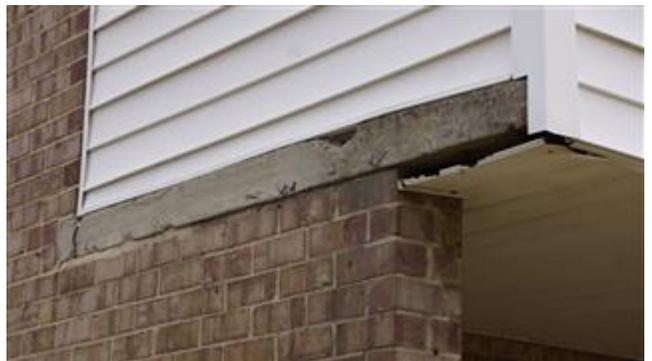
Based upon casual observation of the visible parts of the decks from the ground it appears that these deck structures exhibit a normal aging process, with some cracking and initial concrete degradation, as well as areas of previous repair noted. However, a detailed observation of the deck structures, guardrails, connections, and other appurtenances has not been made. As it is not the intent of this report to assess the structural integrity of these deck structures, it is recommended that the Association retain the services of a structural engineer to perform a comprehensive inspection of the elevated deck structures and their support systems in order to establish their structural integrity.

We noted no major defects which appear to be significant, although cracking in the concrete decks near support structures, cracks in supporting brick masonry, and spalling of brick at balcony bearing locations is noted. These defects should be closely monitored to determine if any of these conditions worsen over time.

MillerDodson strongly recommends that the Association retain the services of a Structural Engineer to conduct thorough and periodic evaluations of the building structure, the balconies, and any other structural features of the community.

We recommend for the Association implement an annual inspection and power-washing program. Installation of carpet or other water trapping coverings should be prohibited, and potted plants should be placed on raised feet to allow for proper air circulation and drying.

Additionally, we recommend the application of appropriate sealants or coatings to the top surface and exposed edges of the concrete deck, as well as recaulking all railing post mounted into the deck slab. The underside of the concrete deck should be left untreated or treated with a breathable finish to allow entrapped moisture to escape.

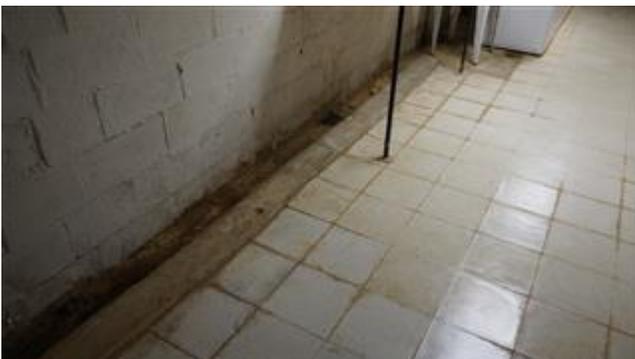
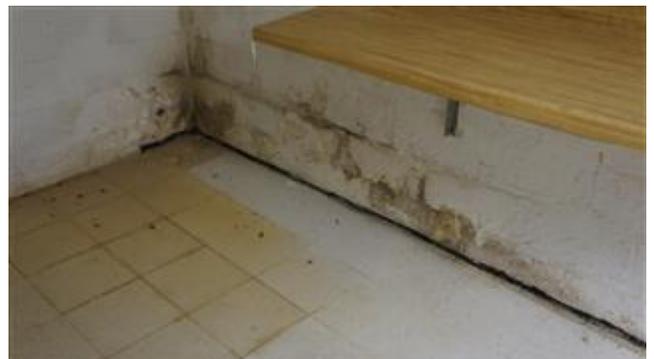
The vinyl flooring tile condition varies from good to rather poor. The latter being the result of the intrusion of water into a few of these rooms, which is causing these tiles to buckle and discolor. Tiles that have become loose have the potential to become tripping hazards. It appears that some type of drainage system has been installed in a few of these spaces in order to divert surface water to sump pits. In some cases, the covers to the sump pit are incorrectly installed which may present a hazard.

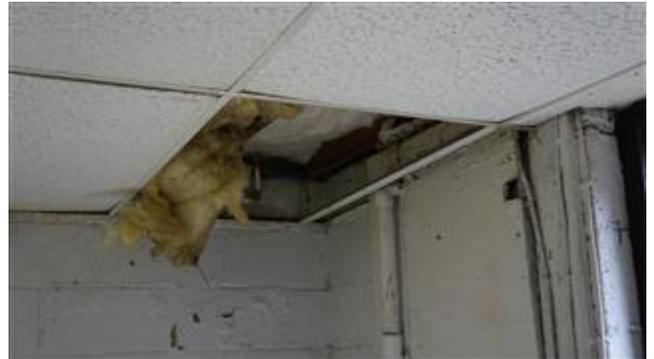
The condition of these ceilings ranges from fair to poor, as numerous instances of loose, missing, stained, and damaged ceiling panels is noted.

It is important that the integrity of these ceilings tile be maintained as it helps to insulate the above spaces to protect piping installed above the tile. Any gaps or missing tile will allow cold air to penetrate the space above the tile, increasing heat loss from the conditioned space increasing the chances of freezing the piping above the tile. We recommend that the tile be inspected in the fall and after any work is completed in the space above the tile.

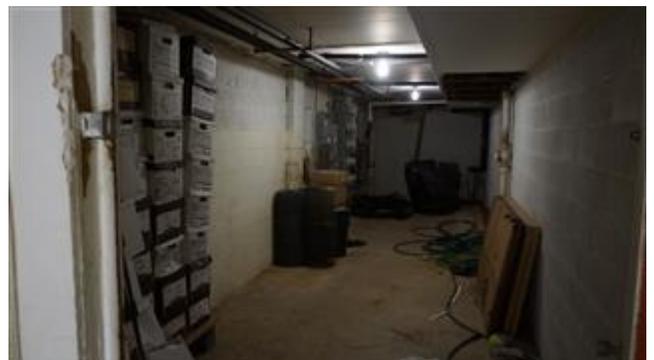
The condition of these light fixtures ranges from good to poor, as some fixtures appear to be newer or have been retrofitted with LED luminaires while others are in poor condition with inoperative luminaires and stained diffusers noted.

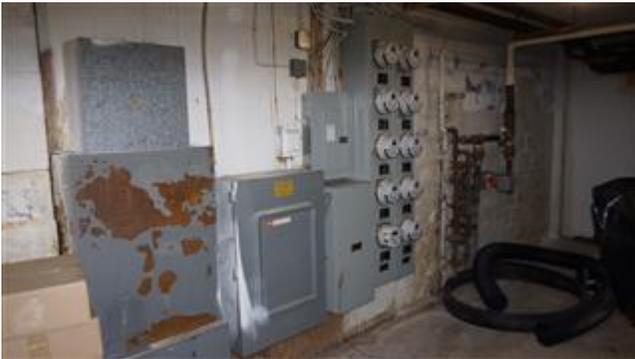
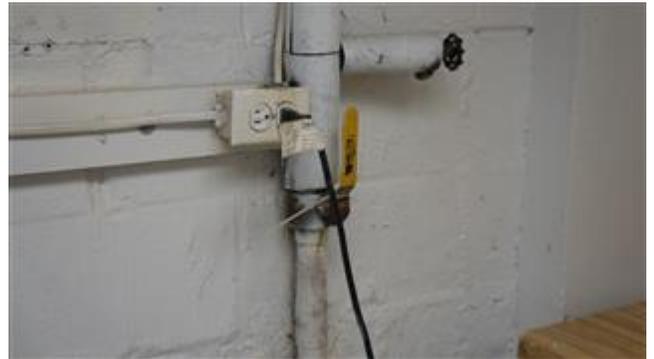
**Building Electrical Service.** The Association maintains the main switchgear at each of the 15 townhouse buildings, as well as the individual distribution panels at each of the 165 units. According to the Association, all electrical panels within all units and in the common areas were replaced in 2019. As a result, it is assumed that all of these replaced systems are in good condition. Stickers visible on some of these panels indicate that they have passed inspection by the authority having jurisdiction.

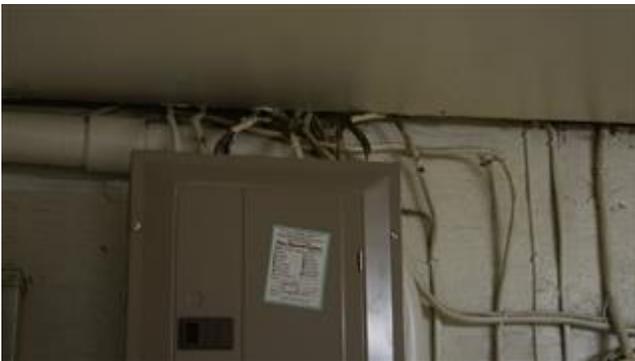
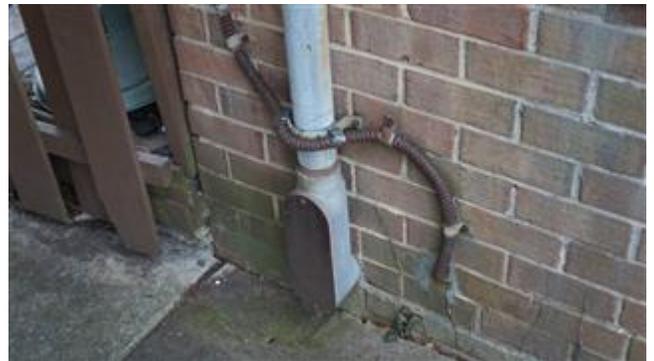
Other components of the overall electrical systems at the buildings appear to be in rather a poor condition. Conditions such as rusting box covers, rusting conduit (some at the exterior), exposed wiring with what appears to be damaged insulation, and improper wiring methods such as cords to sump pumps plugged into what appears to be non-GFI receptacles, were observed. It is recommended that these items be inspected by a licensed electrician to determine if there are any life safety issues associated with these conditions.
