# Property Inspection Report

**Inspection Date: 01/04/2024.**

**Report #: 010424DW2.**

**1215 Alligator Dr.  
Alligator Point, FL 32346.**

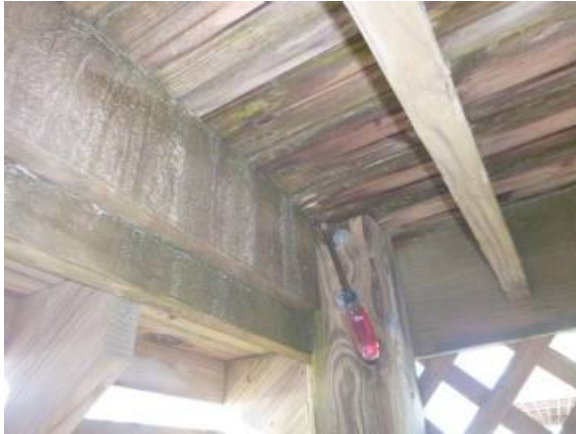
3. Minor wood rot noted below the rear porch entry steps upper landing.

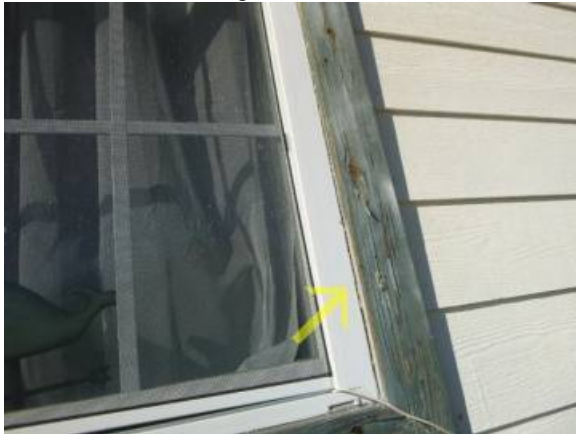
7. Recommend sealing the transition from the trim to the windows.

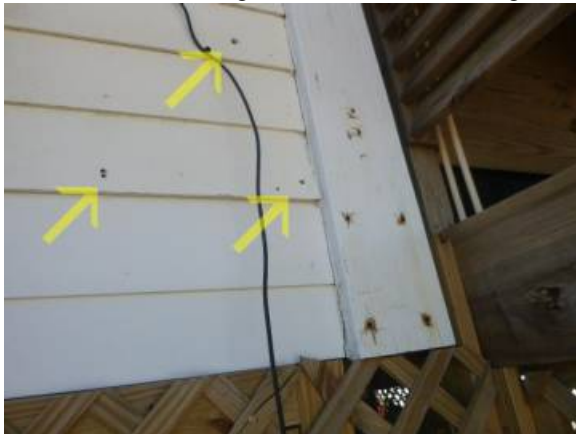
8. Recommend sealing holes noted in the siding as needed.

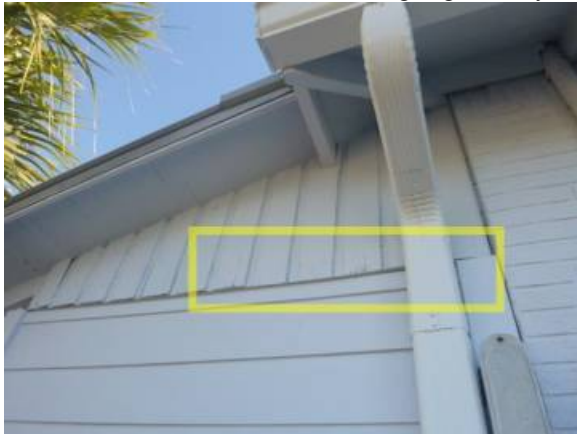
12. Wood rot noted on exterior siding: right side yard front upper siding.

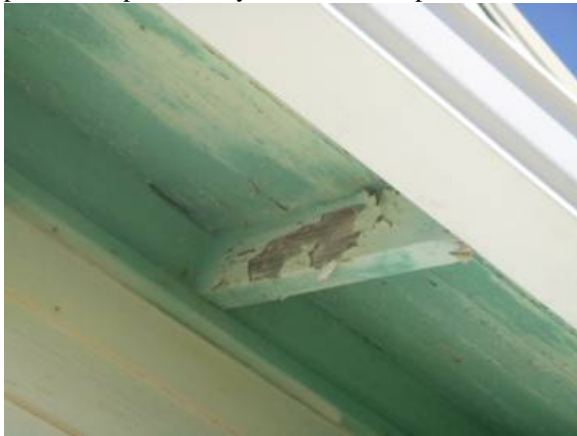
15. Paint on exterior trim is deteriorated and peeling in various areas. Home was built prior to 1978. Care should be taken to insure that all lead base paint safety practices required by the Environmental Protection Agency are followed. Testing for the presence of lead base paint is beyond the scope of this inspection. Recommend a full lead base paint inspection be performed prior to any disturbance of painted surfaces.

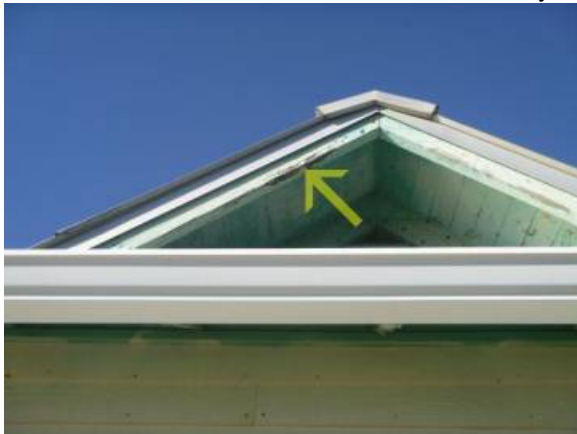
16. Wood rot noted on the exterior trim: left side yard upper gable end fascia framing.

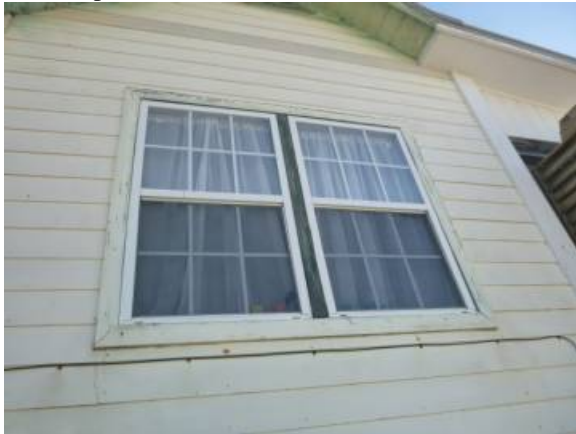
18. The paint and finish on the exterior window trim is missing/deteriorated on the right side yard.

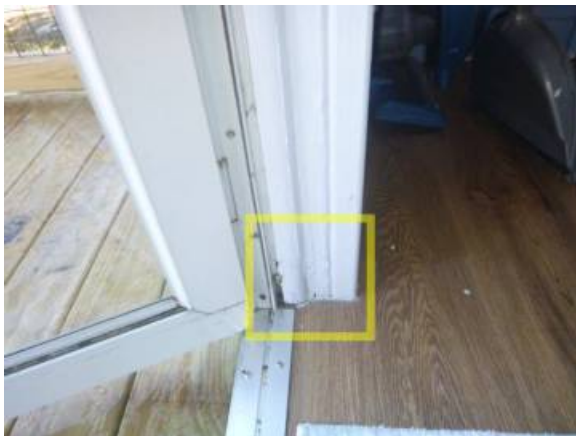
19. Wood rot noted on the exterior trim: front storm door entry frame/jamb.

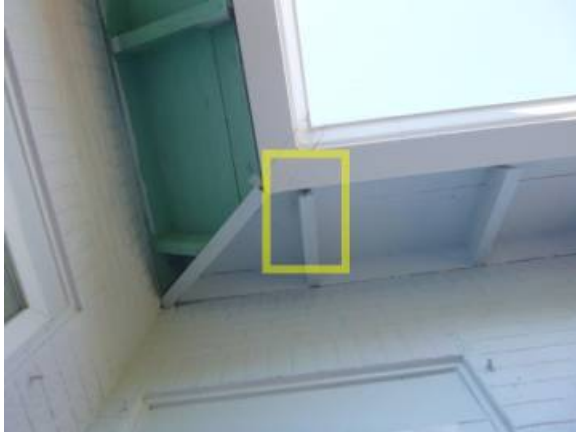
21. Wood rot/possible WDO damage noted on the rafter tail above the AC areas.

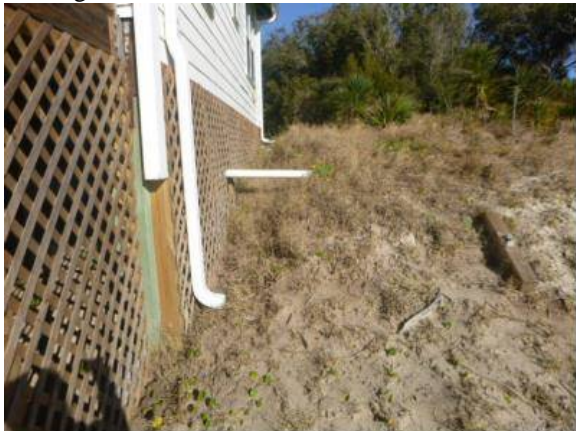
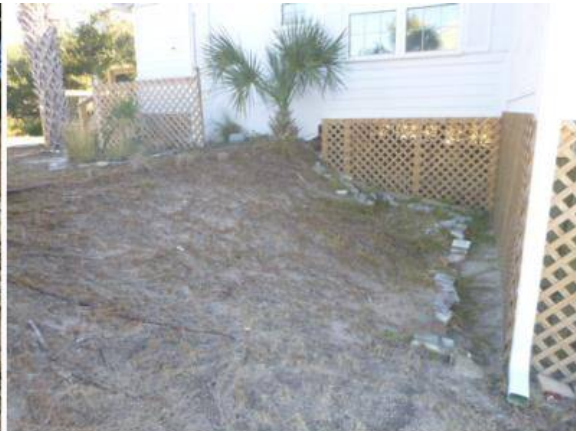
22. The grade along the foundation is improperly sloped toward the structure at the front and both sides of the house. Recommend re-grading to establish proper water flow away from the structure. Moisture intrusion and evidence of water flowing under the house noted.

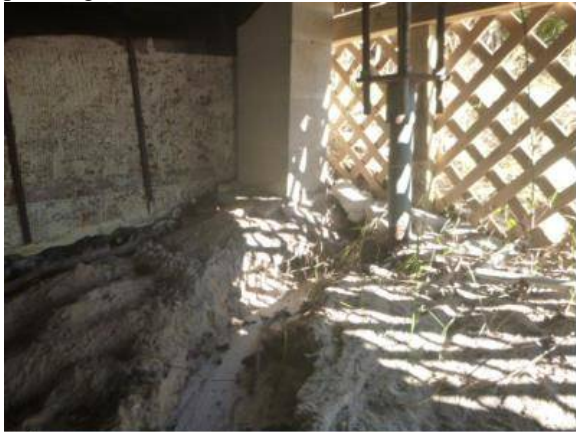
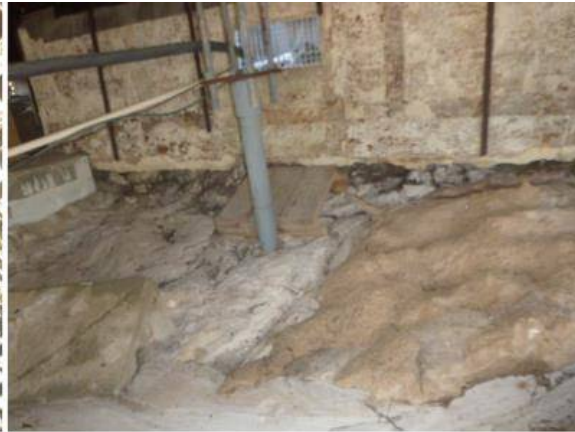
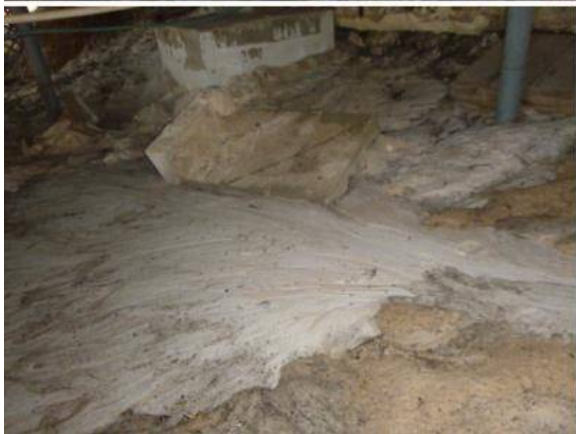
24. Water intrusion noted on the front foundation wall and left side yard grade. Recommend further evaluation by a water proofing contractor.

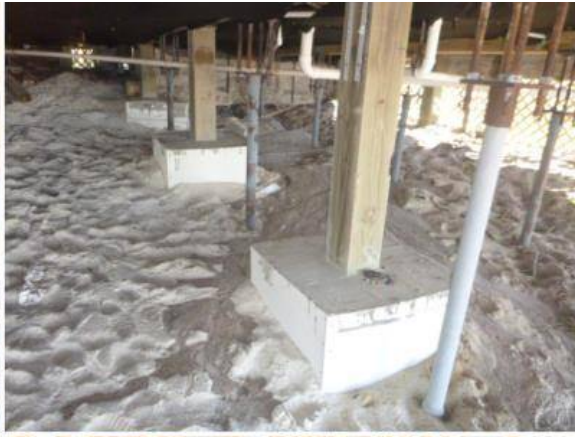
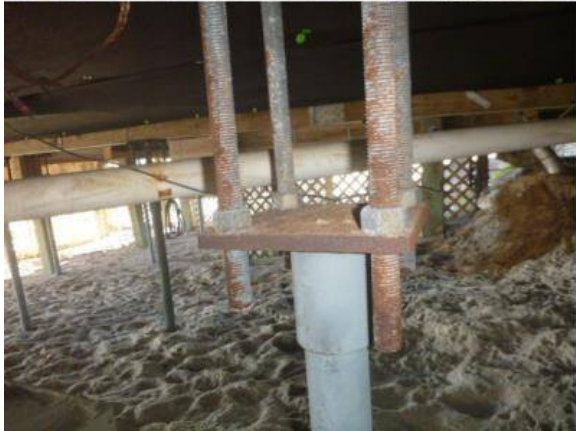
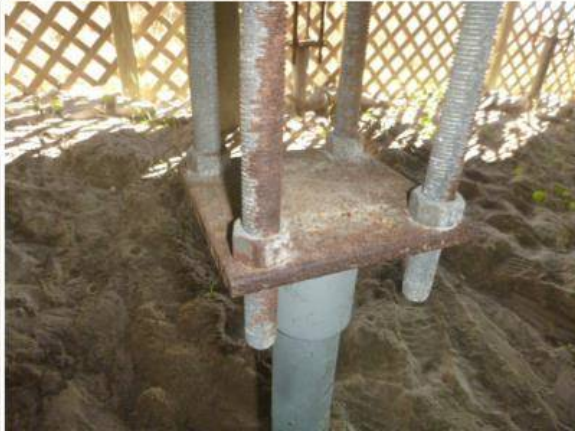
30. Same: Added metal supports appear to have some rust/corrosion. Recommend consulting foundation company who installed the supports on repairs/recommendations on corrosion since installation.

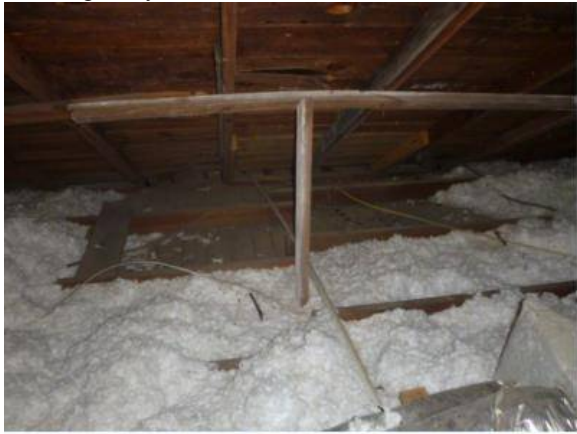
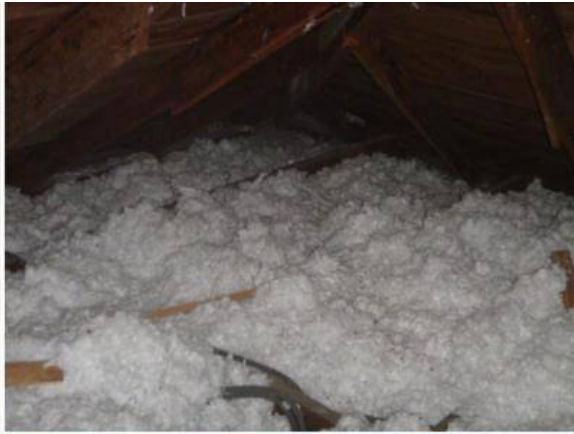
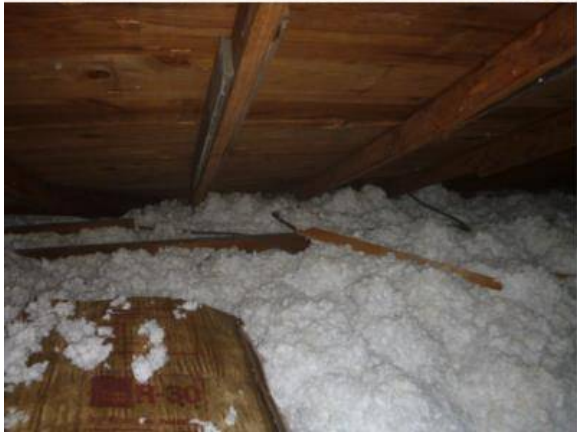
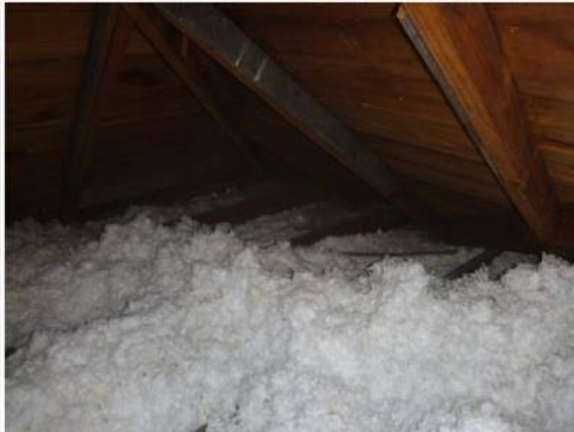
36. Insulation is somewhat disturbed/compacted and the true R-factor at this point in time may be substantially less than that originally installed. Installation of additional insulation is recommended.

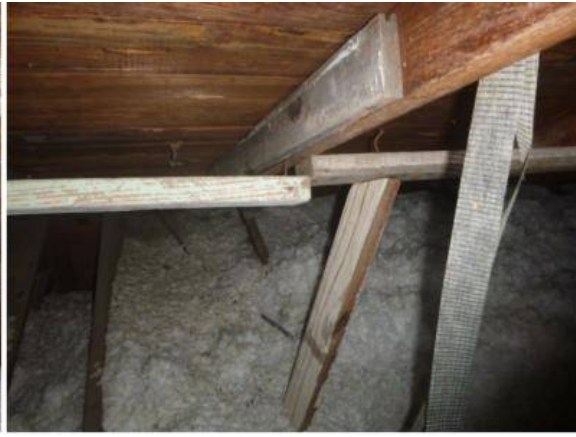
37. Some hip ridges appears to have slight sags from missing or damaged bracing. Recommend further evaluations by a licensed contractor.

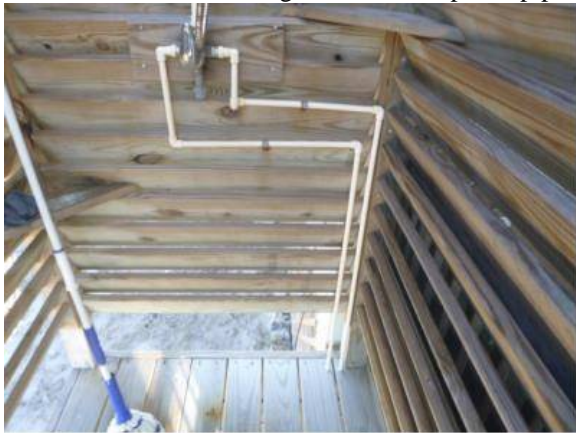
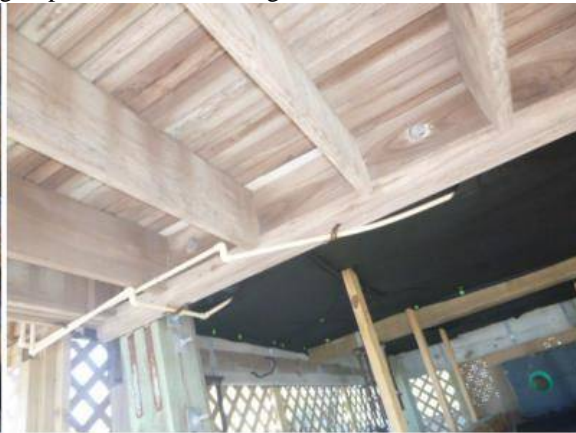
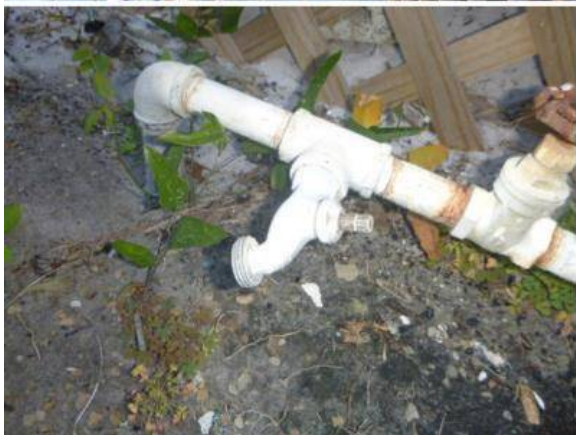
38. Recommend insulating all exterior exposed piping to prevent freeze damage.

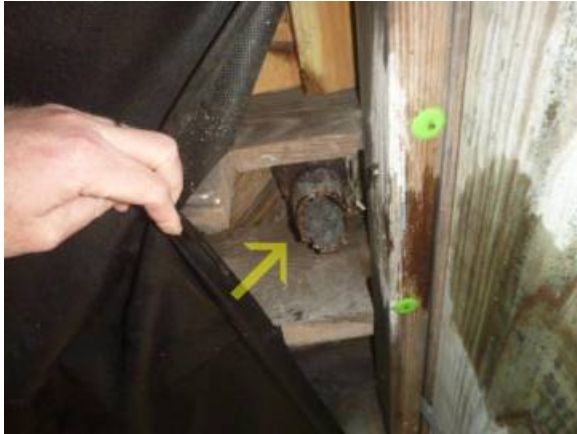
41. The waste drain below the jack and jill bathroom sink is missing, drains on sand below. Recommend repairs by a licensed plumber.

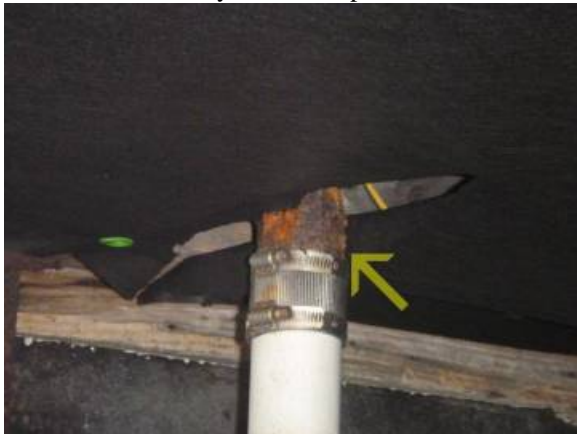
42. Some of the cast iron sewer lines have excessive corrosion and damage. Replacement may be needed. Recommend further evaluation by a licensed plumber.

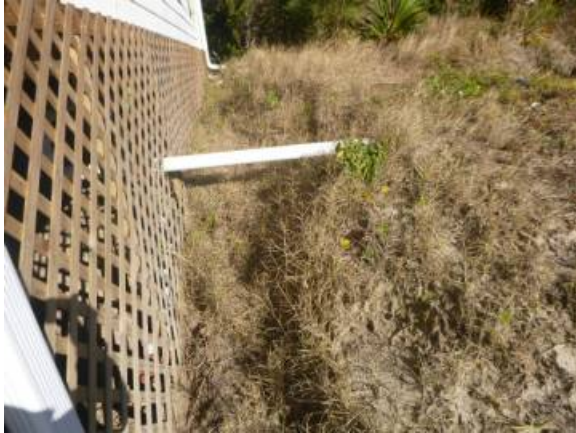
45. The earth / dirt around the septic system is washed out in various locations. The main waste line is exposed.

Recommend full evaluation and repairs as needed by licensed septic tank professional. Septic systems can only be properly evaluated by pumping and examining the tank. This should be done by a licensed septic tank installer. State law dictates that all septic system inspections be performed by a licensed septic tank installer. Periodic pumping of the system is part of normal maintenance.

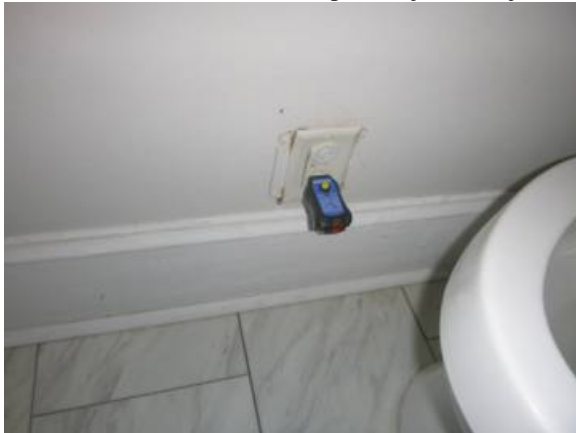
48. Electrical outlet(s) had no power: jack and jill bathroom GFCI outlet.

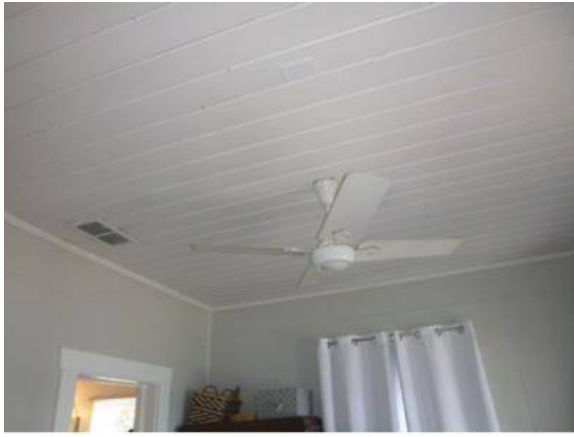
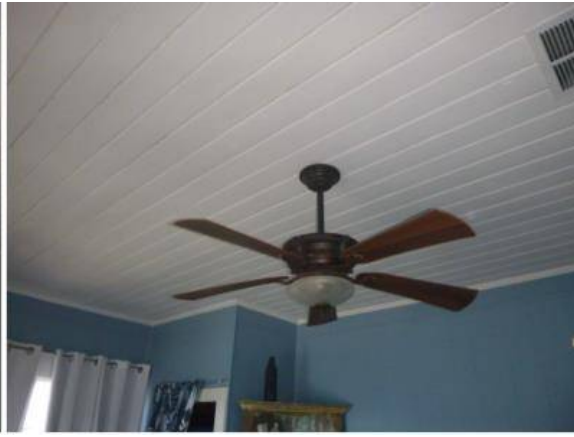
49. Ceiling fans inoperative or marginal: right hall bedroom and master bedroom ceiling fans.

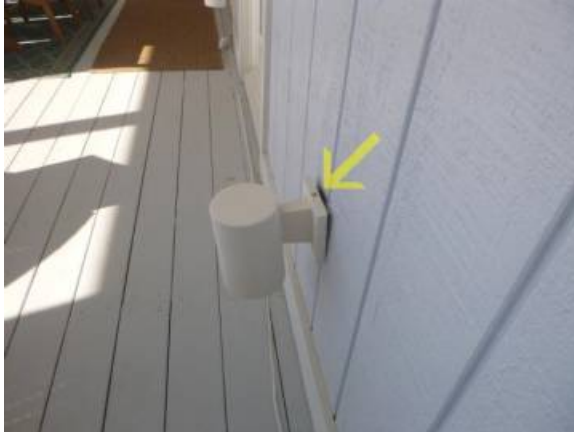
50. Loose light fixture noted at the rear screen porch.

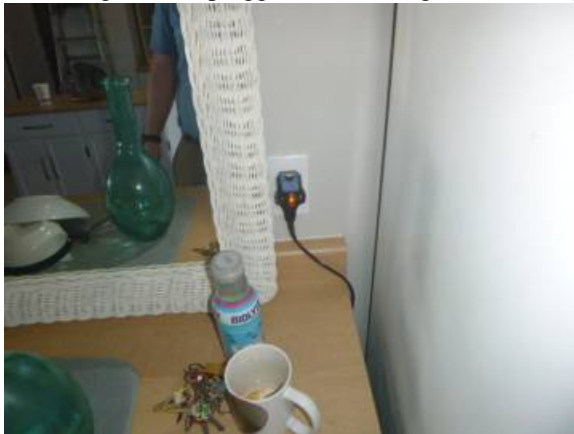
51. Refrigerator is plugged into a non-grounded receptacle. Shock hazard exist.

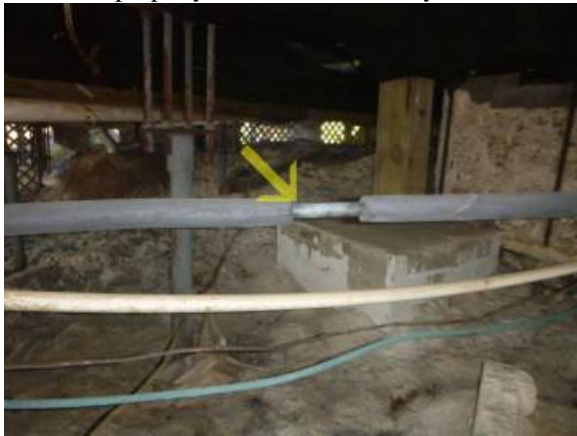
53. HVAC air handler in the crawlspace has an exposed freon line without insulation or breaks in the insulation. Freon line should be properly insulated all the way to the air handler.

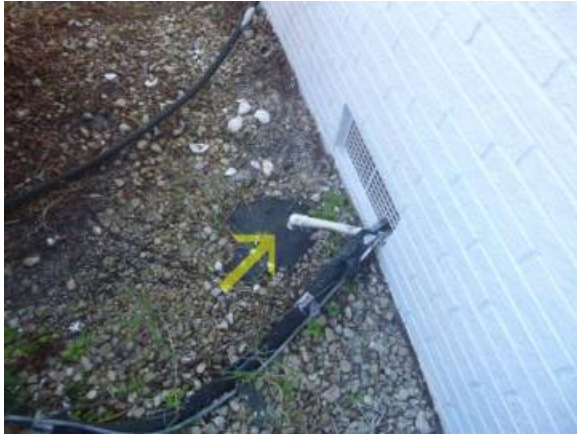
54. Recommend extending the condensation line away from the foundation.

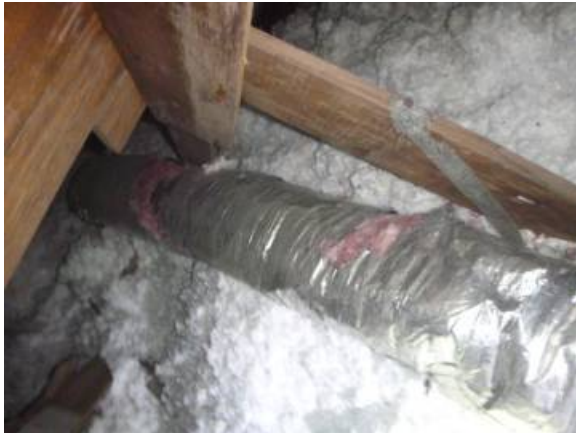
57. HVAC duct work has areas of missing and damaged insulation. Recommend further evaluation by a licensed HVAC technician.

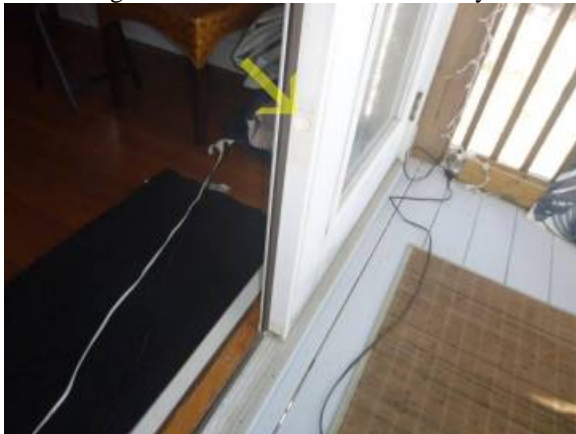
58. The right hall bedroom french secondary door lower pin is inoperable.

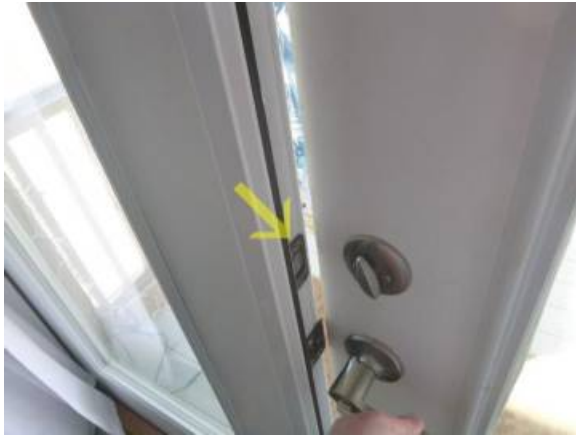
59. The right hall bedroom french secondary door dead bolt is inoperable.

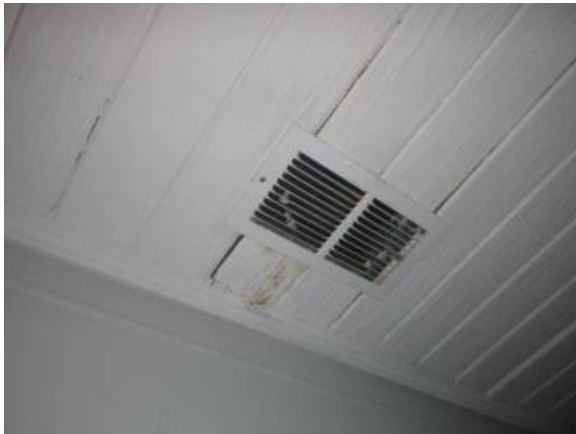
64. There is evidence of condensation damage on ceiling from the HVAC/ductwork, recommend further evaluations by a licensed HVAC tech.

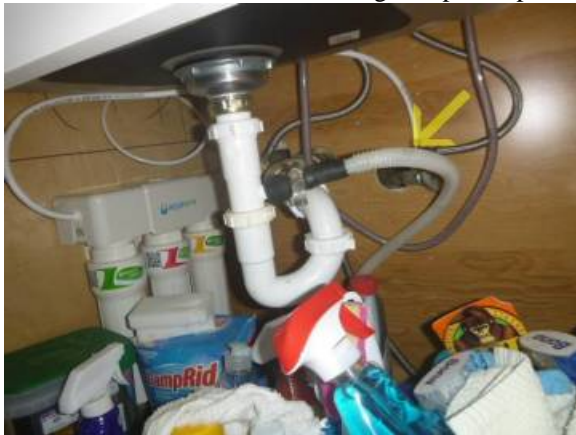
67. Dishwasher drain should be high looped to prevent siphoning.

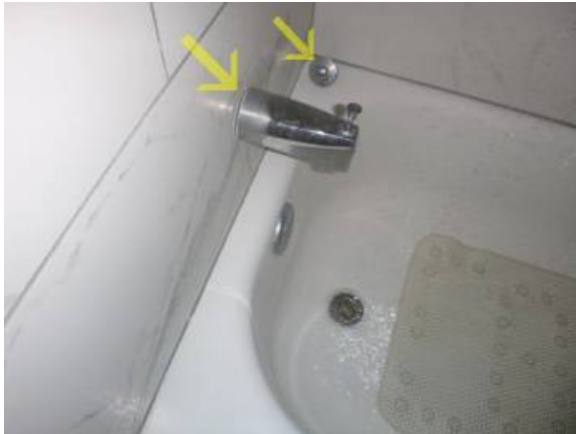
70. The following problems were noted at the tub: drain stopper is removed/missing, Recommend sealing the tub spout to the wall.

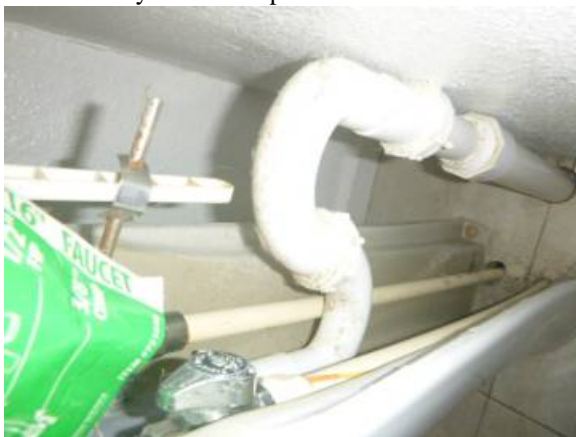
71. The following problems were noted at the sink drain: an improper drain trap is installed. Recommend further evaluation by a licensed plumber.

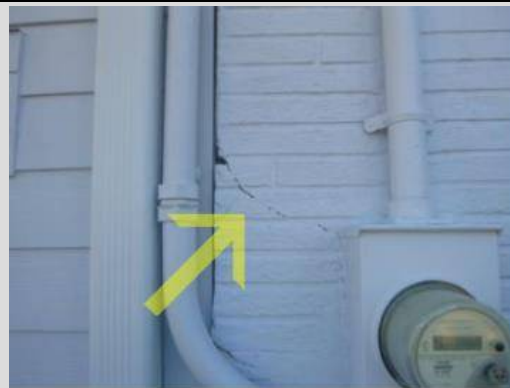
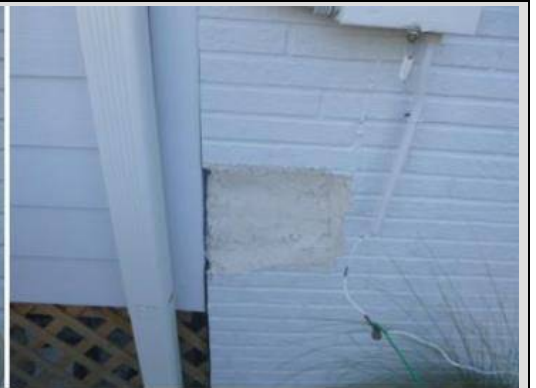
*Damaged/missing stucco noted on the right side yard.*

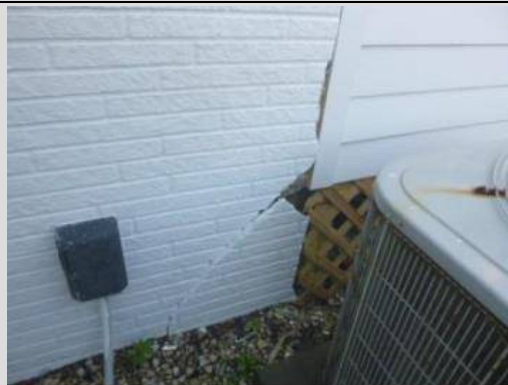
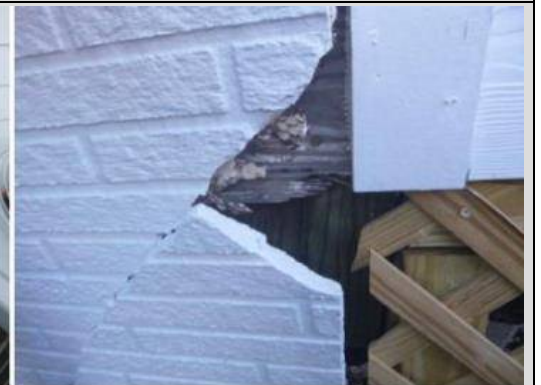
*Cracked/damaged siding noted in the AC area and the exposed wood wall sheathing has wood rot. Recommend repairs by a licensed contractor.*

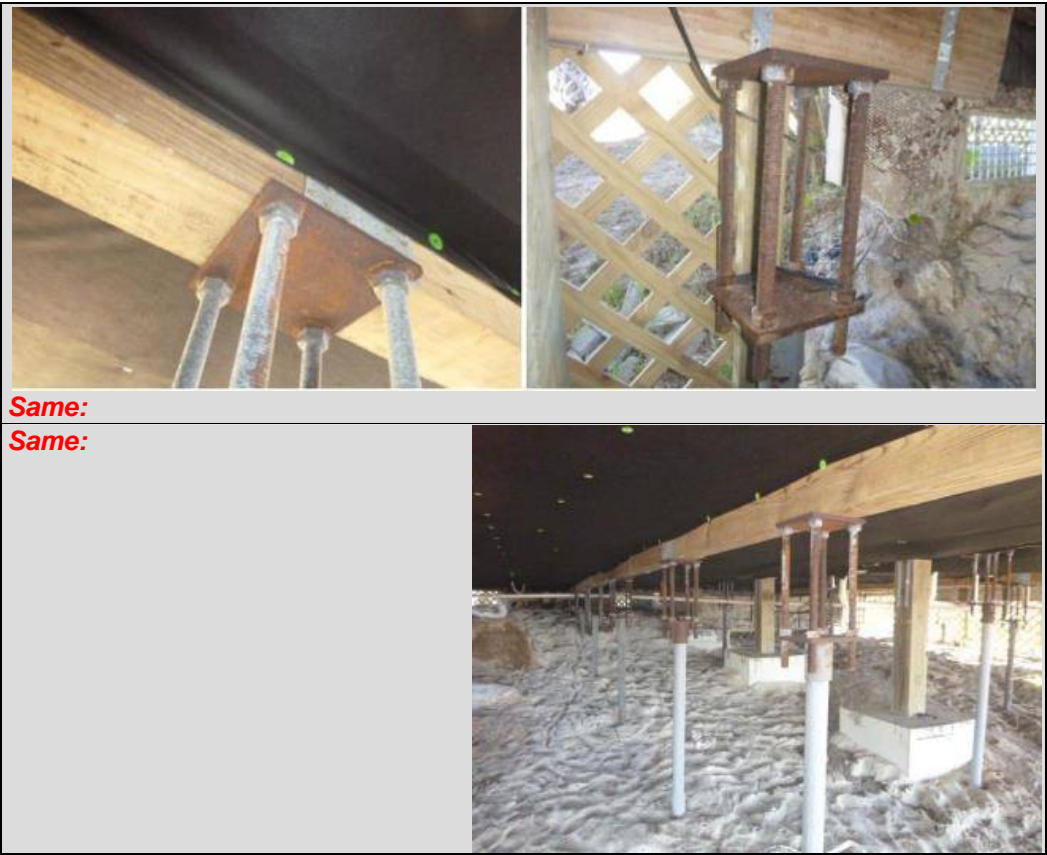
*Same: Added metal supports appear to have some rust/corrosion. Recommend consulting foundation company who installed the supports on repairs/recommendations on corrosion since installation.*

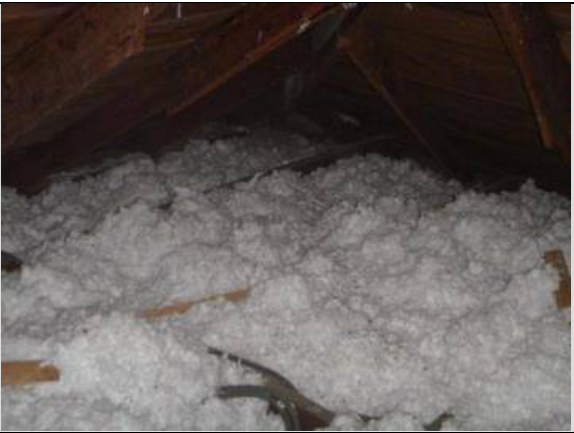
Appeared serviceable, minor staining/damage noted from previous roofs. *Evidence of prior rodent activity was noted. Recommend having a licensed pest control company evaluate rodent activity and entry points and treat/repair as needed.*

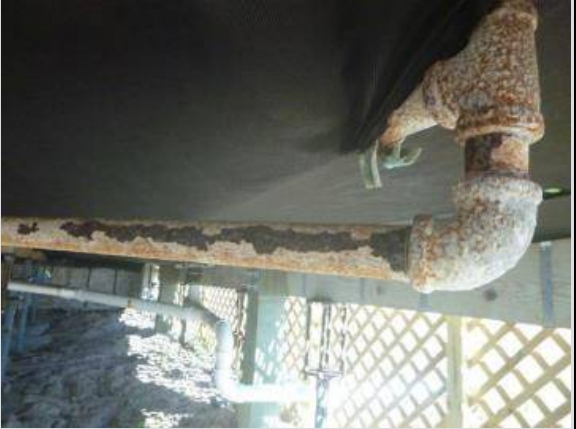
*Rust/corrosion damage noted on exposed galvanized steel piping, recommend further evaluations and repairs by a licensed plumber.*

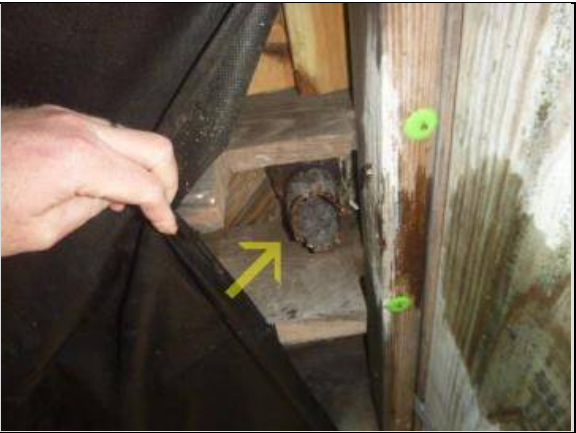
*The waste drain below the jack and jill bathroom sink is missing, drains on sand below. Recommend repairs by a licensed plumber.*

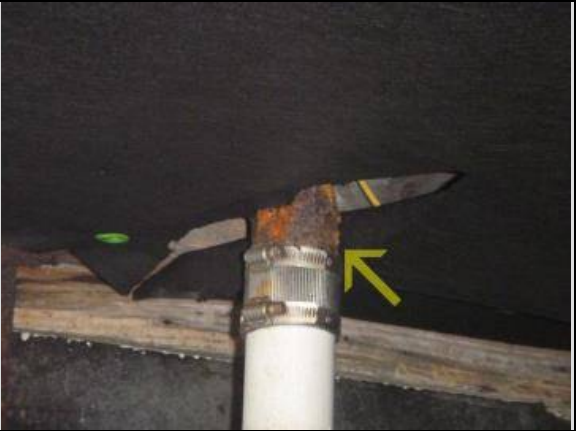
*Some of the cast iron sewer lines have excessive corrosion and damage. Replacement may be needed. Recommend further evaluation by a licensed plumber.*

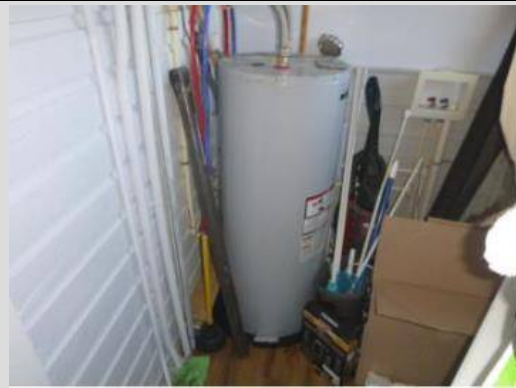
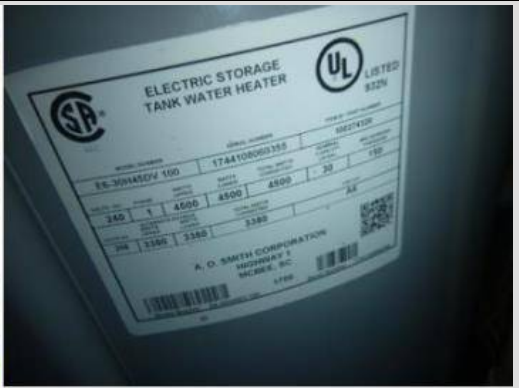
PICTURE OF WATER  
HEATER & PRV:

No shutoff valve at tank. A valve is recommended.

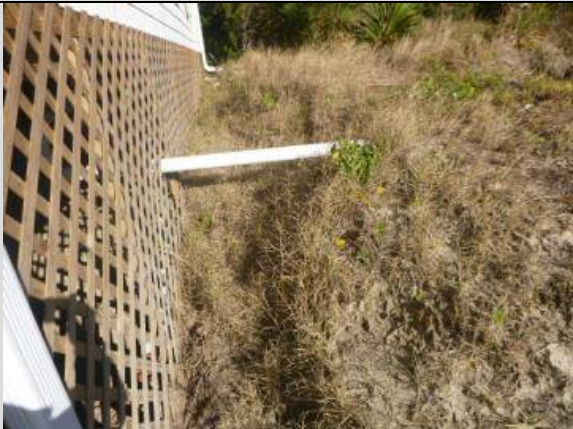
*The earth / dirt around the septic system is washed out in various locations. The main waste line is exposed. Recommend full evaluation and repairs as needed my licensed septic tank professional. Septic systems can only be properly evaluated by pumping and examining the tank. This should be done by a licensed septic tank installer. State law dictates that all septic system inspections be performed by a licensed septic tank installer. Periodic pumping of the system is part of normal maintenance.*

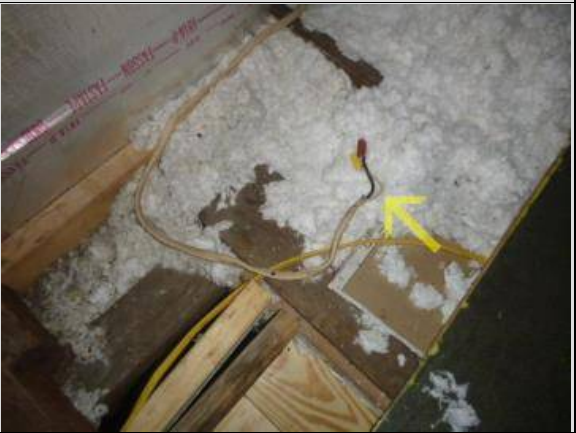
**Recommend adding the wire splice near the attic entry to a covered junction box as needed.**

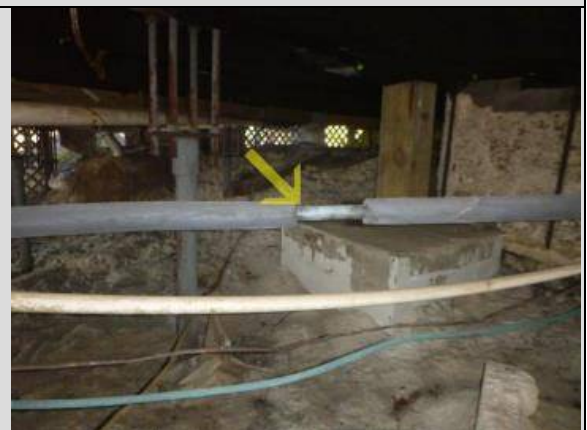
*HVAC air handler in the crawlspace has an exposed freon line without insulation or breaks in the insulation. Freon line should be properly insulated all the way to the air handler.*

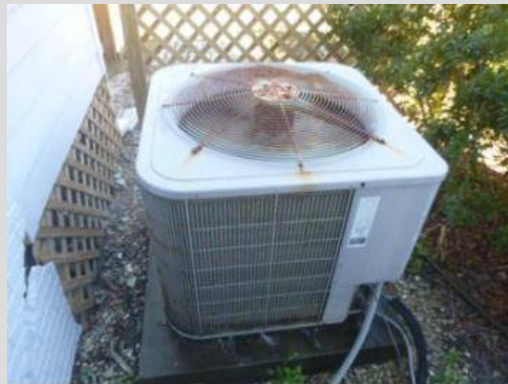
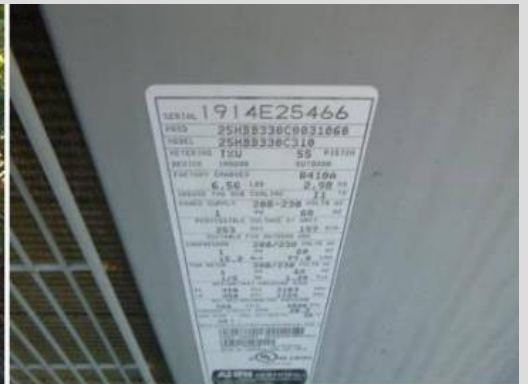
PICTURE OF HVAC  
CONDENSING UNIT:

**Freon line insulation at the outside HVAC condensing unit is deteriorated or missing.**

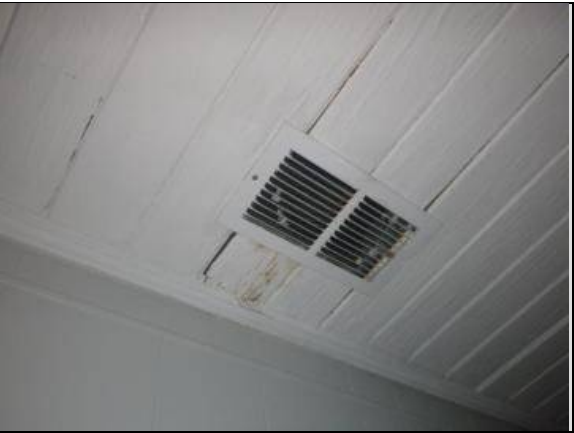
*There is evidence of condensation damage on ceiling from the HVAC/ductwork, recommend further evaluations by a licensed HVAC tech.*

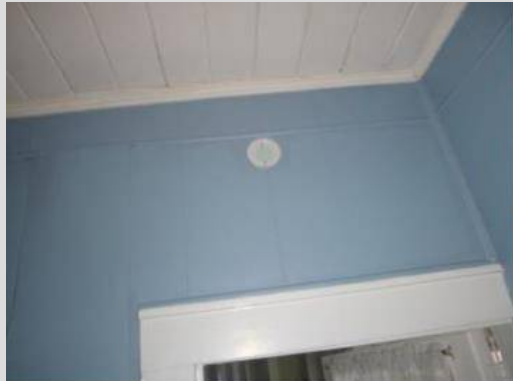
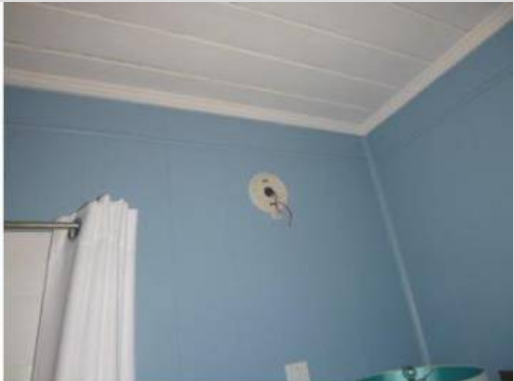
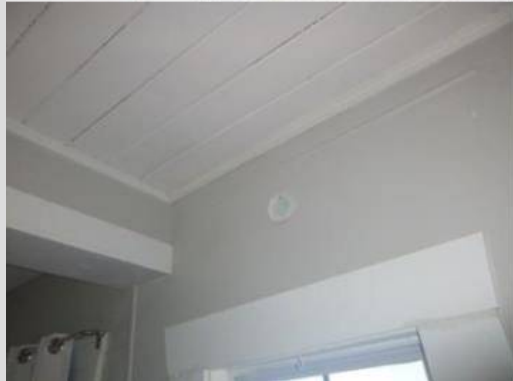
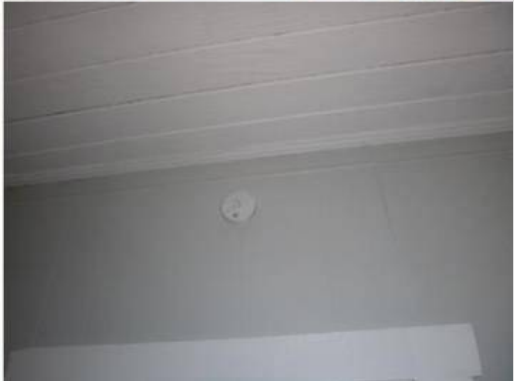
*Missing/inoperable smoke detectors noted, recommend installing smoke detectors in all necessary locations.*

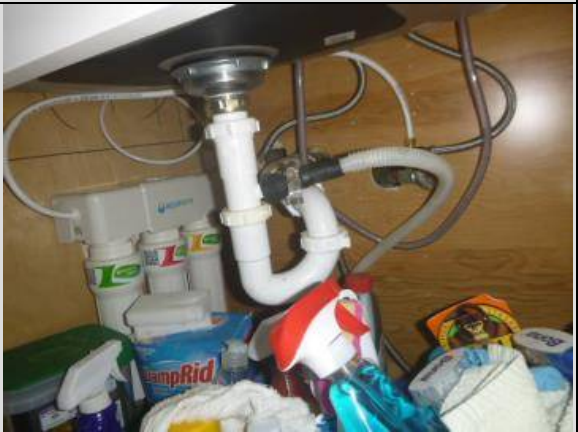
TYPE:	Stainless Steel.
CONDITION:	Appears serviceable, Kitchen sink drain appeared serviceable at time of inspection. Faucet is serviceable, Hand sprayer is serviceable.
PICTURE OF SINK PLUMBING:	<div><div>*</div>

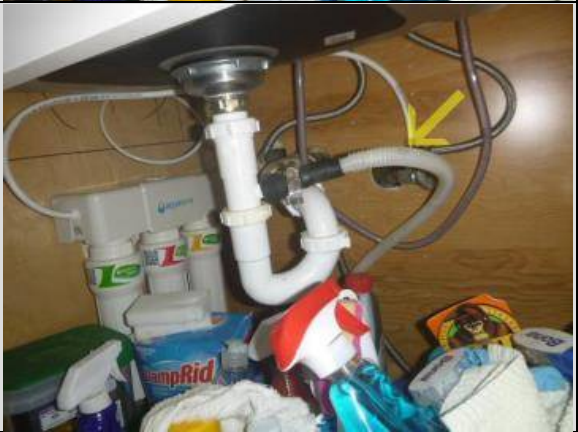
</div>
OTHER KITCHEN SINK OBSERVATIONS:	<div><p><i>Dishwasher drain should be high looped to prevent siphoning.</i></p>

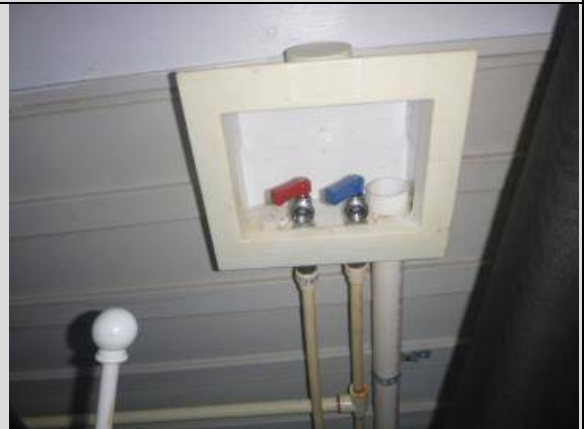
\*  
PICTURE OF WASHING  
MACHINE PLUMBING:

LOCATION:	Front porch.
CONDITION:	Plumbing appears serviceable, Electrical outlet is grounded, 220 Service-operational.

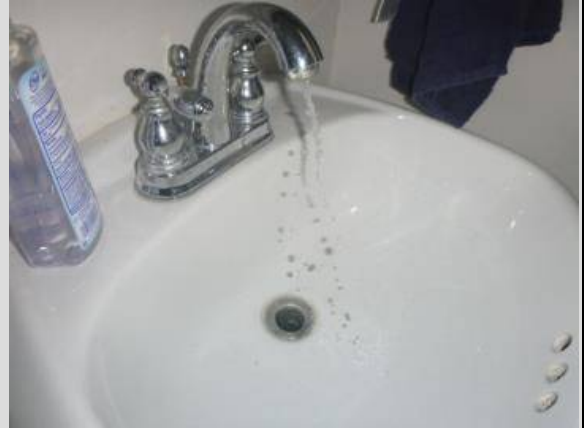
*The following problems were noted at the sink: drain stopper is missing at sink and the aerator appears clogged.*

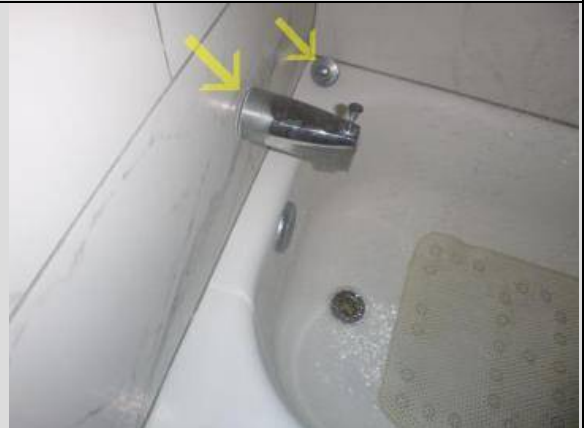
*The following problems were noted at the tub: drain stopper is removed/missing, Recommend sealing the tub spout to the wall.*
