Property Inspection Report

Southern Home Consultants, Inc.

Report #: 082021WO6.

**1215 Alligator Drive.
Alligator Point, FL 32346.**

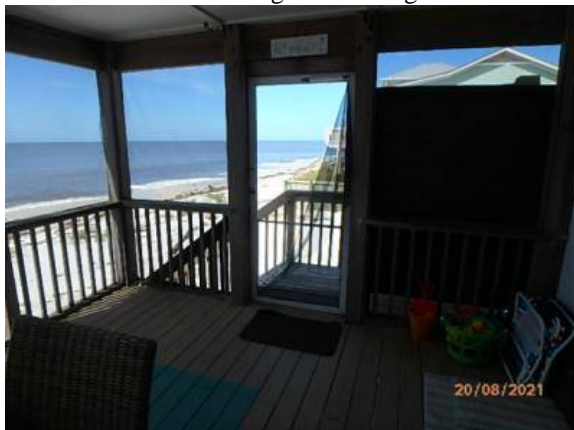
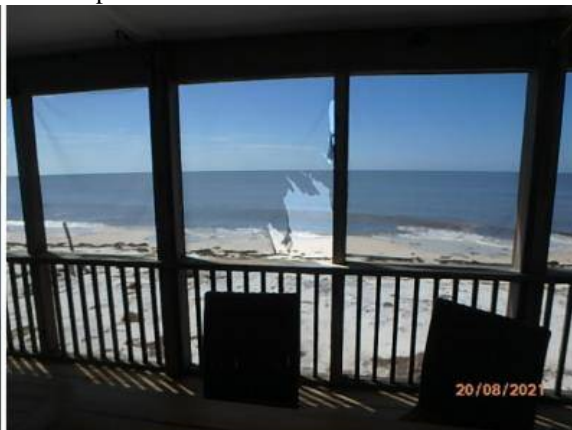
3. Various areas of damaged screening noted at the South side porch / deck area.

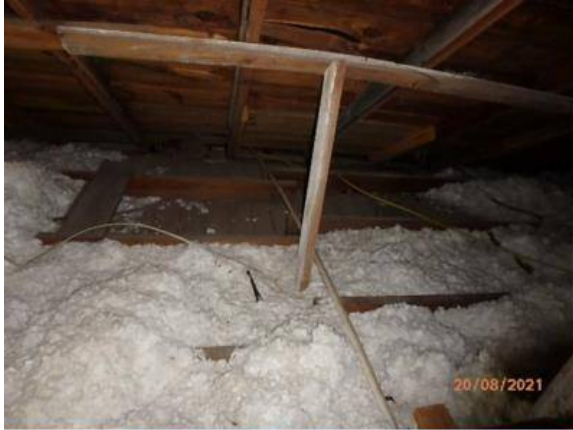
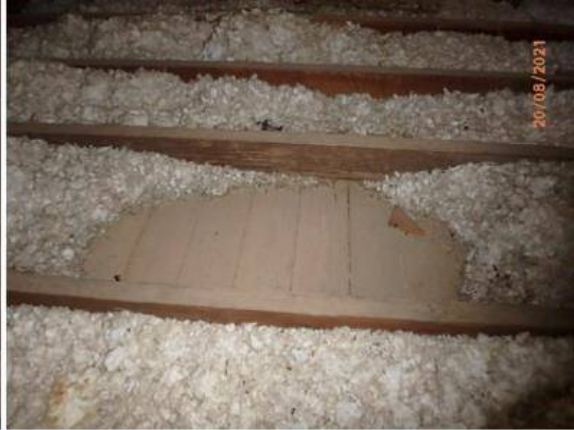
26. Insulation is disturbed resulting in poor coverage in various locations. Recommend installing additional insulation.

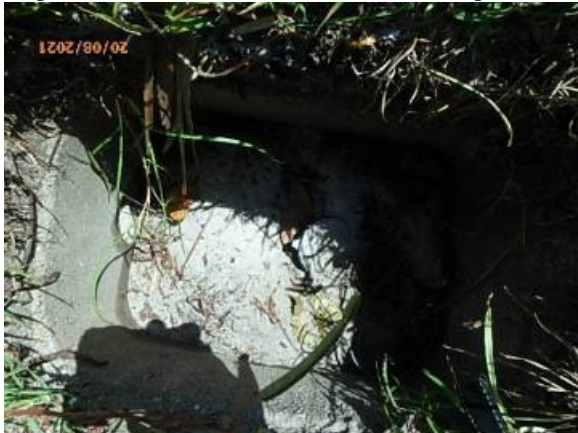
27. The water meter in the front yard should be cleaned of all debris to expose the main water shut off valve to the house. Inspection of meter / shut-off valve was not possible.

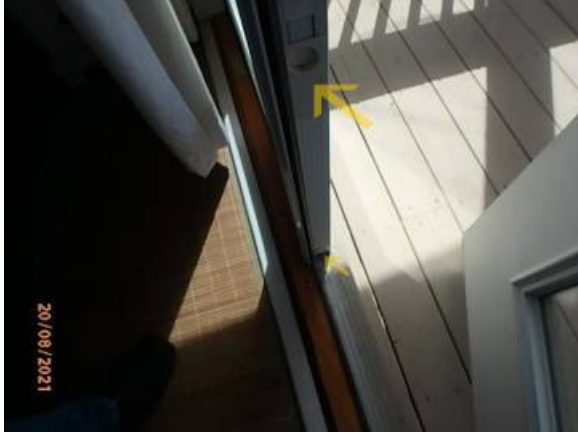
39. SE French door bottom set pin will not disengage. Door could not be opened.

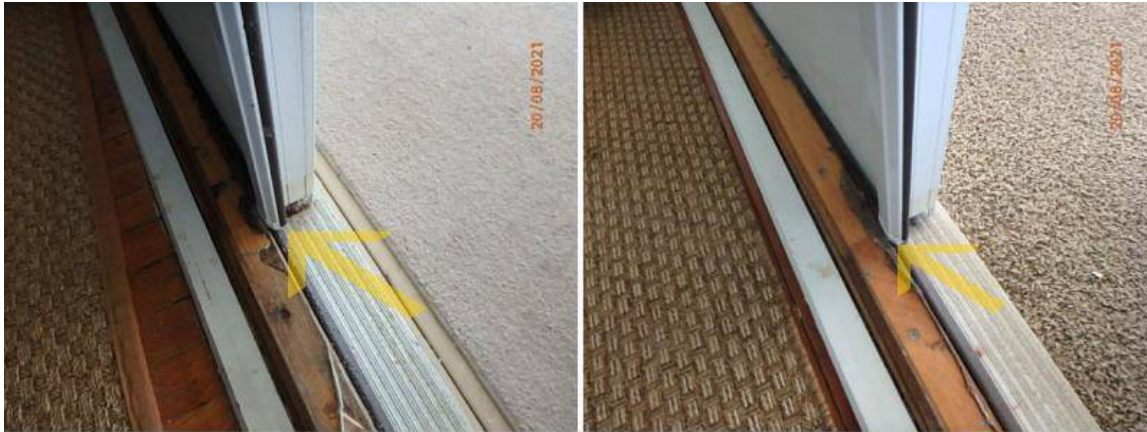
40. The middle french door and the master bedroom french door bottom set pins will not properly engaged due to the bottom of the doors being in conflict with the threshold. Adjustment is needed.

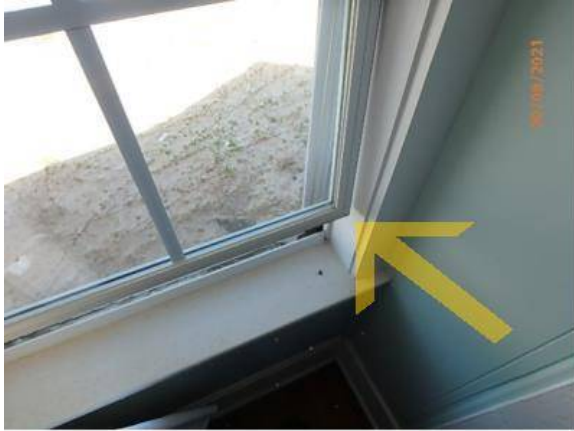
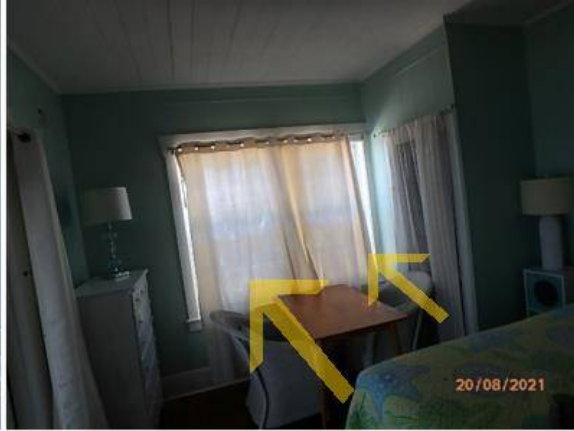
43. Windows will not stay open in the following locations: master bedroom windows, dining area windows. Windows do not stay in track properly.

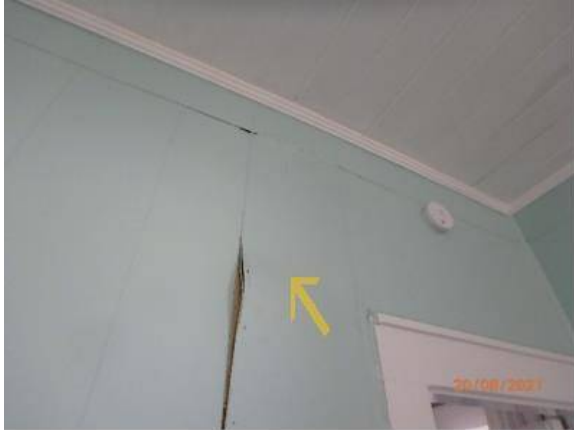
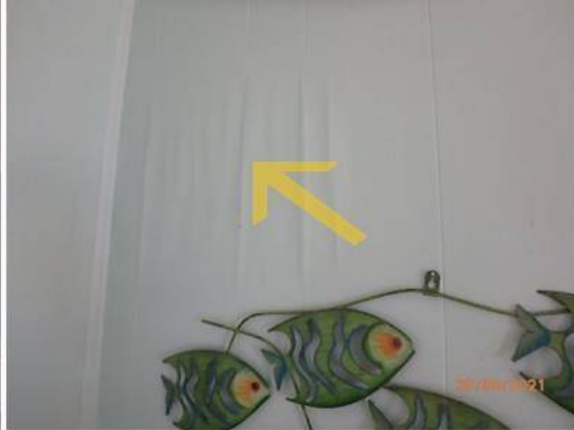
44. Areas of delamination / damage noted at the interior wall covering (Panels) in the master bedroom and SE bedroom.

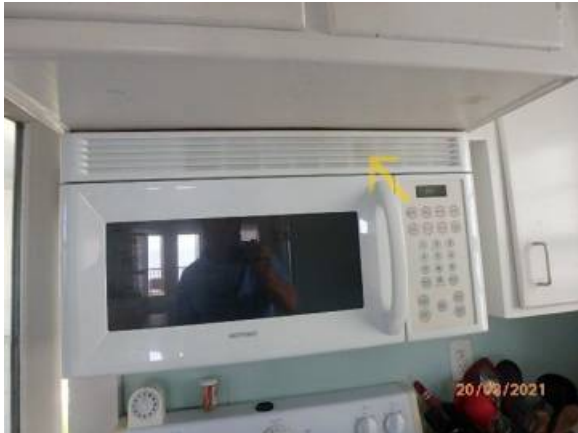
49. The vent fan exhausts under the cabinet above and blows back into the operators face.

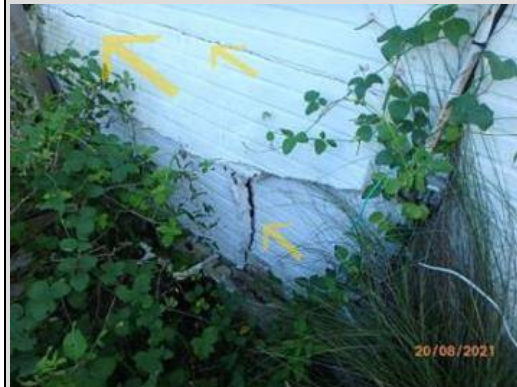
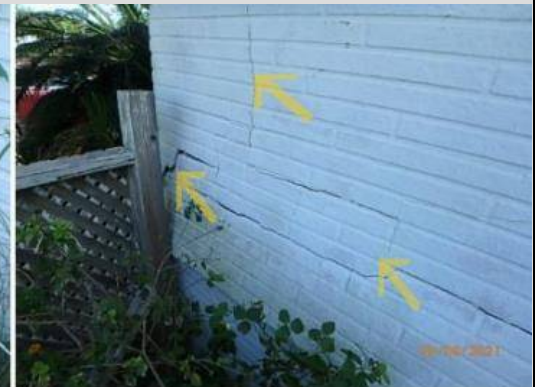
7. Cracking on West side.

Cracking on West side.

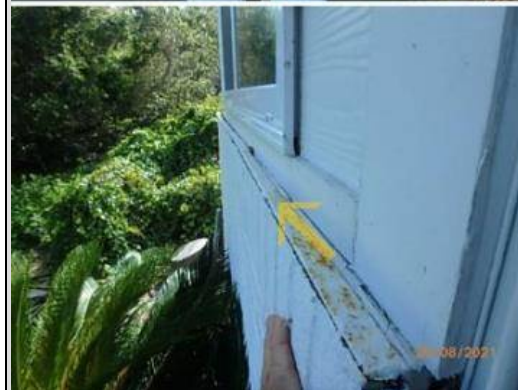
10. Various areas of cracking / damage to stucco at the East side near the front NE corner.

Various areas of cracking / damage to stucco at the East side near the front NE corner.

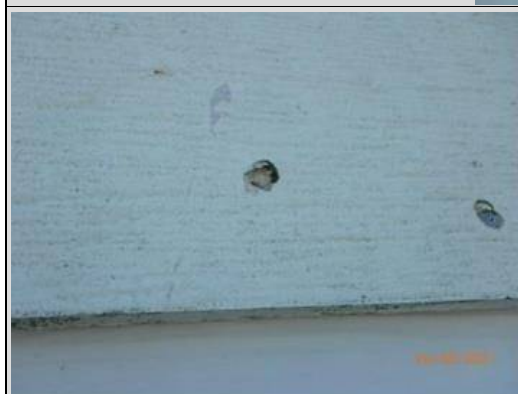
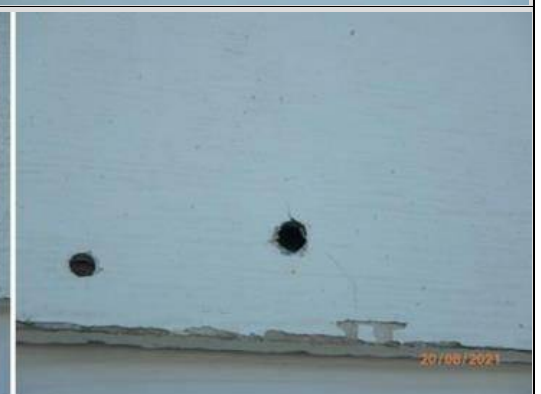
13. The exterior paint is deteriorated and peeling in various locations. The house was built prior to 1978 which brings strict guidelines for paint surface disturbance.

The exterior paint is deteriorated and peeling in various locations. The house was built prior to 1978 which brings strict guidelines for paint surface disturbance.

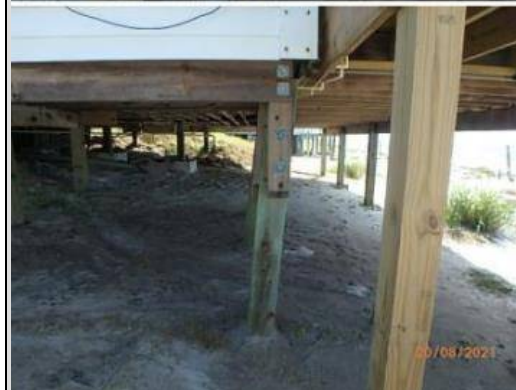
20. Various leaning wood piers / supports noted. Settlement / shifting appears to have occurred. Excessive soil wash-out noted under the structure. Recommend full evaluation by a structural engineer and/or foundation specialist.

Various leaning wood piers / supports noted. Settlement / shifting appears to have occurred. Excessive soil wash-out noted under the structure. Recommend full evaluation by a structural engineer and/or foundation specialist.

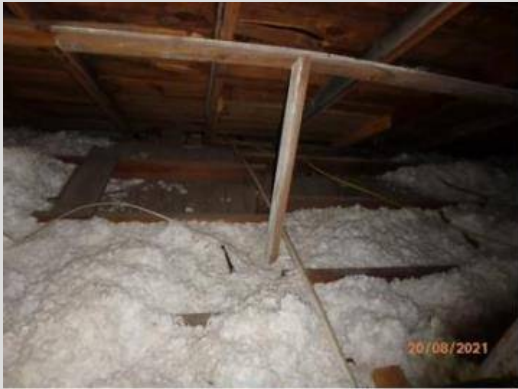
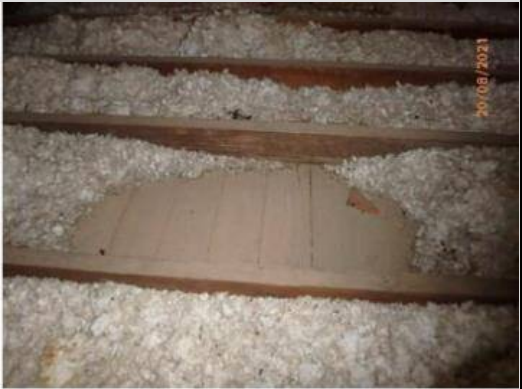
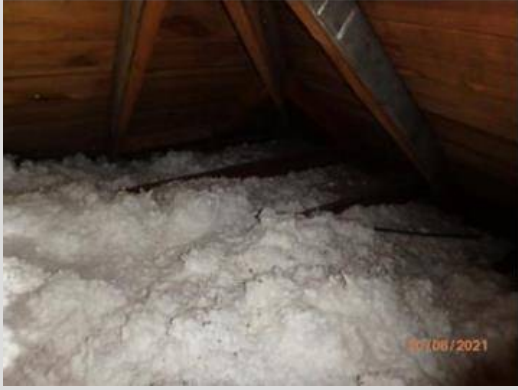
<i>Insulation is disturbed resulting in poor coverage in various locations. Recommend installing additional insulation.</i>
DEPTH 8-9 inches.
FRAMING TYPE ROOF Conventional type Framing.
FRAMING TYPE Conventional type Framing.
CEILING Attic framing/trusses appeared serviceable.

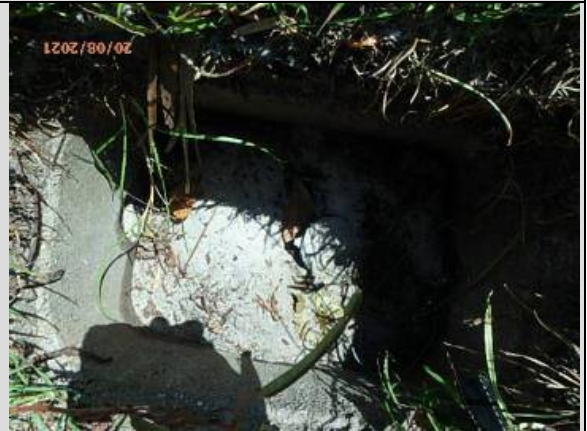
The water meter in the front yard should be cleaned of all debris to expose the main water shut off valve to the house. Inspection of meter / shut-off valve was not possible.

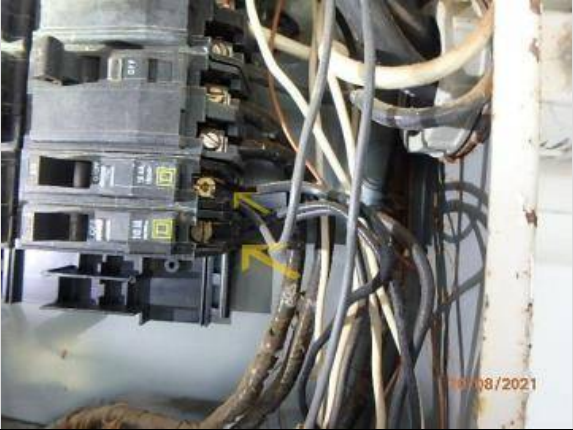
</div>
MAIN PANEL CONDITION:	<div><p><i>Multiple wires are connected to a single lug on a circuit breaker (2 locations) in the electrical panel where only one wire should be connected.</i></p>

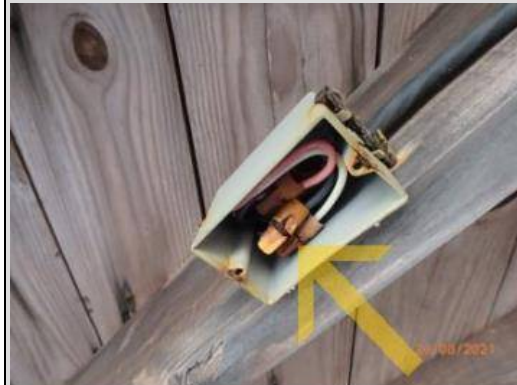
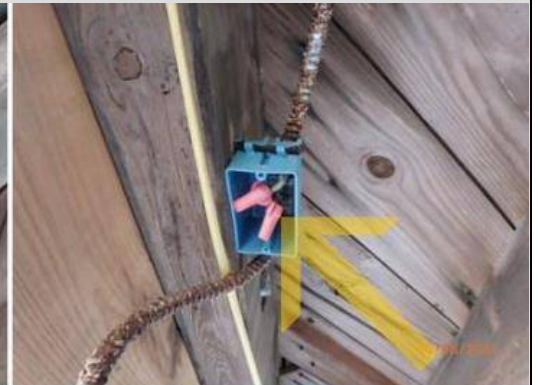
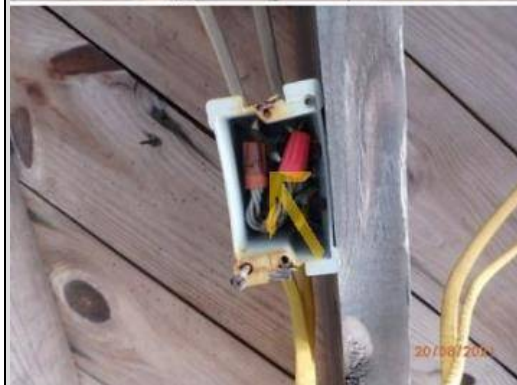
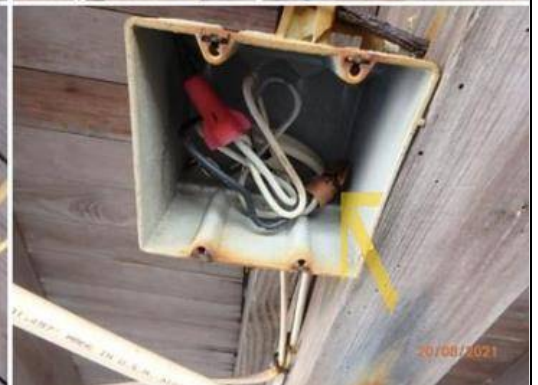
Various uncapped junction boxes noted under the house. Exposed connections noted with areas of rust / damage to the "Wire nuts".

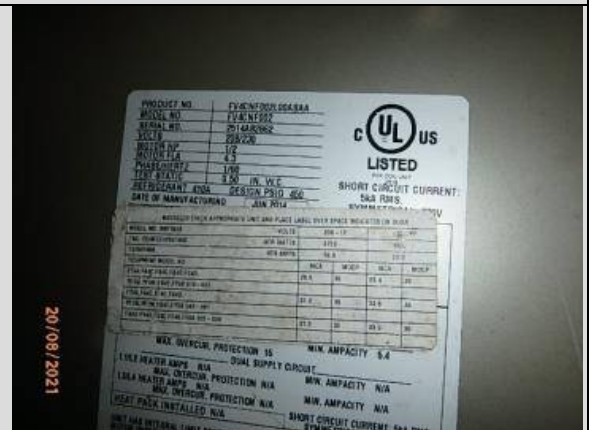
Carrier.

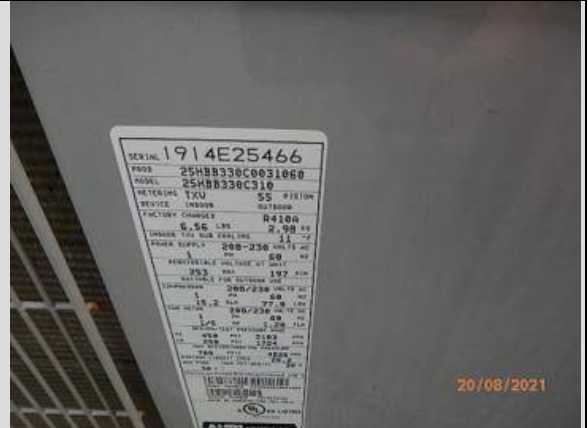
A/C TYPE:
POWER SOURCE:
COMPRESSOR AGE:
DATA PLATE
INFORMATION:

Central, Electric.
220 Volt, Electrical disconnect present.
2014.
Carrier.

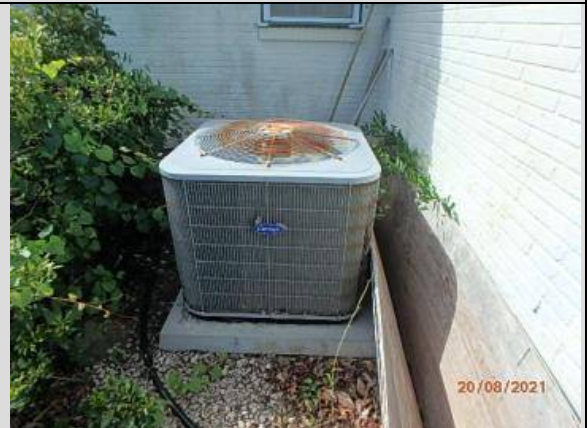
CAPACITY OF UNIT:
A/C SYSTEM
CONDITION:
CONDENSATE LINE:
NORMAL CONTROLS:
PICTURE OF HVAC
CONDENSING UNIT:

2.5 ton.
Appears serviceable.
Condensate line installed.
Appear serviceable.

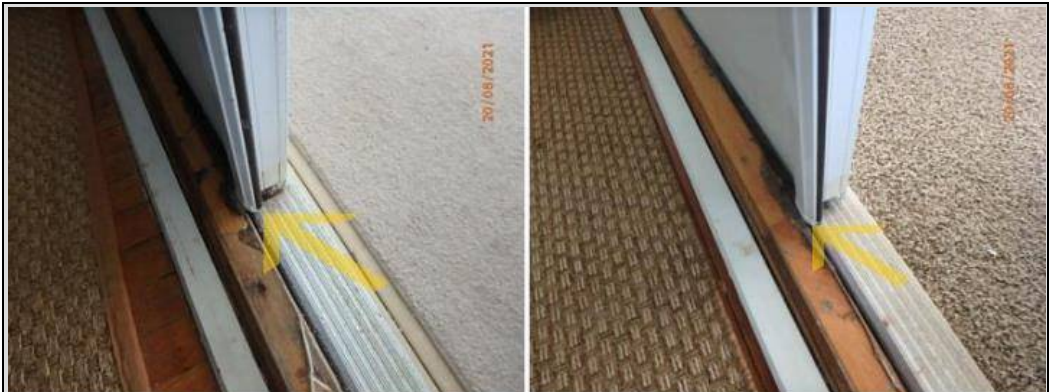
SE French door bottom set pin will not disengage. Door could not be opened.

The middle french door and the master bedroom french door bottom set pins will not properly engaged due to the bottom of the doors being in conflict with the threshold. Adjustment is needed.

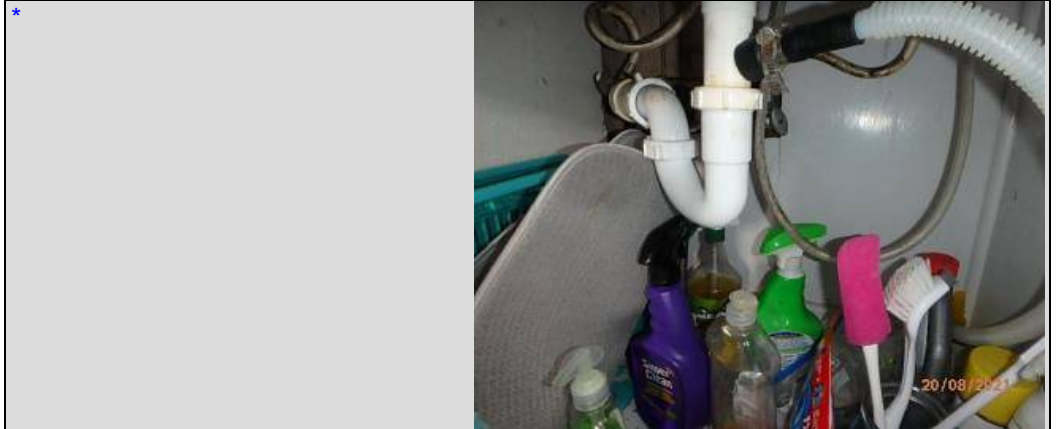
PICTURE OF SINK
PLUMBING:

Appears serviceable, Kitchen sink drain appeared serviceable at time of inspection. Faucet is serviceable, Hand sprayer is serviceable.
