## **RV Inspection Report**

**Inspection Date:** 4/29/2021

**RV Model: 2018 George Town Forest River GT5 36B5**

**Blue Line Mobile RV Service**

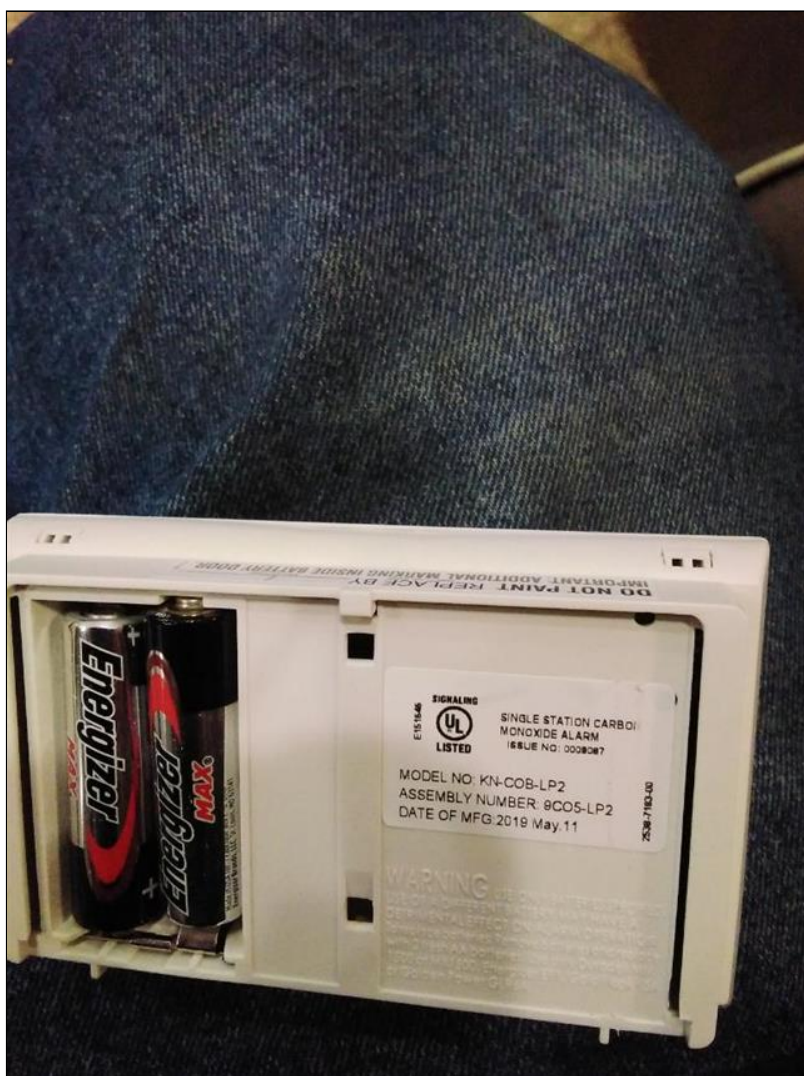
rear plate on carbon monoxide detector

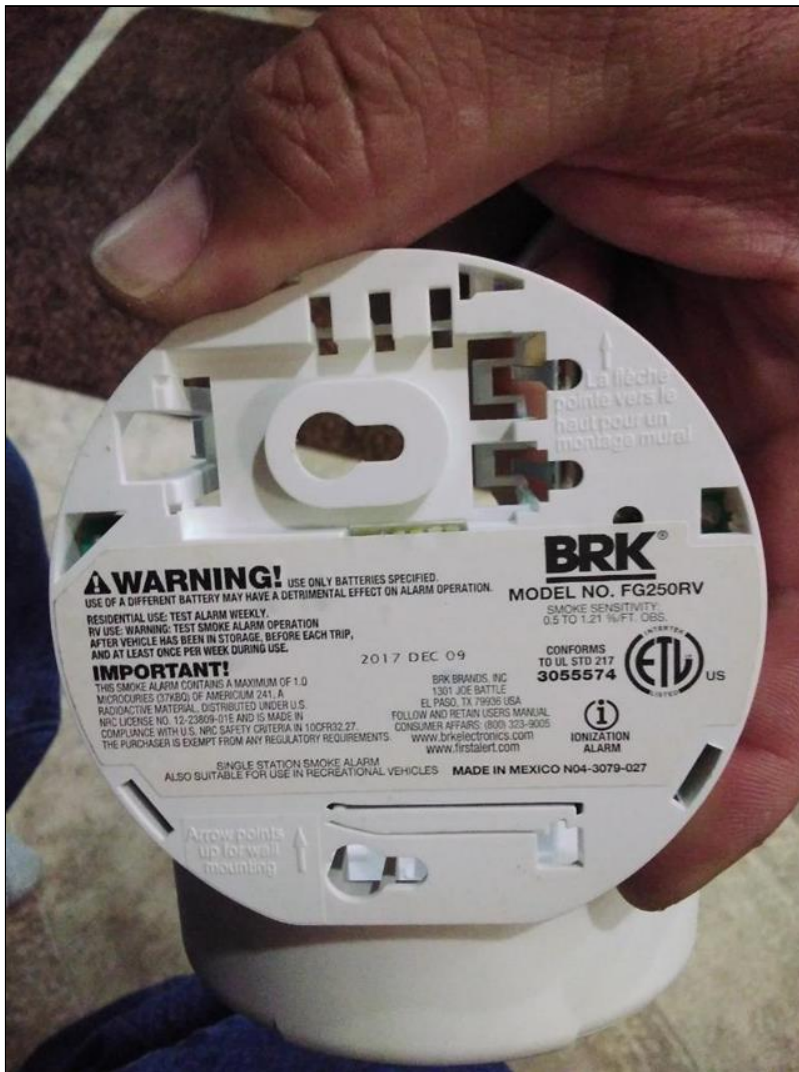
Comments: Acceptable  
Backside of smoke detector

back of smoke detector

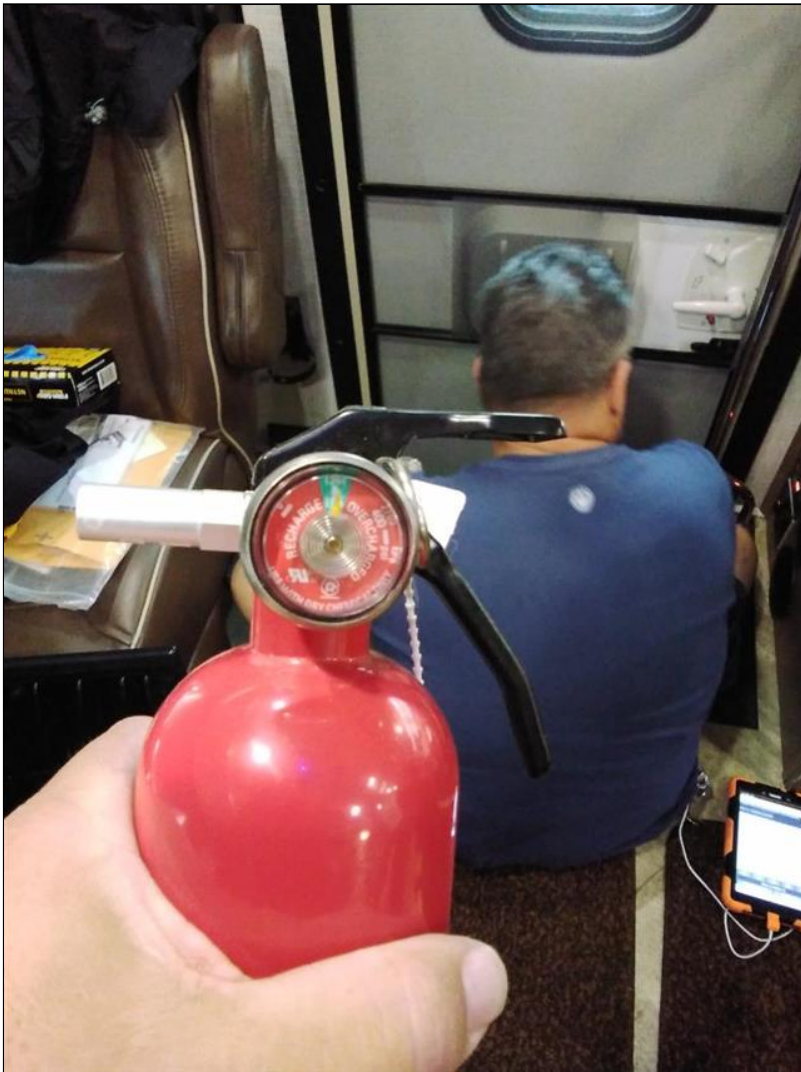
Comments: Acceptable

fire extinguisher gauge
