RV Inspection Report

2018 Cruiser RV, Stryker, ST-2916, Athens, Texas 75751

Inspection Date: 4/22/2021

Blue Line Mobile RV Service

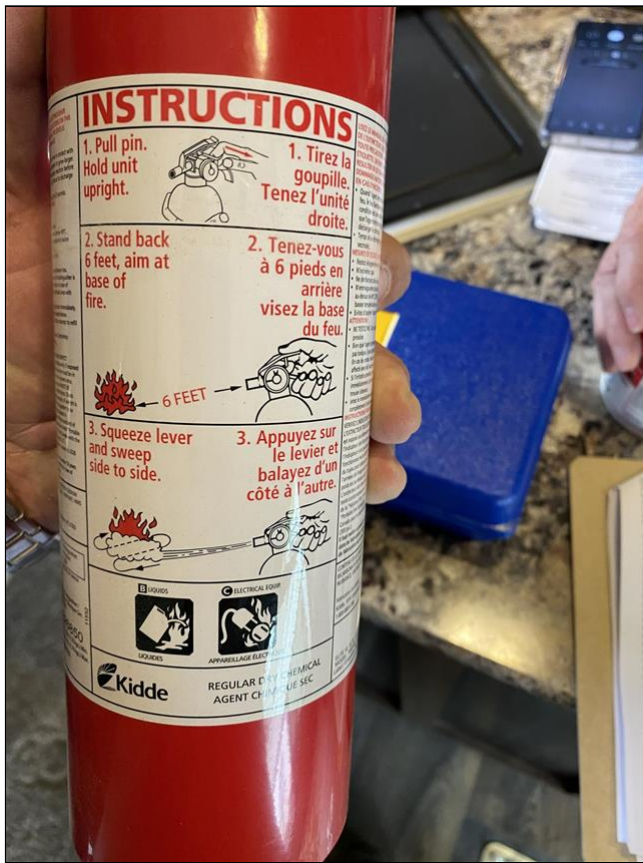
(1) Rear ramp door extinguisher

Comments: Acceptable

Ramp door extinguisher

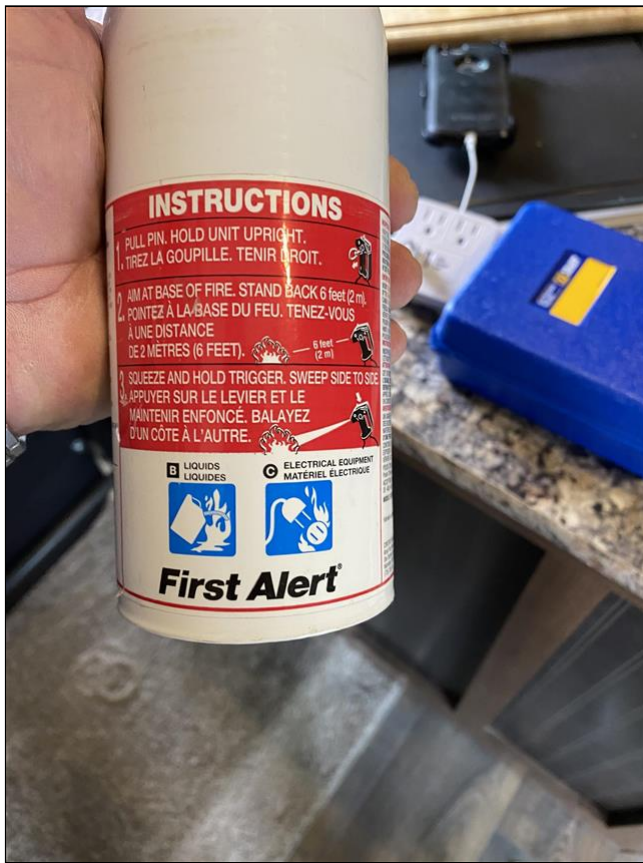
(2) main door extinguisher

main door extinguisher

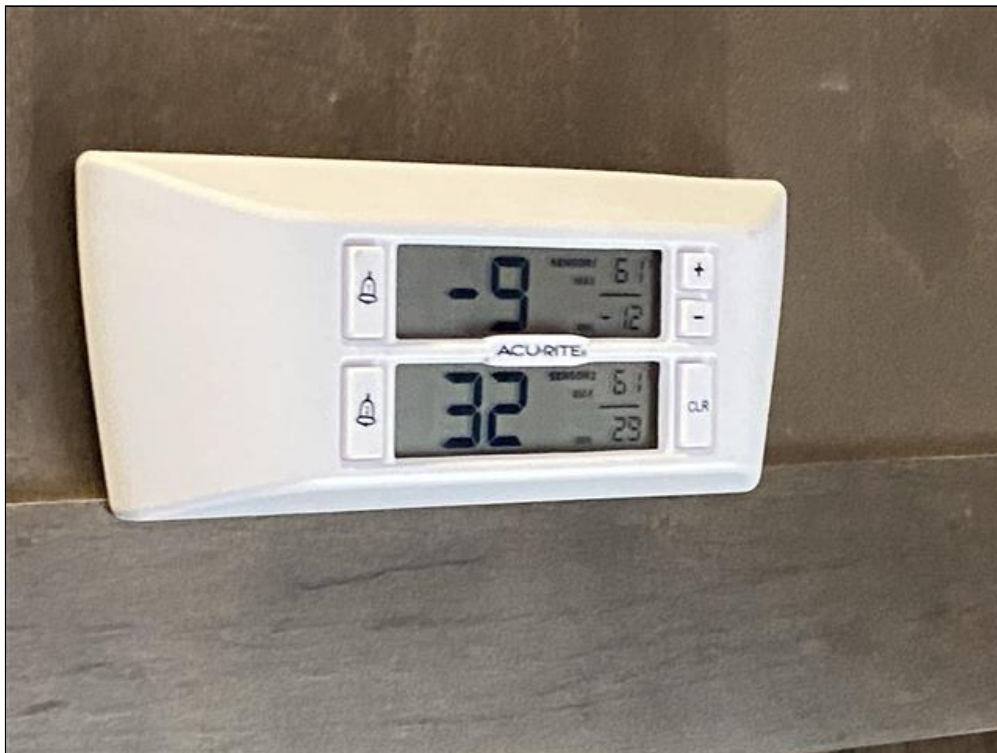
(1) Refrigerator temperature gauge from inside upper cabinet, to the right of frig

Frig Temp Gauge
