Report of Marine Survey

"Sample 2002 Sea Ray 340"

"2002 Sea Ray 340 w twin Mercury 8.1S Horizon engines"

August 21, 2020

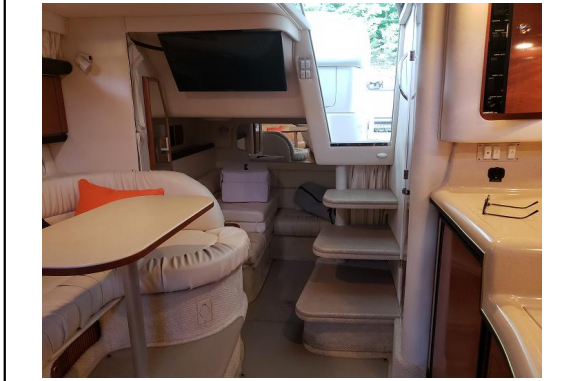
One light did not power on in the aft berth.

Berth Aft

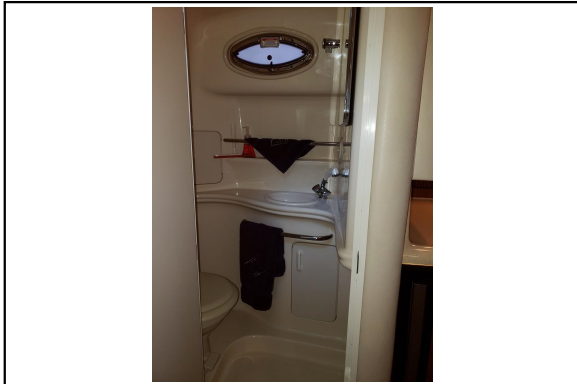
Head Overview

- * **HEADS:** There is a head with manually operated Vacu-flush toilet. There is a single basin molded fiberglass sink with extending faucet which doubles as the shower head. Ventilation is aided by a porthole. The lights powered on and an air conditioning vent was allowing cool air into this area.

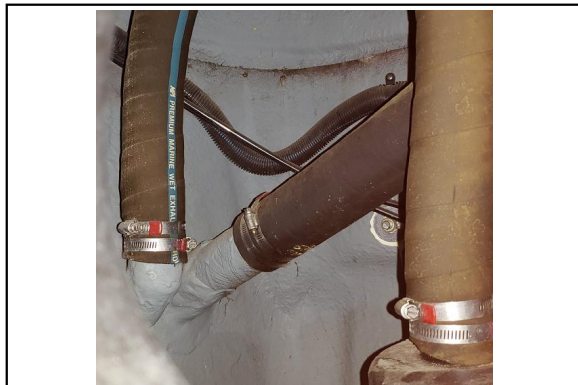
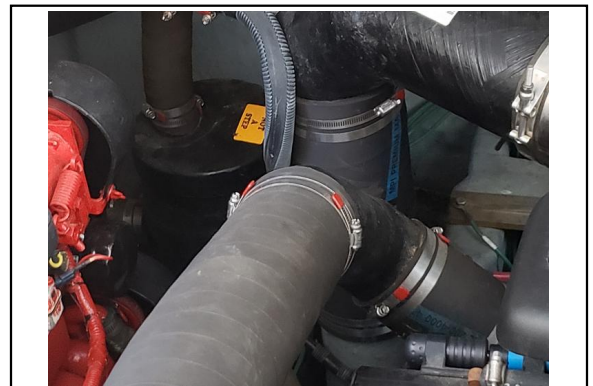
Exhaust Hoses Double Clamped

Engine Exhaust Hoses Double Clamped (2)

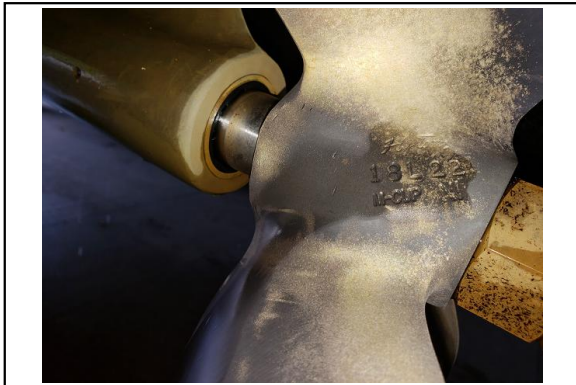
Propeller Info Port

- * **PROP SHAFTS:** The propeller shafts were tested during the haul out portion of the survey and found to be rock solid. The propellers had no movement in them and they appeared to be without deficiency. The propeller strut on the port side appeared to have been removed and replaced recently because white silicone was hanging loose. The starboard strut appeared to be original installation.

[A.1] The port propeller strut appears to have been removed and replaced recently. It seems likely that this strut is the source of the water in the port side of the engine compartment.

The port side propeller shaft strut appeared to have under gone recent maintenance and the silicone used to seal the unit to the hull appears to be improperly selected.

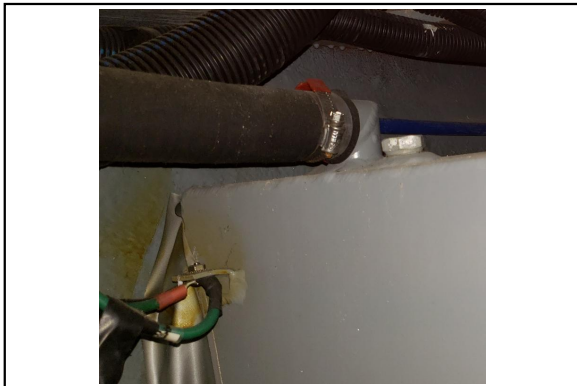
FUEL TANKS: The port fuel tank was visible, the starboard tank was not. The port side fuel inlet hose was solid. I could not see the upper end of the hose to ensure it was double clamped, the end that attaches to the fuel tank was double clamped per ABYC & USCG standards. Having one of these hoses come off and then pouring fuel into your boat is a bad idea so when able during scheduled maintenance, you should have a mechanic remove the necessary "whatever" and have them ensure the fuel inlet hoses are all double clamped.

Fuel Tank Inlet Hose Double Clamped

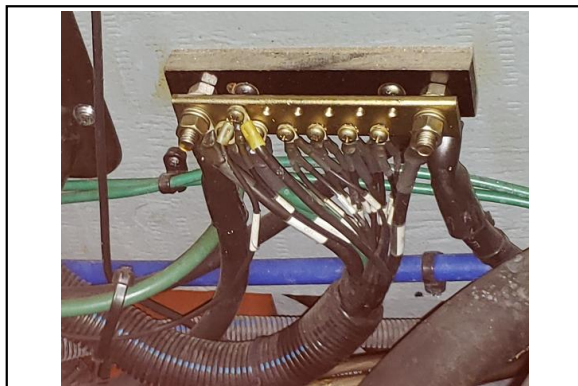
BONDING SYSTEM: The ship's electrical system is bonded together to prevent electrolysis and galvanic corrosion. The wires and the bus appeared to be without corrosion.

Bonding System Intact & Clean

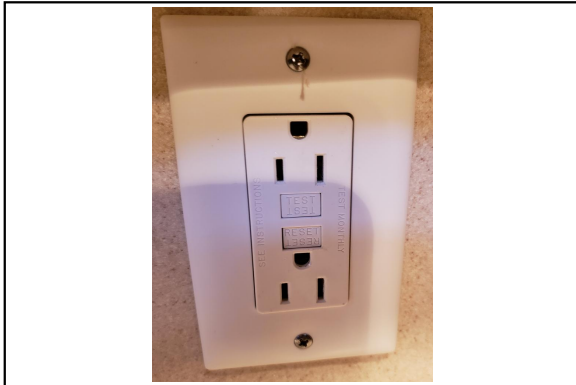
OUTLETS: Outlets in wet areas are protected by GFCI. The "on-deck" outlet is further protected by a self closing cover. I tripped the GFCI outlet and it was able to be reset. No polarity issues were noted.

Electrical Outlets are GFCI

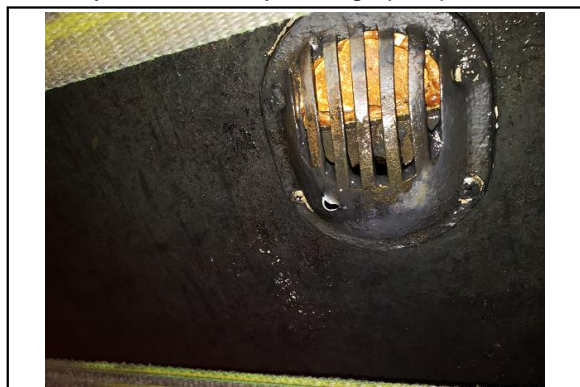
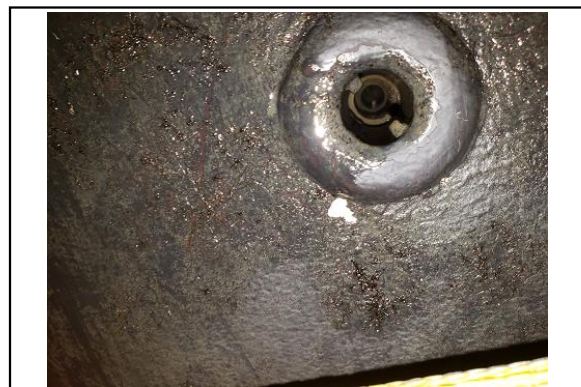
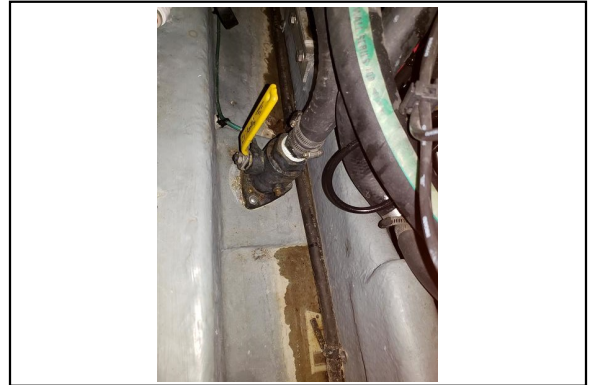
NOTE: All under water thru hulls where sighted were double clamped, their hoses in good shape and their sea cocks moved easily. There is no regulatory authority in the United States which requires double clamps on under water thru hull hoses, but it is simply a matter of good seamanship. If those hoses come off, you're dealing with a 1 inch hole in your boat and your bilge pumps are not designed to handle that much water.

Under Water Thru Hull Clear (2)

Under Water Thru Hull Clear (3)

Under Water Thru Hulls Double Clamped (2)

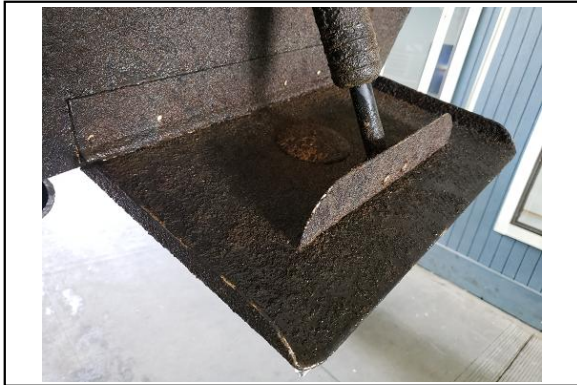
Trim Tab Starboard

- * **ZINC (HULL ZINC):** Sacrificial anodes were present on the trim tabs and they appeared to be in good condition although they were covered with marine growth and could not be directly observed.

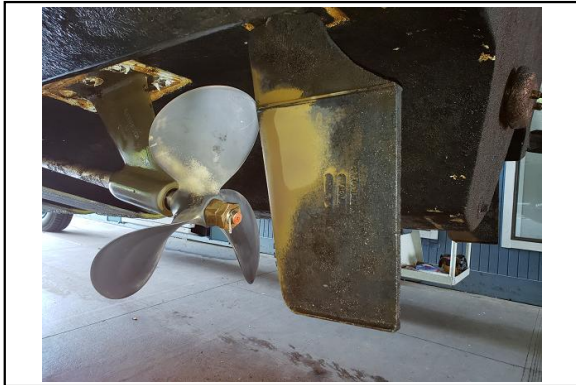
Rudder Outside View Port

The rudders, propellers (18R22) & propeller shafts and struts were solid with no movement noted.

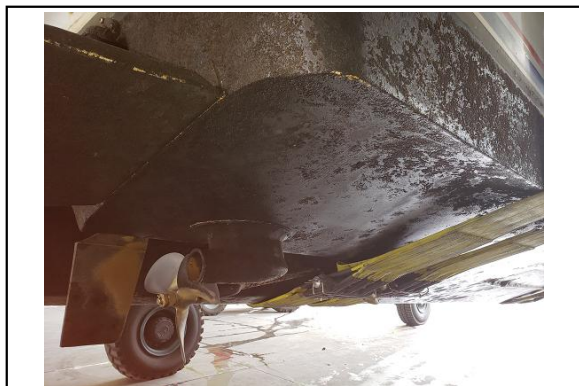
Bottom SB Aft

The bottom appears to be in good condition, it's paint relatively strong. No blisters were observed and the paint appeared to still provide adequate protection to the hull.

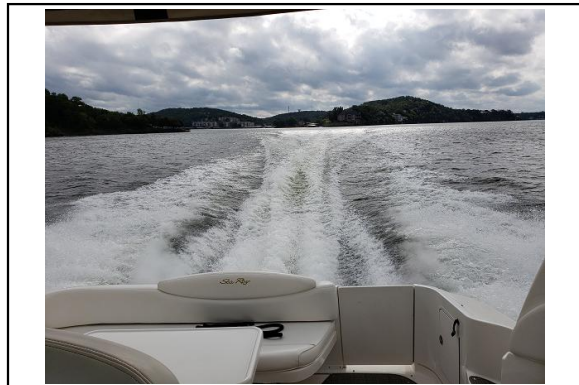
Sea Trial Port RPMs 4600

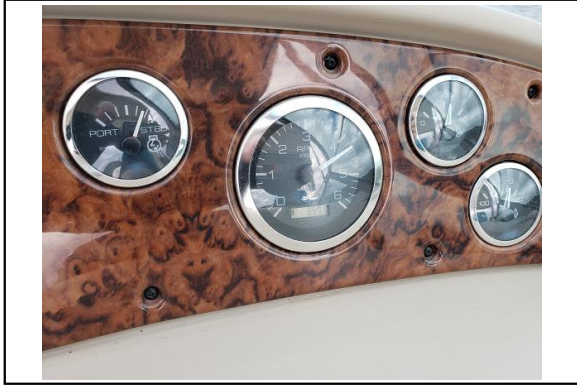
Sea Trial Starboard RPMS 4300
