**"2002 Sea Ray 340 w twin Mercury 8.1S Horizon engines"**  
***"Quinn-Tes-Sen-Tial"***

## **Report of Marine Survey**

Conducted by  
Brad Bolz

10-10-2018

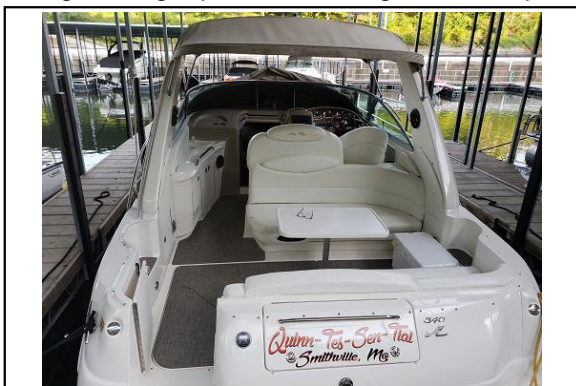
**Cockpit Overview**

The cockpit has flat wiring running around some of it's sole's exterior and the captain - navigator's area. This wiring provides blue light when triggered by a rocker switch at the far starboard edge of the helm station. A portion of this wiring no longer provides blue light and has pulled away from the cockpit sole's bulwark.

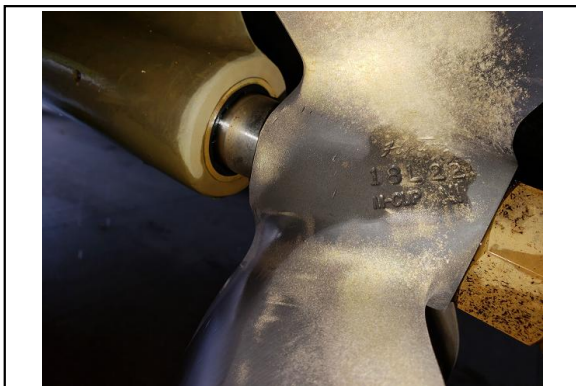
Propeller Info Port

\* **PROP SHAFTS:** The propeller shafts were tested during the haul out portion of the survey and found to be rock solid. The propellers had no movement in them and they appeared to be without deficiency. The propeller strut on the port side appeared to have been removed and replaced recently because white silicone was hanging loose. The starboard strut appeared to be original installation.

[A.1] The port propeller strut appears to have been removed and replaced recently. It seems likely that this strut is the source of the water in the port side of the engine compartment.

[A.2] The prop shafts do not have sacrificial anodes attached.

FINDINGS	RECOMMENDATIONS
<b>A.1 (PAGE 12) PROP SHAFTS:</b> <b>The port propeller strut appears to have been removed and replaced recently. It seems likely that this strut is the source of the water in the port side of the engine compartment.</b>	<i>Investigate, replace &amp; renew as necessary. If you can learn whom did this work, they may provide some sort of warranty.</i>
<b>A.2 (PAGE 12) PROP SHAFTS:</b> <b>The prop shafts do not have sacrificial anodes attached.</b>	<i>Add protective anodes to the prop shafts to guard against stray electrical currents and galvanic corrosion.</i>
<b>A.3 (PAGE 13) BATTERIES:</b> <b>The batteries positive terminals are not fully covered to prevent accidental shorts.</b>	<i>ABYC E-11 requires any continuously energized part to be physically protected with boots, an enclosure or some other cover. These are usually at the batteries and the connections in the starting circuit. Whether it's a positive battery terminal or the positive starter post, if it's not protected by overcurrent protection (breaker or fuse), then it needs a boot or enclosure.</i>

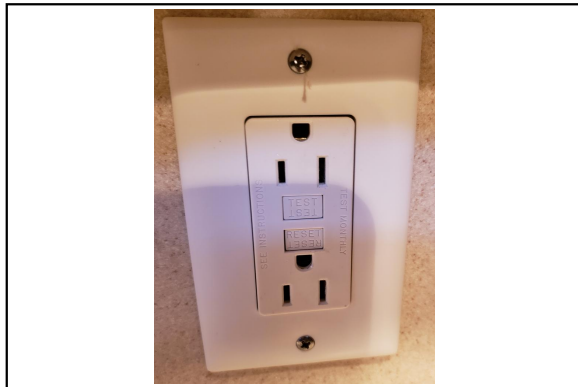
**OUTLETS:** Outlets in wet areas are protected by GFCI. The "on-deck" outlet is further protected by a self closing cover.

**Electrical Outlets are GFCI**

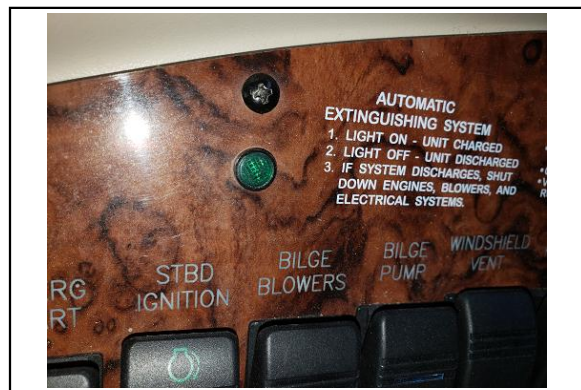
Helm Fire Extinguisher Shows Charged

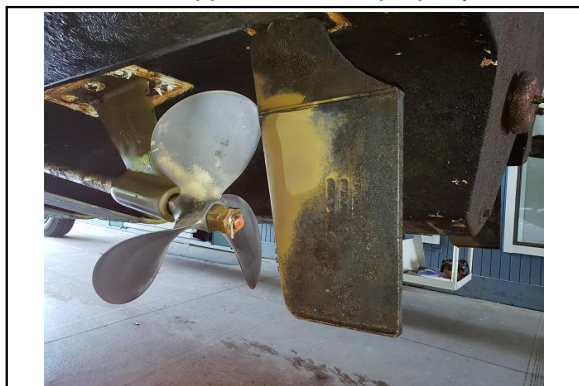
**Rudder Outside View Port**

The rudders, propellers (18R22) & propeller shafts and struts were solid with no movement noted.

The port side propeller shaft strut appeared to have under gone recent maintenance and the silicone used to seal the unit to the hull appears to be improperly selected.

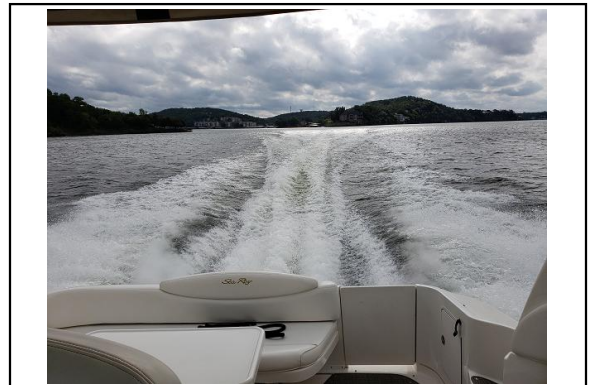
Sea Trial Proof (2)

Sea Trial Port RPMs 4600

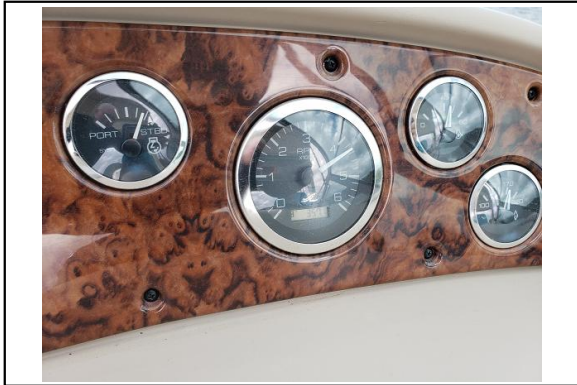
Sea Trial Starboard RPMS 4300
