**RE: West Central Fire District Station Scoping Services  
Phase 1 Report**

# ***WEST CENTRAL FIRE DEPARTMENT***

## **FACILITY ASSESSMENT**

# ABOITE STATION 180

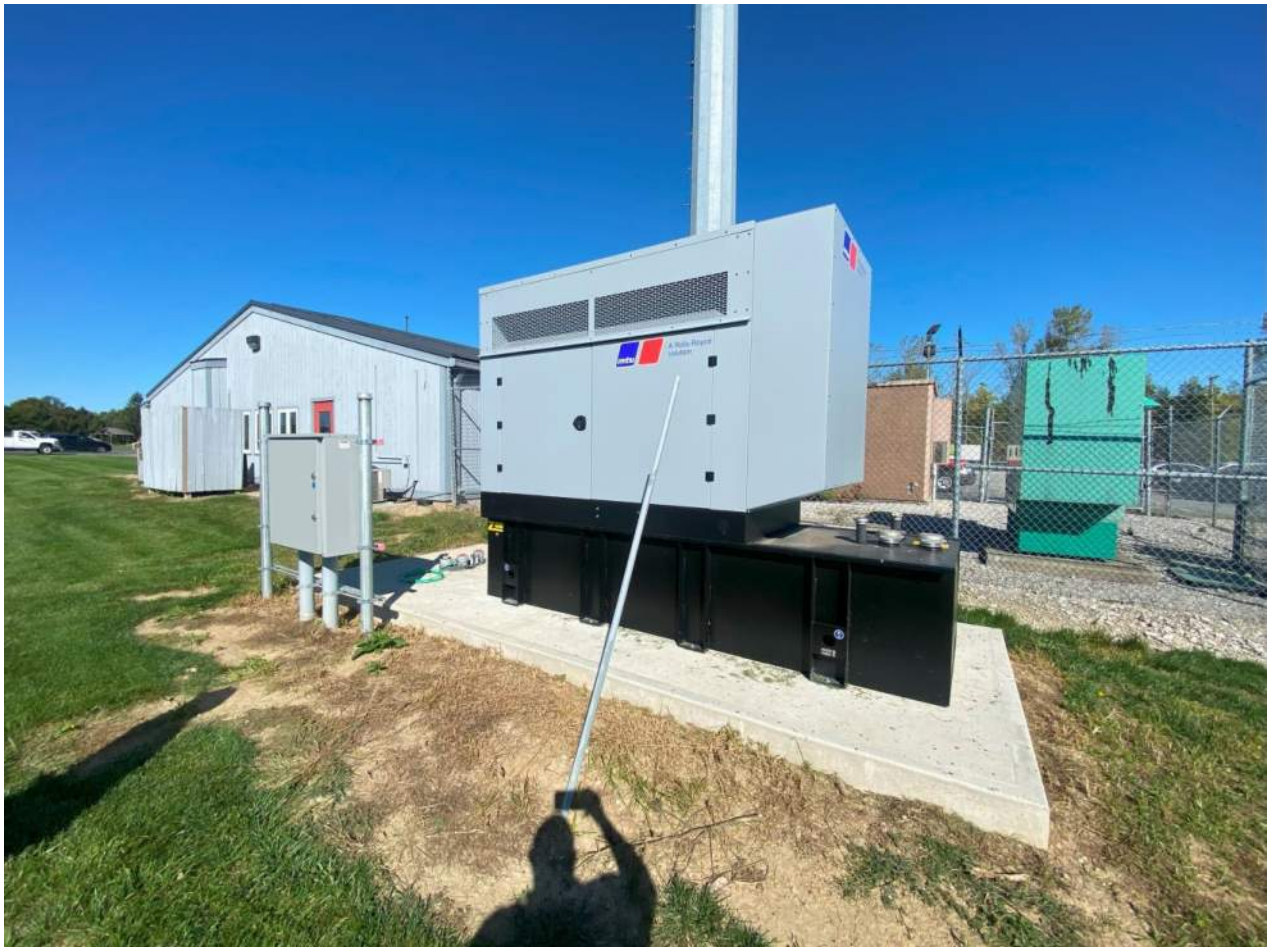
New MTU Diesel generator, installation in progress.

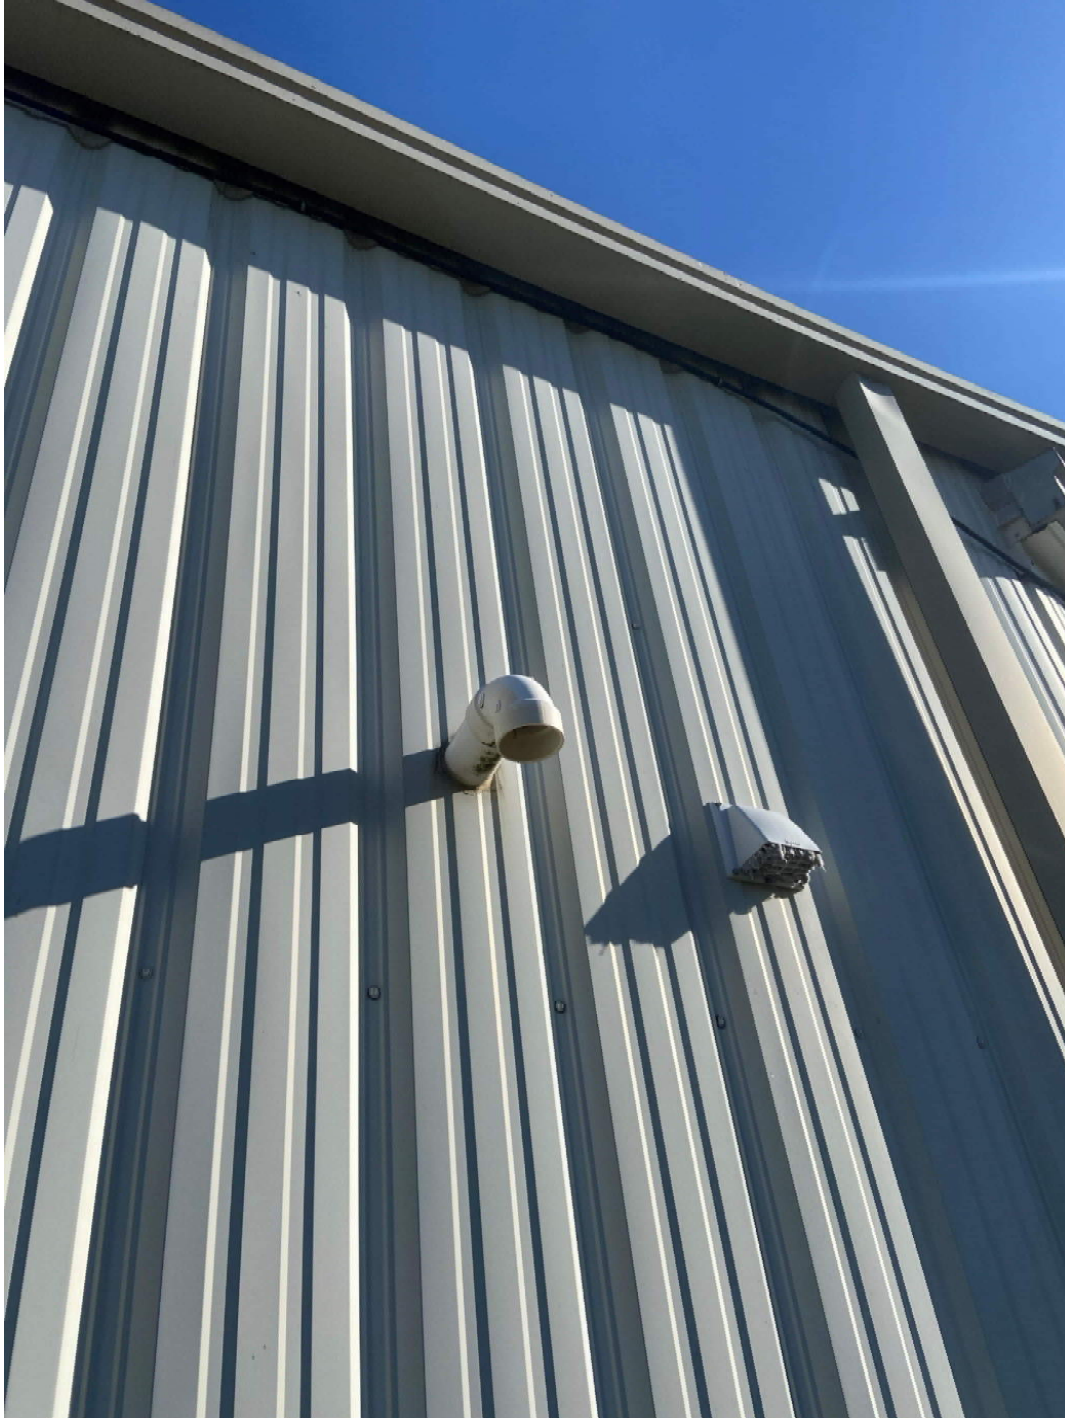
Dryer exhaust duct is tied to a general exhaust fan duct and has a birdscreen on the building termination vent that is clogging with lint. Dryer duct should be reinstalled as a standalone duct system without a screen at the termination.

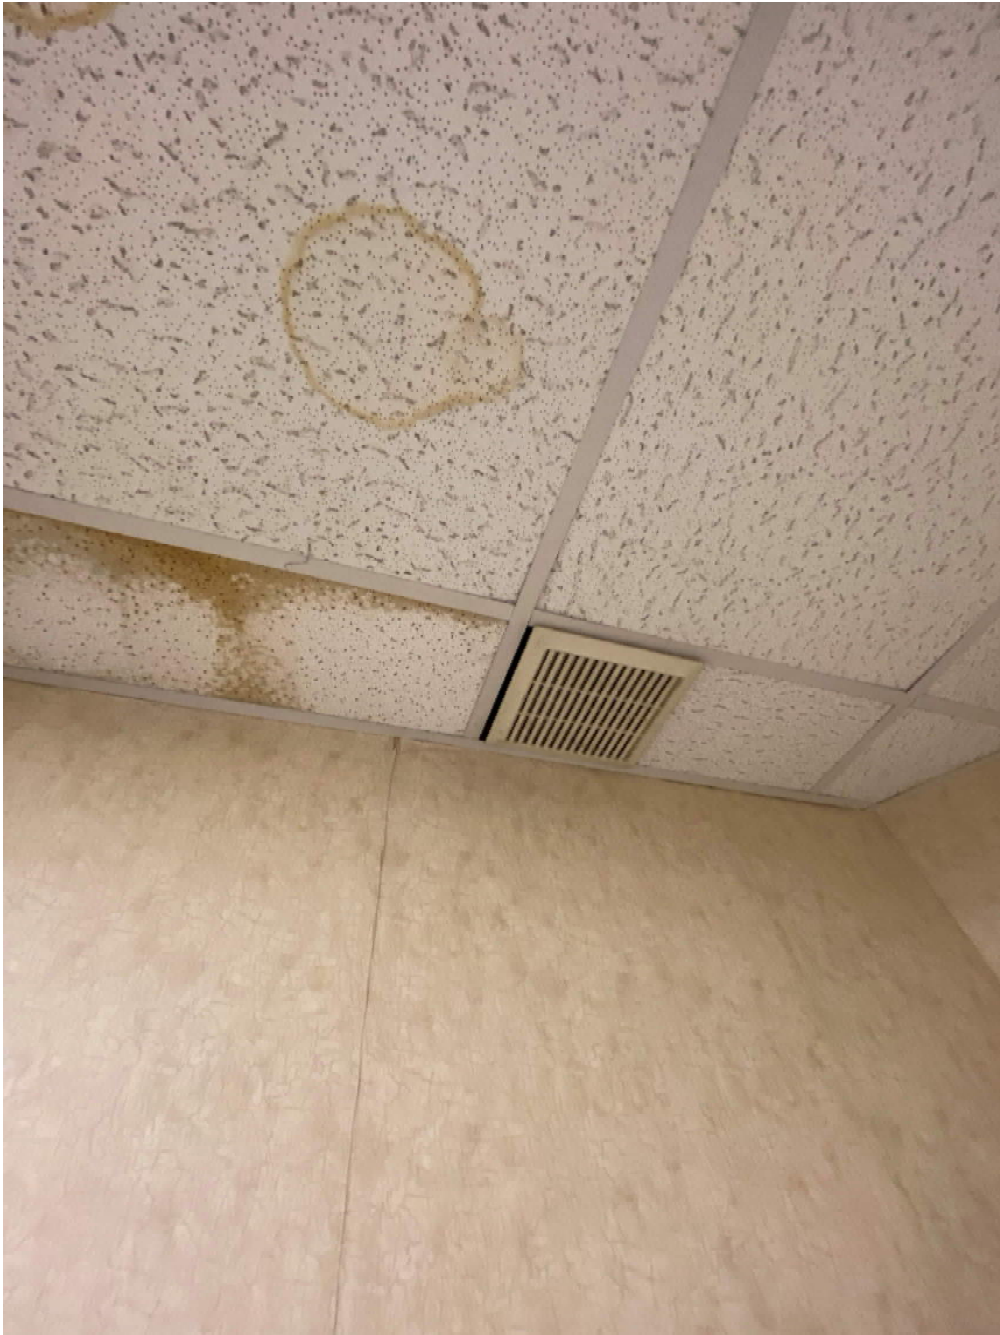
Ceiling exhaust fans in bathrooms are at end of life. Additionally, several bathrooms do not have code required exhaust. Recommend installing new exhaust fans for all bathrooms (4 total)

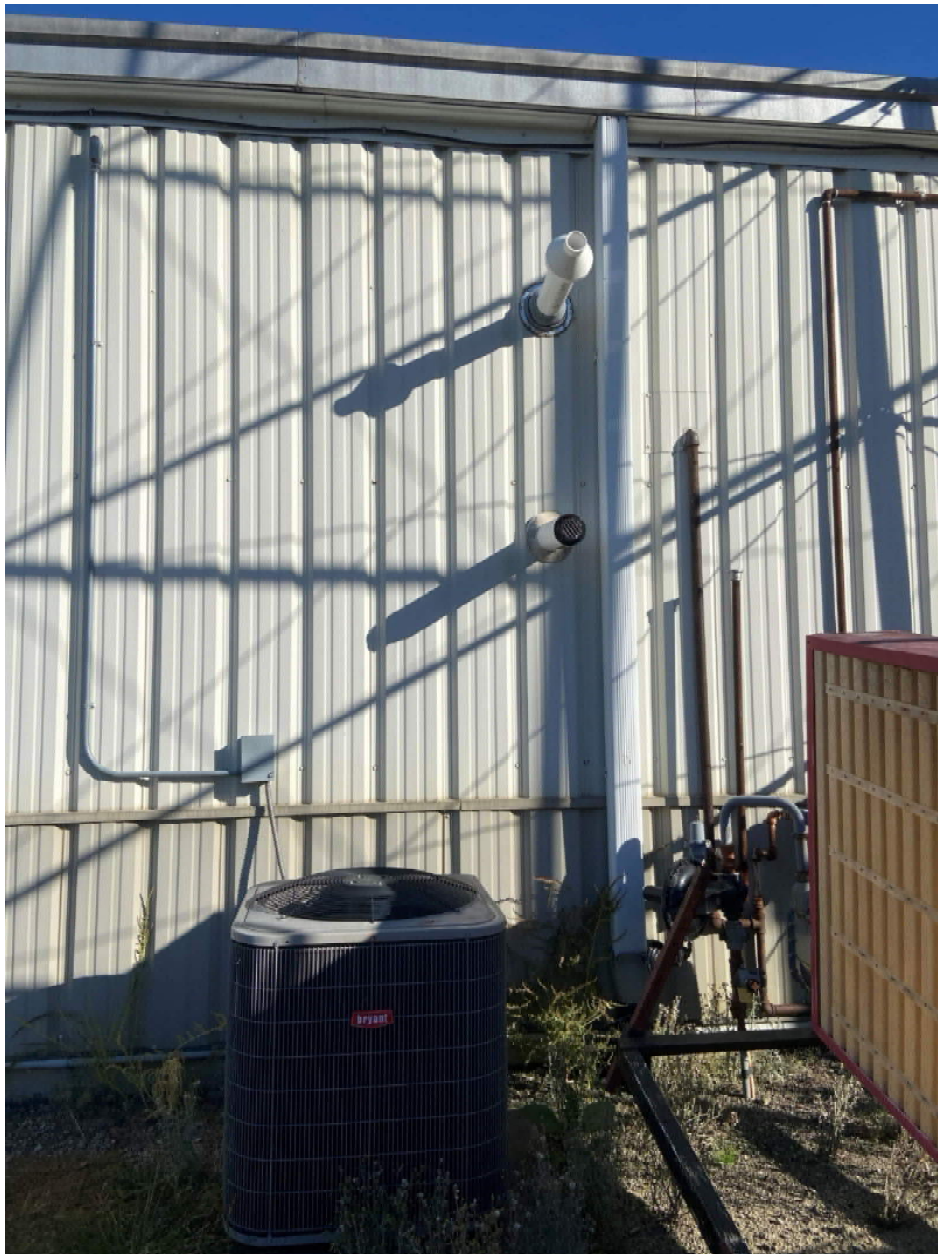
Existing main building HVAC has no ventilation intake. A new outdoor air intake must be installed to meet current codes.

Existing main building HVAC installed in 2015. Equipment has approximately 7-10 years of life left. Equipment is single stage equipment which is not well suited for systems supplying continuous outside air ventilation. A system with at least 2 stages of cooling is recommended for this use to prevent humidity issues. Recommend replacement of system to allow for adequate performance with ventilation and to refresh the lifespan of the systems to match other renovation work.

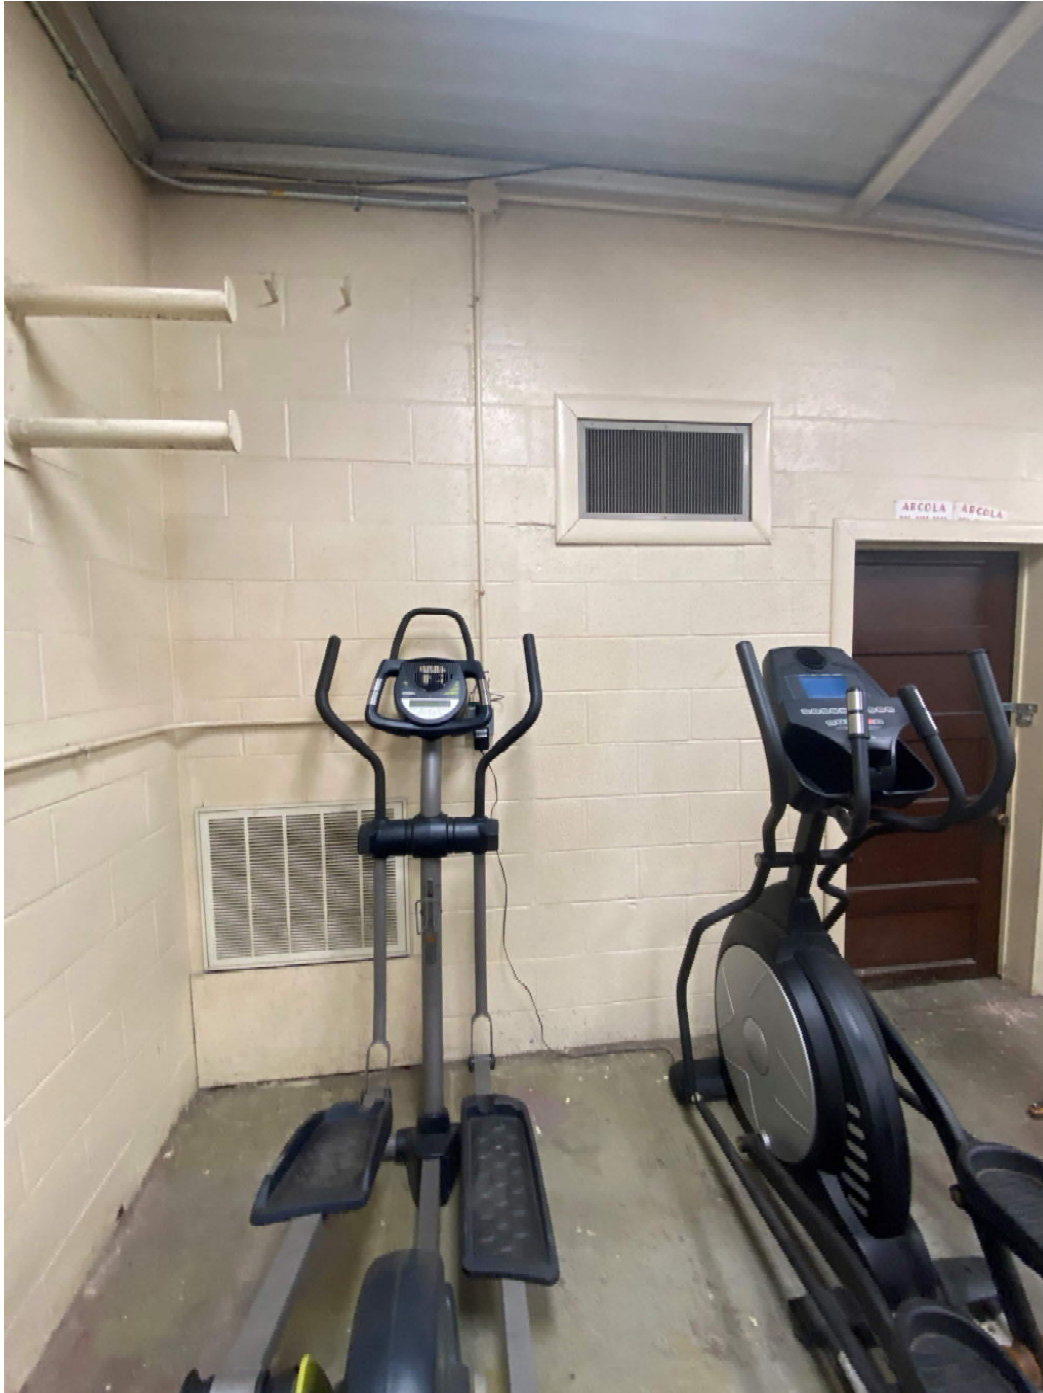
Old half of building served by a single heating only furnace. The furnace is at end of life and should be replaced. This half of the building also has no ventilation and will require exhaust systems and unit heaters if intended to be used as a vehicle bay. If intended to be used as living space/storage a new split AC system should be provided.

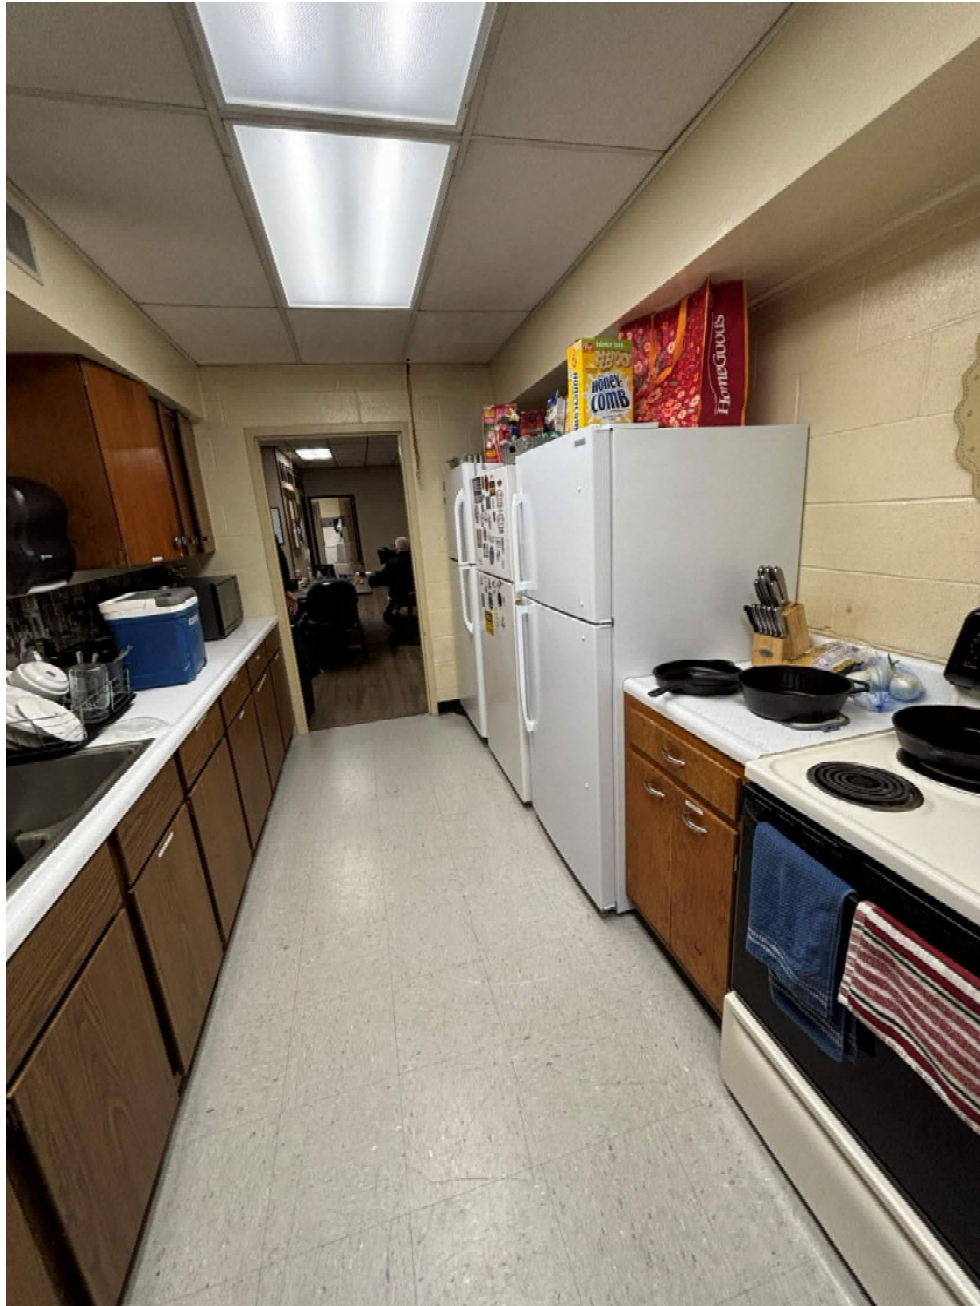
Existing stove does not have a hood installed above it. A new range hood should be installed to meet current codes.

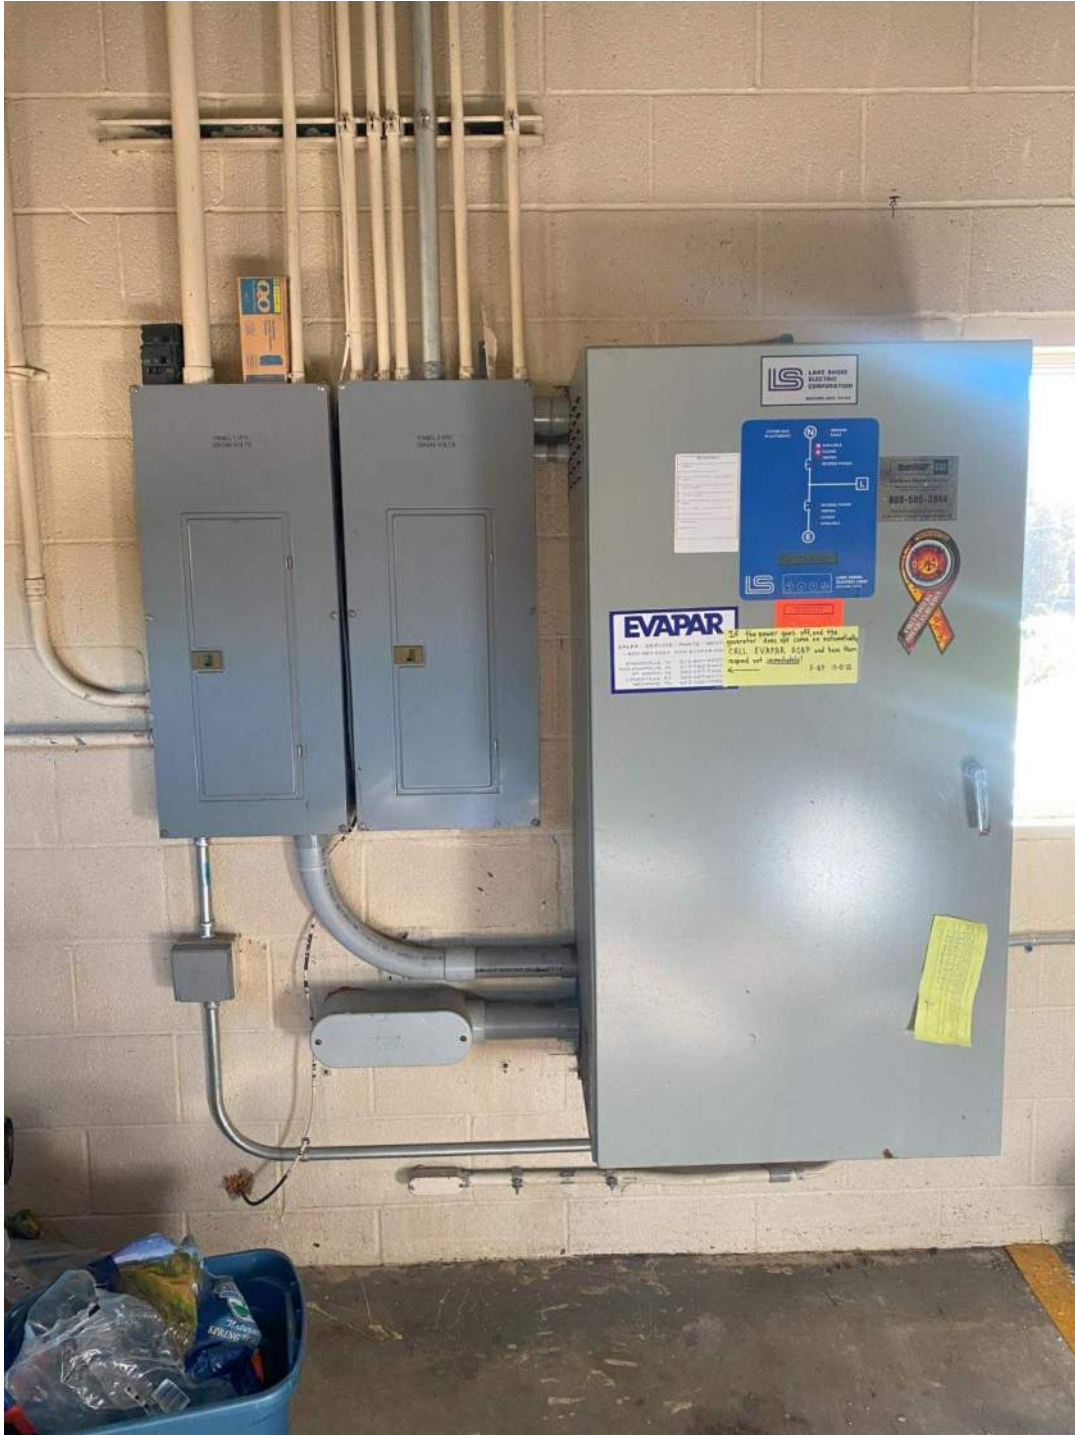
Existing electrical service and transfer switch.

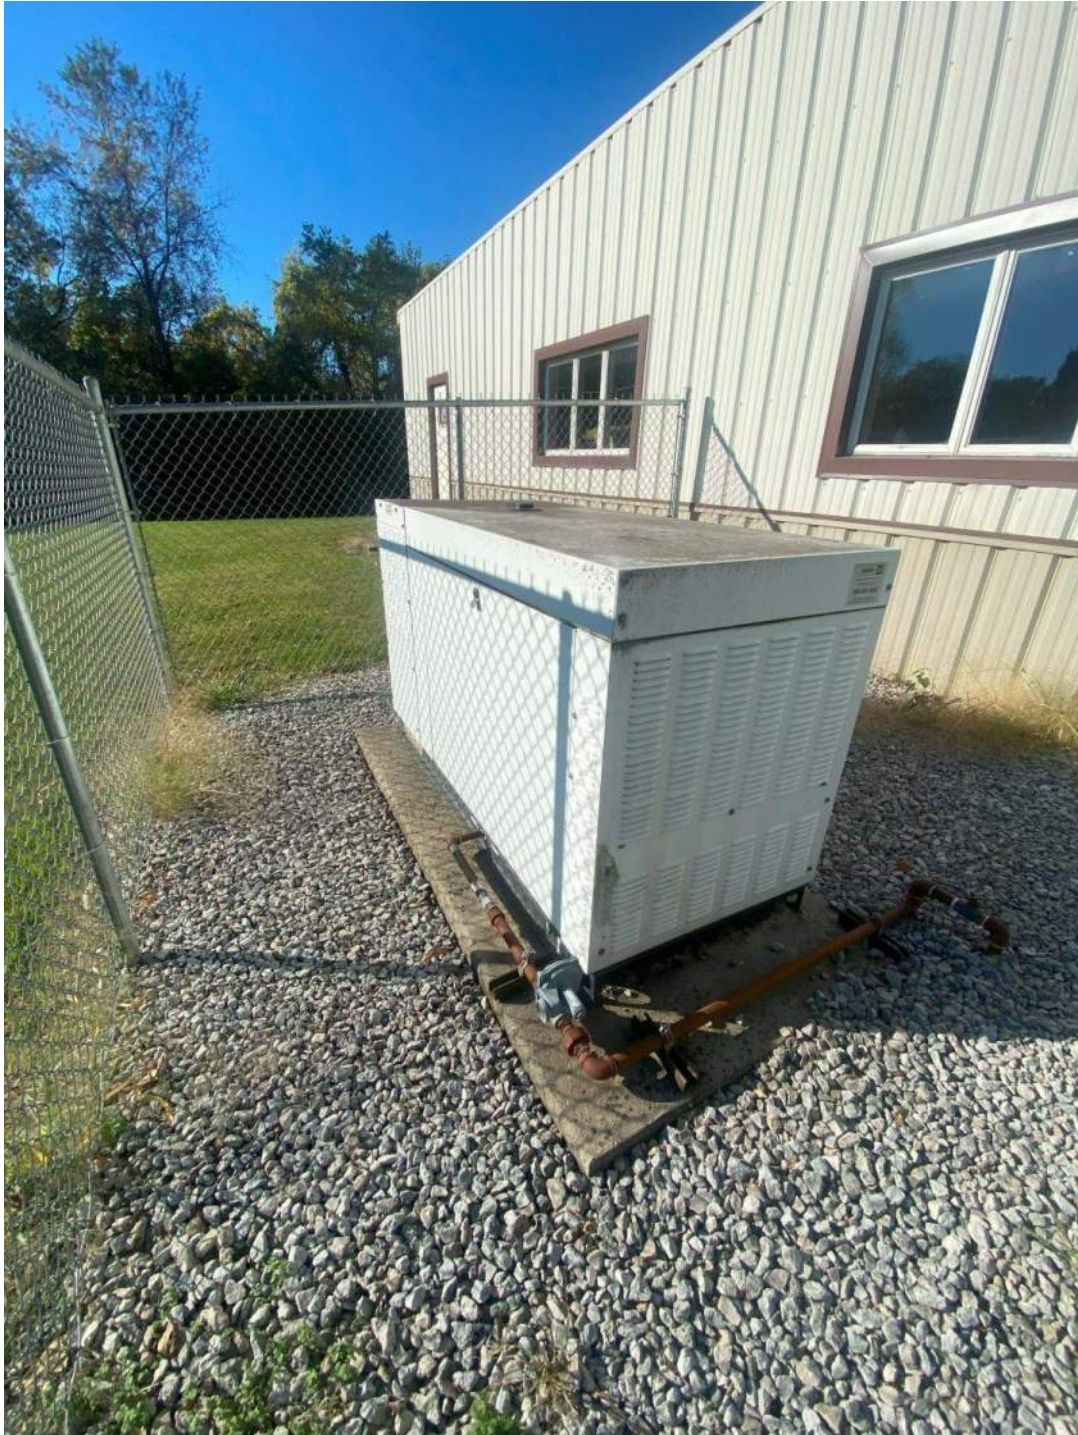
Existing generator.

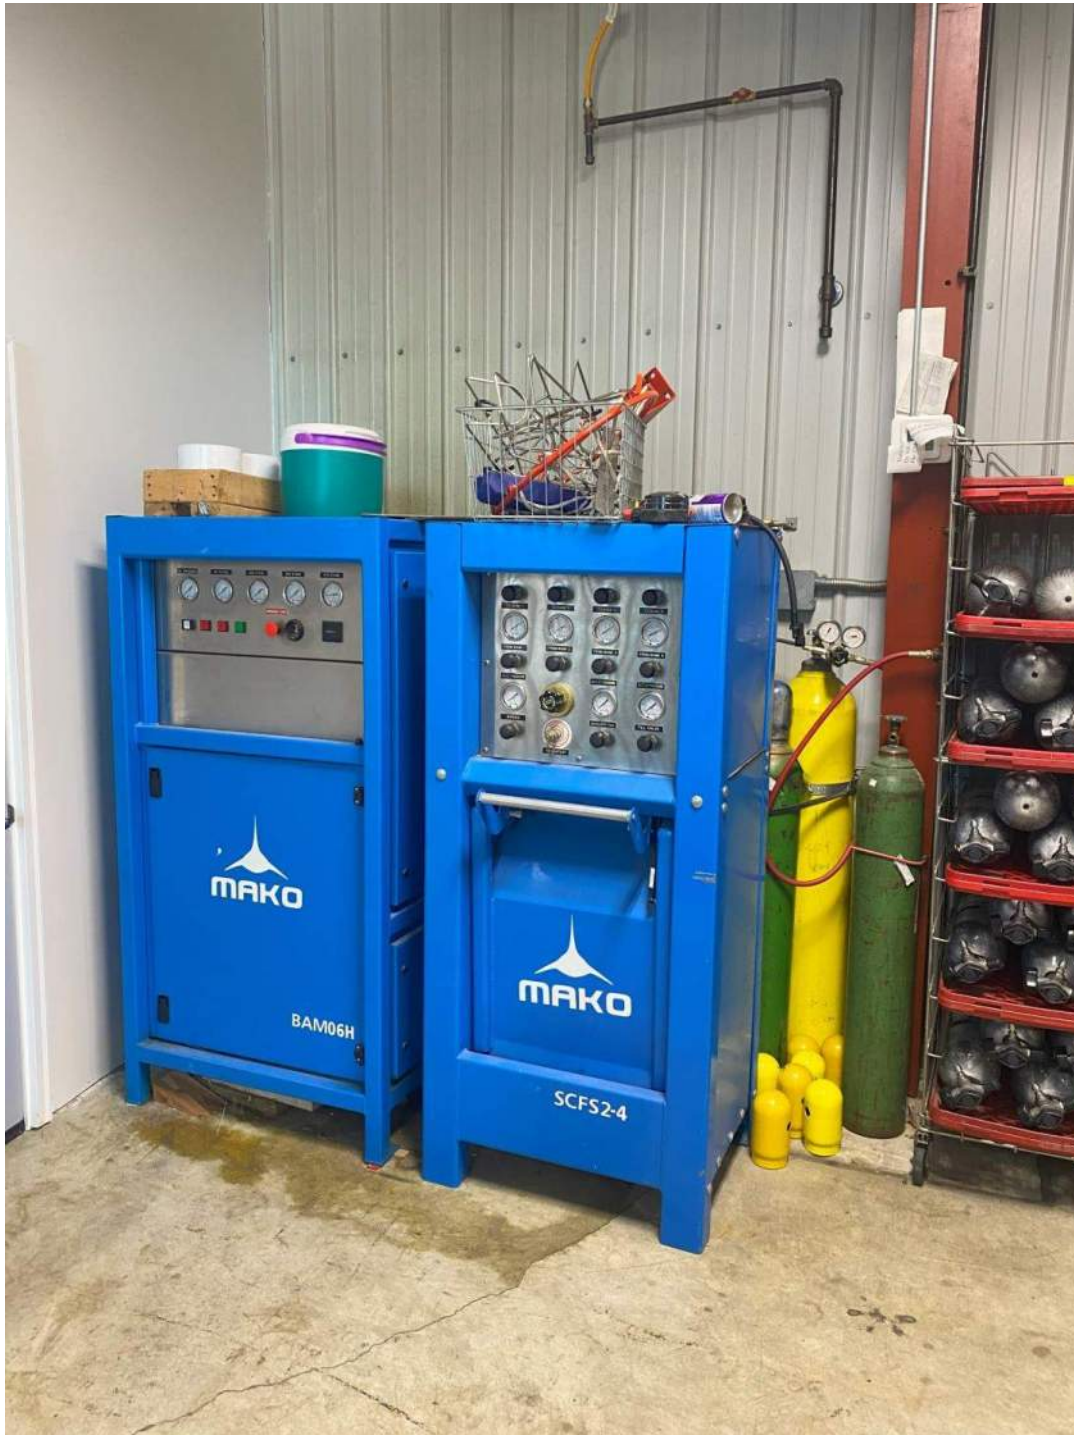
Existing SCBA compressor that trips breaker whenever turned on. Also, is not owned by the fire station, is owned by Arcola Inc.

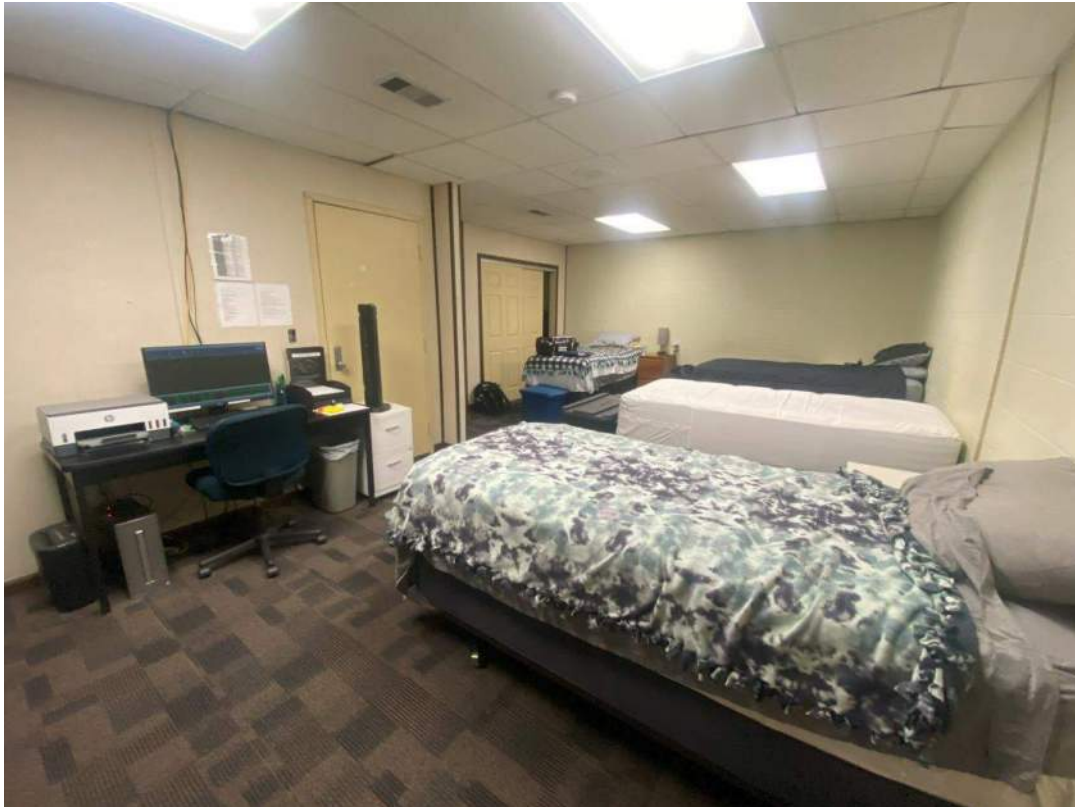
Existing PC used for the Spillman software that resides within Bunk Room because there is no dedicated office.
