Re: Former Deer Run Golf Club Property, Located at the Northeast Quadrant of Red Bug Lake Road and Eagle Circle, within Unincorporated Seminole County, Florida

Facility Conditions Assessment Report

GAI Consultants Community Solutions Group in association with **Rhodes+Brito Architects** developed this Conditions Assessment Report for the Deer Run Country Club facilities for the **Seminole County Leisure Services Department, Greenways and Natural Lands Division**. The Deer Run Clubhouse is located at 300 Daneswood Way, Casselberry Florida 32707. The Golf Course consists of an 18-hole course and is surrounded by residential property.

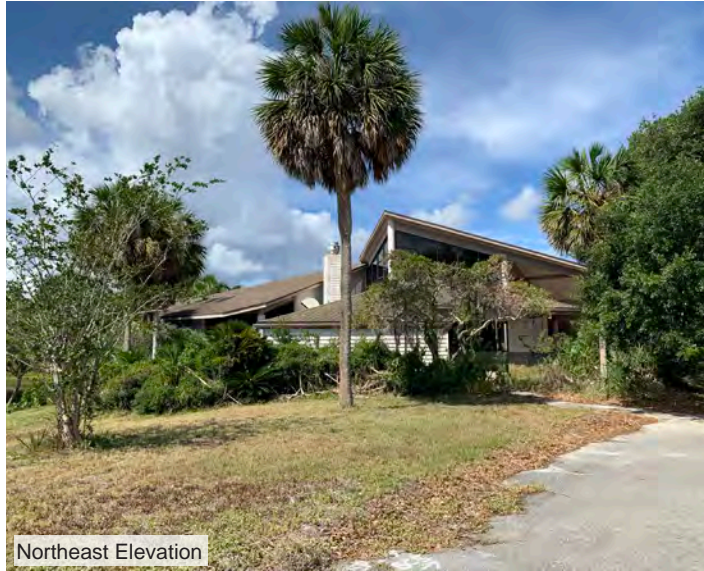
BUILDING ENVELOPE= 11,572 sq.ft.

- Portions of the building envelope have vegetative overgrowth
- Exterior siding has dirt build-up and portions of siding is in need of repair
- Building structure seems sound
- Needs paint
- Repair gutter system
- Entry handicap ramp too steep
- Several holes detected in siding
- Wood rot in several areas

- Cut back overgrown vegetation on exterior walls
- Clean and paint exterior walls
- Patch and repair siding where needed
- Update gutters
- Provide an accessible route into the building

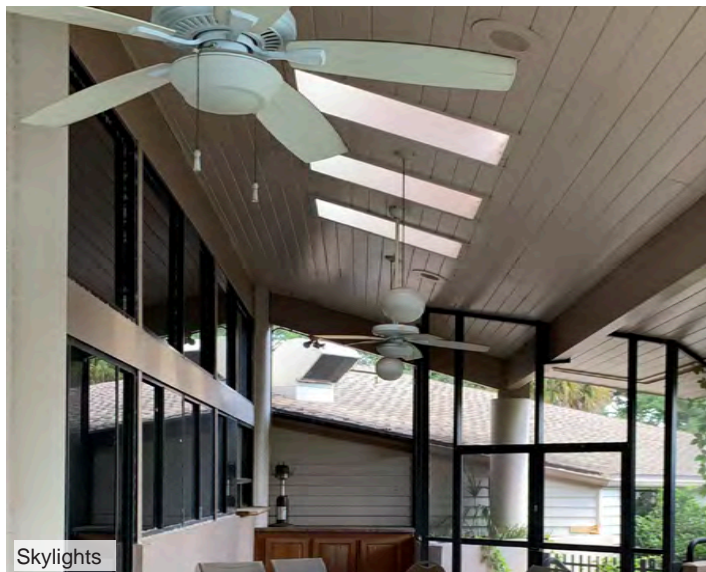
Skylights

- Some doors and associated trim have water damage
- Some of the maintenance doors are damaged
- Overgrown vegetation on windows and doors
- Windows are non-insulated single pane

- Replacement and cleaning of windows, skylights, storefront, doors, and hardware where needed
- Clean and repaint framing of fenestrations where needed
- Replace threshold
- Seal all points

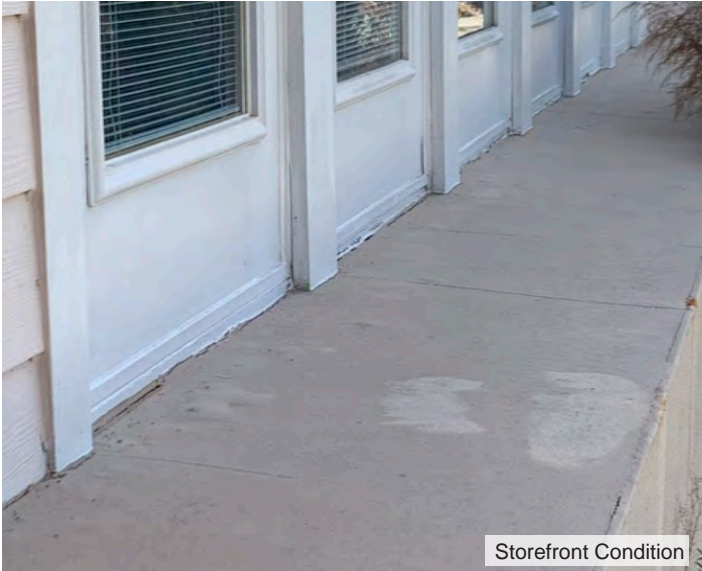
Storefront Condition

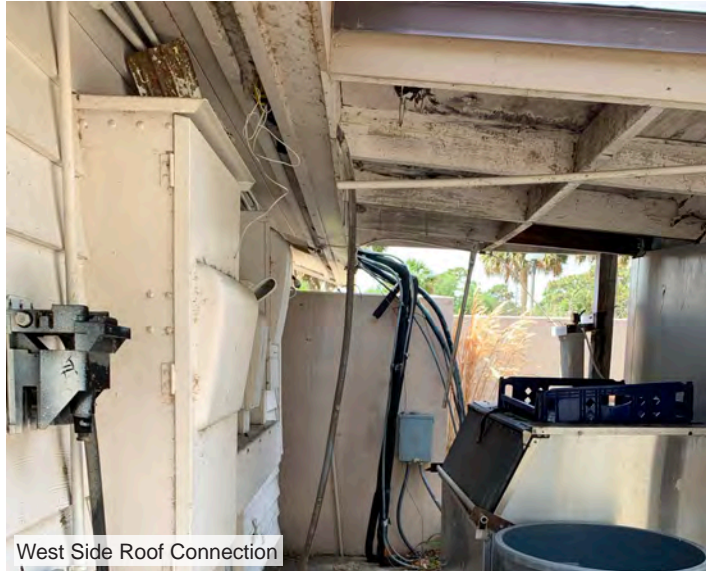
West Side Roof Connection

- Main room looks good, should have several more years of serviceable life
- Roofs near service area and external restrooms have structural and water damage
- Downspouts and some gutters are damaged
- Areas of roofs have openings

- Replacement of gutter system
- Clean and repaint soffit
- Replace damaged roof structure and roofing

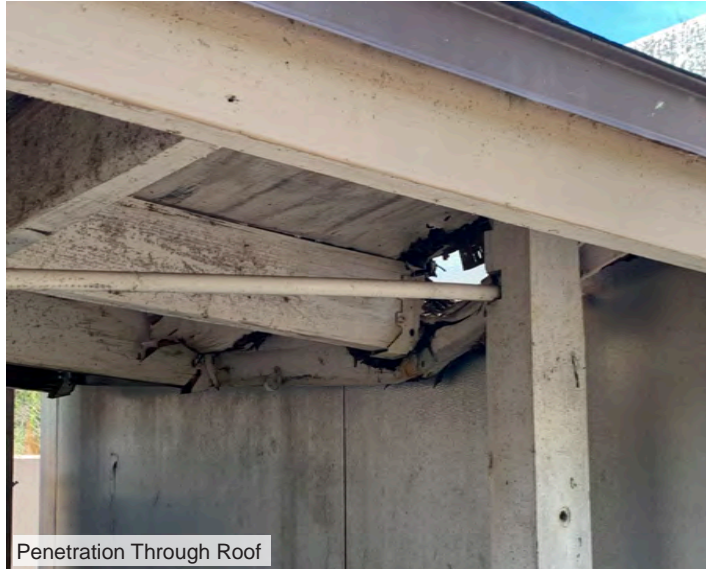
Penetration Through Roof

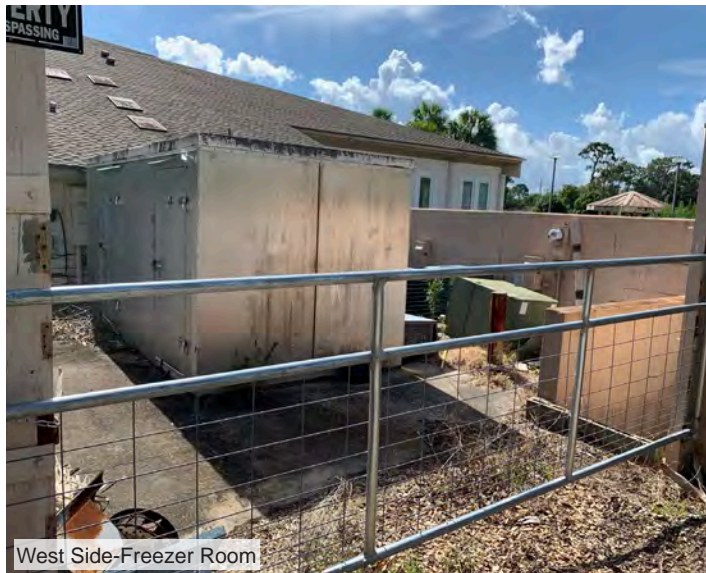
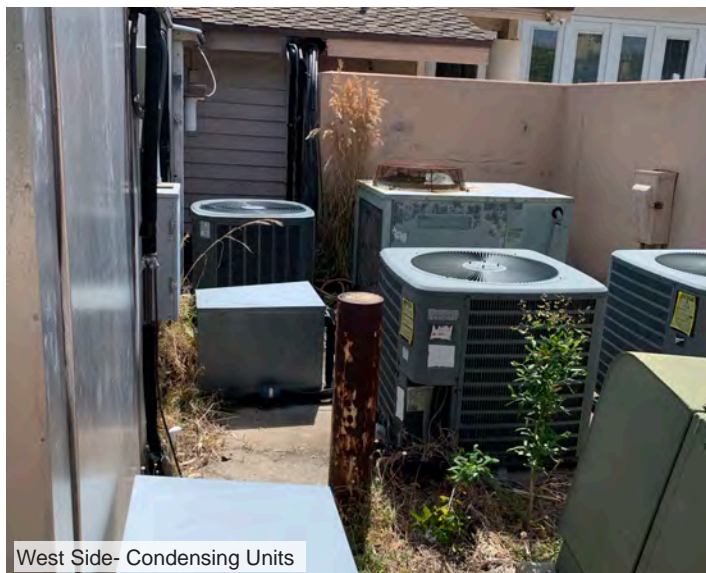
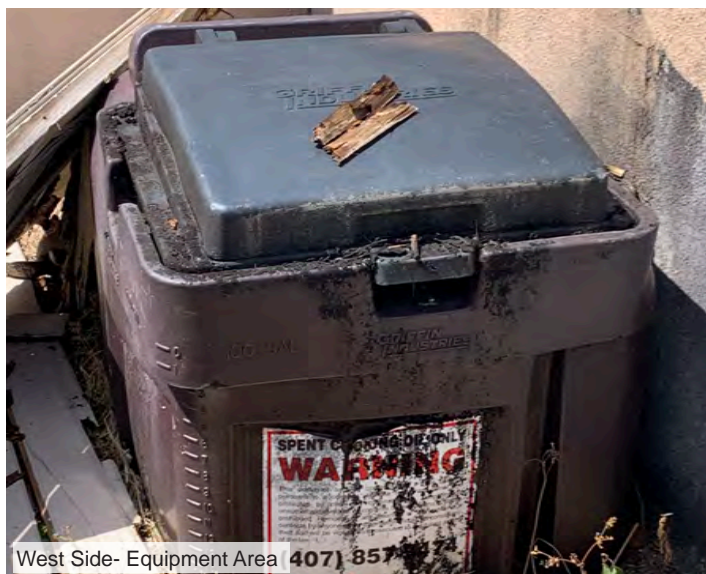
Equipment

- HVAC condensing units lack adequate space
- HVAC system appears to be at the end of its serviceable life
- Swimming pool is no longer in service
- Overgrown vegetation around equipment and pool area
- Freezer room exterior panels are damaged
- Rusting of pool pump room door
- Unable to review locked walk-in freezer

- Remove overgrown vegetation around equipment area
- Replace HVAC system
- Fix damaged panels on freezer room

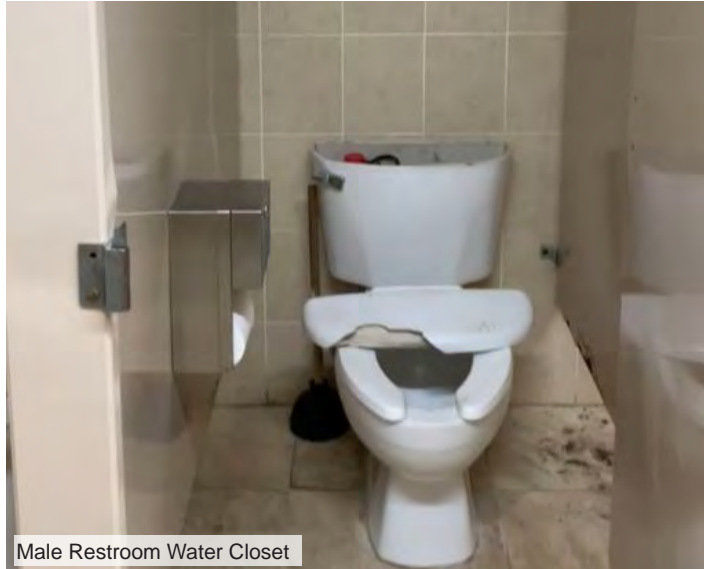
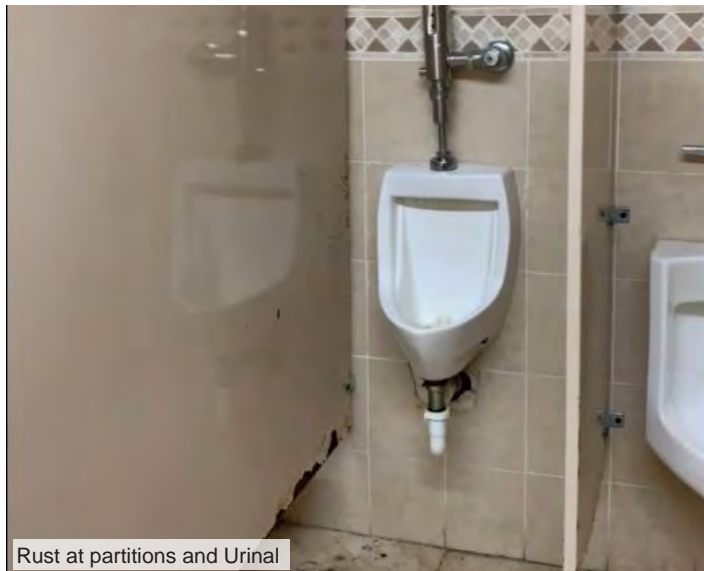
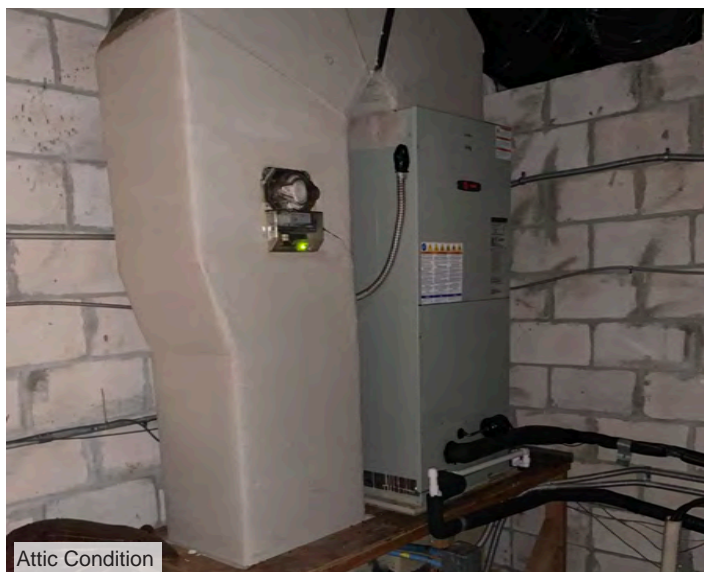
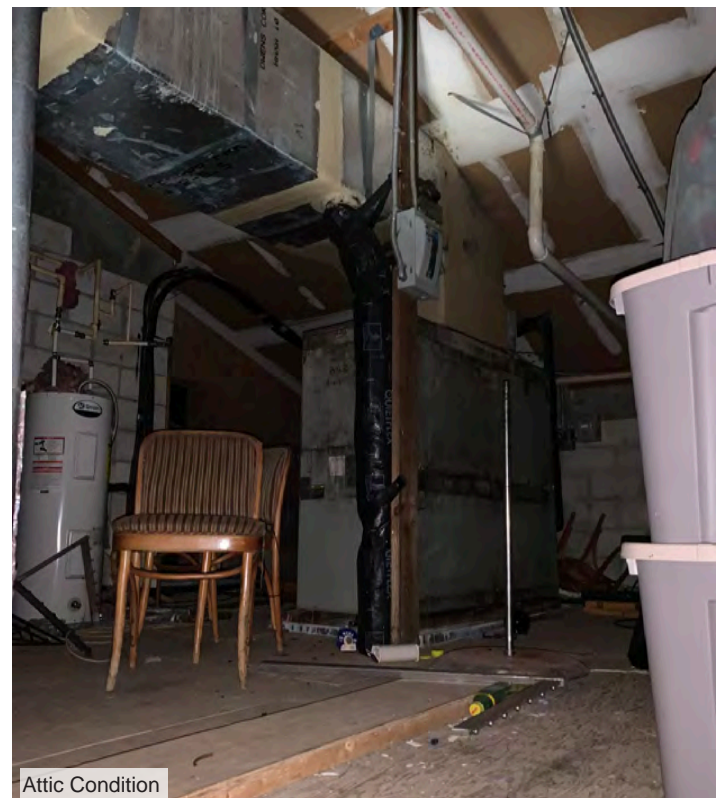
Furniture, Fixtures & Equipment

- Broken toilet elements in men's restroom
- Broken elements and debris in storage areas
- Rusting bathroom partitions
- Wear and tear on kitchen equipment
- Restrooms are not ADA compliant
- Most of the electrical panels do not have spares; does not meet building code
- HVAC at the end of its life span
- Flooring needs updating

- Repair or replace bathroom fixtures and partitions where needed
- Repair and/or replace kitchen equipment
- Consult and electrical engineer to address the panel issues
- Test kitchen hood and Ansul system
- Service grease trap system
- Prep, repair, and paint all surfaces

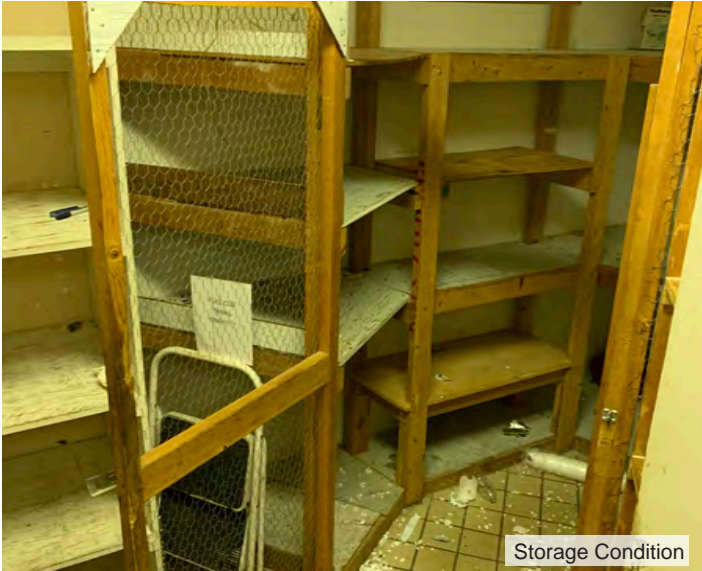
Storage Condition

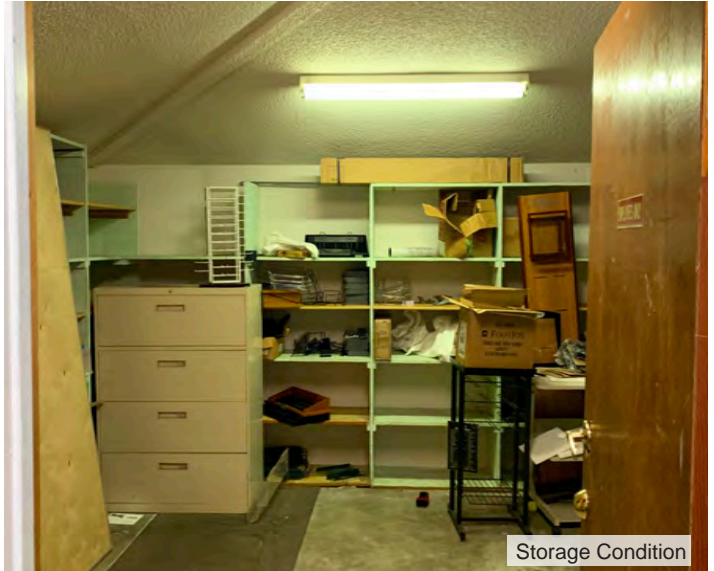
Storage Condition

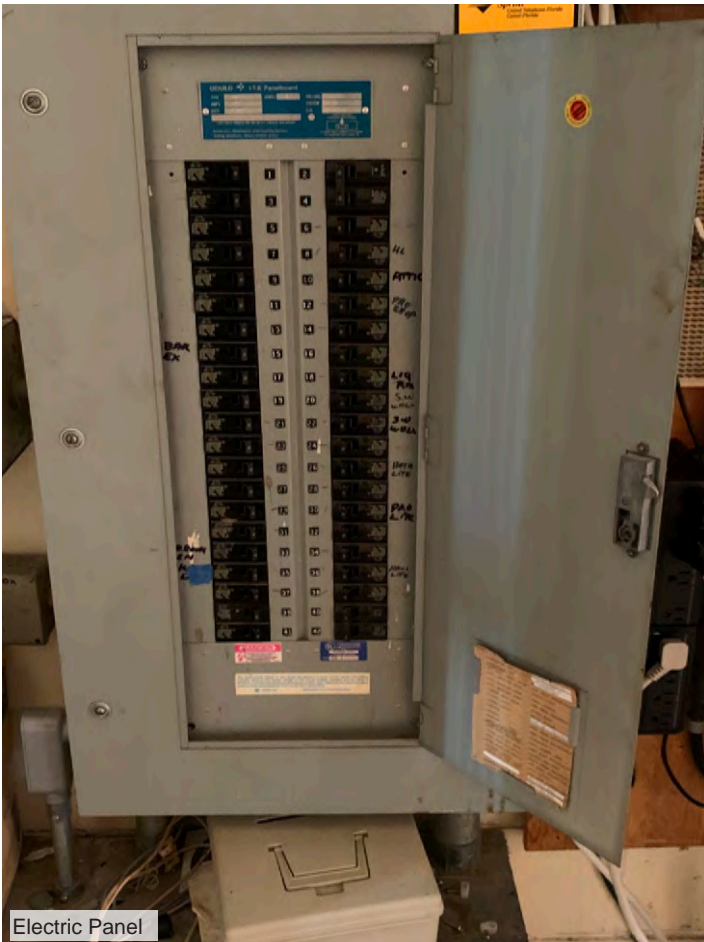
Electric Panel

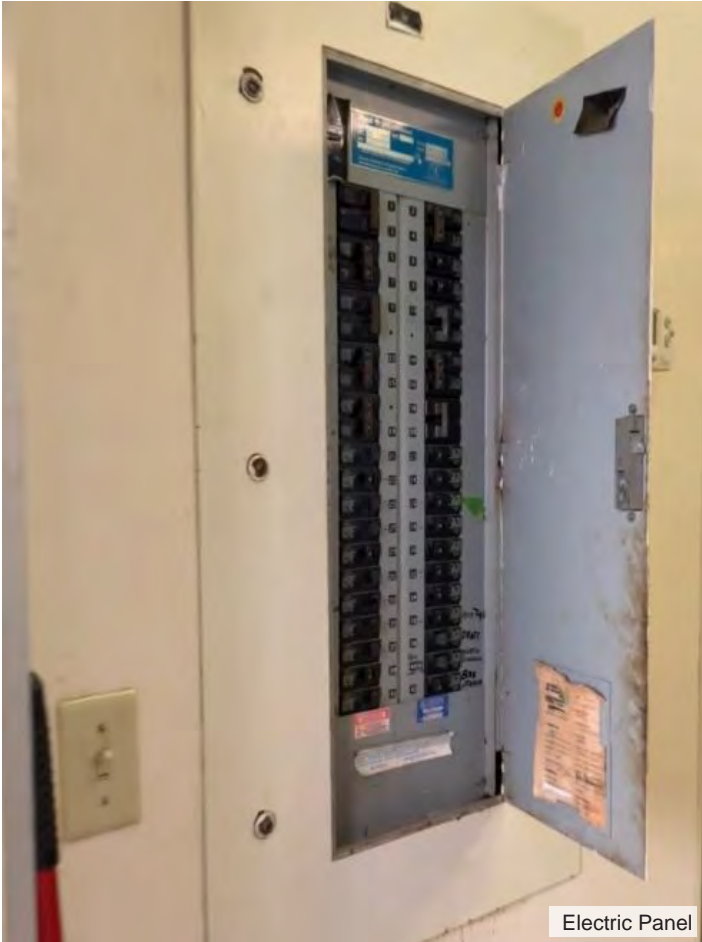
Electric Panel

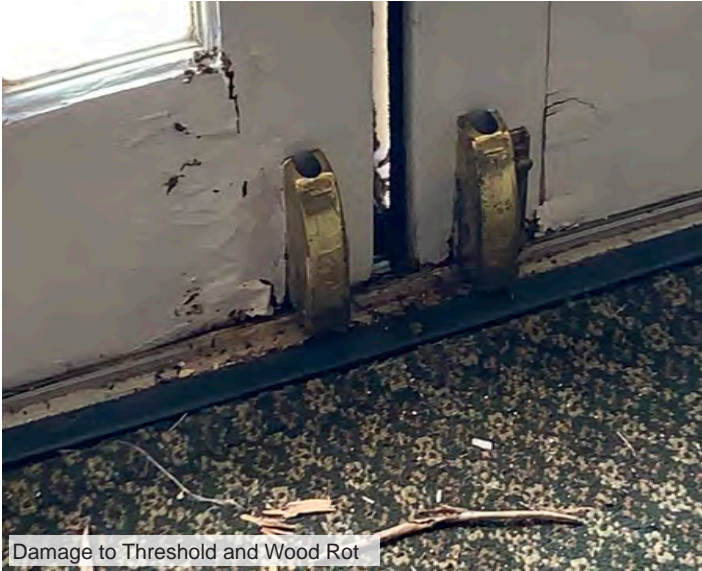
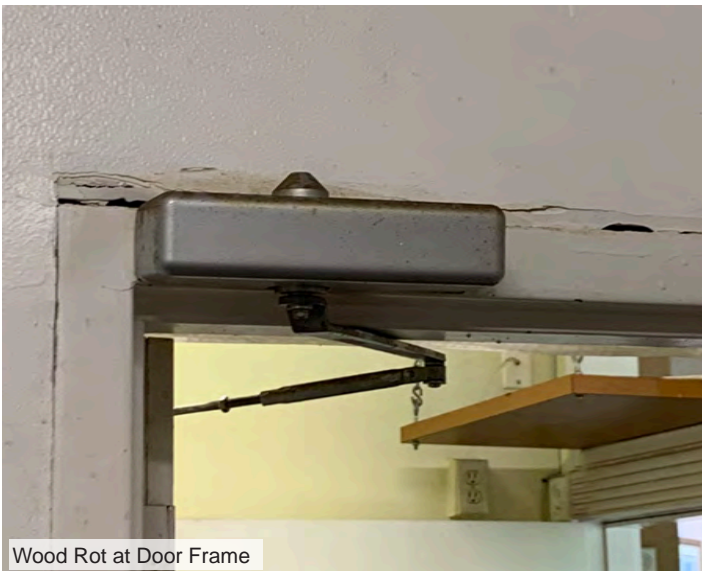
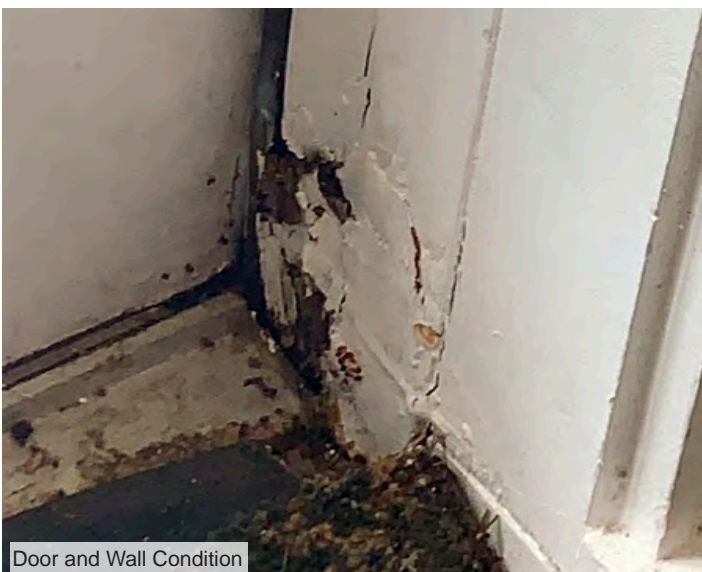
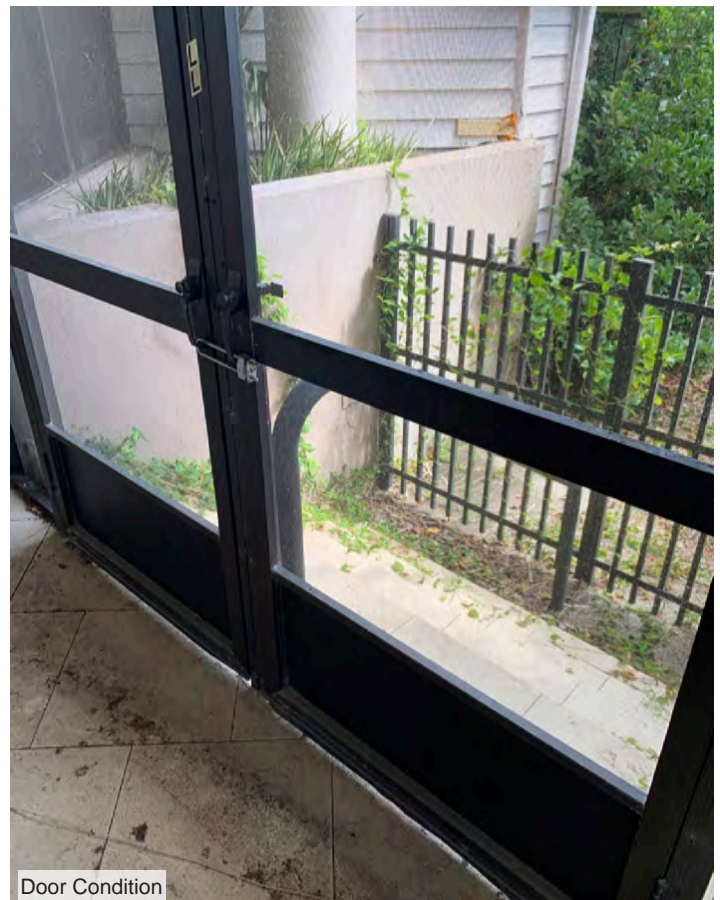
Door Conditions

- Wood rot visible at door frames and thresholds

- Replace all doors that have water damage issues

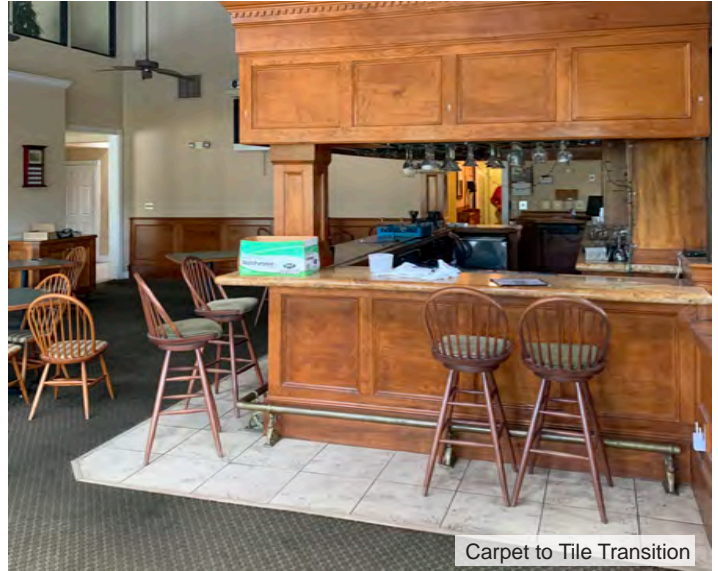
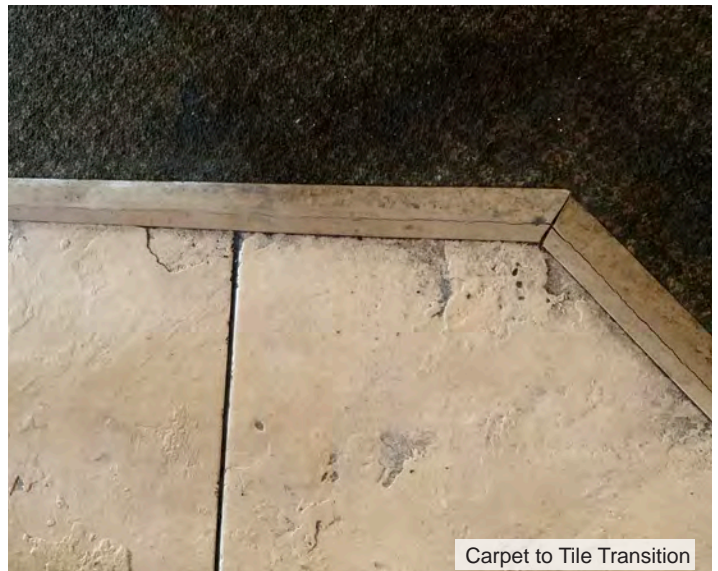
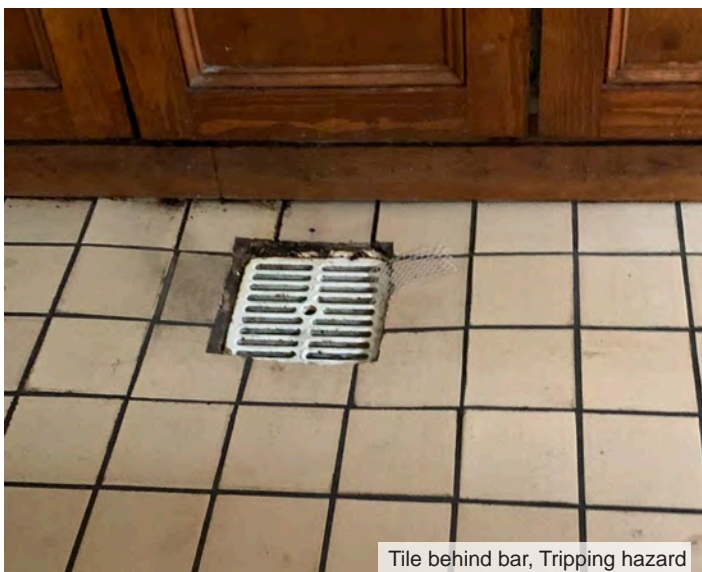
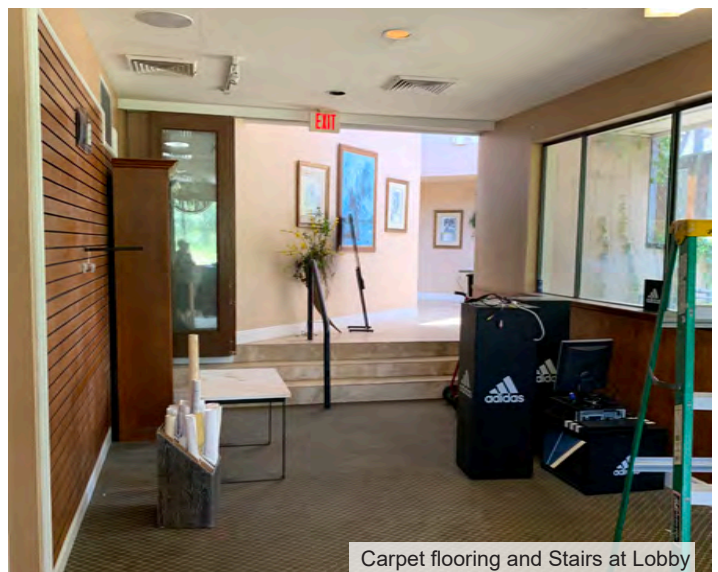
Floor Conditions

- Change in floor materials presents tripping hazards
- Carpet has mold
- Tripping hazard seen at drain area behind the bar
- Lobby area to shop is not ADA accessible

- Flooring should be replaced
- Floor drains should be repaired to avoid tripping hazards

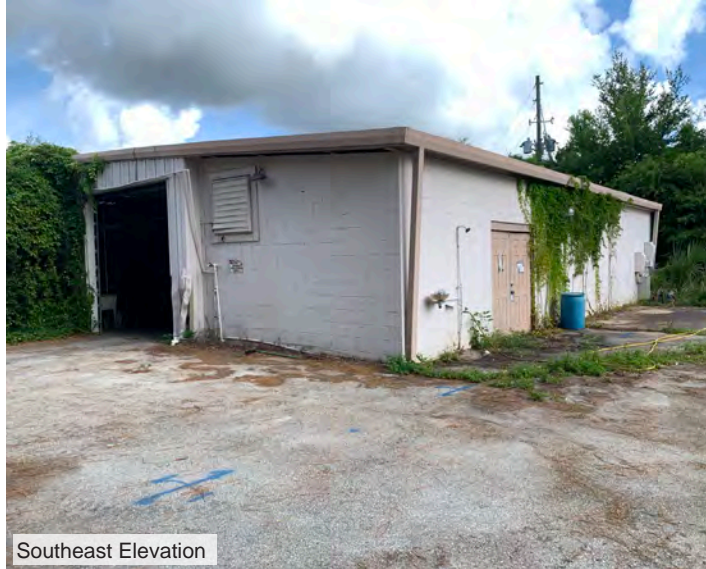
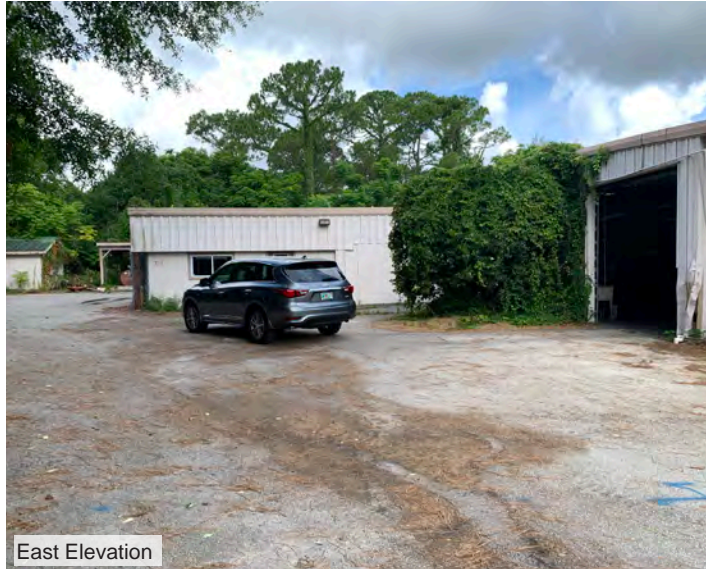
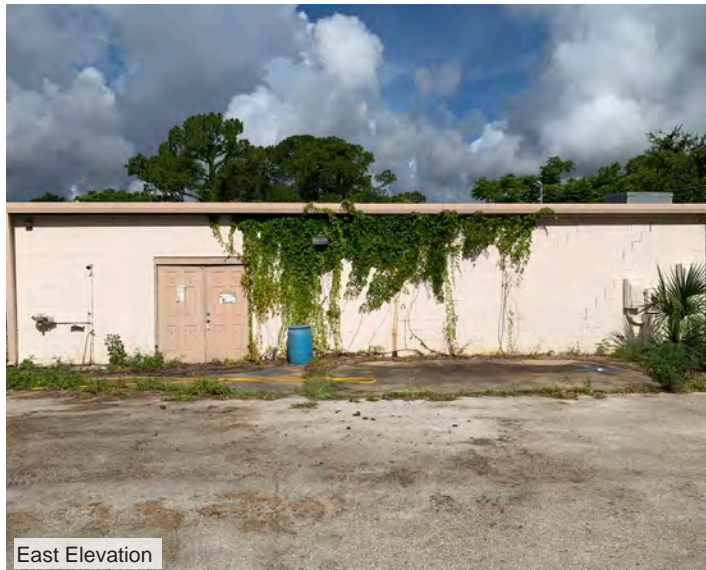
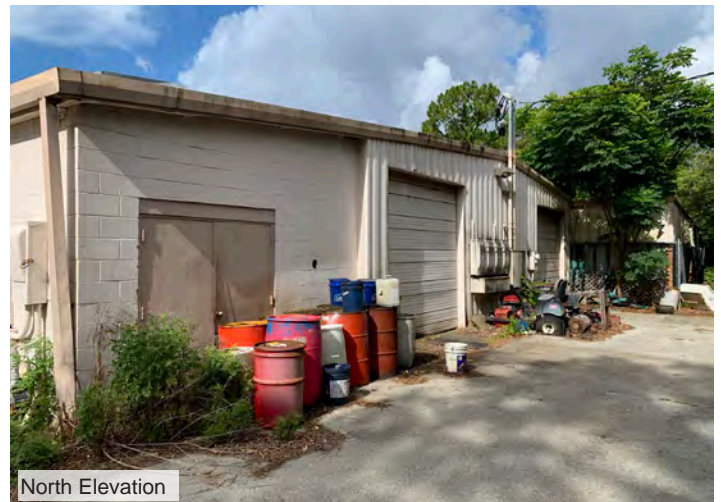
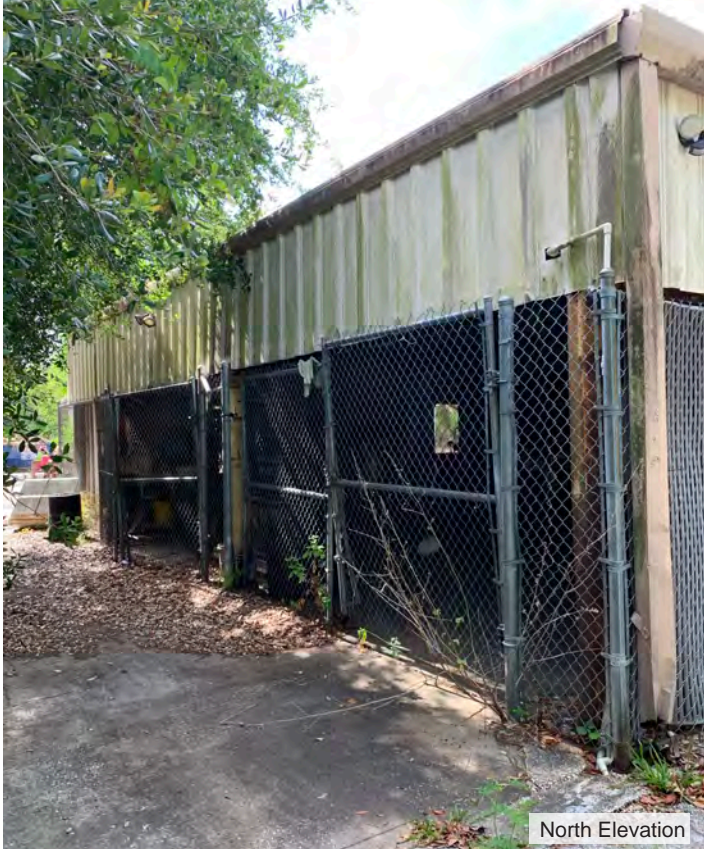
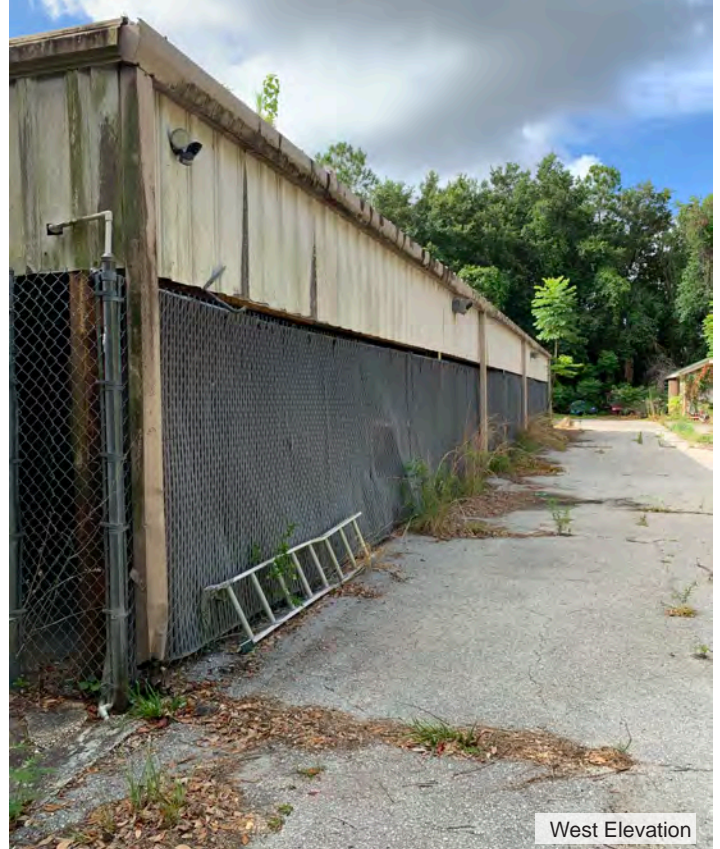
- Overgrown vegetation in various areas of the building envelope
- Cracks in the east elevation CMU infill wall
- Wear and tear in exterior finishes
- Damage to gutter and downspouts
- Damaged exterior lighting
- Exterior soffit material is missing
- No sign of insulation
- Fence enclosure is not operational
- Structural damage to several columns (due to vehicle impact) and beams (rust)
- Damage to metal siding

- Remove overgrown vegetation on building envelope and walkways
- Repair cracks in CMU wall
- Clean and repaint exterior walls
- Replace exterior lighting
- Replace gutter and downspout system
- Repair structural damage
- Install shop ventilation system
- Repair roof
- Install new fence gates

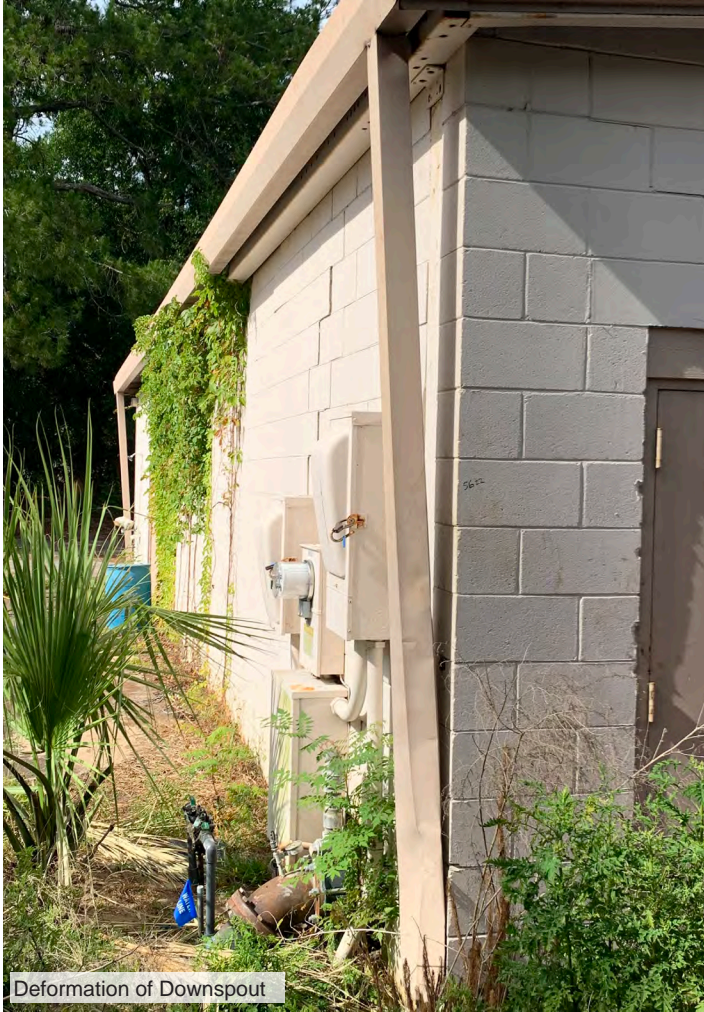
Deformation of Downspout

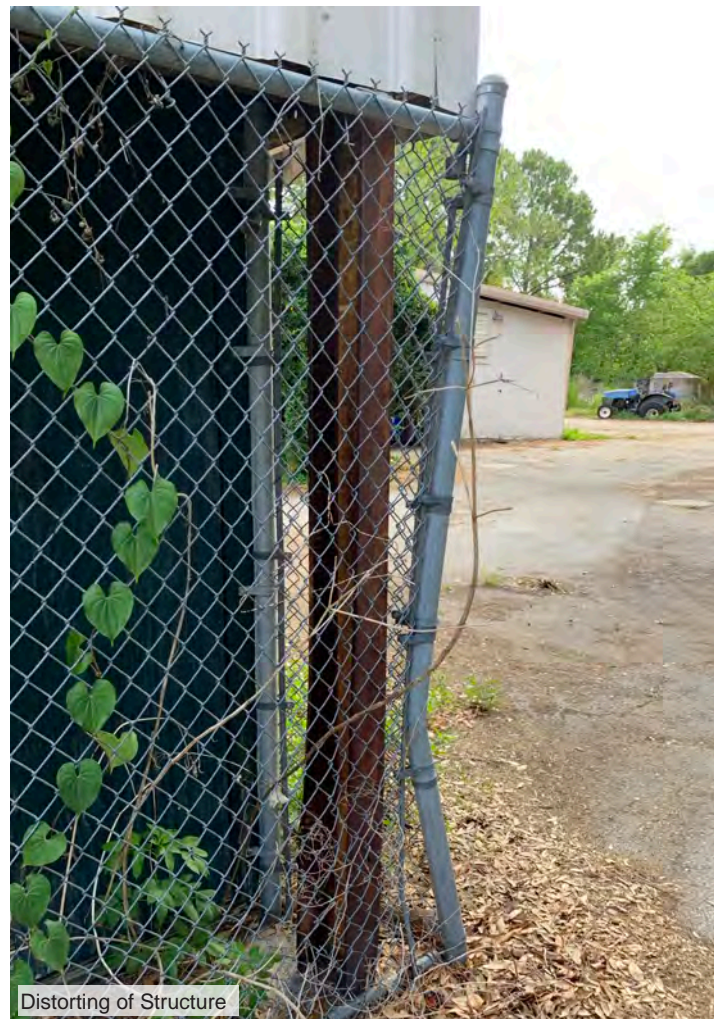
Distorting of Structure

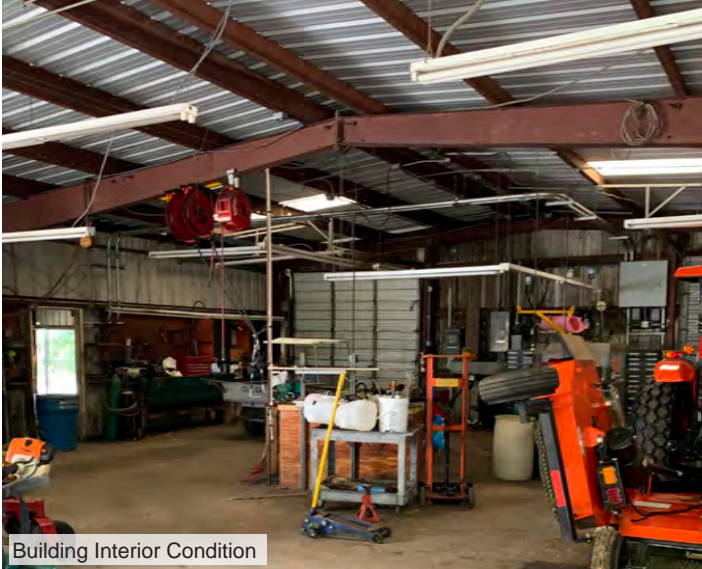
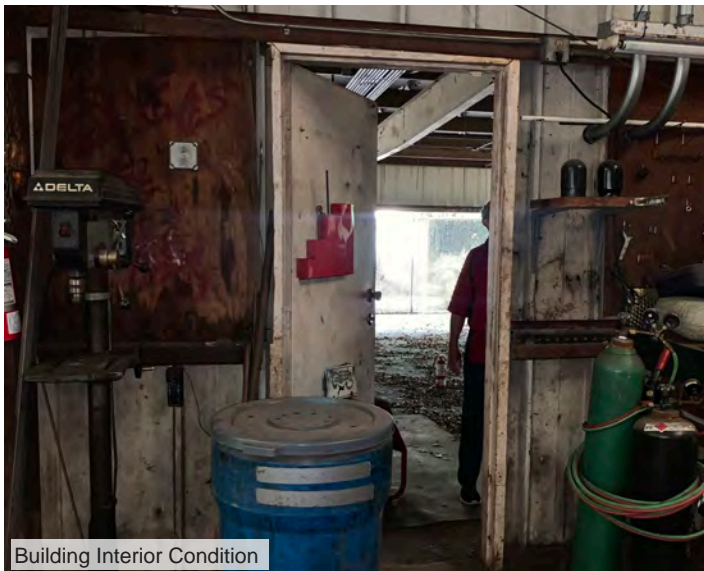
- Water intrusion apparent in ceiling, walls, and doors
- Wear and tear with finishes, fixtures and equipment
- Various door thresholds do not meet current Florida Building Code accessibility requirements
- Electrical panels do not have spares
- Rusting in structural elements
- Unsealed wall penetrations
- Lighting components damaged
- Restrooms are not ADA compliant
- No apparent insulation in office or restroom
- Office suite HVAC (window unit) needs updating

- Address the water intrusion issues in the ceiling, walls and doorways
- Clean, repair and replace fixtures where needed
- Repair or replace lighting components
- Properly seal wall penetrations
- Consult a structural engineer to address the degree of damage to the structural framing elements
- Consult an electrical engineer to address the panel overloading issue
- Replace interior lighting
- Renovate office and restroom

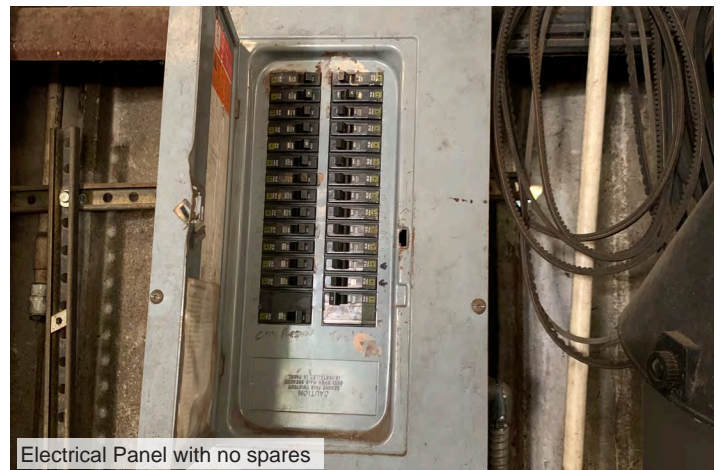
Electrical Panel with no spares

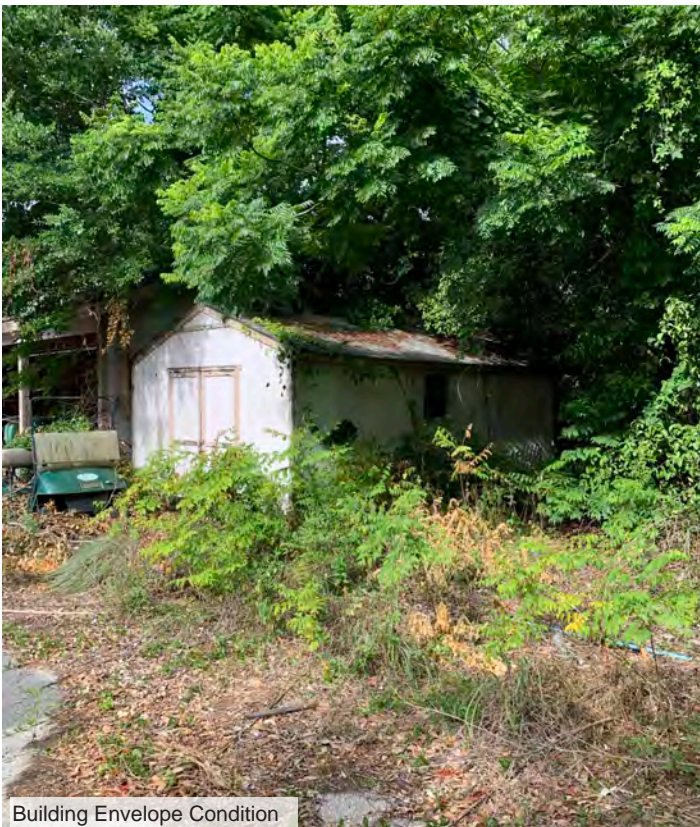
Building Envelope Condition

- Overgrown vegetation in various areas of the building envelope and walkways
- Debris on roof system
- Wear and tear on finishes
- Water damage at fascia
- Gutter system needs replacement
- Fuel tank containment area is overgrown with vegetation, needs refurbishment

- Remove overgrown vegetation from building envelope and walkways
- Remove debris from roof and assess any damage caused by vegetation
- Clean and repaint building envelope
- Repair/replace roofing
- Have a structural audit to confirm wood frame stability

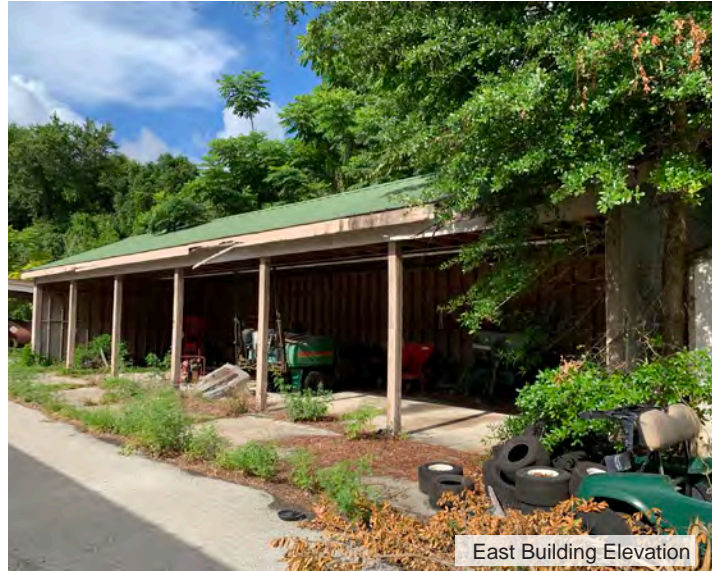
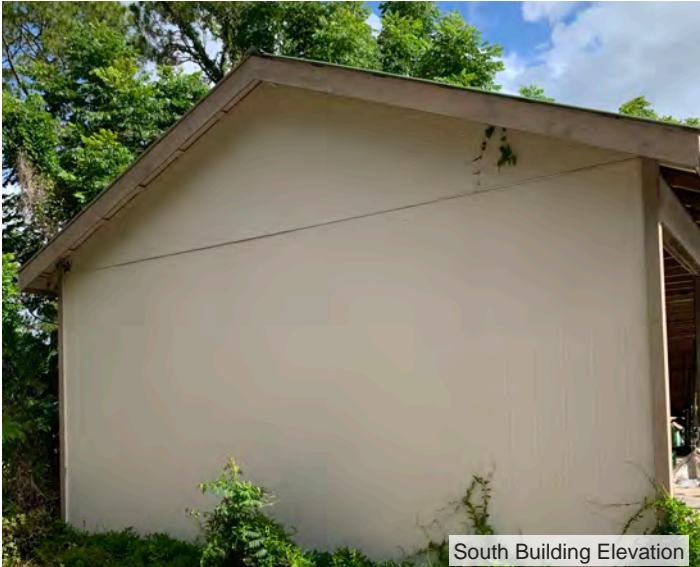
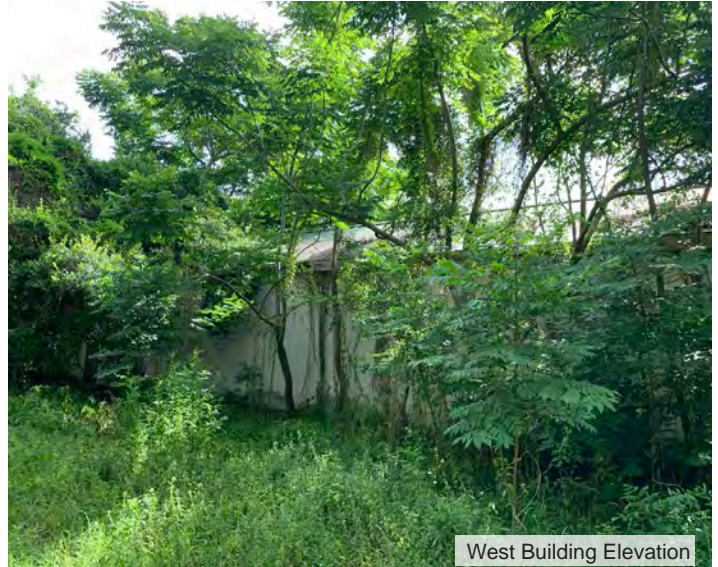
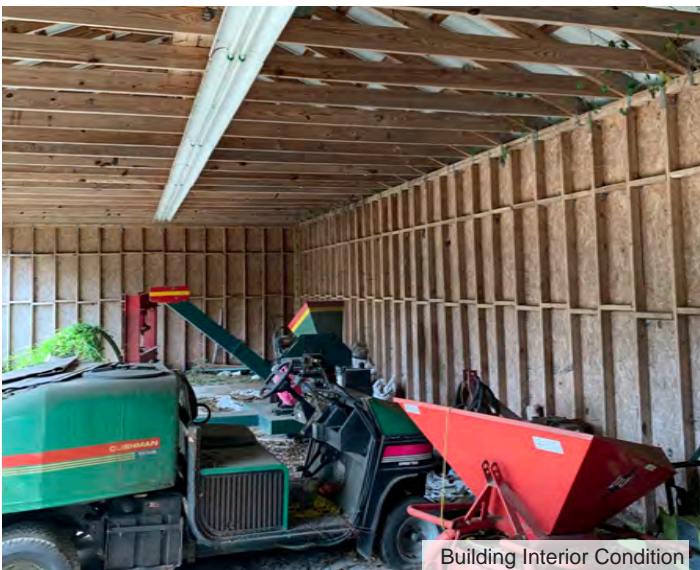
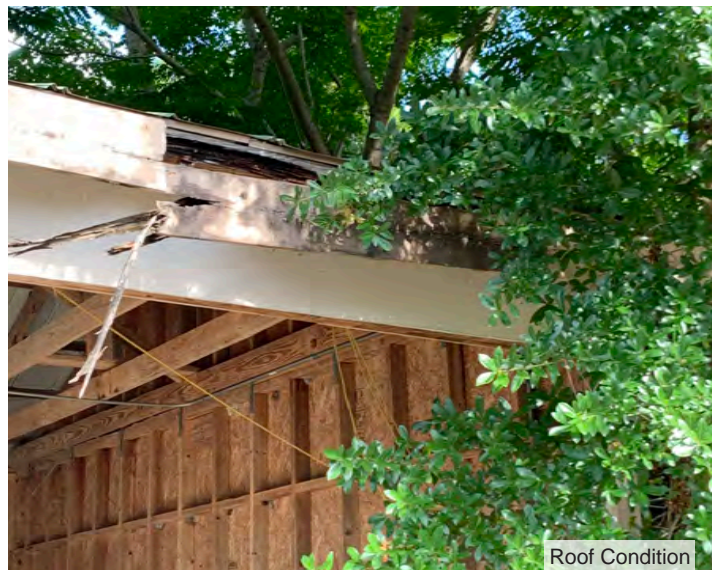
- Overgrown vegetation in various areas of the building envelope and walkways
- Damage to roof system
- Wear and tear on finishes

- Remove overgrown vegetation from building envelope and walkways
- Repair damage to roof fascia
- Clean and repaint building envelope

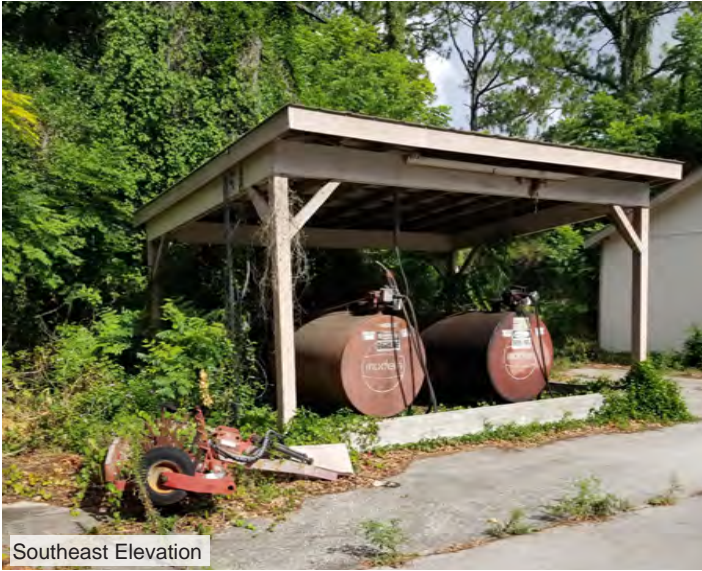
Southeast Elevation

- Overgrown vegetation in various areas of the building envelope and floor slab
- Wear and tear on finishes
- Fuel tanks pose a potential environmental issue

- Remove overgrown vegetation from building envelope and floor slab
- Clean and repaint building envelope

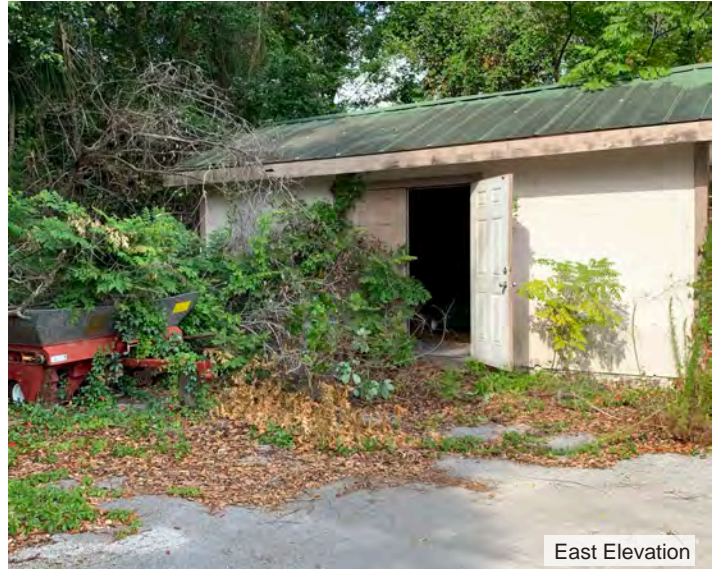
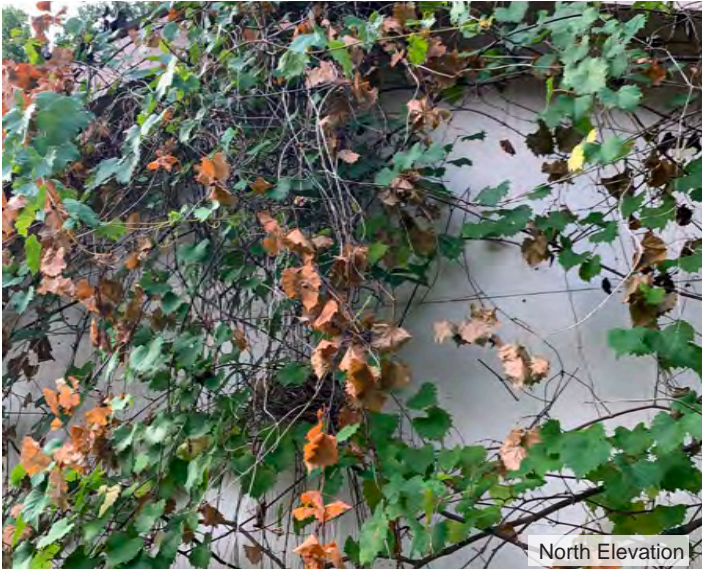
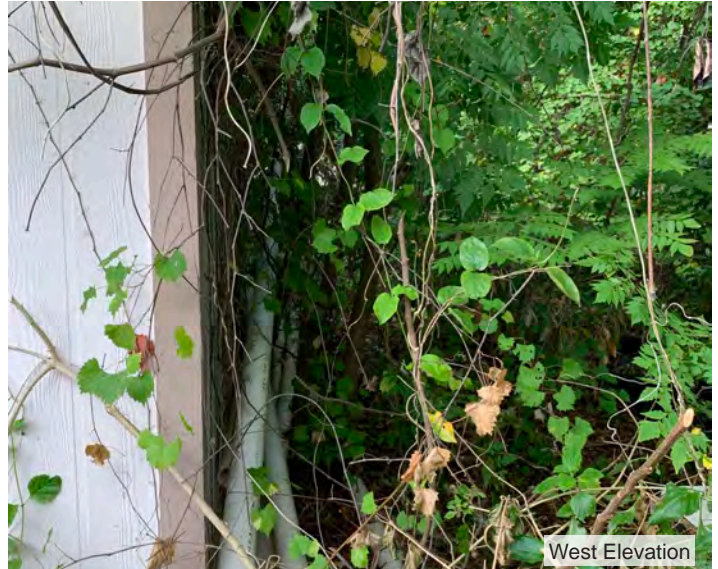
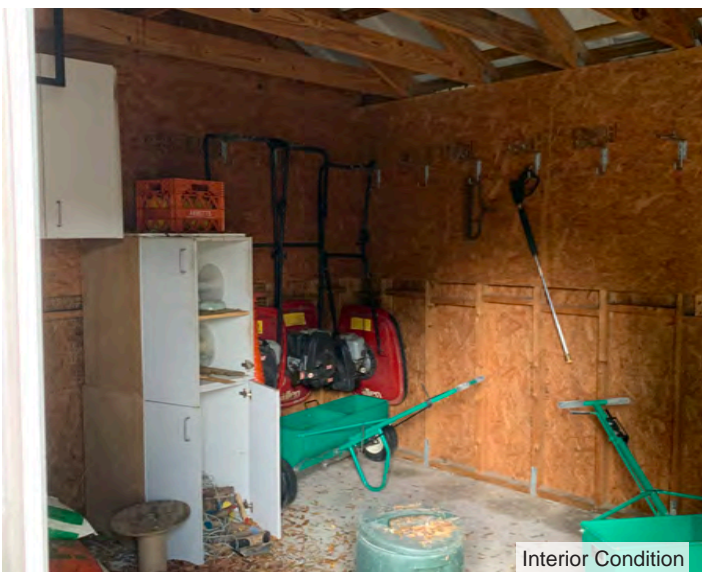
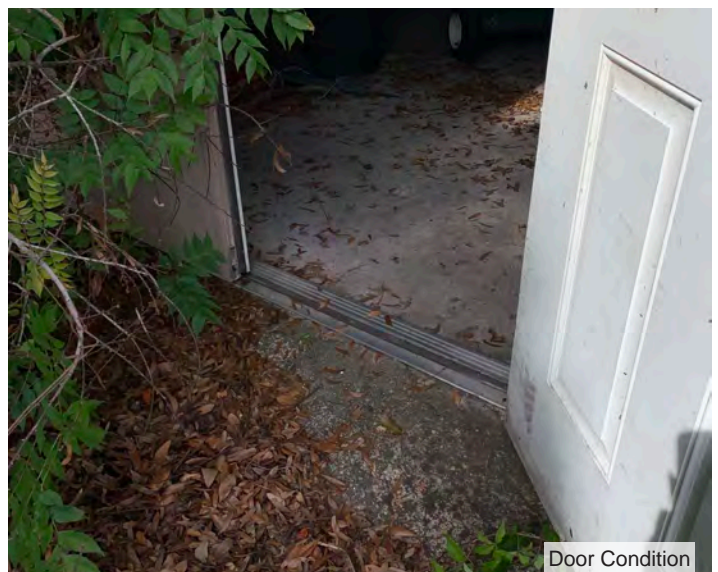
- Overgrown vegetation in various areas of the building envelope and floor slab
- Wear and tear of finishes on exterior and interior
- Debris on the interior

- Remove overgrown vegetation from building envelope and floor slab
- Clean and repaint building envelope and interior surfaces
- Clean debris on the interior
