Re: Former Deer Run Golf Club Property, Located at the Northeast Quadrant of Red Bug Lake Road and Eagle Circle, within Unincorporated Seminole County, Florida

Facility Conditions Assessment Report

GAI Consultants Community Solutions Group in association with **Rhodes+Brito Architects** developed this Conditions Assessment Report for the Deer Run Country Club facilities for the **Seminole County Leisure Services Department, Greenways and Natural Lands Division**. The Deer Run Clubhouse is located at 300 Daneswood Way, Casselberry Florida 32707. The Golf Course consists of an 18-hole course and is surrounded by residential property.

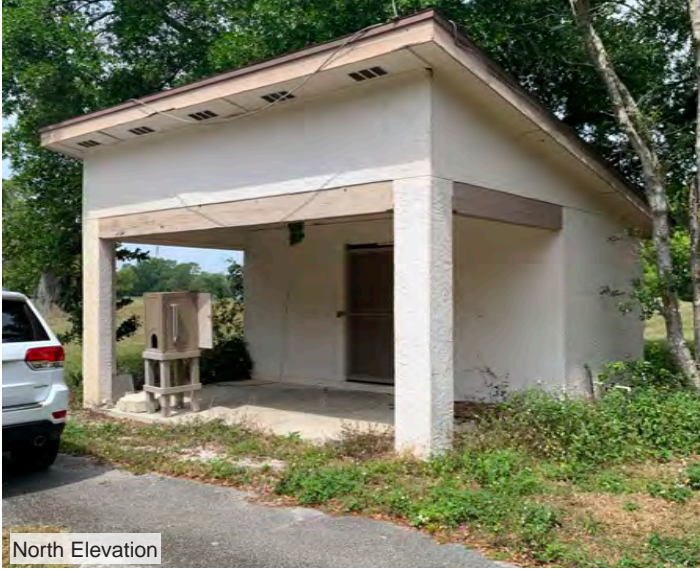
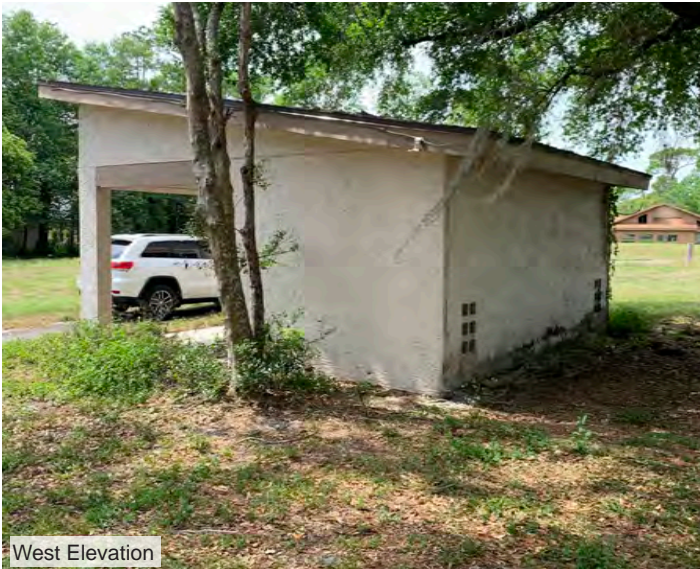
Restroom Building

- Overgrown vegetation in various areas of the building envelope
- Restroom is not accessible from the exterior due to elevated threshold
- Roof needs to be replaced along with fascia and possible water damage to roof joist
- Missing gutter system
- Damaged exterior lighting
- Ventilation is under sized
- No visible exhaust system
- No natural light

- Remove overgrown vegetation
- Replace roof system and repair associated wood fascia, joist, and insulate
- Clean, repaint and paint exterior walls
- Replace all lighting
- Install gutter and downspout system
- Gut and reconfigure restroom to meet accessibility code requirements
- Update electrical service
- Scope sanitary line for possible clogs
- Install exhaust system
- Paint interior and exterior surfaces

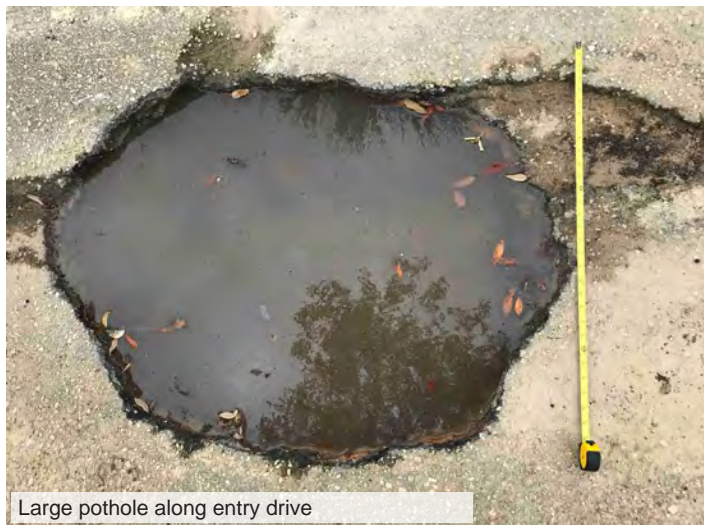
1. Majority of asphalt parking lot is in good to fair condition with normal age-related cracking throughout. Some large potholes and ruts were also present

Large pothole along entry drive

- Fill and repair all potholes and ruts.
- Consider asphalt parking overlay (1" max)
- Remove asphalt areas surrounding large trees and increase planting areas to minimize conflicts with roots.
- Remove any concrete paths/curbing no longer needed for cart use.
- Remove asphalt and construct parking islands to comply with County code. Consider using permeable paving or reinforced turf areas to replace the center parking stalls to reduce run-off.
- Remove debris blocking spillway from main parking area to adjacent ditch. Consider planting the ditch to create a sustainable rain garden.
- Provide regular maintenance of ditches and drainage structures
- Pool/Deck area needs to be redesigned for future use. Removal of pool and deck is required. Perimeter wall may be retained or removed depending upon final design of a new patio.

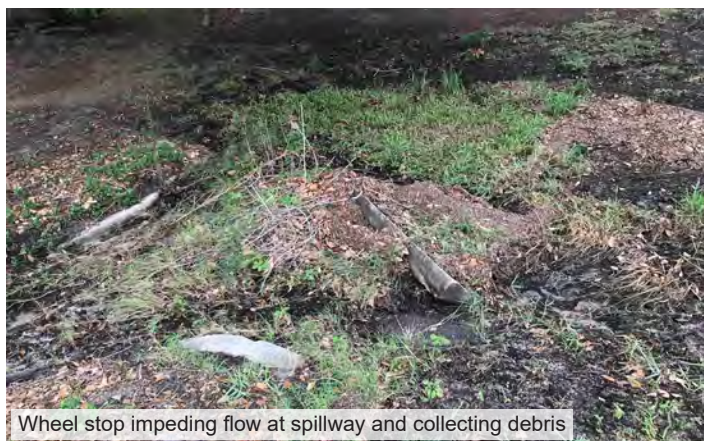
5. The main parking area doesn't have required parking islands to comply with County Code
6. Main parking area is reliant on sheet flow from west to east. Run-off is collected at a concrete spillway and directs the flow into a grassed area then toward an adjacent ditch. At the eastern end of the ditch there is an overflow structure that flows into an adjacent creek. The spillway is blocked by an overturned wheel stop and debris.

Wheel stop impeding flow at spillway and collecting debris

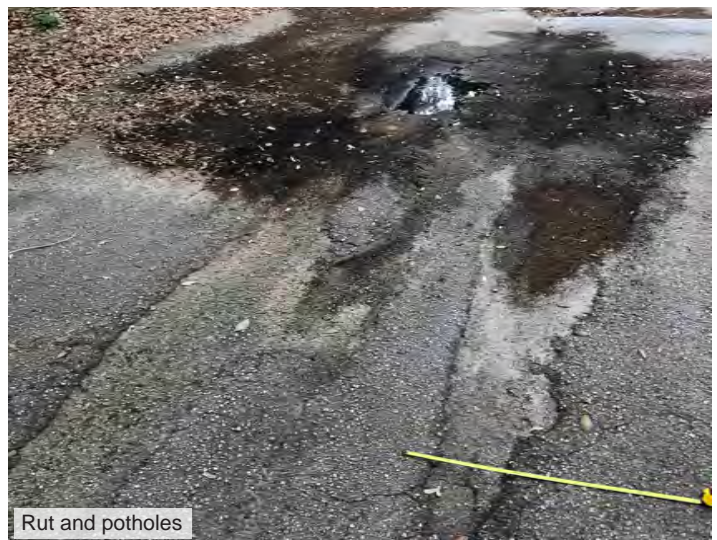
Rut and potholes

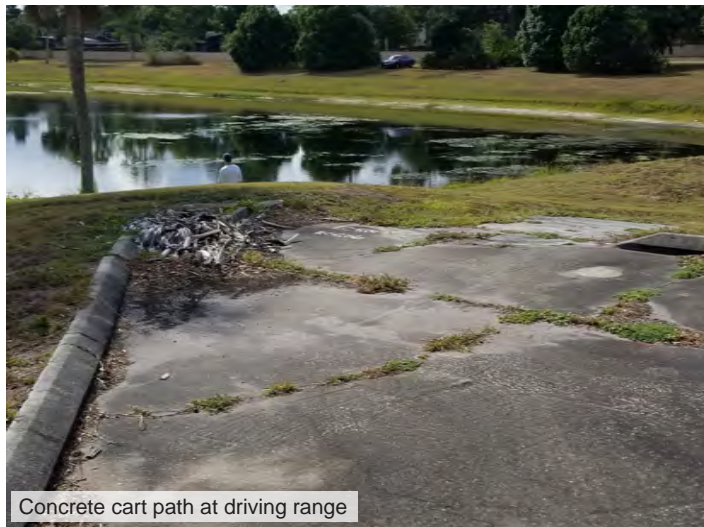
1. With the property no longer serving as a golf course, there are excessive concrete and asphalt access ways as well as curbing.
2. Ramps at the main entry (9% slope) and from the pool deck (24% slope) exceed ADA standards (8% slope with handrails)
3. CMU walls in the service area of the clubhouse are in good structural condition with minimal cracking visible
4. Some rust is visible on walls at locations or railing connections and along the edge of face.
5. All roadway light poles are rusted. Some fixtures are functional

Concrete cart path at driving range

- Remove any paving not necessary for future use and replace with grass or other permeable material
- Remove and replace ramp at the main entry to comply with ADA standards. If the pool deck area is redesigned for future use the ramp and stair in its current location should be removed. A new accessible route from this area into the building will be needed.
- Have a structural engineer verify the structural integrity of any perimeter walls
- If the wall at the pool deck is retained, repair or replace rusted railings and repair the wall.
- Replace all roadway fixtures and light poles. Existing fixture locations should remain. Use LED fixtures throughout.

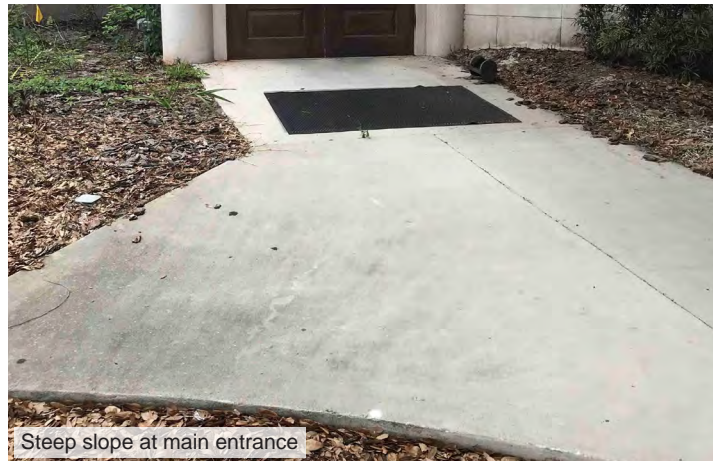
Steep slope at main entrance

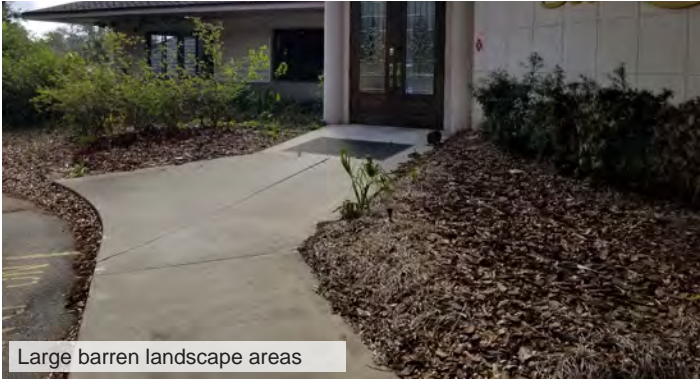
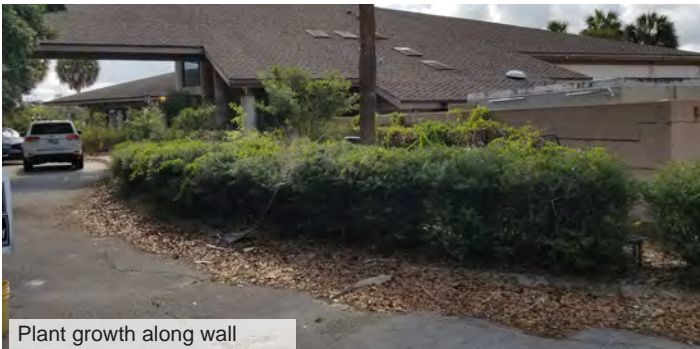
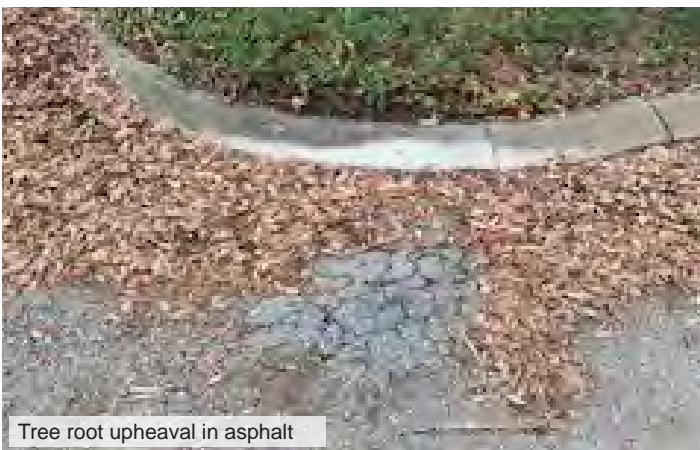
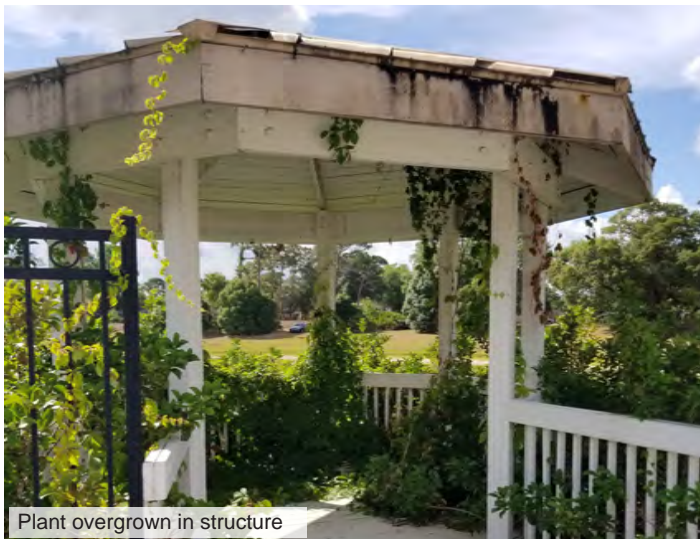
1. Walls and structures are overgrown with plant material.
2. Various plant materials are encroaching inward on walkways.
3. Pockets of barren landscape in high visibility areas
4. The main parking area doesn't have parking islands and shade trees to comply with County Code.
5. Early signs of upheaval from large tree roots noted in the asphalt.

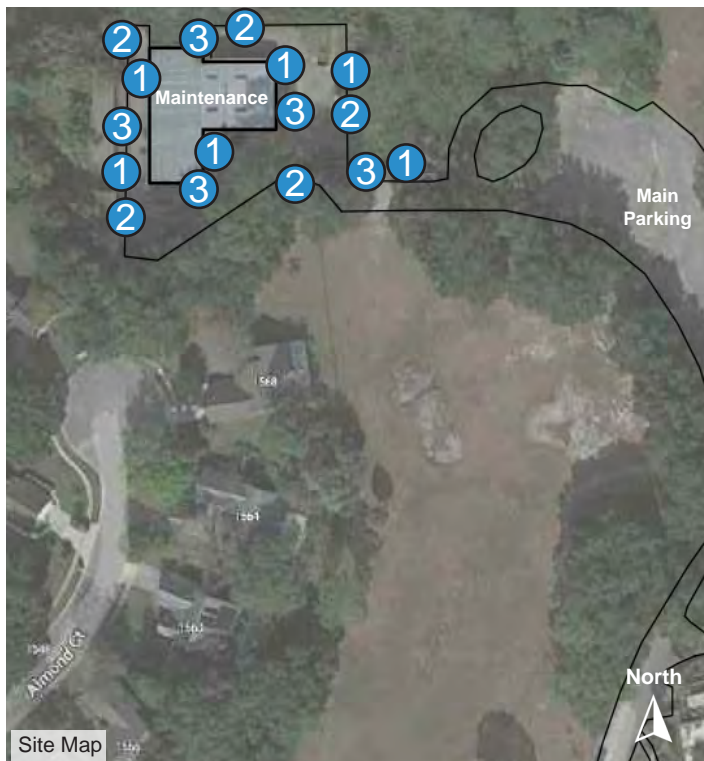
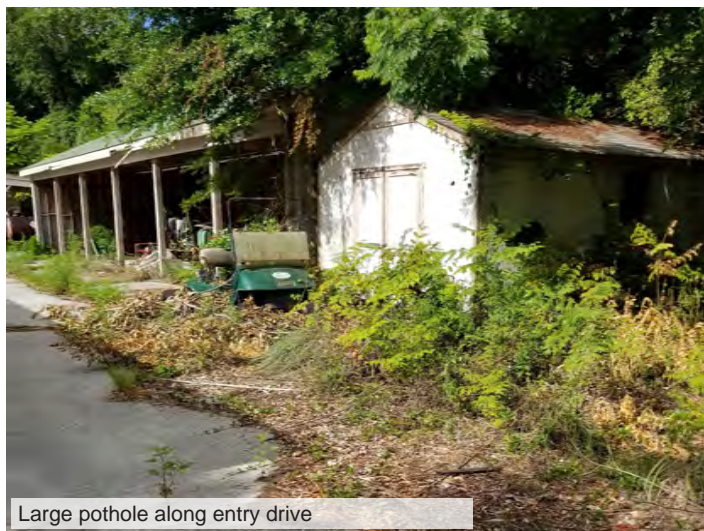
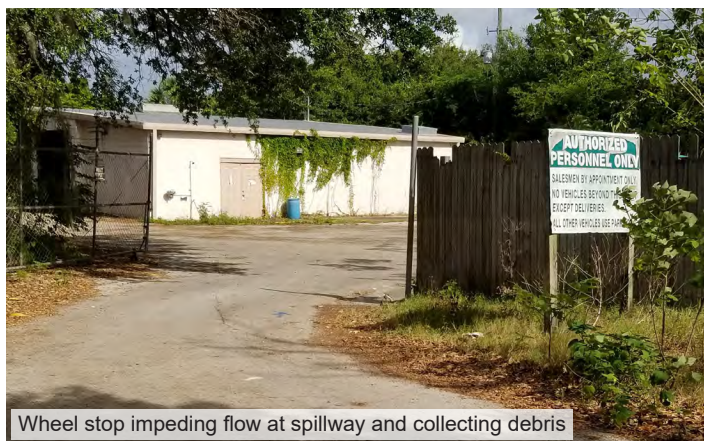
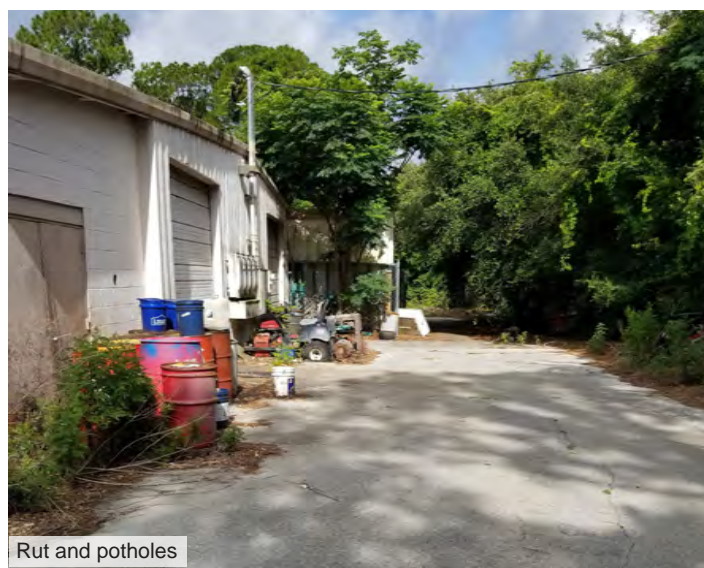
1. Trash and non-functioning equipment litters the site
2. Based on visual inspection, inadequate drainage appears to be a result of landscape debris and deposited runoff sediment.
3. Landscape is overgrown with debris noted throughout.

- All trash to be removed from area
- Prune/Remove vine growth along structures and walls.
- Prune back overgrown hedge plantings and shrub material adjacent to asphalt. All dead plant material to be removed. It is expected that removing all landscape debris in locations will improve drainage.
- Ensure all trees have a minimum clear trunk height of 3 feet above all building structures or 8 feet from finish grade (whichever is greater).

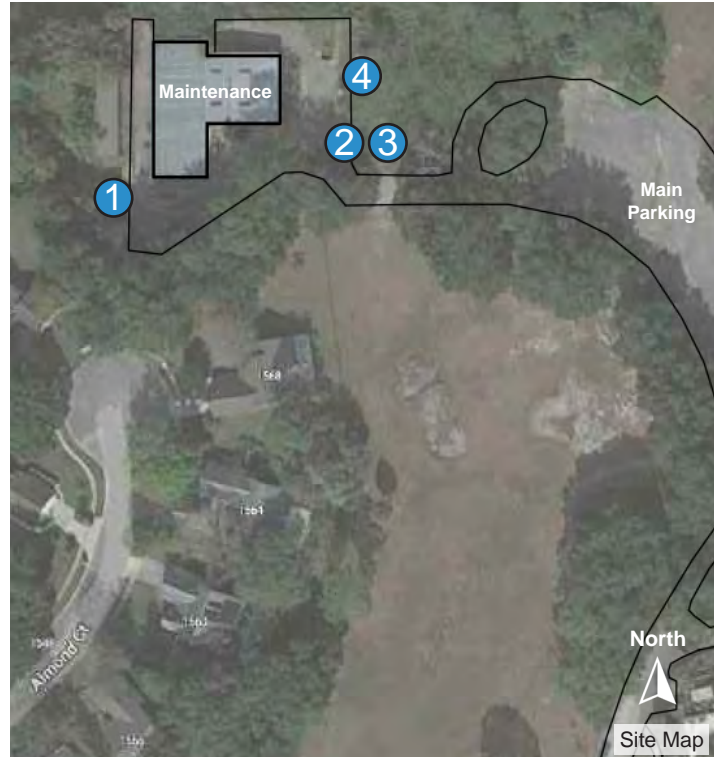
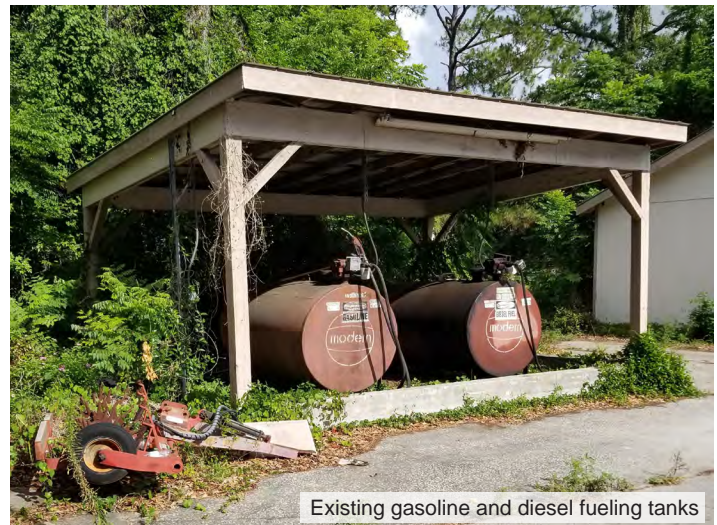
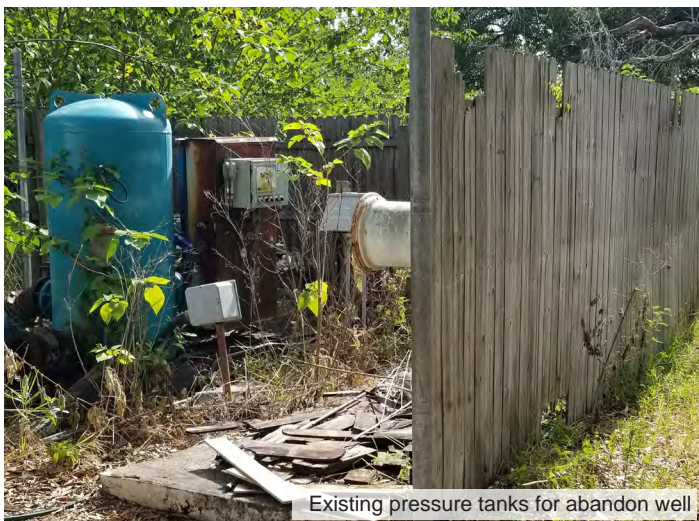
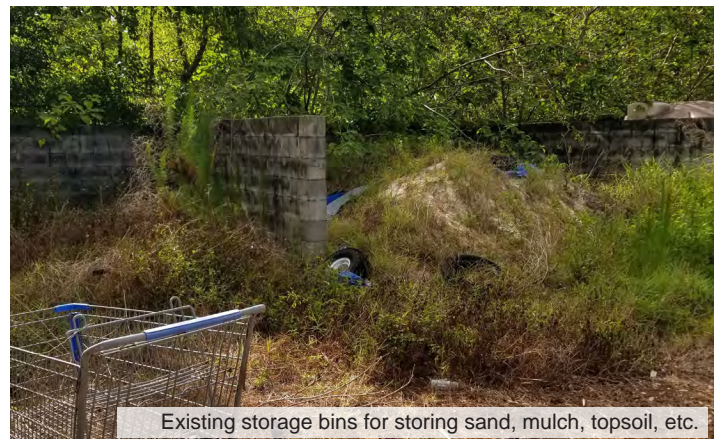
1. Aging gasoline and diesel fuel tanks should be assessed for possible contamination of the immediate area, if not already completed.
2. Irrigation pressure tank and well have been abandoned at the southeast corner of the property.
3. Wood fence at the entrance to the maintenance area is damaged.
4. Storage bins area overgrown with plant material and filled with abandoned stored material.

- Verify that fuel tank area has had an environmental assessment. If not assessment needs to be completed to determine if remediation is required.
- Remove abandoned irrigation/well equipment.
- Remove/Replace wood fence with galvanized chain-link fence (match existing perimeter fence) to secure maintenance area.
- Remove all trash and landscape material from storage bins but retain the bins for future storage and use.
- Preserve existing turbine pump and well located within the maintenance building
