**Tiffany Lake Association, Inc.**  
**West Palm Beach, FL**

Report #: 46769-0  
Beginning: January 1, 2023  
Expires: December 31, 2023

**RESERVE STUDY**  
**"Full"**

March 15, 2023

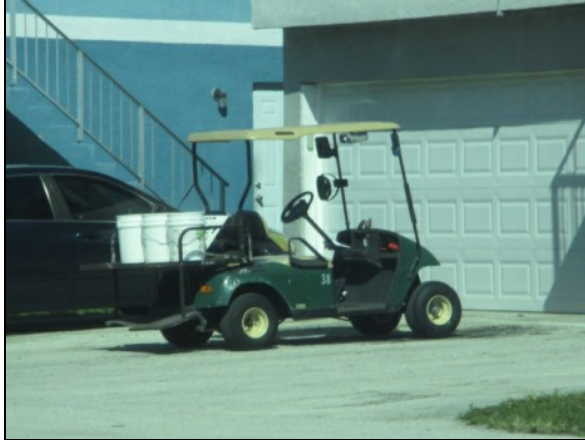
**Comp #: 2599 Golf Cart - Replace**

History: Per information provided, client plans to replace golf cart in 2023

Comments: Routine maintenance should be performed to maximize useful life of the cart. Useful life will depend on application and level of daily use, but plan to replace at the approximate interval shown below. Unless otherwise noted, cost estimates reflect replacement with comparable type, either new or lightly used. Minimal or no subjective/aesthetic value for this component. Useful life is based primarily on normal expectations for service/performance life in this location. Unless otherwise noted, remaining useful life expectancy is based primarily on original installation or last replacement/purchase date, our experience with similar systems/components, and assuming normal amount of usage and good preventive maintenance.

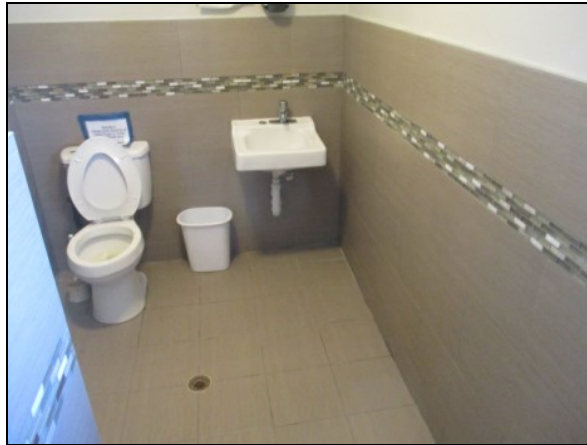
Comments: Men's bathroom noted to include approximately 270 GSF of tile flooring, (1) sink, (1) toilet, (1) urinal, and (1) ceiling light. Women's bathroom assumed to be of similar size, style, and condition.

Fair condition: Bathrooms determined to be in fair condition typically exhibit some light to moderate signs of use and age. Finishes are clean but showing some wear. All fixtures are assumed to be functional, but may be becoming outdated at this stage. Generally in serviceable condition.

As routine maintenance, inspect regularly and perform any needed repairs promptly utilizing general Operating funds. Typical remodeling project can include some or all of the following: replacement of plumbing fixtures, partitions, countertops, lighting, flooring, ventilation fans, accessories, décor, etc. Costs can vary greatly depending on scope of work involved. Unless otherwise noted, estimates shown are based primarily on light to moderate cosmetic remodeling, not complete "gut" remodel projects.

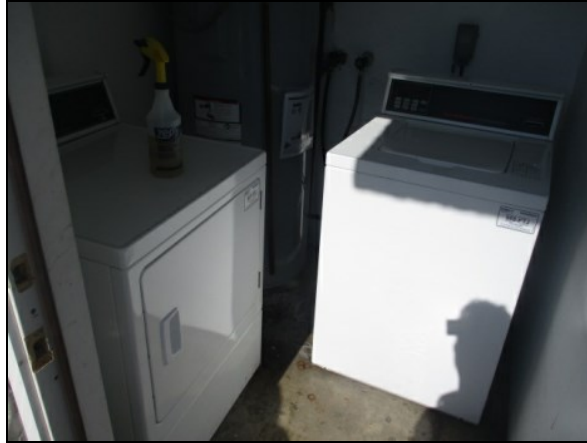
**Comp #: 2761 Laundry Machines - Replace**

Per information provided, the Client is reportedly not responsible for the replacement of laundry machines. As such, there is no basis for Reserve funding at this time. However, the findings within this report are not intended to be a legal opinion and we reserve the right to revise this component if the Client is found to be otherwise responsible.

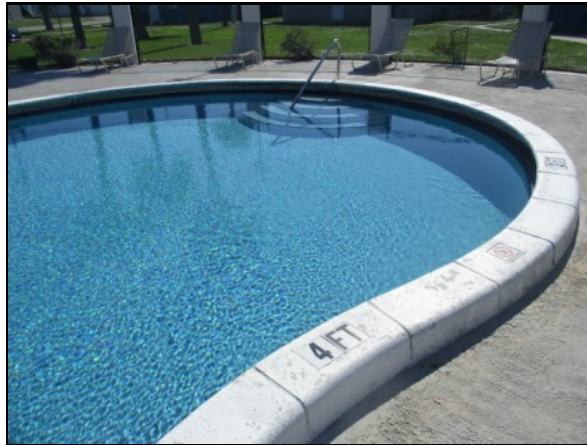
### Comp #: 2763 Pool Deck Furniture - Replace

History: At time of inspection, low quantity of furniture noted at pool area. Client plans to replace/add pool furniture in near future. Funding shown below accounts for a general allowance to replace furniture based on size of pool deck area.

Comments: We recommend regular inspections and repair or replacement of any damaged pieces promptly to ensure safety. Protected storage of furniture when not in use can help to extend useful life. Best practice is to replace all pieces together in order to maintain consistent style and quality in the pool/recreation area. Individual pieces can be replaced as needed each year as an Operating expense. Costs can vary greatly based on quantity and type of pieces selected for replacement. Funding recommendation shown here is based on replacement with comparable number and quality of pieces as existing.

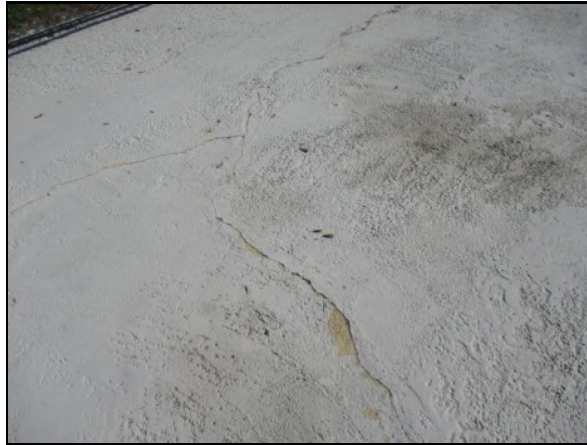
**Comp #: 2767 Pool Deck (Coated) - Seal/Repair**

Comments: Poor condition: Coatings determined to be in poor condition typically exhibit significant, easily noticeable inconsistency in color and/or texture, and may have more advanced signs of age such as increased frequency and severity of cracking and peeling, in some cases exposing lower sections of decking system or substrate material.
