Quality Home Inspections , LLC
12720 Castlewood
Wichita Ks 67206
316 990-0600
francisthehomeinspector@gmail.com

Confidential Inspection Report

224 N Anywhere St.
Wichita, KS 60000

January 21, 2014

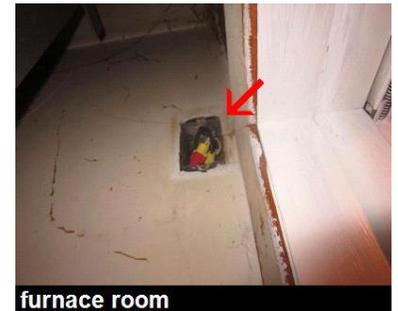
BRANCH WIRING:

9. Copper sheathing, Open junction boxes are noted-in the furnace room, Connections not made within junction boxes- Hazard condition exists, in crawlspace towards the front of the home.

Copper sheathing, Open junction boxes are noted-in the furnace room, Connections not made within junction boxes- Hazard condition exists, in crawlspace towards the front of the home.

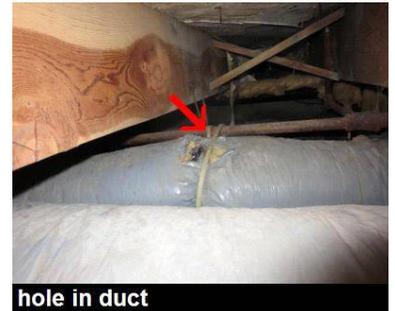
DUCTS/AIR SUPPLY:

17. Crushed ducts noted, air leaking by the furnace area, Duct is in contact with dirt, recommend bracing or getting

it off the ground. Low air volume noted on some runs, A licensed mechanical contractor should be called to make further analysis of the ductwork system and do necessary repairs

Crushed ducts noted, air leaking by the furnace area, Duct is in contact with dirt, recommend bracing or getting it off the ground. Low air volume noted on some runs, A licensed mechanical contractor should be called to make further analysis of the ductwork system and do necessary repairs
