UPRIGHT PIANO PIANO SERIAL NO.28021

CHRONICLE OF THE RESTORATION PROCESS OF A BLUTHNER UPRIGHT PIANO OF 1885

By RICHARD YOUNG PIANO RESTORATIONS IN THE YEAR OF 2019

BLUTHNER UPRIGHT PIANO REBUILD:

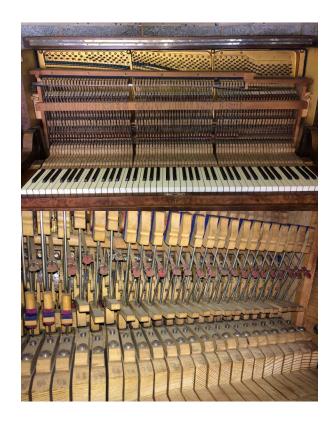
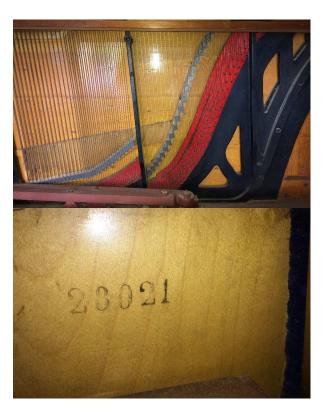
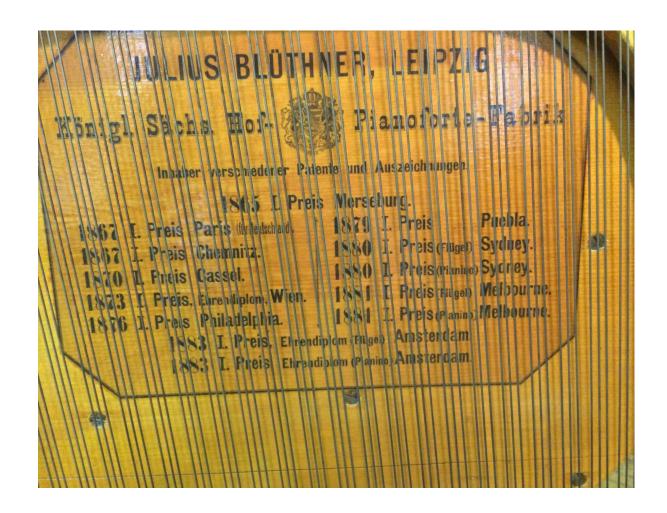
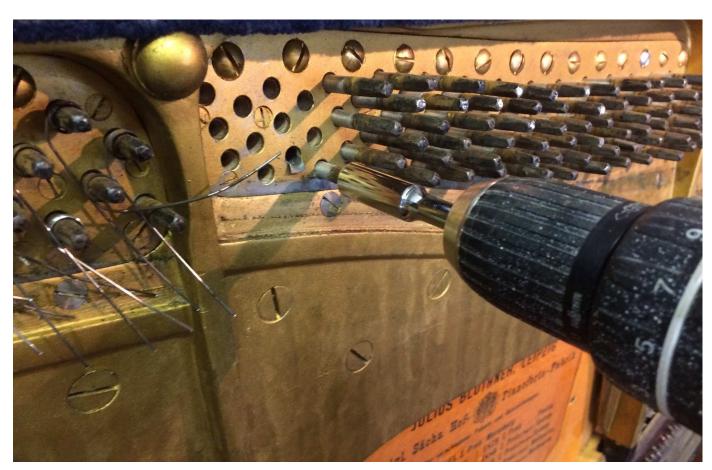
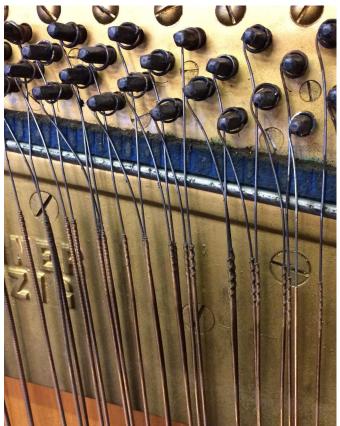
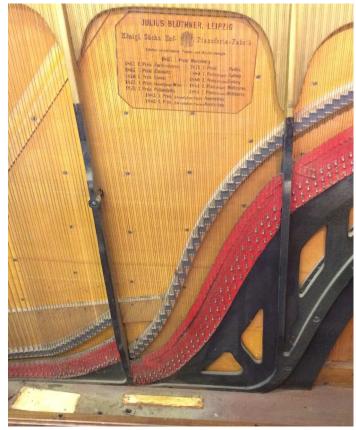
28/6/19 The first major procedure is to strip the soundboard of old varnish and assess its condition. There are a few splits in the board which will be rectified by installing wood shim. Then the whole soundboard will be refinished in many coats of clear varnish. The soundboard transfer will be replaced with one of the same design.

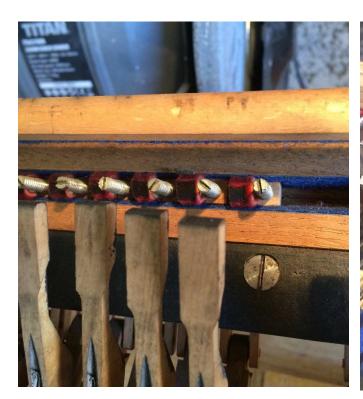
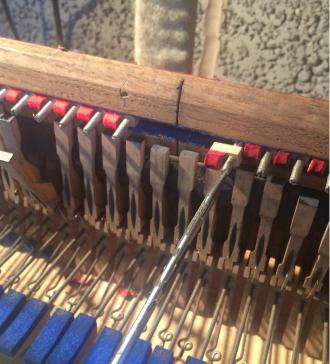
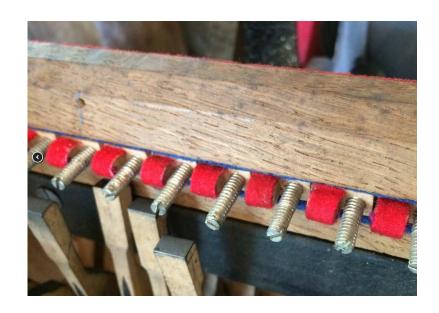
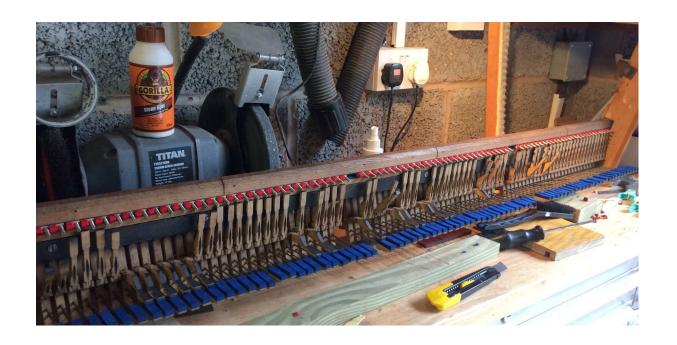
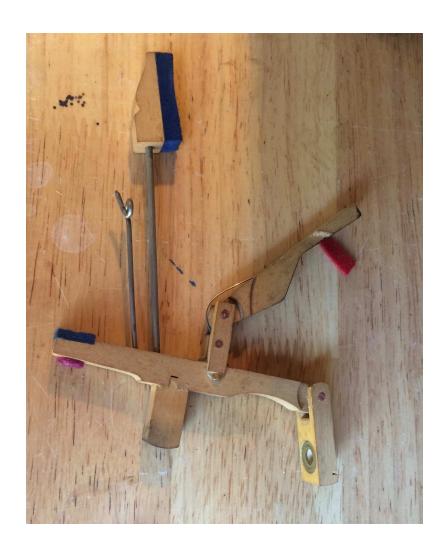
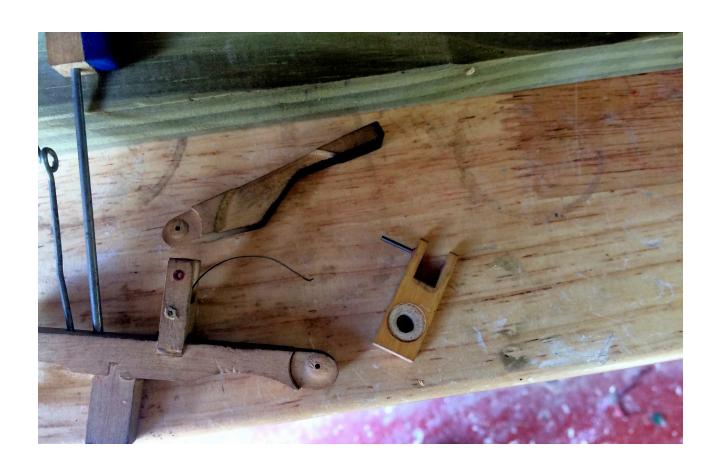
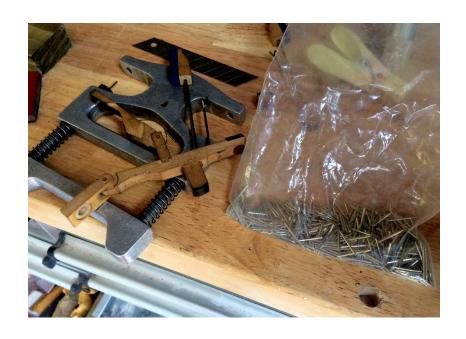
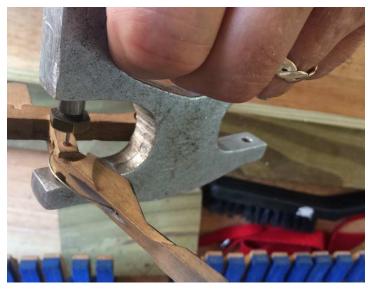
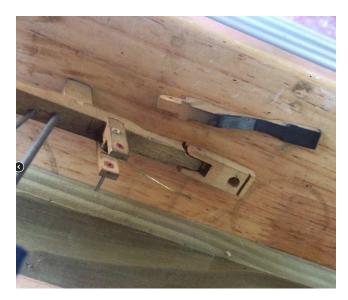
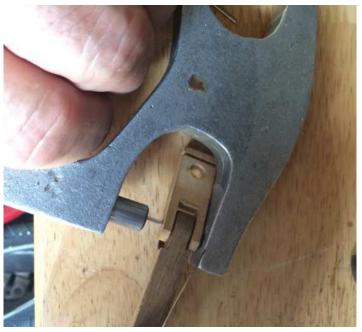
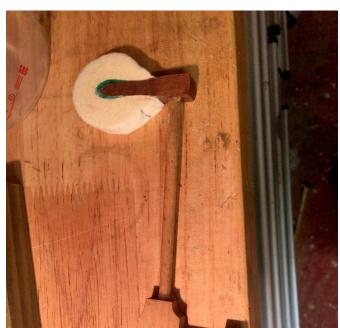
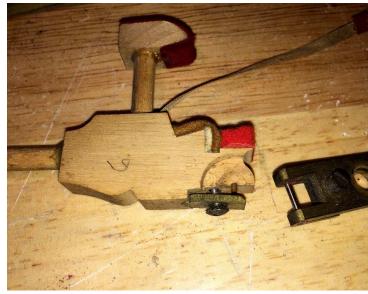
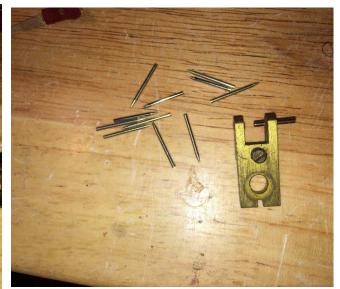
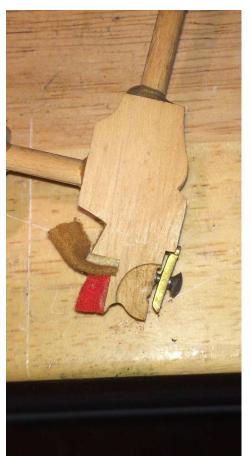
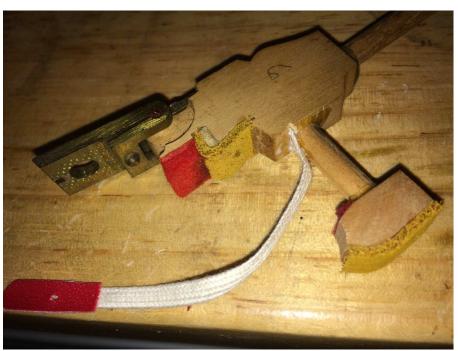
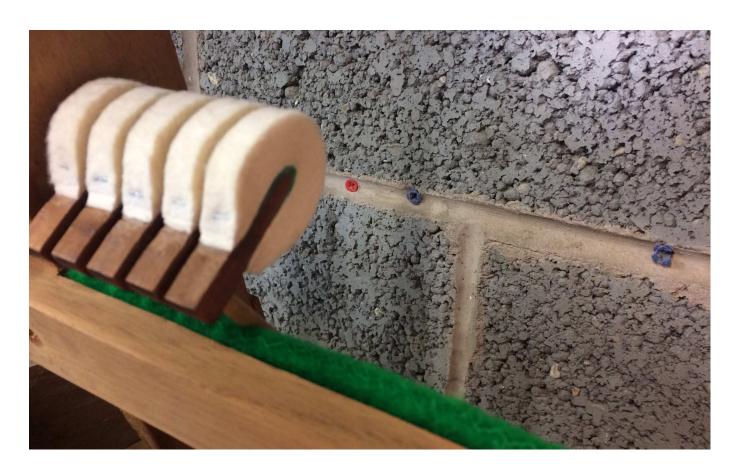
All the keys installed on the keybed, now attention is drawn to the rebuild of the action. Firstly disassembly and assessing work to be done. This involved replacement of the letoff pads that were worn badly in places, re pinning the wippen assemblies with new correct size pins, cleaning the return springs which were in perfect condition, re graphite the jacks that connect with the pads above for smooth working.

The new recovered hammers arrived back yesterday and work commenced on re pinning the flanges, replacing the buckskin on the butts and catchers, replacing the bridle tapes and finally fitting the hammer assemblies to the hammer rail of the action.

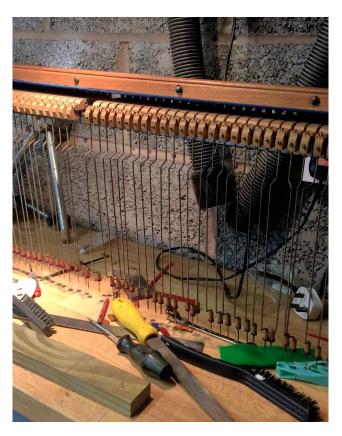
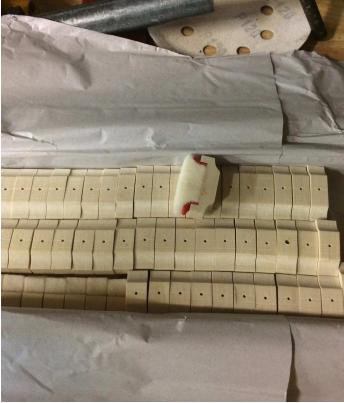
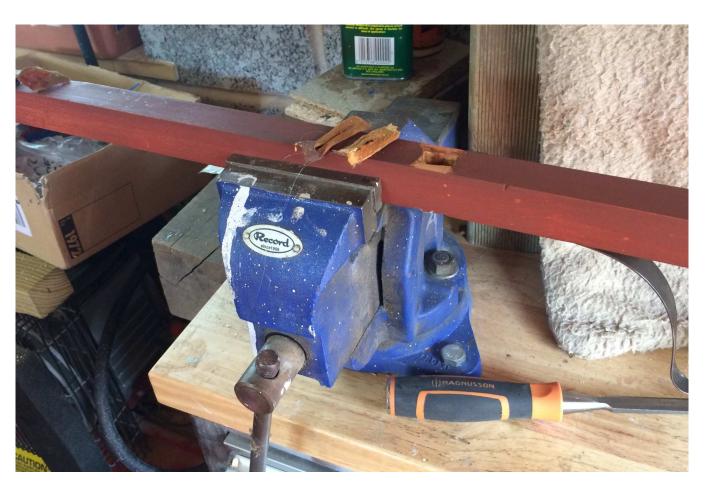
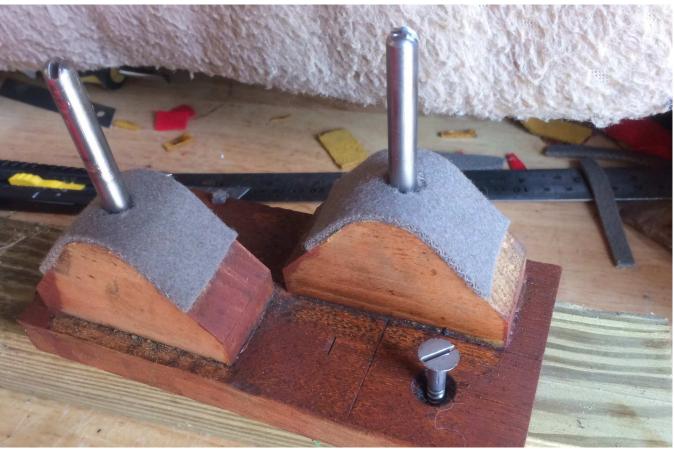
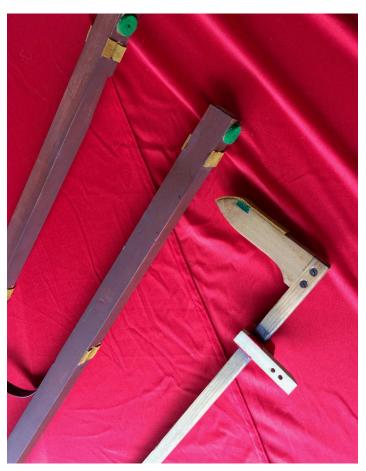
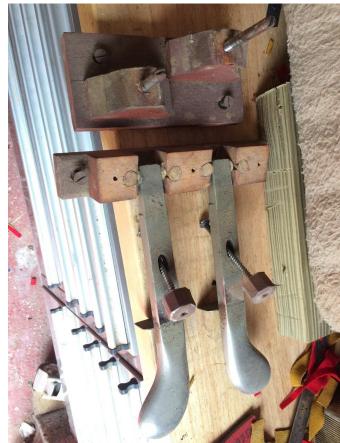
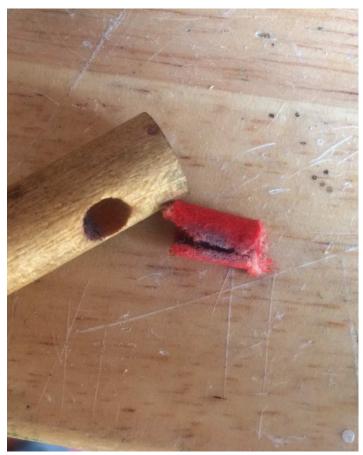
week ending 2/8/19 This week was the turn of the damper system. It is an overdamper design which by experience is not the best as all pianos these days are of underdamper design. Early pianos tended to use overdampers but they do not fully damp off the notes, especially in the higher register. Steinway and Bechstein never incorporated this design and always used underdampers and it odd that a high quality piano like a Bluthner used this system.

Of course we have to use what is there and make it as efficient as possible. For this reason we have decided to completely replace the damper heads as there is a company in Germany that manufactures them for overdamper pianos. Normally it is usual to remove the old felts and re glue new ones on to the heads and this is a much cheaper way of getting a result but we had great difficulty in finding correct felt so we searched for alternatives and found a company that actually made the complete head with the felt, The difference in price is vast. New felts are around £50 compared to a complete damper set at £400.

7/8/19 The pedals and linkages were taken apart and all worn felts replaced and yesterday they were installed into the case. Also the bass strings have been fitted. The action is then fitted to the piano without the damper system for now as the fine adjustments are easier to locate with the damper rail removed. Firstly the shift adjustment had to be set up so that when the left pedal is depressed the hammers are adjusted so that they only hit 2 of the 3 strings in the tenor and treble and only one in the bass. This took over a day to get right and still there is some fine adjustment to be done later.
