STUDY OF CPAC* TREATMENT FOR MOTORCYCLES

2002 V Rod treated

2003 V Rod untreated

Written by Rich Moran – May 2012 – Images taken May 2012

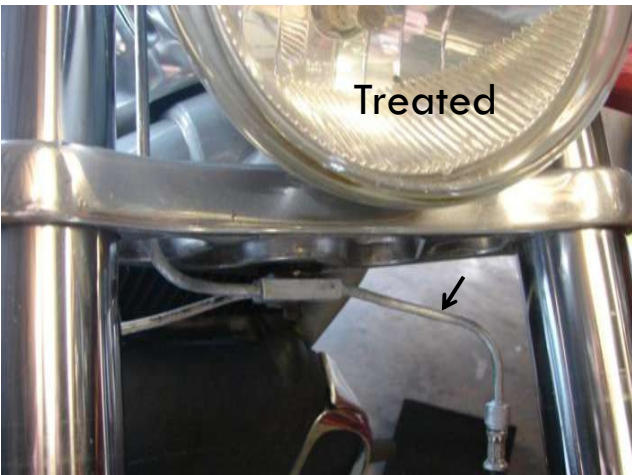
Treated and maintained with Rust Cop
– this 2002 chrome fender bracket
remains free of corrosion.

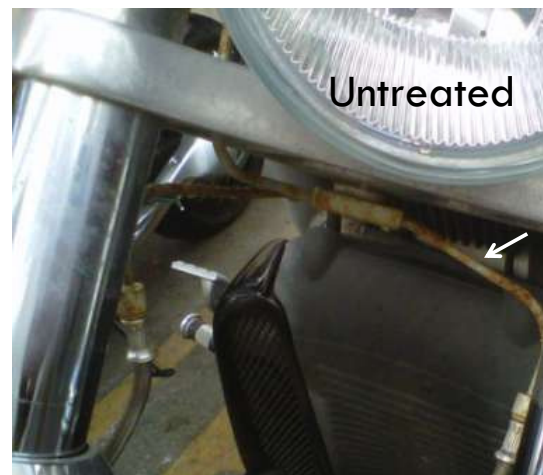
Untreated the chrome plating on this
fender bracket has lifted and is curling
due to sandwich corrosion from between
the fender and bracket.

This is easily prevented with regular
applications of Rust Cop.

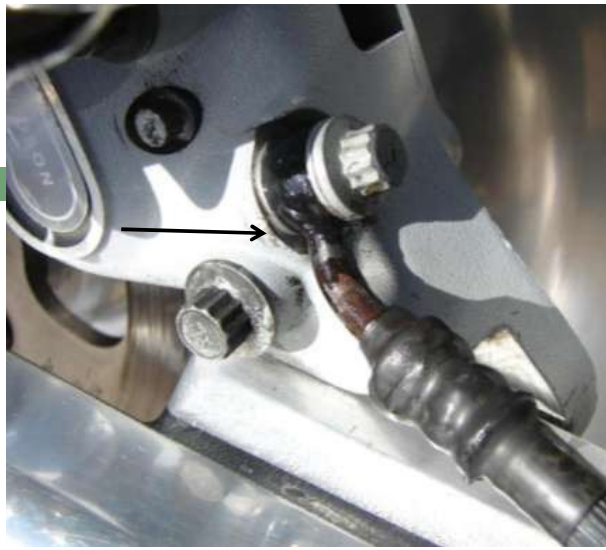
While we failed to get an image of the unprotected rear brake line, we are under the advice that this banjo connection is a major issue with corrosion on all Harley Davidsons.

Note the heat shrink black tubing between the rubber brake line and the fitting. The heat shrink tubing over time loses tension due to UV and weather exposure.

When the tubing relaxes, water can enter the assembly which left unprotected will ultimately cause brake line failure which is a dangerous condition to have occur on any vehicle, two wheel or other wise.

We have faithfully kept up with treatments at 6 month interval here as well as other hot spots found on the V Rod. We also follow an annual treatment schedule and wash the bike at least once a month with Salt Away to reduce the chloride attack due to salt laden trade winds.
