# Rob Smith Property Investigations

## Property Inspection Report - Confidential

1234 Happy Trails Dr., New Place MO, 23777  
Inspection prepared for: Larry & Mary Sample  
Agent: Im A. Realtor - Best Home For You

Inspection Date: 9/1/2012 Time: 8am to 11am  
Age: Built in 2004  
Weather: Sunny

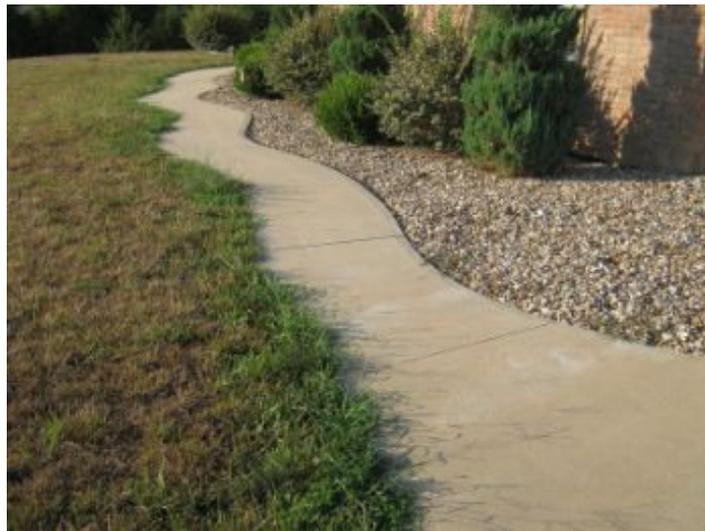
- Observed walkway to be in good shape and normal condition.
- Common cracks/Seal as needed.

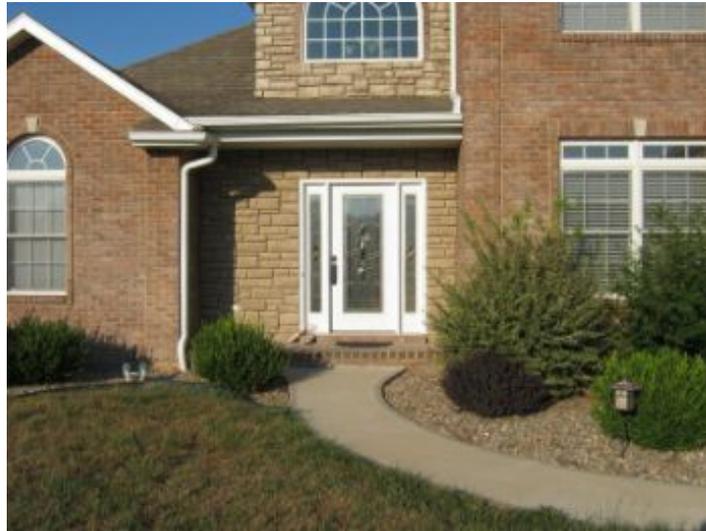
### **4. Steps, Stoop, Porch**

- Observed to be in good shape and normal condition.

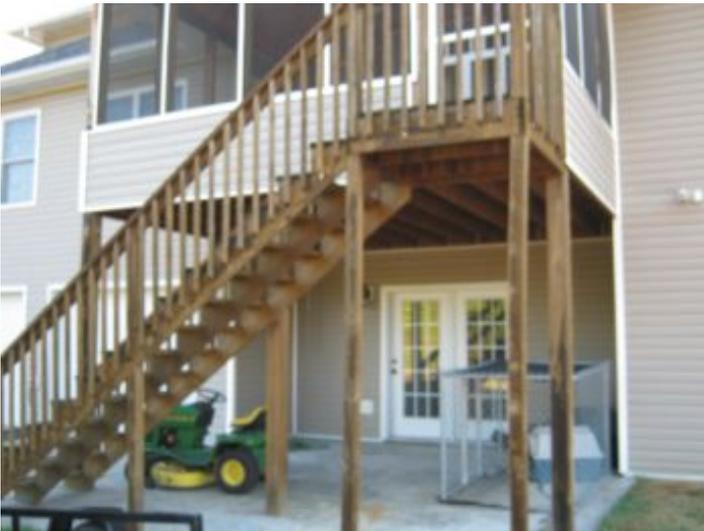
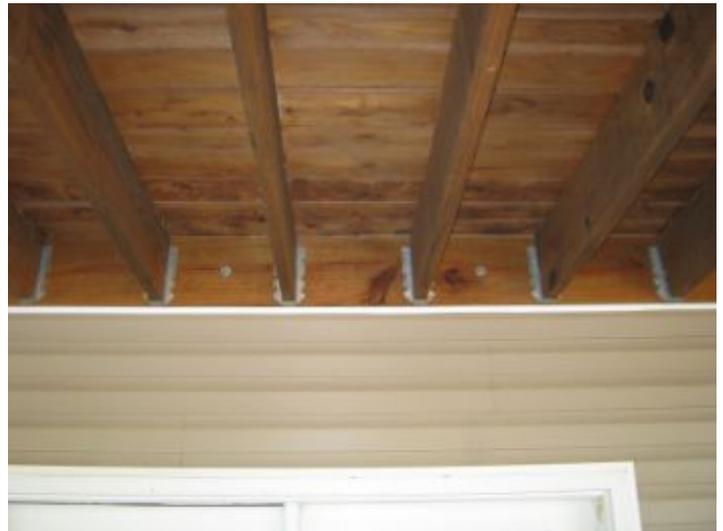
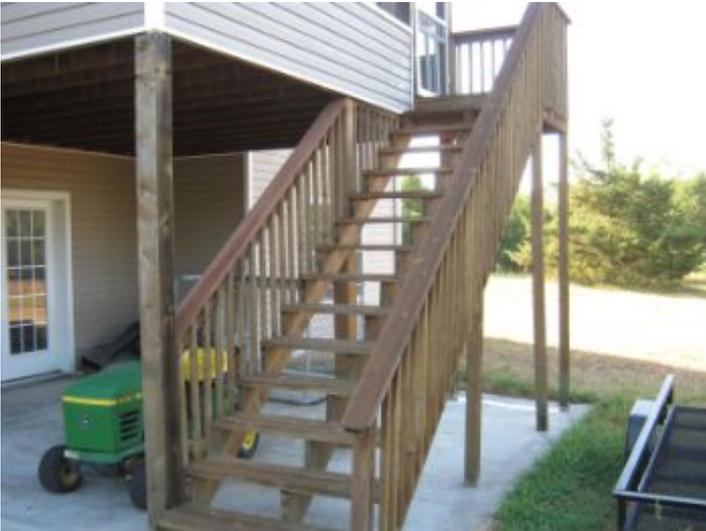
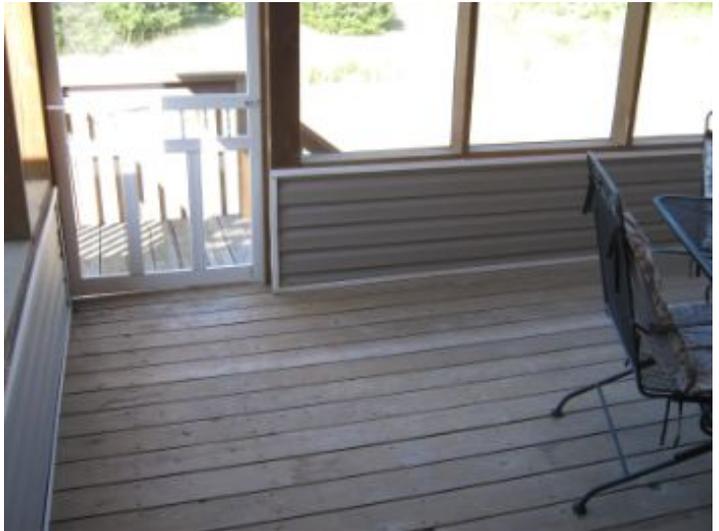
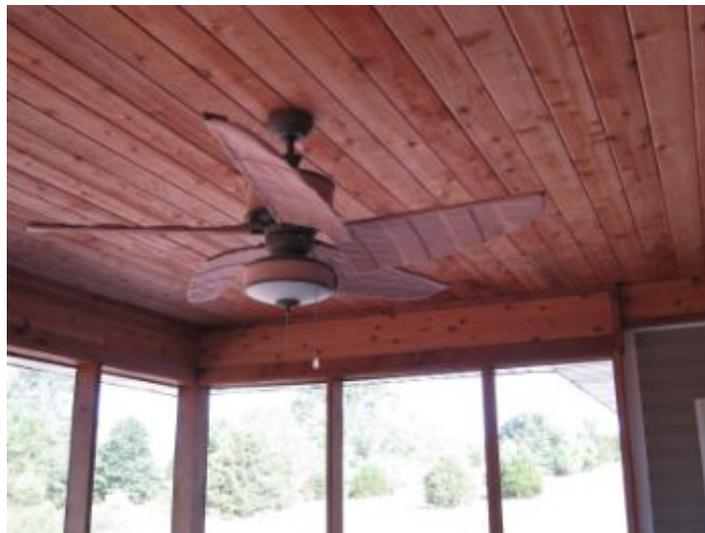
## 5. Deck, Balcony

- Appears in satisfactory and functional condition with normal wear for its age. Appears to be a sound structure.
- **MAINTENANCE:** Whether treated or not, it is important to keep a wood deck surface free of all forms of fungal growth and debris that retains moisture and will cause the deck to eventually rot. Recommend cleaning and resealing the deck annually. Cleaning can be accomplished by scrubbing the deck with a sodium-hypochlorite (bleach) and Tri-Sodium-Phosphate (TSP) deck wash and then rinsing with a pressure washer. Finally, a wood deck should be recoated with a good-quality deck sealant.

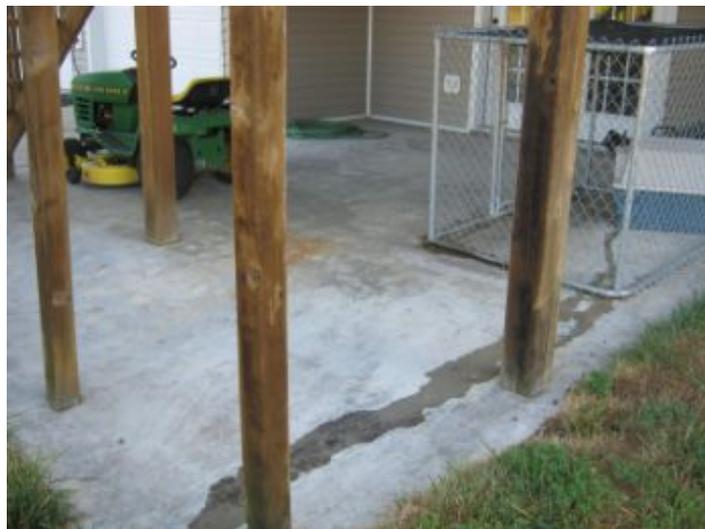
## 6. *Patio, Flatwork*

- General overall condition appear satisfactory with surfaces in good condition.
- Common cracks/Seal as needed.

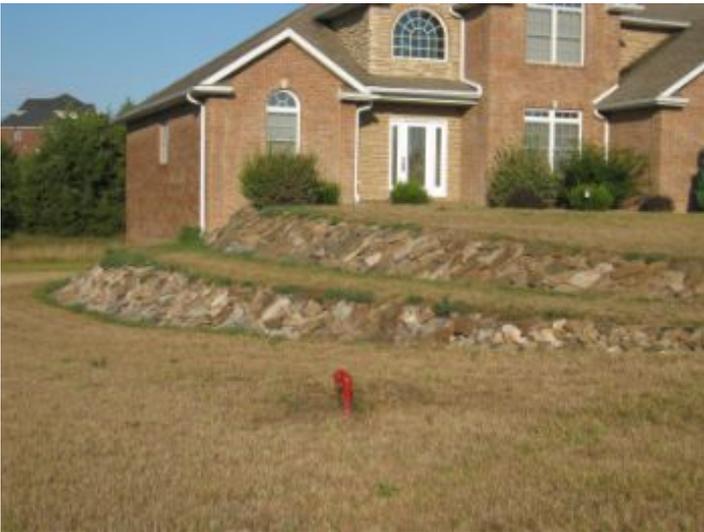
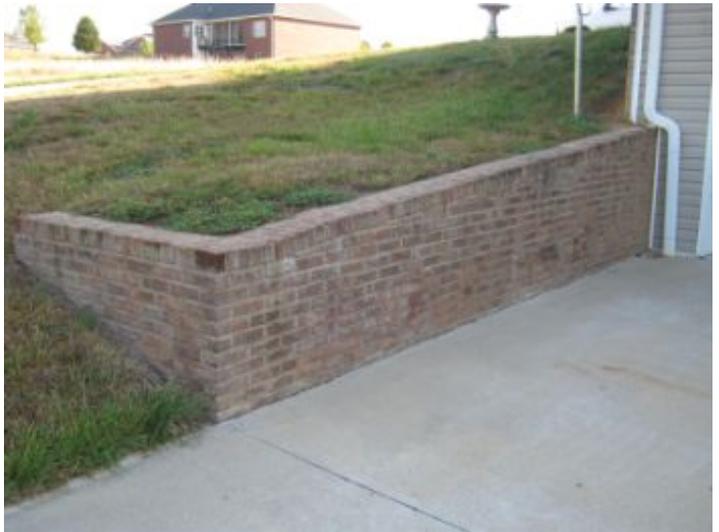
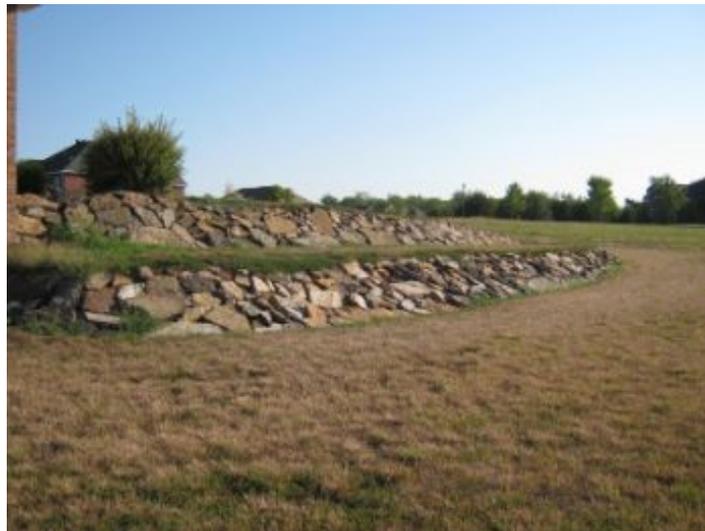
## 7. Retaining Walls Affecting Structure

Observations: Observed to be functional and in normal condition.

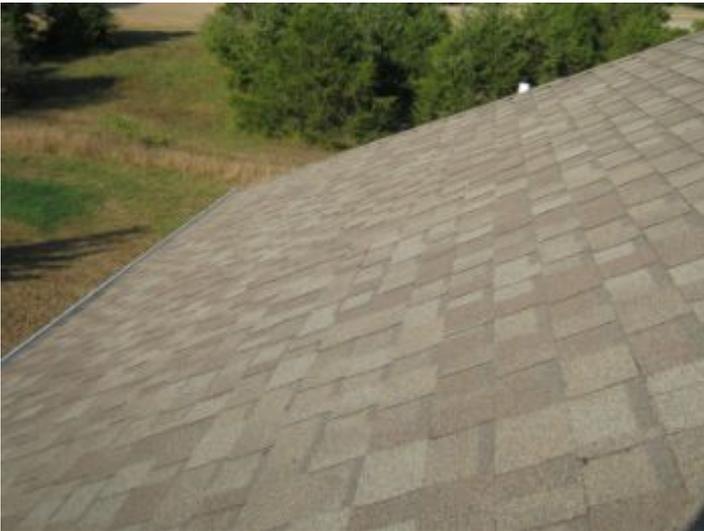
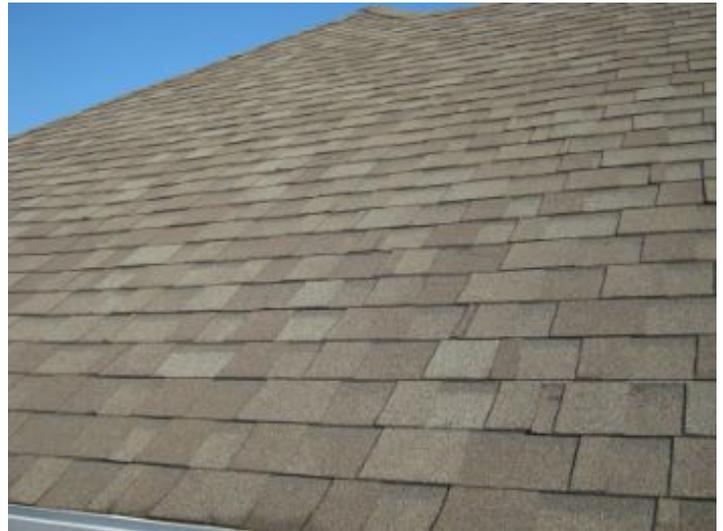
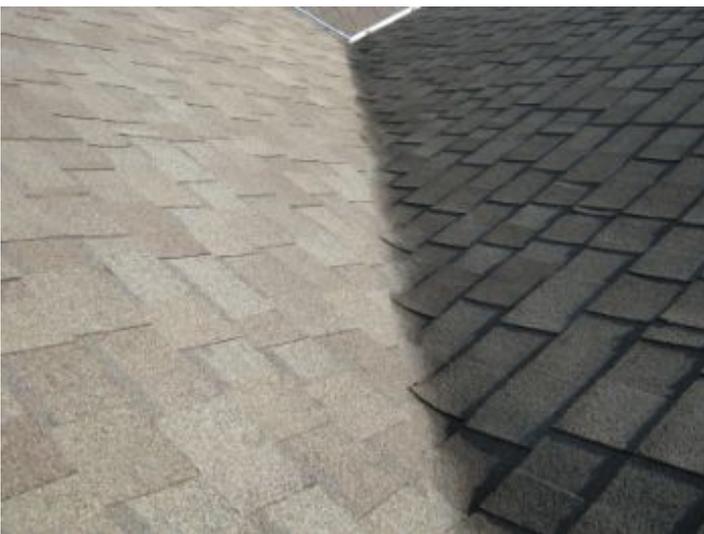
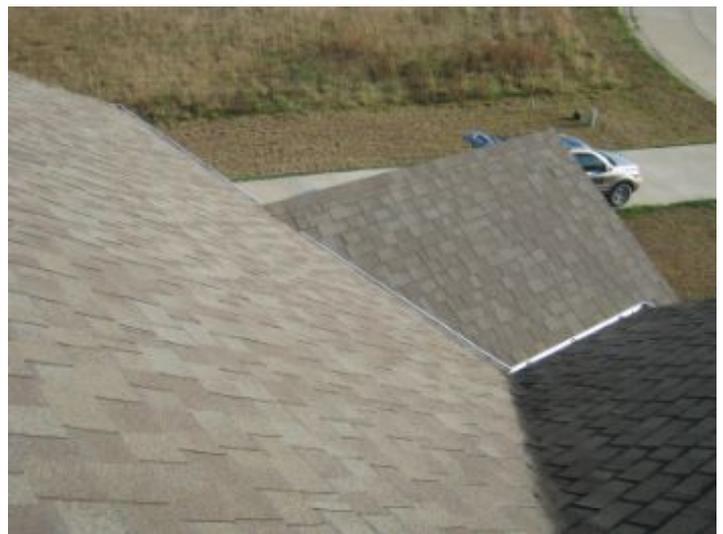
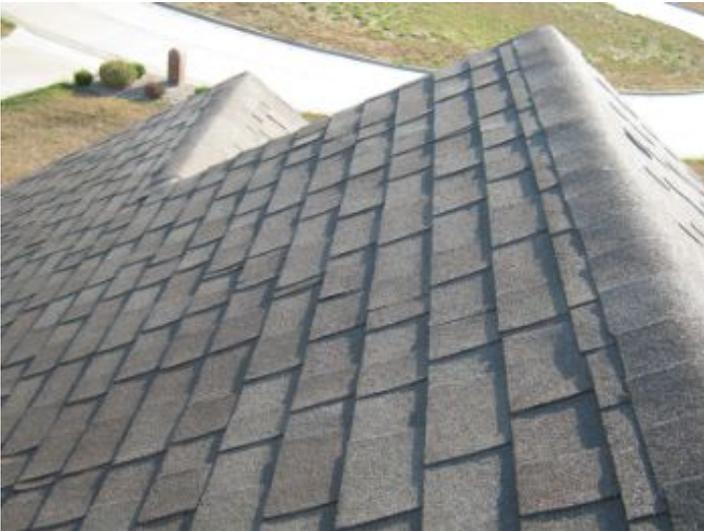
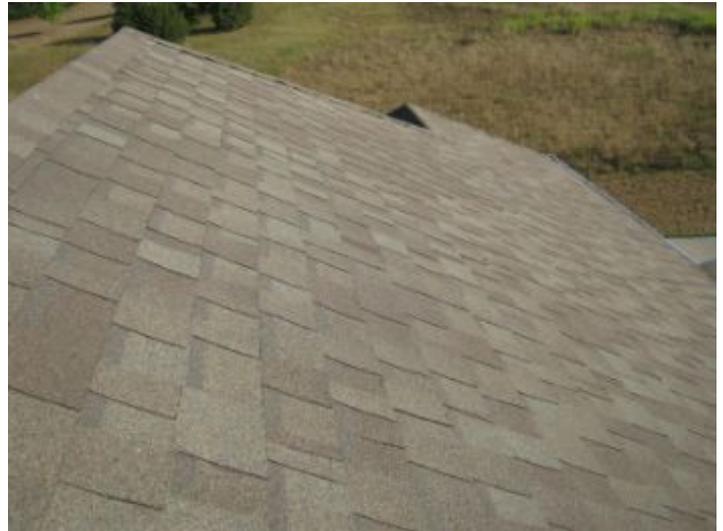
- Roof appeared serviceable and in good condition at time of inspection. No prediction of future performance or warranties can be offered.
- FYI: Fiberglass composition (asphalt) shingles typically have an expected lifespan of 15 to 20 years for standard shingles. This can fluctuate due to variables such as color, building orientation, amount of sunlight received, as well as adequate attic ventilation.
- FYI: Once a roof reaches the ten (10) year mark, it is a good idea to have the roof inspected for any signs of aging every three years. A roof that has some routine maintenance in its second half of life will outperform those that are not maintained.
- These shingles appear to be in the second third of their life cycle.
- Balding (Loss of grit surface)

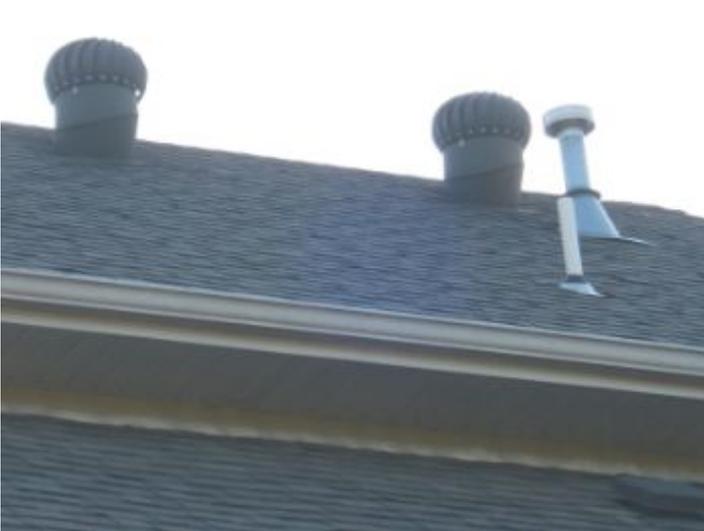
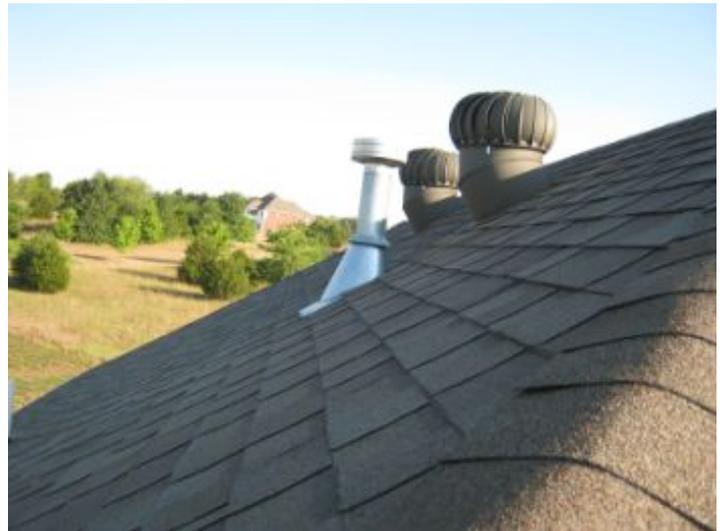
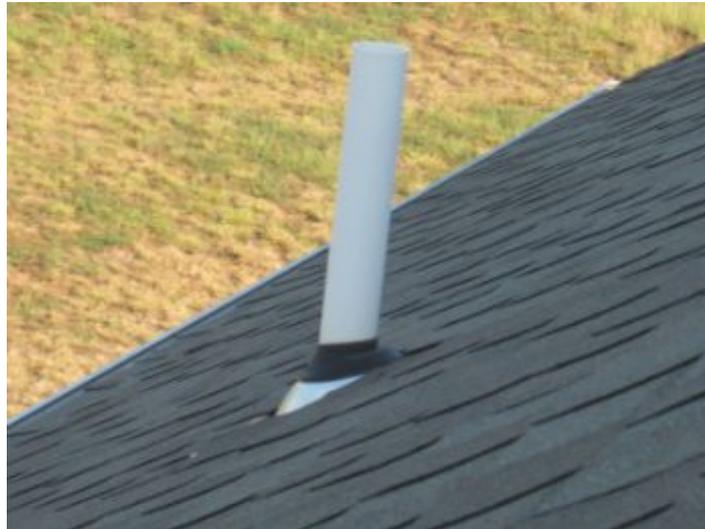
- Roof penetrations were observed to be properly flashed and in good condition.
- Plumbing vent stack flashing boot(s) appeared functional.

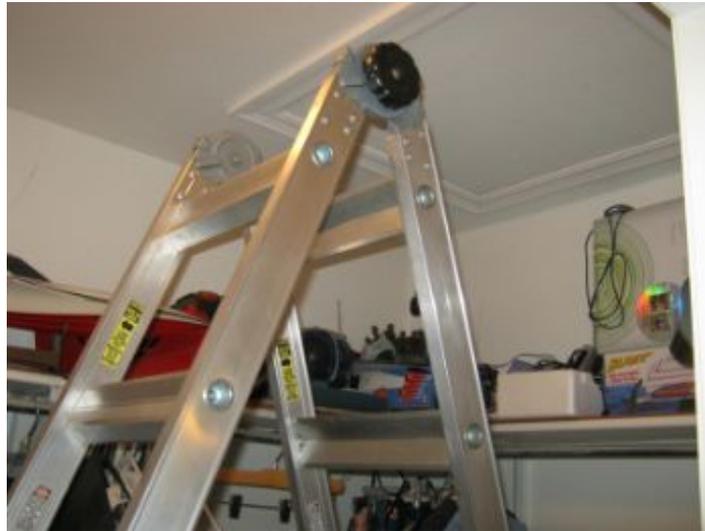
- Appeared functional - no insulation over access cover.
- Entering attics that are heavily insulated can cause damage to the insulation and attic framing. Attics with deep insulation cannot be safely inspected due to limited visibility of the framing members upon which the inspector must walk. In such cases, the attic is only partially accessed, thereby limiting the review of the attic area from the hatch area only.

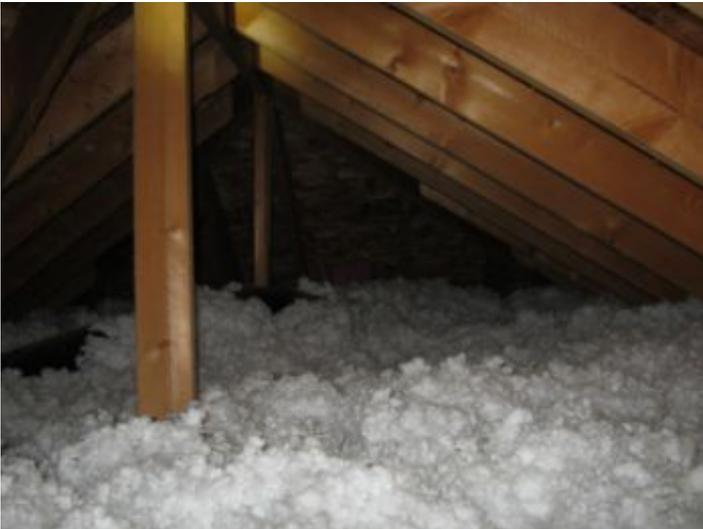
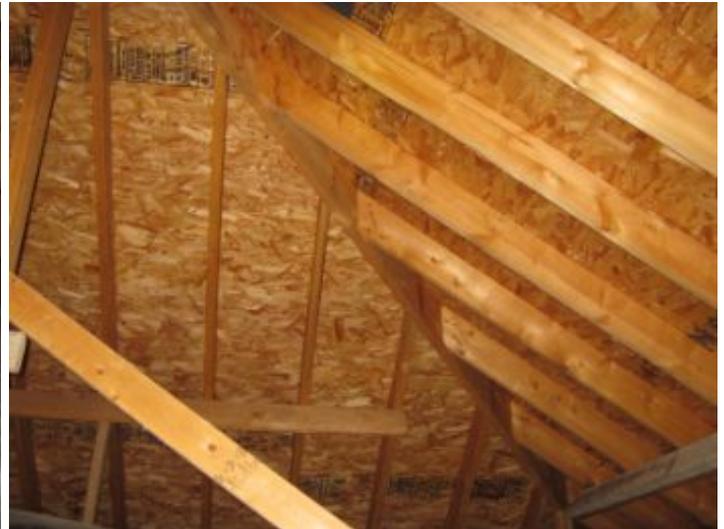
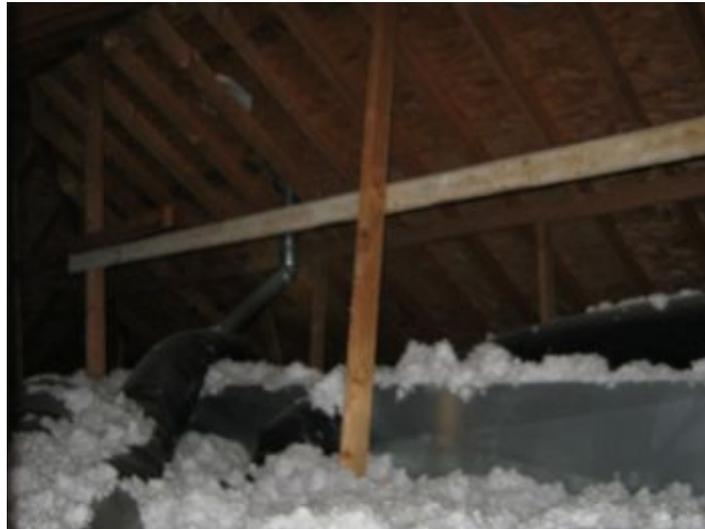
## 2. Framing

- Appeared in normal condition for age of structure.

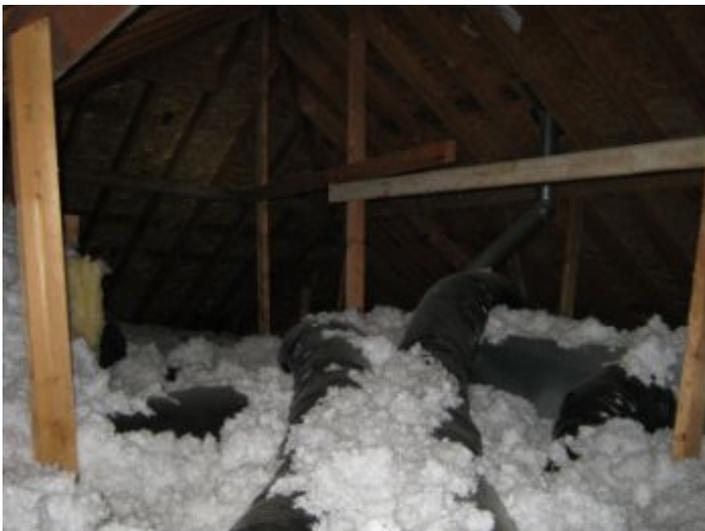
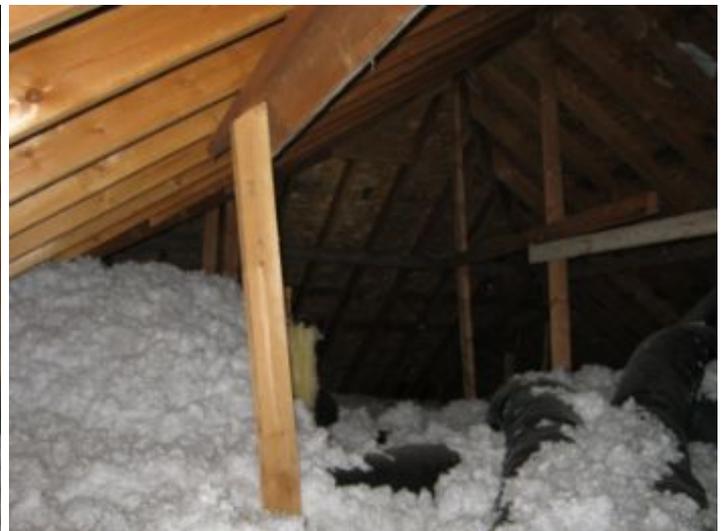
- Insulation level in the attic is typical for homes this age
- Visible insulation appears adequate.

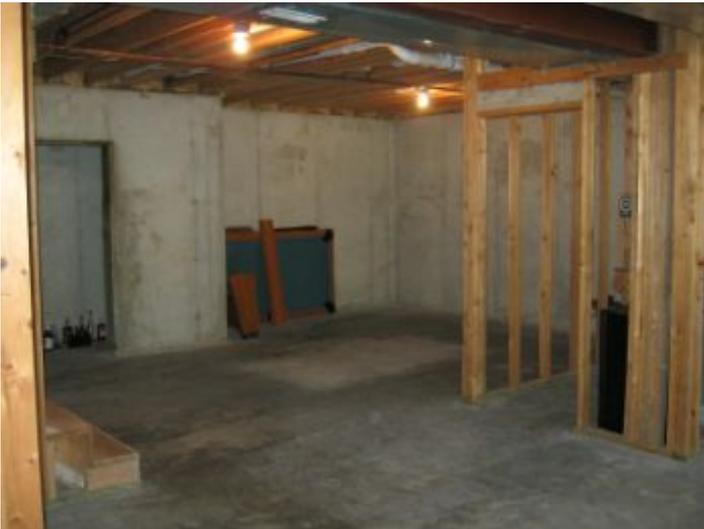
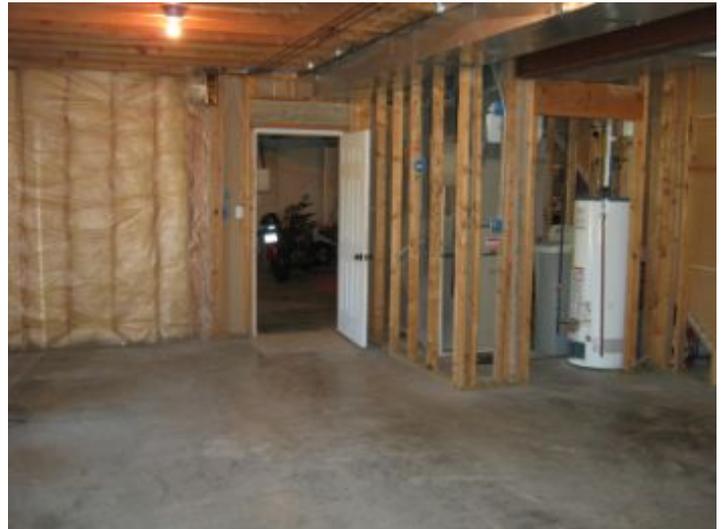
## 2. Foundation Walls

- No deficiencies noted at the visible portions of the foundation walls of the structure.
- Common cracks. Recommend monitoring over time for increased cracking activity. Recommend sealing of current cracks to minimize intrusion of water/moisture/insects/radon into the building.
- Limited review due to storage of personal property and finished walls.
- Visible portions of foundation wall were dry at the time of the inspection.

Common cracks. Recommend monitoring over time for increased cracking activity. Recommend sealing of current cracks to minimize intrusion of water/moisture/insects/radon into the building.

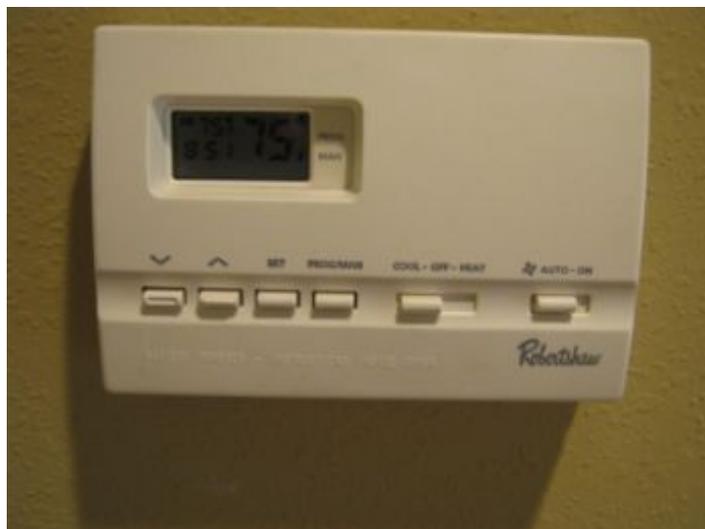
- Observed to be operational and in good condition.
- Thermostats are not checked for calibration or timed functions.

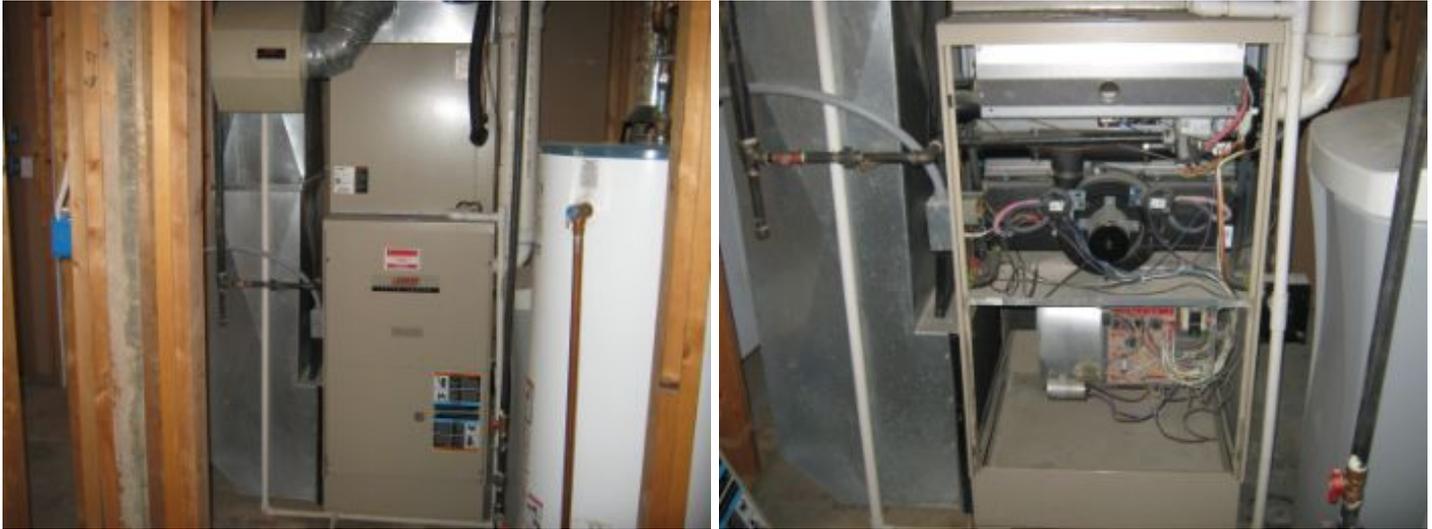
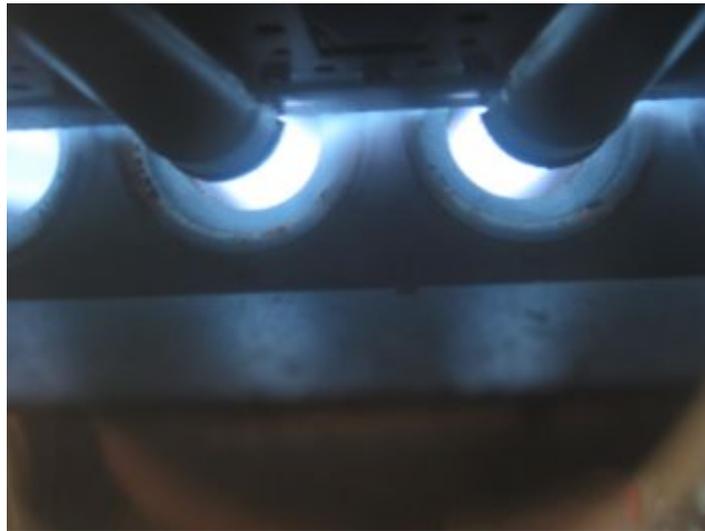
## 2. Heating System

- Observed to be operational and in good condition.
- Annual/Seasonal professional HVAC inspection and cleaning service contract is recommended.

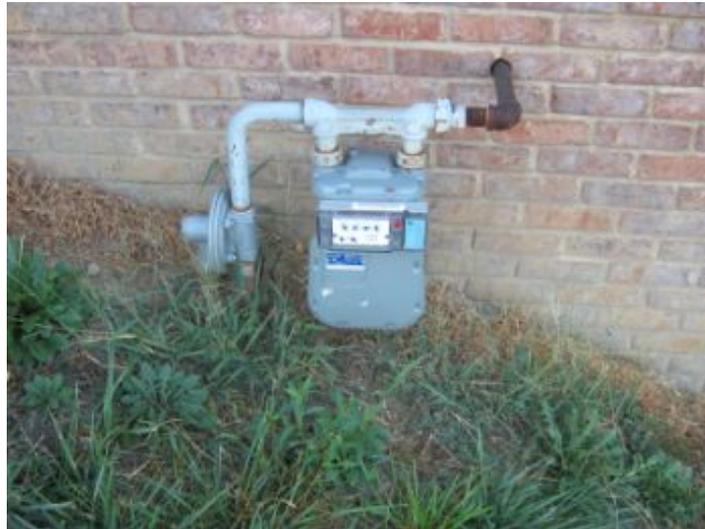
## 3. Energy Source

- Observed to be serviceable and in normal condition.

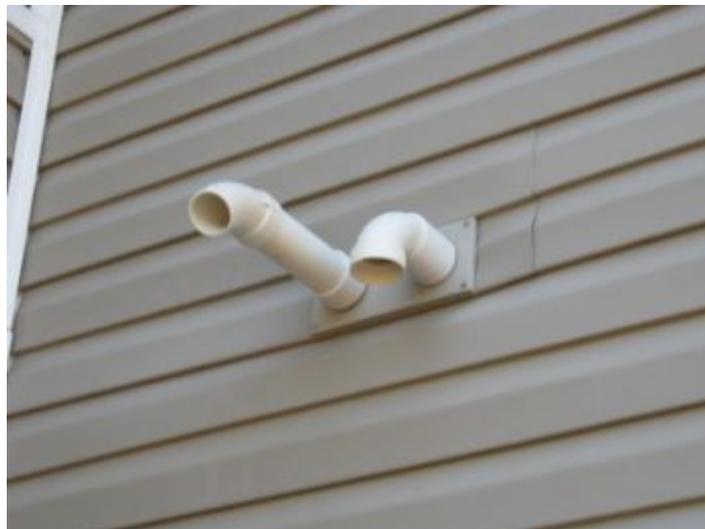
- The visible portions of the vent pipes appeared functional and in normal condition for age of system.

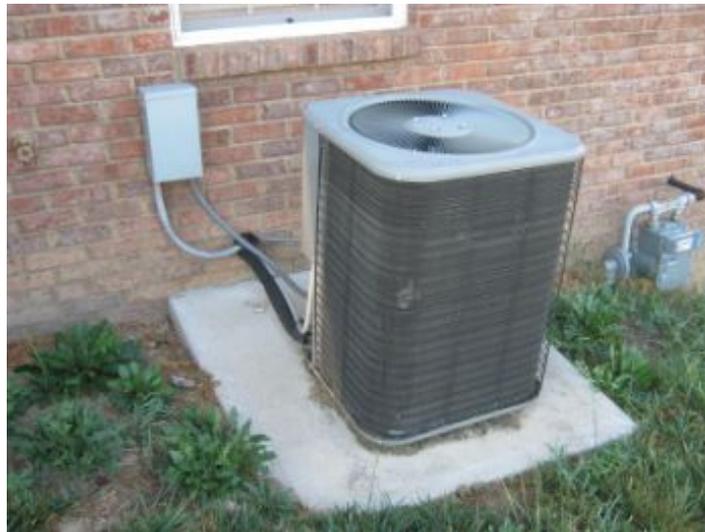
- Observed to be operational and in good condition for age of system.
- Annual/Seasonal professional HVAC inspection and cleaning service contract is recommended for all homes.

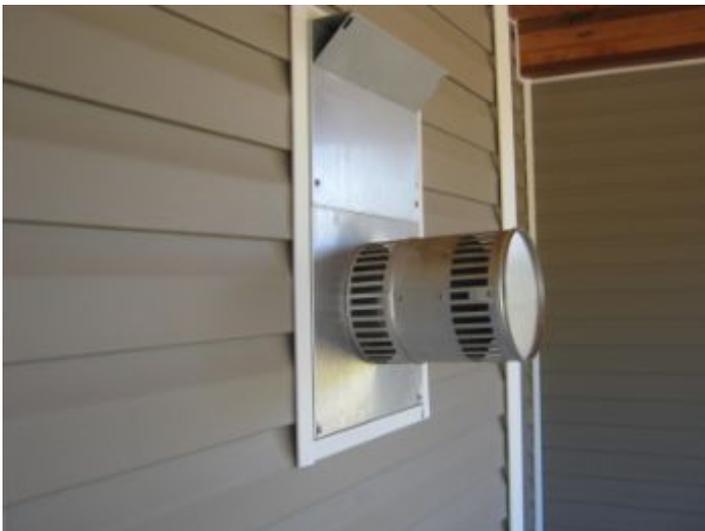
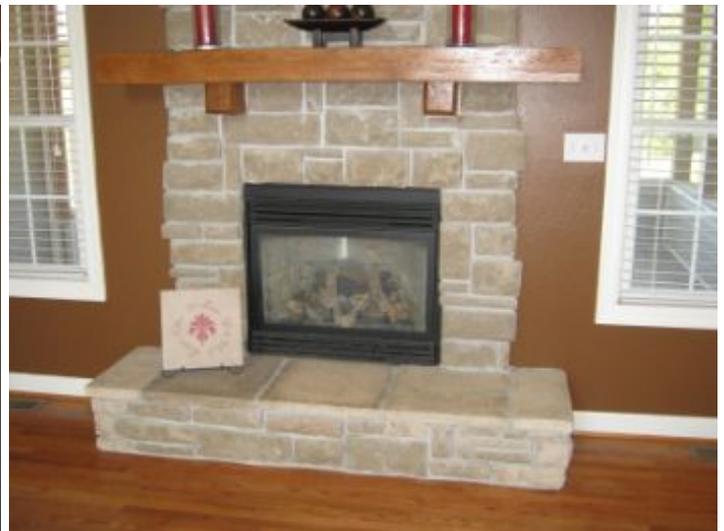
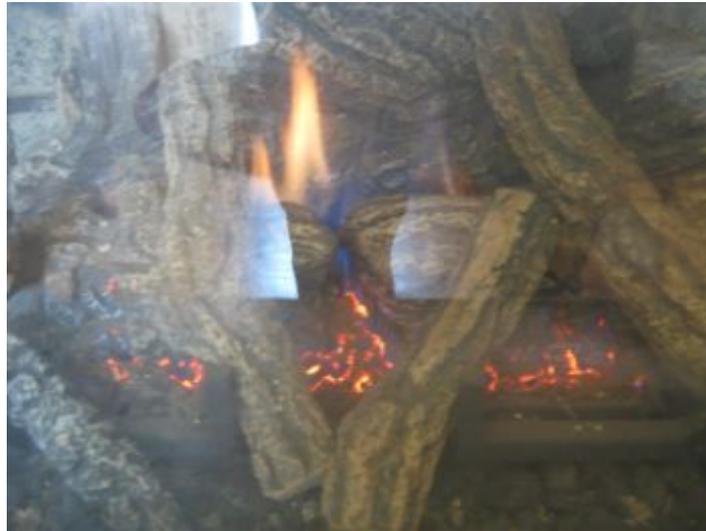
- Observed to be functioning and in serviceable condition.

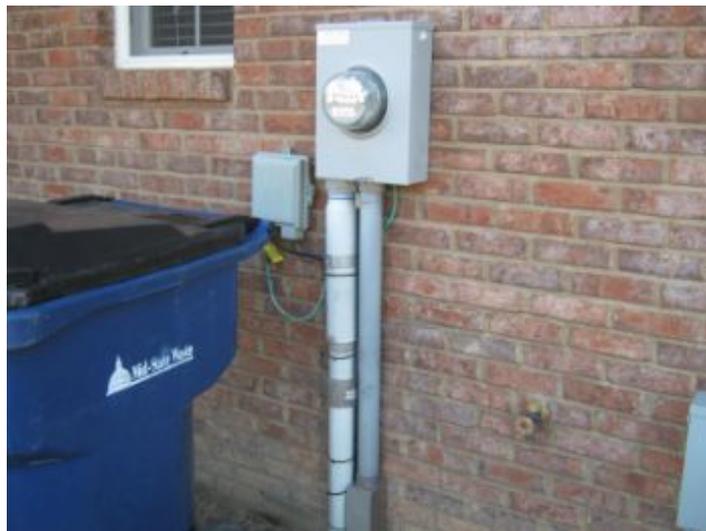
- Observed to be in good condition.

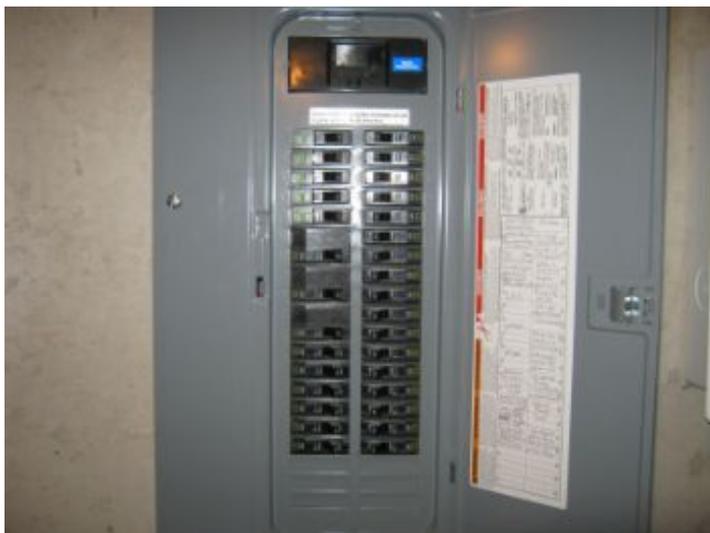
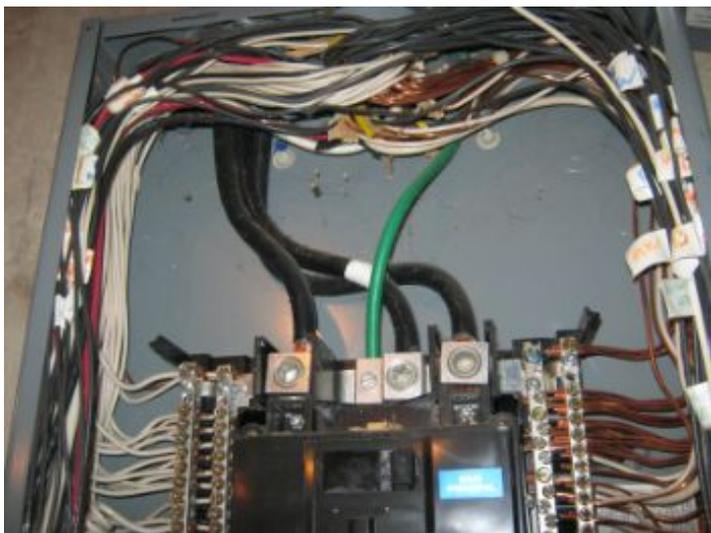
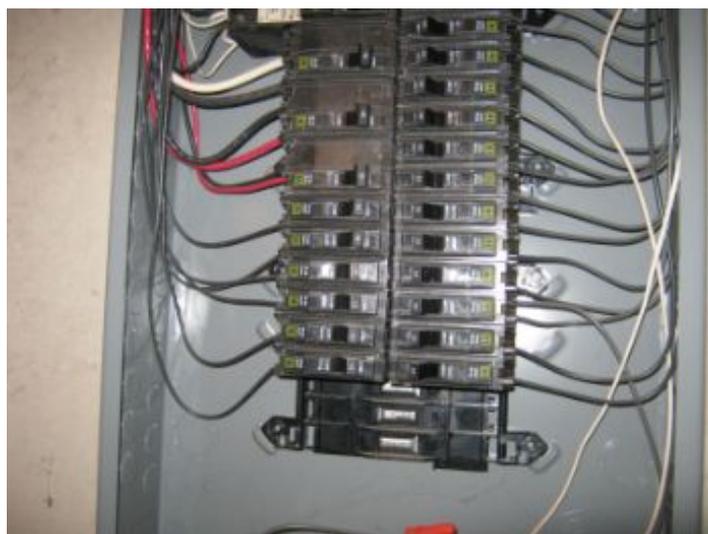
- Observed to be serviceable and in normal condition.
- The main panel appears to have some room for future upgrades or additions to the system.

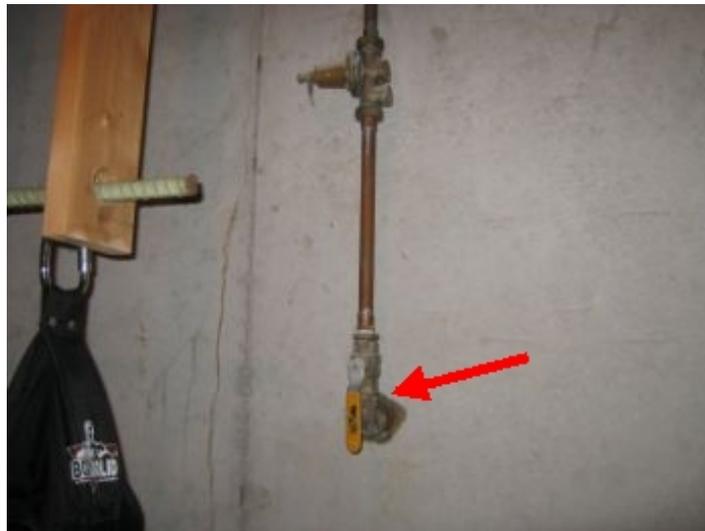
- Observed the shutoff to be in normal/operating condition.

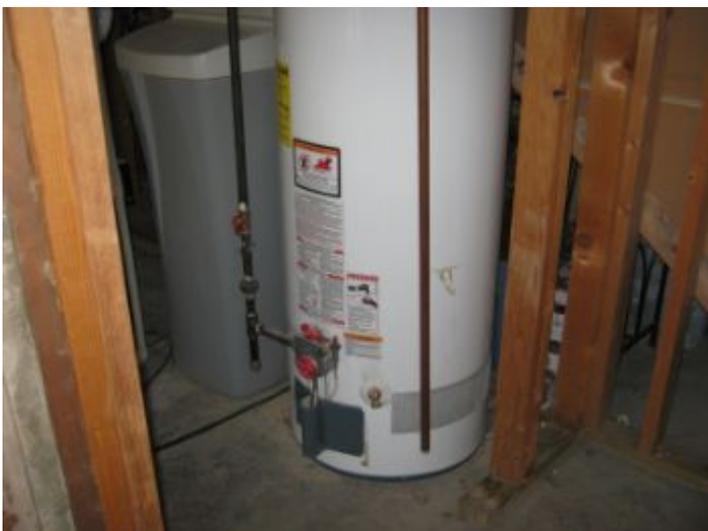
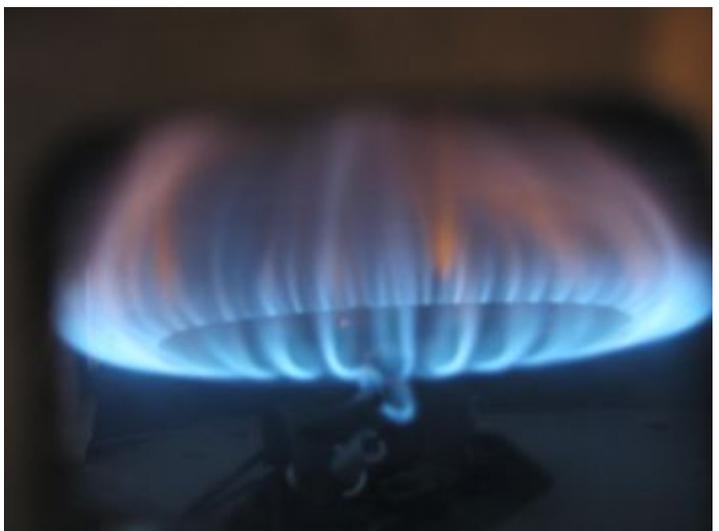
## 11. Water Heater(s) Condition

- Observed to be serviceable and in good condition.
- No deficiencies noted with the Temperature Pressure Relief (TPR) valve and discharge pipe.

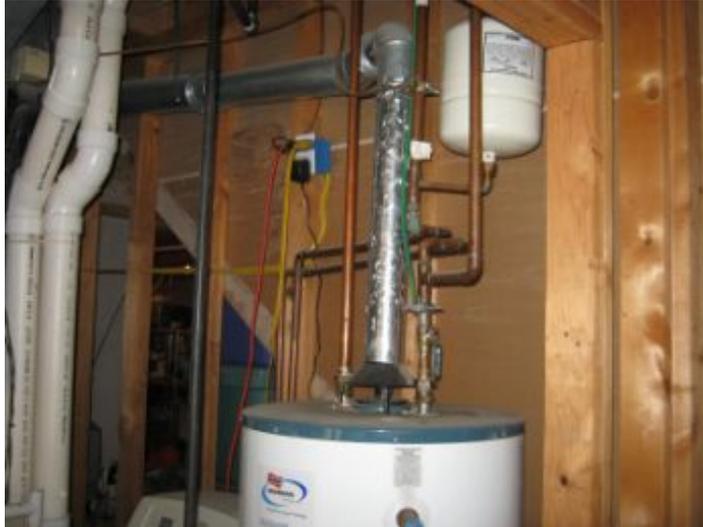
## 12. Water Heater Vent System

- Appeared functional and in good condition.

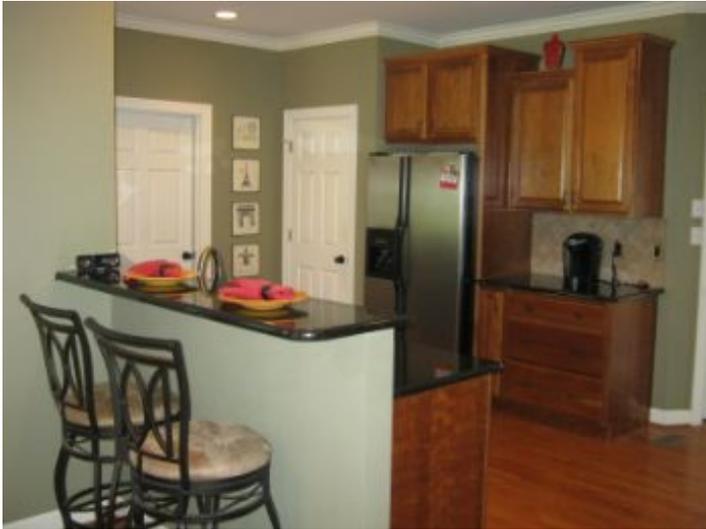
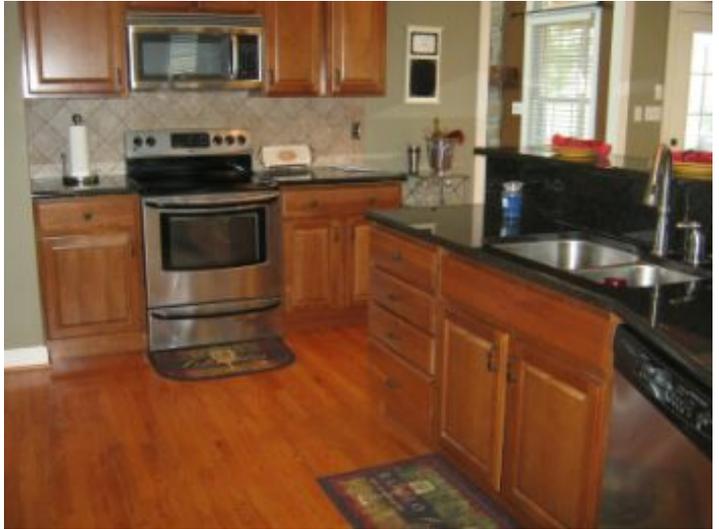
- Walls and ceilings were observed to be in good condition.
- Some cosmetic, common small cracks and typical flaws in drywall finish noted. This is normal wear for age of home.

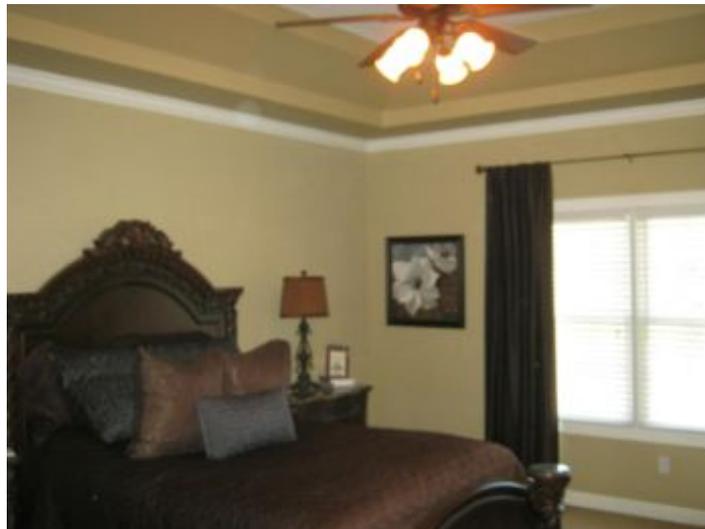
- General condition of walls and ceilings appeared in good condition.
- Some cosmetic, common small cracks and typical flaws in wall and ceiling finish noted.

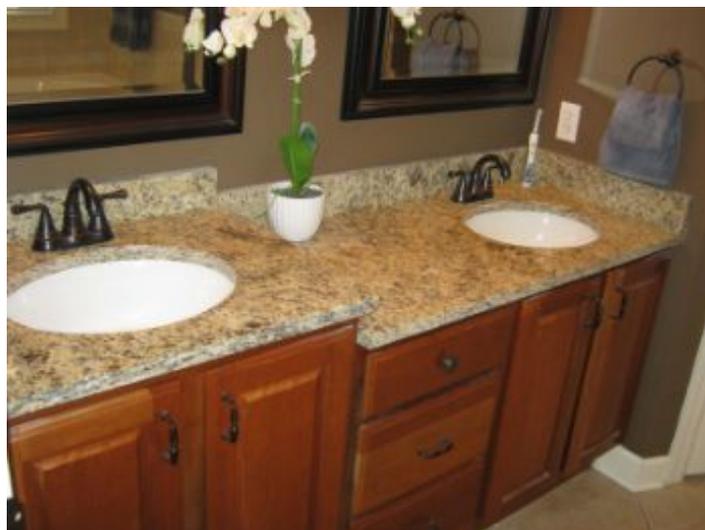
- Observed to be functional and in good condition.

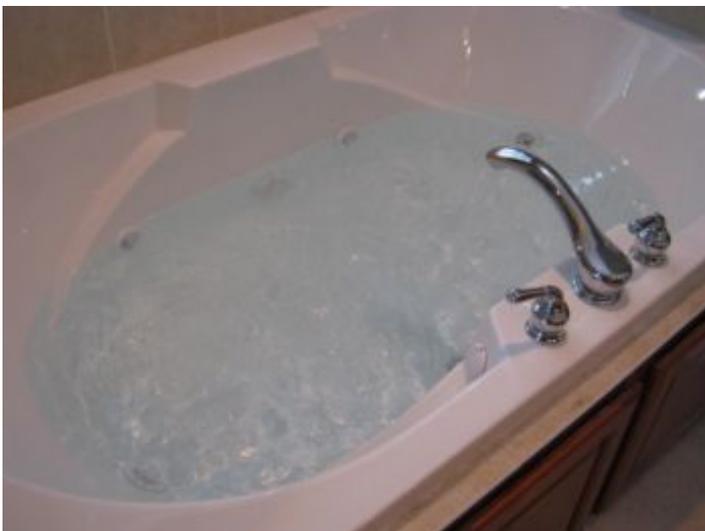
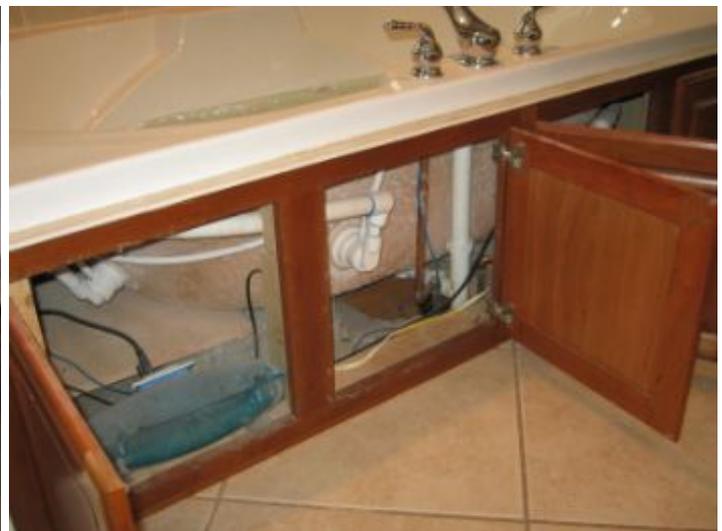
- Observed to be operational and in good condition.
- Whirlpool tub was filled to a level above the water jets and operated to check intake and jets. The tub was then drained to check for leaks and/or damage. Pump and supply lines were not completely visible or accessible. The items tested appeared to be in serviceable condition, at time of inspection. If a more detailed report is desired, the client is advised to consult a licensed plumber for a complete review prior to closing.
