# Home Inspection Report

123 ABC Street  
Anytown, USA

Inspected by:  
Greg Glendenning  
Inclusive Home Inspection

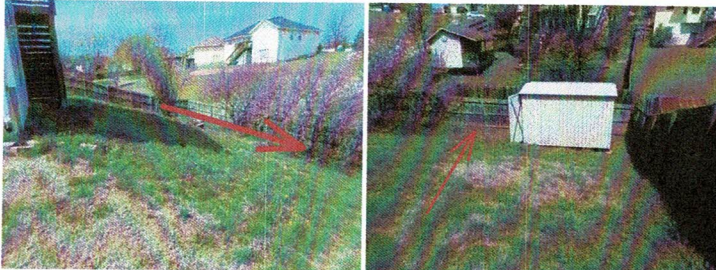
5.      Grading: Moderate slope - Backyard has steep slope away from house to concrete drain basin shared by the community behind the back fence.

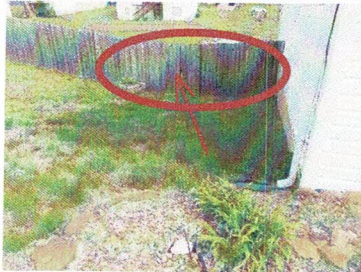
7.      Fences: Wood - Gates on West side of house need adjustment and maintenance.

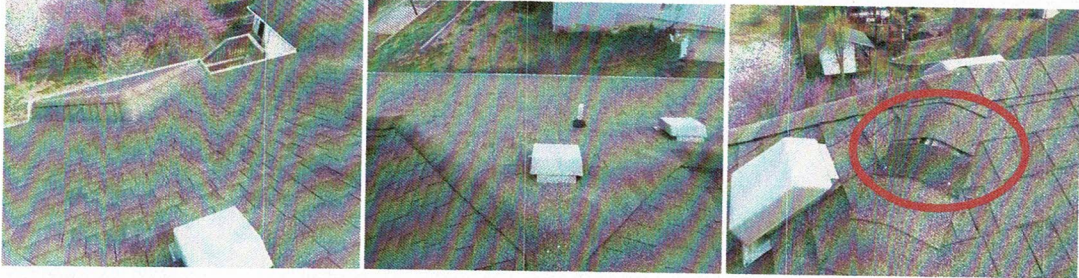
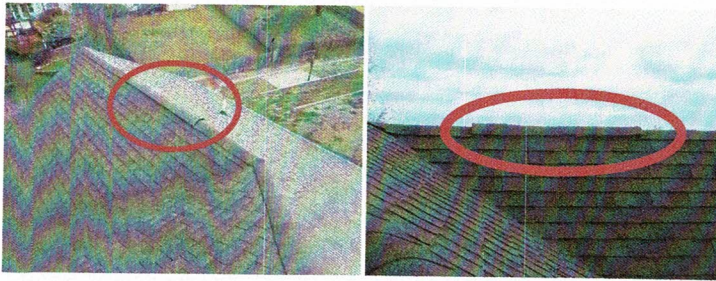
Material: (continued)

1. Method of Inspection: On roof
2.      Material: Asphalt shingle - In 3 locations on the ridge caps, shingles need to be repaired and or replaced. It appears in at least 2 of the locations, prior repairs may have been attempted. A qualified roofing contractor should be contacted for further inspection and estimate for repairs.

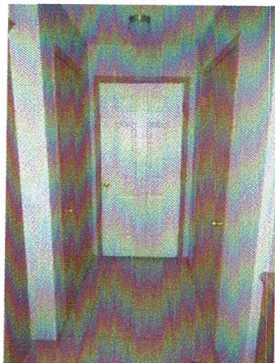
9.      Ceiling: Painted gypsum board. Crack is present in the gypsum board seam. This crack is due to expansion/contraction. A qualified drywall contractor should be contacted for estimate of repair.

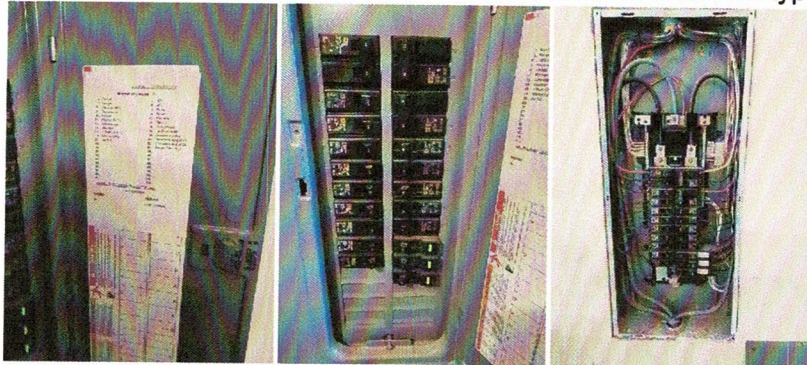
10.      Manufacturer: Square D - It is rare to have a list of breakers typed, legible and easy to follow!

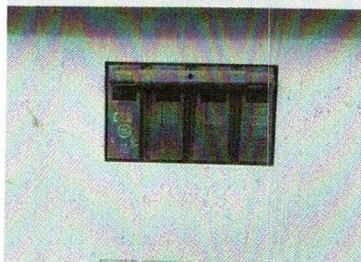
12.      Main Breaker Size: 150 amp - Located below electric meter on East side of house.

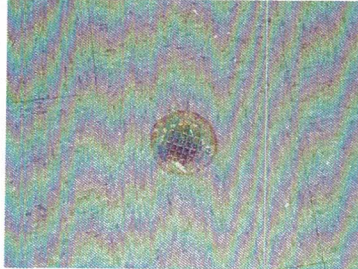
- 1.  Ceiling: Painted gypsum board - Basement is 85% finished.
- 2.  Walls: Painted gypsum board - Basement is 85% finished.
- 3.  Floor: Carpet, concrete, ceramic tile, vinyl flooring.
- 4.  Floor Drain: Surface drain - Located in basement, laundry room.

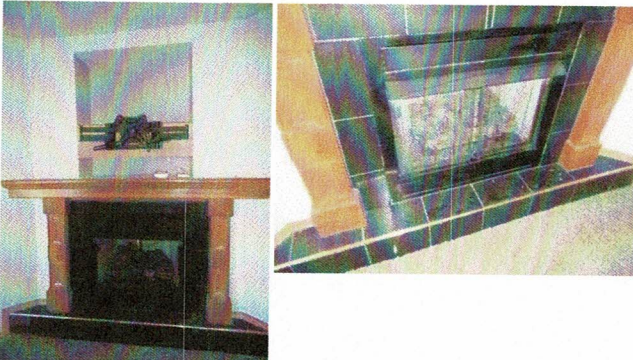
- 3.  Fireplace Insert: Not inspected - Natural gas fireplace was not inspected, control not found. Pilot light was lit. Ask seller for how the fireplace is controlled. Recommend having an authorized fireplace dealer inspect fireplace for functionality.
- 4.  Smoke Chamber: Ventless
- 5.  Flue: Ventless
- 6.  Hearth: Raised

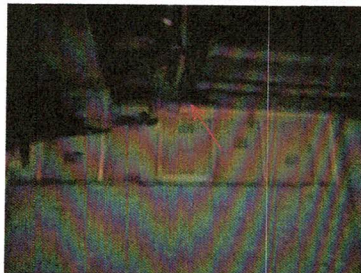
- 2.  Main Water Shutoff: Basement
- 3.  Water Lines: Copper, pex
- 4.  Drain Pipes: PVC
- 5.  Service Caps: Not visible
- 6.  Vent Pipes: PVC
- 7.  Gas Service Lines: Cast iron

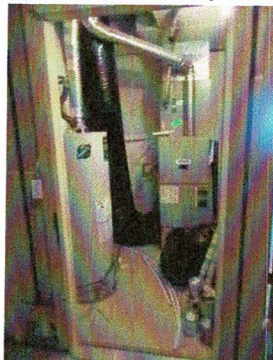
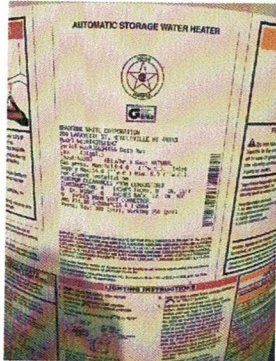
### 9. Manufacturer: Bradford-White

14.      TPRV and Drain Tube: Copper - Blow down and drain from water heater drains in a room that does not have a floor drain. It needs to be piped to the drain in the neighboring laundry room. If the TPRV activates, it will discharge water onto the floor of the basement. Recommend further investigation and pricing from licensed plumber.

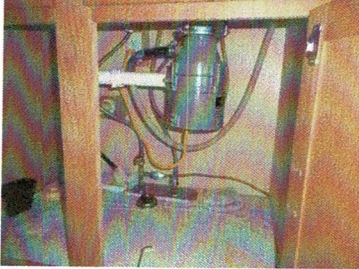
5. Air Gap Present?  Yes  No Air gap was not present under the sink. Air gap may be located behind dishwasher.

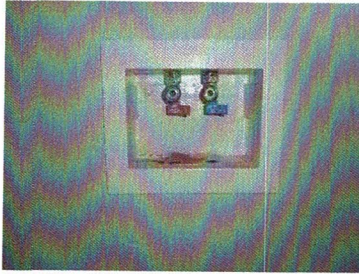
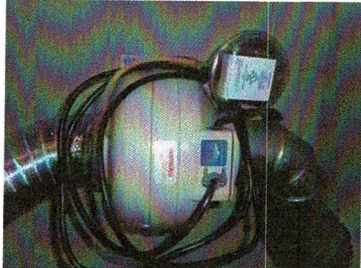
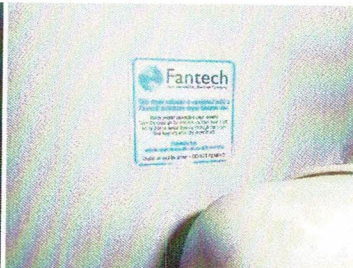
- 1.      Ceiling: Painted gypsum board
  - 2.      Walls: Painted gypsum board
  - 3.      Floor: Vinyl floor covering
  - 4.      Doors: Hollow wood
  - 5.      Electrical: 110 VAC/220 VAC
  - 6.      Smoke Detector: Not present.
  - 7.      HVAC Source: Heating system register
  - 8.      Washer Hose Bib: Gate valves
9.      Washer and Dryer Electrical: 110-240 VAC
10.      Dryer Vent: Metal flex with a booster fan - Fan was not tested for performance
