# Precision Home Inspections

## Property Inspection Report

1234 Your Street, Tacoma, WA 98404  
Inspection prepared for: Your Name  
Date of Inspection: 10/22/2016 Time: 11:00 PDT  
Age of Home: Built 1962 Size: 1940 sq ft  
Weather: Sun, recent heavy rain

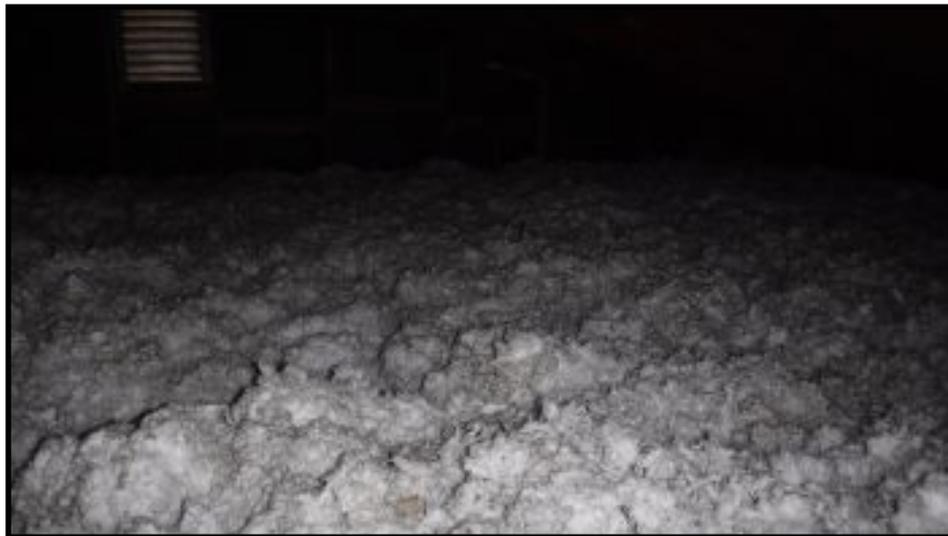
Materials: Unfinished fiberglass batts noted. • Loose fill insulation noted.  
 Depth: Insulation averages about 8 inches in depth  
 Observations:  
 • Insulation is in good condition  
 • **Insulation is sparse in some areas, recommend evenly distribute attic insulation upon completion of any work in the attic**

Attic insulation is in good condition

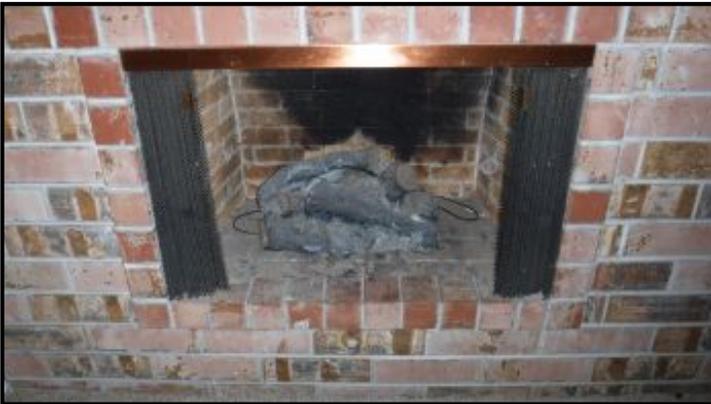
- The wood-burning fireplace may not be in compliance with new regulations
- There are new regulations regarding the ownership and use of wood-burning fireplaces. See [www.ecy.wa.gov](http://www.ecy.wa.gov) for further reference
- **The fireplace insert is in need of cleaning and ash removal**

Brick fireplace is in good condition
