HOW TO PREVENT YOUR BIKE FROM KILLING YOU!

Simon Pellaud, in a recent 9/2019 French pro race, snapped his fork just below the stem. How did this happen and how can you prevent this from happening to you?

During a recent bike fit, a client wanted to invert his stem, changing it from '-10' to '+10'. Simple enough, just unbolt the stem from the handlebars and fork and flip it over. Luckily, by doing this revealed a hidden danger that many bikes are probably suffering from. In this article, I will take you through what I found and the process of how to fix it.

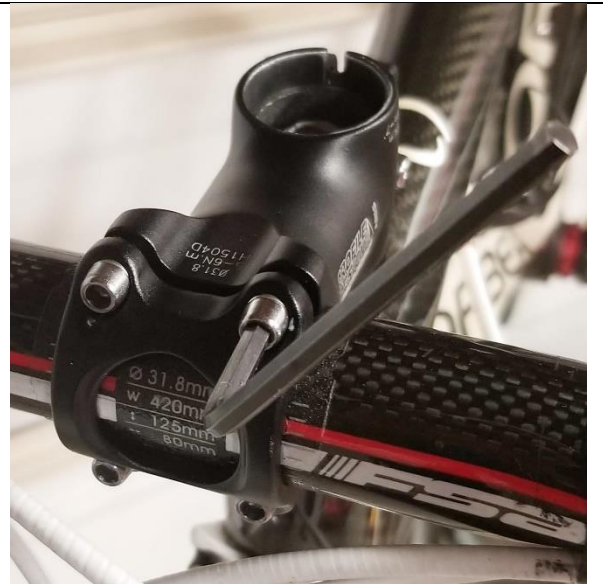
As soon as I removed the stem cap, I noticed a BIG problem. Do you see it? Take a guess, will discuss later.

But first and as promised, let's discuss the **BIG PROBLEM**. This is the smallest compression plug I have seen. So small that there is absolutely **NO** support for the steerer tube from being crushed by the stem pinch bolts.

In fact, the compression plug was actually entirely below the bottom of the stem. Ideally, you want the compression plug to completely support the steerer tube along the full length of the stem.

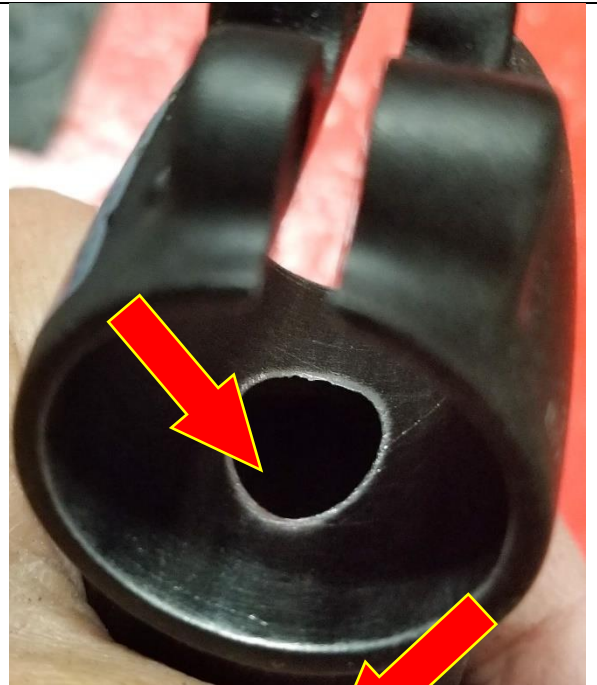
After sanding. Notice all burrs and sharp edges removed, nice and smooth now.

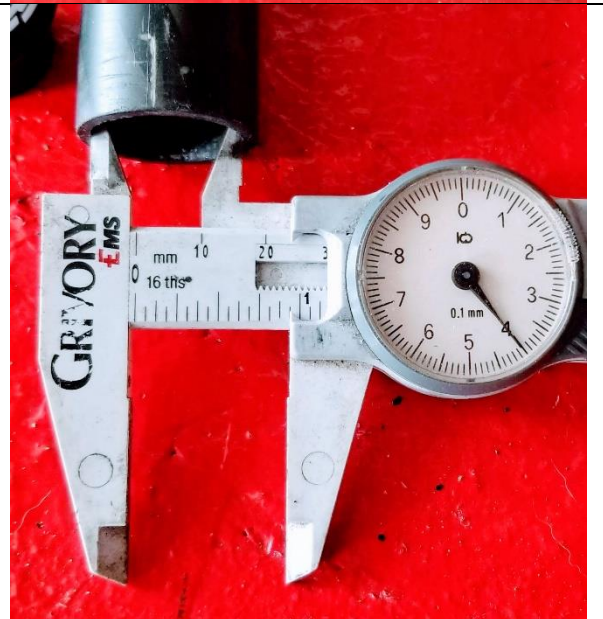
The inside diameter (ID) of the steerer tube measures 24mm

The outside diameter (OD) of the stem cap measures 20.75mm which is 3.25mm smaller than the ID of the steerer tube.

NOPE, no support here.
