Fawn Lake Shelton, WA

Report #: 31686-6
Beginning: January 1, 2026
Expires: December 31, 2026

RESERVE STUDY Update "With-Site-Visit"

April 14, 2025

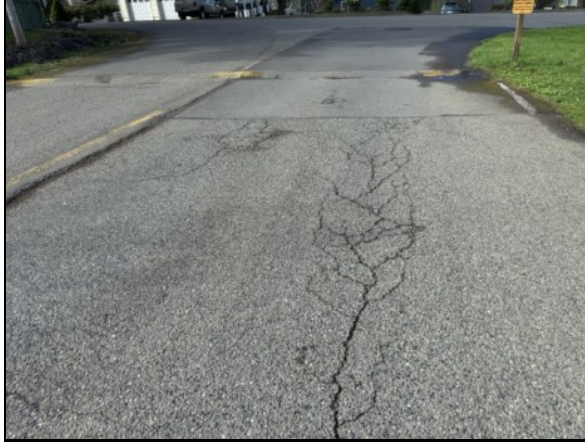
Comp #: 108 Asphalt Road - Resurface 1/6**Quantity: Approx 1/6 of 336,000 SF****Location:** Asphalt roadways within property perimeter (56,000 SF), except already planned 2020 local resurface and Alpine Avenue**Funded?:** Yes. Meets National Reserve Study Standards criteria for Reserve Funding**History:****Comments:** Continued phased asphalt work. Photo may not be representative of phasing.**Useful Life:**

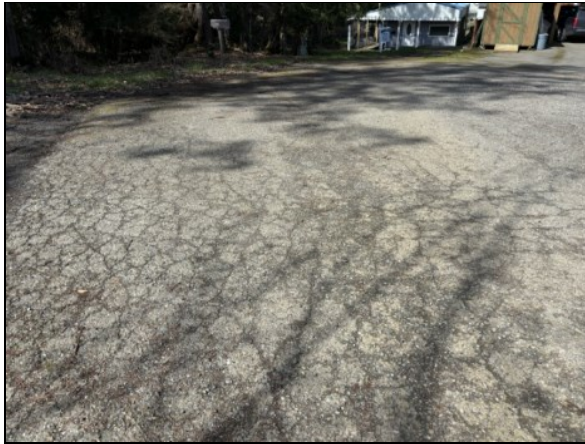
Comp #: 110 Asphalt Road - Resurface 1/6**Quantity: Approx 1/6 of 336,000 SF****Location:** Asphalt roadways within property perimeter (56,000 SF), except already planned 2020 local resurface and Alpine Avenue**Funded?:** Yes. Meets National Reserve Study Standards criteria for Reserve Funding**History:****Comments:** Continued phased asphalt work. Photo may not be representative of phasing.**Useful Life:**

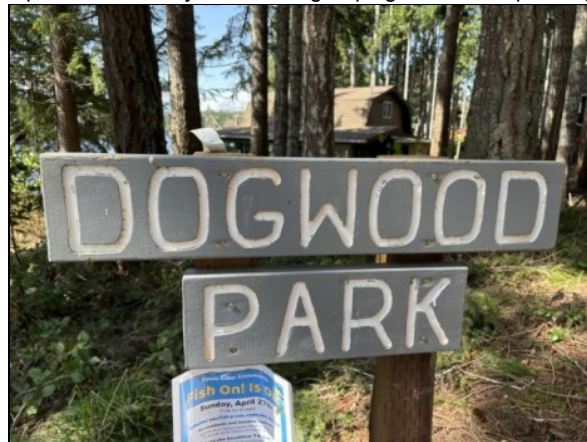
Comments: Assorted ages / types of signs (wood/metal) in varying condition with no major instability or damage noted. Continue to evaluate regularly, repair and replace individually or in small groupings from the operating budget.

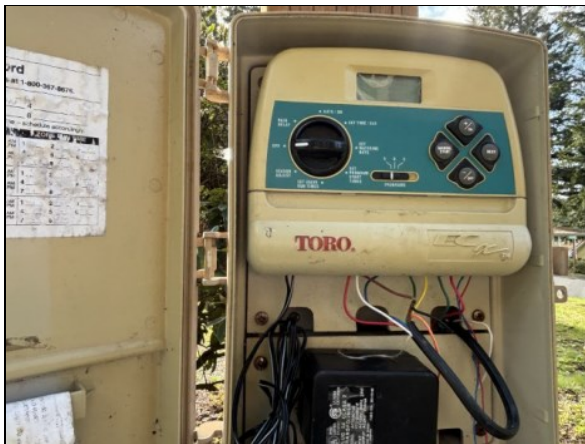
Comments: No widespread problems reported for assorted small systems. Reports of Office area with (7) zones, Lilac Park (3) and Madrona Park with (4). As routine maintenance, inspect regularly, test systems, repair as needed from operating budget. Follow proper winterization and spring start up procedures. The elements within this component are generally low cost, have a typical failure rate that is difficult to predict and are best suited to be handled thru the operating budget. No reserve funding suggested at this time.

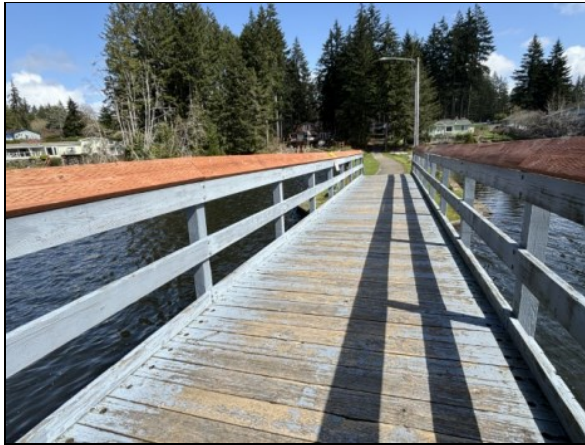
Comp #: 250 Causeway Foot Bridge - Rpr/Replace**Quantity: ~450 SF, wood****Location:** Causeway bridge between Dogwood and Madrona Parks**Funded?:** Yes.**History:** Varies**Comments:** Bare wood/faded paint on wood decking but appears stable. This wood structure (8' x 55' structure) with wood railings, sits atop concrete piers. No comprehensive, expert evaluation of structure in recent years is known or was provided for our review. Assumed to have been originally constructed in mid 1960's with some apparent history of subsequent replacement since. Definitive repair / replacement history, scope was not provided. Going forward, reserve funding recommend for large scale replacement of wood decking, railing systems along with allowance for local structural member at the 30-40 year interval below. Provide cleaning, painting and minor spot repair as operating budget in between such intervals.**Useful Life:**

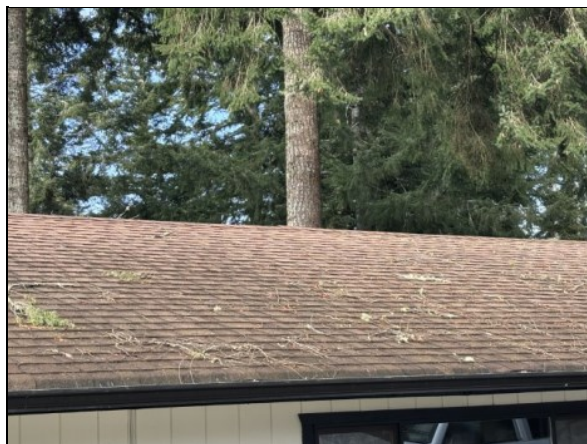
We recommend professional inspections at least twice annually and after wind storms, promptly replacing damaged / missing shingles or any other repair as may be needed to ensure that the water proof integrity of the buildings is maintained. Provide any roof cleaning, treatment for moss as annual operating expense. Keep roofs, gutters and downspouts clear and free of debris to allow water to evacuate from rooftops as designed. For purposes of long term financial planning, anticipate practical useful life at roughly the 20-25 year time frame indicated below.

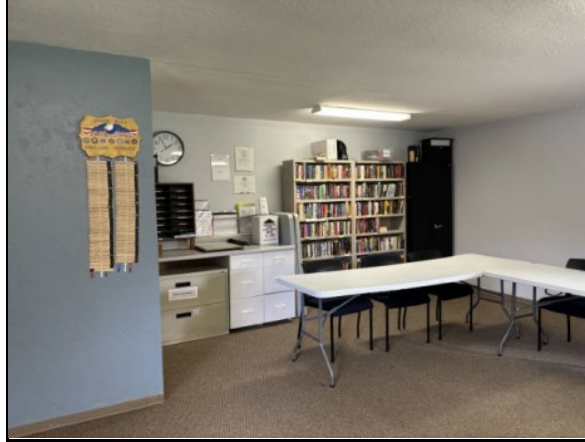
Comments: No major deterioration of office interiors which have simple, utility appearance. Plans in previous components for significant remodel of office and existing maintenance buildings. Current level of interior finishes, amenities could continue to be maintained as operating budget items for individual projects such as repainting, replacement of HVAC, lighting, assorted flooring, cabinets, etc. For now, no reserve funding recommended with current level of interior finishing. Update in future reserve studies as conditions merit.

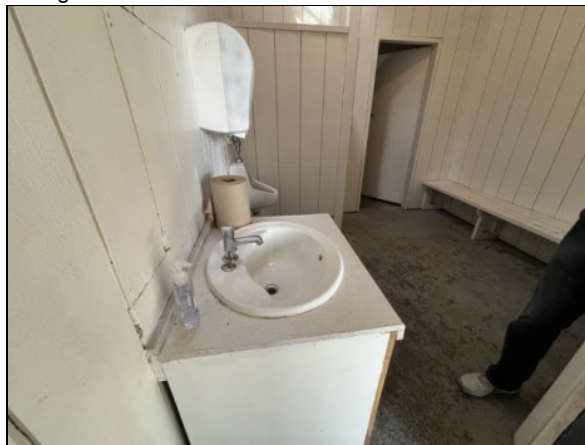
Comments: No obvious major deterioration noted of (2) Madrona Park bathrooms and the office bathroom. The showers for the park bathrooms were reportedly decommissioned in 2005, now used for storage. Inspect regularly, continue to perform any needed repairs / replacement promptly utilizing operating budget. Under current pattern of care, no recommendation for setting aside funds for large scale refurbishing.

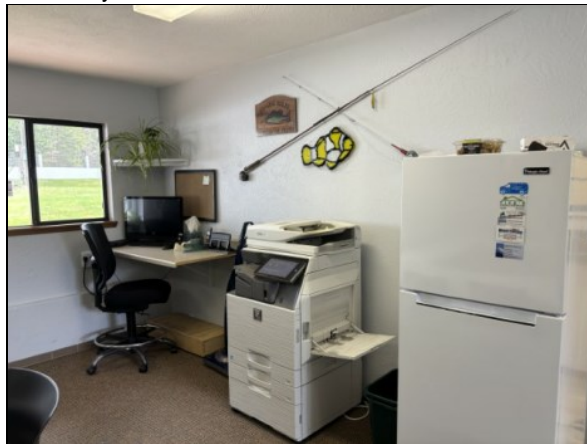
Comp #: 660 Equipment, Office/Meeting - Replace

Comments: A variety of office equipment which varies in ages, brands, condition and styles. No anticipation for replacement of all pieces as comprehensive project with assumption pieces can be replaced as needed from operating funds. We note the large printer, a Sharp brand MX-5141 is currently leased.

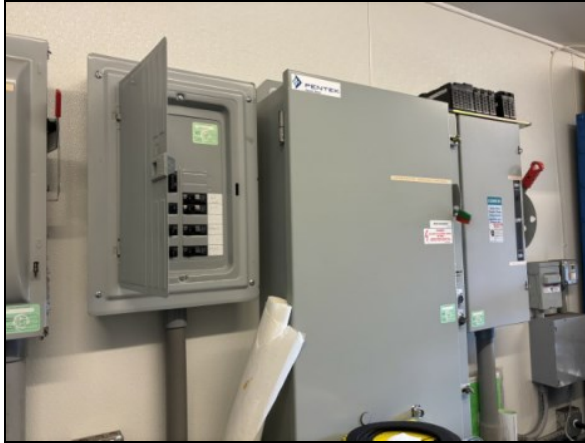
Comp #: 800 Electrical/Plumbing-Repair/Replace

Comments: Systems of varying ages with no significant problems reported at this time. Assessing both the electrical and plumbing systems is beyond the scope of a reserve study. Treat electrical or plumbing repairs as ongoing maintenance expense for now. If significant needs emerge, funding may be incorporated into future reserve study updates. No predictable basis for reserve funding at this time.

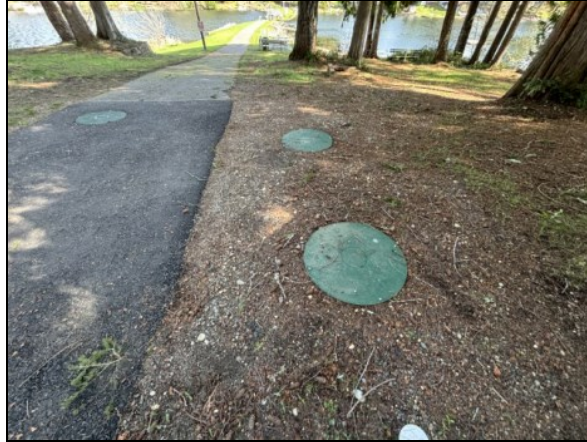
Comp #: 804 Septic System, Madrona Park-Replace**Quantity: (1) system****Location:** Serving Madrona Park Bathrooms**Funded?:** Yes.**History:** Work in 2023 included replacement of one of two tanks**Comments:** In 2023, one of the two tanks was replaced with 1500 gallon two component tank. No problems currently reported but Client reports might be best to include budget allowance as shown in future for drainfield or other work. The timing and costs could vary but best to include budget allowance.

It is our understanding the original septic system was installed in the mid 1960's. Ongoing evaluation by expert can help further define work and costs.

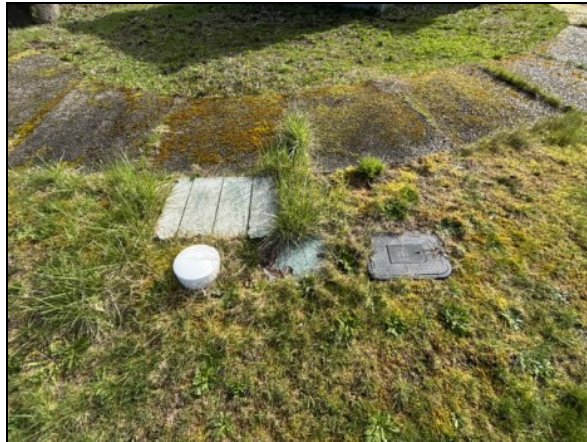
Comp #: 806 Septic System, Office - Replace**Quantity: (1) system****Location:** Serving Office**Funded?:** Yes.**History:** None known**Comments:** No major costs known of this system and no problems reported.

It is our understanding the original septic system was installed in the mid 1960's. Ongoing evaluation by expert can help further define work and costs. Budget allowance included here.

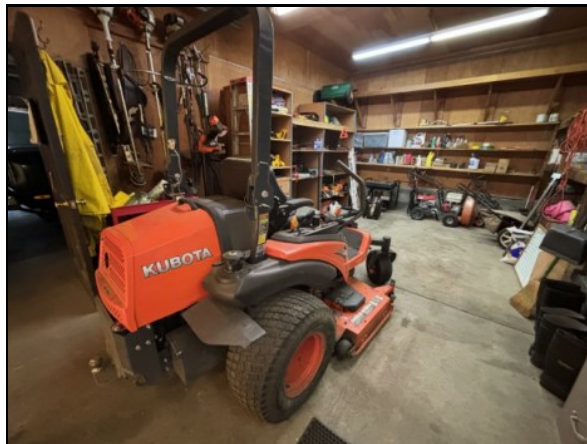
Comp #: 825 Zero Turn Mower - Replace

Comments: No problems reported of this piece. Service routinely and plan for replacement as shown. Could vary based on usage.

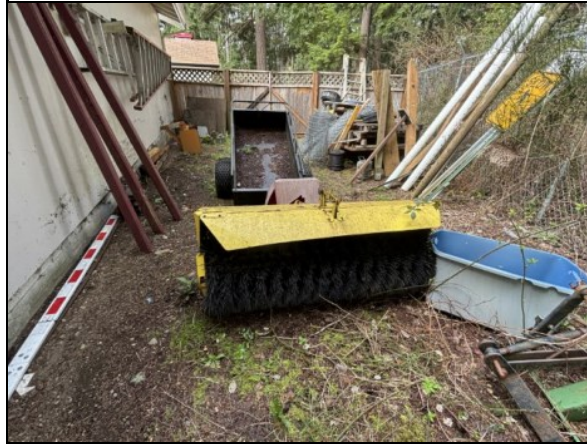
Comp #: 826 Attachments, Broom/Blade - Replace**Quantity: (2) assorted****Location:** 471 SE Crescent Drive**Funded?:** Yes.**History:** Varies

Comments: Older JD 60 street broom and JD blade attachments used with tractor with no problems reported to us. Brushes were replaced in 2014 but actual street broom attachment was reportedly replaced last in 2004 and blade attachment may have been replaced last in 1999. Ongoing maintenance assumed from annual operating funds; eventual intervals of equipment replacement timed to coincide with new tractor are factored below.

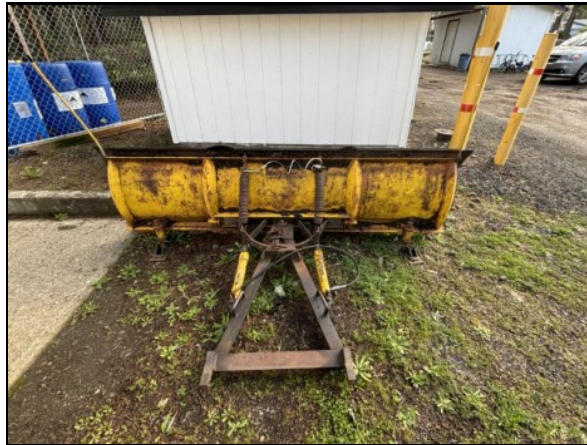
Comp #: 827 Attachment, Snowplow - Replace**Quantity: (1) metal plow****Location:** 471 SE Crescent Drive**Funded?:** Yes.**History:**

Comments: We noted rust and deterioration, however no functional problems reported of plow attachment used with current Dodge pick-up. Ongoing maintenance assumed from annual operating funds with eventual intervals of equipment replacement shown here.

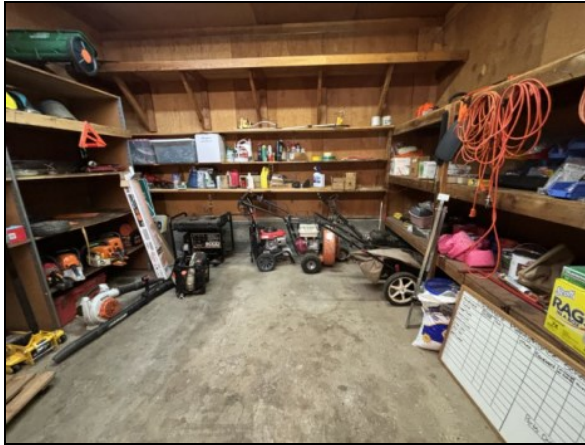
Comp #: 828 Small Equipment/Tools - Replace

Comments: Assorted equipment such as pressure washers, air compressors, push mowers and other small tools, etc. on site. No comprehensive replacement anticipated and no piece that meets typical reserve fund threshold individually. These pieces can be repaired/replaced as needed from annual operating budget with no predictable basis for reserve funding.

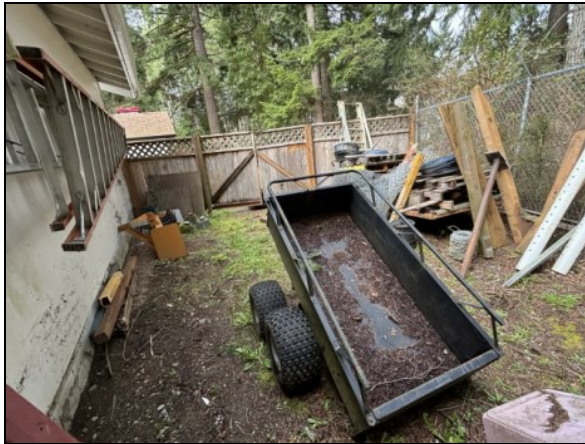
Comp #: 830 Utility Trailers, Small - Replace

Comments: No problems reported of several small utility trailers. Individual replacement when needed from operating funds is assumed since expense for each is less than \$3,000.

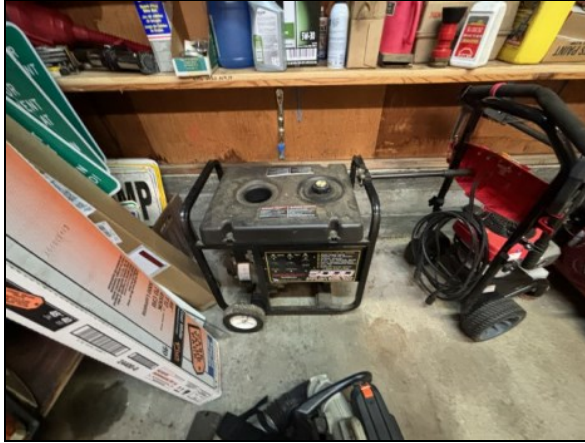
Comp #: 832 Generator, Small - Replace

Comments: No problems reported of small 5000 watt generator. Typical useful life is dependent upon usage. Replacement assumed from operating budget since expense would likely be under \$3,000 for similar type.

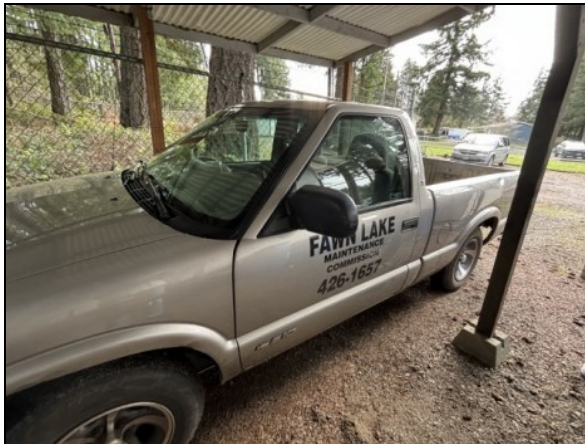
Comp #: 840 Truck, 2003 - Replace

Comments: No problems with this small pick-up truck reported. Client previously discussed preliminary plans to replace, transition to more utilitarian vehicle such as a new John Deere Gator with costs here considering this.

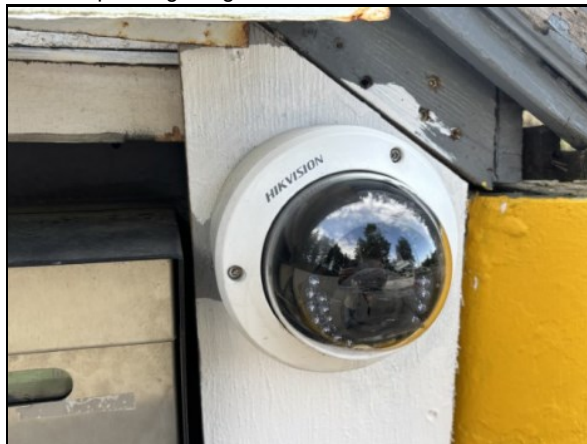
Comp #: 850 Surveillance System - Replace

Comments: No problems with surveillance system reported. System generally includes cameras, DVR and monitor. Anticipate integrated equipment replacement of existing every 4-8 years to maintain contemporary functionality at level indicated below. Treat any spot replacements needed as operating budget item in between these intervals.

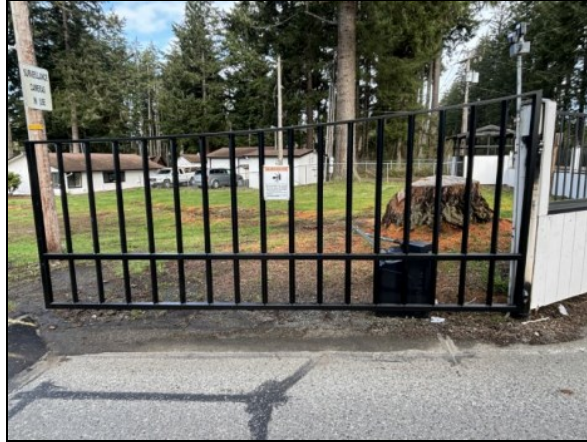
Comp #: 860 Vehicle Entry Gates - Replace**Quantity: (2) metal, swing****Location:** Adjacent to main entry/exits**Funded?:** Yes.**History:** Entry gate replaced 2024; both replaced previously in 2001 as part of larger project**Comments:** The entry gate was recently replaced in 2024 and at the time of our April 2025 site visit, the exit gate was off-site being painted (operating cost).

We recommend regular professional maintenance, painting when needed and repairs to help extend useful life cycles. Current practice is to leave the entry-side gate open during daytime since additional barrier arm controller impedes vehicle traffic. Funding factored for eventual replacement with one gate shown per cycle since ages are different.

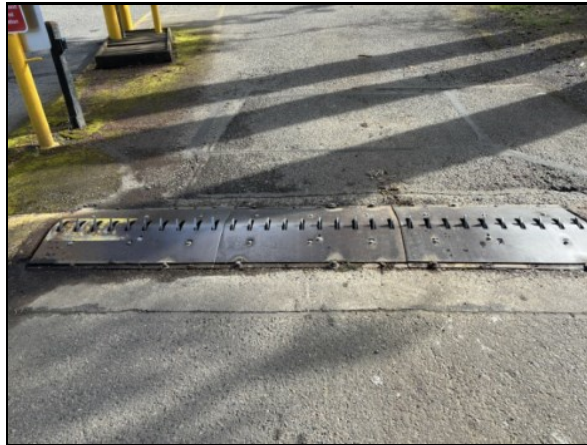
Comp #: 862 Exit Gate Spikes - Replace**Quantity: (1) set of spikes****Location:** Installed at exit gate**Funded?:** Yes.**History:** Repaired in 2022/23**Comments:** Reported to us in early 2025, spikes were recently counterbalanced.

No problems reported with eventual replacement shown.

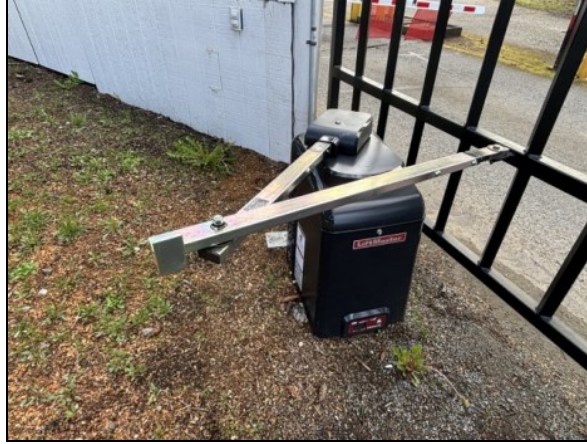
Comp #: 864 Vehicle Gate Operators - Replace**Quantity: (2) LiftMaster CSW24UL****Location:** Adjacent to main entry/exits**Funded?:** Yes.**History:** Replaced in 2024; replaced in 2014**Comments:** Both hydraulic swing arm operators are like new as just replaced in 2024 with no problems reported. We did not observe functioning as entry gate is left open during the day and exit gate was off-site during our April 2025 site visit getting painted.

Plan for replacement as shown. Continue to treat minor repairs as general maintenance expense.

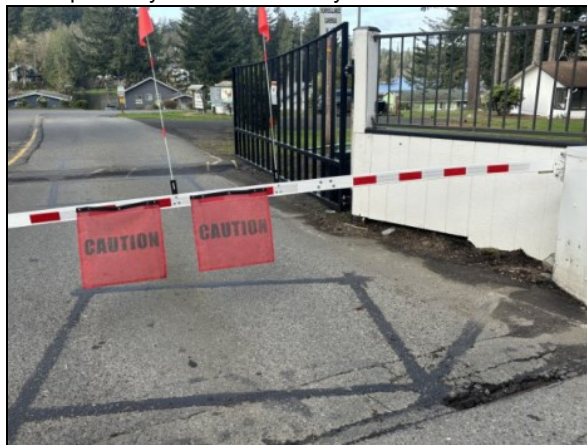
Comp #: 866 Barrier Arm Operator - Replace**Quantity: (1) DKS 1601, Sally arm****Location:** Adjacent to main entry**Funded?:** Yes.**History:** Replaced in 2024; replaced in 2014**Comments:** No problems observed during our site visit; we observed functioning.

Anticipate replacement at typical life expectancy of between 5-10 years.

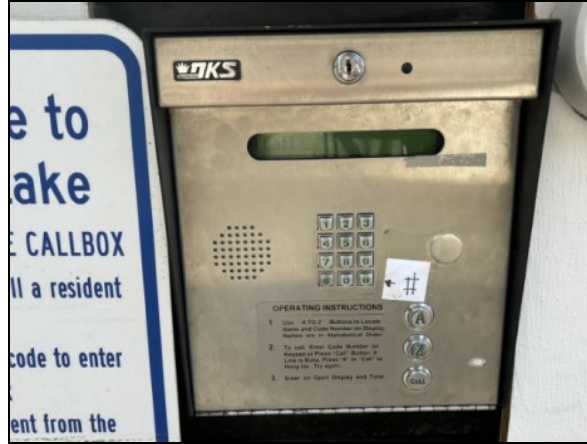
Comp #: 868 Entry Access/Panel - Replace

Comments: No problems with current panel noted. We observed to be functioning during our site visit.

Replacement is often prompted by technological obsolescence, exposure and constant usage / wear, future panel replacement at the more typical 8-12 year interval is factored for financial planning purposes. Note: individual owners are responsible for any remote controllers provided as a pass thru expense.

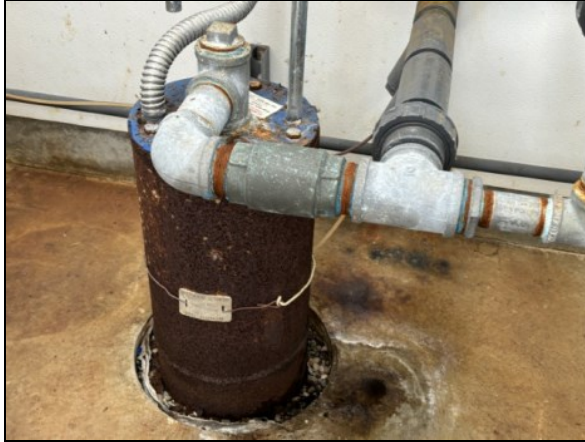
Comp #: 902 Wells - Replace**Quantity: (4) active****Location:** Division 2, Lot 1 and 2, Division 5, Lot 11**Funded?:** No. Useful life not predictable or extended**History:** Well #1 was reportedly drilled in 1966, Well #2 in 1968, Well # 3 in 1981 and Well # 4 in 1993

Comments: There are four wells on the property. Well #1 was reportedly drilled in 1966, Well #2 in 1968, Well # 3 in 1981 and Well # 4 in 1993. More information about background, depth, supply, etc. details for these can be found within the revised comprehensive Water System Plan. Information within that plan did not indicate any predictable time frame for the need to drill a new well within the current water system planning period which ends soon in 2024. Note that without any known deficiencies of aquifer, service life of wells can be extended, sometimes 80-100 years or more. Your water system plan should be updated regularly to detail current and future projected water needs. At this point, no predictable basis for reserve funding.

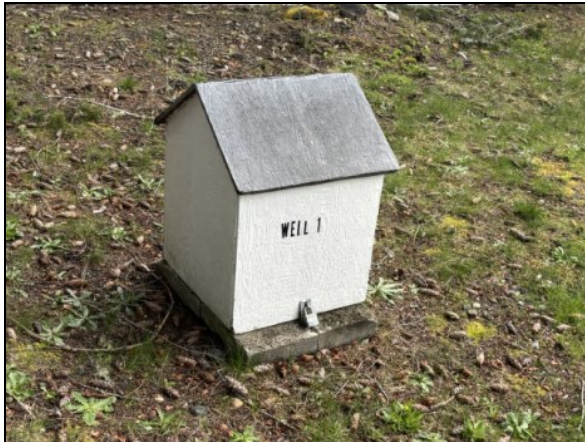
Comp #: 904 Well Pump/Motor #1 - Replace**Quantity: (1) 5 HP submersible 4"****Location:** At common area entry property near bus stop**Funded?:** Yes.**History:** Pump and motor were reportedly replaced last in either 2006 or 2007

Comments: No problems reported of pump/motor at Well #1. Information previously reviewed indicates well depth of 71' and 55 GPM capacity. Pump and 5 HP motor were reportedly replaced last in either 2006 or 2007; that project cost history was not provided. For planning purposes, assume a typical useful life of between 10-20 years; similar sizing as present. Include integrated pump / motor controller replacement for trouble free operation when projects take place. Regular testing and inspection should be factored within the operating and maintenance budget.

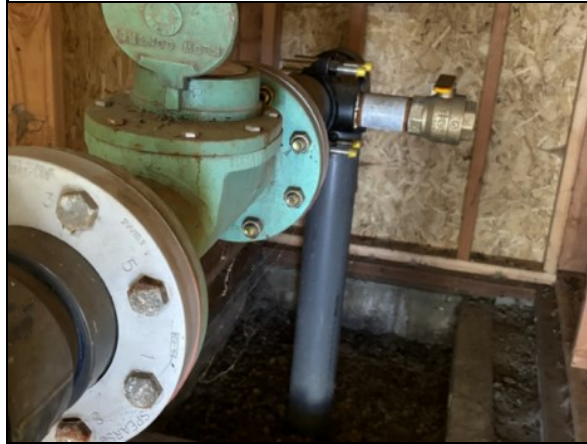
Comp #: 904 Well Pump/Motor #2 - Replace**Quantity: (1) 20 HP submersible 6"****Location:** Within small equipment shed between office and road at entry property at office**Funded?:** Yes.**History:**

Comments: No problems reported of pump/motor at Well #2. Information previously reviewed indicates well depth of 67' and 105 GPM capacity. For planning purposes, assume a typical useful life of between 10-20 years; similar sizing as present. Include integrated pump / motor controller replacement for trouble free operation when projects take place. Regular testing and inspection should be factored within the operating and maintenance budget.

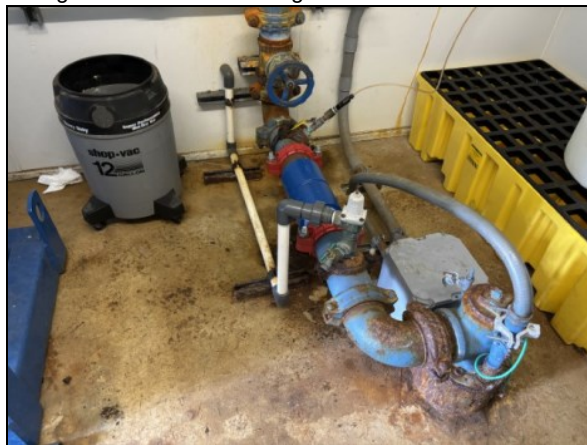
Comp #: 904 Well Pump/Motor #3 - Replace**Quantity: (1) 25 HP submersible 6"****Location:** Within large equipment building next to shop area entry property at office**Funded?:** Yes.**History:** Pump and motor were reportedly replaced last in either 2006 or 2007

Comments: No problems reported of pump/motor at Well #3. Information previously reviewed indicates well depth of 205' and 160 GPM capacity. For planning purposes, assume a typical useful life of between 10-20 years; similar sizing as present. Include integrated pump / motor controller replacement for trouble free operation when projects take place. Regular testing and inspection should be factored within the operating and maintenance budget.

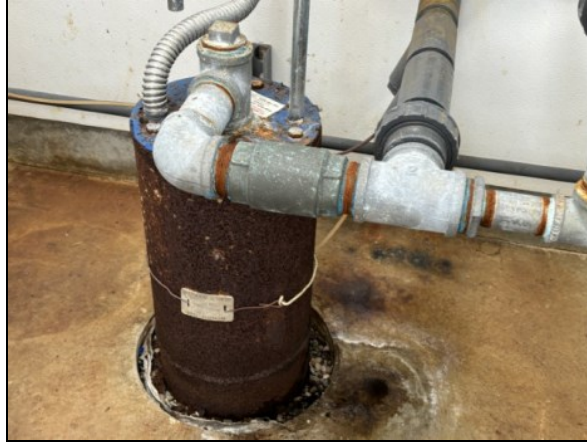
Comp #: 904 Well Pump/Motors #4 - Replace**Quantity: (2) 5 HP submersible 4"****Location:** On the lake side of SE Crescent Dr. just to the West of Young Ave. intersection**Funded?:** Yes.**History:**

Comments: No problems reported of pump/motor at Well #4. No problems reported of Well #1. Information previously reviewed indicates well depth of 180' and 180 GPM capacity. For planning purposes, assume a typical useful life of between 10-20 years; similar sizing as present. Include integrated pump / motor controller replacement for trouble free operation when projects take place. Regular testing and inspection should be factored within the operating and maintenance budget. Your WFI (Water System Inventory) Form updated last on 6.14.2019 indicates well depth of 180' and 180 GPM capacity.

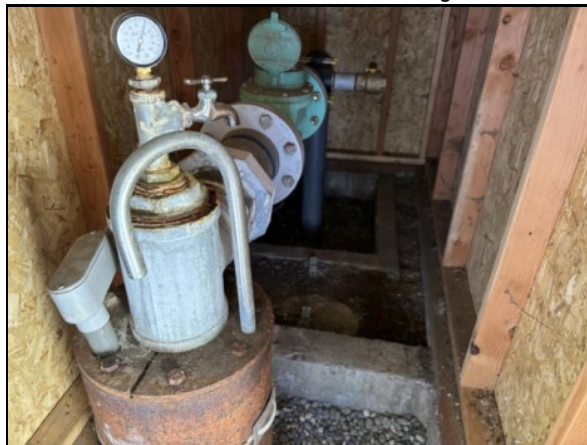
Comp #: 906 Source Flow Meters - Replace**Quantity: (4) source meters****Location:** Wells**Funded?:** No. Individual cost projected to be too small**History:**

Comments: No problems reported, however ages vary significantly with some very old according to your last 2004/2008 WSP (Water System Plan) which indicated 1966 (Well #1), 1981 (Wells #2 and #3) and 1994 (Well #4) for last installations. The typical useful life expectation for meters to ensure accuracy is ordinarily in the 10-15 year range. In any event, roughly \$1,000-\$1,200 expense of individual replacements, when needed, do not merit reserve designation.

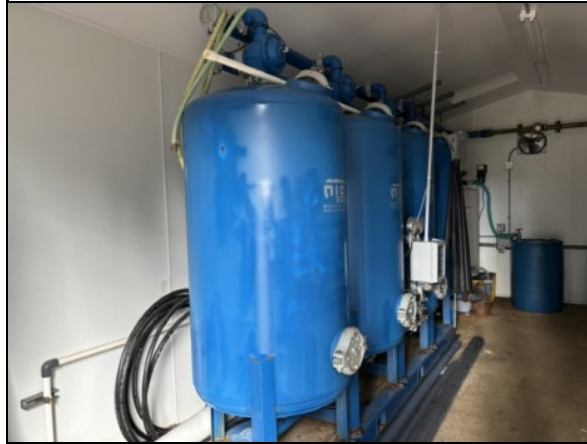
Comp #: 907 Filter System, 2009 - Replace**Quantity: (4) tank system****Location:** Within large equipment building next to shop area entry property at office**Funded?:** Yes.**History:** Reportedly refurbished last in 2009

Comments: No problems noted of filtration system. Raw water is directed from Well #3 to this ATEC commercial system which utilizes media to remove iron and manganese. Reportedly refurbished last in 2009, paid by insurance company after fire destroyed building. No reported problems at present. Assuming proactive maintenance continues, anticipate 30-40 year replacement cycles of equipment factored below for planning purposes.

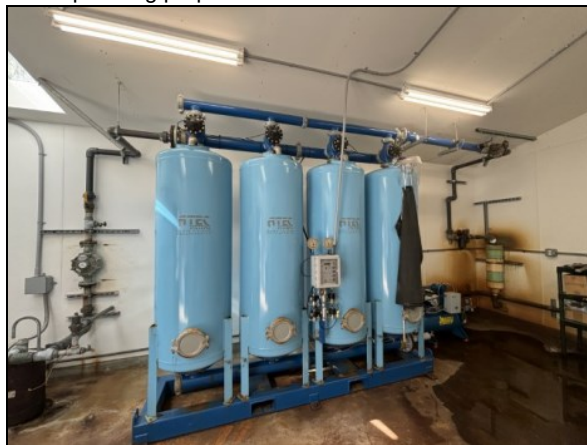
Comp #: 907 Filter System, 2012 - Replace**Quantity: (4) tank system****Location:** Within building on the lake side of SE Crescent Dr. just to the West of Young Ave. intersection**Funded?:** Yes.**History:** Reportedly replaced last in 2012; segregated portion reportedly ~\$60,000

Comments: No problems reported of filtration system. Raw water is directed from Well #4 to this ATEC commercial system which utilizes media to remove iron and manganese; installed in 2012 as part of \$103,300 project (segregated portion reportedly ~\$60,000). No reported problems at present. Assuming proactive maintenance continues, anticipate 30-40 year replacement cycles of equipment factored below for planning purposes.

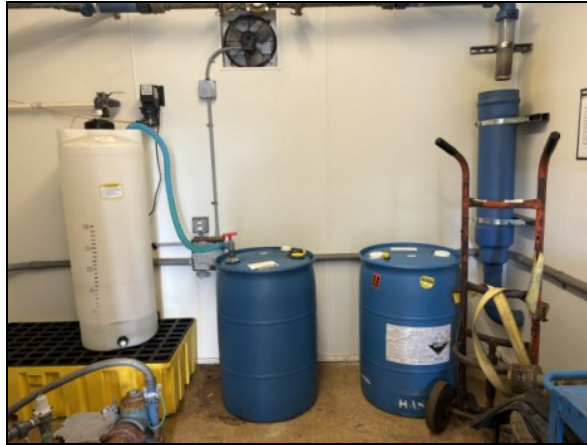
Comp #: 908 Treatment Systems - Replace**Quantity: (2) systems**

Comments: No problems reported of integrated treatment systems likely replaced last in 2009 (Well #3) and 2012 (Well #4). Going forward, we recommend 10-14 year replacement allowance for integrated systems factored below for planning purposes.

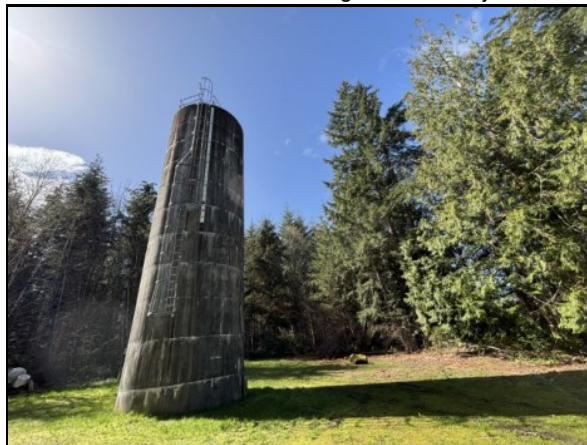
Comp #: 910 Storage Tank #1, Concrete - Replace**Quantity: (1)~55,246 gal, 14' X 48'**

Comments: This above-grade concrete tank was reportedly installed in 1974 (per your 2008 revised WSP). As with our last site visit, some dirt/grime and local cracking/efflorescence visible on exterior walls, however no significant spalling or obvious leaks known. Inspection/repairs and cleaning anticipated in 2025 (#911/912). Our research suggests planning for typical service life of roughly 60 years for concrete tanks. Continue to monitor closely and perhaps have engineer evaluate when remaining useful life draws close to five years or if more cracking / spalling, leaks become prevalent. Note; some possibility of change for storage needs may exist for future years, as well as multitude of other design criteria - adjust in future reserve updates as conditions merit.

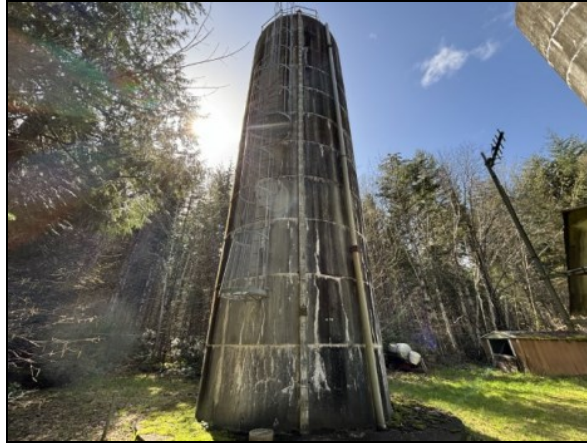
Comp #: 910 Storage Tank #2, Concrete - Replace**Quantity: (1) ~59,850 gal, 14' X 52****Location:** South side of Alpine Ave. two lots East of Cabana Ave. intersection**Funded?:** Yes. Meets National Reserve Study Standards criteria for Reserve Funding**History:** Reportedly installed in 1997 at expense of \$98,900

Comments: This slightly larger above-grade concrete tank was reportedly installed in 1997 at expense of \$98,900. As with our last site visit, some dirt/grime and local cracking/efflorescence visible on exterior walls, however no significant spalling or obvious leaks known. Inspection/repairs and cleaning anticipated in 2025 (#911/912). Our research suggests planning for typical service life of roughly 60 years for concrete tanks. Continue to monitor closely and perhaps have engineer evaluate when remaining useful life draws close to five years or if more cracking / spalling, leaks become prevalent. Note; some possibility of change for storage needs may exist for future years, as well as multitude of other design criteria - adjust in future reserve updates as conditions merit.

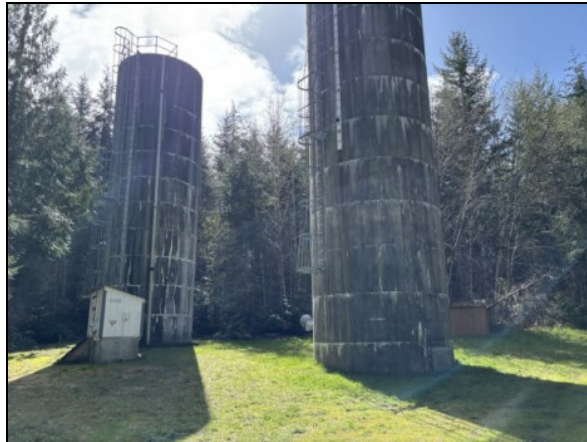
Comp #: 911 Storage Tanks, Int.-Inspect/Repair**Quantity: (1) 55k gal (1) 60k gal****Location:** South side of Alpine Ave. two lots East of Cabana Ave. intersection**Funded?:** Yes.

History: Anticipated inspection, cleaning, repairs in 2025. Previous interior inspection 2021 at expense of \$5,600 with additional expense for local repair needs cited; previous 2017 at expense of \$5,100

Comments: Inspection, cleaning (#911) and repairs to hatch anticipated in 2025 subsequent to our April 2025 site visit. Continued inspections are imperative to identify problems proactively which can help reduce downtime and costs.

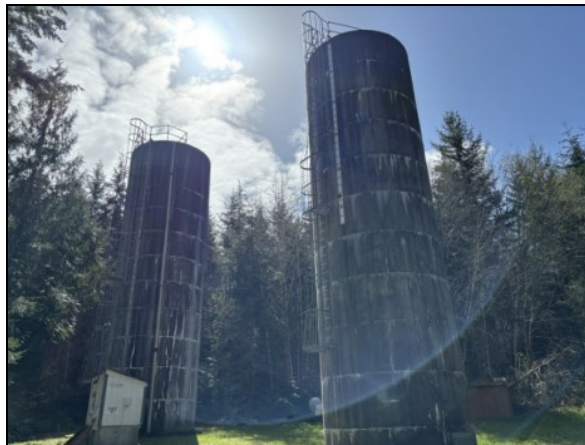
Comments: Exterior surfaces are without any protective coating (as typical for concrete reservoirs). Build-up of mineral staining noted for both tanks along with some local corrosion of steel components. Definitive maintenance history was not provided but no apparent plans for large scale exterior cleaning were expressed going forward. No reserve funding suggested for now but professional inspection should be performed to determine if action is needed on exteriors in order to reach the useful life cycle in this study.

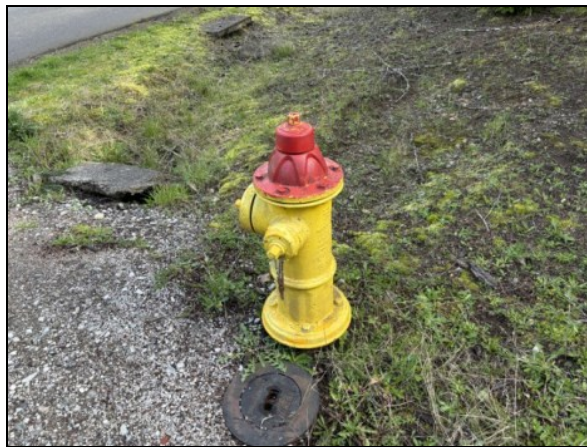
Comments: Reported to us, on-site staff refurbishes hydrants as needed. No current needs / plans expressed regarding addition of more fire hydrants for fire flow spacing and coverage; no reported problems. Community Representative indicated a few fire hydrants receive maintenance refurbishing every year. Since hydrants are typically long lived, maintenance to sustain is inexpensive and individual replacement costs are likely under \$3,000, we recommend continuing to handle as annual operating budget items. Track needs and expense patterns closely in future reserve updates to form any basis if cyclical funding is appropriate.

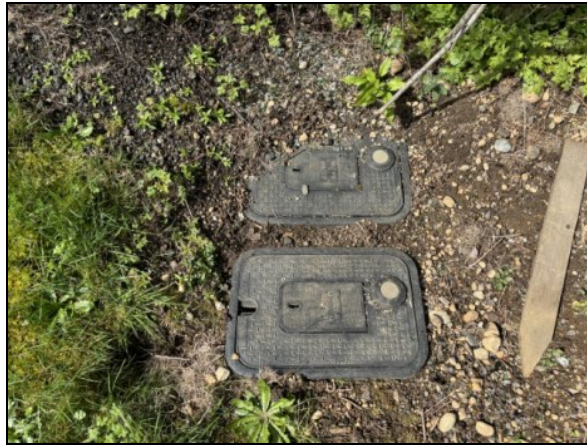
Comp #: 974 Water Meters - Replace**Quantity: (486) meters****Location:** Water service points of community**Funded?:** Yes.

History: Initially installed between 2007-2011 as part of \$171,000 project; your previous plans to replace all by 2021 were deferred to 2023

Comments: No widespread problems known. Individual consumption meters were initially installed between 2007-2011 as part of \$171,000 project. Estimated useful life of meters is typically 10 years with replacement intervals recommend to help ensure minimal leakage, function and accuracy. Carefully track and update in future reserve study updates as conditions merit.

Useful Life:
20 years**Remaining
Life:**
13 years
