2 London Road Terrace London Road,  
Moreton-in-Marsh, Gloucestershire,  
England, GL56 0HN

**PROPERTY VISIT DATE**  
27/03/2025

**PREPARED ON BEHALF OF**  
Hayman Joyce

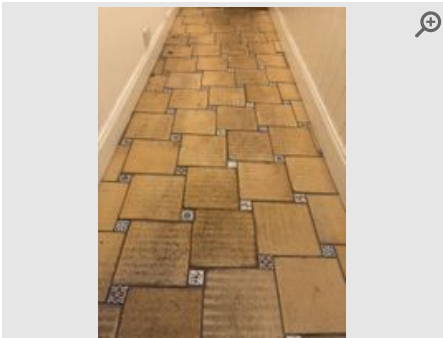
Floor

| 1 Entrance/Hallway | | | | |
|---|---|---|---|---|
| 1.8<br>Floor | Tiled. Discoloured patches. Grouting intact. Loose debris present. Dirty<br>Signs of wear evident consistent with age of floor. See photos for more details. | ● Fair | ● Very Poor | <a href="#">1 photo</a> |

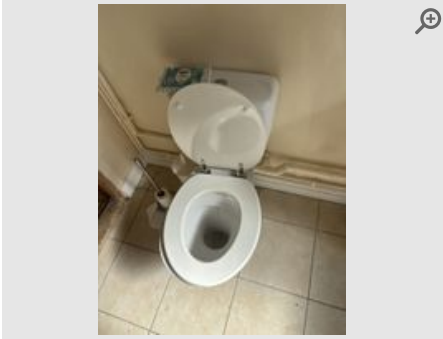
Toilet

| Item | Description | Condition | Cleanliness | Photos |
|---|---|---|---|---|
| 2.10<br>Toilet | Porcelain. Wooden seat & lid. Flush intact. Lid appears loose. Soiled inside. Base<br>dirty. Tank dusty/dirty. White<br>Free of cracks/chips. Flush intact. Seat secure and intact. See photos for significant<br>detail, including cleanliness to pan, tank and base (if/where applicable). | ● Fair | ● Poor | <a href="#">1 photo</a> |

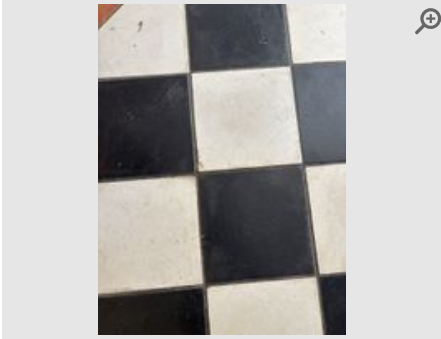
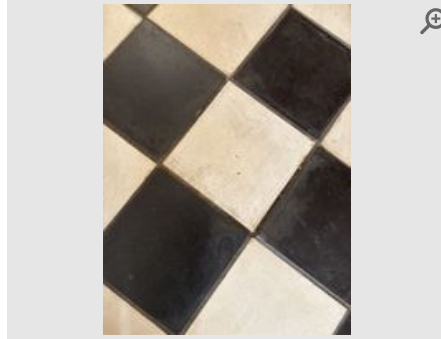
## Floor

| Item | Description | Condition | Cleanliness | Photos |
|---|---|---|---|---|
| 3.3<br>Floor | Tiled. Wooden threshold strip. Loose debris present. Dirty. Black. White Some minor cracks to tiles (see pictures) minor marks present to some tiles. | ● Fair | ● Poor | 📷 <a href="#">2 photos</a> |

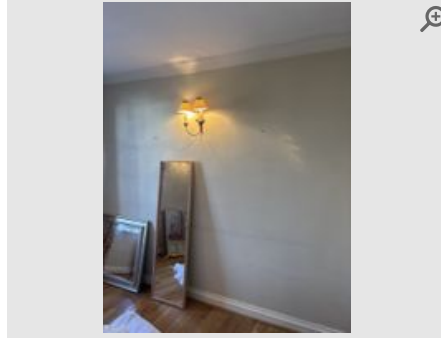
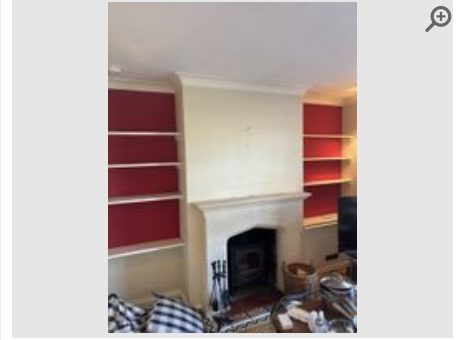
| Reference | <b>4.6.2</b> |

| Item | Description | Condition | Cleanliness | Photos |
|---|---|---|---|---|
| 4.6<br>Walls | Plastered & painted. Picture hooks/nails present. Rawl plug/nail holes present. 9 in total. Dusty. Stains present<br>Some minor surface marks and discolouration. See photos for significant detail, including picture hooks, filled and rawl plug holes (if/where applicable). | ● Fair | ● Poor | <a href="#">3 photos</a> |

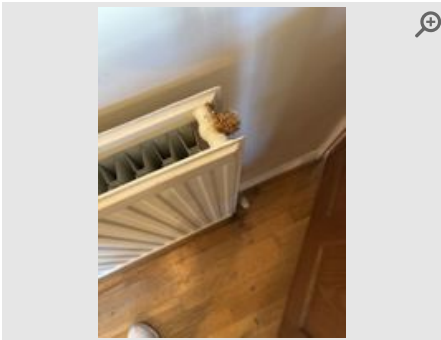
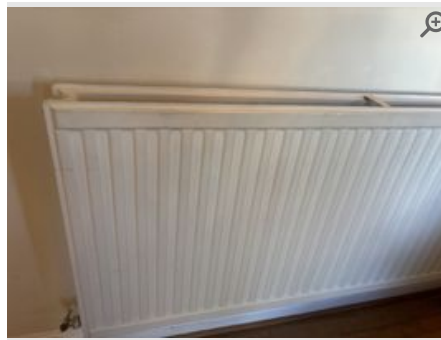
| Reference | <b>4.8.1</b> |

| Item | Description | Condition | Cleanliness | Photos |
|---|---|---|---|---|
| 4.8<br>Radiator | White panelled. 1 in total. Signs of rust. Scratched. Scuffed. Marked. Dusty. Magnolia<br>Wall mounted radiator(s) with some light surface marks. Rusted/heavily corroded valve to top right side. See photos for detail. | ● Fair | ● Poor | <a href="#">2 photos</a> |

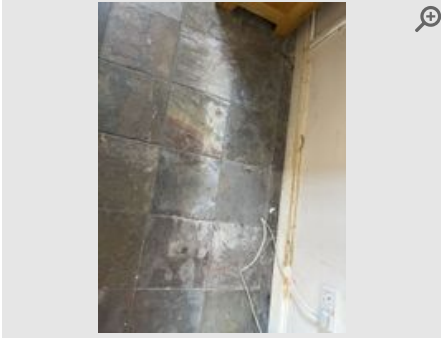
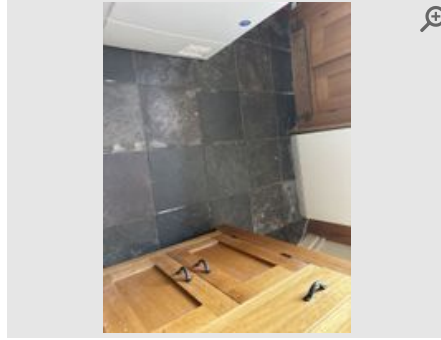
| Reference | <b>6.7.1</b> |

| Item | Description | Condition | Cleanliness | Photos |
|---|---|---|---|---|
| 6.7<br>Floor | Tiled. Loose debris present. Dirty. Dusty. Charcoal<br>Loose debris, requires cleaning. See pictures for details | ● Fair | ● Poor | <a href="#">2 photos</a> |

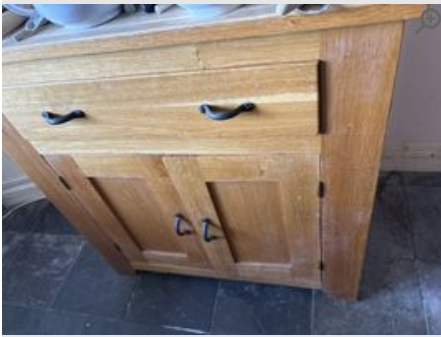
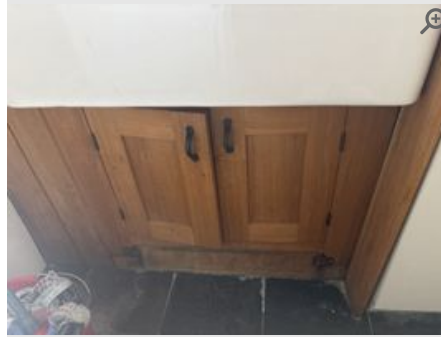
| Reference | <b>6.8.1</b> |

| Item | Description | Condition | Cleanliness | Photos |
|---|---|---|---|---|
| 6.8<br>Kitchen Cupboards/Units | Base units present. 4 hinged doors. Solid wood. Fixed handles. Wood shelving. All shelving is intact. Free of items inside. Grease/food residue inside. Greasy/Dirty handles<br>All handles and hinges intact. Free of items inside. Some signs of wear evident. See photos for significant detail, including stains inside and out, scratches and food residue (if/where applicable). | ● Fair | ● Poor | <a href="#">2 photos</a> |

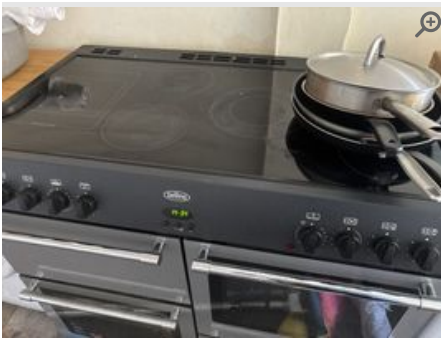
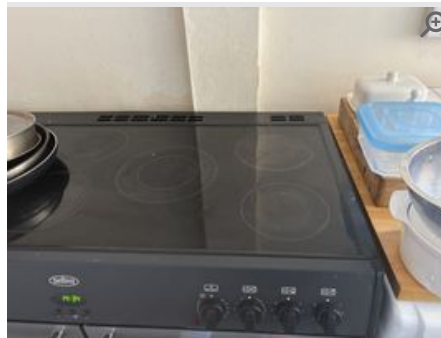
| Reference | <b>6.11.1</b> |

| Item | Description | Condition | Cleanliness | Photos |
|---|---|---|---|---|
| 6.11<br>Hob | Induction hob. 6 rings. Scratches/scuffs present. Dried food present. Belling<br>Some signs of light surface marks evident. See photos for significant detail, including stains, scratches, scorch marks | ● Fair | ● Poor | <a href="#">2 photos</a> |
