The Tour

SUBJECT: REPORT ON THE TENTH AND FINAL RE-MEASURE OF
WATERLINE W1A AND W2A BENCHMARK ELEVATIONS IN THE
WOODLANDS, TEXAS IN MARCH 2020.

RE: Review of Twelveth (12th) Re-measure of the Waterline W1A and W2A Benchmark Elevations in the Woodlands, Texas in March 2021

W2A Geological Monitoring Survey

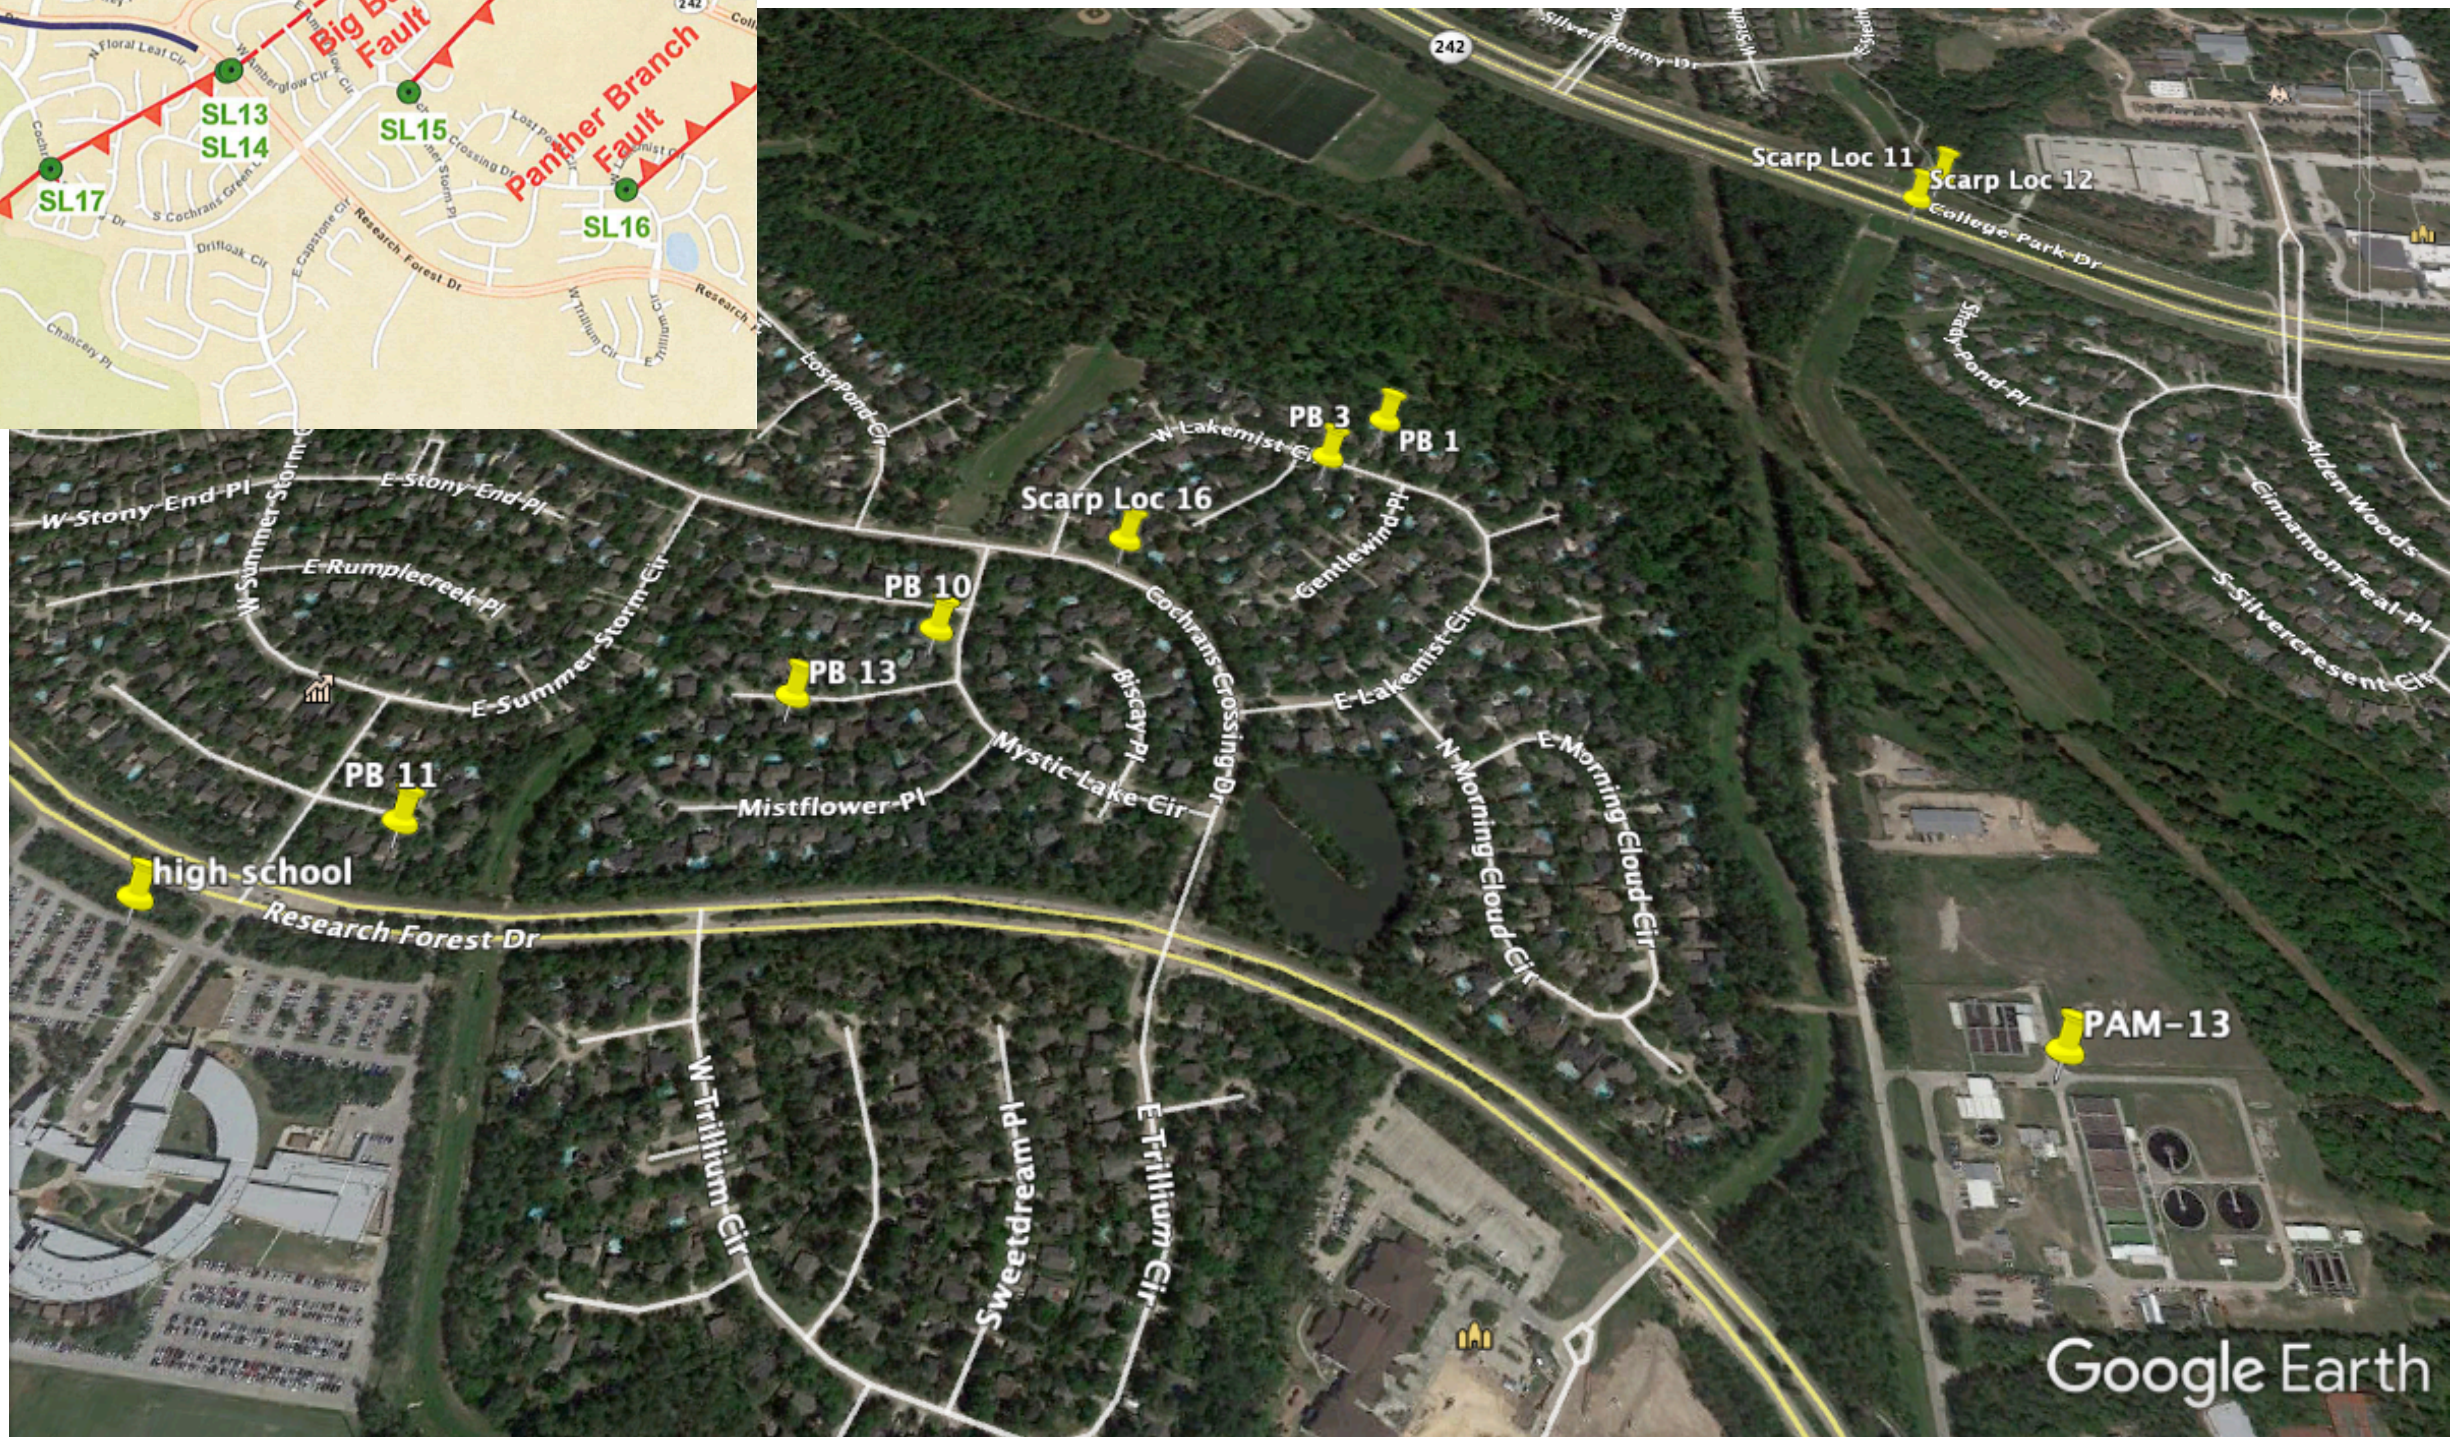
Google Earth

This March, 2011 photograph shows the parking lot fault clearly evident prior to Terracon's 2012 W2 Segment Fault study (and shows an alternate survey path suggested by a fault model of the PB Fault from elevation sections).

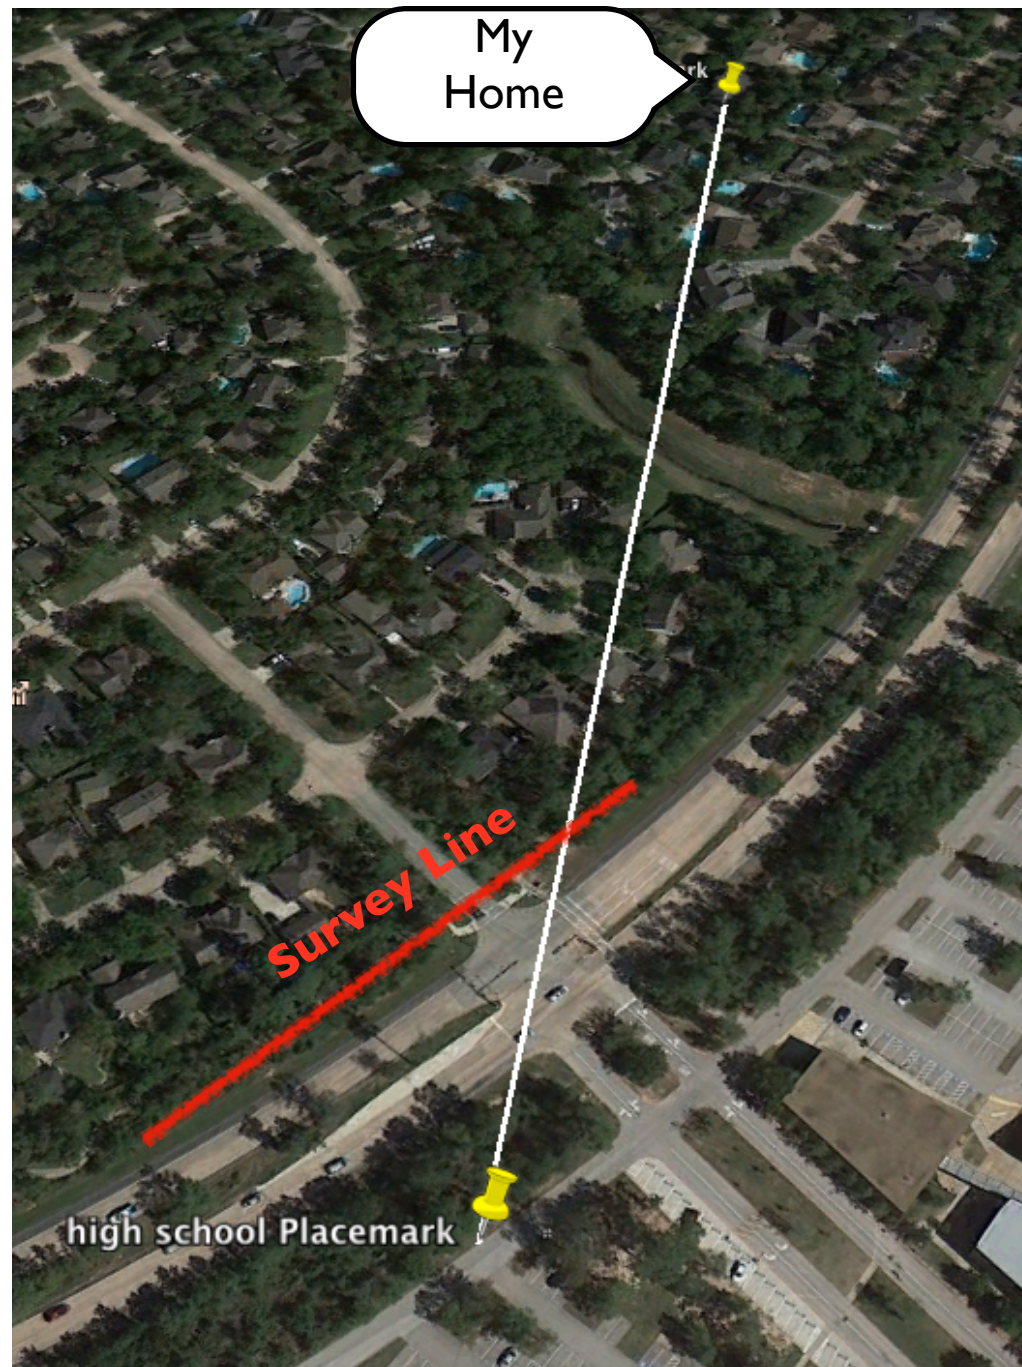
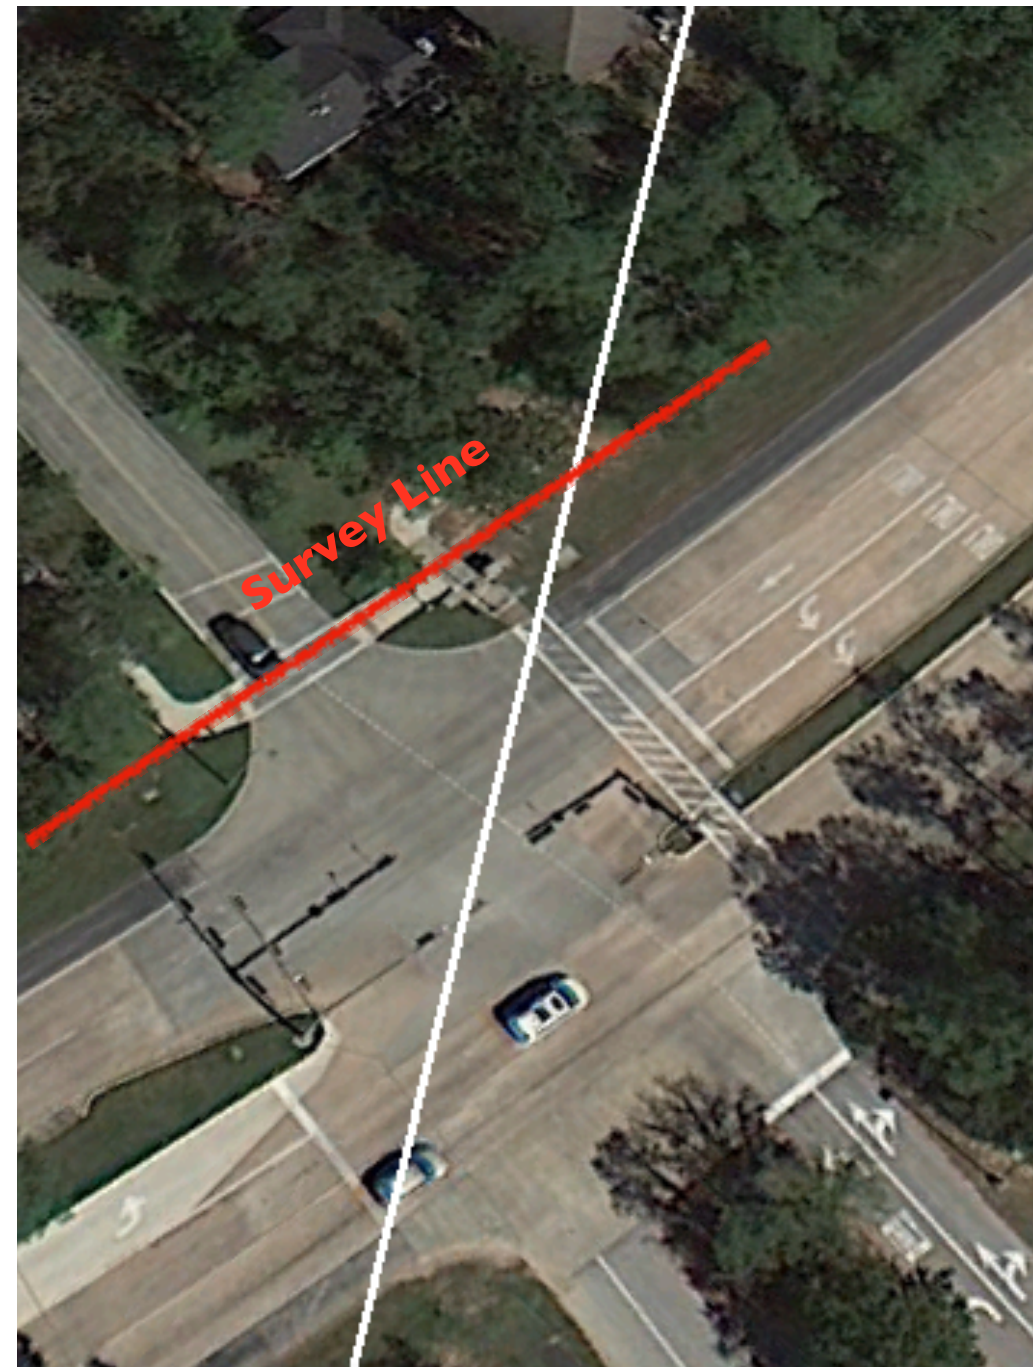
Where does Panther Branch Cross Research Forest?

This slide shows changes in elevation of each of the 19 elevation monuments over six years along with the location of the fault that was predicted to SJRA management in August, 2013 before the GRP pipeline was placed in the ground across the Panther Branch Fault.

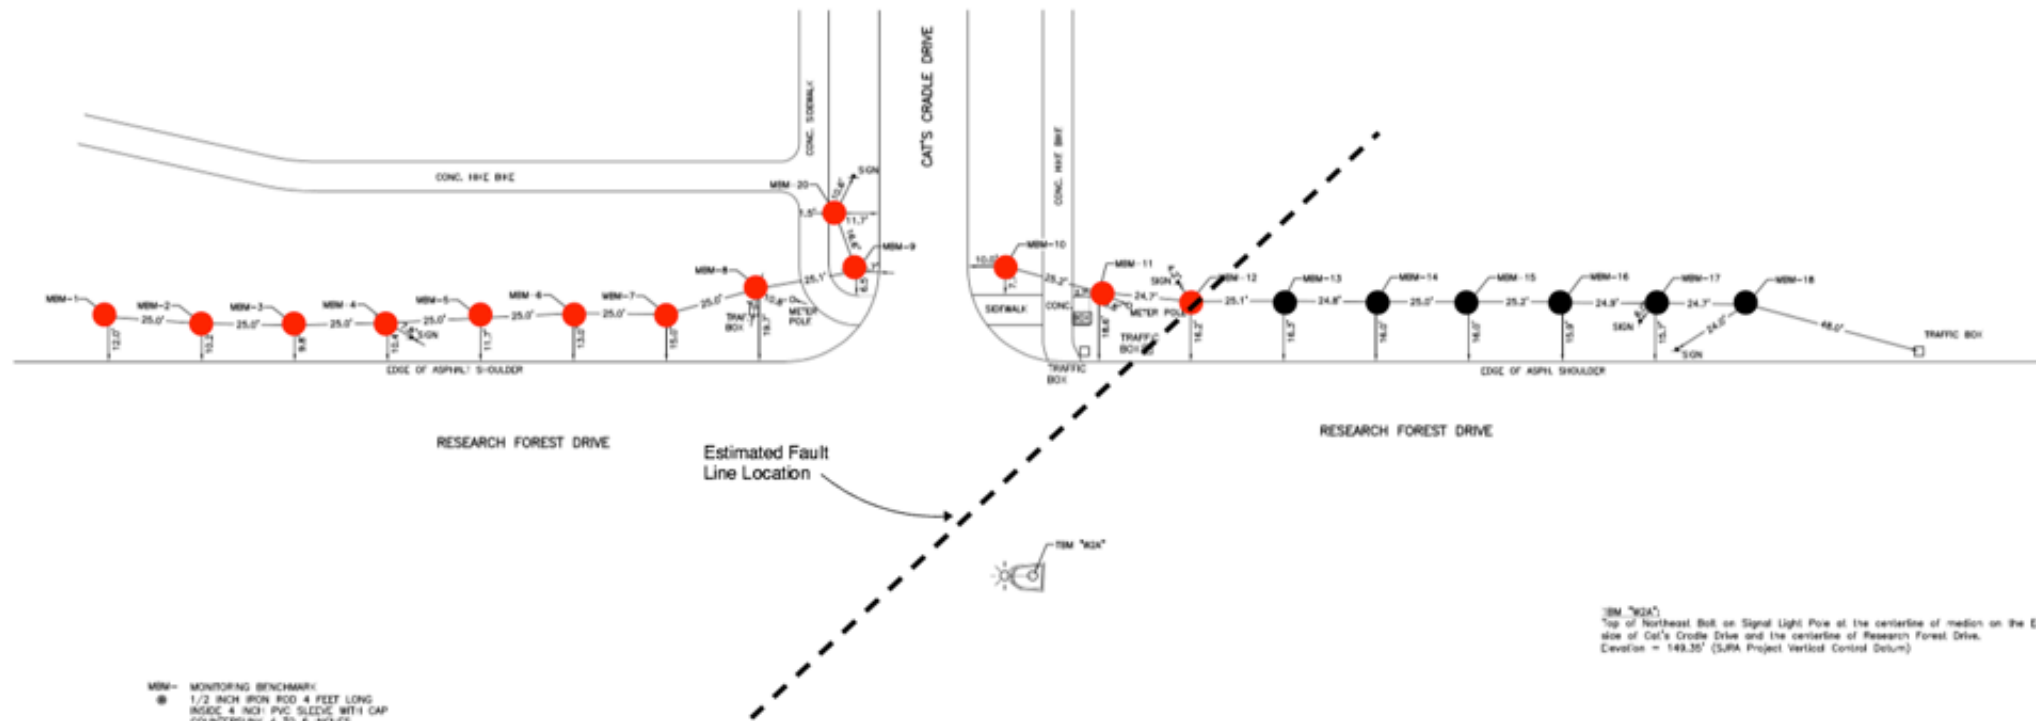
AT THE HALFWAY POINT...

"I should have added...they need to exceed 0.15 feet per year"

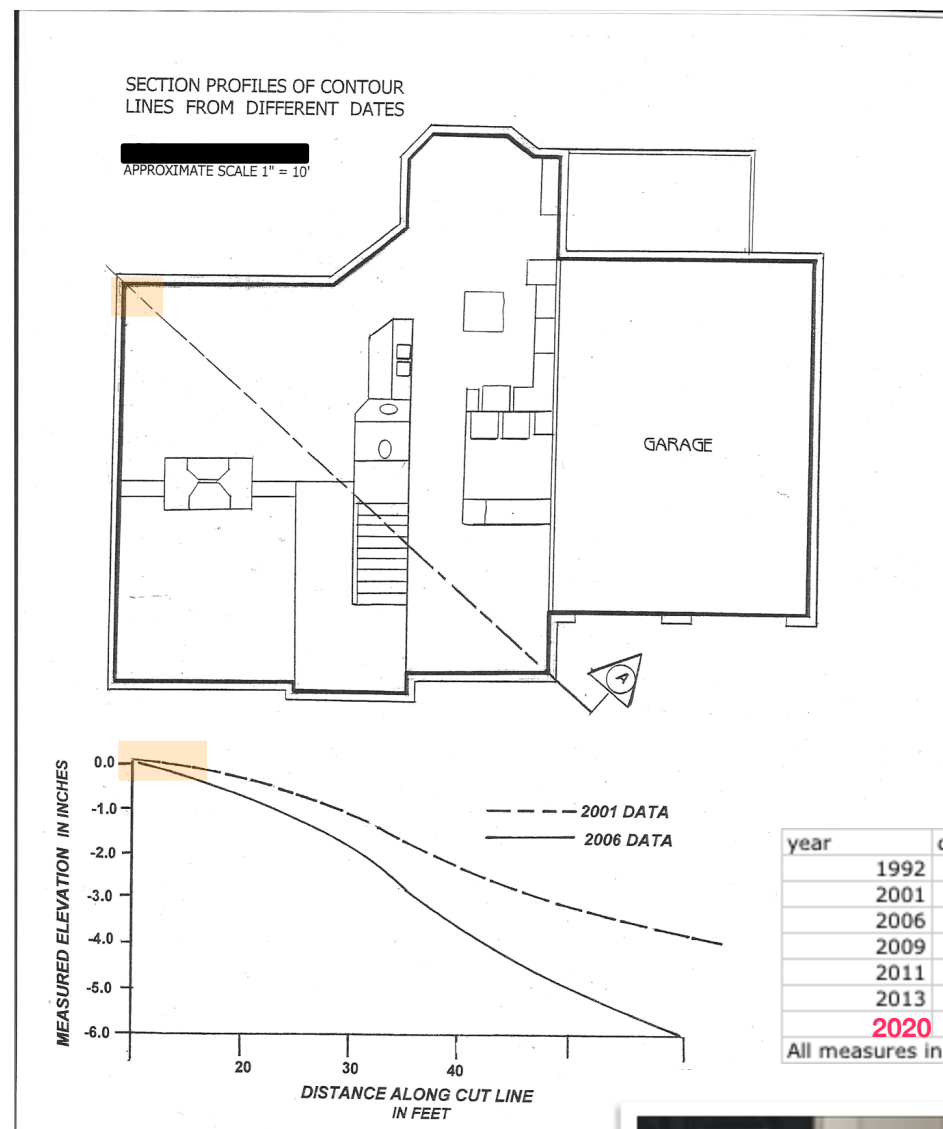
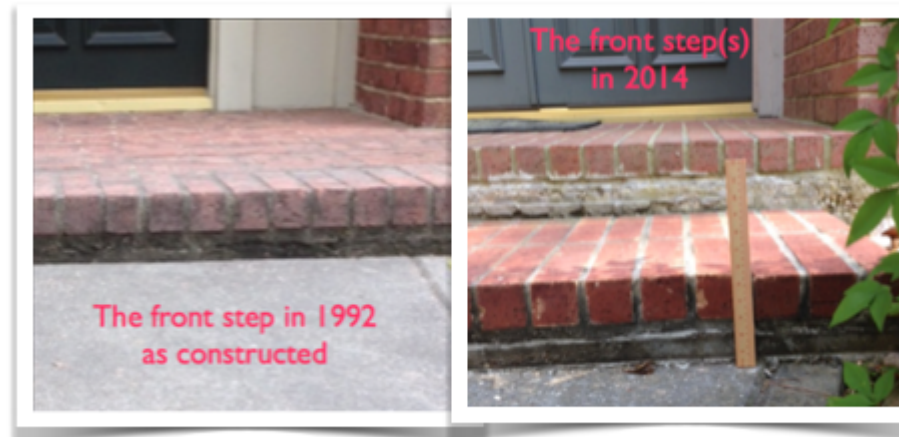
GRP PROGRAM BENCHMARK

The contour map in relation to Scarp Location 16 and TWHS parking lot suggests that my house straddles the Panther Branch fault on a very close perpendicular diagonal line to the contour vector.

If this observation is substantiated by a qualified geologist, my foundation may provide a useful benchmark to SJRA GRP Program to measure the effectiveness of switching from ground water to surface water, post July 2014.
