# HOME INSPECTION REPORT

May 2, 2018

STREET ADDRESS CITY, STATE

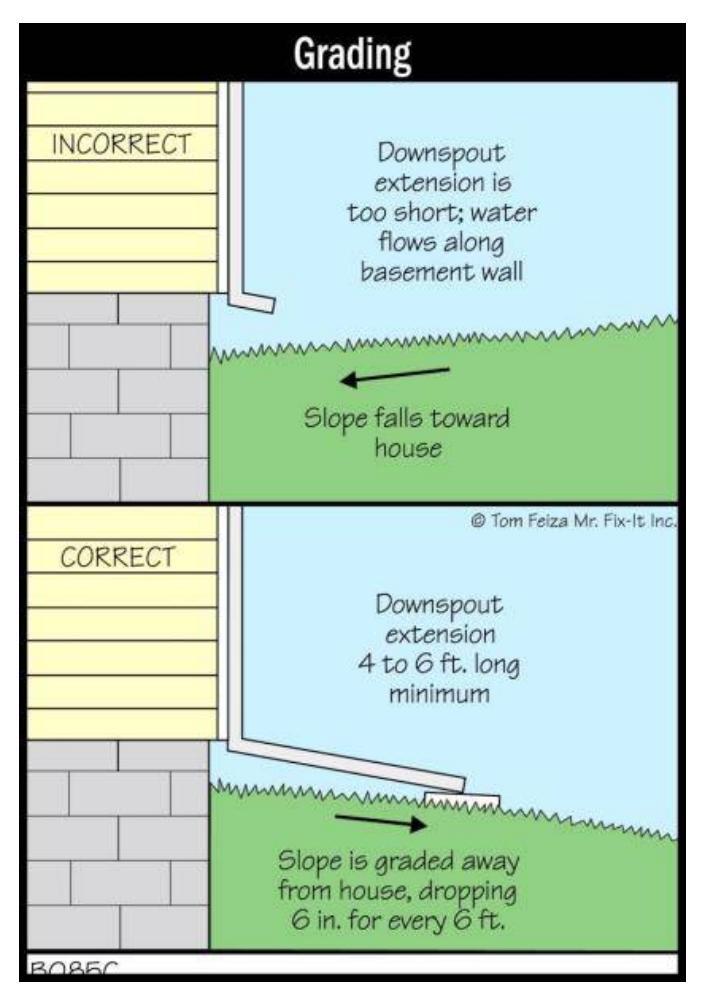
# 2.1 SLOPE WITHIN 10 FEET OF HOUSE:

Level to Negative grade, which may contribute to a water condition in the basement is noted at the rear. The general guideline is for the grading to drop 6" in the first 6' away from the foundation. This promotes water saturation away from the foundation and lessens the chance for water entry in and under the structure.

Attention Further Evaluation Needed

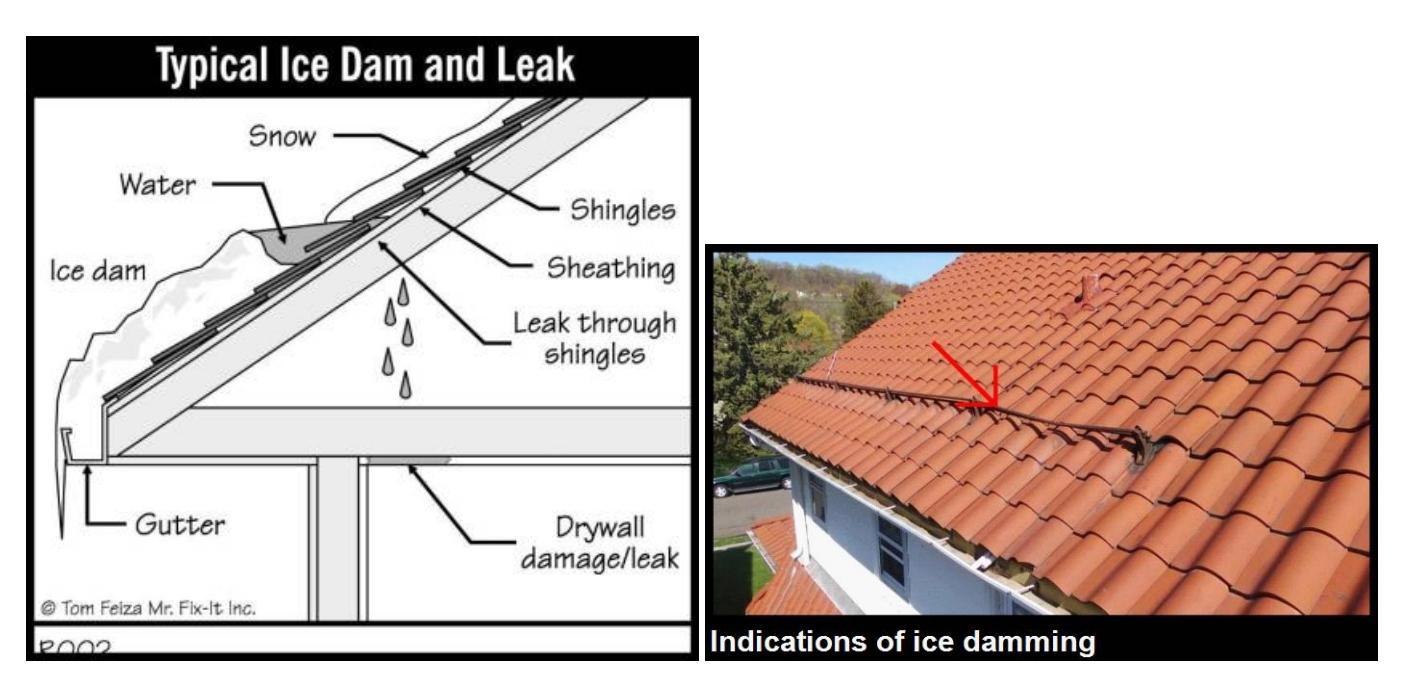
#### 4.4 ICE DAMMING

NOTE: The shape of the rear front and roof may tend to trap snow and ice during the winter months. This may make the roof vulnerable to leakage from ice-damming. See the adjacent diagram for better understanding of this condition. Modifications to the roof can substantially reduce potential for leaks that result from "ice damming". Ask the current home-owners is they have experienced leaks while there was snow on the roof in the past. Contact a competent roofer regarding the necessity of any changes.

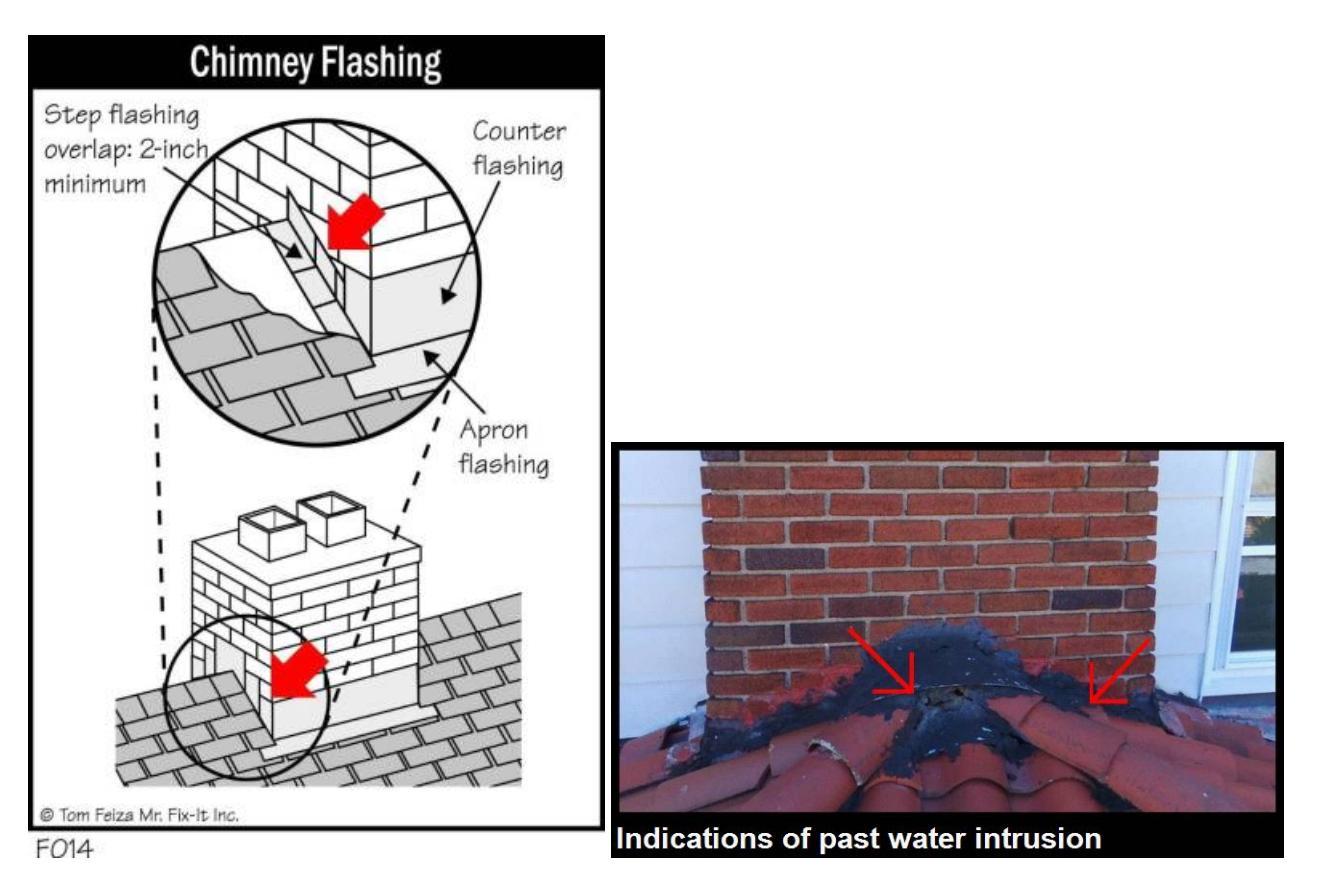
#### 4.12 ROOF FLASHING:

Application of mastic suggest past water intrusion. The nature and scope of repairs should be discussed with the present home-owner and the repairman, who performed the repair.

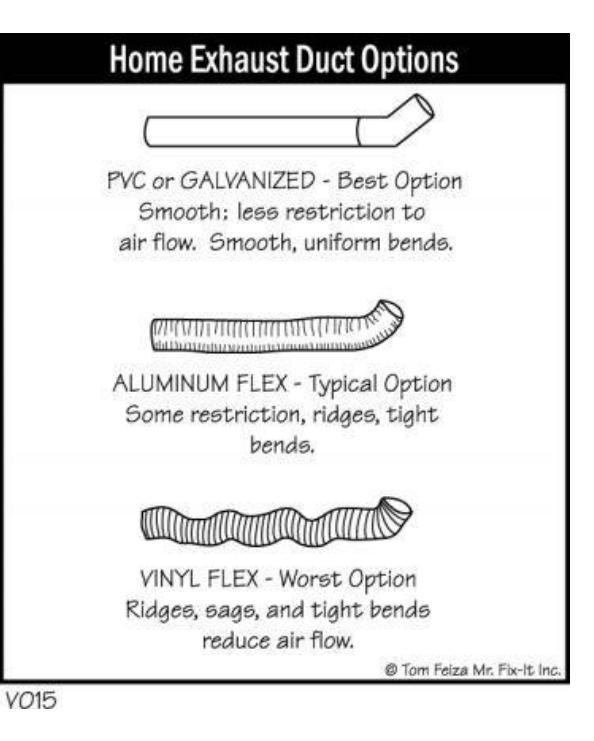
#### 6.20 DRYER VENTING:

The dryer vent is routed with plastic flex duct. The CPSC stated that plastic dryer vent ducting is a fire hazard and should be upgraded to metal for safety. FOR YOUR INFORMATION. There are more fires caused from lint build in the dryer vent pipe than from fireplaces. The long circuitous route taken by the vent makes it vulnerable to clogs. I recommend you check the line when moving in and have it checked regularly. A licensed chimney sweep performs this service.

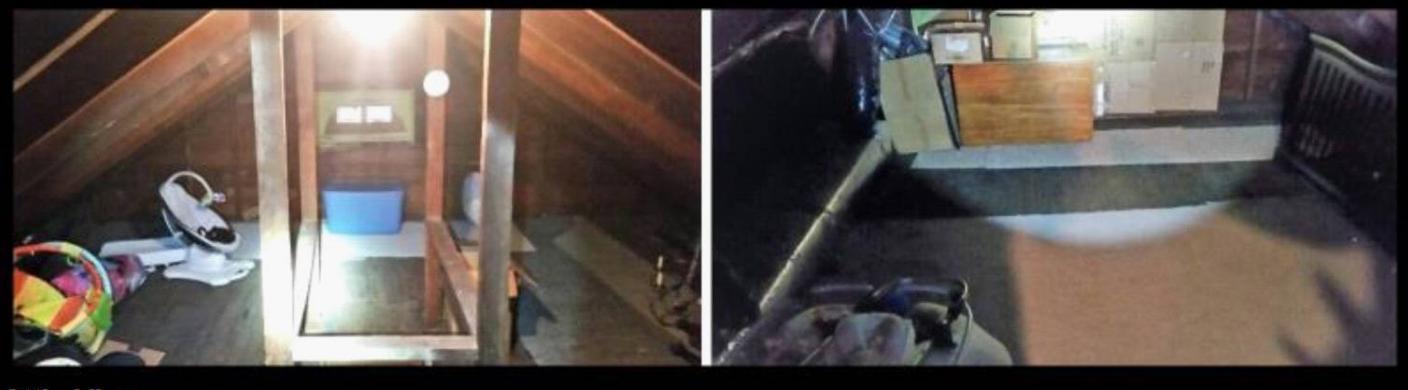
Attic View

The attic appears to be in some aspects, unsatisfactory condition. Deficiencies include, but are not limited to the following; **There is rot of the roof sheathing.** Areas of damaged sheathing should be repaired or replaced as necessary to preserve the integrity of the roof. **There is a cracked rafter, which should be repaired.** The roof system framing includes 2X8@24 (or greater span)OC (on center) This configuration is common in older homes and generally proves to be adequate, but would not comply with modern building standards. There is considerable storage in the attic limiting the inspector's ability to fully check the area. A re-evaluation of this condition should be performed when conditions permit.

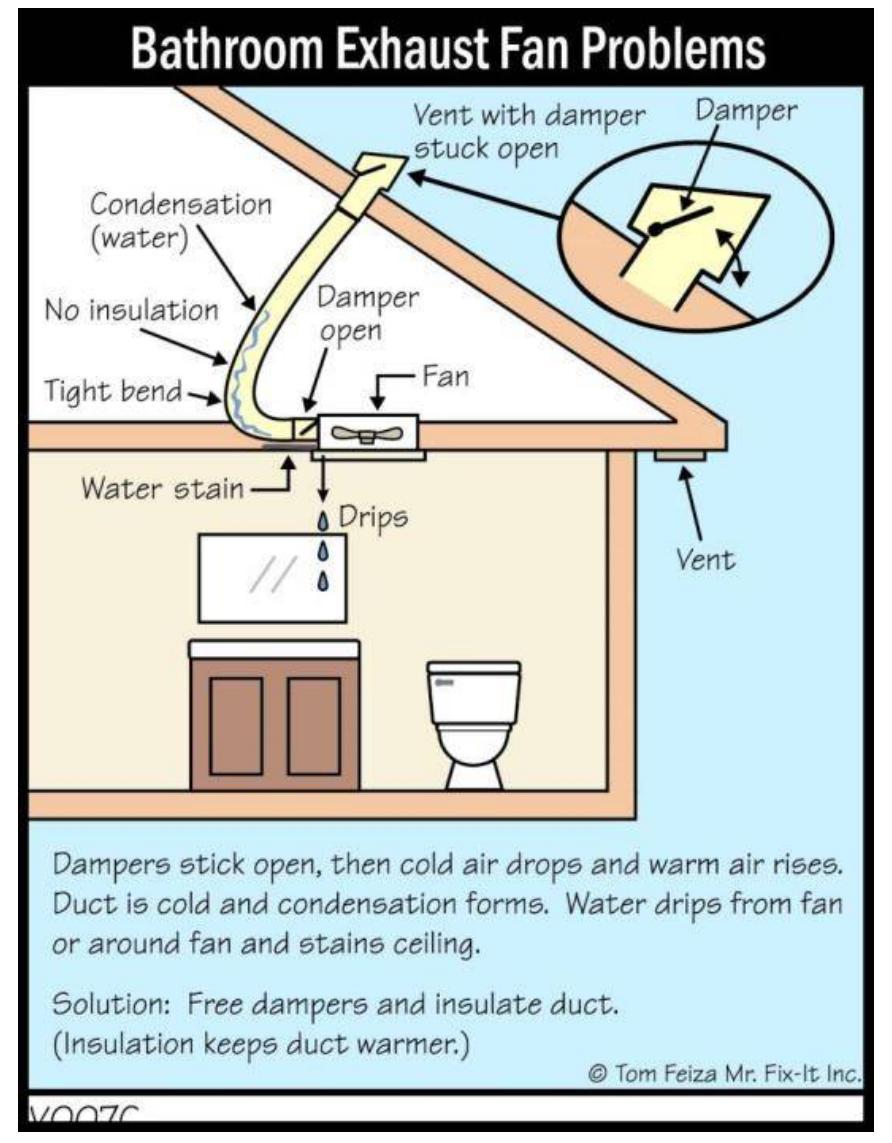
# 11.9 EXHAUST FAN DUCTING:

The bathroom vent fan ducts are in some aspects, unsatisfactory condition. The vent duct is un-insulated, which may promote the development of condensation (water) that can block the duct and cause water staining of the ceiling.

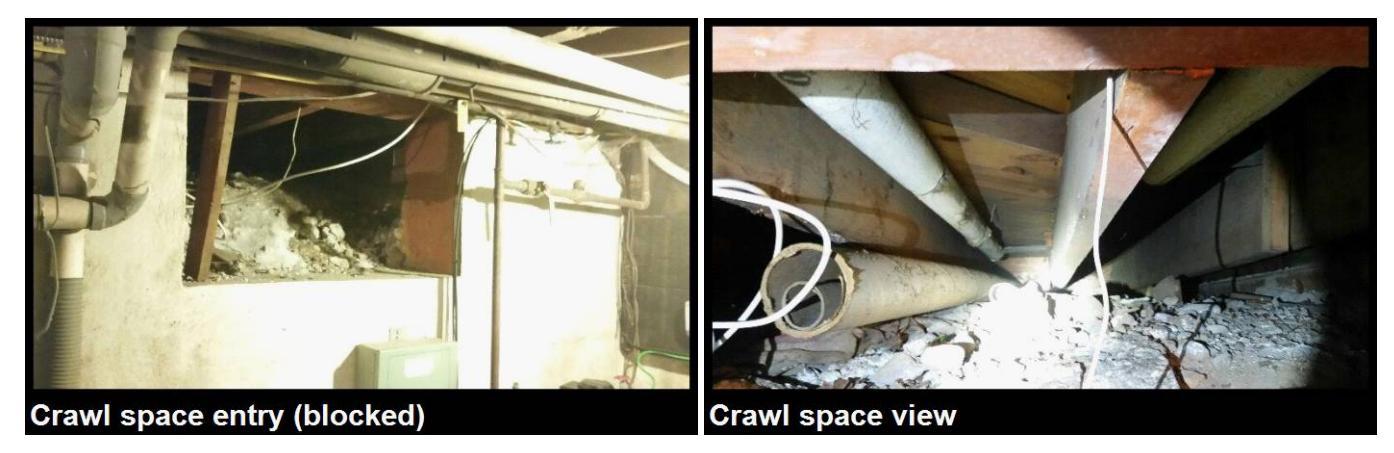
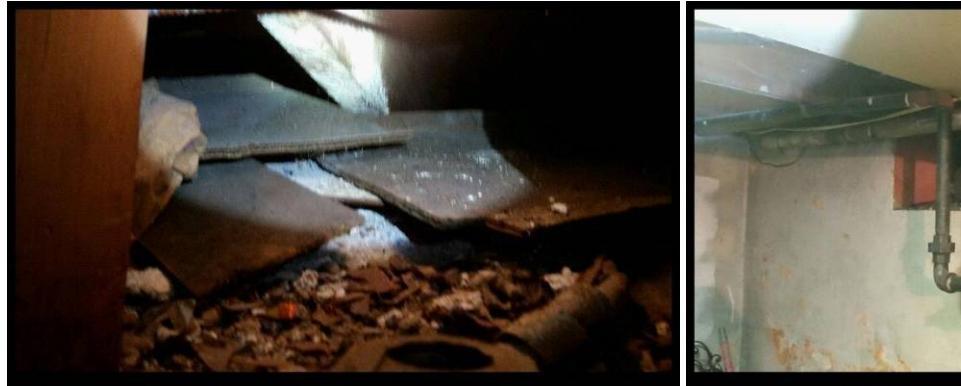
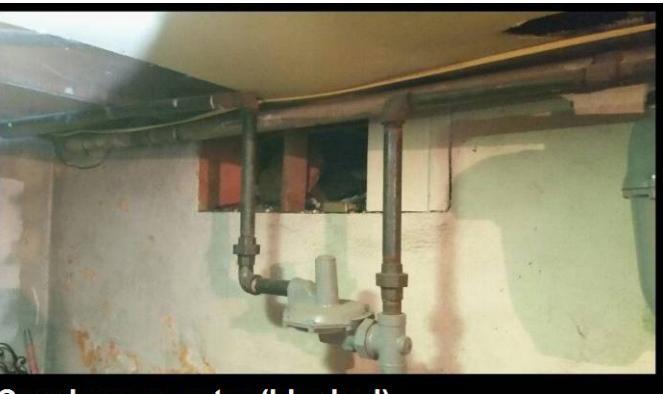
Viewed the right crawlspace area from the entry hatch with a high powered light. Current standards for entering and inspecting a crawlspace are 24" vertical clearance and 30" width clearance. This limitation is for the safety of the inspector and also does limit the ability of the inspector to check all areas in the crawlspace. Under some conditions, access can be easily improved and a more thorough evaluation can be made. Improve access so a proper inspection of the area can be performed. There is limited access and visibility of the areas due to; The entry being too small for safe entry and movement, inadequate clearance under/around the framing, insulation, muddy/wet conditions, which could be hazardous to the inspector, and the presence of suspected asbestos, which could pose a hazard to the inspector. The significance of the limitation is that some areas could not be viewed or inspected. Access to these areas should be provided so that an inspection can be done prior to closing. This access should include at least 24" vertical and 30" horizontal clearance.

Crawl space view

Crawl space entry (blocked)

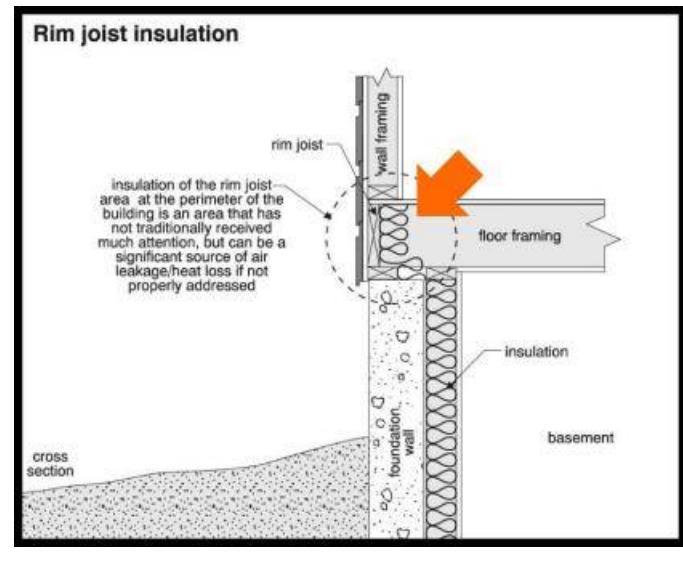
#### 12.15 MAIN FLOOR INSULATION:

The perimeter of the basement area is insulated along the box beam area, which is consistent with building standards in this region. This is beneficial. The insulation does restrict the inspectors' ability to view the adjacent structural framing that is concealed by the insulation. Some of the perimeter insulation has been removed to install telephone, cable and electric cables. The insulation should be re-installed for improved thermal efficiency.

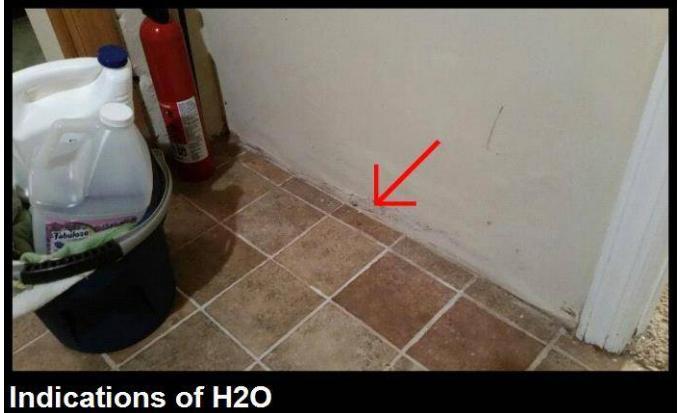
#### 12.16 MOISTURE:

The inspection for water conditions is dependent upon seasonal weather conditions. It is possible that the interior of the home could appear dry during the home inspection, but later develop water conditions. At this time, there are indications of water leakage through the foundation walls into the basement area, which is a "material defect". Weather conditions may increase frequency and intensity of leakage. Additionally, water leaks may result in mold forming. Indications are in the form of water stains/efflorescence on the floor/walls and rot of the walls. It is recommended that a water-proofing contractor be contacted to evaluate the condition and

to ascertain what corrective measures are appropriate/necessary.

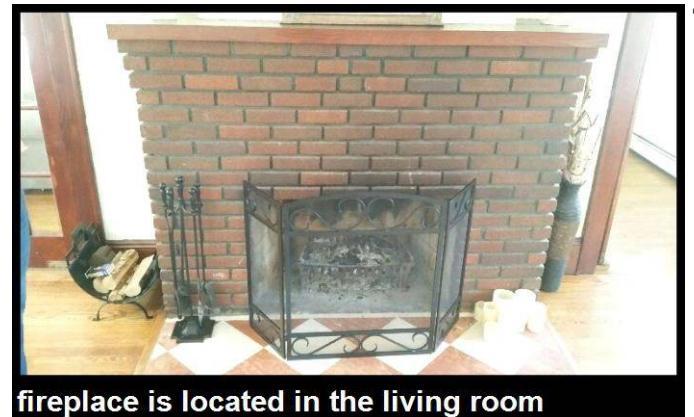
#### 15.6 LOCATION:

The fireplace is in adequate, but in some aspects, unsatisfactory condition. Deficiencies include, but are not limited to the following; **There is carbon staining of the exterior masonry surfaces, which typically indicates poor draft.** This is not confirmed. There is a crack/gap between the firebox and the wall. The significance of this condition is; heat from operating the fireplace could enter this space and cause fire problem. **The firebox is filled with ash and combustion debris.** This limits the inspectors' ability to check all of the interior fireplace area. Have the firebox cleaned and make arrangements for a more thorough evaluation.

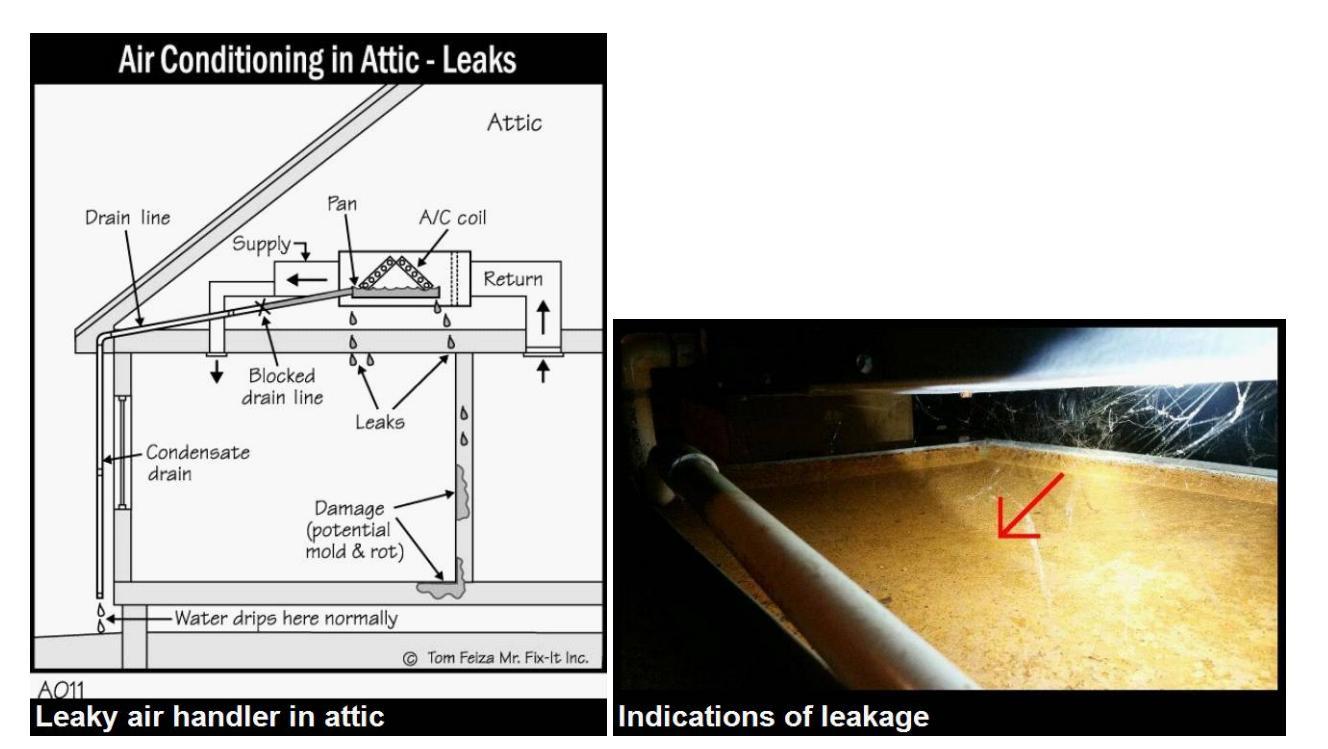
There are indications that the air conditioning system has been a source of leakage. This is indicated by water staining of the exterior metal panels of the air handler as well as water staining/standing water in the drip pan positioned beneath the air handler (see diagram). The condition is sometimes due to failure of the dedicated drains installed in the air handler. A competent contractor should be consulted to more thoroughly evaluate the condition and to perform repairs as are necessary.

NOTE: The drip pan is back-pitched; which is likely to adversely affect function. Repair is recommended.

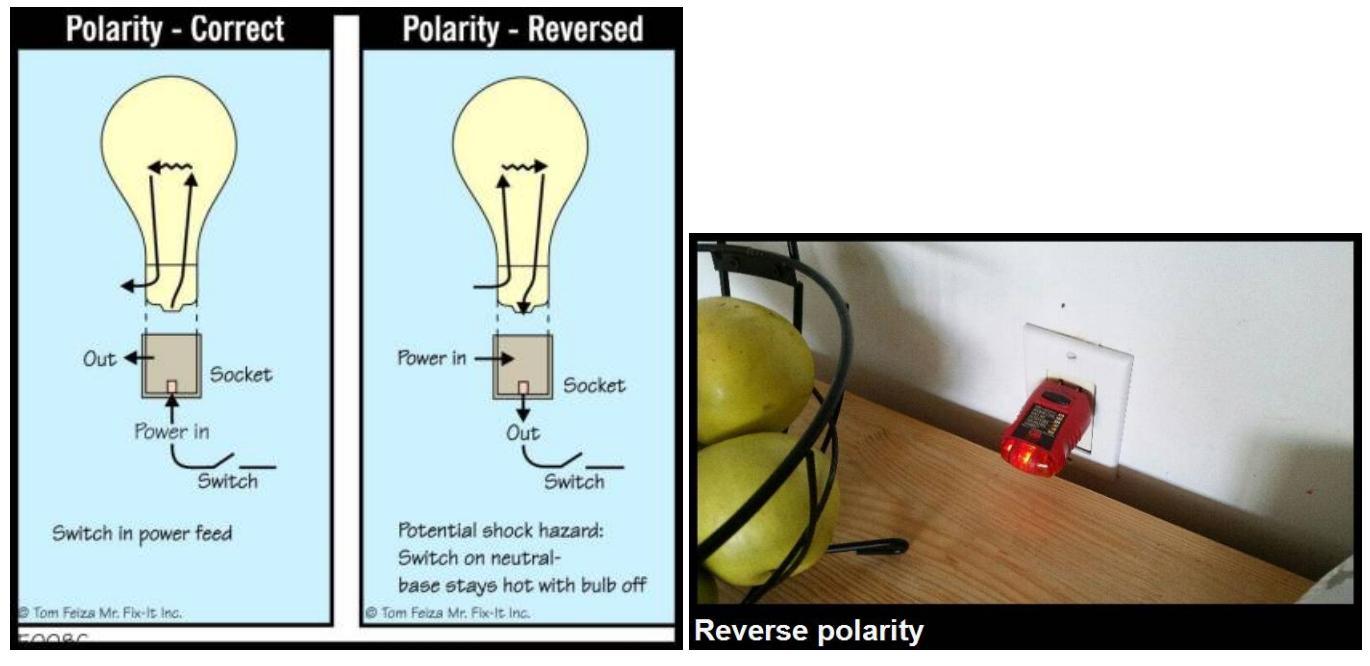
#### 17.10 REVERSE POLARITY

**Reverse polarity is detected in outlet/s.** Reversed polarity in an outlet is most often due to the improper connection of wires to the outlet itself, and is normally easy to correct. Some electronic appliances sustain damage when connected to reversed polarity outlets. Some locations where reverse polarity outlets are present include, but are not necessarily limited to the following: Kitchen.
