# HOME INSPECTION REPORT

Home Inspector License # 24GI 153000 ASHI Certified Inspector 262871 KAUFMANN CONSULTANTS, LLC 17 Cook Avenue, P. O. Box 1222 Madison, New Jersey 07940 (973) 377-4747 FAX (973) 377-7755 www.KaufmannConsultants.com

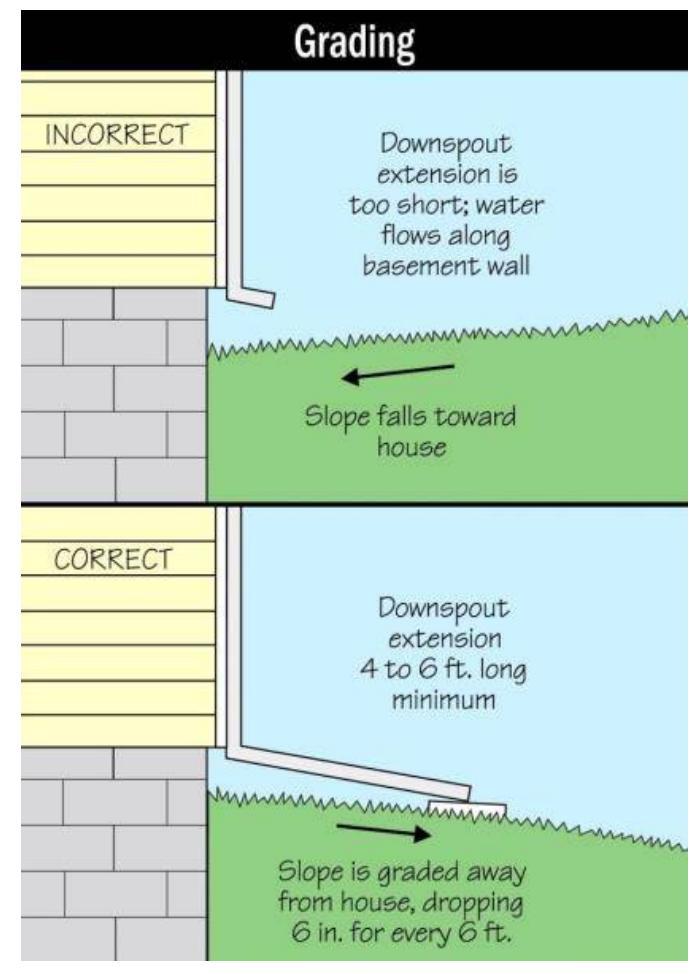
Level to Negative grade, which may contribute to a water condition in the basement is noted at the front, rear, right, and left. The general guideline is for the grading to drop 6" in the first 6' away from the foundation. This promotes water saturation away from the foundation and lessens the chance for water entry in and under the structure. NOTE: There is potential for ponding or puddles due to inadequate drainage in the back yard.

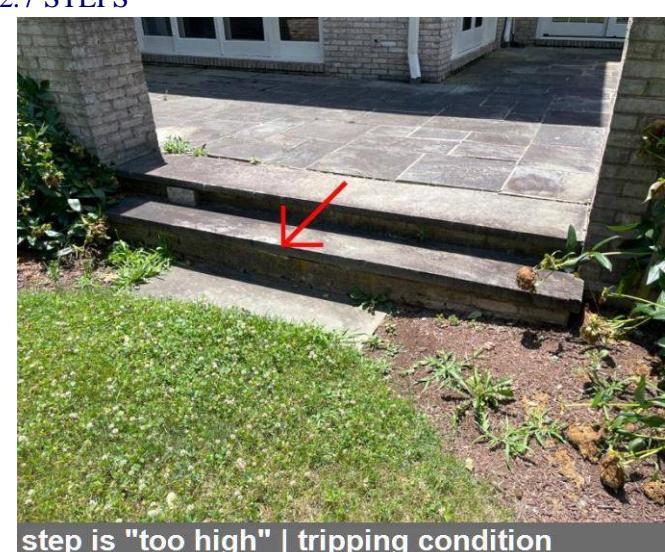
The exterior steps are in some aspects, unsatisfactory condition. Deficiencies include, but are not limited to; The stone steps are loose creating potential for tripping condition. Repair is recommended. The step up to the entry is too high. The significance of this condition is; possible trip condition. A competent contractor should be contacted to more thoroughly evaluate this "material defect"/condition and to perform repairs as necessary.

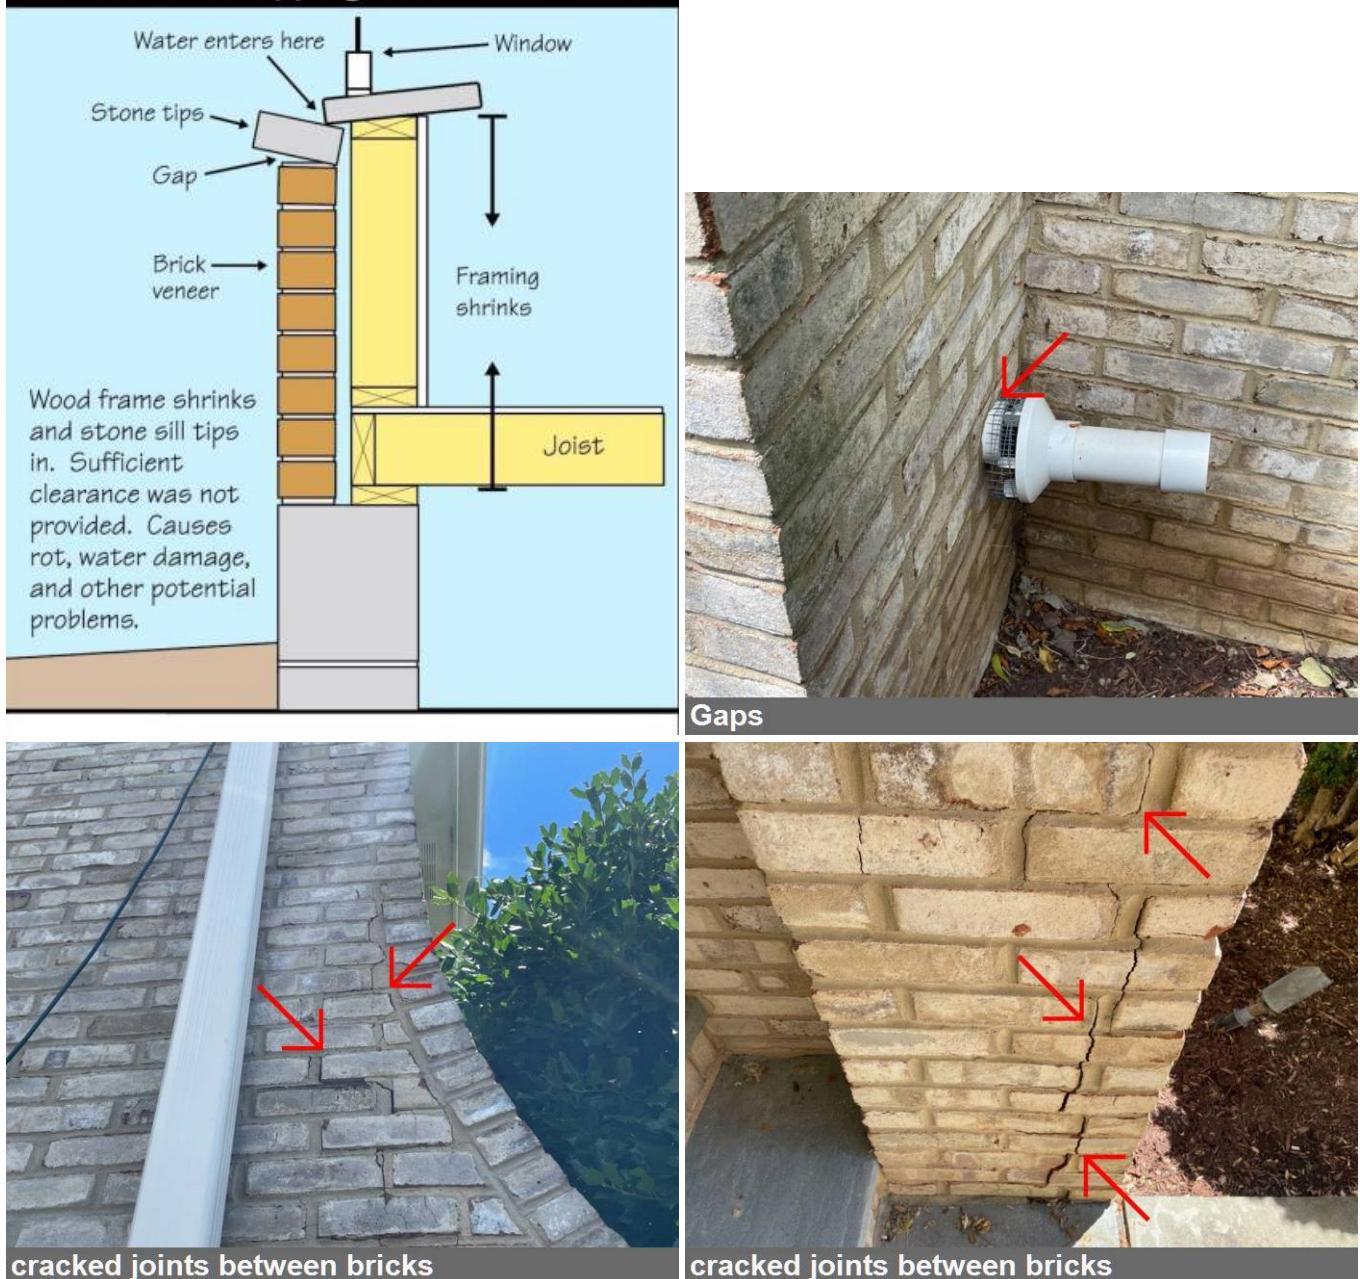
# Stone Sills Tipping – Brick Veneer

3. In this case, this dynamic movement has caused the sills to be "back-pitched", which can allow for leaks through the wall system. Leaks through the wall system could cause rot/mold.

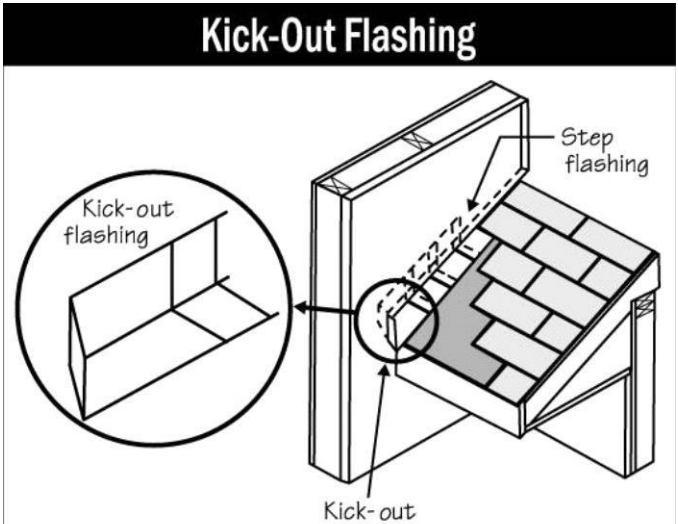
# 3.6 KICK-OUT FLASHINGS

Kick-out flashings insure that water seeping down the roof along the edge of the wall is pushed out away from the exterior wall where the roof terminates. (See the adjacent diagram) <u>These exterior flashings are missing</u> at some locations, which represents a possible "material defect." This shortcoming may allow water to leak into the exterior wall system, which could result in rot and/or mold formulation. These flashings are important and should be installed to restore a weather-tight condition to the home's exterior. The wall systems where these flashings are missing should be tested/inspected to determine if there are current or prior leaks and if damage resulted from this defect.

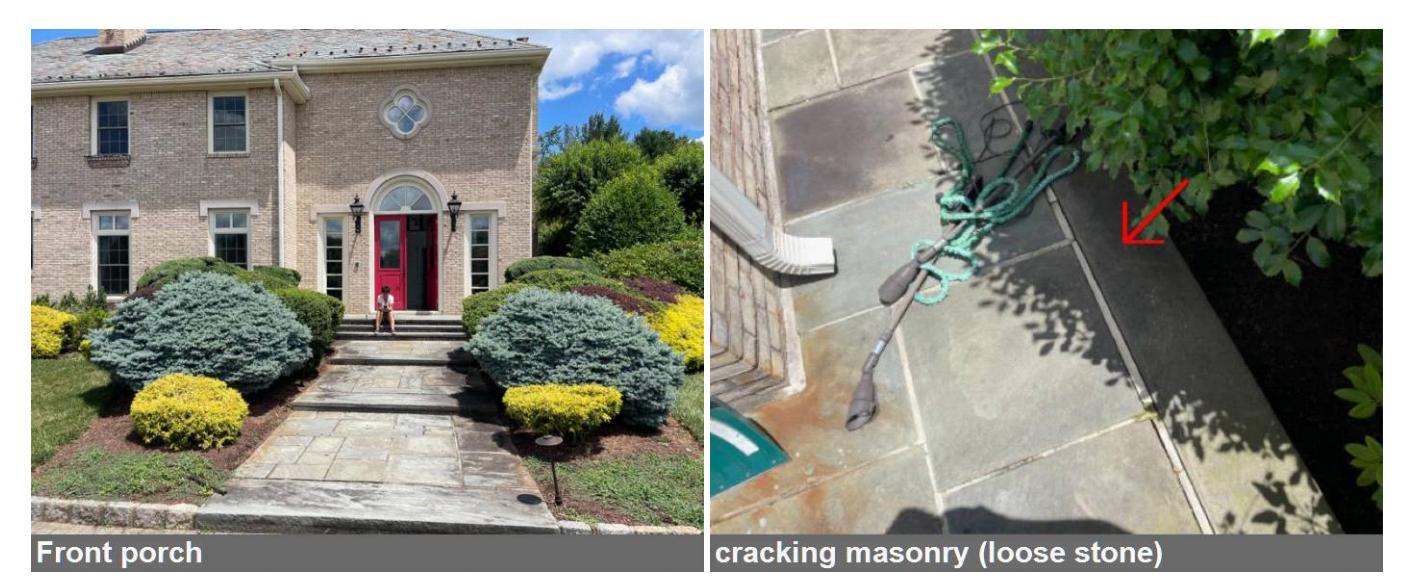
The front porch is unsatisfactory, which could result in loss of functional utility or cosmetic appeal. Deficiencies include, but may not be limited to the following; Settling of the masonry landing results in a negative pitch. The significance of this condition is; water will be channeled to the home's exterior, wood-frame walls. This condition could result in water damage (rot and mold). There is cracking masonry (loose stones), which could indicate structural problems or installation defects. The door bell is inoperable. There is some cracking of the masonry materials; which should be repaired by a qualified mason/contractor.

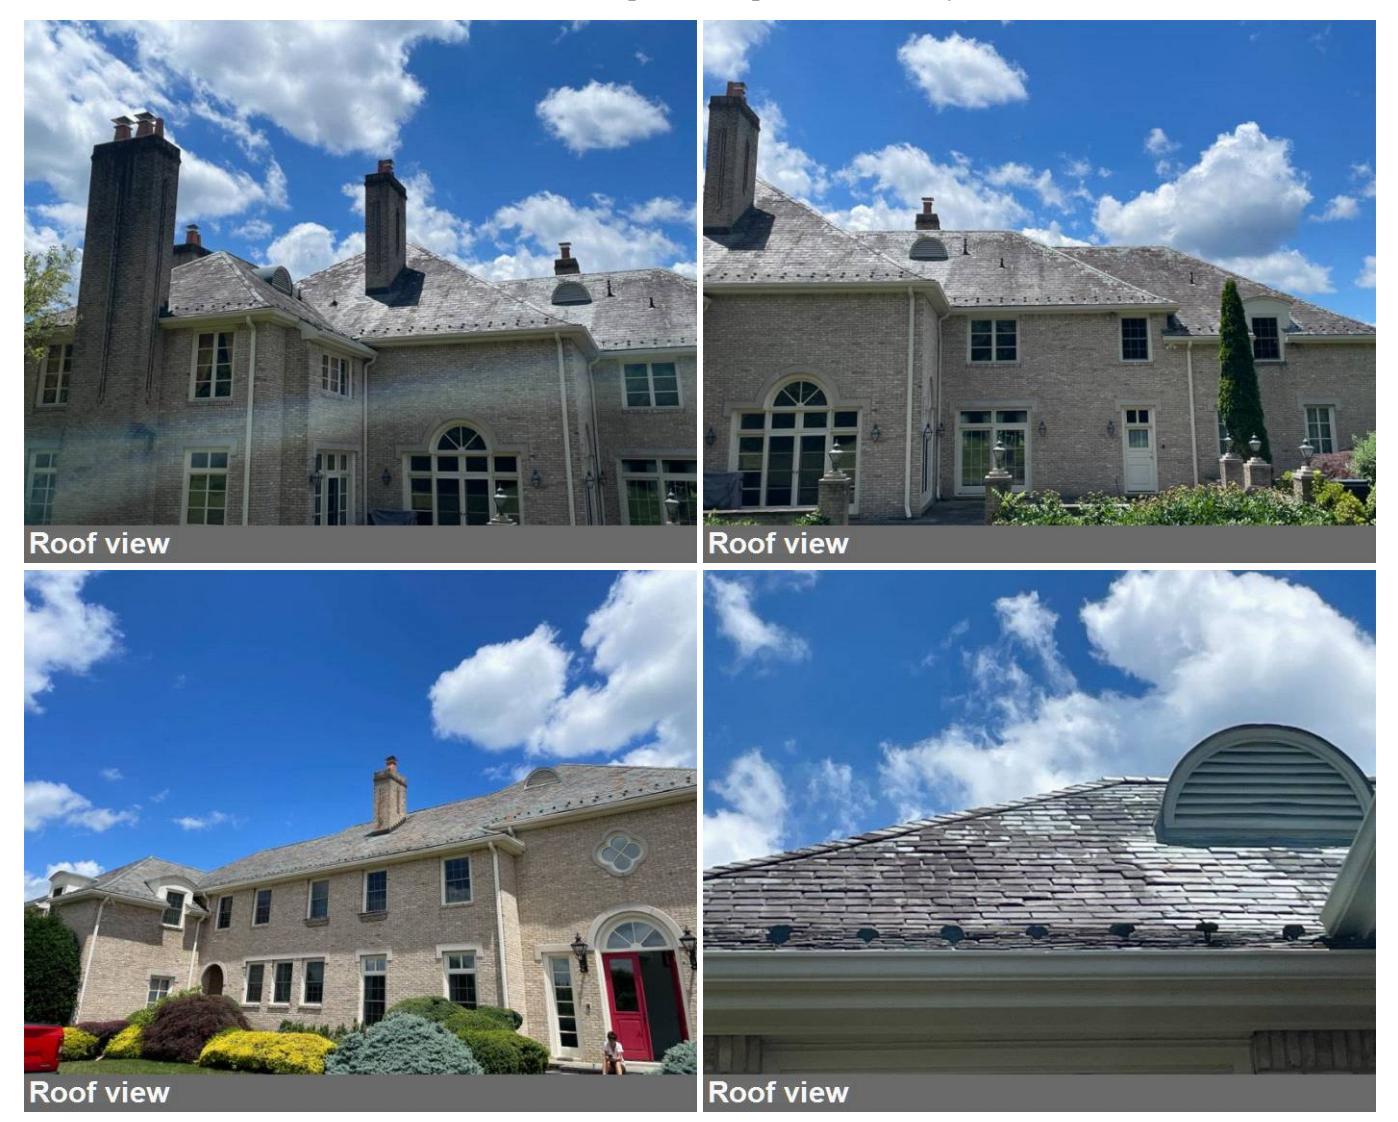
Permanent repairs likely include replacement of defective slates, which is expensive. Permanent repairs should be undertaken as soon as possible and preferably, prior to the end of the inspection contingency period. The roof shows signs of active leakage indicating the need for immediate repair. There is moss mold and fungus forming on the old slates. This condition is primarily due to inadequate roof venting. Cleaning is expensive, but generally restores much of the slate's beauty. NOTE: Repair of slate roofs can be expensive. For this reason, estimates for repair should be obtained prior to the end of the inspection contingency period. Contact a competent slate roofing contractor to evaluate the conditions and to perform repairs as necessary.

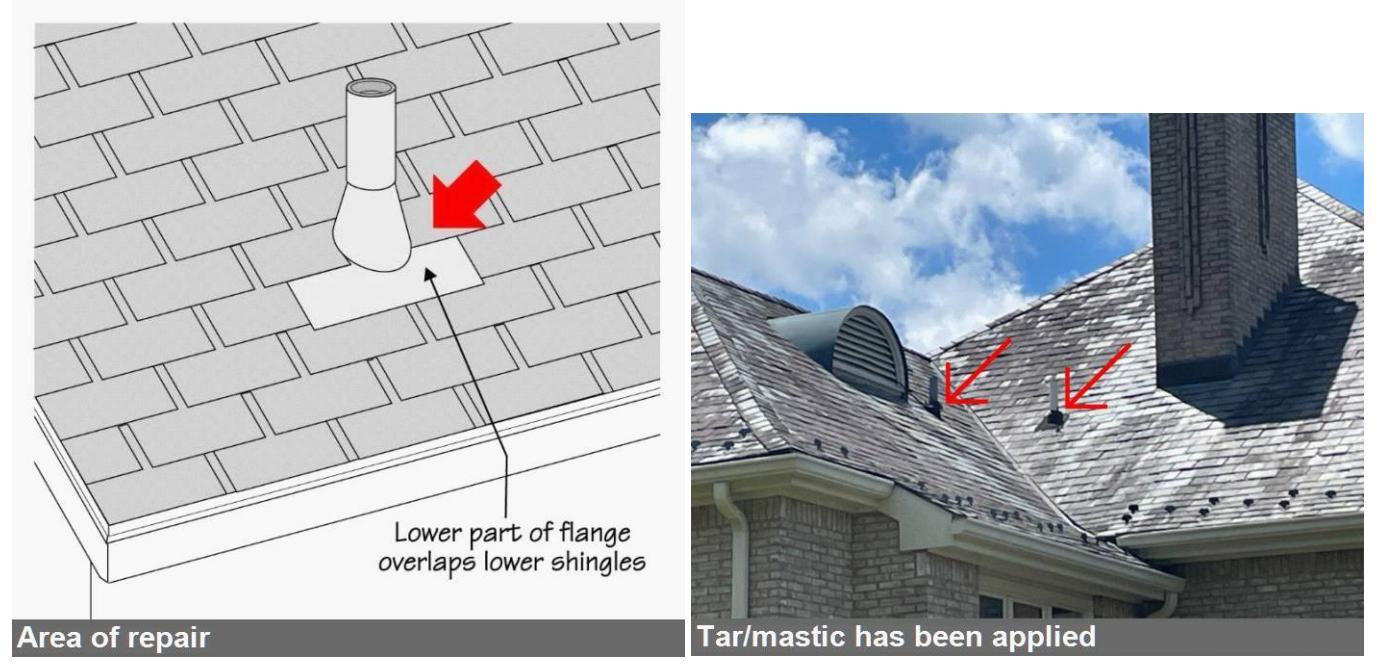
# **Plumbing Vent Flashing**

The plumbing vent roof flashings have been repaired/patched/tarred indicating some degree of problems at these areas in the past. Correctly installed flashings do not require repair unless they are at the end of their useful serviceable life. The nature and scope of repairs should be discussed with the present home-owner and the repairman, who performed the repair. Replacement of the flashings should be anticipated.

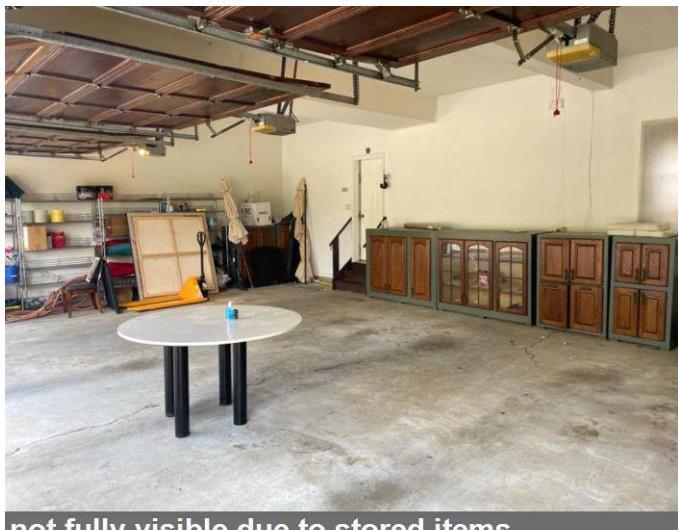
The concrete floor, where visible, is in acceptable condition. Normal settling cracks were noted. The floor and sections of the walls were not fully visible due to stored items. This limitation could prevent detection of defects, particularly termite and wood destroying insect infestations. A re-evaluation of this condition should be performed when conditions permit.

# not fully visible due to stored items

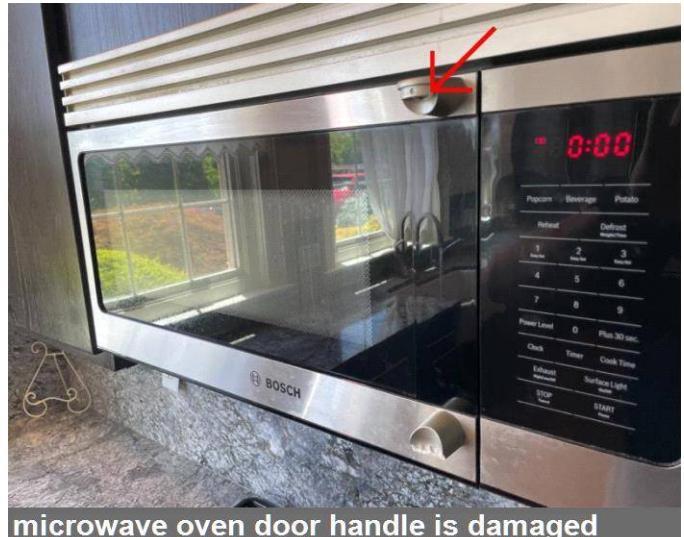
The microwave oven is inoperable/malfunctioning; indicating the need for maintenance/repair. The microwave oven door handle is damaged. Replacement is recommended.

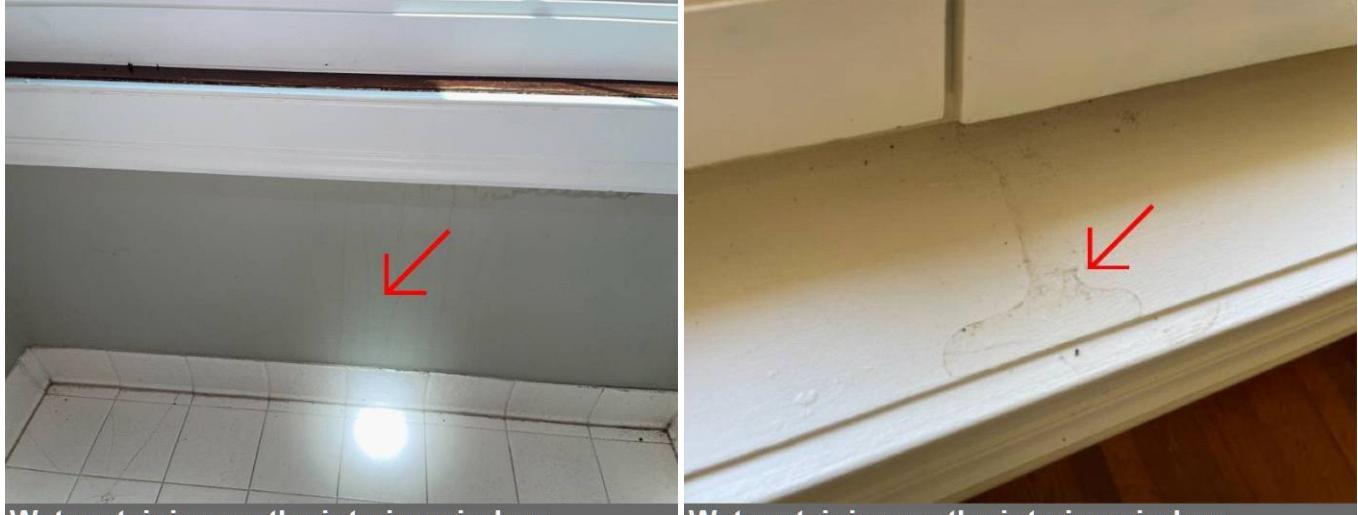
have identified the obvious bad seals that were identified during the inspection. Repair is normally more expensive than replacement. The window hardware is inoperable. Replacement is recommended. Water staining on the interior window surfaces indicates leakage that should be repaired. A competent contractor (specialist) should be contacted to more thoroughly evaluate these "material defects"/conditions and to perform repairs as necessary.

# Water staining on the interior window

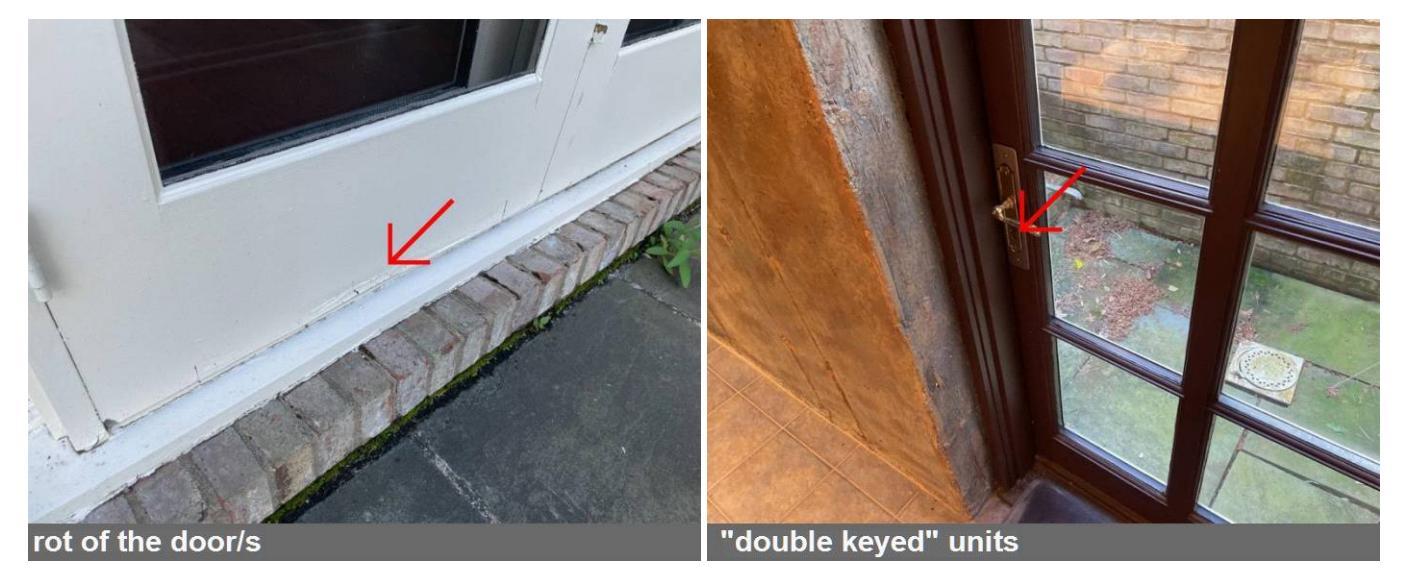
The exterior doors are in some aspects, unsatisfactory condition. Deficiencies include, but are not necessarily limited to the following; There is rot of the door/s. The exterior doors are not weather-tight indicating the need for adjustment and/or replacement/installation of proper weather stripping.

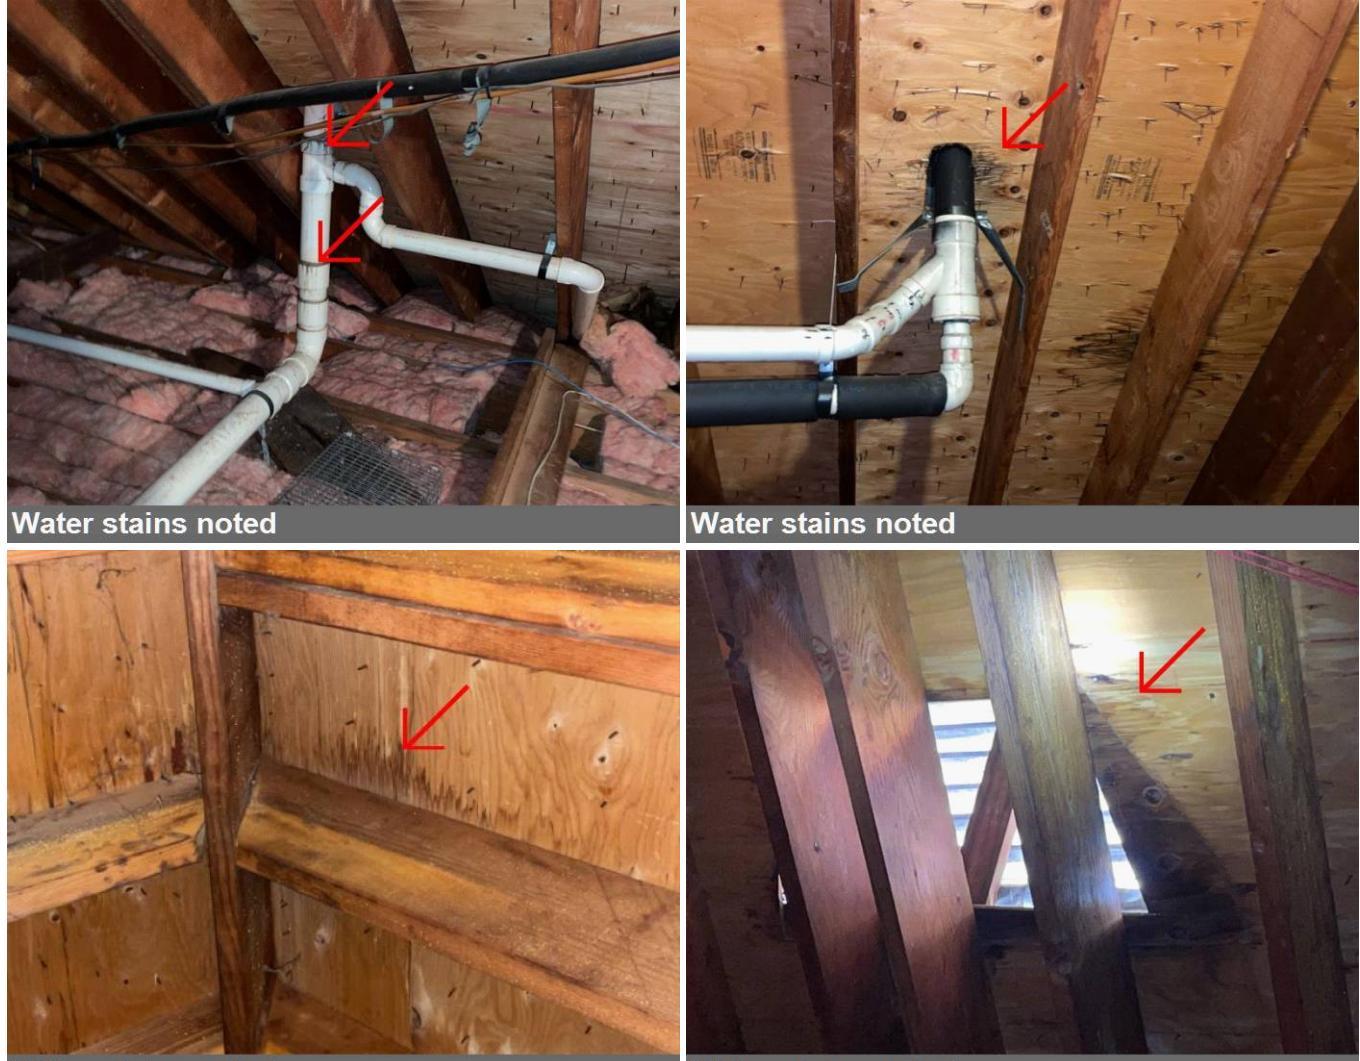
Water stains noted on the underside of the roof, which appear to be from past leaking. Documentation regarding roof repairs in this area should be obtained prior to closing. If no documentation is available, have these areas checked by a competent roofing contractor. If corrective action can be documented, monitor these areas, particularly during adverse weather conditions (rain) to detect any recurrence of the defect.

Water stains noted

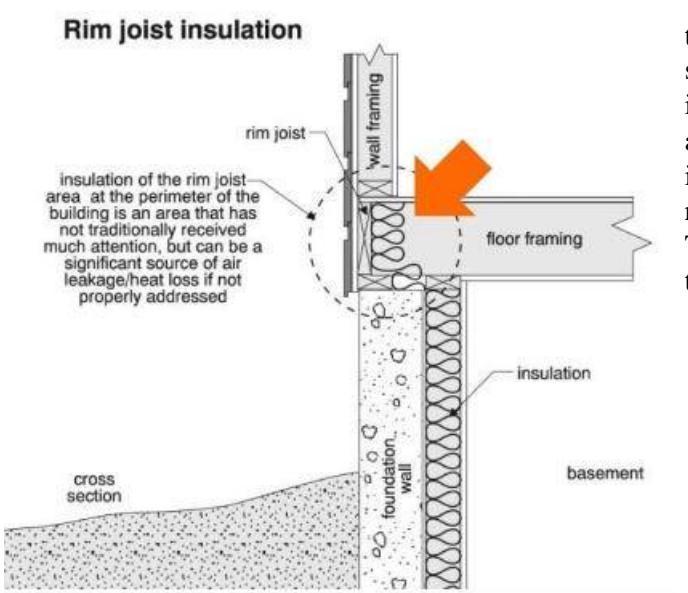
The perimeter of the basement area is insulated along the box beam area, which is consistent with building standards in this region. This is beneficial. The insulation does restrict the inspectors' ability to view the adjacent structural framing that is concealed by the insulation. Some of the perimeter insulation has been removed to install telephone, cable and electric cables. The insulation should be re-installed for improved thermal efficiency.

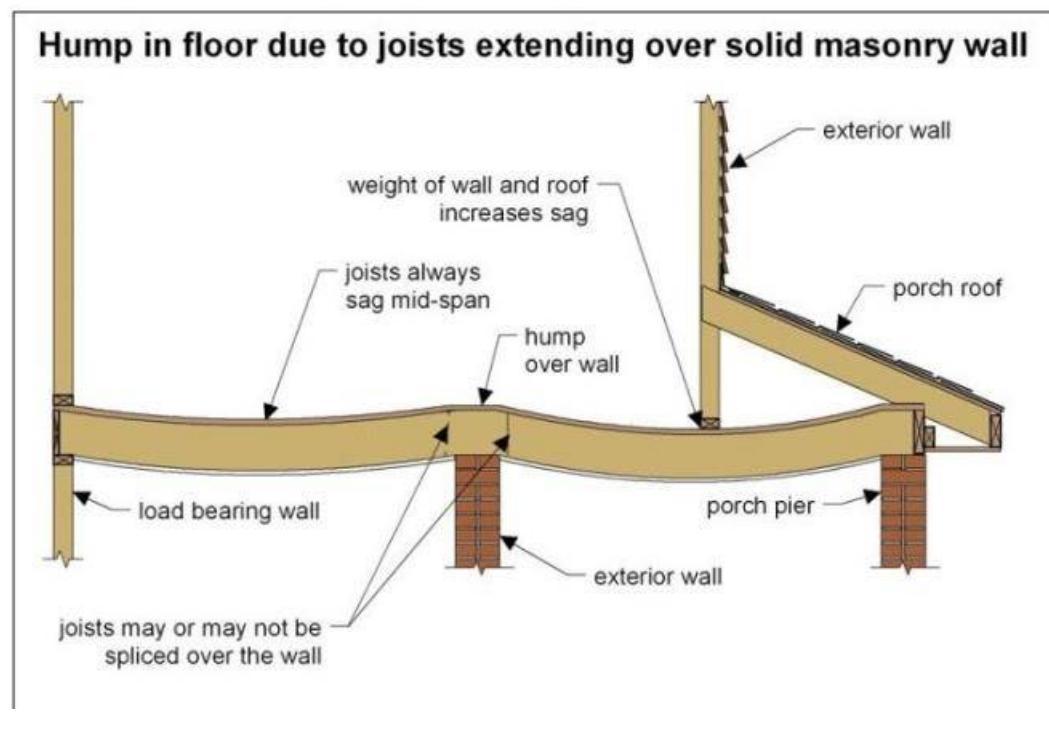
The western framing technique, also referred to as platform framing, is utilized in modern (post WWII) wood frame construction and is an improvement over older framing practices. This superior technique provides improved strength and fire resistance over old methods and is currently utilized in new construction. Deficiencies include. but may not be limited to the following: This home's structural

framing has "settled" over time. The condition is unavoidable in most older homes, but also occurs in newer homes. The causes include, but may not be limited to;

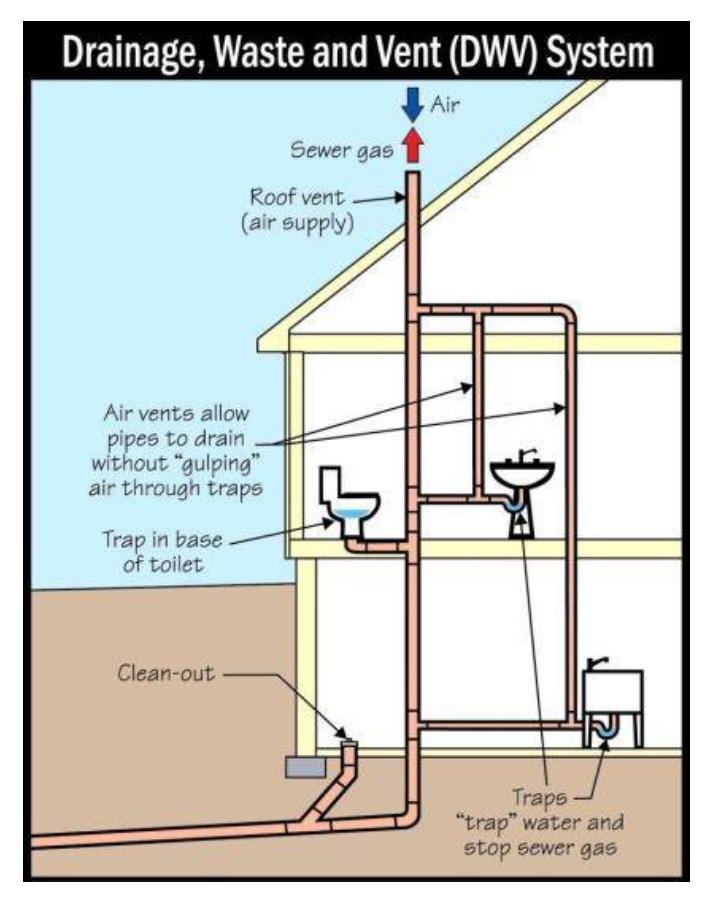
The home's waste piping is made of plastic piping. This is the most common of materials used in newer structures. The waste piping appears to be in some aspects, unsatisfactory condition. Note: Waste lines which are not visible are not part of these conclusions.

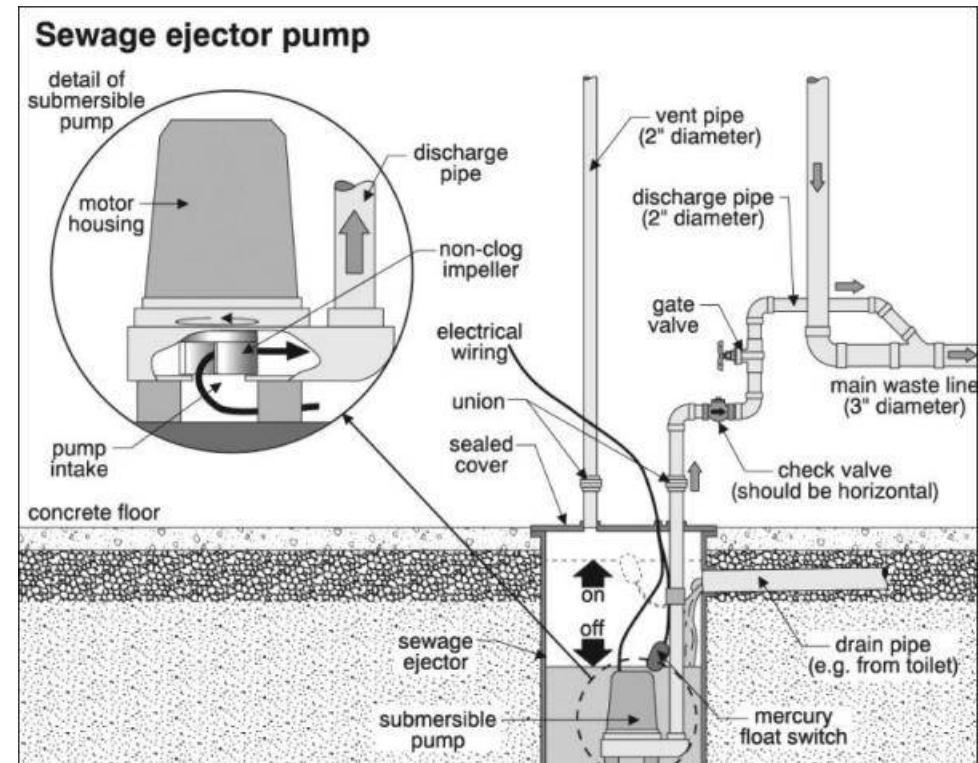
#### 14.8 DRAIN FLOW:

Waste flow, as can be determined by operating the plumbing fixtures, appears adequate.

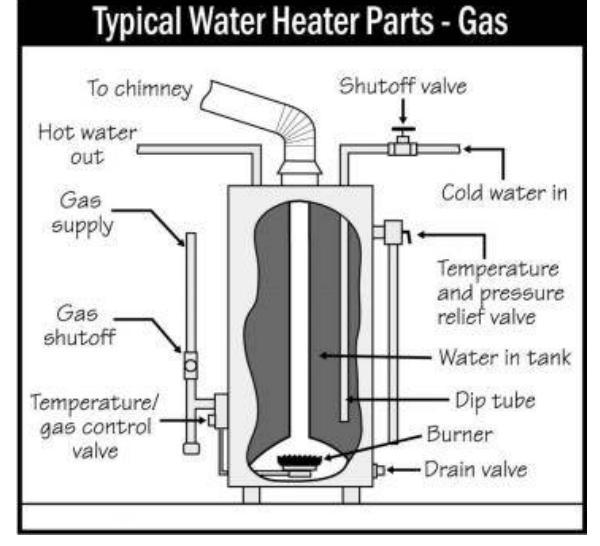
The conventional gas-fired water heaters burn gas under a steel container of water until it reaches a pre-set temperature. As hot water is drawn through the water system to the fixtures, the gas jet re-ignites and heats additional hot water. The cycle repeats itself again and again until the need for additional hot water is met and the units shuts down. In addition, the unit will turn on automatically to maintain a desired temperature 24/7.

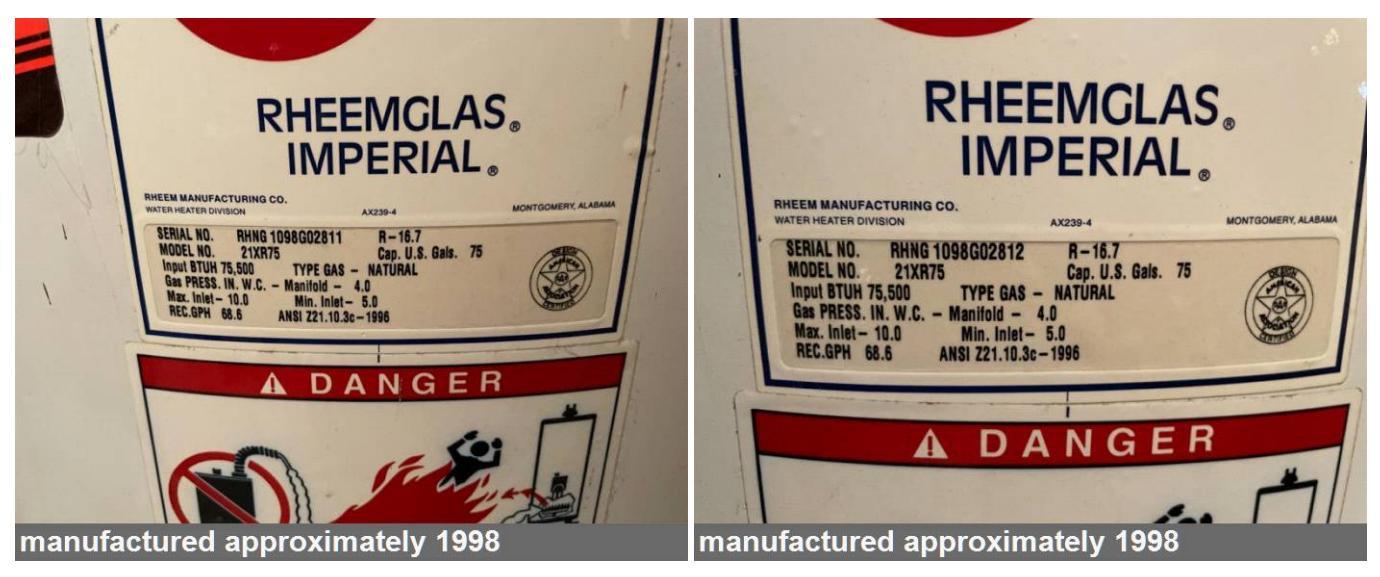
# 15.3 APPROXIMATE AGE:

The water heaters are believed to have been installed/manufactured in 1998.

The water heaters are in some aspects, unsatisfactory condition. Deficiencies include, but are not necessarily limited to the following; The pipes coming to the unit are corroded indicating a past/present leak. The water heaters are older units that have functioned beyond what would be considered a normal serviceable life. Replacement should be anticipated.

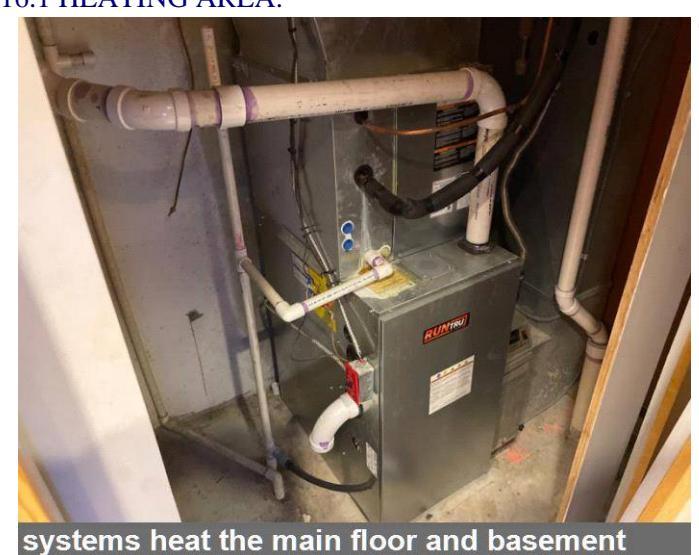
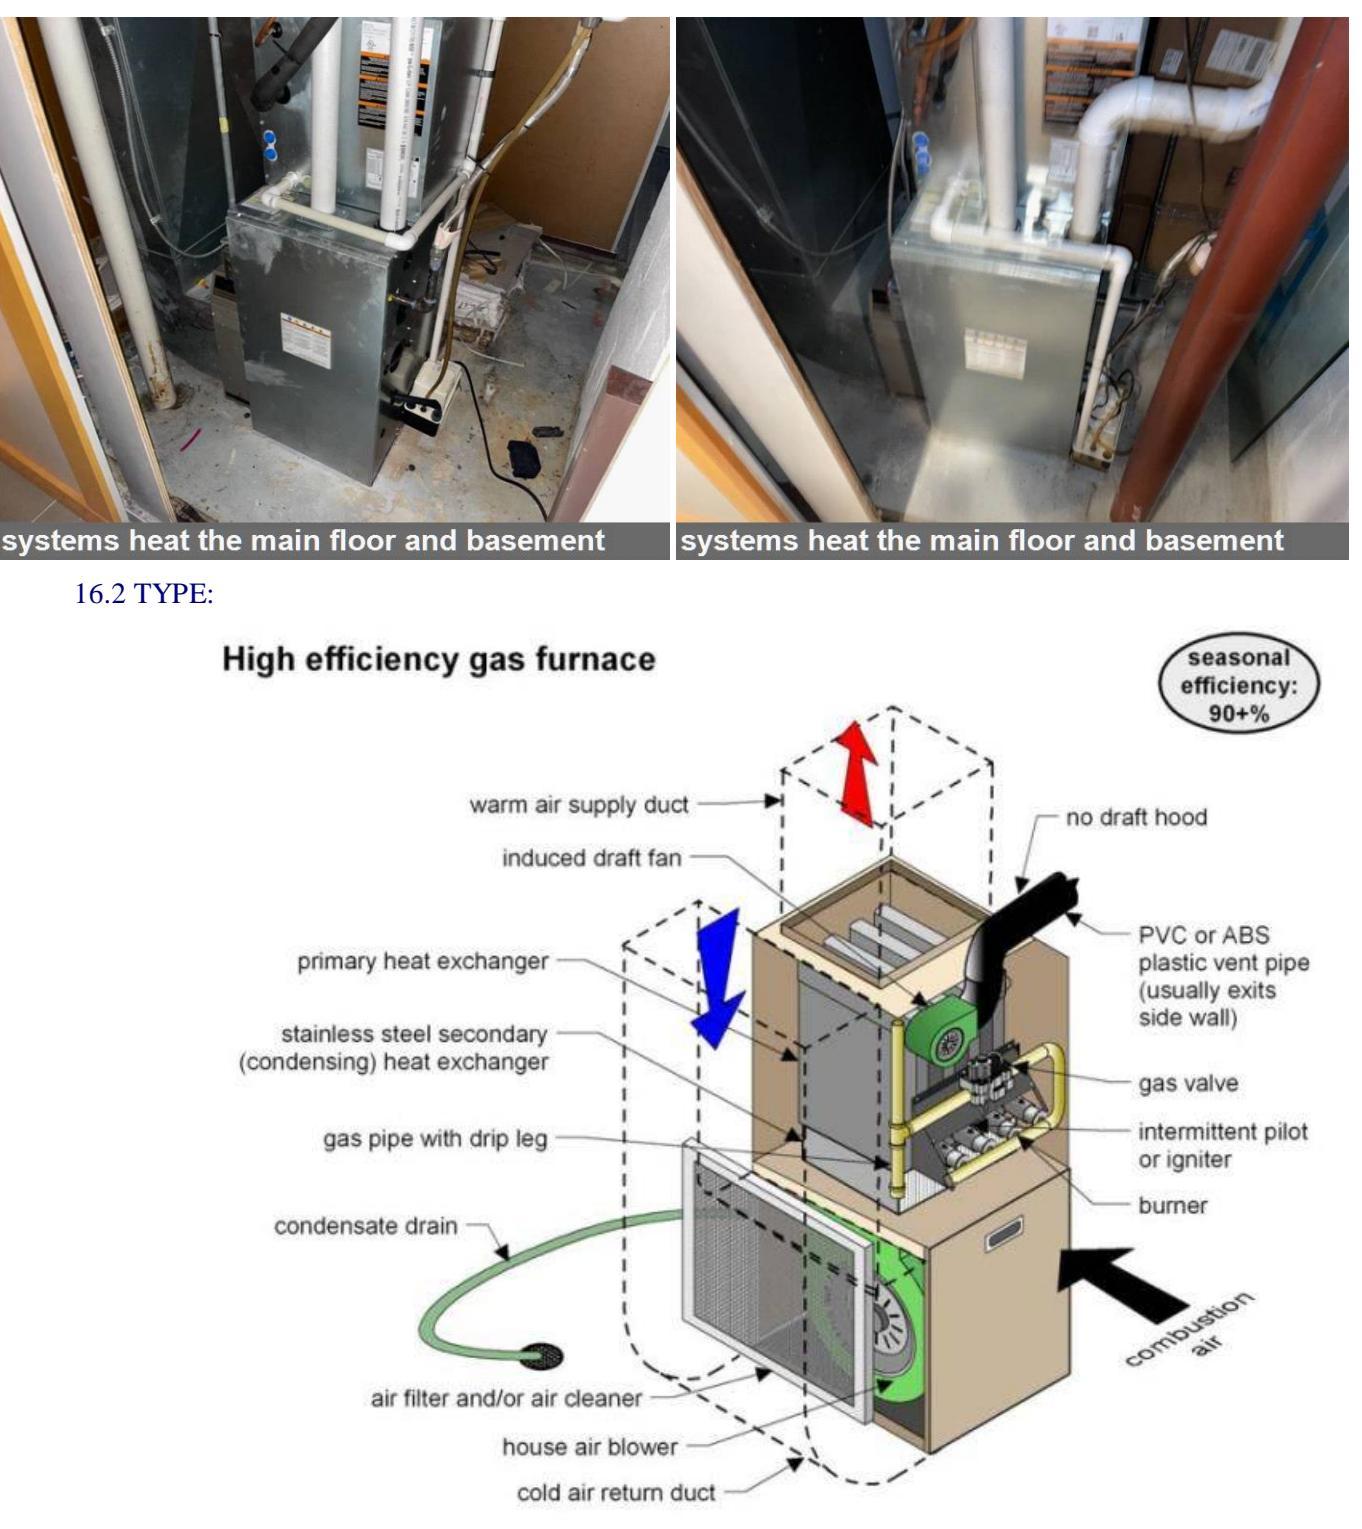
These systems heat the main floor and basement.

The furnaces are in some aspects, unsatisfactory condition. There are signs that exhaust condenses inside the flue vent and the condensate seeps back down the flue vent to the furnace. This condensate (carbonic acid) may corroded the furnace components over time. In addition, leaks from the exhaust system have safety implications if neglected. An HVAC contractor should be consulted to more thoroughly evaluate the condition and to perform repairs as are necessary. The heating system fan is malfunctioning. The fan is making a loud sound (grinding/whining); this could indicate failing components or some other defect. This could result in premature failure of the system/components. Replacement/repair of the fan components is recommended.

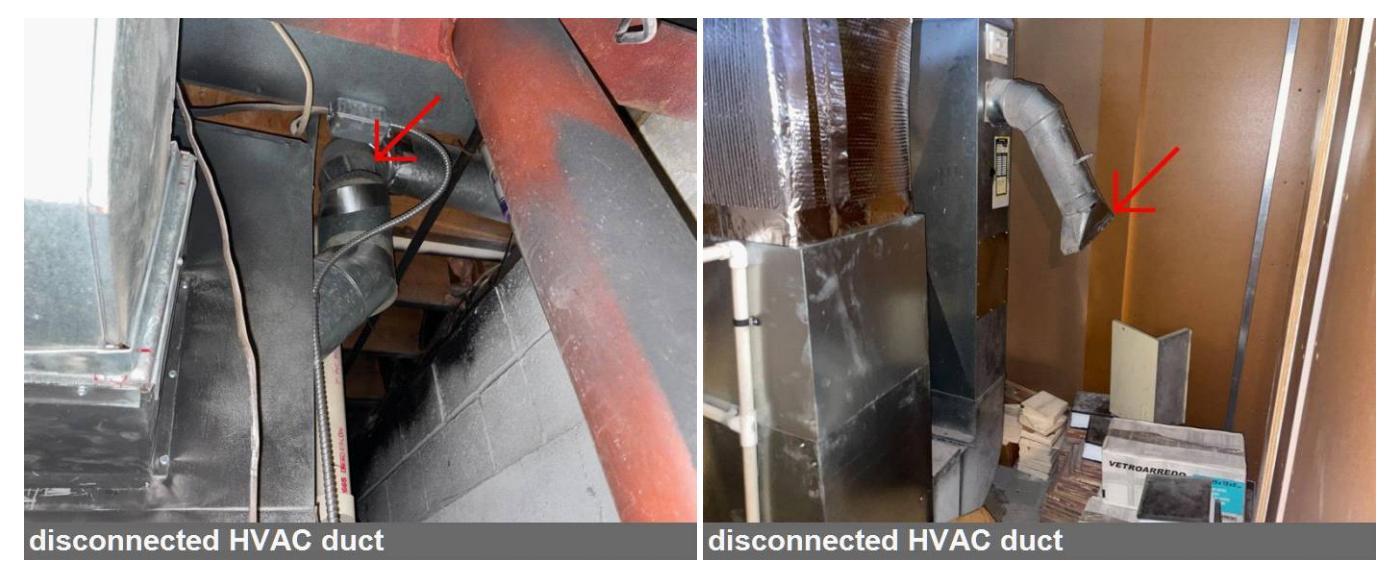
There are indications that the HVAC ducts have been professionally cleaned. This is indicated by holes present in the ducts. The holes are capped with plugs. Documentation about this maintenance should be obtained, if available, at the time of closing. There is a disconnected HVAC duct. The significance of this condition is; loss of thermal efficiency will result. Have the duct repaired. The distribution heat/cooling ducts are located on the interior walls; which may adversely affect function of the heating system and may potentially allow for "cold spots" in living areas. Recommend contacting a licensed Heating Ventilation Air Conditioning (HVAC) specialist to perform repairs as necessary.

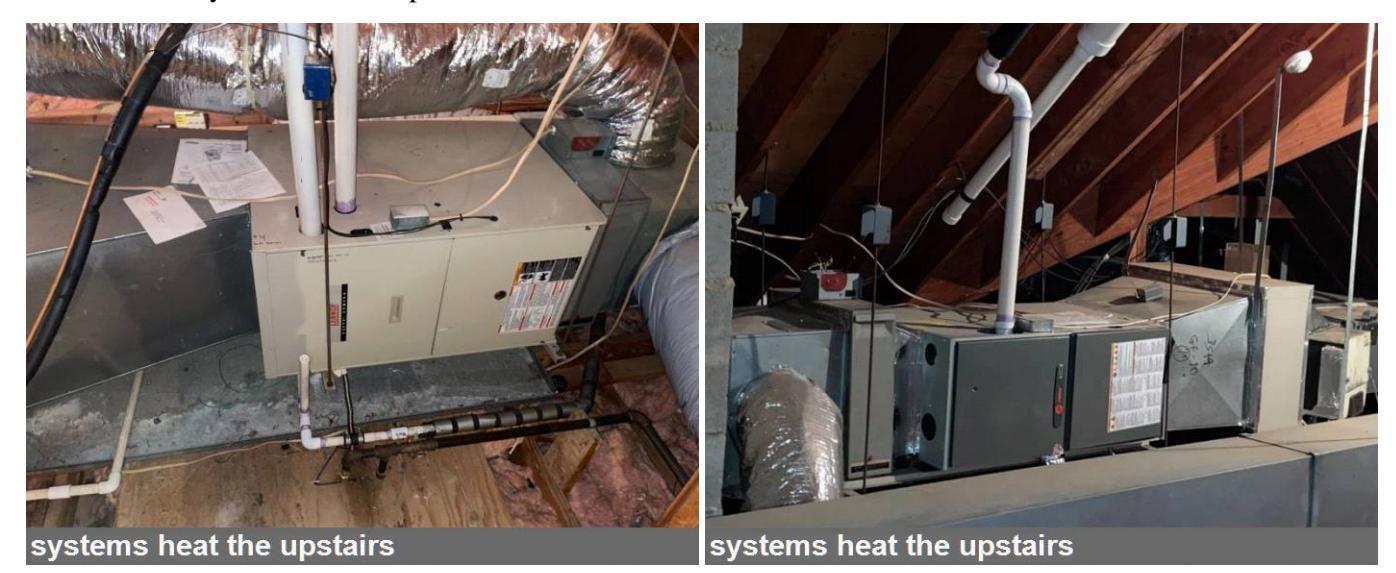
These systems heat the upstairs.

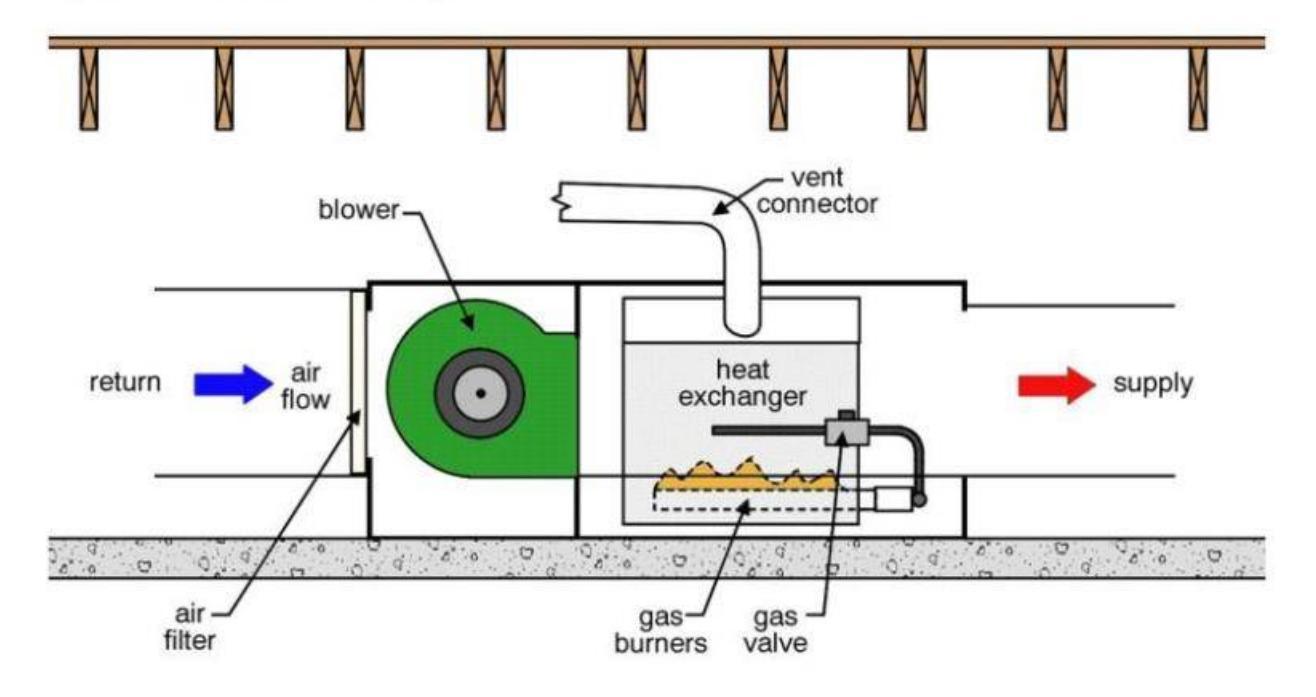
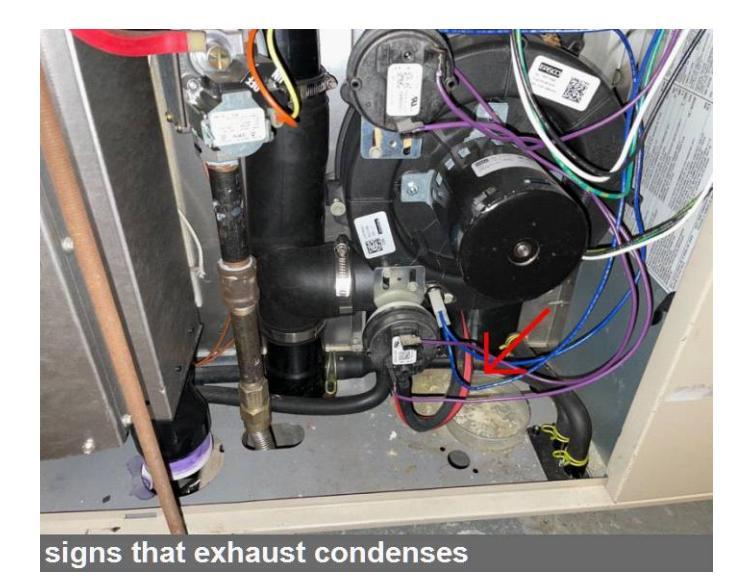
Due to the fact that attic spaces are typically not heated, there are potential problems with drains that discharge the condensed water vapor from the unit. These problems can include freezing conditions that cause ice build up, leaks and water/mold damage.

The furnaces are in some aspects, unsatisfactory condition. <u>There are signs that exhaust condenses inside the flue vent and the condensate seeps back down the flue vent to the furnace.</u> This condensate (carbonic acid) may corroded the furnace components over time. In addition, leaks from the exhaust system have safety implications if neglected. An HVAC contractor should be consulted to more thoroughly evaluate the condition and to perform repairs as are necessary. NOTE: These are older units (manufactured approximately 2003) that are in operational condition. They are working beyond their projected service life and any additional use is a bonus. Replacement should be anticipated. Contact an HVAC contractor before the inspection contingency expires to more thoroughly evaluate the system and to obtain estimates for replacement.
