# HOME INSPECTION REPORT

Home Inspector License # 24GI 153000 ASHI Certified Inspector 262871 KAUFMANN CONSULTANTS, LLC 17 Cook Avenue, P. O. Box 1222 Madison, New Jersey 07940 (973) 377-4747 FAX (973) 377-7755 www.KaufmannConsultants.com

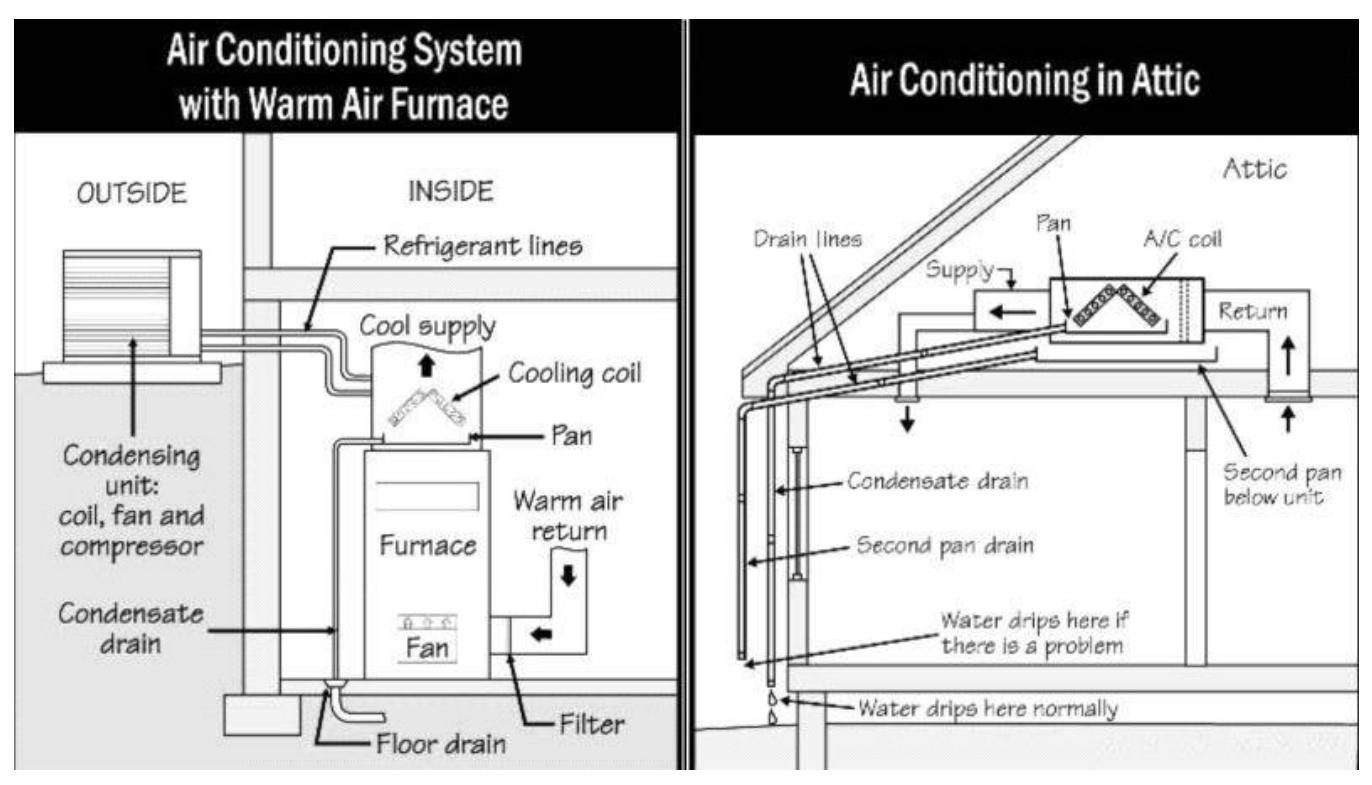
# **17.3 SYSTEM CONDITION**

<u>The cooling system is in need of maintenance/repair.</u> The cooling system(s) are inoperable/malfunctioning. Contact an HVAC contractor before the inspection contingency expires to more thoroughly evaluate the system and to obtain estimates for replacement.

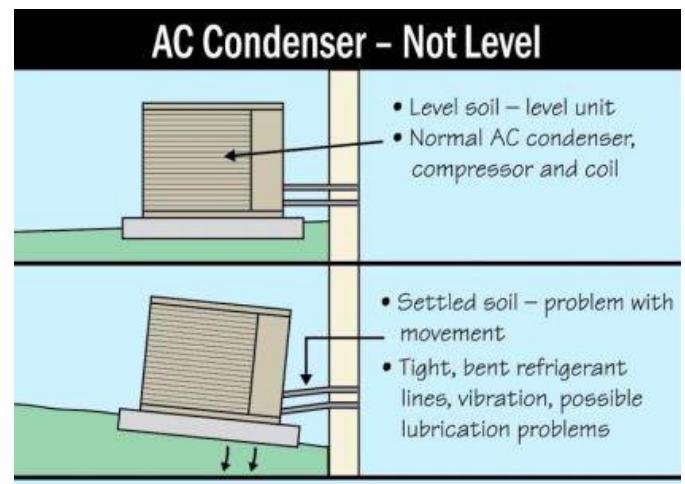
The condensers, also commonly called the compressors, are in some aspects, unsatisfactory condition. The condenser is older and may have a limited future serviceable life. Replacement should be anticipated. The dunnage that supports the condenser has settled or may not have been properly leveled at the time of installation. The condition could result in damage to the refrigerant lines and vibration, which could cause defects and premature failure. Re-leveling of the condenser is recommended. There is vegetation growing on or near the condenser unit. This can reduce the efficiency of the unit. Clean/clear the unit of all vegetation and debris. The fins on the condenser are damaged. These fins allow air to dissipate heat to the atmosphere during normal operation. The significance of this condition is; the damaged fins can adversely affect function/efficiency. A competent contractor should be contacted to more thoroughly evaluate this "material defect"/condition and to perform repairs as necessary. Due to the age and overall condition of these systems/components, a future serviceable life will be limited. Replacement should be anticipated. Budget for this contingency.

If an AC condenser settles with the soil, the refrigerant lines can be damaged and the compressor may be damaged if operated.

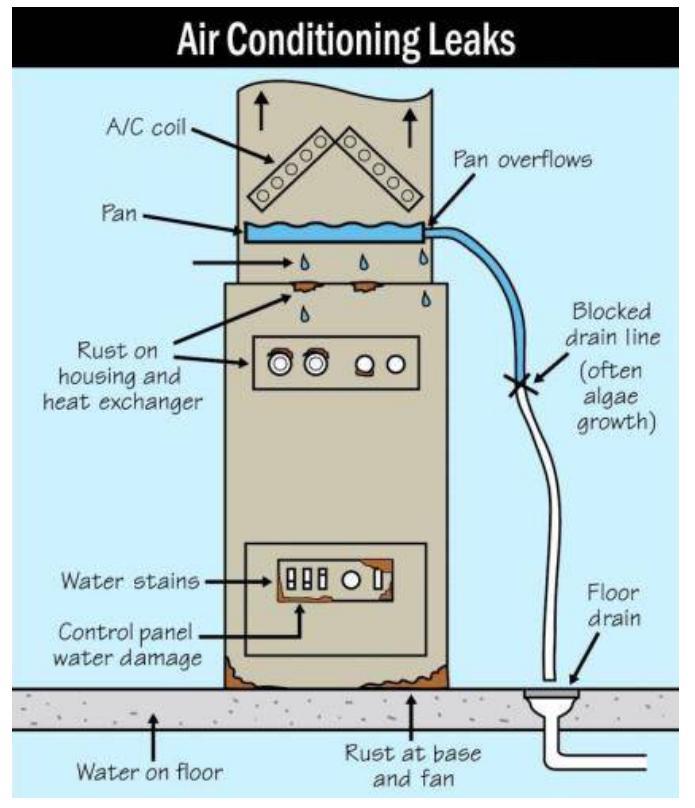
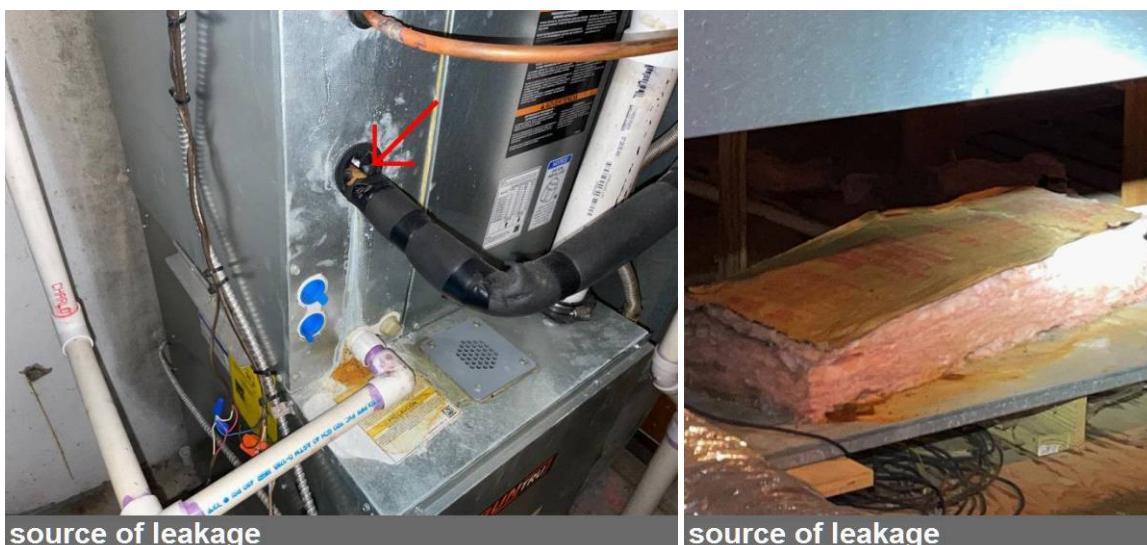
#### **17.5 AIR HANDLER LEAKS**

There are indications that the air conditioning system in the basement has been a source of leakage. This is indicated by water staining of the air handler housing components and the equipment below the unit. This is common and normally routine maintenance to clear the drains is sufficient, but not always. Under some circumstances the repair is difficult and expensive. Contact a competent heating and cooling contractor to more thoroughly evaluate the system and perform necessary repairs as necessary. There are indications that the air conditioning system has been a source of leakage. This is indicated by water staining of the exterior metal panels of the air handler as well as water staining/standing water in the drip pan positioned beneath the air handler (see diagram). The condition is sometimes due to failure of the dedicated drains installed in the air handler. A competent contractor should be consulted to more thoroughly evaluate the condition and to perform repairs as are necessary.

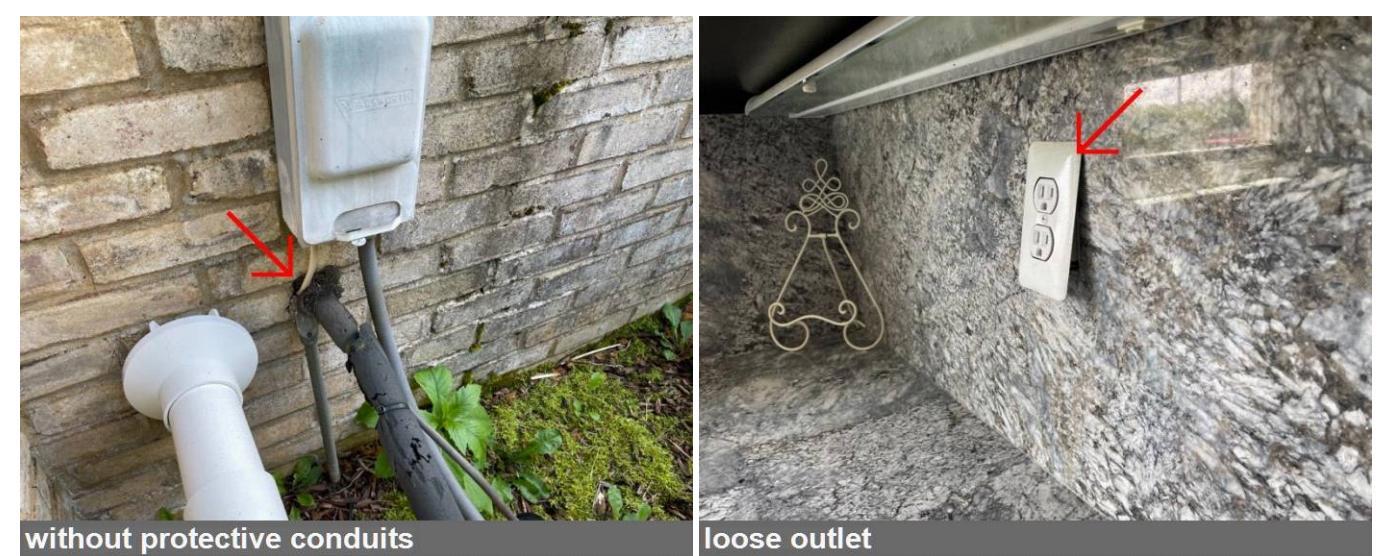
<u>There are some incorrectly installed or malfunctioning electric components, which represents a "material defect".</u> <u>These defects should be repaired.</u> The significance of this condition is; reduced reliability, reduced efficiency and, under extreme conditions, a possible shock hazard or fire concern. All defective electric defects should be further evaluated/repaired by a licensed electrician for improved reliability and safety. Deficiencies include, but may not be limited to the following:

Some of the electric conductors/components were installed without the correct number of fasteners/junction boxes. Fasteners and junction boxes are used to secure the conductors and protect the integrity of the connections. This condition may not create a hazard, but is a "red flag" indicating an un-professional level of installation. A

conductor passes through the foundations without protective conduits. The significance of this condition is; the conductor insulation could be damaged resulting in malfunctioning circuitry. A licensed electrical contractor should be consulted to more thoroughly evaluate the condition and to perform repairs as necessary.

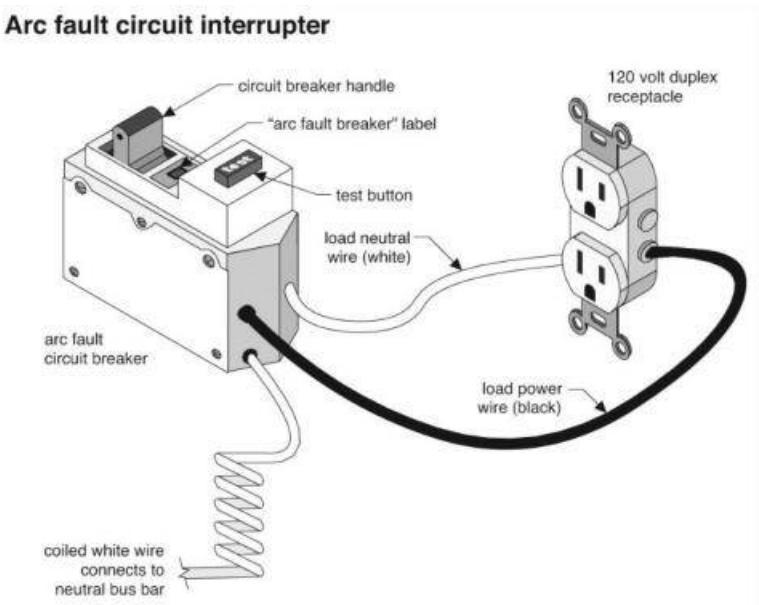
#### 18.11 AFCI PROTECTION:

The electrical system does not have Arc Fault Circuit Interrupter (AFCI) protection. The installation of these safety components may not be required in existing structures, but should be considered as part of up-grading the electrical system and improving safety.

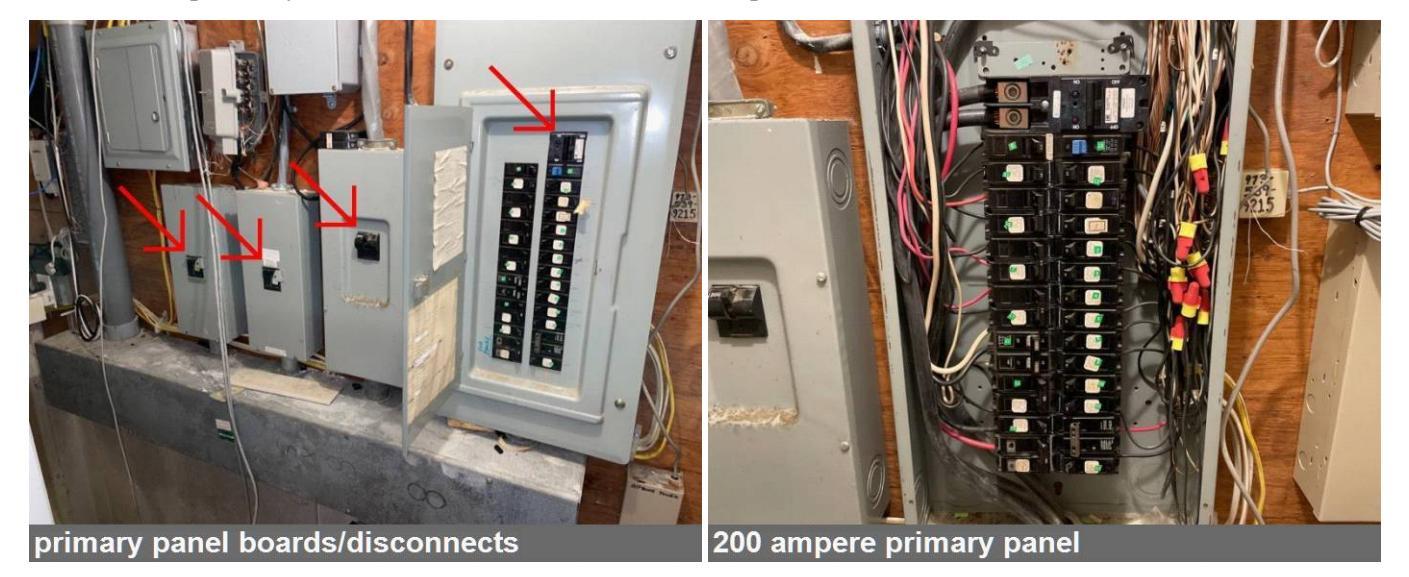
#### **18.15 PANEL CONDITIONS**

Wiring conditions inside the electric panel are unsatisfactory. Deficiencies include, but may not be limited to the following conditions; **There are incorrect brand breakers in the panel, which could result in failure/fire.** A licensed electrician should be contacted to more thoroughly evaluate this "material defect"/condition and to perform repairs as necessary.

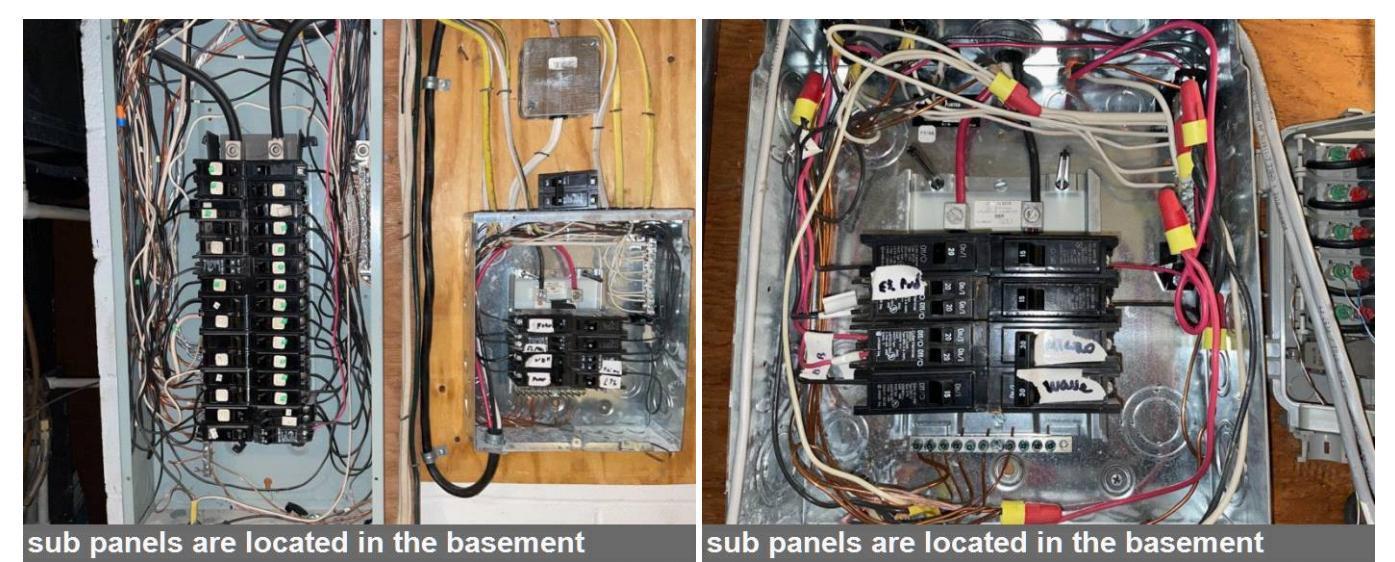
The wiring methods inside the electric sub panel are in need of maintenance/repair. Deficiencies include, but may not be limited to the following conditions; Double Lugging of the branch wiring to the circuit breaker(s) was noted at some of the breakers. This occurs when more than one conductor is attached to a single circuit breaker. There is potential for overload of the circuit and/or connections becoming loose, which could cause interruption of power, arching (fire concern) or other electric related problems. In addition, the condition does not comply with modern electric system standards, with few exceptions. Combined neutrals is detected inside the sub panel. Some of the neutral lugs have more than one neutral conductor secured under a single lug. The condition is common in older panels that have limited space for additional circuits and in "crowded" panels where access to the correct lug is restricted. Panel manufacturers recommend that only one neutral conductor beneath one lug creates a potential hazard for the electrician working on the system and also for the occupants during normal use. Consideration should be given to having a licensed electrician reposition the white clad (grounded conductors/neutral wires) so that no more than one neutral conductor is secured under each lug. Some of the panel cover screws are missing. Replacement is recommended. There are incorrect brand breakers in the panel, which could result in failure/fire. It is recommended that a licensed electrician further evaluate the panel and repair as needed.
