HOME INSPECTION REPORT

Prepared by Kyle Kaufmann

KAUFMANN CONSULTANTS, LLC

INSPECTION LOCATION

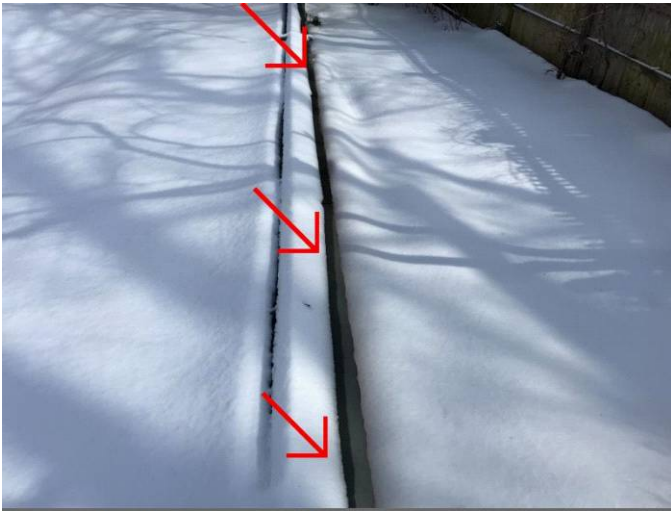
There is no guardrail installed at the top of the retaining wall. (See the below photograph) Consider that the ledge of a retaining wall could be an attractive nuisance for children, but adults could also be vulnerable to a fall from these areas. A retaining wall at least thirty inches tall, with a walking surface above, should have a guardrail installed. Another option is to plant heavily on the upper side of the wall to limit access to the edge of the wall.

no safety railing above wall

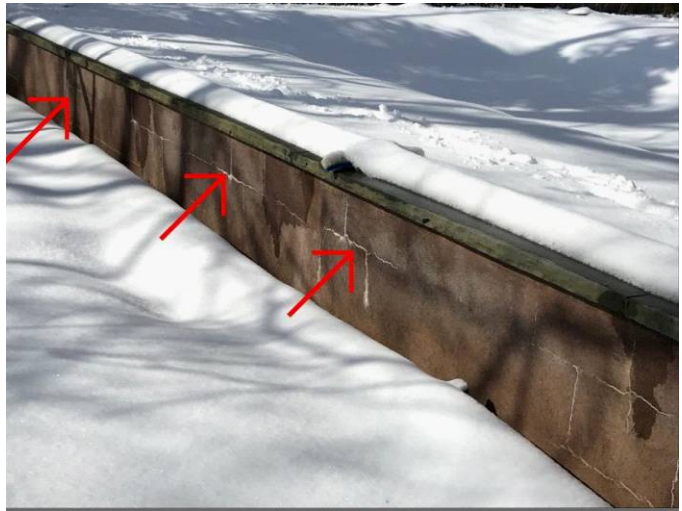
The masonry retaining wall appears unsatisfactory. **There is cracking/deteriorated masonry; which could adversely affect performance of the component.** (See the below photograph) Degraded performance could result in damage to other components. Have the cracks repaired as necessary.

cracking/deteriorated masonry

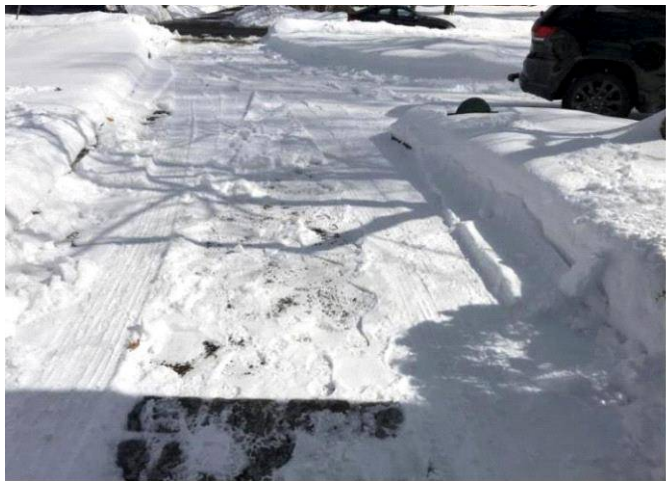
Snow prevented full evaluation

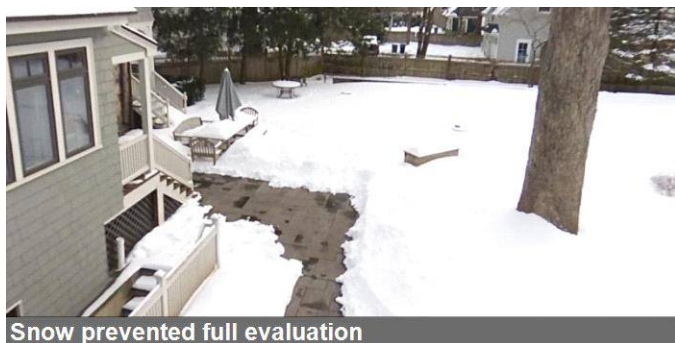
Snow prevented full evaluation

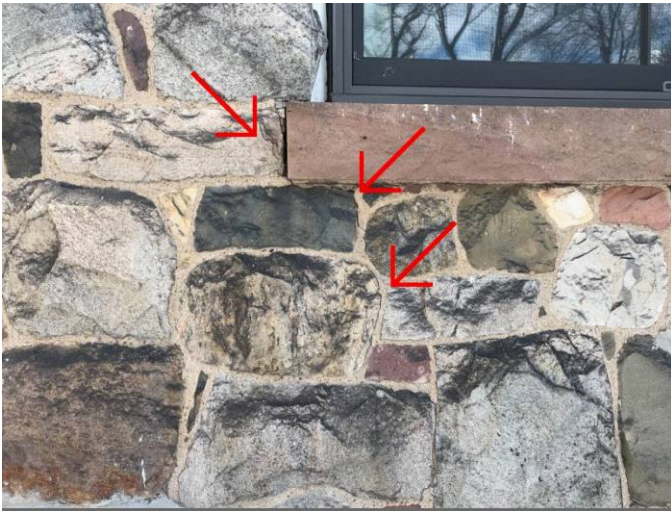
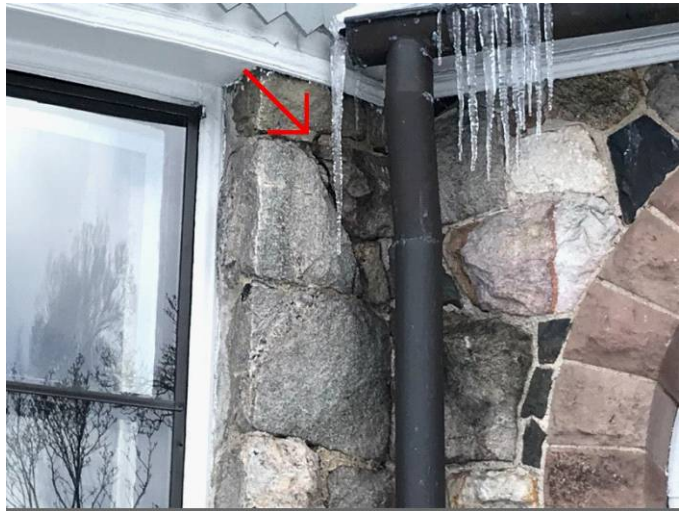
The stone and mortar veneer appears to be in some aspects, unsatisfactory condition. There is cracking of the mortar between the stone and mortar veneer. (See the below photographs) Cracks can allow for leaks through to the wall system, which could cause rot and mold. Have these cracks checked and repaired by a qualified contractor to restore the exterior. In addition, there is no visible drainage path for moisture to escape the wall system. Proper installations of masonry veneers require some method of draining the exterior walls. Typically, a weep screed (seam) will be visible at the bottom of the application, above doors and windows and at other openings in the exterior surface. These holes allow moisture to drain from the wall and alleviates potential for damage. If not installed, moisture may become trapped in the wall system, which could cause rot and mold.

cracking of the mortar

A competent contractor should be contacted to more thoroughly evaluate this "material defect"/condition and to perform repairs as necessary.

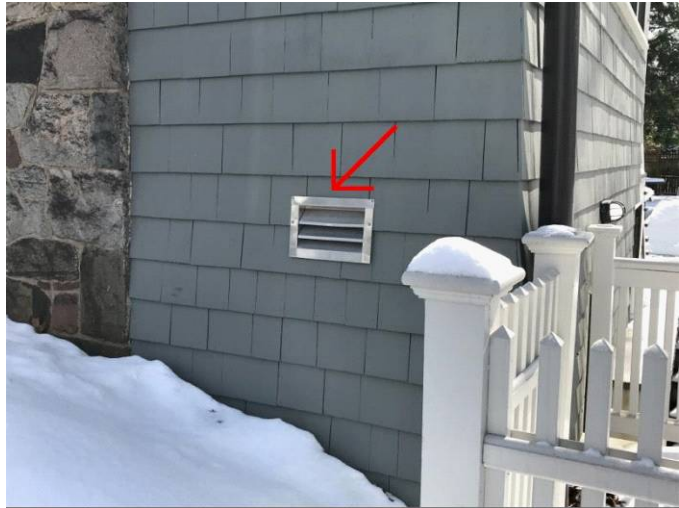
missing or defective flashings

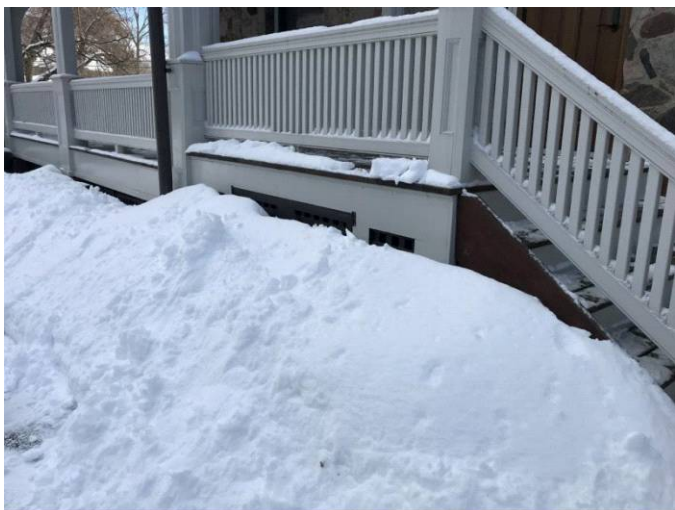
NOTE: Snow cover limits access and visibility underneath the porch. (See the below photograph), A re-evaluation of the conditions should be conducted when conditions permit (before closing)

snow limits access underneath

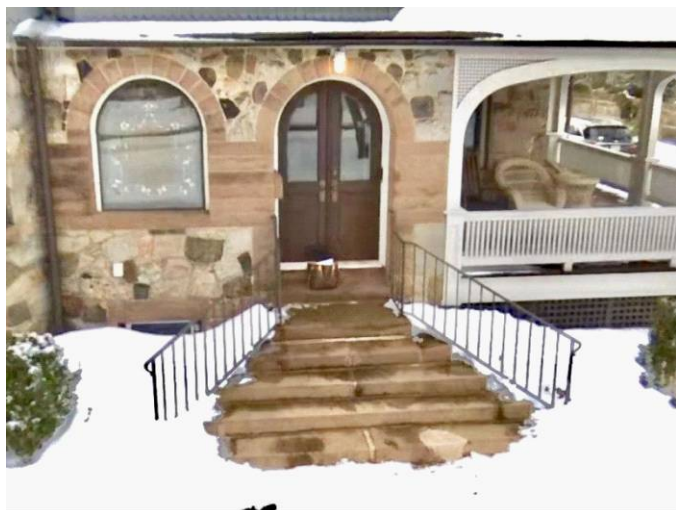
The right, front porch is unsatisfactory, which could result in loss of functional utility or cosmetic appeal. Deficiencies include, but may not be limited to the following; There is rot of the wood porch decking, which could result in loss of functional utility. (See the adjacent/below photograph) Replacement/repair of the damaged/rotted components is recommended.

front porch | snow prohibits full view

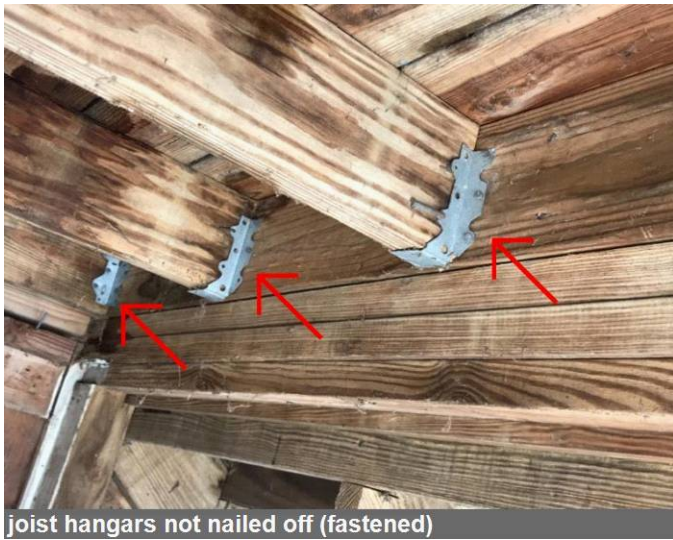
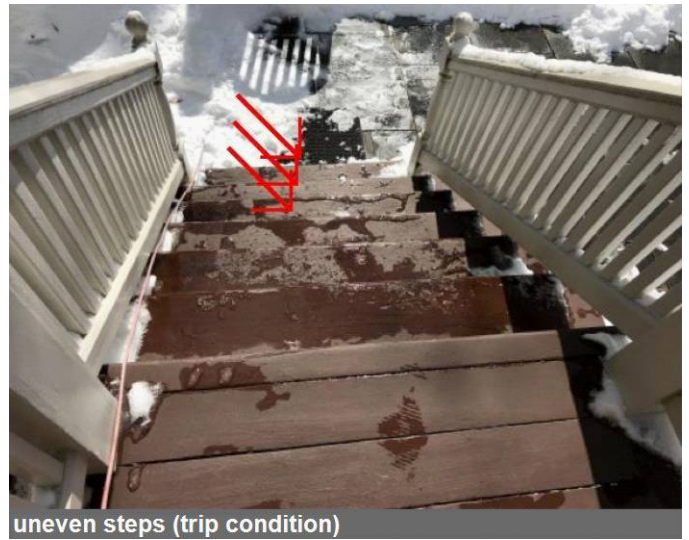
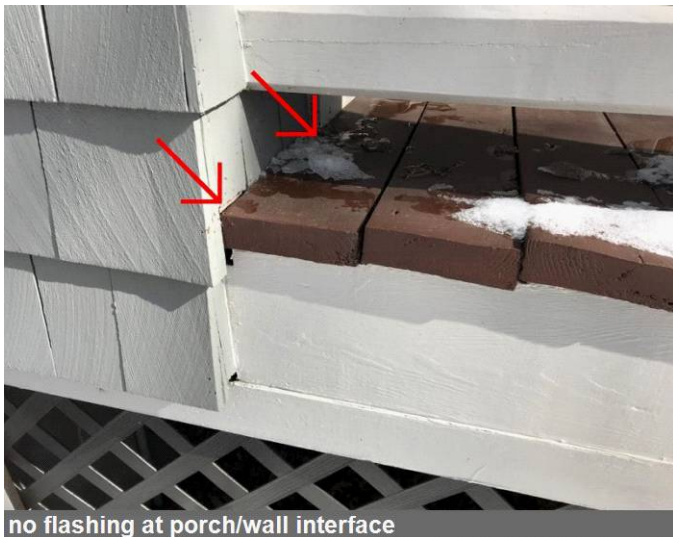
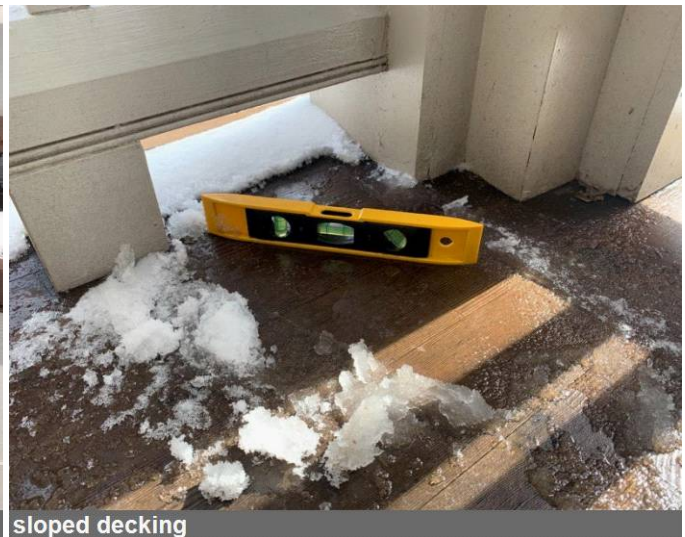
The joist hangers that support the landing structure are not properly fastened. The significance of this condition is degraded performance. There is no visible flashing between the porch landing and the exterior wall which resulted in potential for leakage. A competent contractor should be contacted to more thoroughly evaluate this "material defect"/condition and to perform repairs as necessary.

NOTE: The elevation of the decking is very close to the elevation of the door. Normally, there is a step up into the door from the deck. The significance of this condition is; the step up makes creation of a water-tight seal at the deck/wall interface easier to achieve. This interface is vulnerable to leaks and subsequent rot.

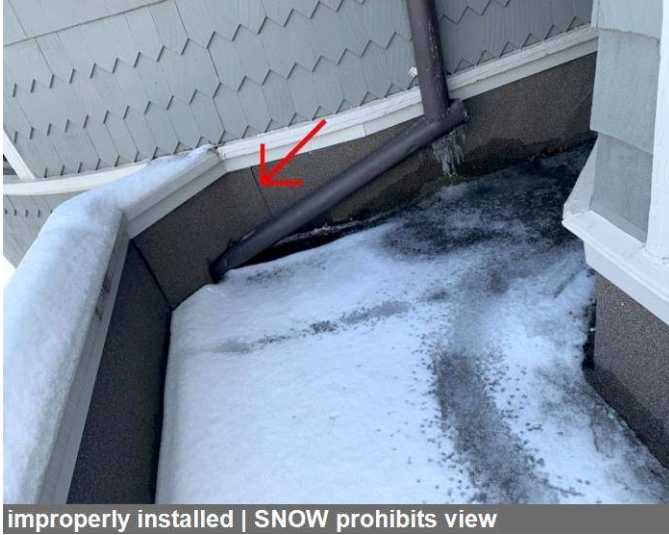
The balcony is unsatisfactory. The 77 lb roof covering is improperly installed (see the adjacent photograph). roofing over the deck appears to have depressions where water ponds after rainfall. (see the adjacent photograph) The significance of this condition is; ponding on a roof deck could shorten the serviceable life of the surface. Contact a qualified contractor to evaluate the condition(s) and to perform necessary repairs.

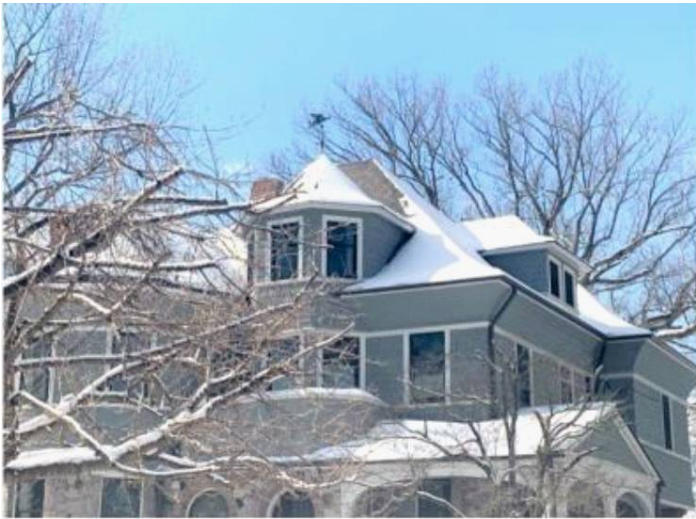
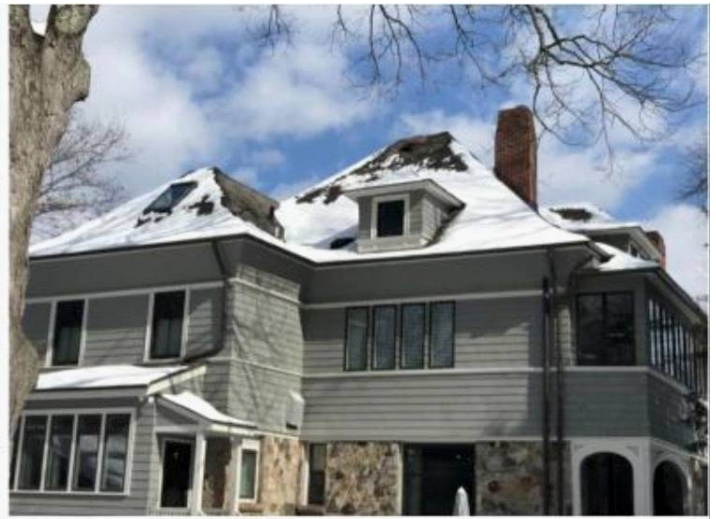
The roof is in leak-free condition at this time. **NOTE: Portions of the roof are covered with snow and therefore cannot be thoroughly evaluated. A re-evaluation of this condition should be performed when conditions permit.**

roof is in leak-free condition

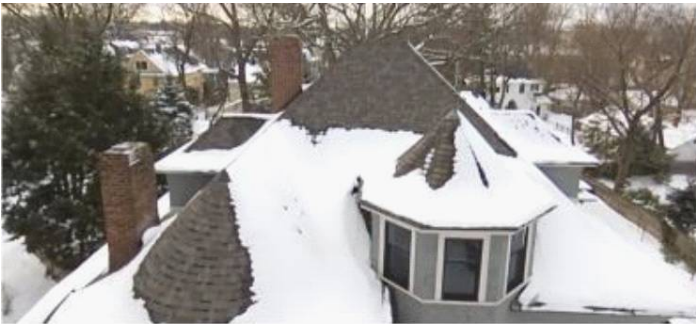
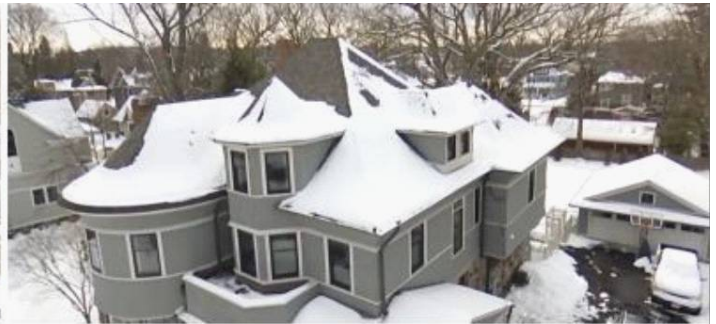
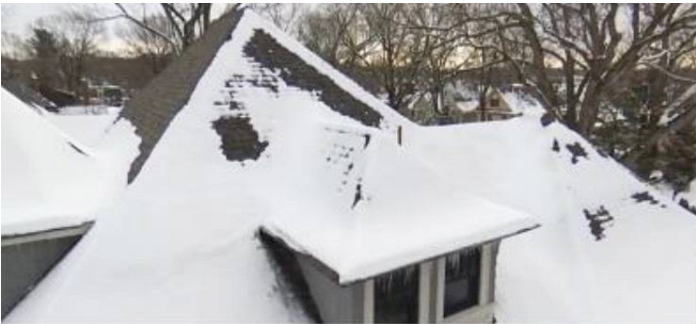
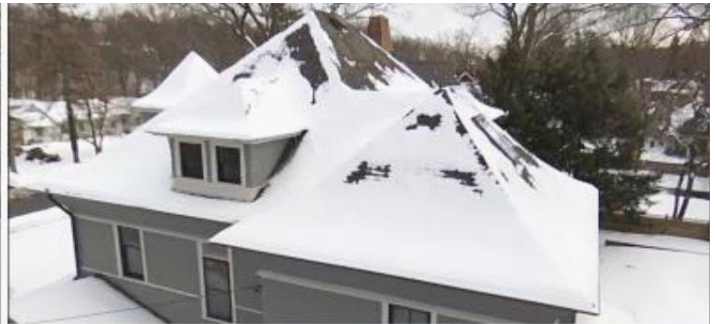
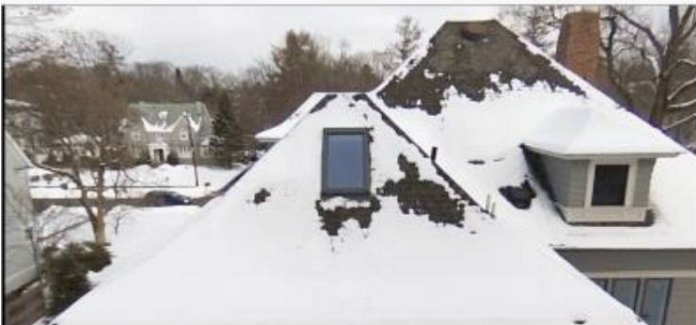
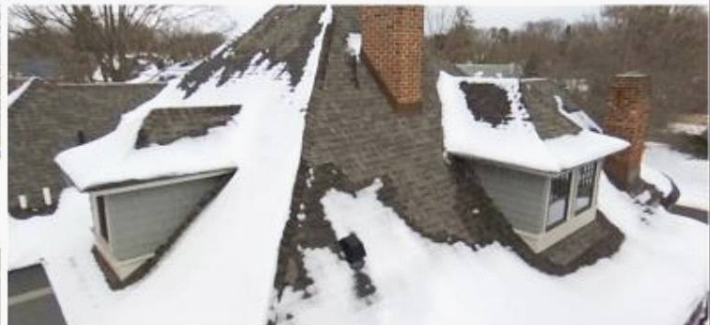
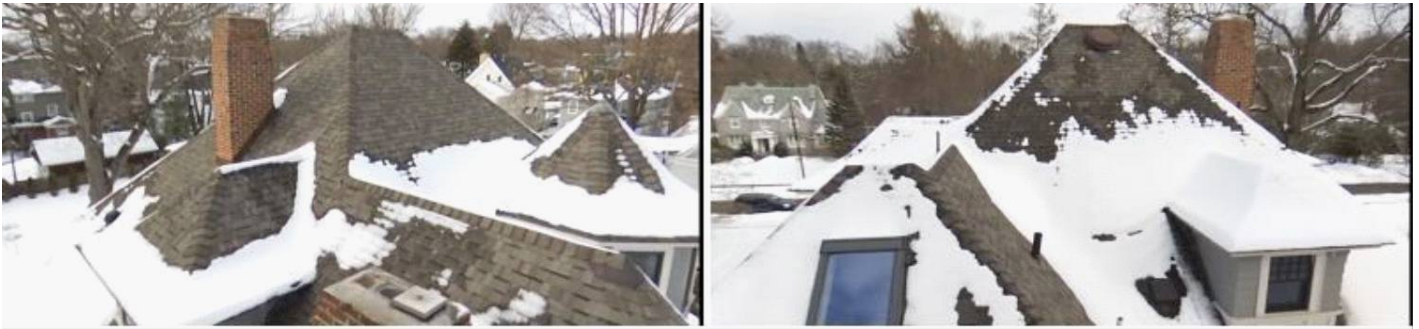
Roof view (snow prevented full evaluation)

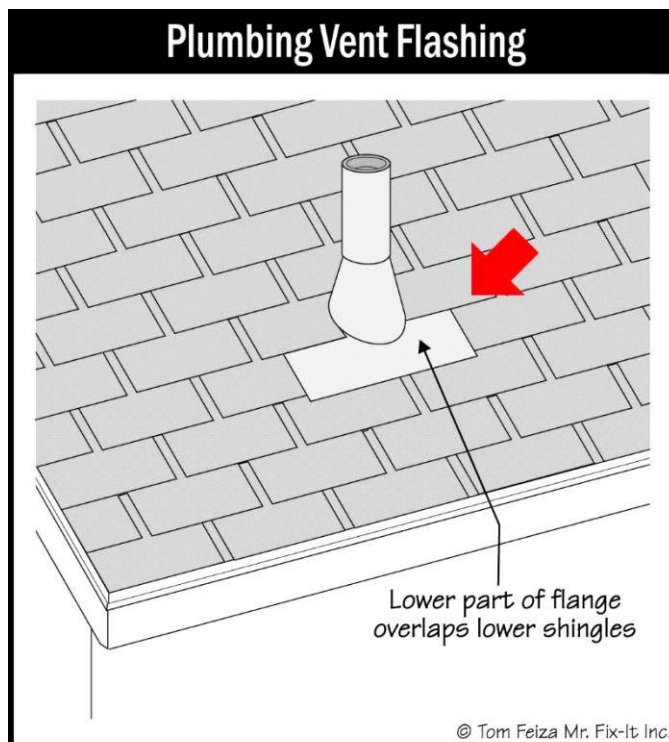
The plumbing vent flashings, where visible at the rear, and/or air venting flanges were observed. These flashings seal the seams around the roof penetrations to insure that water does not seep through the roof during rainfall/snow. These are common sources of leakage and maintaining these penetrations is important. These roof penetrations appear satisfactory at this time.

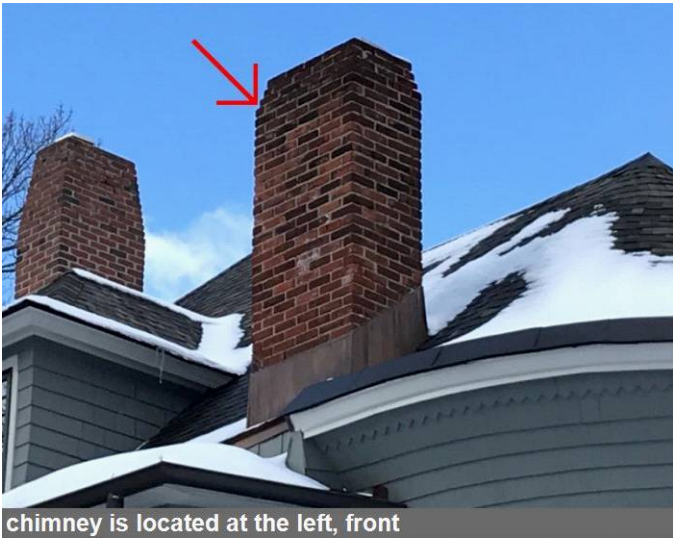
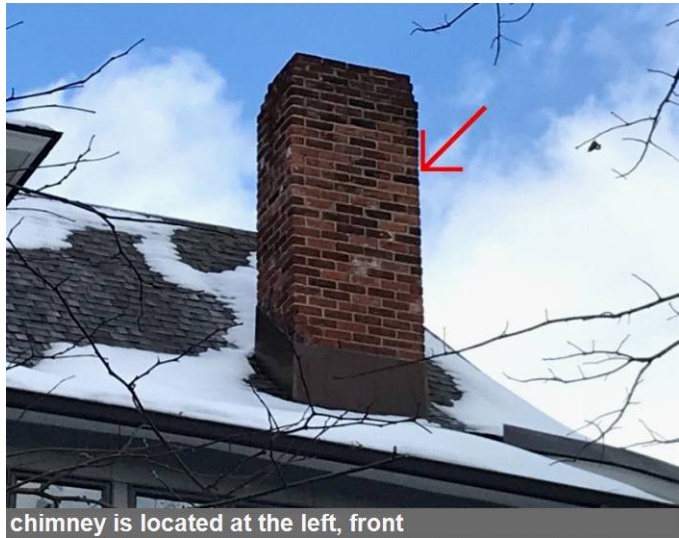
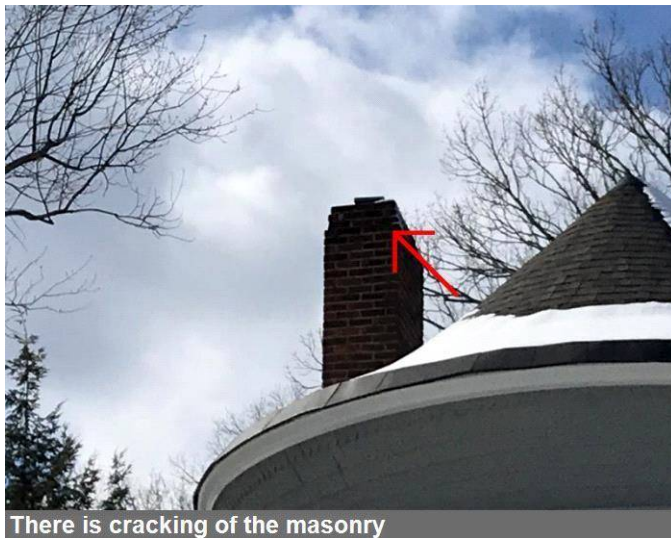
4.9 CHIMNEY CONDITION:

The masonry chimney is in some aspects, unsatisfactory condition (material defect). There is cracking of the masonry structure (see, upper, front).

The masonry chimney is in some aspects, unsatisfactory condition (material defect). Deficiencies include, but may not be limited to the following: There is cracking of the masonry structure (see, upper, front). Cracks could also be present inside the structure, which could represent a fire condition. (See the below photographs) The cracks could be a source of water leakage through the structure. This is common above the roof line where the materials are exposed to severe weather. Nonetheless, repair is recommended. The chimney flue that carries the exhaust out of the home may be inadequately sized. The significance of this condition is; The configuration could allow toxic exhaust to spill into the living spaces, which creates an unsafe condition. A licensed contractor should be contacted to calculate the flue

capability and to make repairs as necessary.

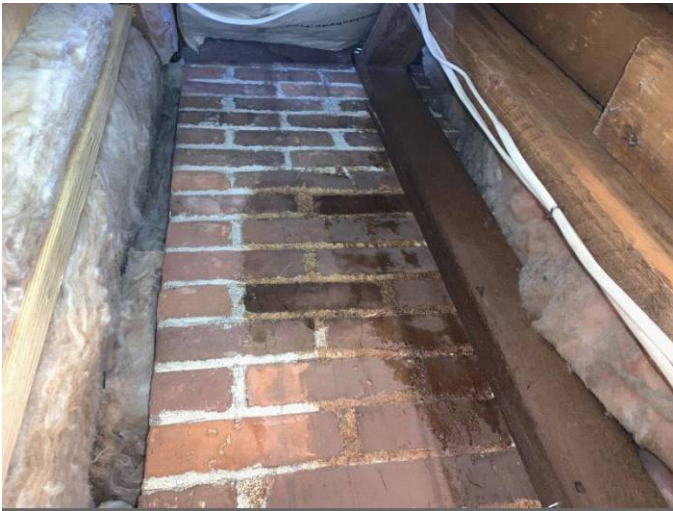
NOTE: There is suspected carbon staining of the portion of the chimney that is visible from the interior. (See the below photograph), The significance of this condition is; this could indicate the use of oil-heating system in the past. Oil heating systems frequently used buried oil tanks. Abandoned, buried oil tanks represent a possible environmental hazard. A competent contractor should be contacted to more thoroughly evaluate this "material defect"/condition and to perform repairs as necessary.

possible carbon staining

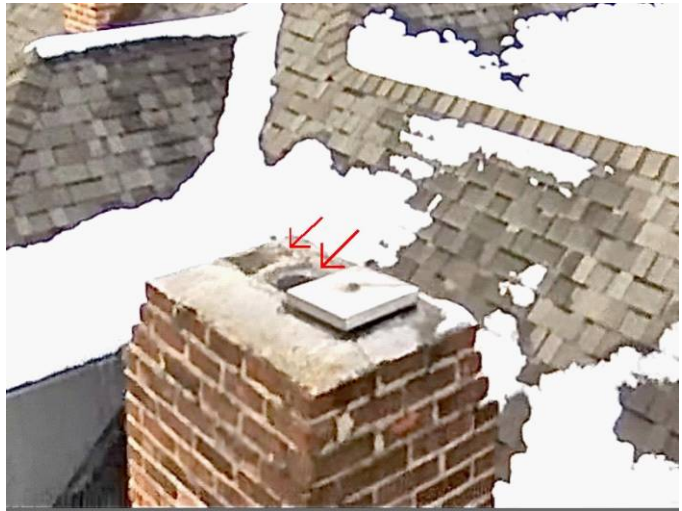
A chimney cap is NOT installed. This allows water into the chimney system and can accelerate deterioration of components. The chimney serves the boiler, the fireplace, and the water heater.

chimney caps are NOT installed

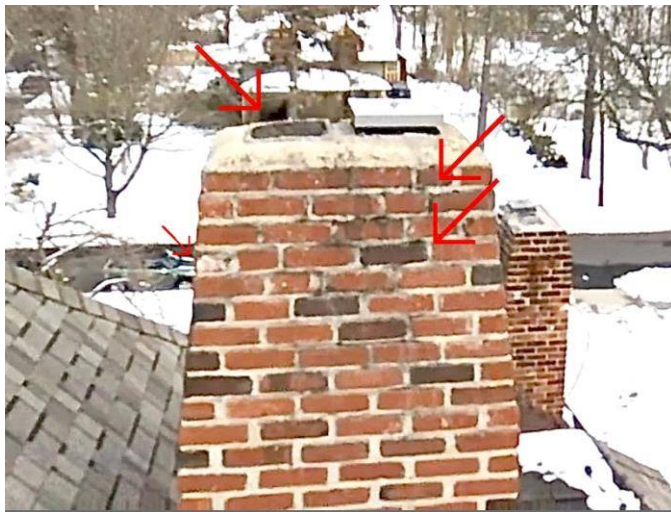
4.13 CHIMNEY CONDITION:

spalling | cracking masonry | Missing cap

The masonry chimney is in some aspects, unsatisfactory condition (material defect). Deficiencies include, but may not be limited to the following: There is some spalling (cracking) of the bricks, particularly above the roof line. This occurs when the brick absorb water during rain or snow. The moisture freezes and chips small pieces of the bricks away. This creates even more area to absorb moisture and eventually the need for repair.

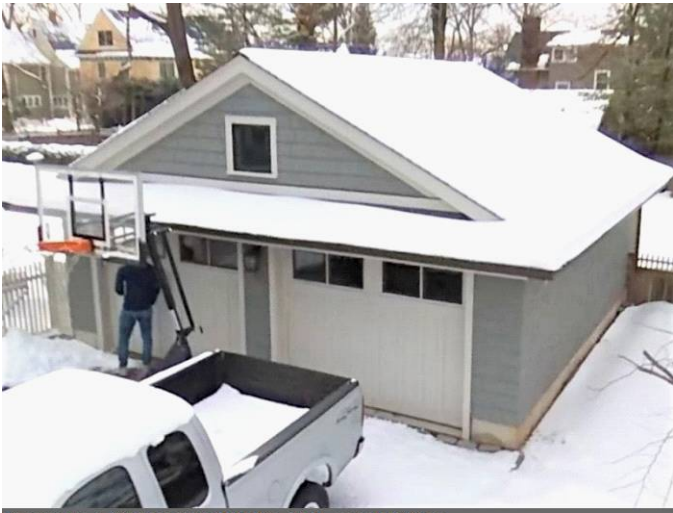
In general, the garage is in some aspects, unsatisfactory condition. Deficiencies include, but are not necessarily limited to the following: There is rot of the edge of the roof system due to roof leakage or leakage from the gutter/drains. (See the adjacent/below photographs). The garage attic area also appears to be satisfactory. There is however a significant amount of storage in this area which does limit the inspectors ability to see and access the whole space. Reevaluate when conditions permit.

Garage | Snow prohibits full evaluation

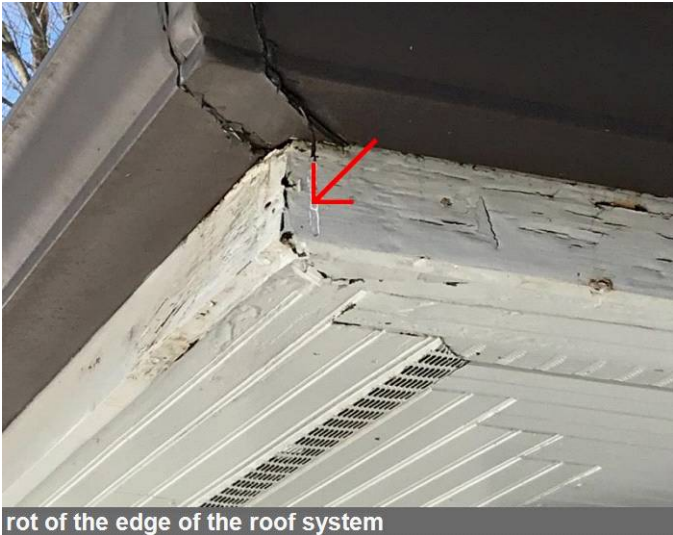
rot of the edge of the roof system

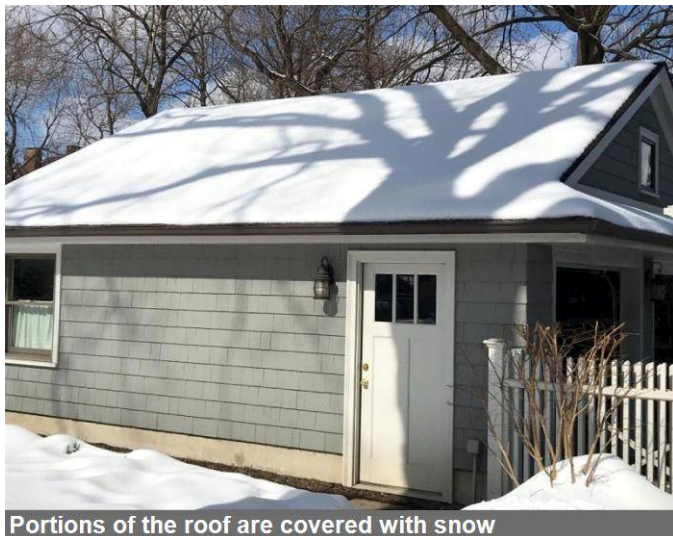
Portions of the roof are covered with snow

NOTE: Portions of the roof are covered with snow and therefore cannot be thoroughly evaluated. (see the adjacent photograph) A re-evaluation of this condition should be performed when conditions permit.

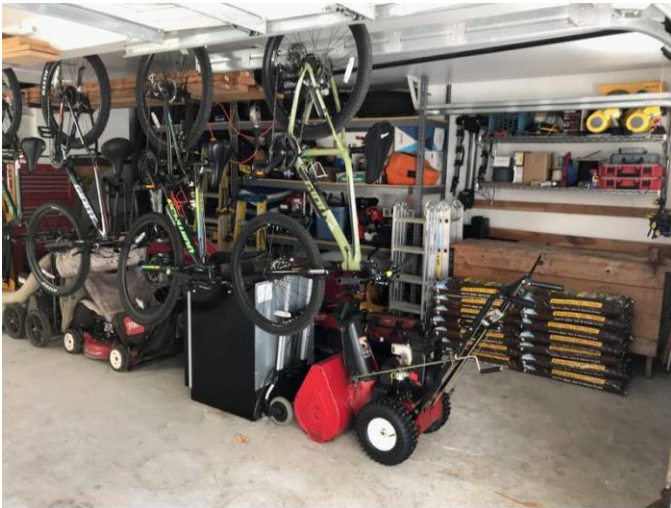
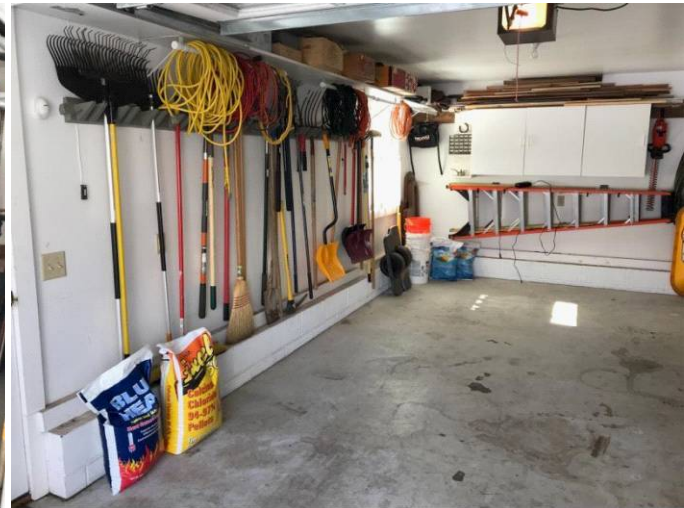
The concrete floor appears to be in satisfactory condition. No cracks of significance were noted. Floor was not fully visible due to stored items. (See the below photographs)

not fully visible due to stored items.

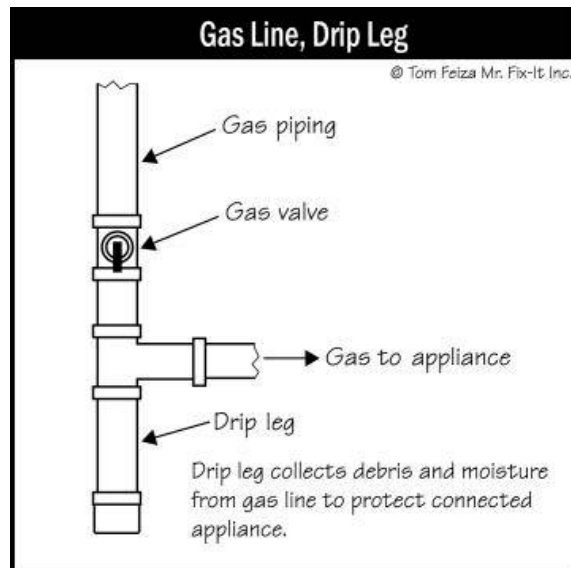
P043

The gas line is installed without a "drip" leg. This important configuration is used to alleviate potential for dust and debris from entering the appliance where it can create an obstruction to the gas valve. If this occurred, the appliance may not be able to shut down properly. This could be a fire concern.

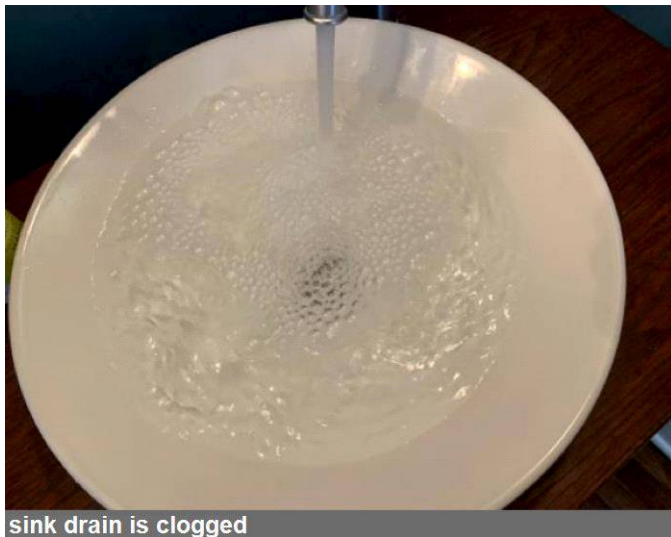
The faucet, sink and drain lines are in need of maintenance. Deficiencies include, but may not be limited to; The sink drain is clogged, which limits the use of the fixture. Maintenance/repair is recommended.

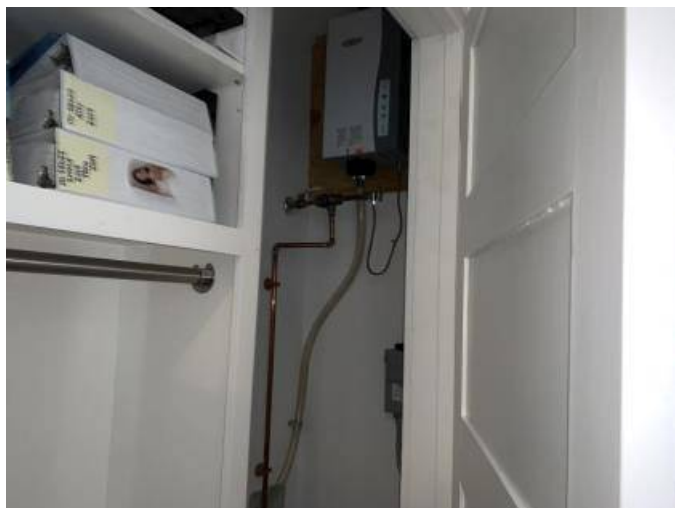
The steam generator is inoperable. An evaluation of this component is beyond the scope of the Home Inspection. Contact a specialist in this regard to evaluate the component/condition prior to closing.

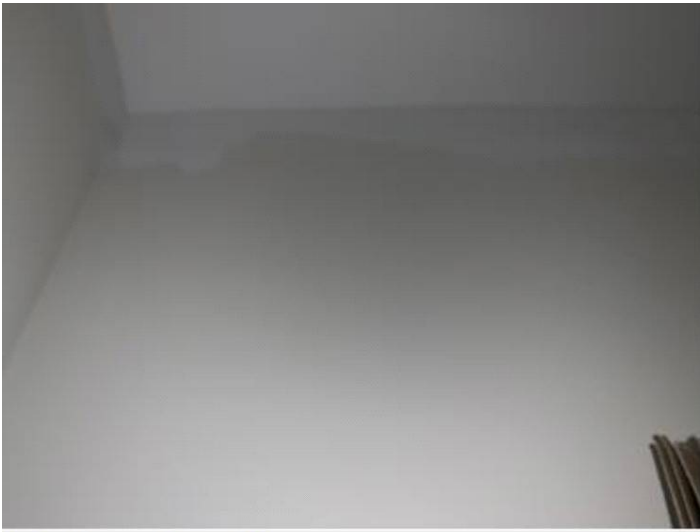
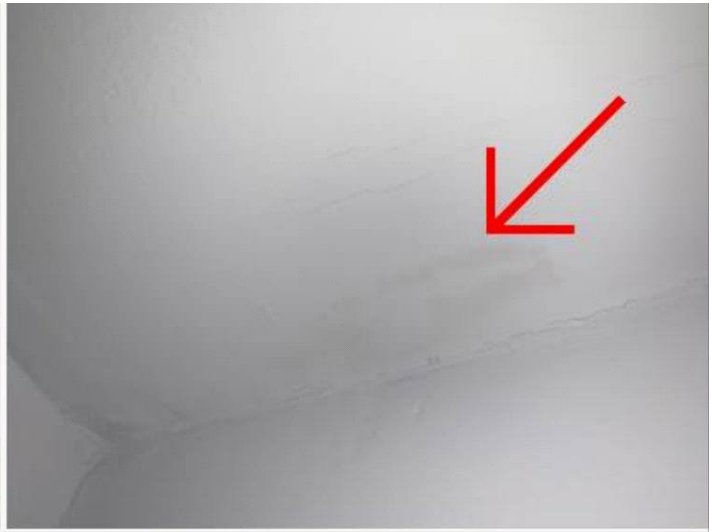
There is staining consistent with leakage due to roof leaks, plumbing leaks or condensation. Have the sources of the leaks identified, repaired and the areas re-finished as necessary. These areas were checked with a moisture meter and found to be WET at the time of inspection. There are ceiling/wall surfaces that may have been damaged from prior leaks. These areas have not been completely or properly repaired/finished. Additional finishing will be necessary to restore these areas. The condition indicates the need for maintenance. The complexity and the cost of this work is un-determined.

Discoloration | H2O stains

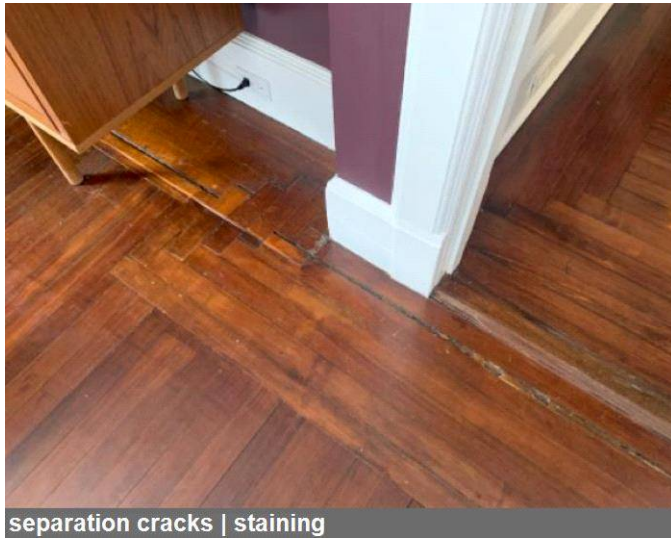
The floor system has noticeable low points commonly encountered in older homes. This is likely related to settling or deflection of the home's structural framing over time. There are also relative high points. The high points are possibly located over "strong" points in the structure. As the framing deflects over time, these "strong" points do not deflect or bend due to their relatively high load bearing capability. The two conditions conspire to make the unevenness more noticeable. Generally, no corrective actions are undertaken because straightening the floors is somewhat impractical, expensive, and there is no significant structural impact in most situations. Most people simply live with this condition and monitor the home's structural framing for changes that would indicate a serious concern. There are floor pops at the

second floor of the house. This is where the sub-floor material is improperly secured to the joists. These areas should be re-secured. There is water damage to the flooring. Sometimes stains can be sanded over, but this cannot be confirmed. Have a floor contractor check the floors and obtain estimates for re-conditioning the floors.

There are scratches/stains in the floor surfaces. Repair of the floor surfaces is recommended.

Normal wood floor joint separation cracks were observed. The condition is sometimes due to exposure to moisture/water and/or inadequate venting. The condition is also sometimes attributed to normal wear and tear. Have the floors re-finished as necessary.

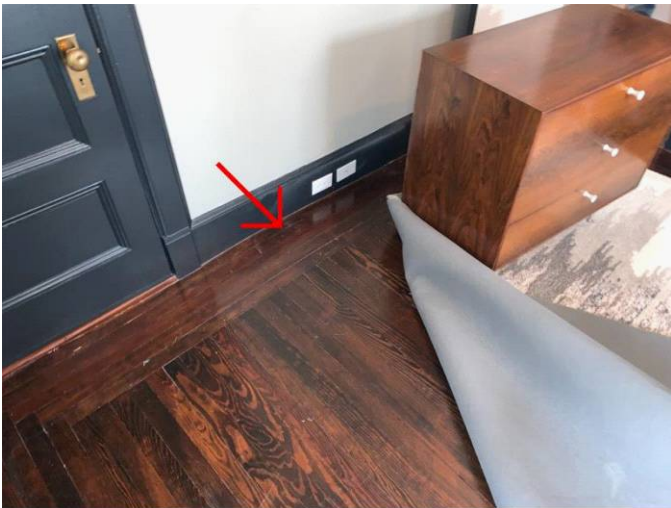
floor pops at the second floor

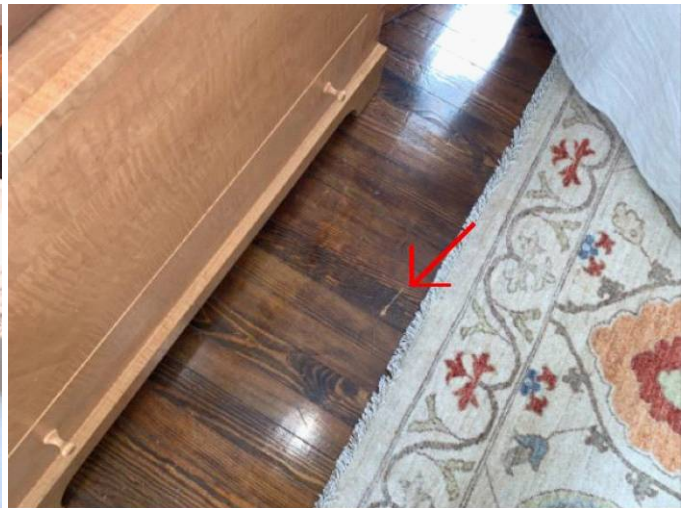
Scratched/damaged floor surface

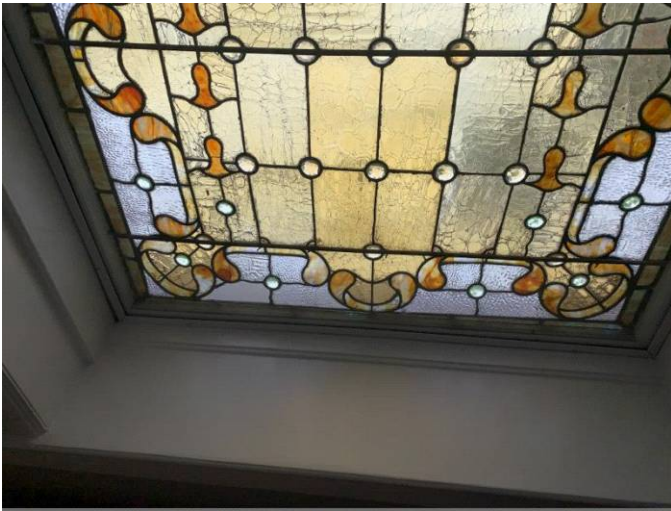
Some of the window units are damaged/broken beyond normal wear and tear. The significance of this condition is: This could adversely affect function of the component; in addition, further damage of the window/unit could result. Repair/replacement is recommended.

window units are damaged/broken

A competent contractor should be consulted to more thoroughly evaluate the condition of the windows and to perform repairs as are necessary.

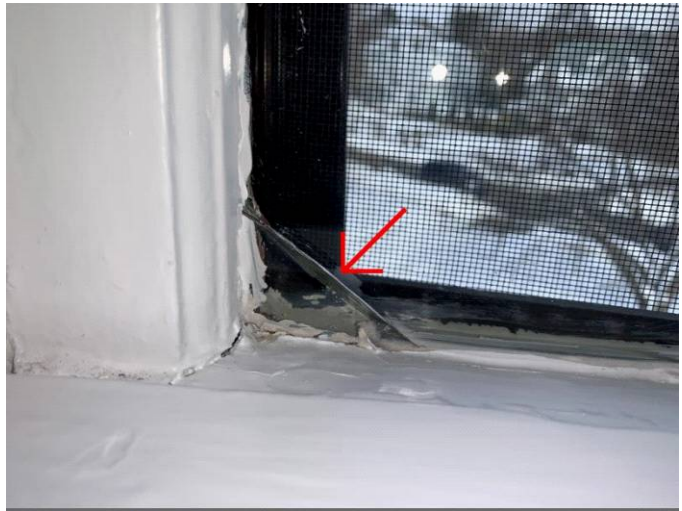
Cracked window glass

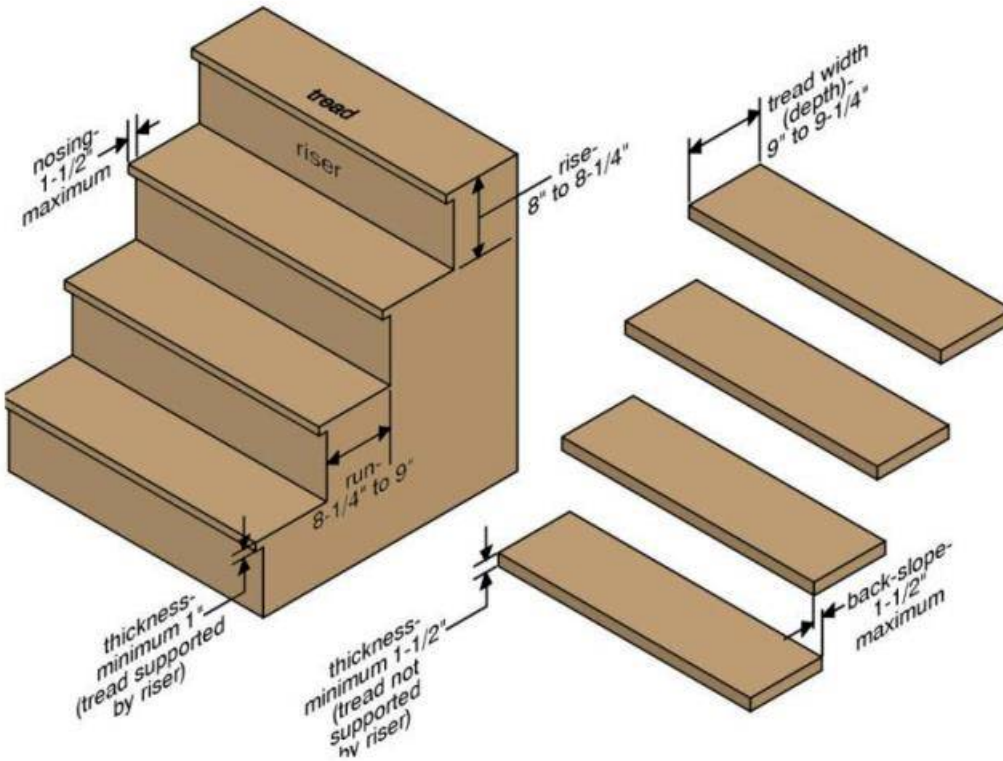
The basement, main floor, and 3rd floor stairs are in some aspects, unsatisfactory condition. Defects include, but are not necessarily limited to the following; The dimensions of the stairs and risers are uneven. This configuration would not comply with modern building standards. This creates a potential tripping condition. Repair/modification is difficult and possibly expensive. Components of the stairs are sagging with loose treads and risers indicating possible problem underneath.

Have the support structure repaired for improved safety. Components of the stairs are squeaky with loose treads and risers indicating possible problem underneath. The condition is quite common in older homes, but should be checked and repaired as necessary. Railings adjacent steps are primarily for safety. In general, railings should extend the full length of the steps, have no gaps greater than 4" and extend to a minimum height of 36". The railings are in some aspects, unsatisfactory condition. Defects include, but are not necessarily limited to the following; The railing is too short. Current standards are for the railing to be at least 36" high.

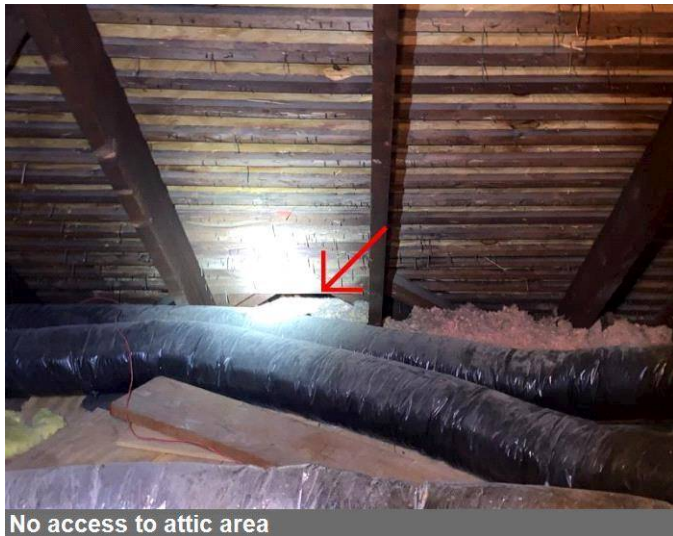
No access to attic area

NOTE: There is no access provided to an attic area. As a result of limited/restricted attic access, the inspector was not able to view the structure, insulation, mechanical, or venting components in these areas. In addition to these items, the inspector was not able to verify the presence of current or past roof leaks or any resulting damage. Consideration should be given to having an access provided so that a proper evaluation of the area can be performed prior to closing.

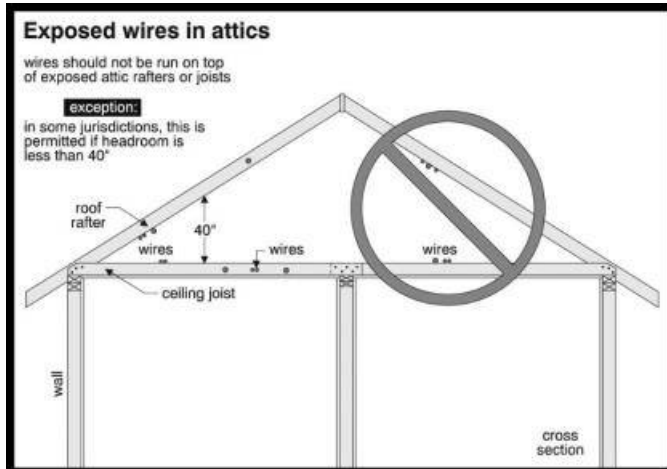
Deficiencies include, but may not be limited to the following; there are open "J" boxes in the attic area. proper covers should be installed. Some electric conductors are simply laying on the ceiling beams (attic floor joists). This configuration could result in damage to the conductors and possible injury when people traverse the attic space. This configuration would not comply with modern building standards. A competent contractor should be consulted to more thoroughly evaluate the condition and to perform repairs as are necessary. NOTE: The attic insulation prevented the viewing of much of the attic electrical. Did Not Evaluate concealed components.

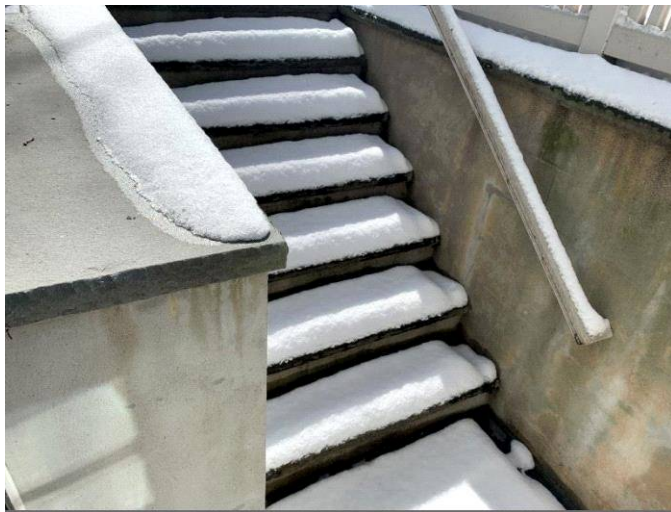
Exterior Stairwell

be reinspected when conditions permit. The use of a de-humidifier in the basement will help control humidity and reduce the opportunity for mold and mildew growth. The exterior masonry stairwell appears to be serviceable. There are indications of water leakage through the side walls. This is indicated by water staining. The drain appears to be functional. Periodic cleaning should be anticipated. Failure to maintain the drain could result in flooding of the interior.

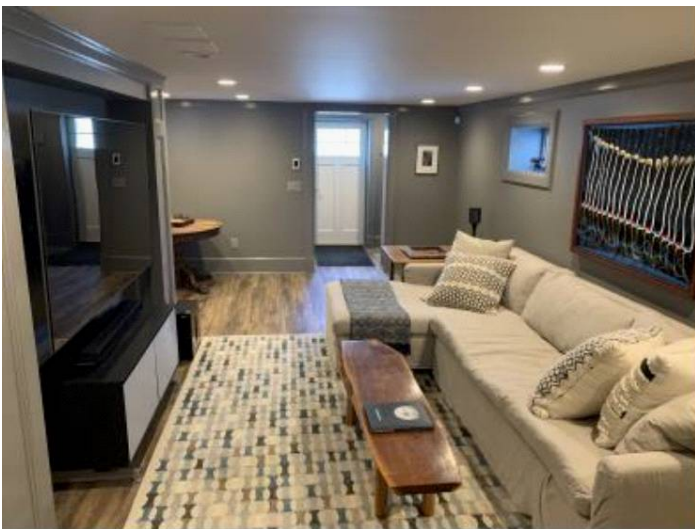
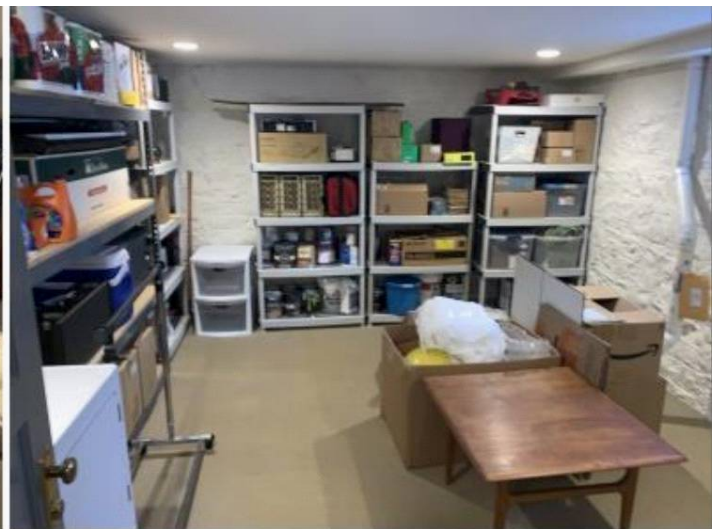
Finished areas of the basement prevent complete inspection of the structural framing and foundation walls. Those areas which could not be viewed were not evaluated. Due to the finished floors, walls and/or ceilings in the lower level of this structure, there is extremely limited to no accessibility to the wood framing for inspection. Many buildings have hidden wood destroying insect infestation/damage that a competently performed wood destroying inspection may not detect under these conditions. Have a licensed pest control company implement a preventative maintenance program to prevent future infestation. There is a large amount of personal property presently being stored in the basement and, for this reason, some sections of this area cannot be thoroughly viewed or evaluated. These areas should

Finished areas prevented full evaluation
