HOME INSPECTION REPORT

Prepared by Kyle Kaufmann

KAUFMANN CONSULTANTS, LLC

INSPECTION LOCATION

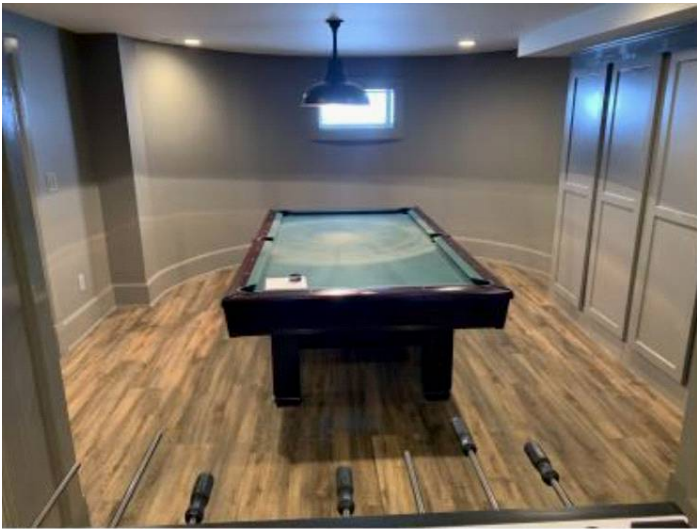
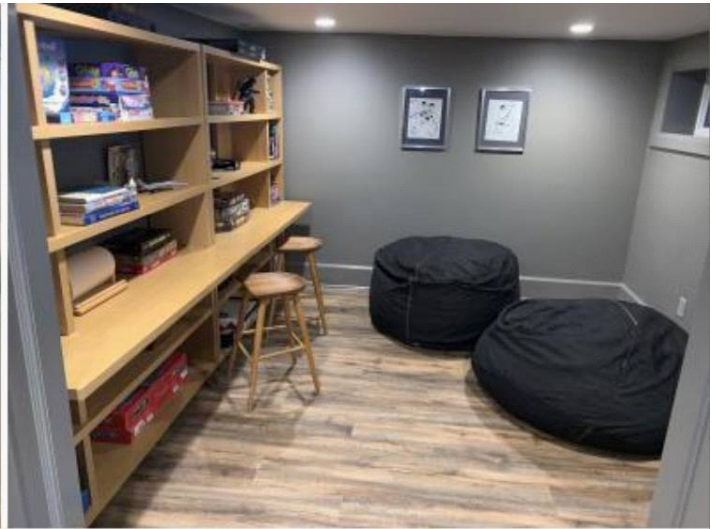
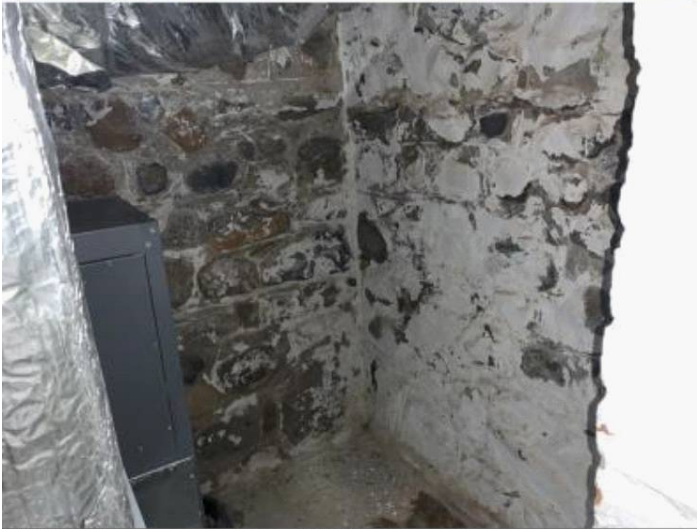
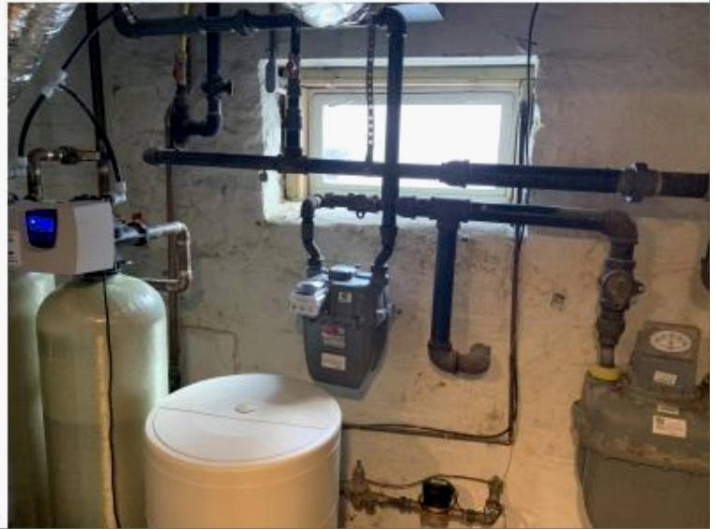
Finished areas/storage prohibits full view

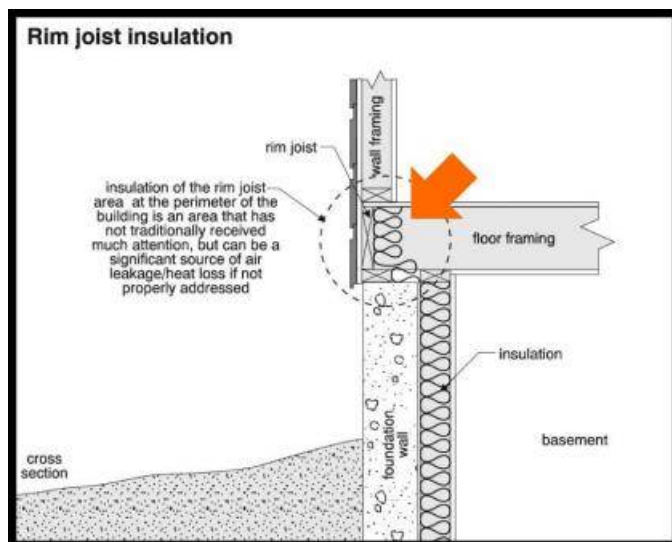
The perimeter of the basement area is insulated along the box beam area, which is consistent with building standards in this region. This is beneficial. The insulation does restrict the inspectors' ability to view the adjacent structural framing that is concealed by the insulation. Some of the perimeter insulation has been removed to install telephone, cable and electric cables. The insulation should be re-installed for improved thermal efficiency.

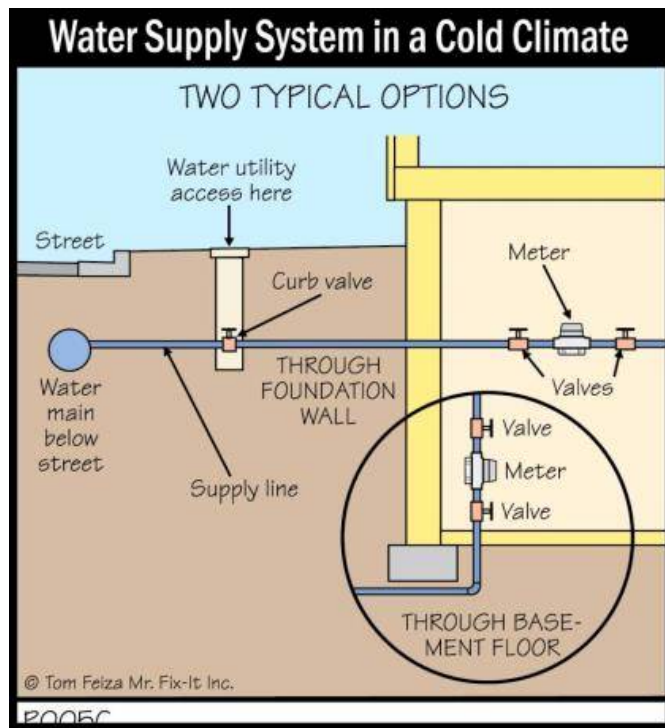
The predominant water main piping viewed was: copper, The exposed main line was approximately, 3/4" diameter pipe, which is a common size pipe. Deficiencies include, but may not be limited to the following: **There are un-insulated water pipes that could freeze, which can cause water and mold damage.** Recommend installing insulation on all water piping vulnerable to freezing conditions. The condition indicates the need for maintenance. The complexity and the cost of this work is un-determined.

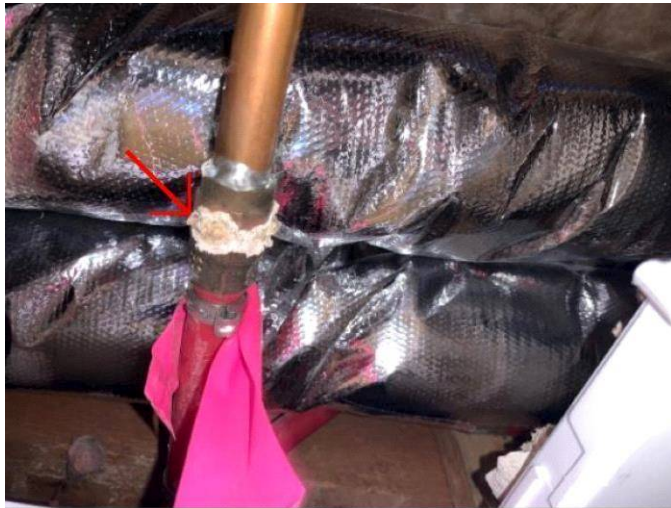
"pinhole" leakage from piping/fittings

Deficiencies include, but may not be limited to the following: There is "pinhole" leakage from some of the piping. (see the adjacent photograph) These pipes should be replaced. There are old corroded isolation valves/pipes. These are leak-free at this time, but may leak when operated. Eventual replacement should be anticipated. There are also missing isolation valve handles. The significance of this condition is; The valves cannot be used without handles. Replacement is recommended. There are un-insulated water pipes, which could freeze during cold weather. Freezing pipes can burst and leak. Install insulation on exposed

water pipes to alleviate this condition. The PEX water piping is loose. The significance of this condition is; This could result in leakage. leaks can cause rot/mold. A licensed plumbing contractor should be contacted to more thoroughly evaluate these "material defects"/conditions and to perform repairs as necessary.

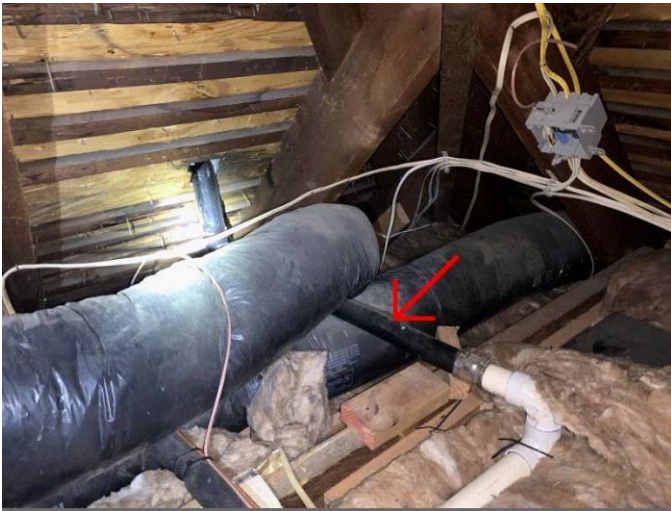
The plumbing system includes; PVC, ABS (plastic), lead, galvanized, and iron piping. The waste piping appears to be in some aspects, unsatisfactory condition. Deficiencies include, but may not be limited to the following: There are back-pitched vent pipes in the attic. This can block venting of sewer gases and result in leakage. There are pin hole (small) leaks that have developed in the waste piping. Vent pipes terminate too close to a bedroom window. (See the above photograph) The condition may allow sewer gases to enter the living spaces. This configuration would not comply with modern building standards. A licensed plumbing contractor should be contacted to more thoroughly evaluate these "material defects"/conditions and to perform repairs as necessary.

Back pitched vent pipe in attic area

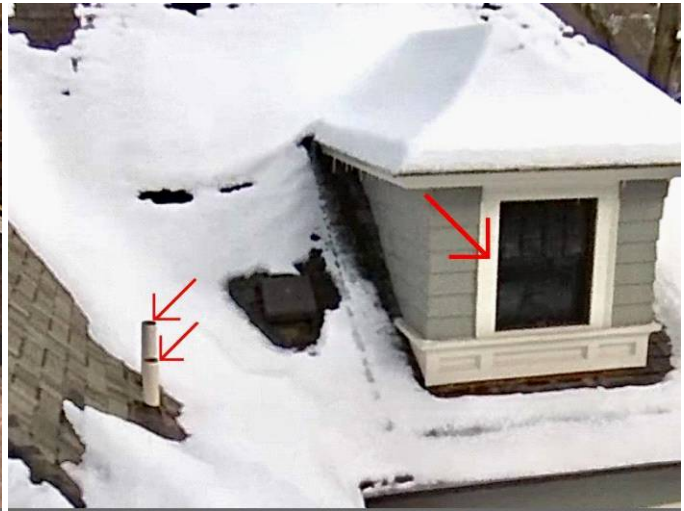
terminates too close to a bedroom window

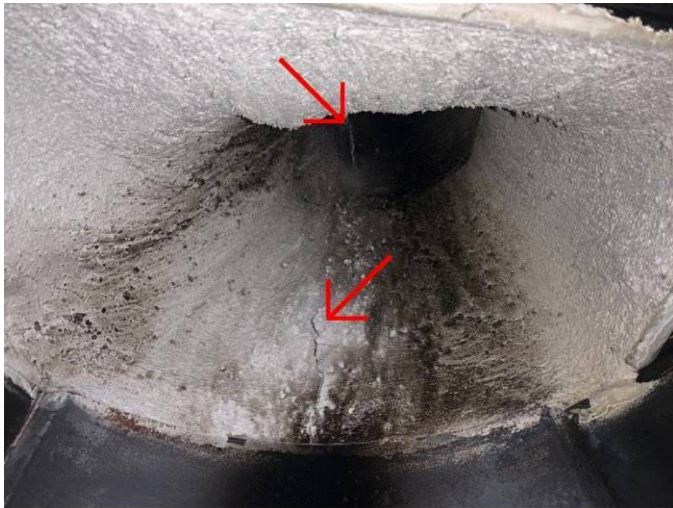
should be addressed for safe operation of the fireplace. **There is cracking masonry at the interior of the flue** (See the below photograph/s). There is cracking of the hearth/firebox seam. This crack should be repaired to alleviate the potential for a fire condition. A certified/licensed "chimney sweep"/contractor should be consulted to more thoroughly evaluate the conditions and to perform repairs as are necessary.

view of flue liner/smoke-chamber (cracked)

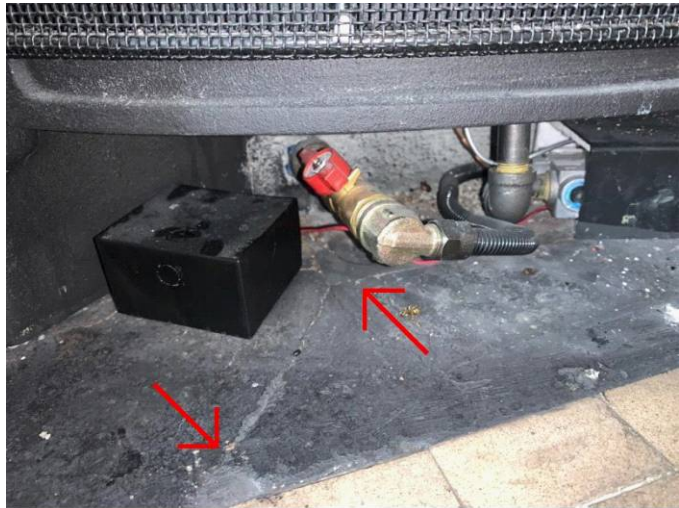
cracking of the hearth/firebox

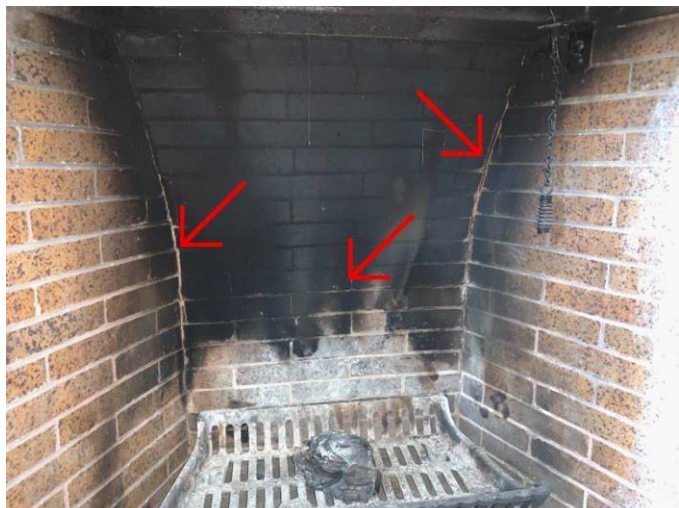
cracking masonry

The fireplace is in some aspects, unsatisfactory condition. Deficiencies include, but are not limited to the following; There are signs of water leakage into the fireplace. The source is from the upper chimney area and is not located with certainty. Have the interior of the chimney checked for the source of the leakage. The smoke chamber and flue are dirty and should be cleaned. The soot accumulation prevents the inspector from seeing the lower sections of the flue and chimney clearly. There is cracking of the mortar from between the firebricks and cracking of the bricks in the firebox area. This is a reflection of normal wear and tear, but should be addressed for safe operation of the fireplace. There is a crack/gap between the firebox and the wall. The significance of this condition is; heat from operating the fireplace could enter this space and cause fire problem. **Repairs are needed to restore the integrity to the unit. It is recommended that a Chimney Sweep further evaluate and determine the extent of needed repairs.**

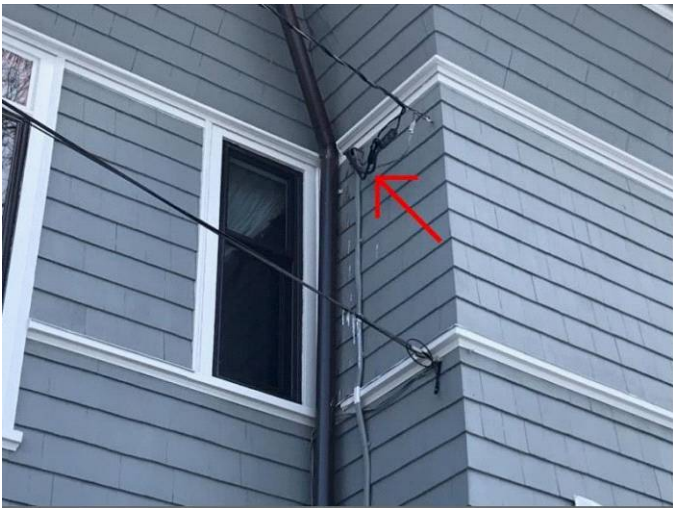
The service drop and entrance wires are in adequate, but in some aspects, unsatisfactory condition. Deficiencies include, but are not necessarily limited to the following; The drop is too close to the adjacent window (laundry). This configuration would not comply with modern building standards. There are safety concerns regarding this installation. Have the electric company and a licensed electrician check and repair as necessary. If no corrections are deemed necessary by these professionals, have their comments documented prior to closing. A licensed electrical contractor should be consulted to more thoroughly evaluate the condition and to perform repairs as are necessary.

Too close to window | HAZARD

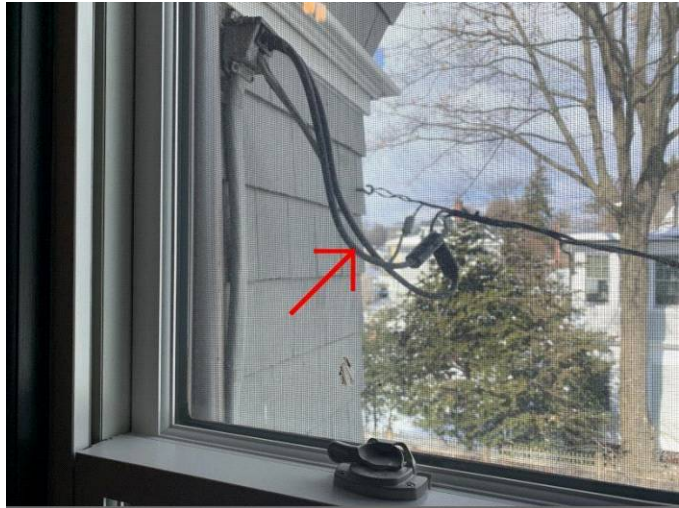
Too close to window | HAZARD

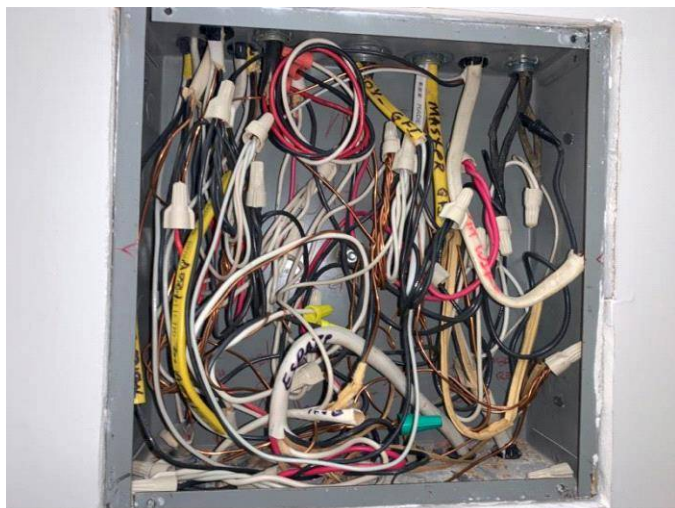
"pig tail" connections inside the panel

There are some incorrectly installed or malfunctioning electric components, which represents a "material defect". These defects should be repaired. The significance of this condition is; reduced reliability, reduced efficiency and, under extreme conditions, a possible shock hazard or fire concern. All defective electric defects should be further evaluated/repared by a licensed electrician for improved reliability and safety. Deficiencies include, but may not be limited to the following:

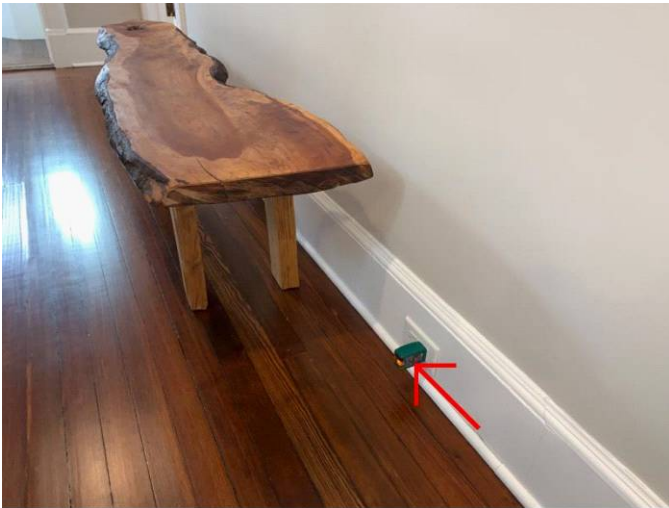
Ungrounded outlet/s detected

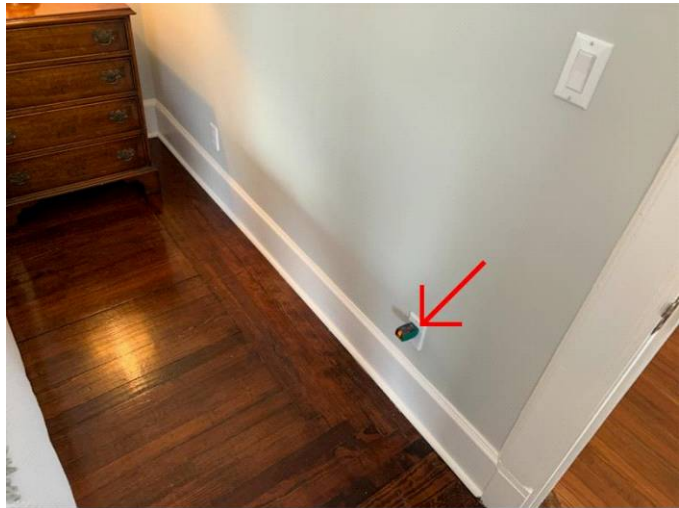
Ungrounded outlet/s detected

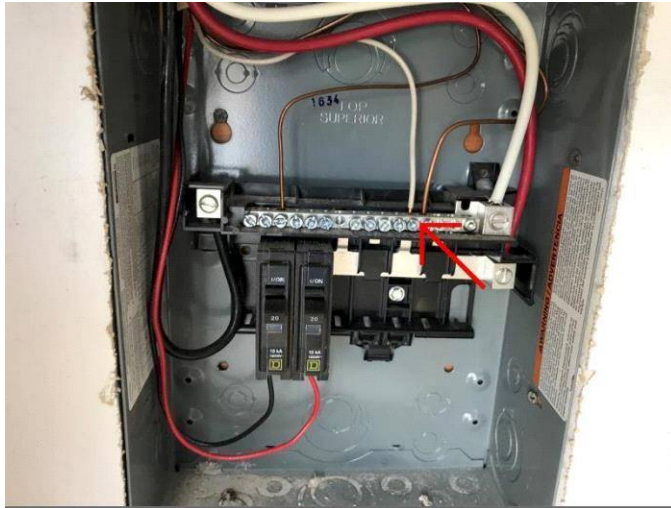
Improper wiring in panel | HAZARD

The wiring methods inside the electric sub panel are in need of maintenance/repair. There are common/grounded conductors (normally white in color) and ground conductors (normally bare wires) on the same bus in the sub panel. This configuration would not comply with modern building standards and is potentially hazardous. It is also recommended that a licensed electrician inspect the impassively of the conductors. It is suspected that there are oversize breakers at this location. It is recommended that a licensed electrician further evaluate the panel and repair as needed.

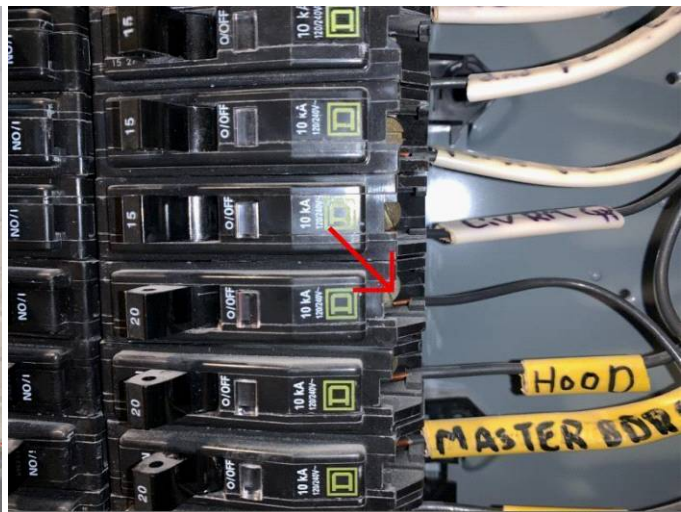
The wiring methods inside the sub panel are in need of maintenance/repair. Deficiencies include, but may not be limited to the following conditions; The over-current protection appears to be over-sized at some locations creating a potential electric hazard. It is recommended that a licensed electrician further evaluate the panel and repair as needed.

improperly sized over-current protection

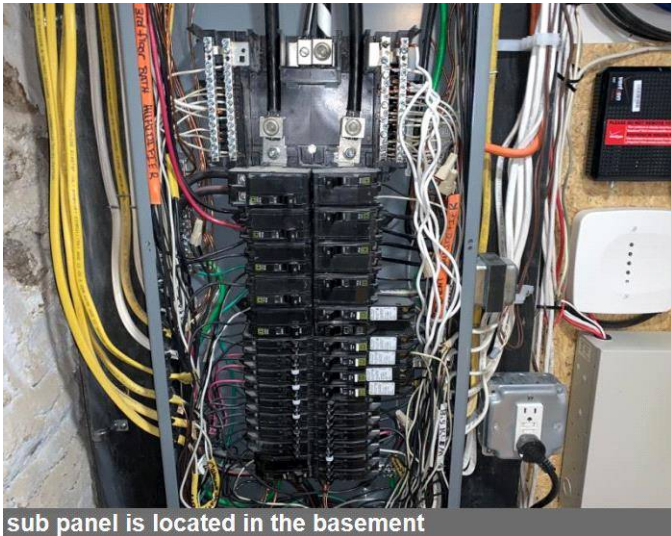
The wiring methods inside the sub panel are in need of maintenance/repair. There are "paired up" 120 volt breakers with a mechanical device. These connectors are considered unsafe due to probability of failure to function properly. Replacement with correct breakers is recommended. The sub panel appears to be over-loaded. Contact a qualified contractor to evaluate the condition(s) and to perform necessary repairs.
