## HOME INSPECTION REPORT

July 20, 2024

KAUFMANN CONSULTANTS, LLC

### REPORT SUMMARY

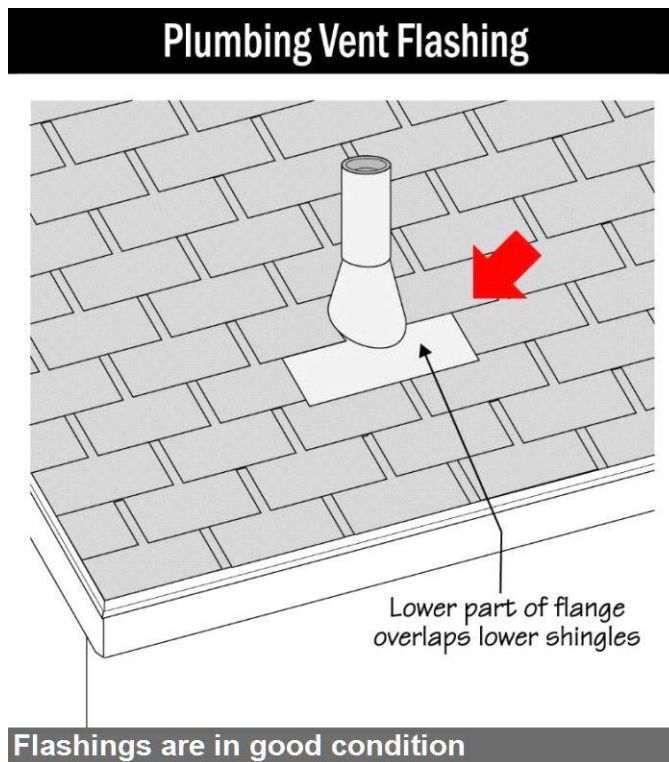
#### 4.7 ROOF PENETRATIONS CONDITION:

The plumbing vent flashings or air venting flanges were observed. These flashings seal the seams around the roof penetrations to insure that water does not seep through the roof during rainfall/snow. These are common sources of leakage and maintaining these penetrations is important. These roof penetrations appear satisfactory at this time.

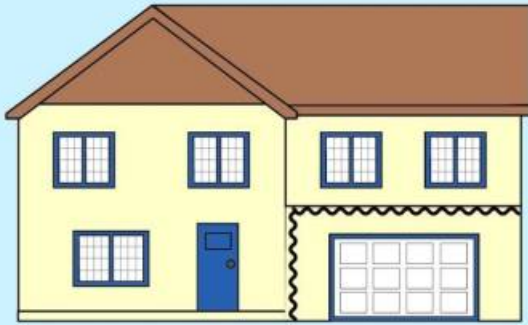
## Garage/Home Fire Resistance

The fire barrier/shield is in some aspects, unsatisfactory condition. There are holes/gaps through the fire shield/barrier wall and/or ceiling. It has been a long standing practice to create and maintain a one hour fire shield/barrier between the attached garages and the interior living spaces. It is common for holes to be cut through the fire shield/barrier over time to install utilities, etc. as part of up-dating a home. Nonetheless, these holes should be re-insulated and the drywall material and/or plaster restored. This should be considered part of long term maintenance. There is some water staining/damage due to leakage from above this space.

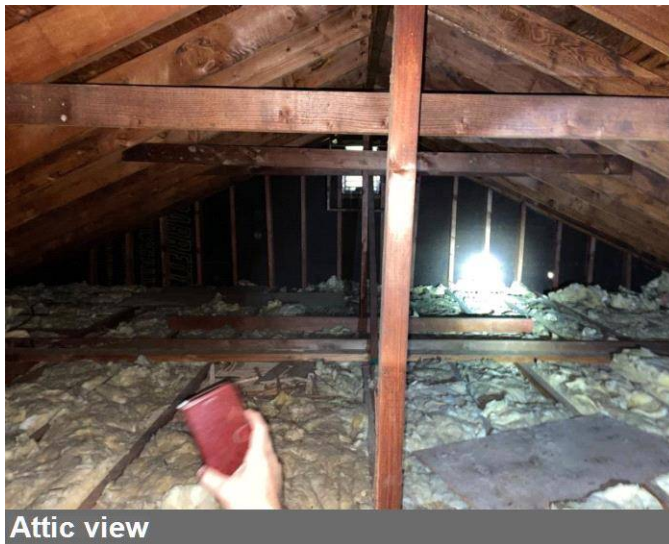
Attic view

The attic appears to be in some aspects, unsatisfactory condition. There is a cracked rafter, which should be repaired. The roof system framing includes 2X6@16OC (on center) This configuration is common in older homes and generally proves to be adequate, but would not comply with modern building standards.

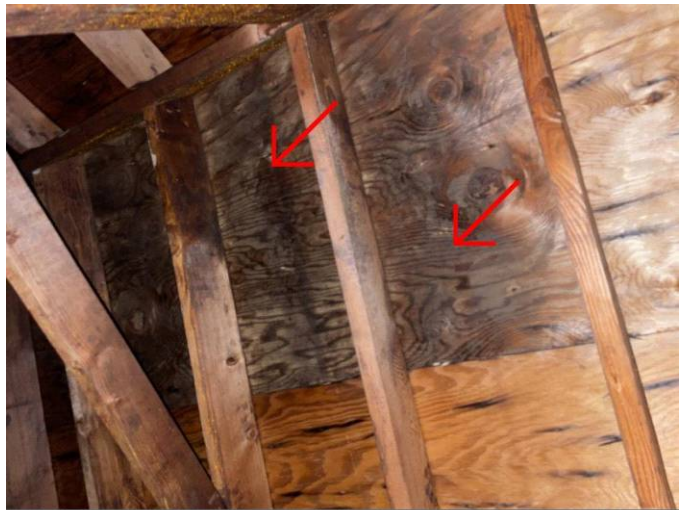
18. There is suspected mold forming on the underside of the roof at the nails. Lack of cool-air venting allows for condensation to form on the nails. This stains the roof decking. There is suspected mold forming in the attic space.

suspected mold forming

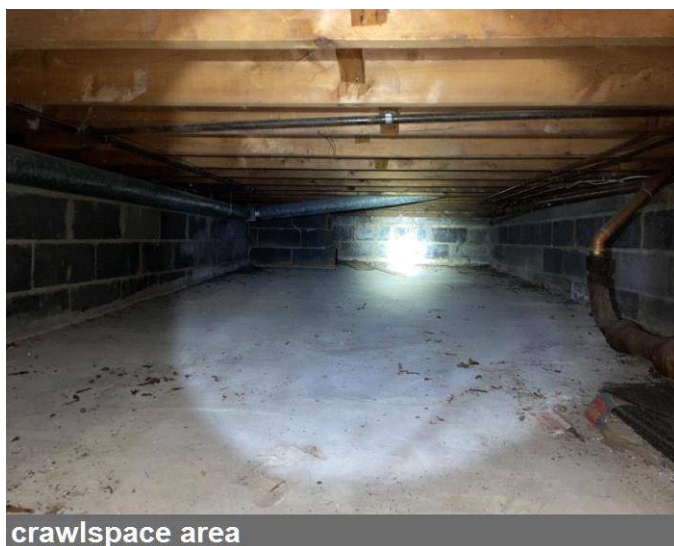
Viewed the left crawlspace area from the entry hatch with a high powered light. Improve access to the space so that a thorough inspection can be completed prior to the end of the inspection contingency period.

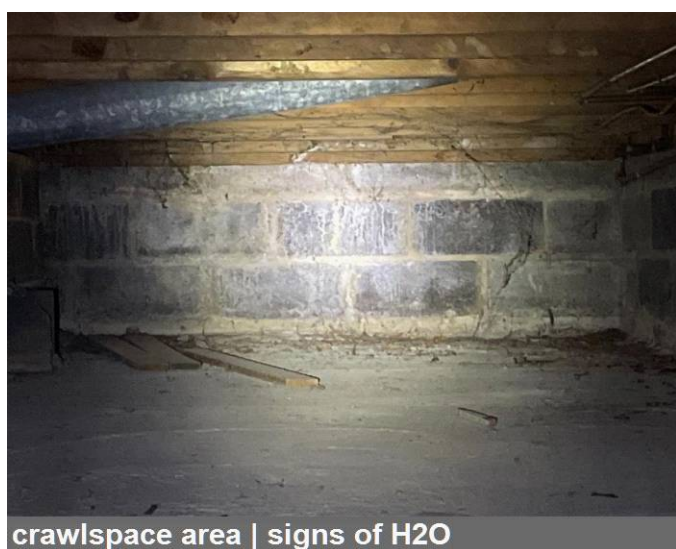
19. At this time, there are indications of water leakage through the foundation walls into the crawlspace areas. Weather conditions may increase frequency and intensity of leakage. Additionally, water leaks may result in mold forming. Indications are in the form of water stains on the floor/walls as well as efflorescence on the interior wall surfaces. It is recommended that a water-proofing contractor be contacted to evaluate the condition and to ascertain what corrective measures are appropriate/necessary.

crawlspace area | signs of H2O

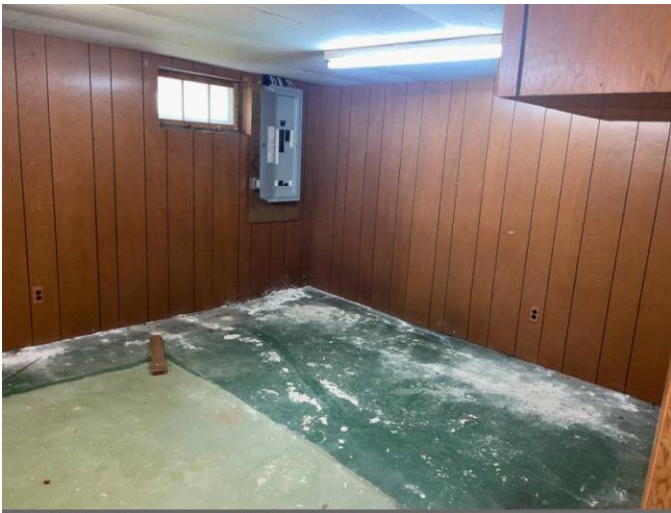
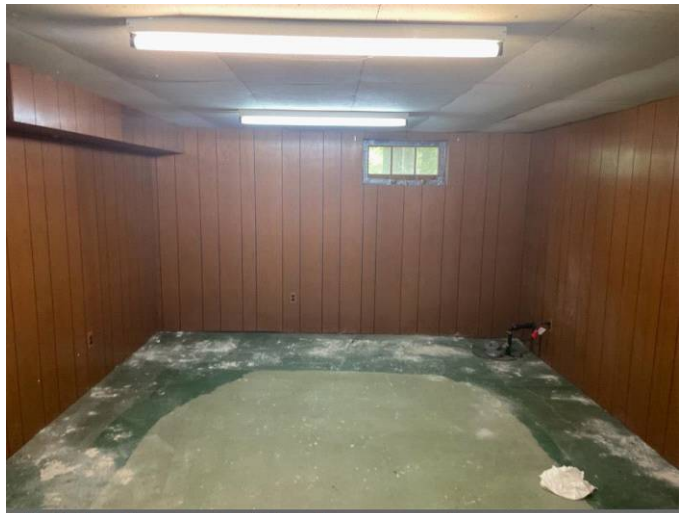
Finished areas of the basement prevent complete inspection of the structural framing and foundation walls. Those areas which could not be viewed were not evaluated. Due to the finished floors, walls and/or ceilings in the lower level of this structure, there is extremely limited to no accessibility to the wood framing for inspection. Many buildings have hidden wood destroying insect infestation/damage that a competently performed wood destroying inspection may not detect under these conditions. Have a licensed pest control company implement a preventative maintenance program to prevent future infestation. The use of a de-humidifier in the basement will help control humidity and reduce the opportunity for mold and mildew growth.

**Finished areas of the basement**

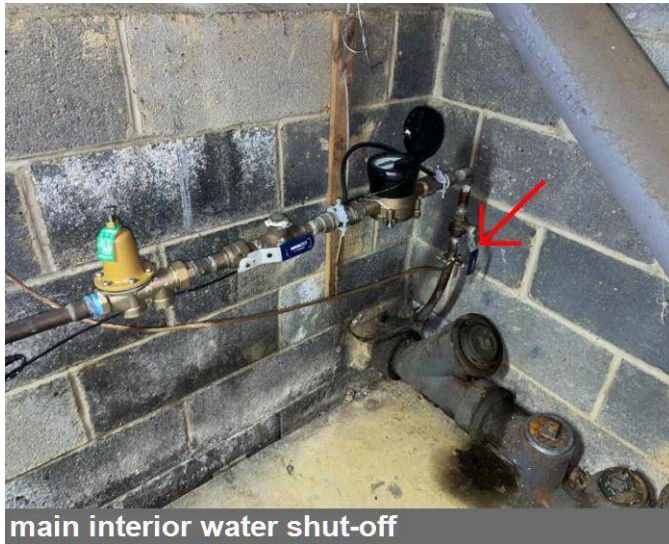
### 13.3 MAIN WATER SUPPLY SHUT-OFF LOCATION:

The main interior water shut-off location is inside the front foundation wall. The operation valve handle cannot be checked. These handles have a tendency to leak when operated. This is partially due to infrequent use. The shut off valve (see adjacent photograph) otherwise appears to be satisfactory and is identified with a blue handle.

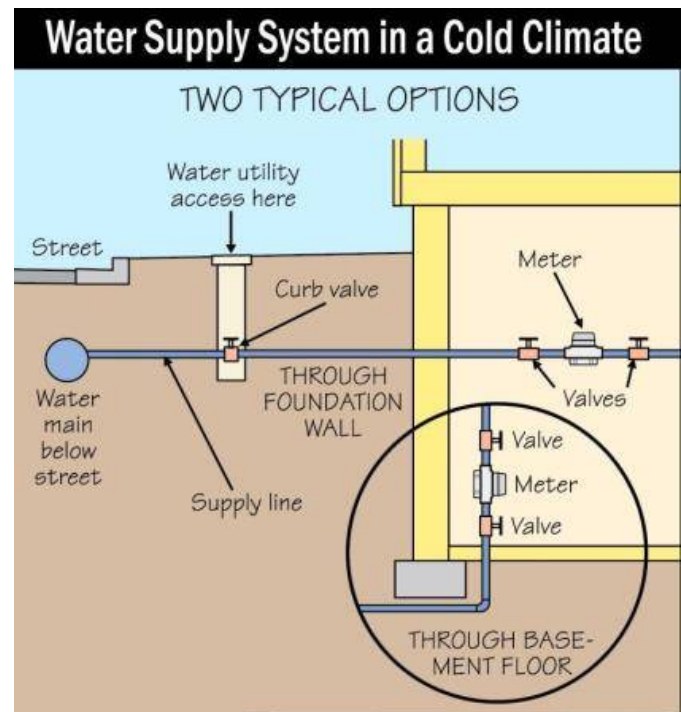
The predominant water main piping viewed was: Copper. The exposed main line was approximately 3/4" diameter pipe, which is a common size pipe. Deficiencies include, but may not be limited to the following: There are un-insulated water pipes that could freeze, which can cause water and mold damage. Recommend installing insulation on all water piping vulnerable to freezing conditions. A licensed plumbing contractor should be contacted to more thoroughly evaluate the condition and to perform repairs as necessary. **NOTE:** *Only the interior portion of the water piping is subject to view. The buried portions of the water piping are not able to be inspected. At this time, there are no tell-tale signs or indications of problems with the buried portions of the piping.*

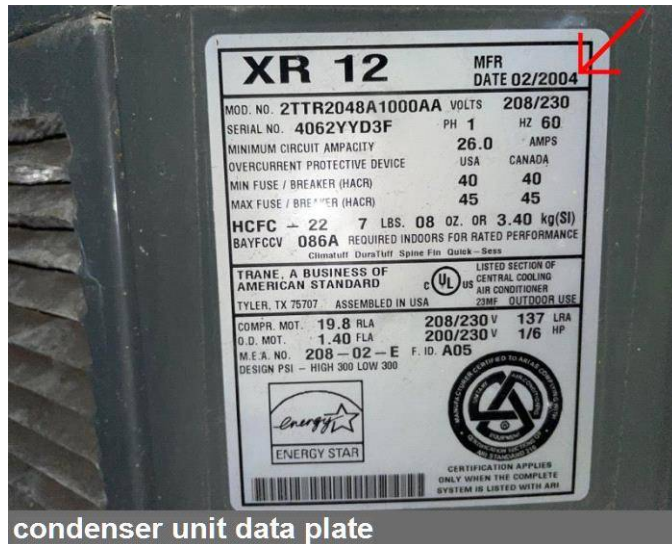
condenser unit data plate

The condenser unit, which dissipates hot air, is located outside of the home appears to be in operable condition. Warm air was being discharged from the fan housing indicating effective heat dissipation to the atmosphere. The refrigerant lines were condensing water, and are adequately secured to the structure. The lines are also reasonably well insulated. The overall service life of a unit of this type is approximately 15-20 years prior to the need for replacement. Older units do require periodic repair. Budget for this contingency if the condenser is older than 10 years.

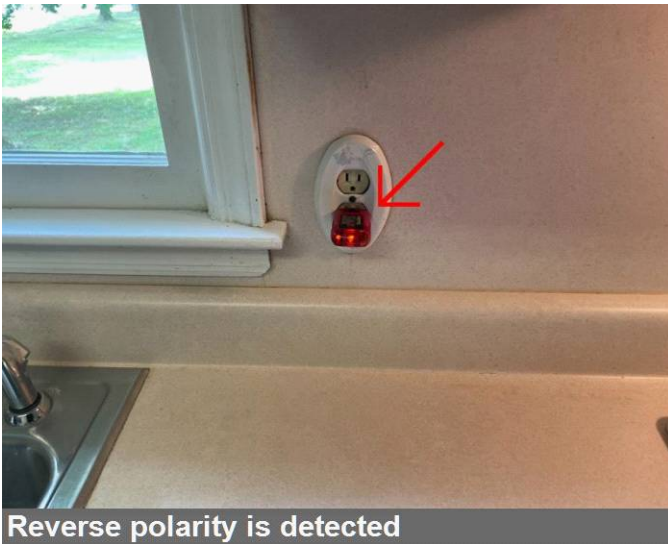
27. There are some incorrectly installed or malfunctioning electric components, which represents a "material defect". These defects should be repaired.

Reverse polarity is detected

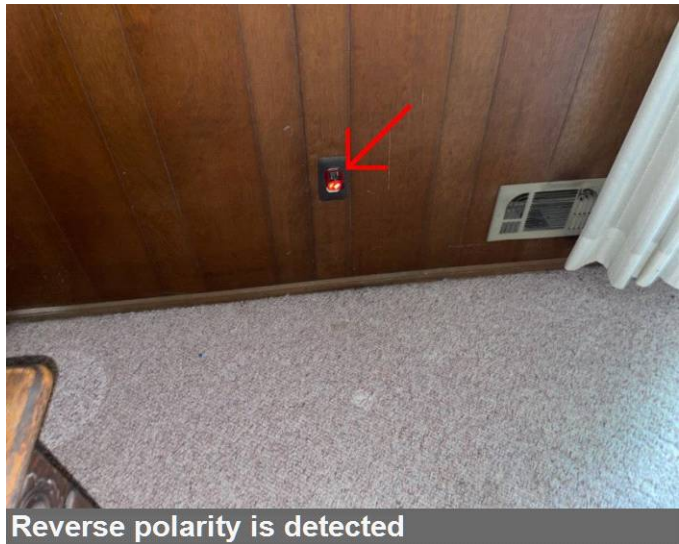
Reverse polarity is detected

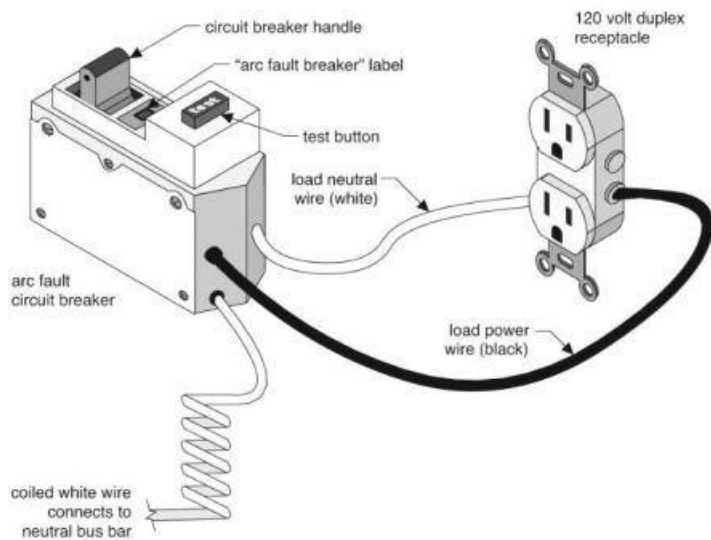
### 17.12 AFCI PROTECTION:

The electrical system does not have Arc Fault Circuit Interrupter (AFCI) protection. The installation of these safety components may not be required in existing structures, but should be considered as part of up-grading the electrical system and improving safety.
