YOUR INSPECTION REPORT

Someplace
Northern, ON P3E Z1Z

Saturday, August 18, 2018

RE: Report No. 1061
Someplace
Northern, ON
P3E Z1Z

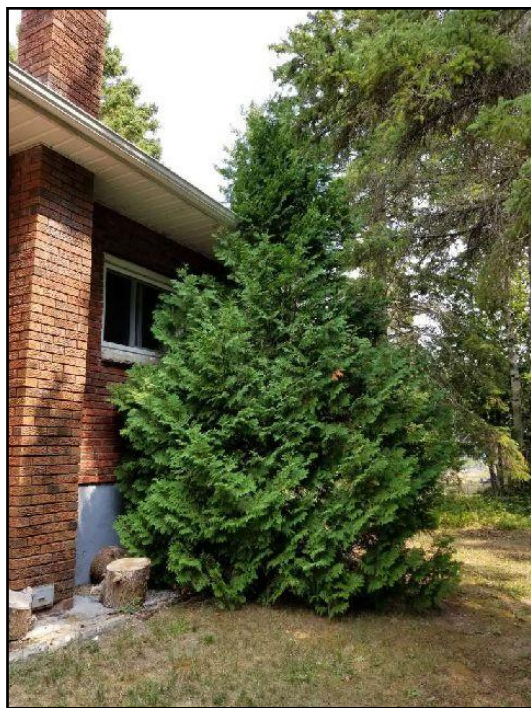
61. Large trees close to building

20. Condition: • [Large trees close to building](#)

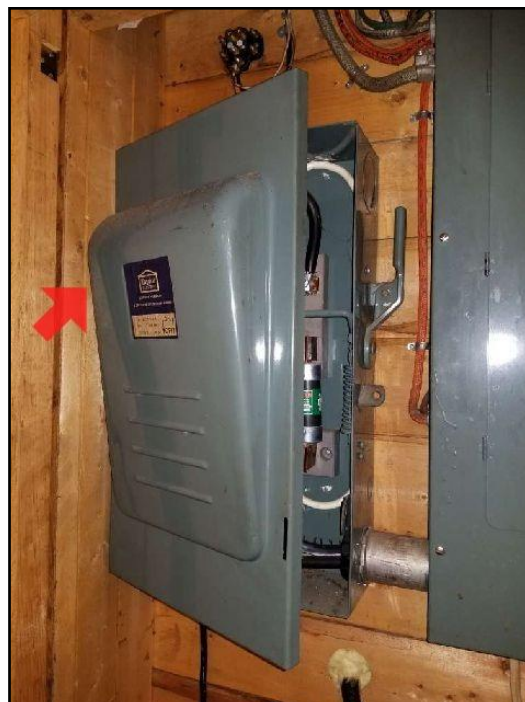
75. Box location poor

23. Condition: • [Box location poor](#)

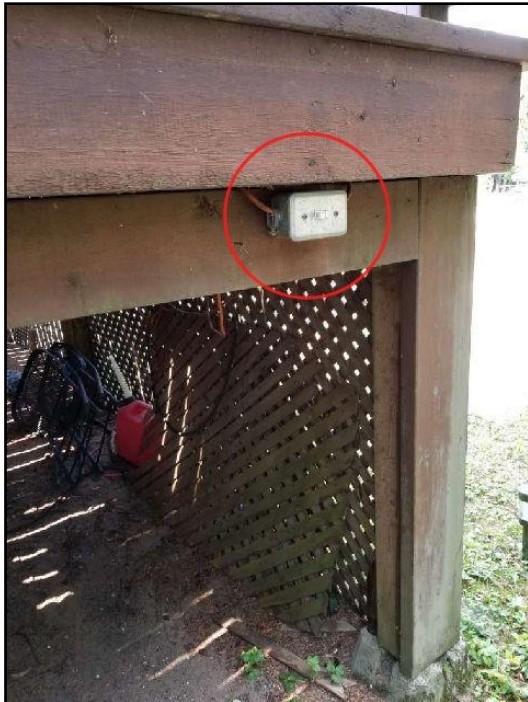
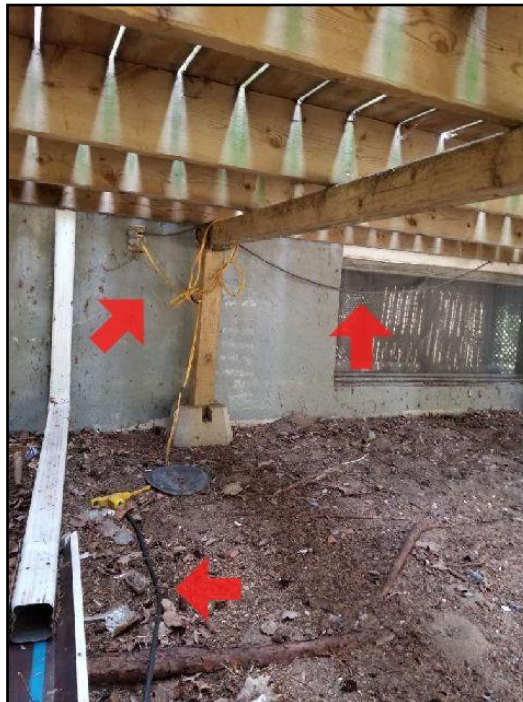
25. Condition: • [Extension cords for exterior outlets \(receptacles\)](#)

Implication(s): Electric shock | Fire hazard

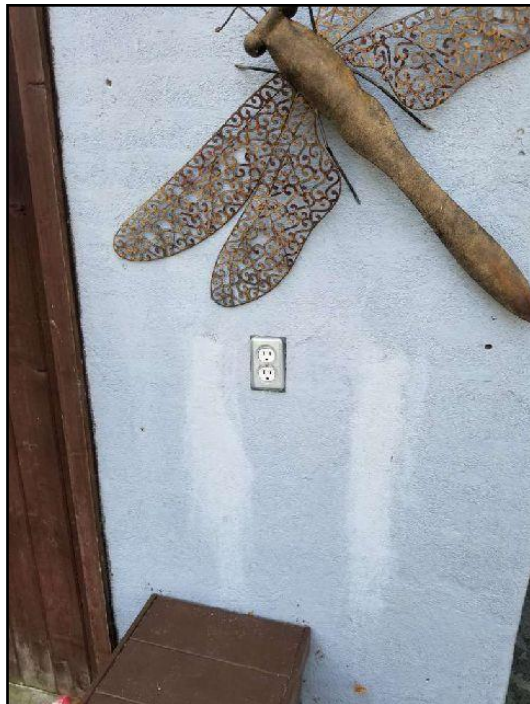
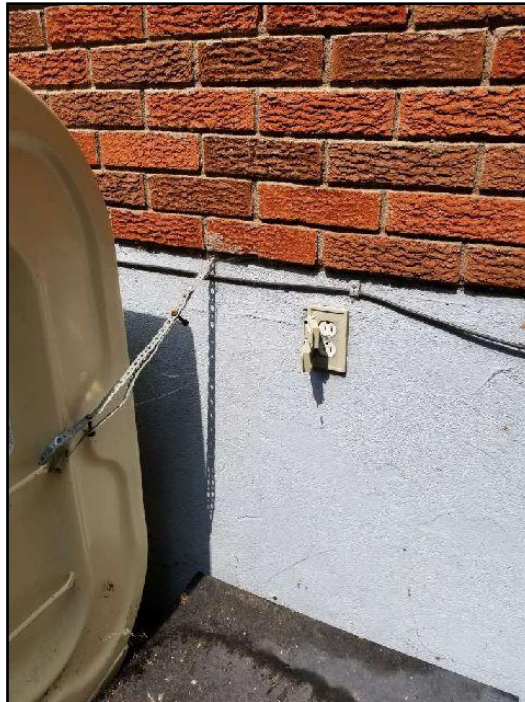
27. Condition: • [No GFCI/GFI \(Ground Fault Circuit Interrupter\)](#)

Recommend installing GFCI (current best practice) for exterior receptacles. Also ensure exterior receptacles are weather tight.

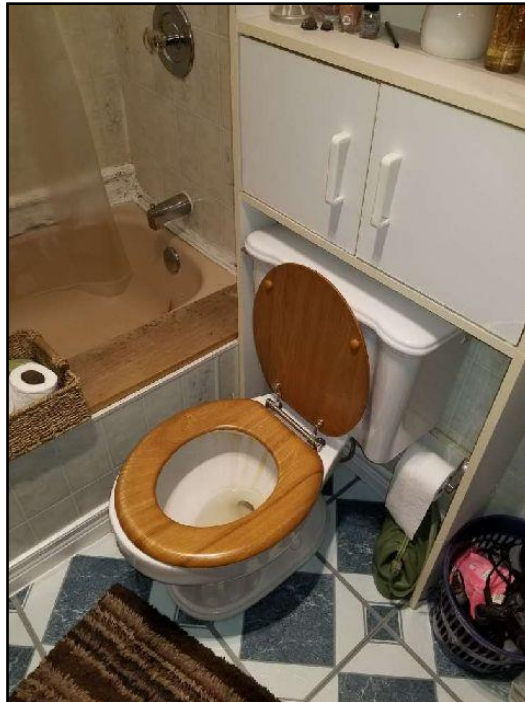
119. *Obstructed or weak flush*

40. Condition: • [Obstructed or weak flush](#)

Implication(s): Chance of water damage to contents, finishes and/or structure | Sewage entering the building

Task: Repair
