**Garden Grove Condominium
Owners Association
*Everett, WA***

Report #: 13381-0
Beginning: January 1, 2023
Expires: December 31, 2023

RESERVE STUDY
"Full"

December 20, 2022

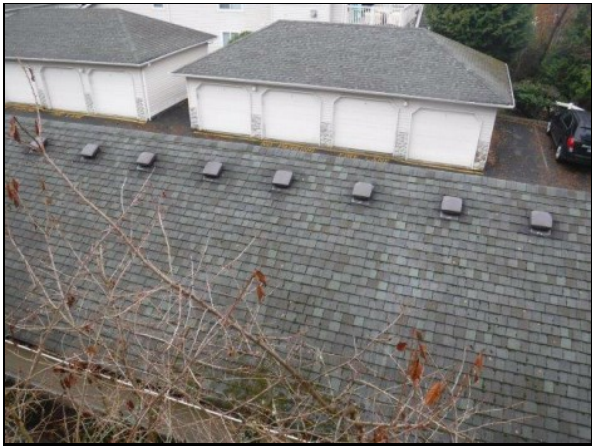
Comp #: 507 Garage Roofs - Repair/Replace

Comments: This component represents replacement of the garage roofs. We have set this component for this project to occur in 2027.

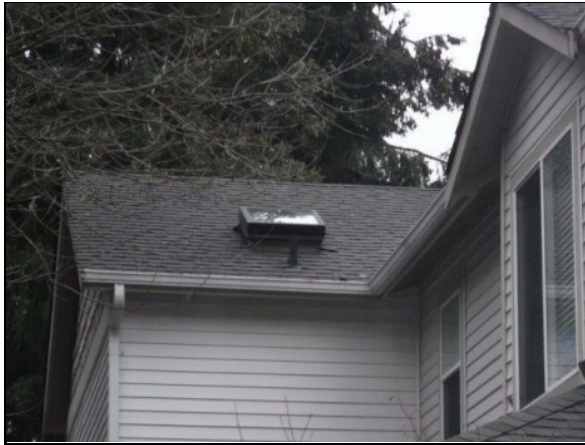
Comp #: 512 Bldg O Skylights - Repair/Replace

Comments: This component represents repair/replacement of the skylights for building O which are assumed to have been replaced during the 2022 roof replacement project.

Observation of the skylights revealed curb mounted skylights with visible portions of flashing. No current water leaks or other problems were reported by the association.

Estimated costs of replacing the skylights does not meet the minimal threshold requirements. Replace the skylights utilizing operating funds or, for best practice and costs efficiencies, simultaneously as the roof.

Inspect the skylights as part of the ongoing roof inspections, and repair as needed to maintain the waterproof integrity. Review the skylight conditions with a consultant or roof contractor while evaluating the roofing project.

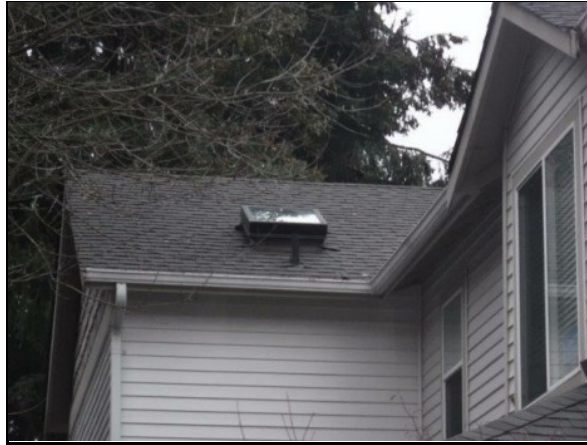
Comp #: 513 2023 Skylights - Repair/Replace**Quantity: 9 fixtures**

Comments: This component represents replacement of 1/4 of the remaining skylights to be replaced in 2023.

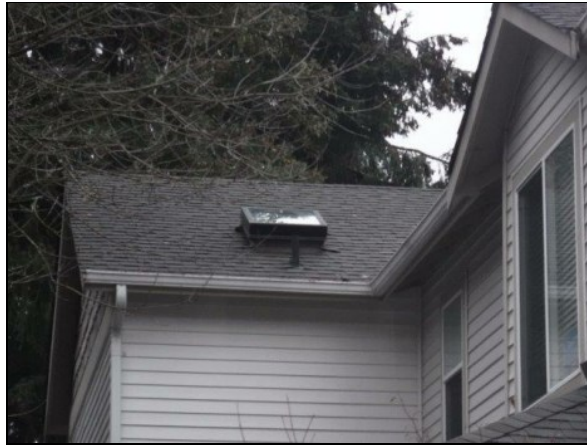
Comp #: 514 2024 Skylights - Repair/Replace**Quantity: 9 fixtures**

Comments: This component represents replacement of 1/4 of the remaining skylights to be replaced in 2024.

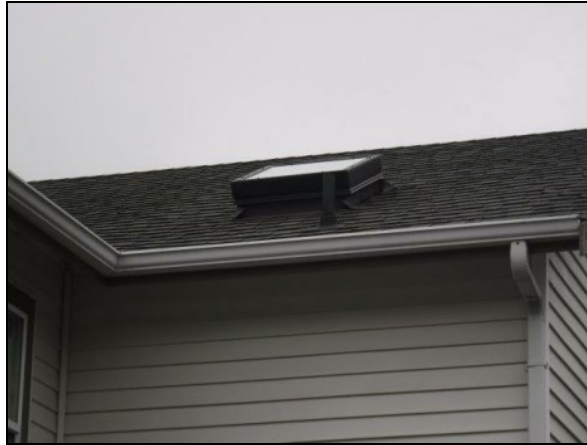
Comp #: 515 2025 Skylights - Repair/Replace

Comments: This component represents replacement of 1/4 of the remaining skylights to be replaced in 2025.

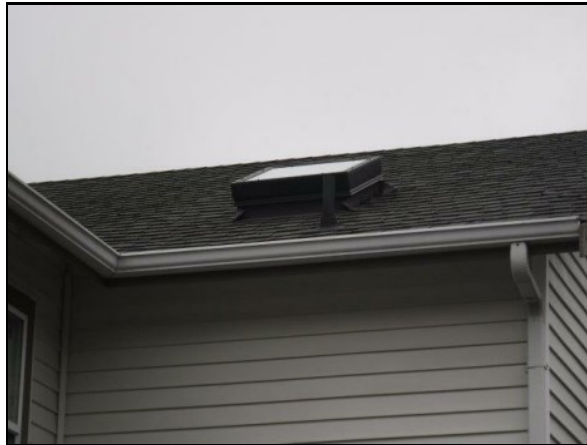
Comp #: 516 2026 Skylights - Repair/Replace

Comments: This component represents replacement of 1/4 of the remaining skylights to be replaced in 2026.

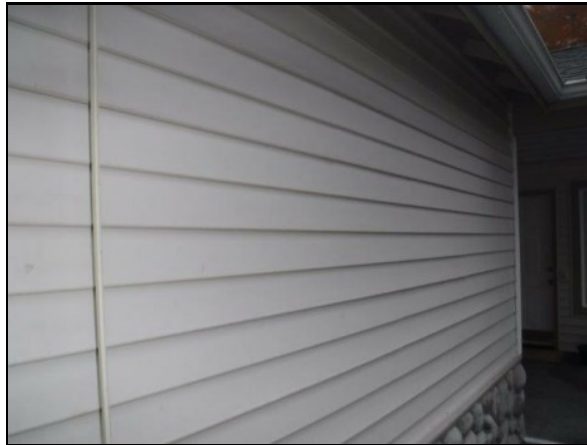
Comments: The vinyl siding was a horizontal clapboard and shingle style. The siding no missing pieces, damage, or unusual wear observed. No view of the critical underlying waterproofing was available as part of our limited visual review.

Siding replacement may ultimately be needed due to the failure of the underlying waterproofing due to degradation over the decades, and/or the end of the useful life of the siding materials from general aging. Many factors influence the useful life, including exposure to (or protection from) wind driven rain, and the quality of the waterproofing and flashing beneath the siding. Evaluate the siding and the critical underlying waterproofing (typically building paper or house-wrap) more frequently as the remaining useful life approaches zero years. Adjust the remaining useful life as dictated by the evaluation. When practical, align with window replacement for cost efficiencies and building envelope integrity. Inspect annually and repair locally, as needed, using general maintenance funds.

Replacing the underlying waterproofing and flashing is projected to require replacement of the vinyl siding. Vinyl siding will typically fade over the years, and when replacing pieces it may be difficult to match the faded color.

Project costs can vary depending upon materials chosen and the condition of the underlying structural framing when exposed. We recommend the Board conduct research well in advance in order to define the scope, timing, and costs; including a plan for some margin of contingency.

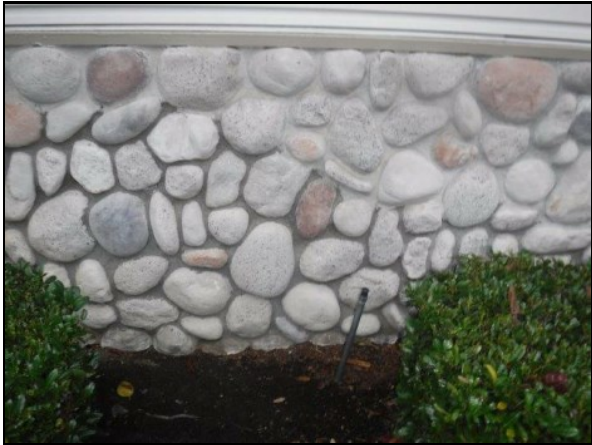
Comp #: 525 Stone Veneer - Maintain/Repair **Quantity: Moderate quantity**

Location: The exterior walls, underlying waterproofing components, and structural components.
Funded?: No. The useful life is not predictable.
History: Installed 1999.
Comments: Some stone veneer was used for cladding on small portions of the buildings. No cracked grout or broken stones were observed during our site visit. During our limited visual review, we are not able to view or evaluate the critical underlying waterproofing and flashings.

Many factors influence the useful life, including exposure to (or protection from) wind driven rain, the quality of the siding material, and the quality of the waterproofing and flashing beneath the siding. Almost all waterproofing systems will degrade over time (years or decades) as it ages.

Stone veneer is a relatively low maintenance item. Inspect periodically, and repair as needed using operating funds.

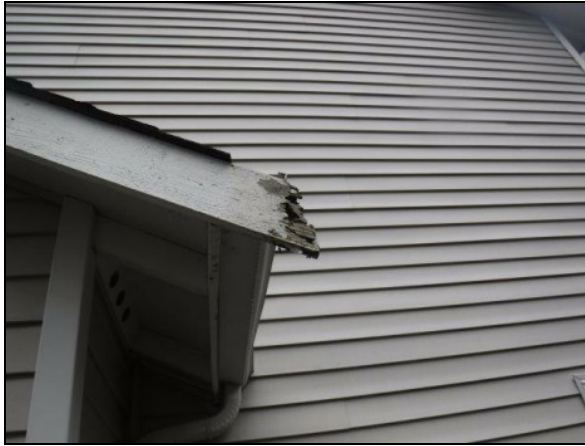
Comments: The ends of several trim pieces were noted to have faded paint and damage.
