Garden Grove Condominium Owners Association *Everett, WA*

Report #: 13381-3
Beginning: January 1, 2026
Expires: December 31, 2026

RESERVE STUDY

Update "With-Site-Visit"

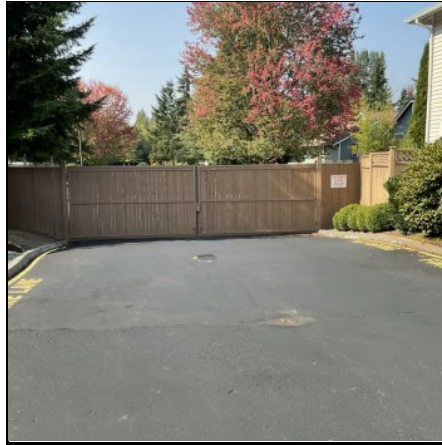
Comp #: 140 Perimeter Fences - Replace**Approx Quantity: 965 LF, Wood****Location:** The west and south community perimeters.**Funded?:** Yes.**History:** Repairs complete in 2025 by Northwest Infrastructure - \$7,573**Comments:** The wood fence did not show evidence of significant damage, instability, or failure. Wood board fence is approximately 6-foot tall and painted, so we were unable to confirm if the posts and rails are a pressure treated material.

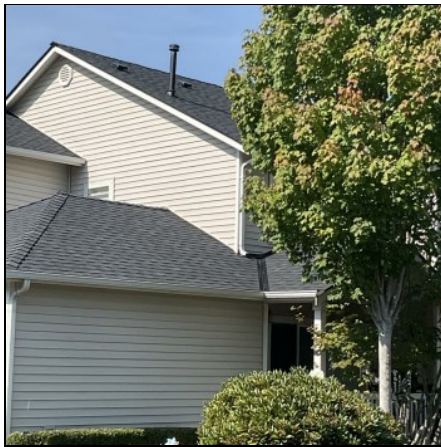
Comments: The vinyl siding was a horizontal clapboard and shingle style. The siding did not show evidence of significant damage, instability, or failure. No view of the critical underlying waterproofing was available as part of our limited visual review.

Siding replacement may ultimately be needed due to the failure of the underlying waterproofing due to degradation over the decades, and/or the end of the useful life of the siding materials from general aging. Many factors influence the useful life, including exposure to (or protection from) wind driven rain, and the quality of the waterproofing and flashing beneath the siding. Evaluate the siding and the critical underlying waterproofing (typically building paper or house-wrap) more frequently as the remaining useful life approaches zero years. Adjust the remaining useful life as dictated by the evaluation. When practical, align with window replacement for cost efficiencies and building envelope integrity. Inspect annually and repair locally, as needed, using general maintenance funds.

Replacing the underlying waterproofing and flashing is projected to require replacement of the vinyl siding. Vinyl siding will typically fade over the years, and when replacing pieces it may be difficult to match the faded color.

Project costs can vary depending upon materials chosen and the condition of the underlying structural framing when exposed. We recommend the Board conduct research well in advance in order to define the scope, timing, and costs; including a plan for some margin of contingency.

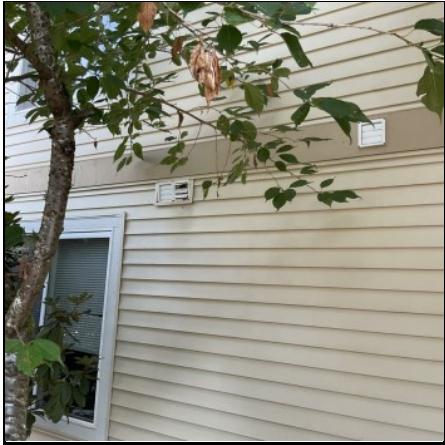
Comments: The vinyl siding was generally clean and free of damage. It was reported that the buildings were cleaned in July 2025.

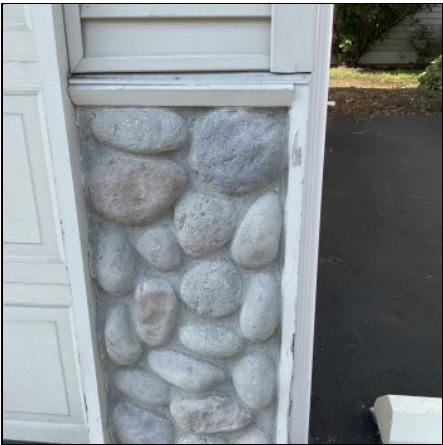
Comp #: 525 Stone Veneer - Maintain/Repair

Comments: Some stone veneer was used for cladding on small portions of the buildings. No cracked grout or broken stones were observed during our site visit. During our limited visual review, we are not able to view or evaluate the critical underlying waterproofing and flashings.

Many factors influence the useful life, including exposure to (or protection from) wind driven rain, the quality of the siding material, and the quality of the waterproofing and flashing beneath the siding. Almost all waterproofing systems will degrade over time (years or decades) as it ages.

Stone veneer is a relatively low maintenance item. Inspect periodically, and repair as needed using operating funds.

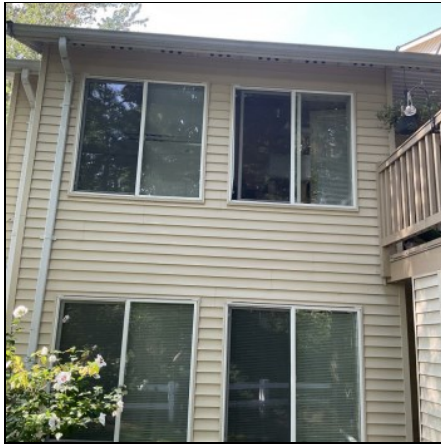
History: Soffit repair and painting in 2025 by Northwest Infrastructure - \$28,289

Comments: The ends of several trim pieces were noted to have faded paint and damage. It was reported that the buildings soffits were repaired and repainted in 2025.

Typical Northwest paint cycles vary greatly depending upon many factors including the type of material painted, surface preparation, quality of the primer/paint/stain, application methods, weather conditions during the application process, moisture beneath the surface, and exposure to weather conditions. Repair areas, as needed, prior to painting/caulking. As routine maintenance, inspect regularly (including sealants), repair locally, and touch-up paint, as needed, using operating funds.

Proper sealant/caulking is critical to keeping water out of the walls, and preventing water damage. Incorrect installation of sealants is very common, and can greatly decrease its useful life. Inspect sealants (more frequently as they age) to determine if failing is occurring. Typical sealant problems include failure of the sealant to adhere to adjacent materials, and tearing/splitting of the sealant itself. As sealants age, and due to exposure to ultraviolet sunlight, they will dry out, harden, and lose their elastic ability. Remove and replace all sealants at the time sealant failure begins to appear. Proper cleaning, prep work, and installation technique (shape, size, tooling of joint) are critical for a long lasting sealant/caulking. Do not install sealant in locations that would block water drainage from behind the siding (e.g. at head flashings).

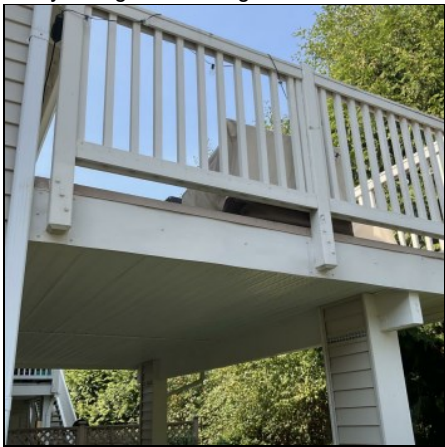
Comp #: 541 Traffic Coated Decks - Resurface

Comments: Direct access to a deck was not available during our site visit and viewing was limited from the ground surface. It was previously reported that the surface of the deck appeared to be a urethane/elastomeric coating. The drip edge of the deck was open. A vertical portion of drip edge flashing was observed. We were unable to view if the coating was turned up the wall a few inches beneath the cladding to prevent water from entering behind the siding. We were unable to determine if the threshold of the door was raised slightly above the deck surface to allow proper flashing. Venting on the underside of the deck, at the soffit below, was observed. Venting is a good practice as it can reduce problems from condensation. The railing connections did not attach through the deck surface. The fewer penetrations through the waterproof surface, the fewer opportunities there are for water penetration.

Re-application of the topcoat periodically is required to maintain its waterproof integrity - see component #542 and 543. If decks are not maintained adequately, significant repair/replacement expenses often occur. In addition to re-application of the topcoat periodically (see next component), over time the underlying base layers and aggregate will wear and need to be redone. This component provides funding for that total system resurface which generally includes stripping the existing layers down to structural decking (plywood/concrete) and reinstalling, including primer/base layers, often metal lath or fiberglass mesh, aggregate broadcast coat for non-slip properties, and completed with a topcoat (see next component) which combines with the cost here for total project. The timing can vary depending on a number of factors including location/orientation of deck, such as inset vs. exposed/uncovered, more weather exposed sides of building (S & W) and if routine top coating has been completed. More exposed, weather sides of buildings may last 20-30 years while inset non-weather sides of buildings may last significantly longer.

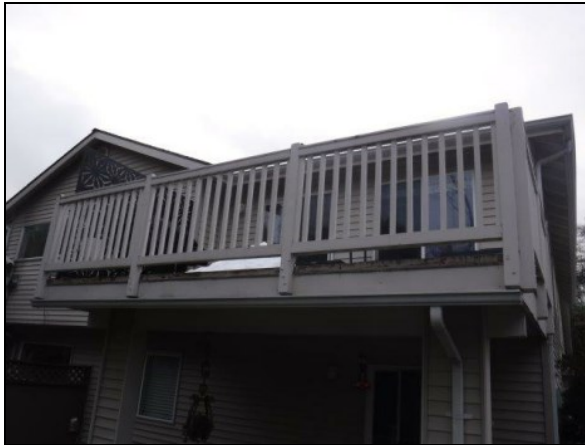
Comments: The deck surface appearance was of a urethane/elastomeric coating. Re-application of the topcoat periodically is required to maintain its waterproof integrity. If decks are not maintained adequately, significant repair/replacement expenses often occur. Proactive coating cycles are cost effective. Extending the time between coatings runs the risk of increased costs due to wear on the second coat in addition to the topcoat and potential water penetration, which can damage the underlying components and greatly increase costs. Elastomeric deck surfaces are typically a three-coat system. The top coat loses thickness each year, primarily from exposure to ultraviolet sunlight, and to a lesser extent wear and tear. If more than the topcoat is allowed to wear off, the surface may still appear to be in 'good' condition, but the waterproof integrity may be compromised by nearly imperceptible "pin holes". Evaluate and repair, as needed, before recoating. Check with your specific manufacturer for cleaning instructions to avoid damage to the coating. Many manufacturers allow cleaning with a mild solution, such as soap and water, TSP, etc.

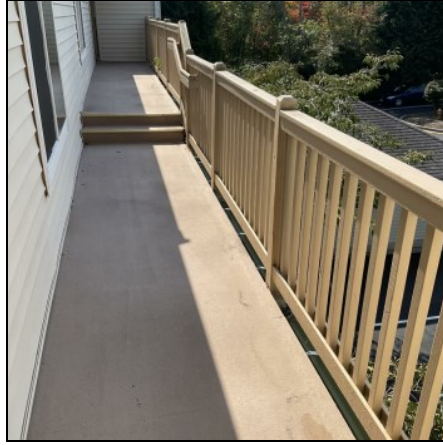
Comp #: 543 Elevated Walkway - Recoat**Approx Quantity: 805 GSF, Elastomeric****Location:** Building CC (#11501).**Funded?:** Yes.**History:** None known.**Comments:** This component represents repairing and recoating the elevated walkway and stair landings of building CC (#11501). Fading of the coating and some evidence of ponding of water were observed.**Useful Life:**

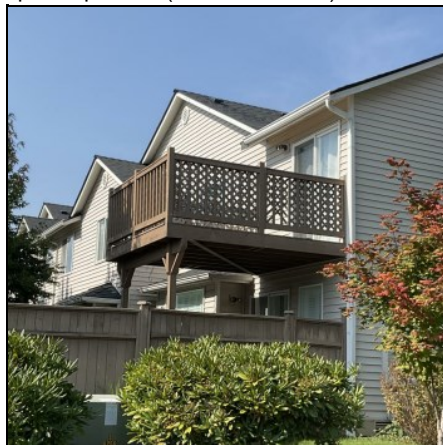
Comp #: 545 Wood Decks - Replace**Approx Quantity: 2,560 GSF, Wood****Location:** Select units.**Funded?:** Yes.**History:** Spot repairs 2023 ~\$13,250**Comments:** The deck surface has open boards that allow water to drain between them. The wood deck surface appears to be stained. No decay of boards was observed.

Funding factored below is for replacing the existing walking surface materials with like-kind materials. The costs may be greater if the structural framing is found to need repair or replacement.

Inspect the deck, stairs, and railings annually, and repair as needed. As part of maintenance, apply water repellent stain/preservative at least every other year. Painting is included in component #533. Almost all exterior wood exposed to the Puget Sound area weather will decay over time, and require replacement. Current building codes require flashing of the ledger joist (at the exterior building wall) to prevent decay from compromising the structural integrity. Options for a longer lasting deck include using thick wood boards or a composite product (increased costs).

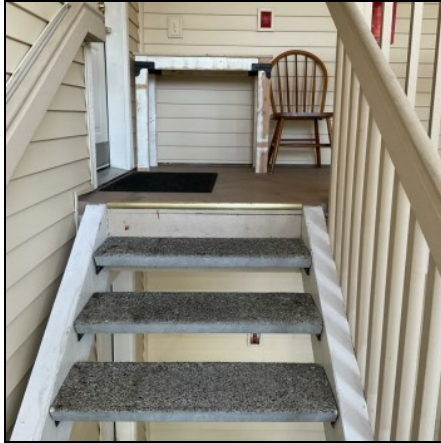
There is no predictable large-scale repairs or replacement at this time. Repair, as needed, using general maintenance funds. As stairs age, and repair needs become evident, funding can be added to future reserve studies.

As routine maintenance, inspect regularly to ensure safety and stability. Repair promptly, as needed, with operating funds. Paint as a part of an exterior paint project - see component #533. Treat corroded metal with a rusted inhibitor to extend the useful life.

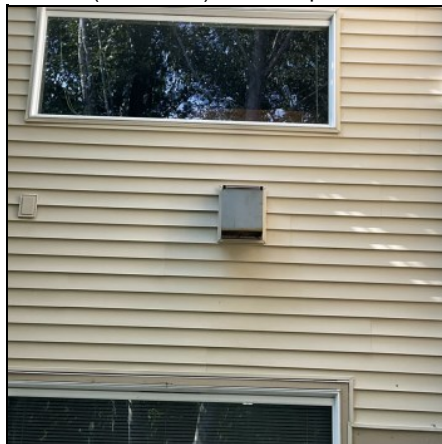
Comp #: 971 Vents - Clean & Inspect**Approx Quantity: 1 Unfunded****Location:** The building exteriors.**Funded?:** No. Costs are best handled with operating funds.**History:** None known.**Comments:** The buildings include multiple vents that serve various purposes. We recommend the Association have the vents inspected and cleaned annually with operating funds. Heightened attention should be given to dryer vents to ensure no blockages have occurred. Dirty/blocked dryer vents (and hoses) have the potential to lead to a fire hazard.**Useful Life:****Remaining Life:**
