PROPERTY INSPECTION  
**REPORT**

**12345 123rd St E, Puyallup, WA 98374**

DATE OF INSPECTION: 10/9/2026

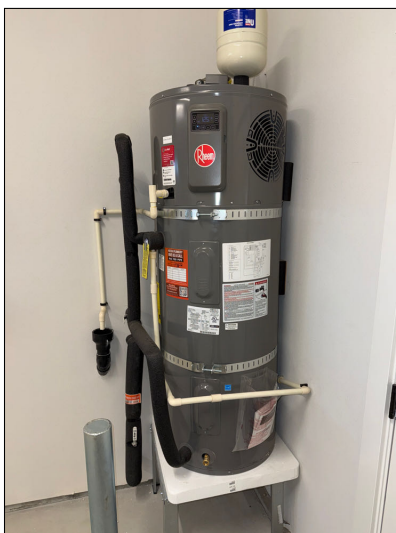
Seismic strapping present.

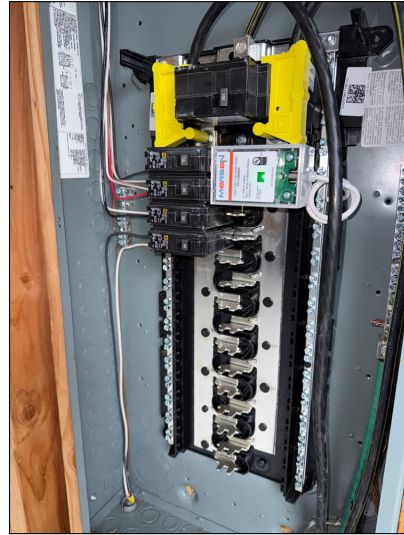
All of the circuit breakers appeared serviceable.

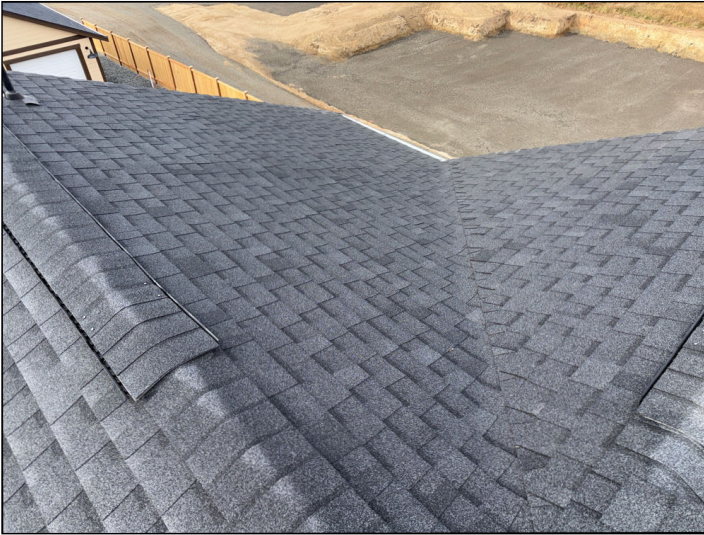
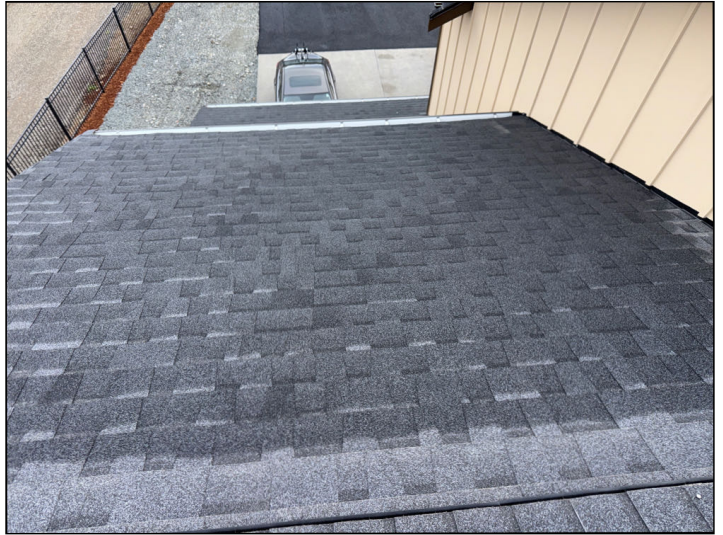
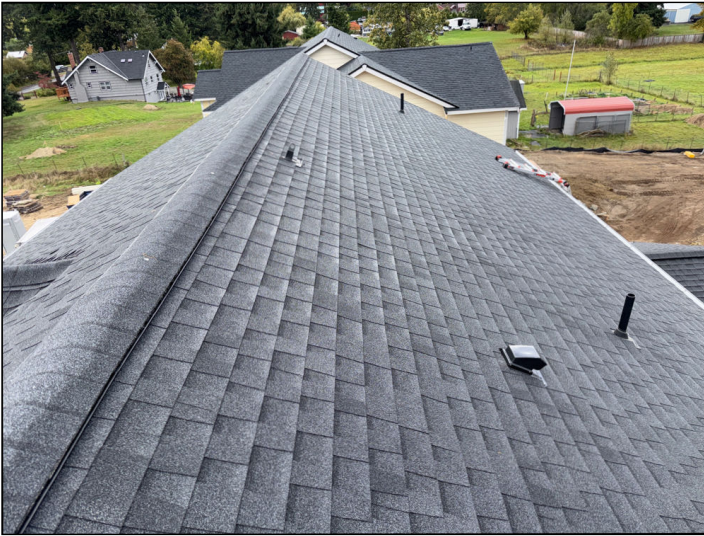
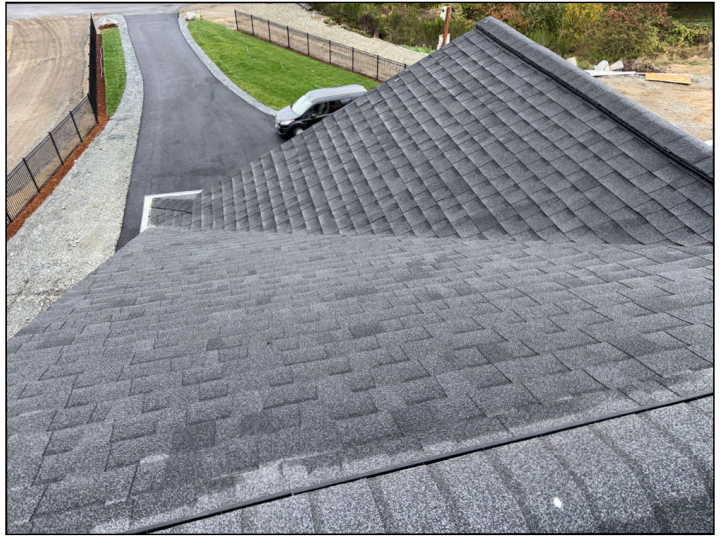
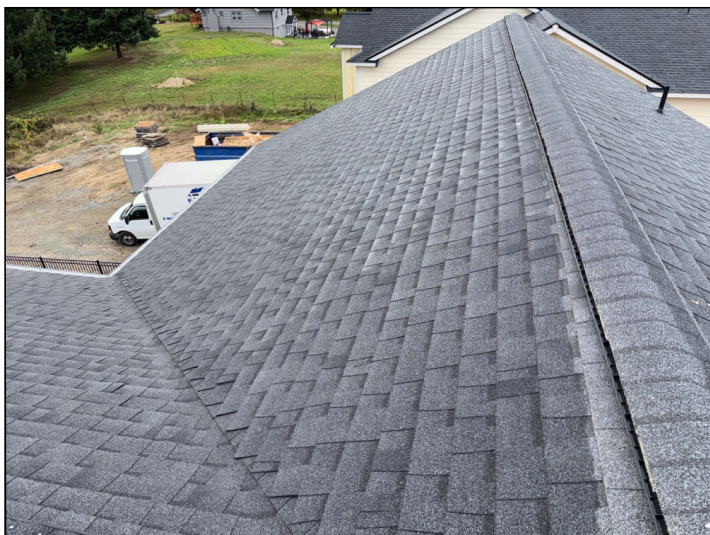
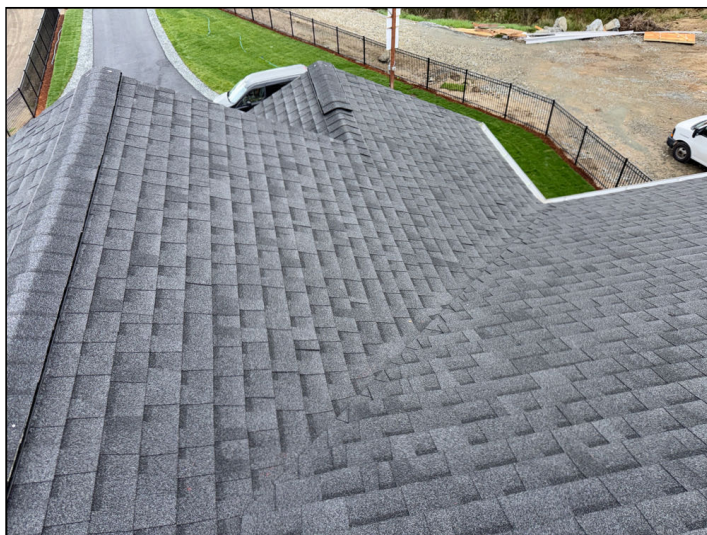
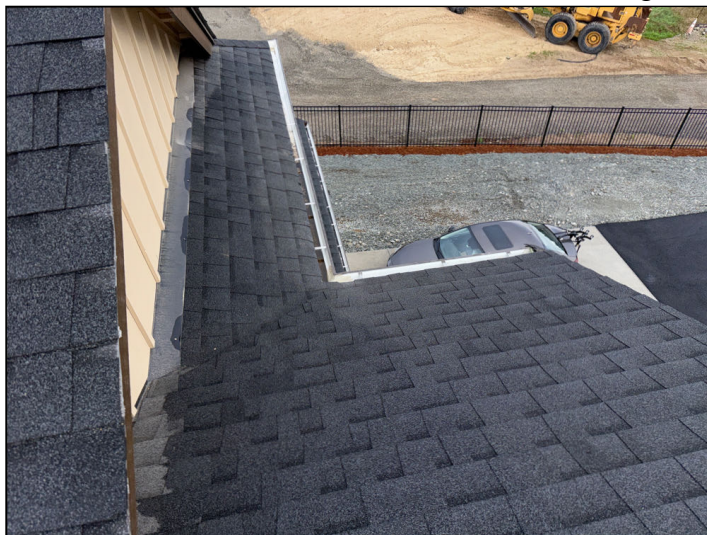
Roof – No Major Concerns

No major safety or functional concerns were observed with the roof covering at the time of the inspection. Routine maintenance and periodic monitoring are recommended.

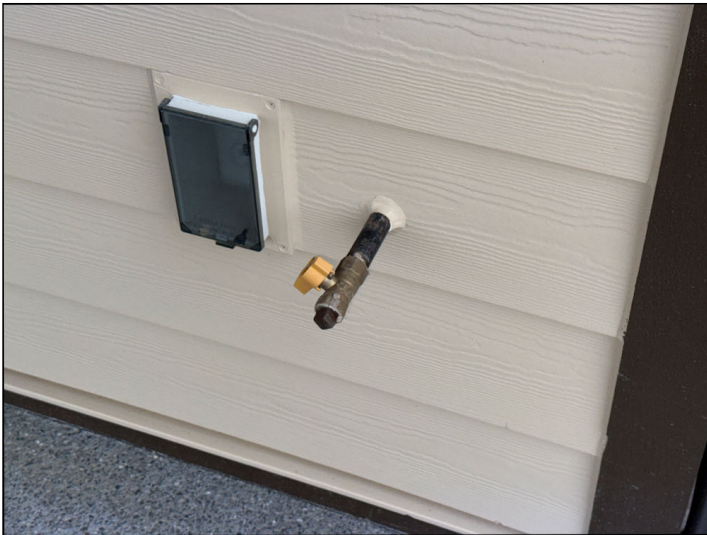
Gas lines have been installed to the back patio for future gas appliances.

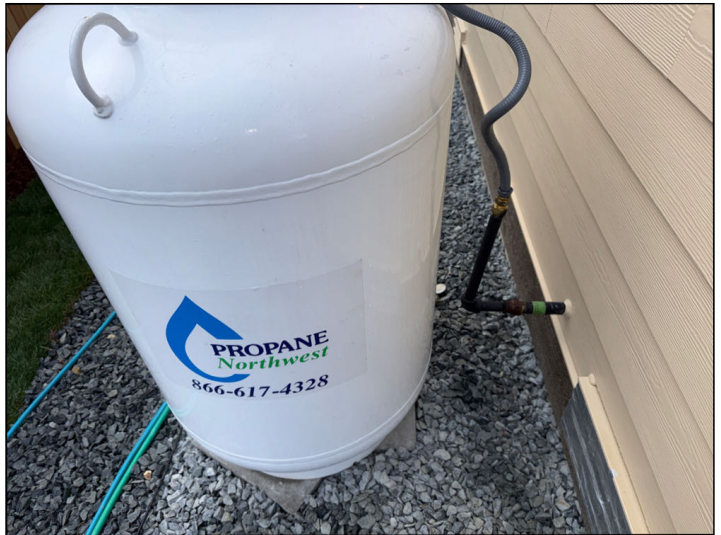
The propane tank was located on the east side of the home.

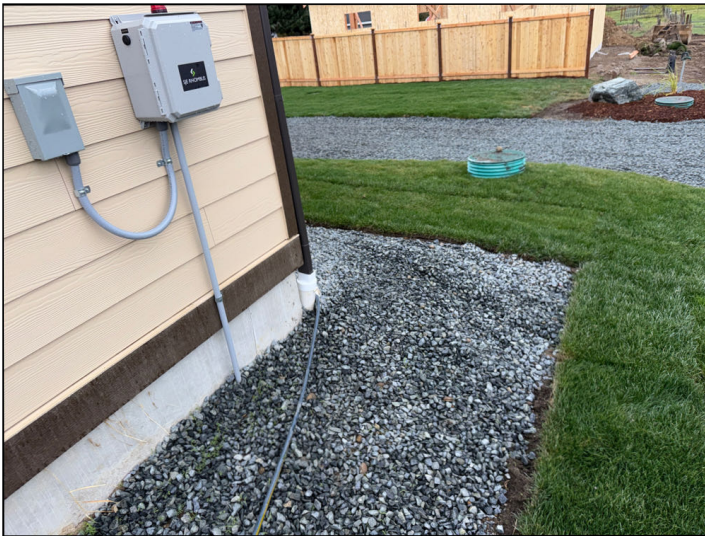
Septic clean out and tanks were noted on the South exterior side of the detached garage.

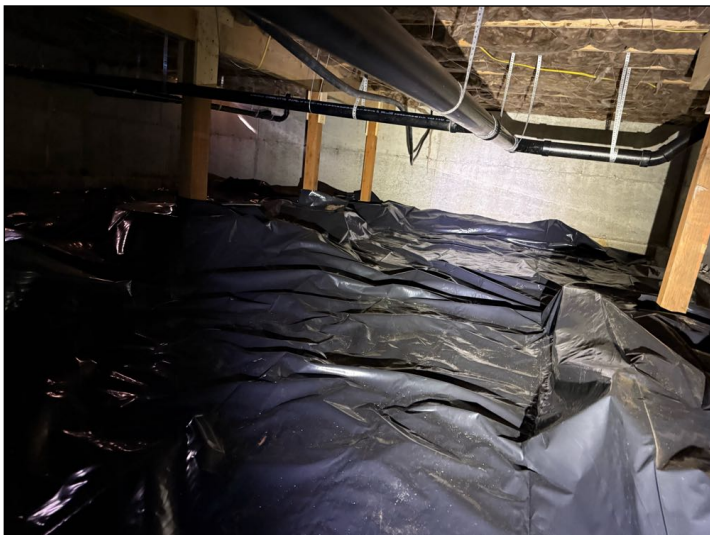
Vapor barrier present and appears to be properly installed.
