PROPERTY INSPECTION  
**REPORT**

**12345 125th St E, Puyallup, WA 98374**

DATE OF INSPECTION: 9/8/2026

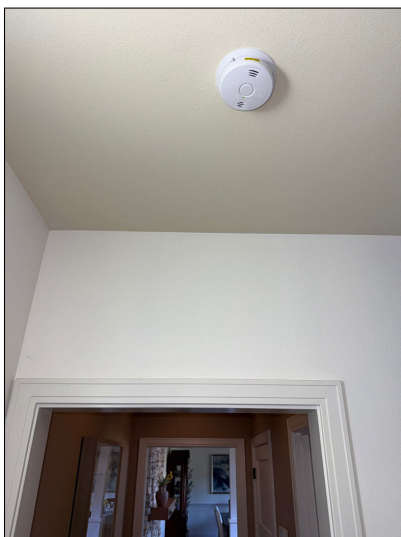
First floor CO and smoke detector noted in mudroom hallway.

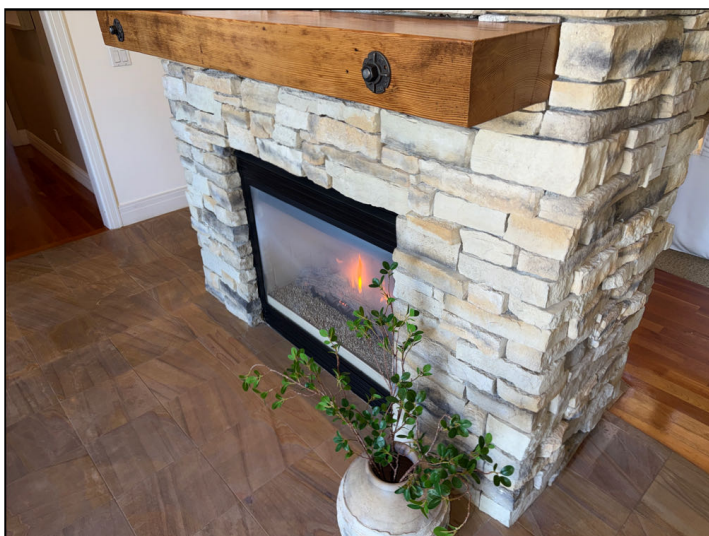
The front entry fireplace was functioning.

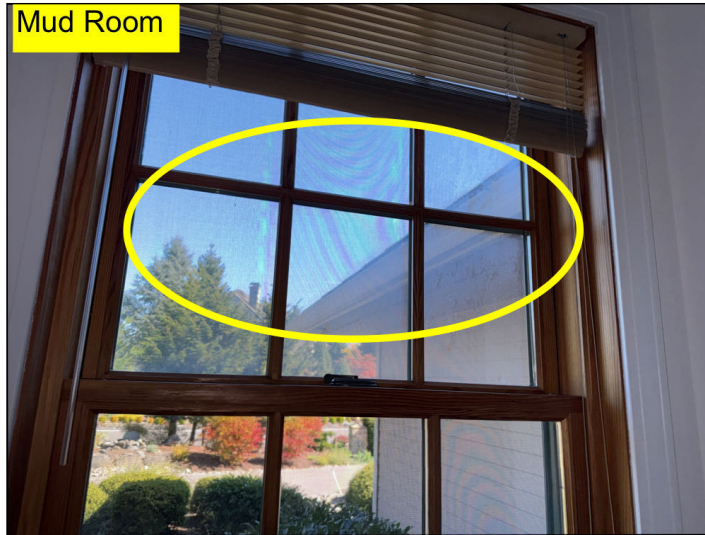
Mud Room

The mud room window shows signs of loss of seal/condensation, recommend repair or replace to provide energy savings and prevent limiting view out of window.

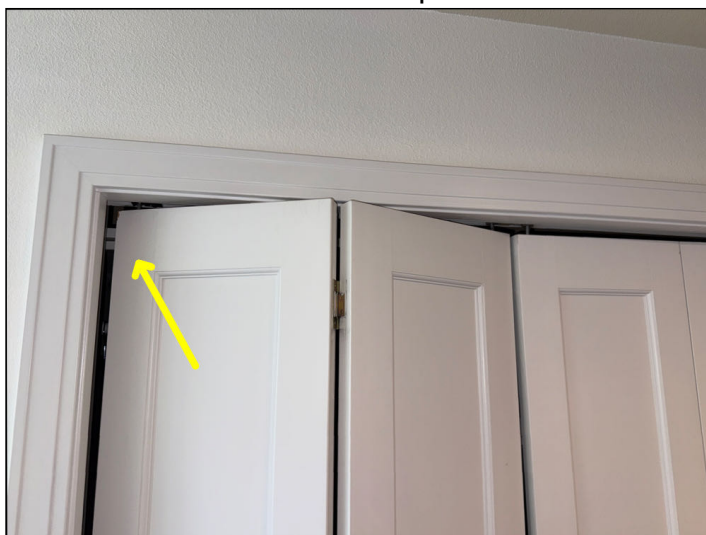
The SE bedroom bi-fold closet door left hand upper bracket was slipping and needs to be secured to keep the door in line.

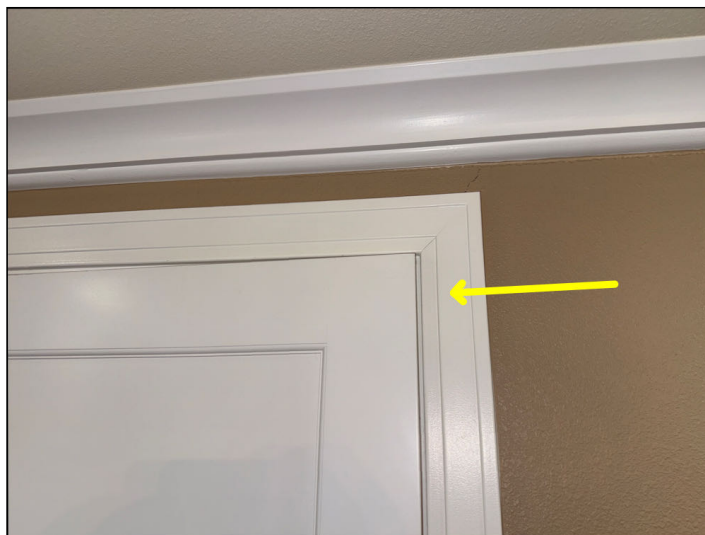
The primary Bedroom closet door binds in the jamb, recommend adjusting door/hardware so that the door opens and closes with ease.

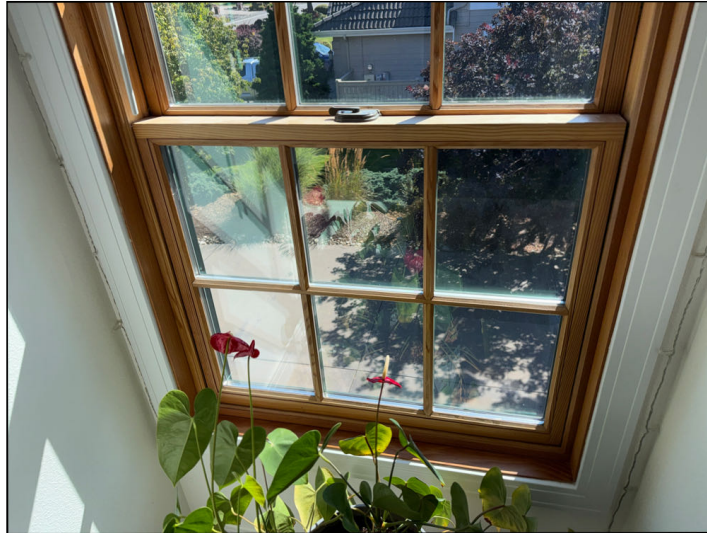
The single-hung window in the southeast bedroom, located on the south elevation, would not open. This may prevent emergency egress. Recommend repair or replacement as needed to restore proper operation and safe emergency escape.

| Interior Areas | | |
|---|---|---|
| Page 14 Item: 10 | Window Condition | <ul style="list-style-type: none"> <li>• The single-hung window in the southeast bedroom, located on the south elevation, would not open. This may prevent emergency egress. Recommend repair or replacement as needed to restore proper operation and safe emergency escape.</li> </ul> |

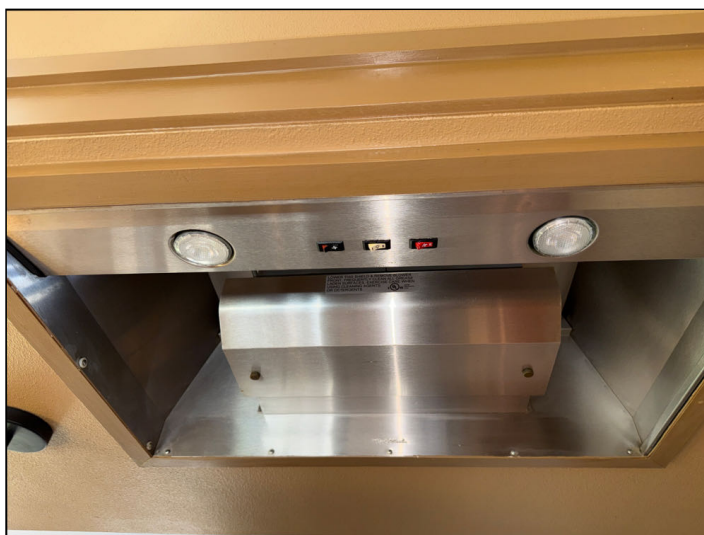
The kitchen exhaust hood did not operate using the visible controls. Recommend confirming with the seller whether an additional switch or control is present. If no additional control exists, have the unit repaired or replaced as needed.

| Interior Areas | | |
|---|---|---|
| Page 20 Item: 11 | Vent Condition | <ul style="list-style-type: none"> <li>• The kitchen exhaust hood did not operate using the visible controls. Recommend confirming with the seller whether an additional switch or control is present. If no additional control exists, have the unit repaired or replaced as needed.</li> </ul> |

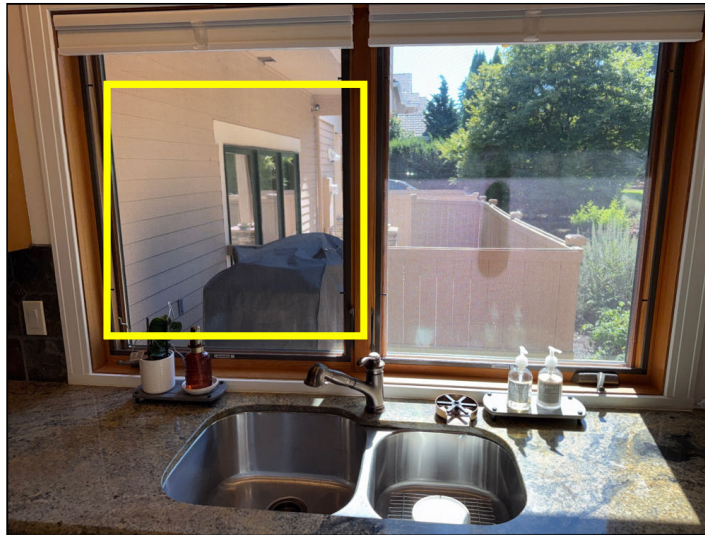
The kitchen casement window to the left of the sink was difficult to close and required pressure from the exterior before it could be locked. Recommend adjusting or repairing the window and hardware as needed for proper operation and secure locking.

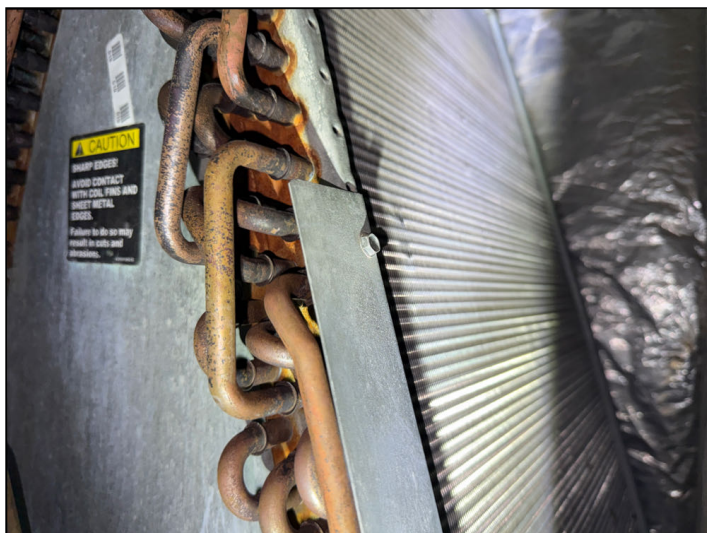
The refrigerant lines were showing signs of age. Functional at the time of the inspection. Recommend budgeting for replacement in the next 5 years.

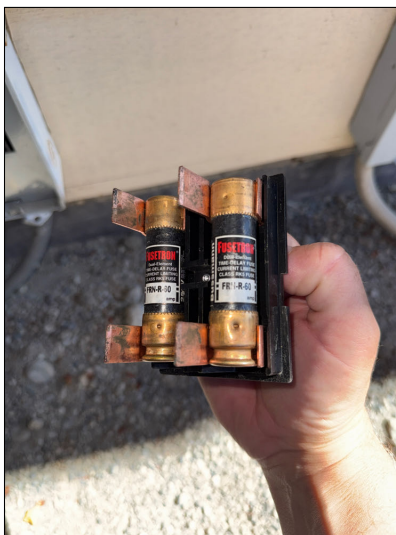
The installed 60-amp fuses match the unit's maximum permitted fuse/breaker rating.

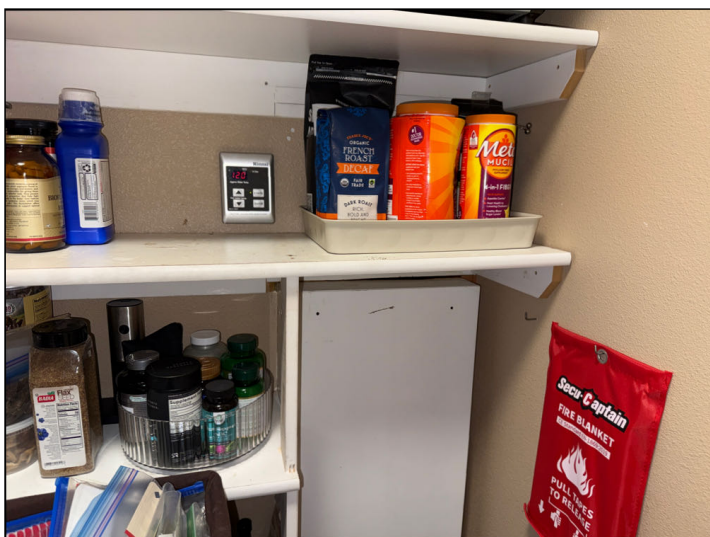
South water heater set at 120 degrees.

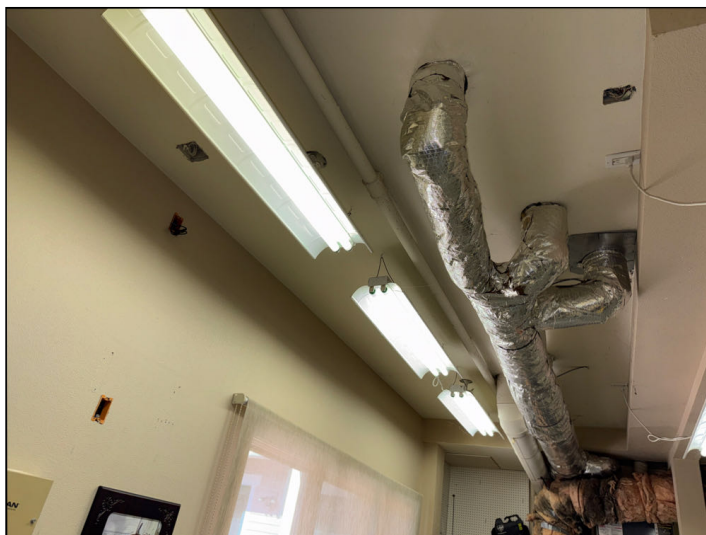
Open junction boxes were observed, which is a safety concern. Recommend installing proper covers, as needed, for safety.

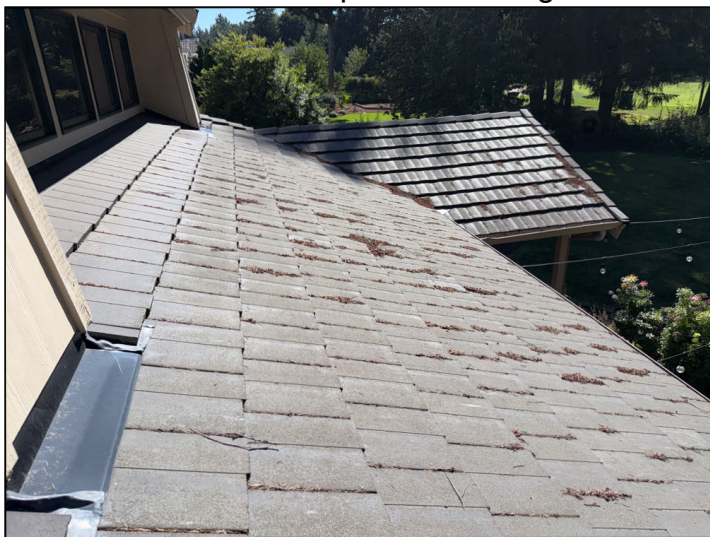
- Cracked roof tiles were noted in the **valley** on the south side of the home, near the garage and leading toward the east dormer. Debris accumulation was also visible in the valley. Recommend evaluation and repair by a qualified roofing contractor to help prevent moisture intrusion.

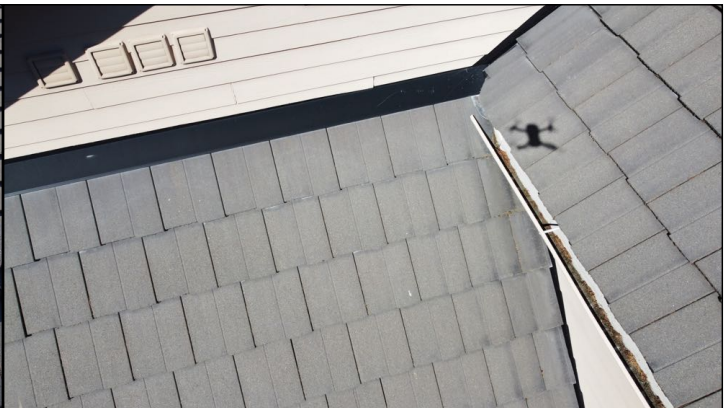
Roof – No Major Concerns

No major safety or functional concerns were observed with the roof covering at the time of the inspection. Routine maintenance and periodic monitoring are recommended.

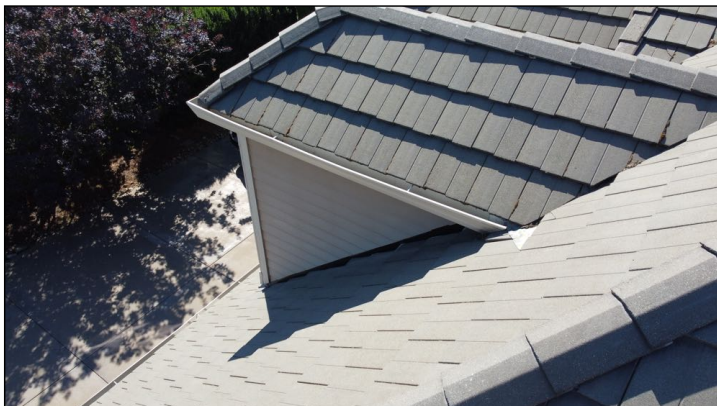
Roof – No Major Concerns

No major safety or functional concerns were observed with the roof covering at the time of the inspection. Routine maintenance and periodic monitoring are recommended.

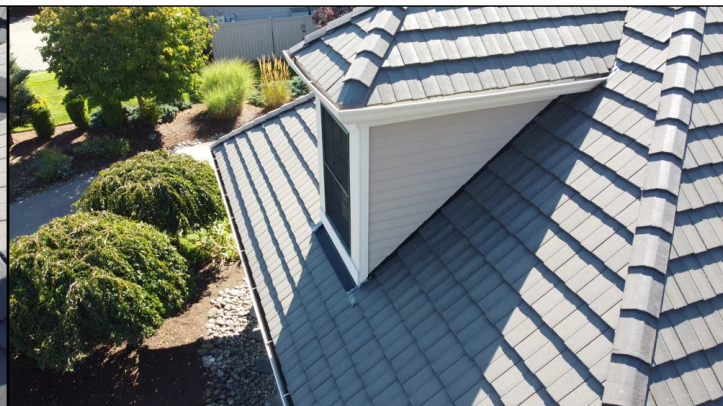
Roof – No Major Concerns

No major safety or functional concerns were observed with the roof covering at the time of the inspection. Routine maintenance and periodic monitoring are recommended.

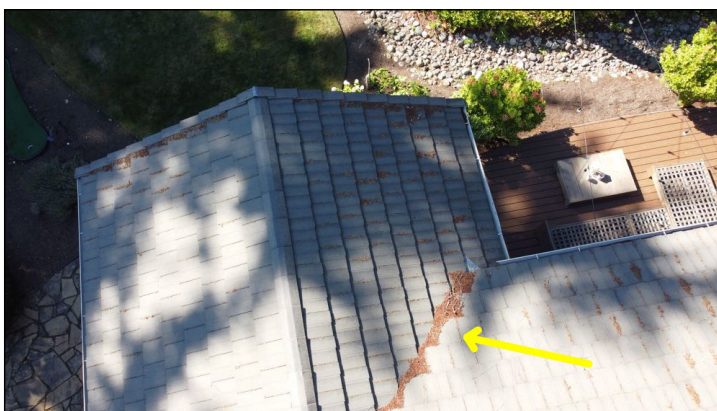
Roof – No Major Concerns

No major safety or functional concerns were observed with the roof covering at the time of the inspection. Routine maintenance and periodic monitoring are recommended.

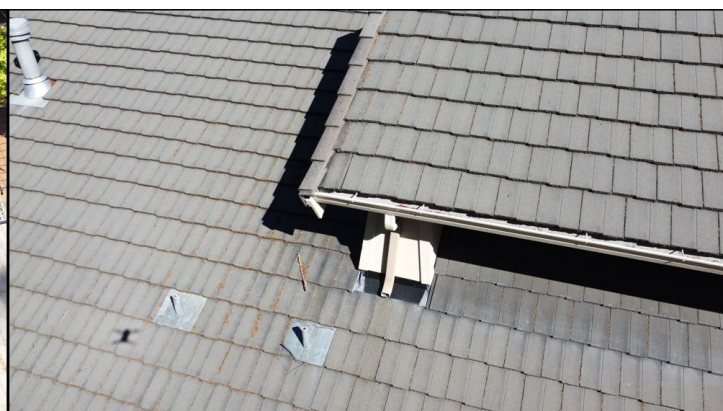
Debris on Roof

Organic debris was observed on the roof surface. Debris can trap moisture and accelerate deterioration of roofing materials. Recommend cleaning the roof as part of routine maintenance.

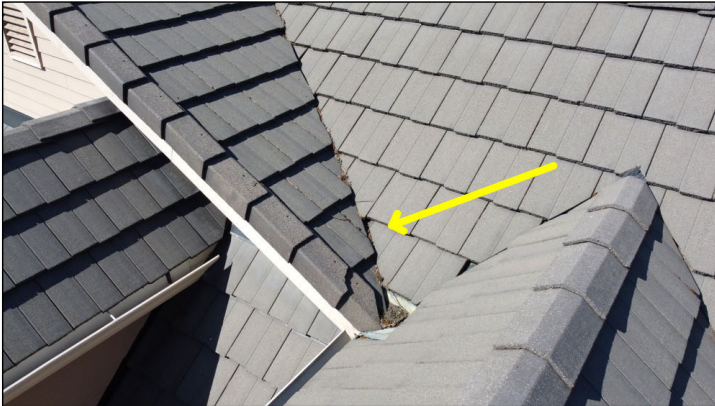
Roof – No Major Concerns

No major safety or functional concerns were observed with the roof covering at the time of the inspection. Routine maintenance and periodic monitoring are recommended.

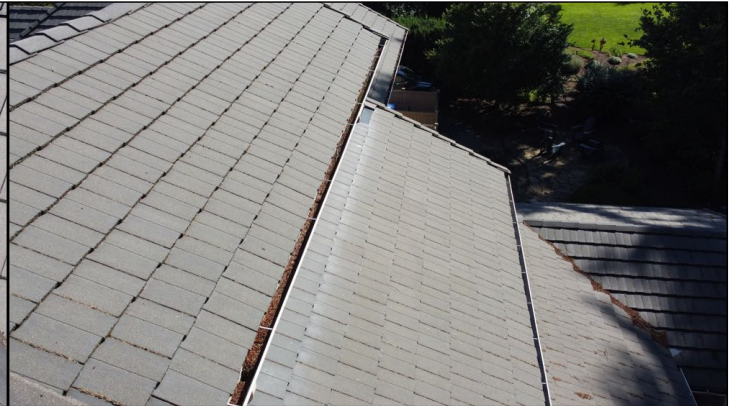
Cracked roof tiles were noted in the valley on the south side of the home, near the garage and leading toward the east dormer. Debris accumulation was also visible in the valley. Recommend evaluation and repair by a qualified roofing contractor to help prevent moisture intrusion.

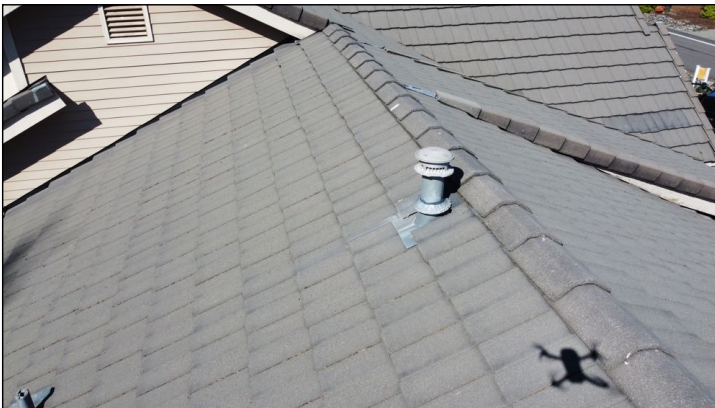
Roof – No Major Concerns

No major safety or functional concerns were observed with the roof covering at the time of the inspection. Routine maintenance and periodic monitoring are recommended.

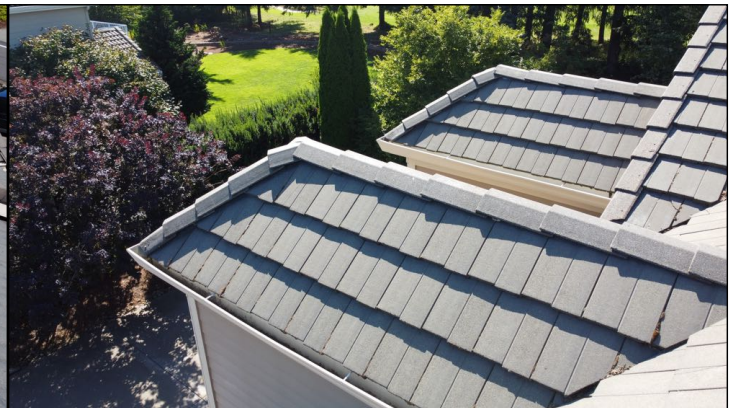
Roof – No Major Concerns

No major safety or functional concerns were observed with the roof covering at the time of the inspection. Routine maintenance and periodic monitoring are recommended.

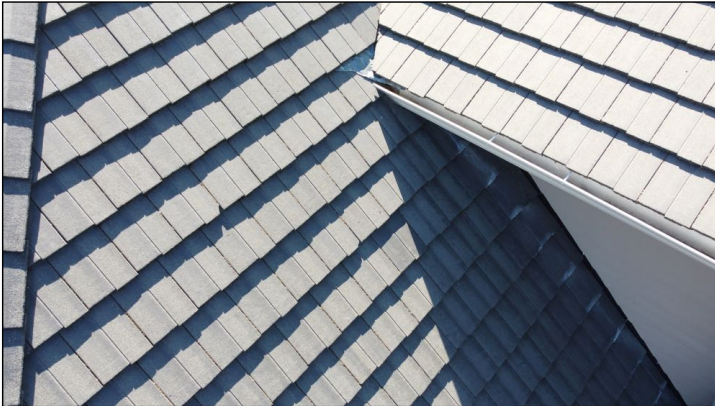
Roof – No Major Concerns

No major safety or functional concerns were observed with the roof covering at the time of the inspection. Routine maintenance and periodic monitoring are recommended.

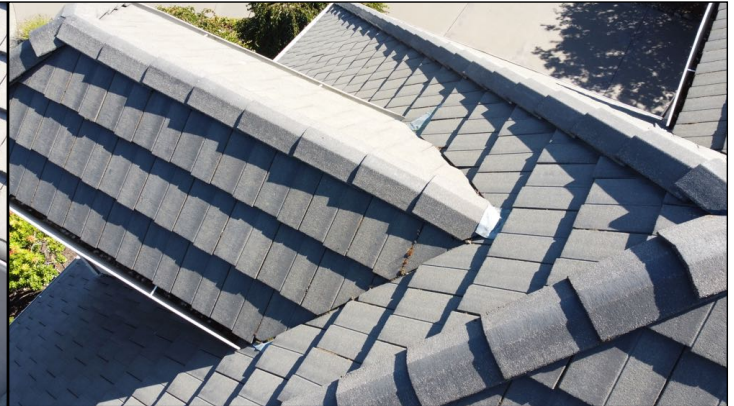
Roof – No Major Concerns

No major safety or functional concerns were observed with the roof covering at the time of the inspection. Routine maintenance and periodic monitoring are recommended.

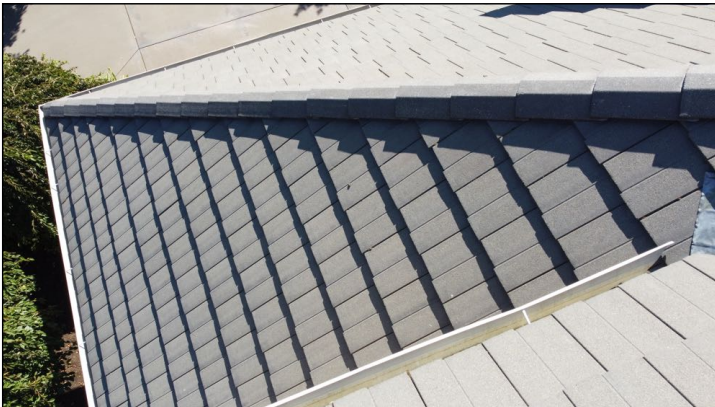
Roof – No Major Concerns

No major safety or functional concerns were observed with the roof covering at the time of the inspection. Routine maintenance and periodic monitoring are recommended.

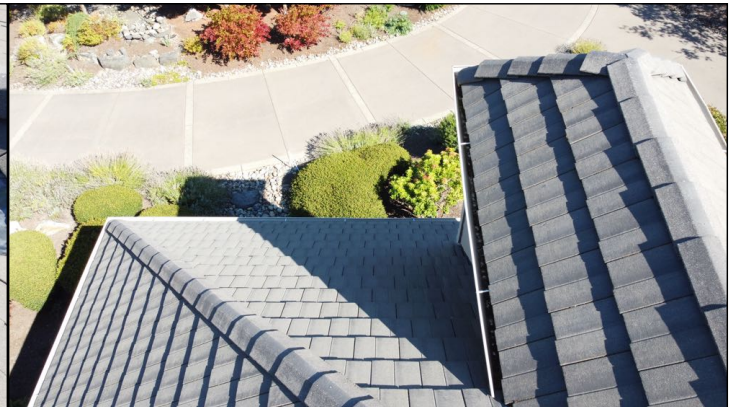
Roof – No Major Concerns

No major safety or functional concerns were observed with the roof covering at the time of the inspection. Routine maintenance and periodic monitoring are recommended.

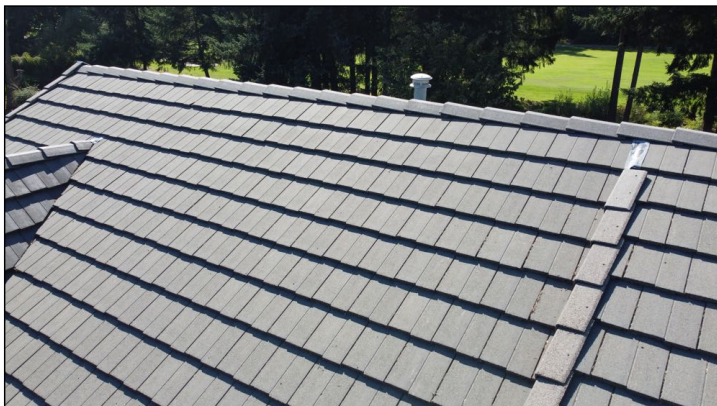
Roof – No Major Concerns

No major safety or functional concerns were observed with the roof covering at the time of the inspection. Routine maintenance and periodic monitoring are recommended.

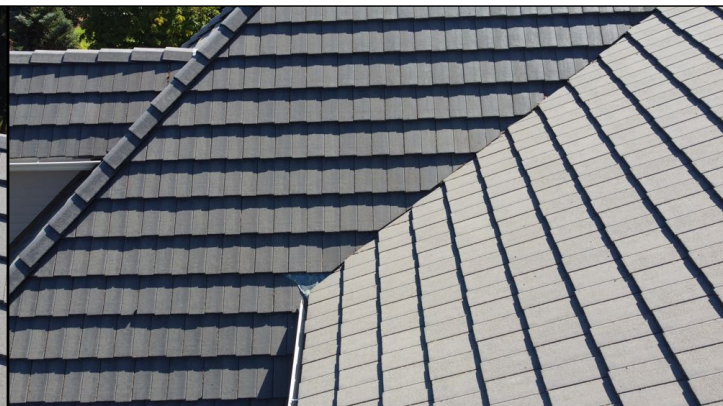
Roof – No Major Concerns

No major safety or functional concerns were observed with the roof covering at the time of the inspection. Routine maintenance and periodic monitoring are recommended.

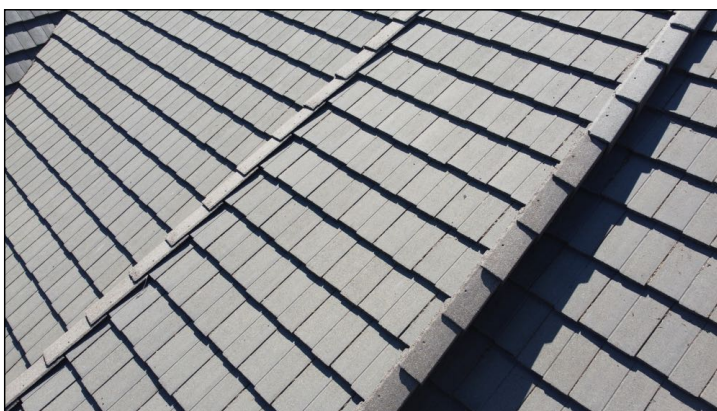
Roof – No Major Concerns

No major safety or functional concerns were observed with the roof covering at the time of the inspection. Routine maintenance and periodic monitoring are recommended.

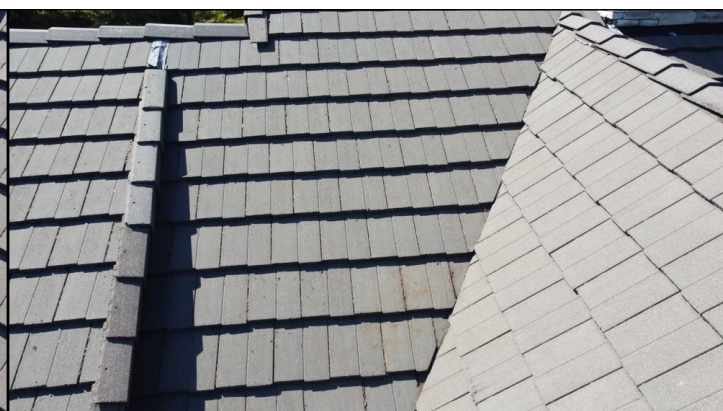
Roof – No Major Concerns

No major safety or functional concerns were observed with the roof covering at the time of the inspection. Routine maintenance and periodic monitoring are recommended.

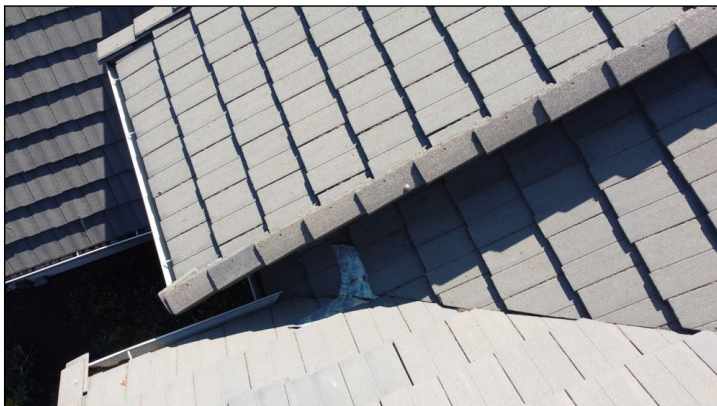
Roof – No Major Concerns

No major safety or functional concerns were observed with the roof covering at the time of the inspection. Routine maintenance and periodic monitoring are recommended.

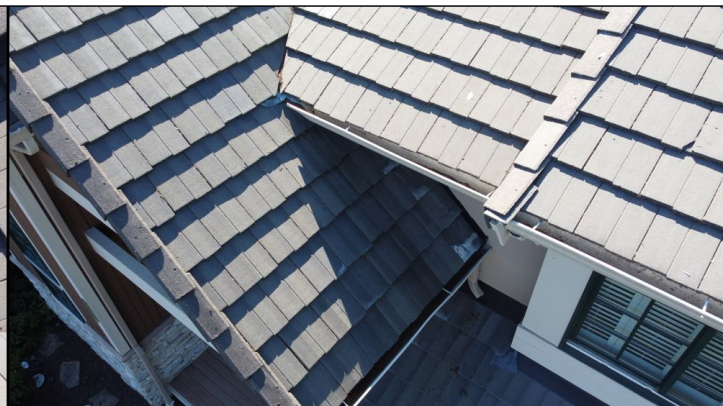
Roof – No Major Concerns

No major safety or functional concerns were observed with the roof covering at the time of the inspection. Routine maintenance and periodic monitoring are recommended.

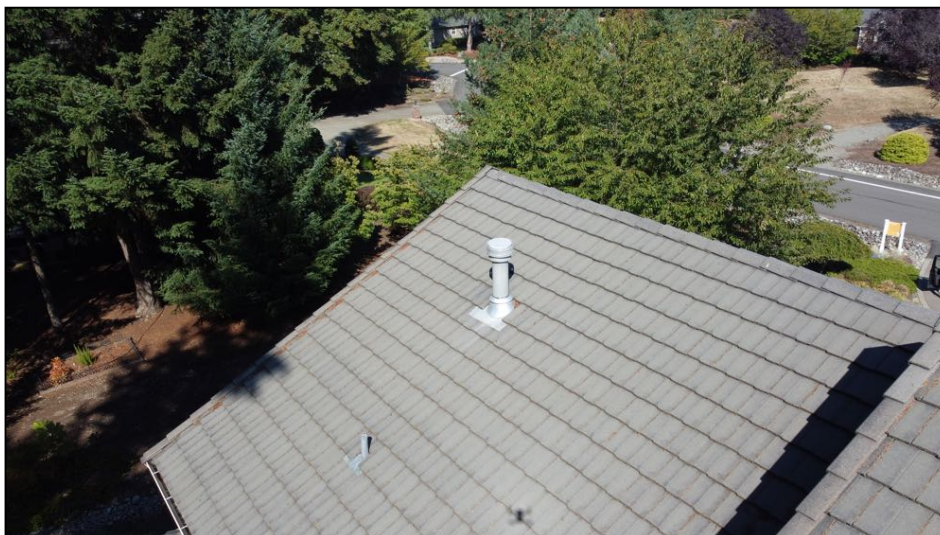
The B-Vent appeared to be in satisfactory condition at the time of the inspection.

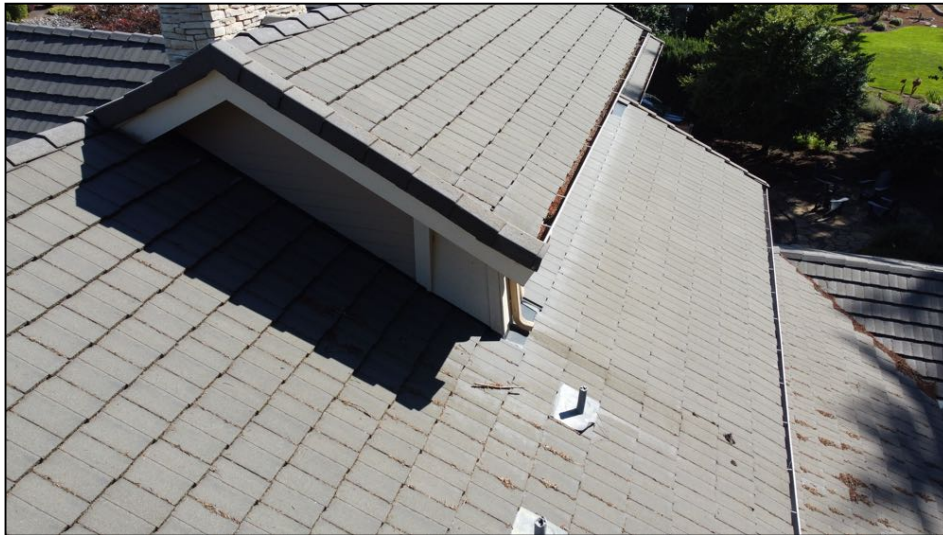
- Clean gutters: Significant amounts of debris evident at the gutters throughout.
- The gutter is dented along the south elevation, which may restrict proper drainage. Recommend repairing or replacing the damaged section as needed.

Clean gutters: Significant amounts of debris evident at the gutters throughout.

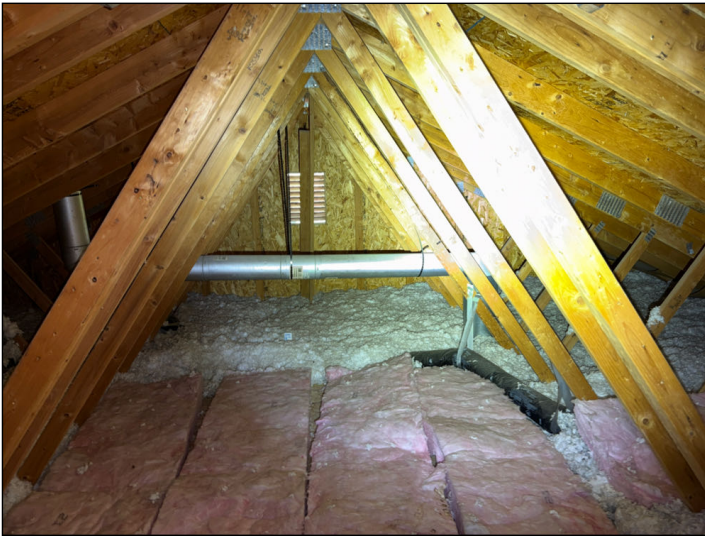
Gable louver vents noted.

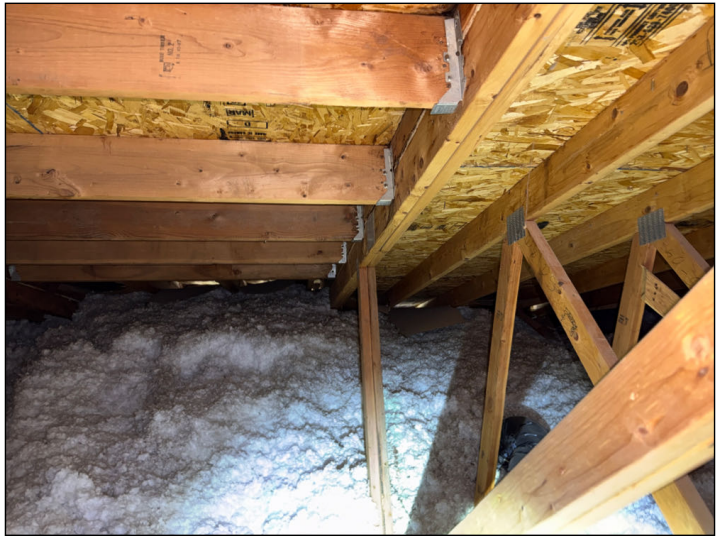
Under eave soffit inlet vents noted.

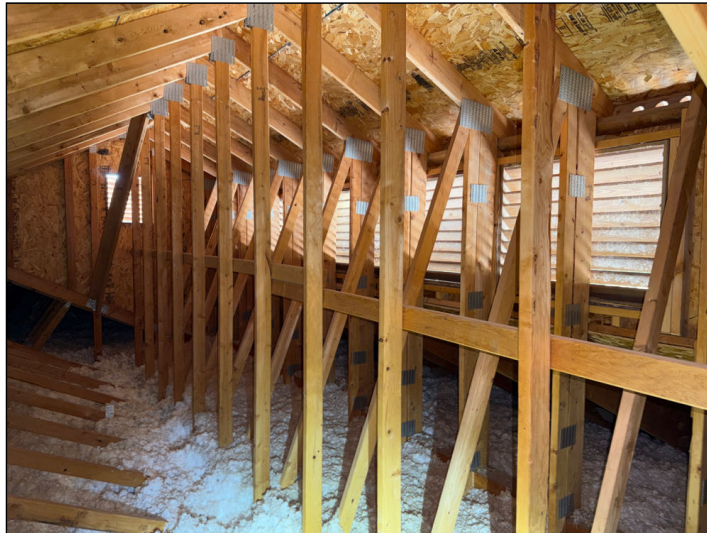
Gable louver vents noted.

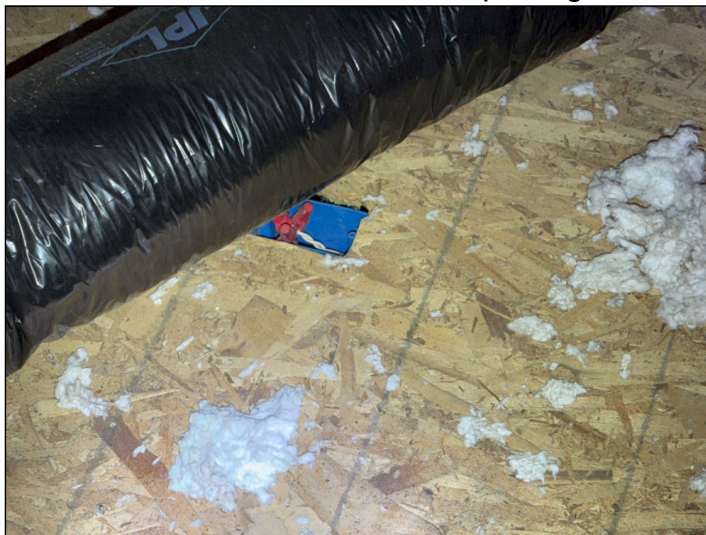
- Electrical Box Covers missing or damaged, which is a potential shock or electrocution hazard, recommend replacing for added safety.

Electrical Box Covers missing or damaged, which is a potential shock or electrocution hazard, recommend replacing for added safety.

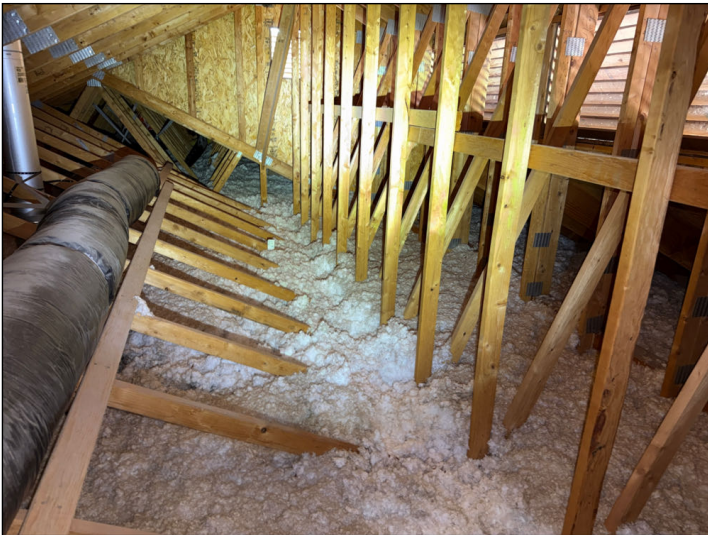
Insulation appears adequate and in good condition.

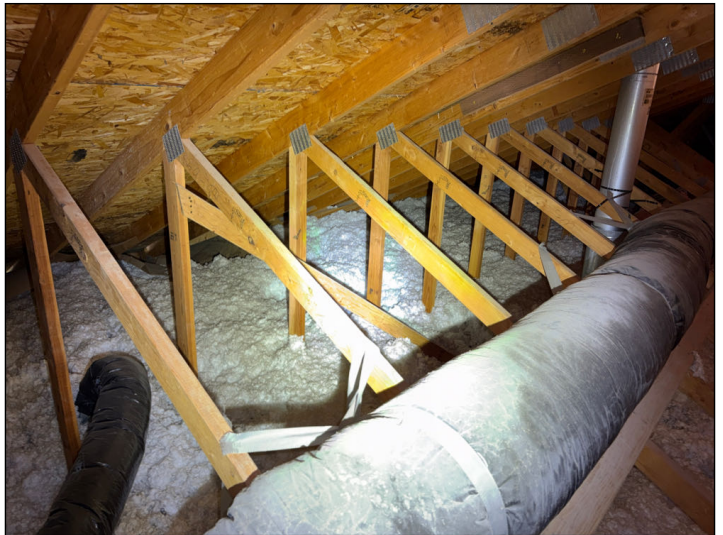
Insulation appears adequate and in good condition.

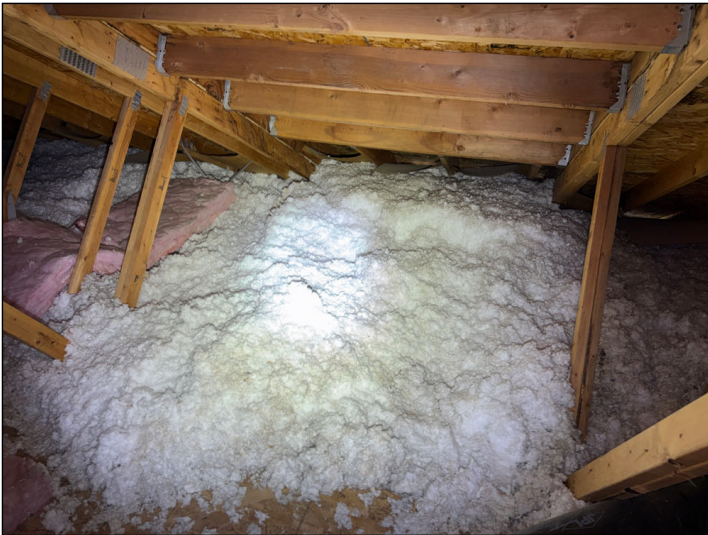
Insulation appears adequate and in good condition.

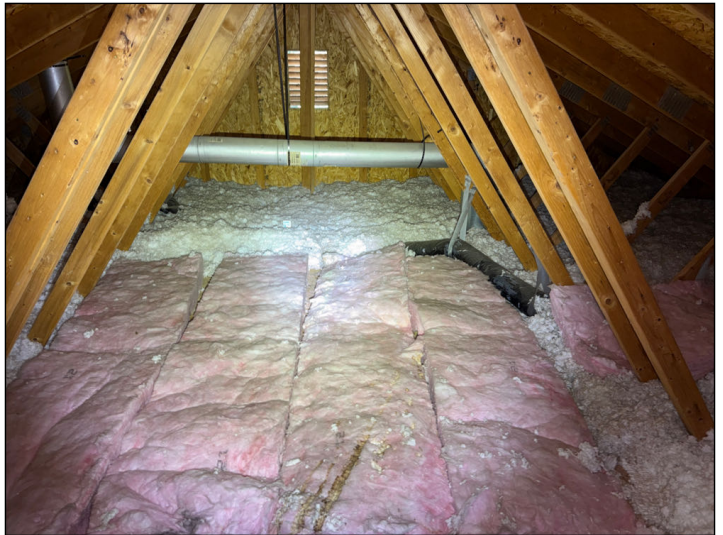
Insulation appears adequate and in good condition.

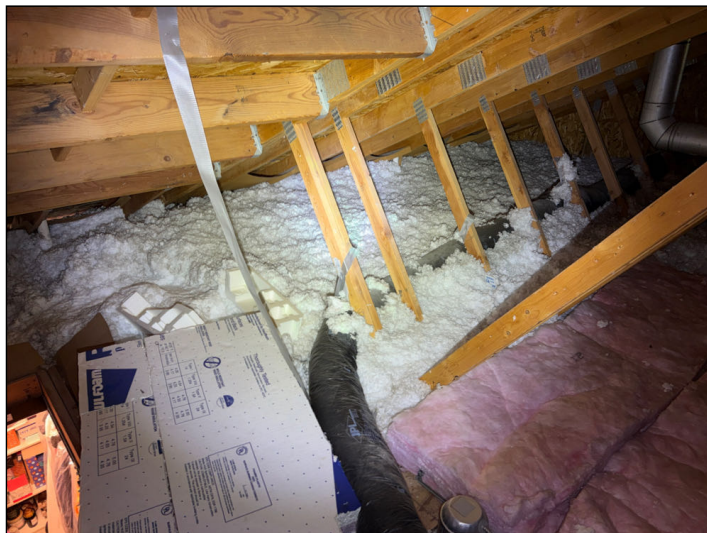
Insulation appears adequate and in good condition.

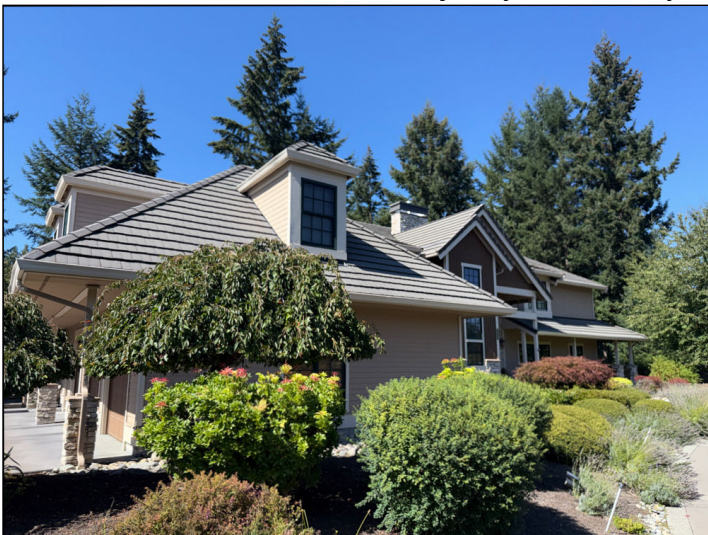
No major system safety or function concerns noted at time of inspection.

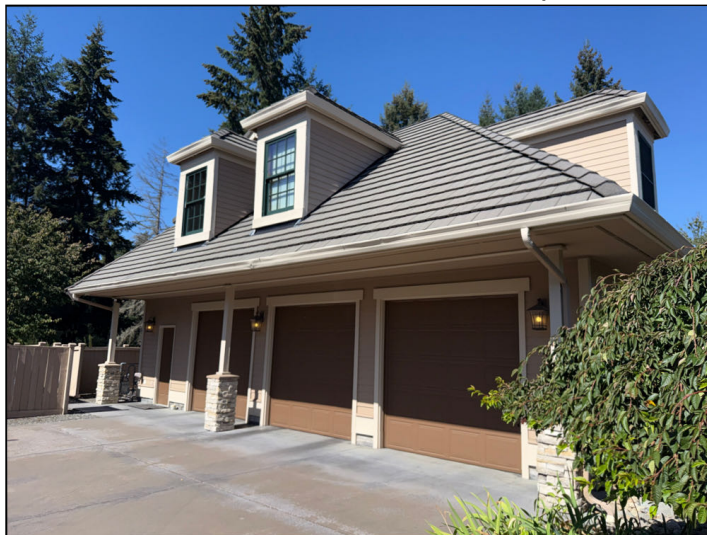
No major system safety or function concerns noted at time of inspection.

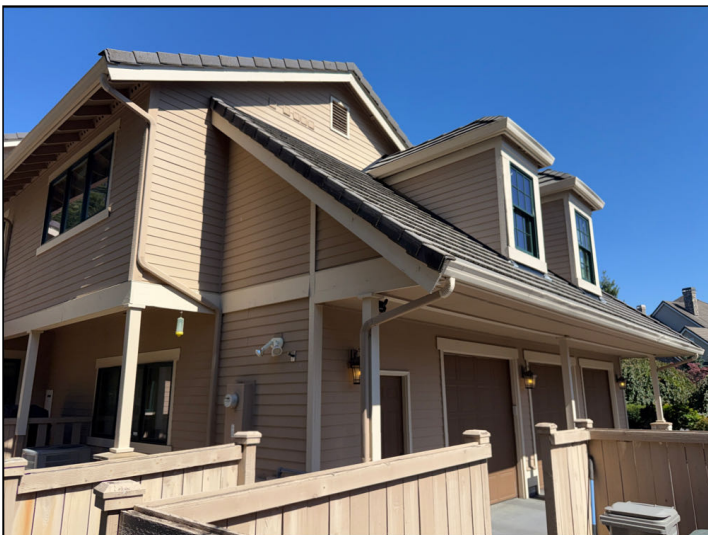
No major system safety or function concerns noted at time of inspection.

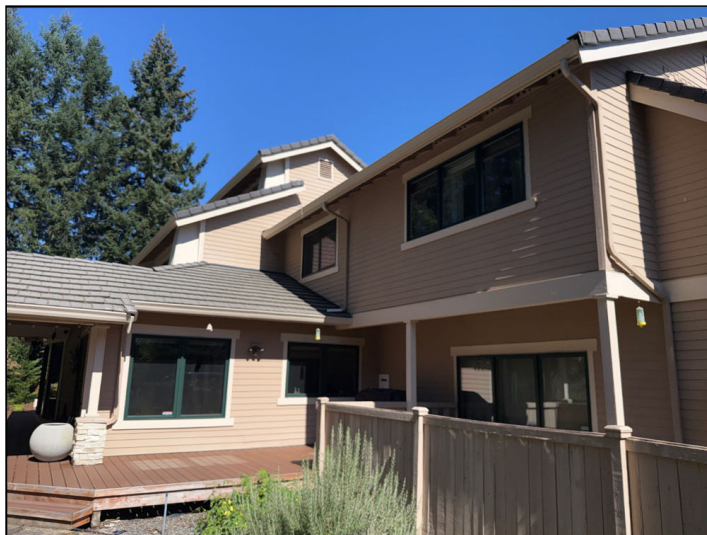
No major system safety or function concerns noted at time of inspection.

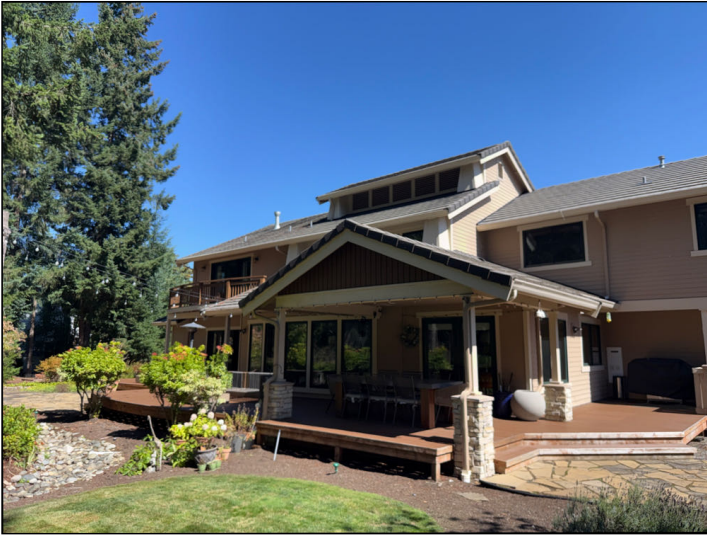
No major system safety or function concerns noted at time of inspection.

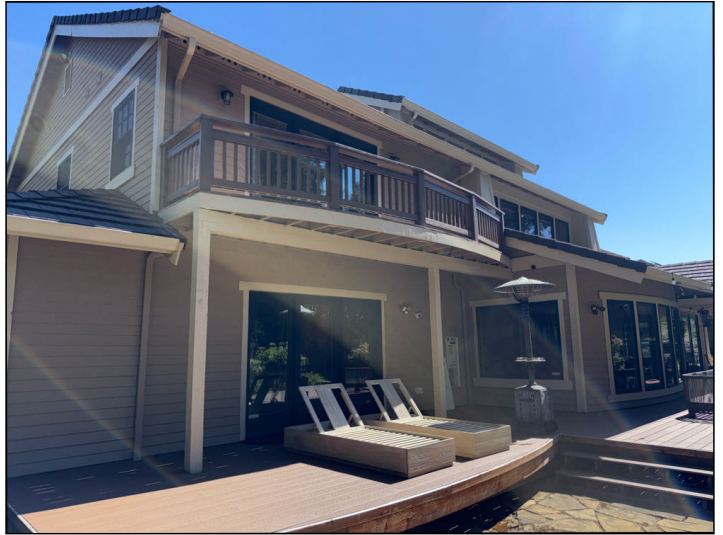
No major system safety or function concerns noted at time of inspection.

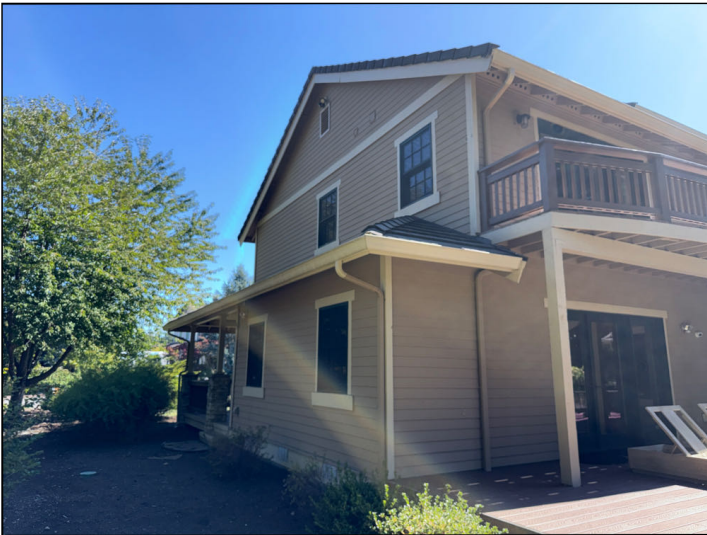
No major system safety or function concerns noted at time of inspection.

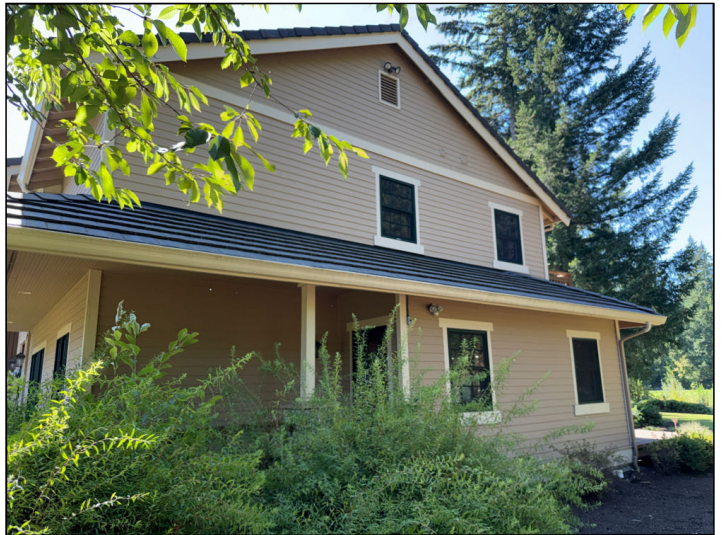
No major system safety or function concerns noted at time of inspection.

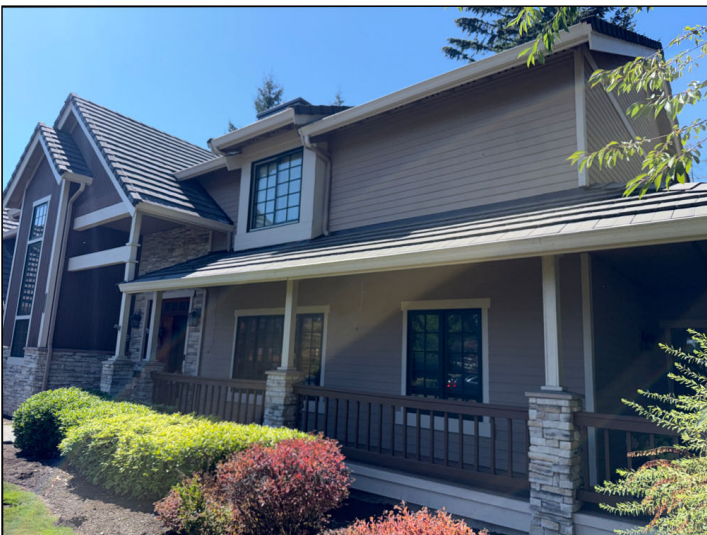
No major system safety or function concerns noted at time of inspection.

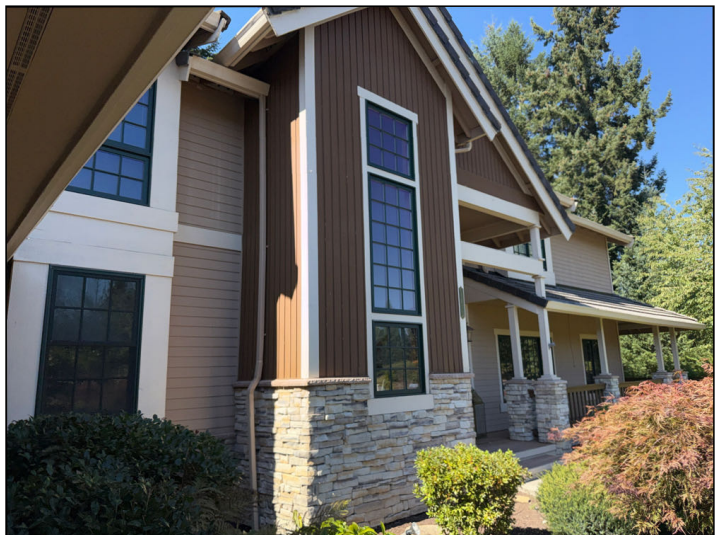
No major system safety or function concerns noted at time of inspection.

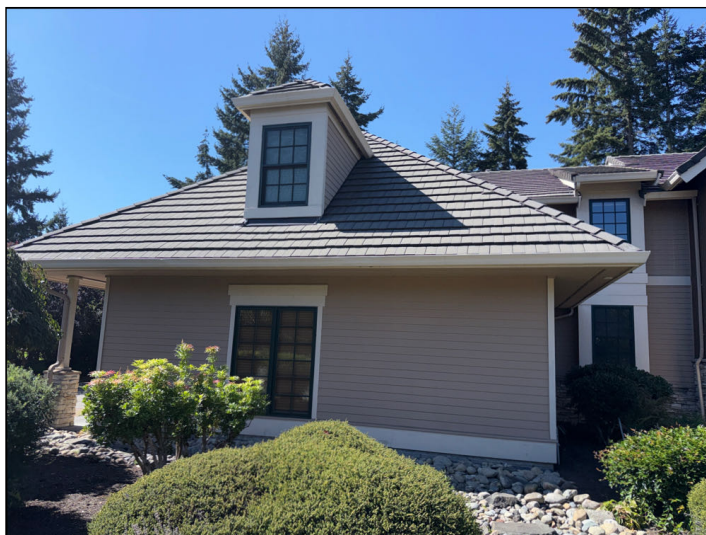
No major system safety or function concerns noted at time of inspection.

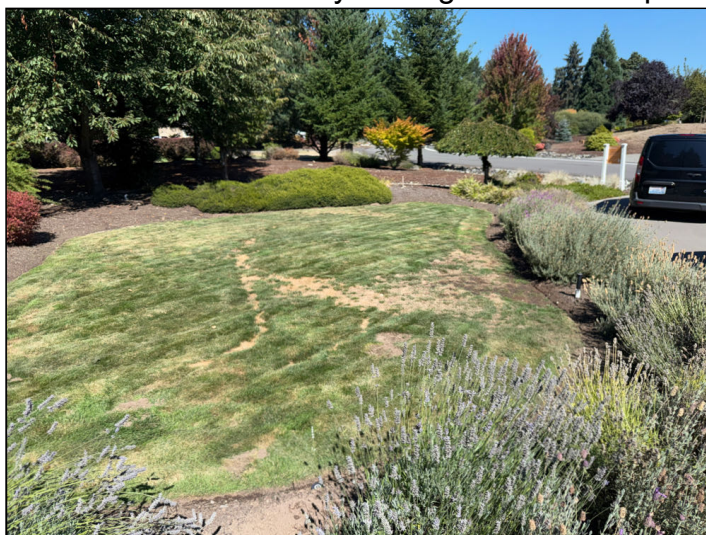
Part of the grass is brown possibly indicating an issue with the sprinklers. Landscaping irrigation is outside of the home inspection scope of work. Recommend evaluation by an irrigation landscaper.

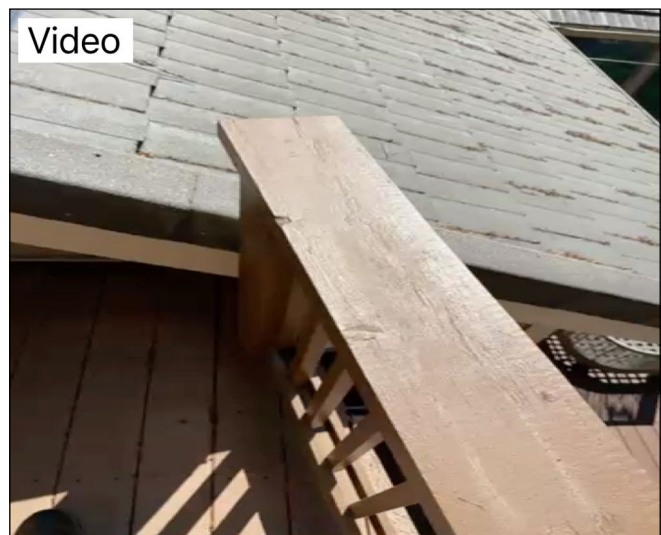
The back 2nd floor deck railings were observed to be loose or unstable. Guardrails should be securely fastened to provide adequate safety for occupants and visitors. Recommend further evaluation and repair as needed to improve stability.

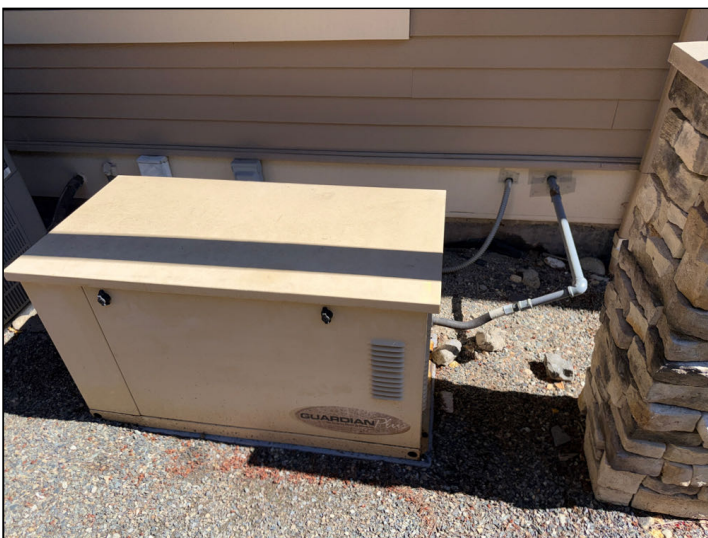
A built-in natural gas generator was present but was not operated or evaluated, as generators are outside the scope of this inspection. Recommend having the system inspected and serviced by a qualified generator technician before use.

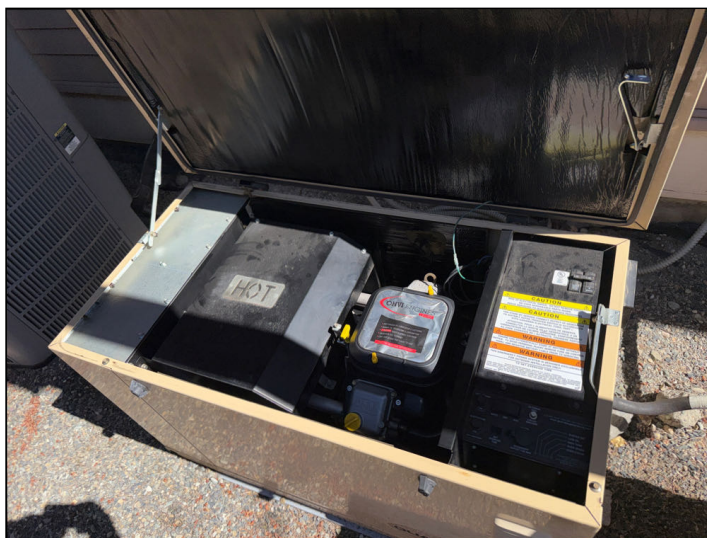
A built-in natural gas generator was present but was not operated or evaluated, as generators are outside the scope of this inspection. Recommend having the system inspected and serviced by a qualified generator technician before use.
