PROPERTY INSPECTION  
**REPORT**

**12345 125th St E, Puyallup, WA 98374**

DATE OF INSPECTION: 9/8/2026

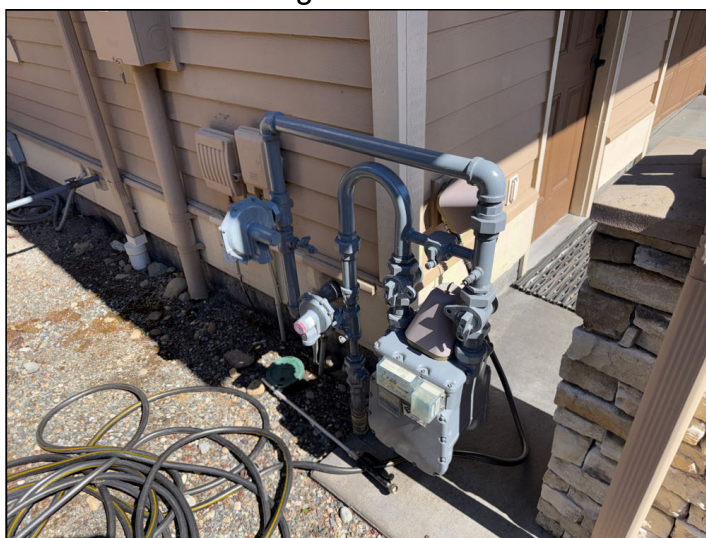
Meter located at exterior West side. All gas appliances have cut-off valves in line at each unit. No gas odors detected.

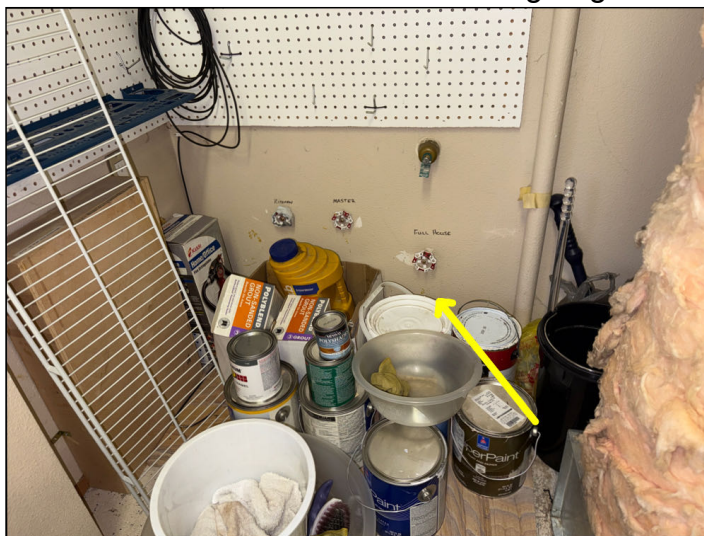
Main water shutoff was located in the garage on the north wall.

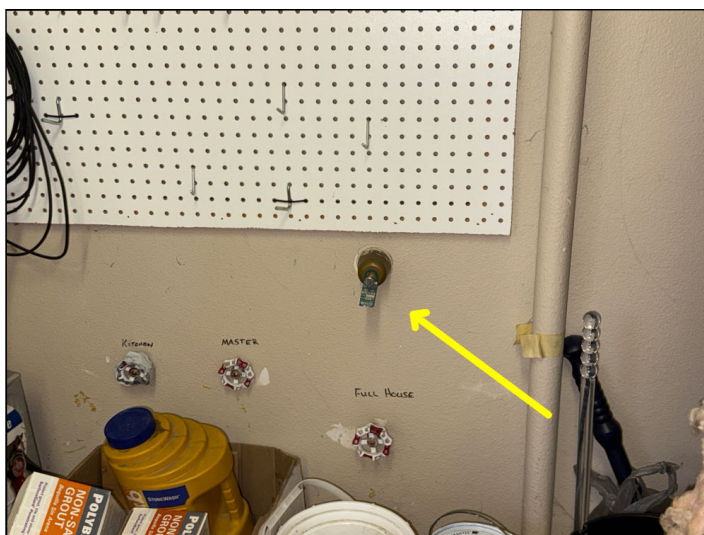
Pressure regulator noted in the garage above the main water shutoff.

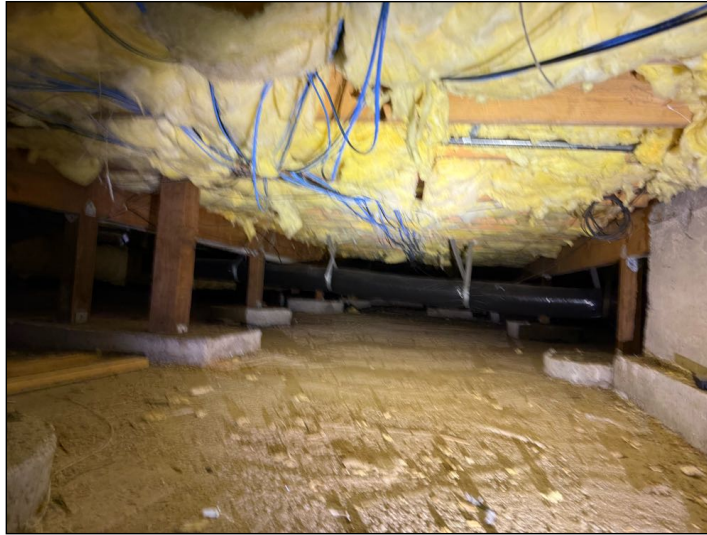
The crawlspace has a concrete floor slab; therefore, a separate ground vapor barrier is not required.

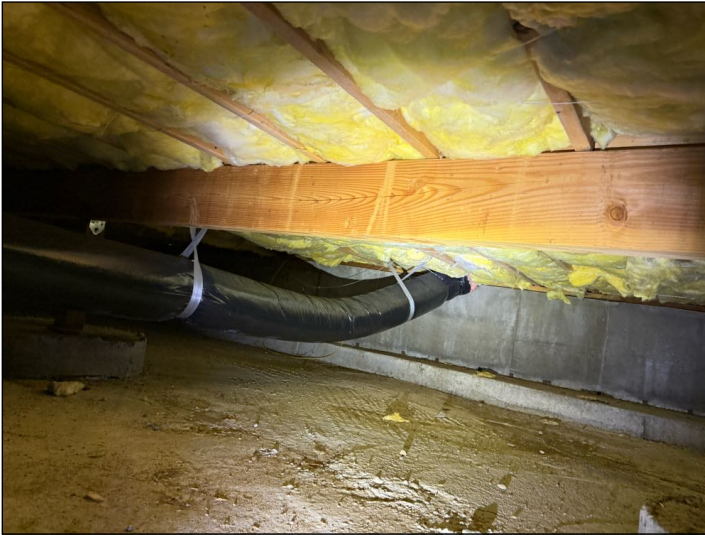
The crawlspace batt insulation was noted to be in place and in good condition.

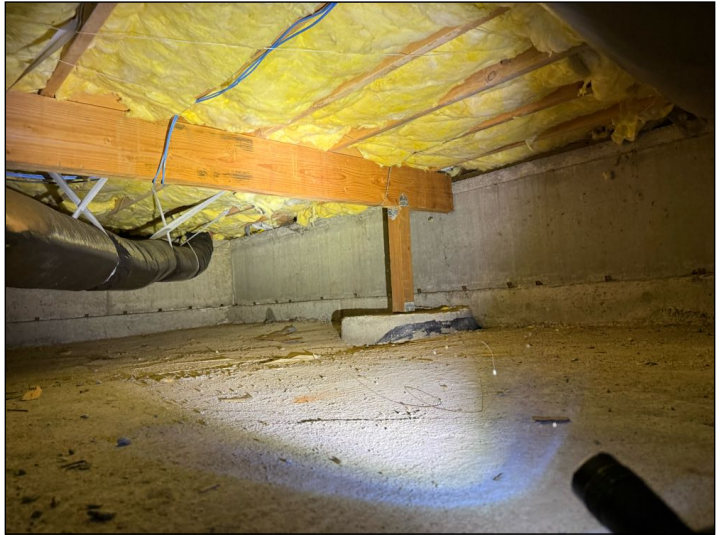
The crawlspace batt insulation was noted to be in place and in good condition.

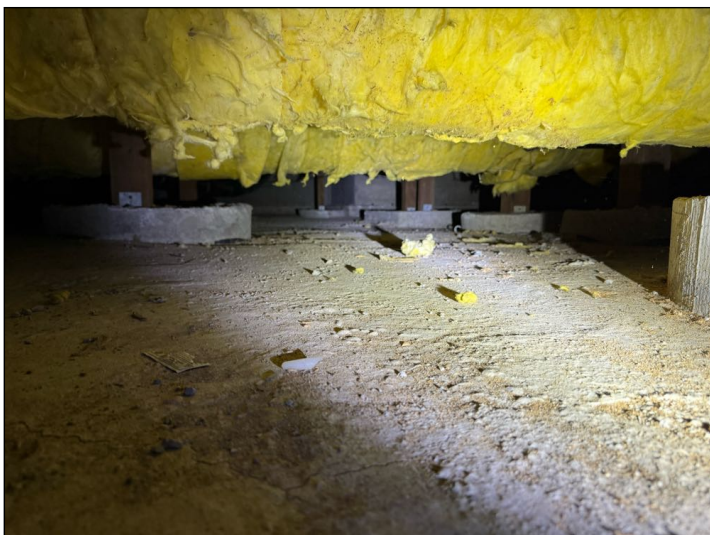
The crawlspace batt insulation was noted to be in place and in good condition.

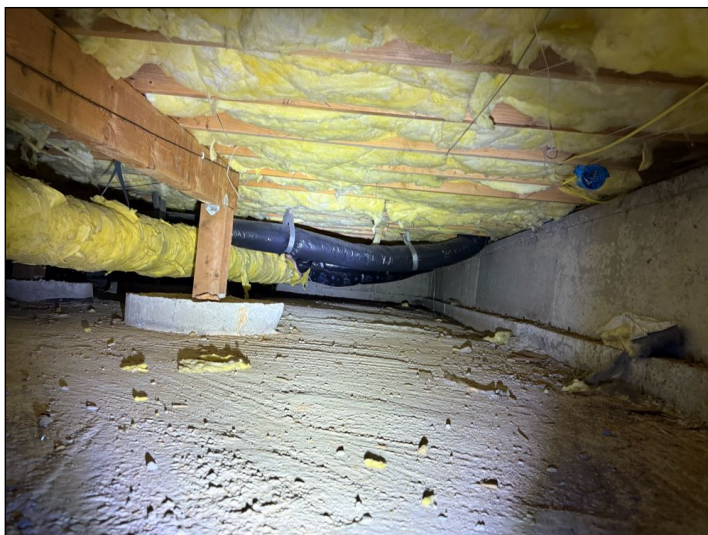
The crawlspace batt insulation was noted to be in place and in good condition.
