## PROPERTY INSPECTION **REPORT**

**12345 125th St E, Puyallup, WA 98375**

DATE OF INSPECTION: 9/10/2026

Year Built: 1986

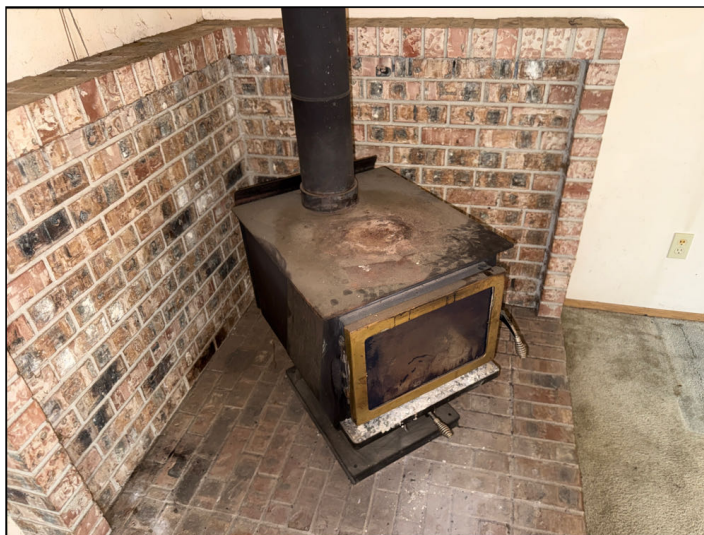
Materials: Masonry fireplace noted.

Recommend having the fireplace stove and venting system professionally cleaned and serviced before use to help ensure safe and proper operation.

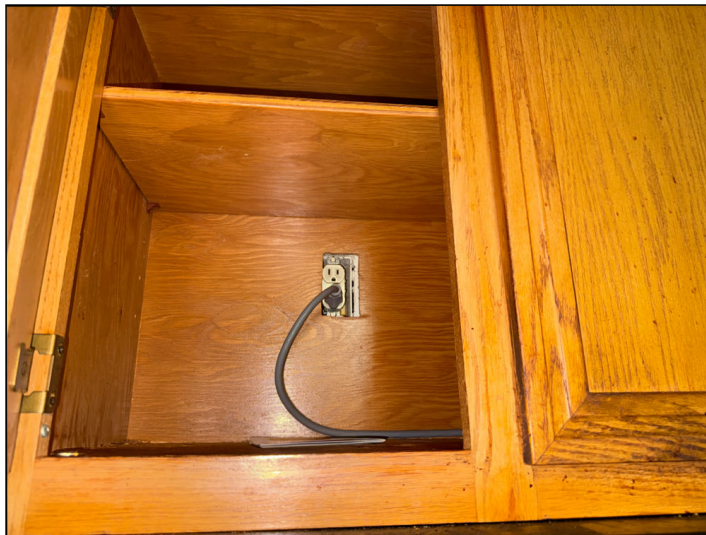
Outlet needs new cover in the cabinet over the range hood.

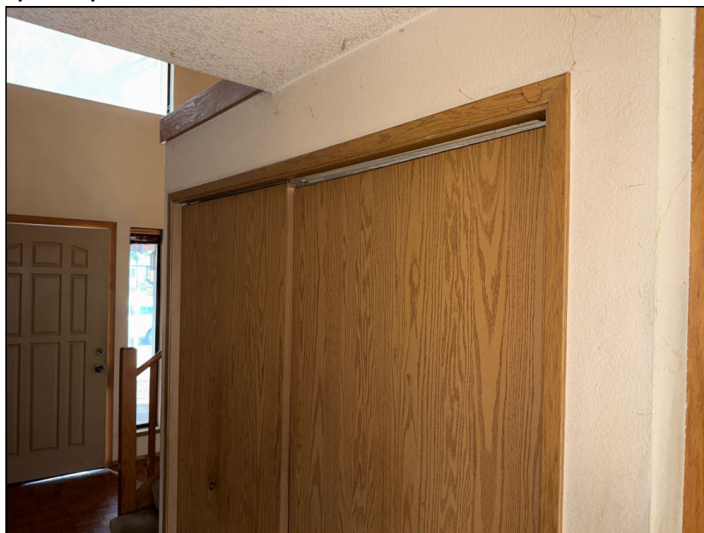
The bi-fold doors at the laundry area are damaged and/or have come off their tracks. Recommend adjusting or repairing the doors as needed for proper operation.

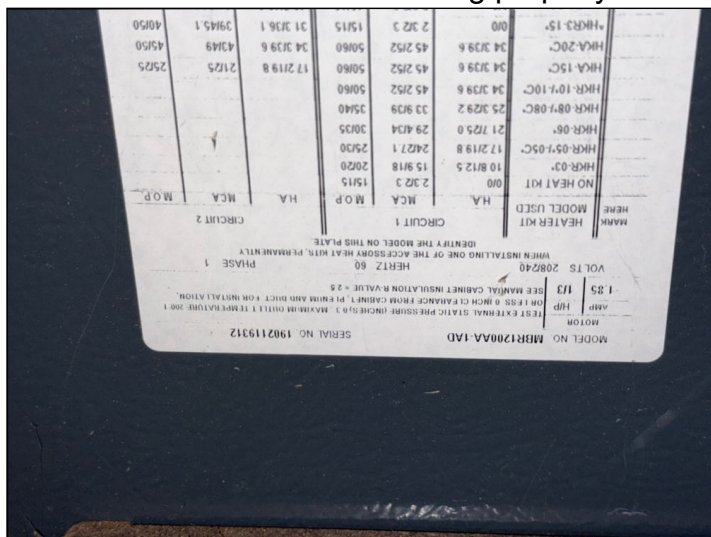
The electric furnace appears to have been manufactured in 2019 and was functioning properly at the time of the inspection.

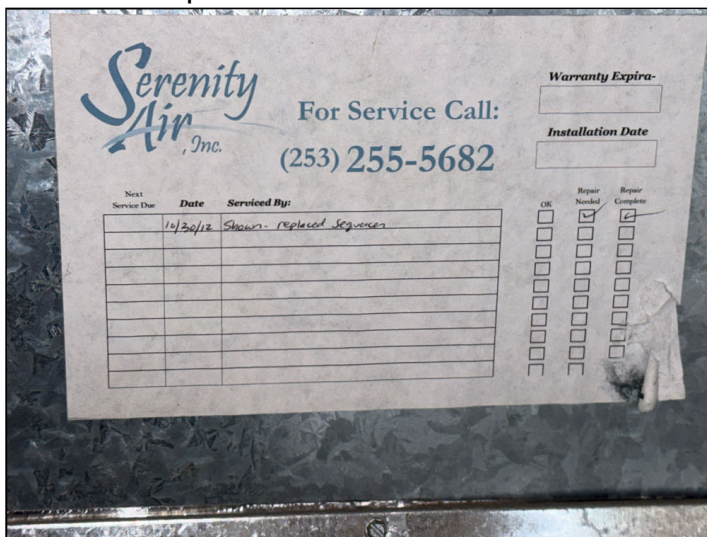
Electric Furnace: Last service date is over one year ago, or is unable to be determined. Although this unit appears to be operating properly from controls, there are areas which cannot be seen without specialized equipment and training. Furnace specialists recommend a complete inspection annually; consider having unit inspected by certified HVAC technician.

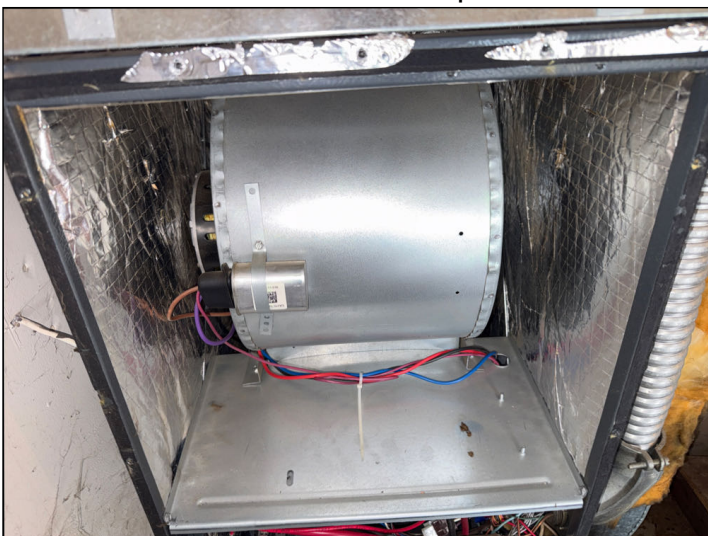
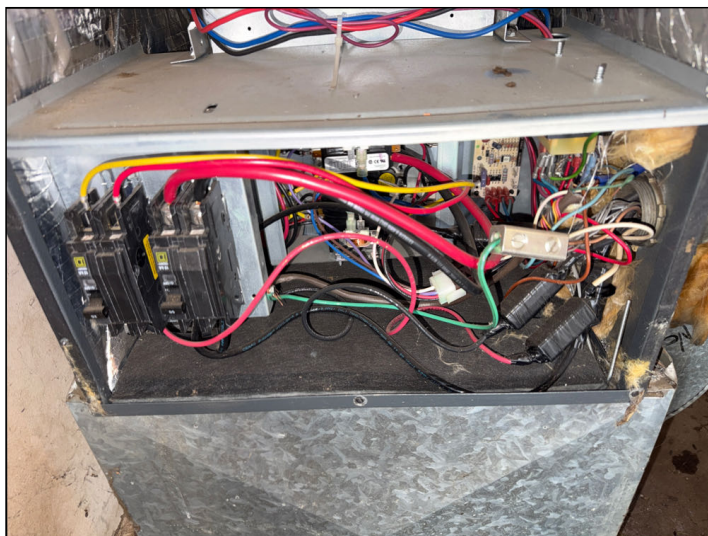
The furnace enclosure appeared to be in satisfactory condition at the time of the inspection.

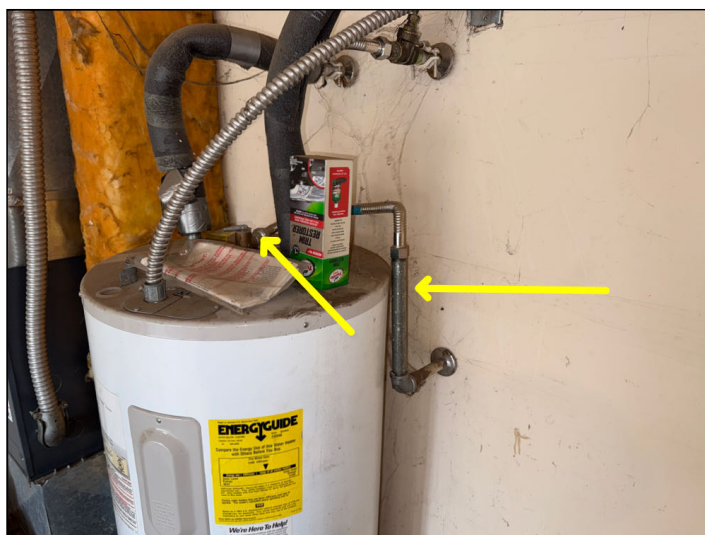
| Interior Areas | | |
|---|---|---|
| Page 25 Item: 6 | TPRV | • The temperature-pressure relief valve (TPRV) drain line is improperly installed. The drain line runs uphill and includes flexible piping, which can restrict proper drainage. Recommend replacing it with an approved rigid drain line that continuously slopes downward to a proper termination point. |

The temperature-pressure relief valve (TPRV) drain line is improperly installed. The drain line runs uphill and includes flexible piping, which can restrict proper drainage. Recommend replacing it with an approved rigid drain line that continuously slopes downward to a proper termination point.

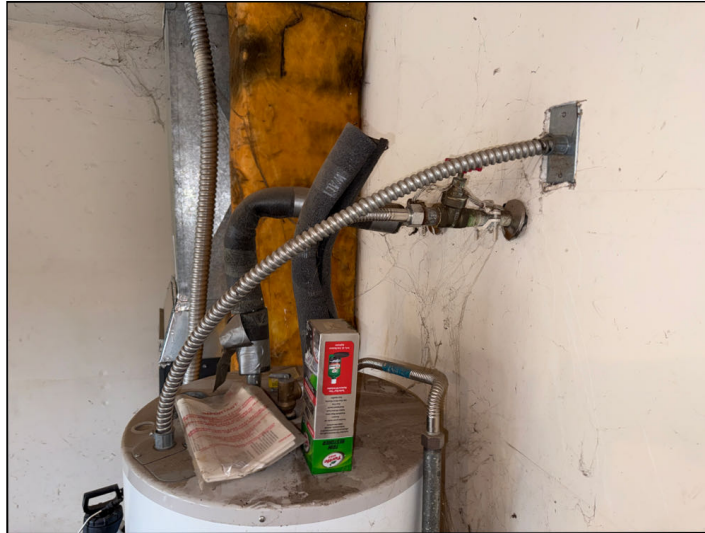
| Page 26 Item: 10 | Plumbing | <ul style="list-style-type: none"> <li>• No <b>expansion tank</b> noted on for the water heater. It is common practice at this point to have the expansion tank installed on the cold water inlet to the water heater. Recommend upgrading to current practices.</li> </ul> |

No expansion tank noted on for the water heater. It is common practice at this point to have the expansion tank installed on the cold water inlet to the water heater. Recommend upgrading to current practices.

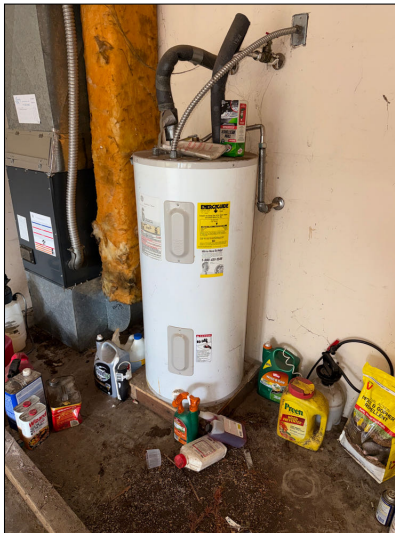
| Page 27 Item: 11 | Strapping | <ul style="list-style-type: none"> <li>• The water heater is not strapped which is required for most loan types. Recommend having two 1 1/2" steel straps 16 gauge, 1/3 from the top and the bottom added before the appraisal.</li> </ul> |

The water heater is not strapped which is required for most loan types. Recommend having two 1 1/2" steel straps 16 gauge, 1/3 from the top and the bottom added before the appraisal.

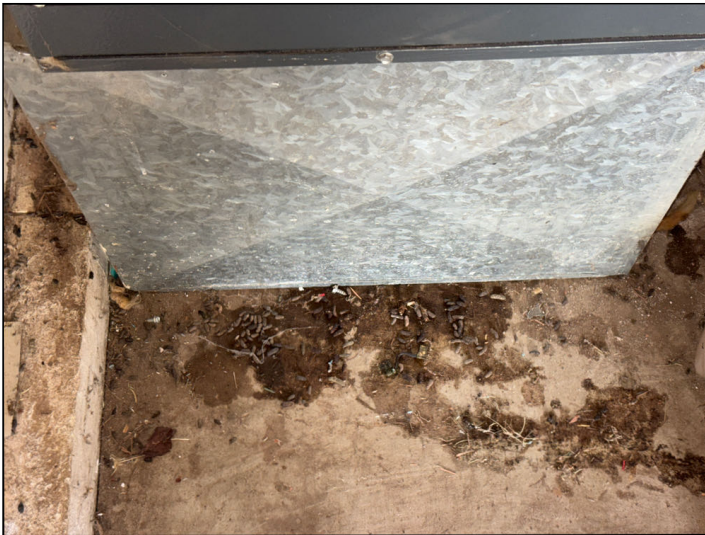
Rodent droppings noted on the concrete floor around the furnace in the garage.

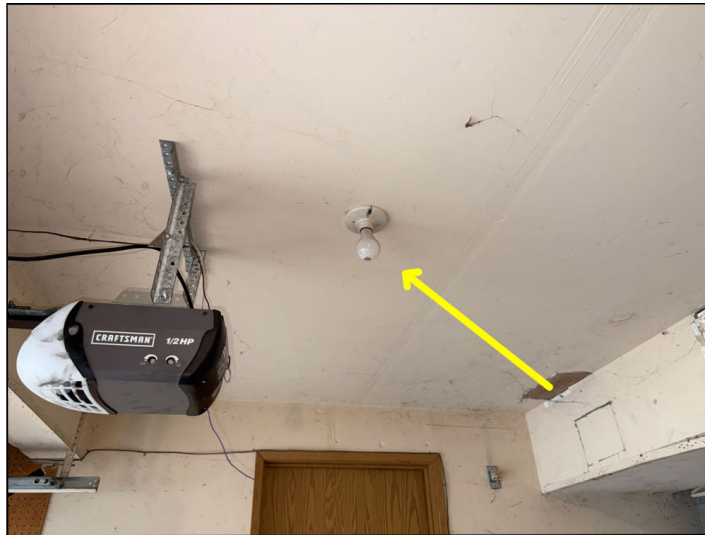
One the garage lights not functioning.

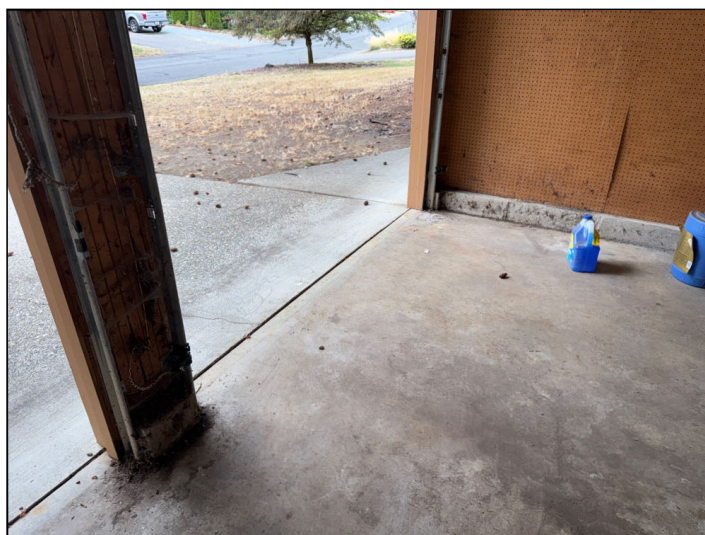
Eye beam system present and operating.

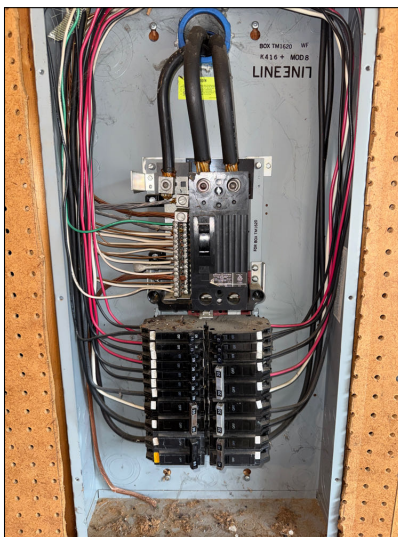
No major system safety or function concerns noted at time of inspection at the main panel box.

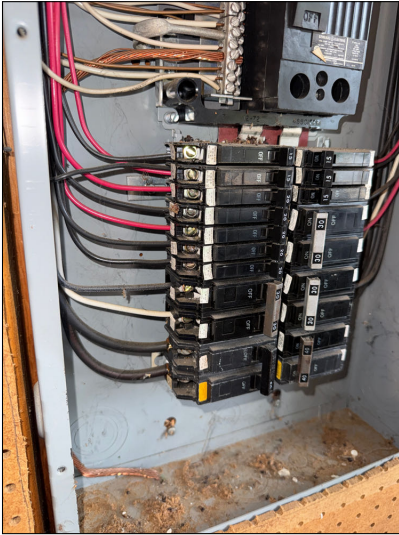
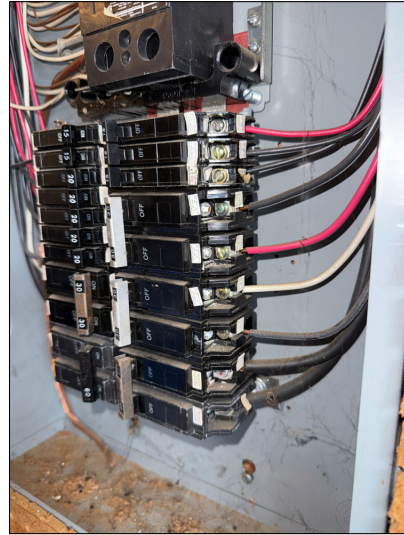
All of the circuit breakers appeared serviceable. All of the circuit breakers appeared serviceable.

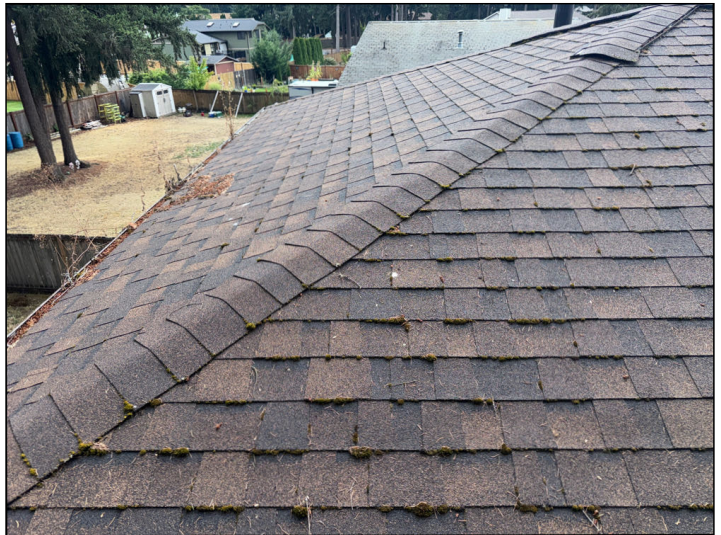
**Debris on Roof**

Organic debris was observed on the roof surface. Debris can trap moisture and accelerate deterioration of roofing materials. Recommend cleaning the roof as part of routine maintenance.

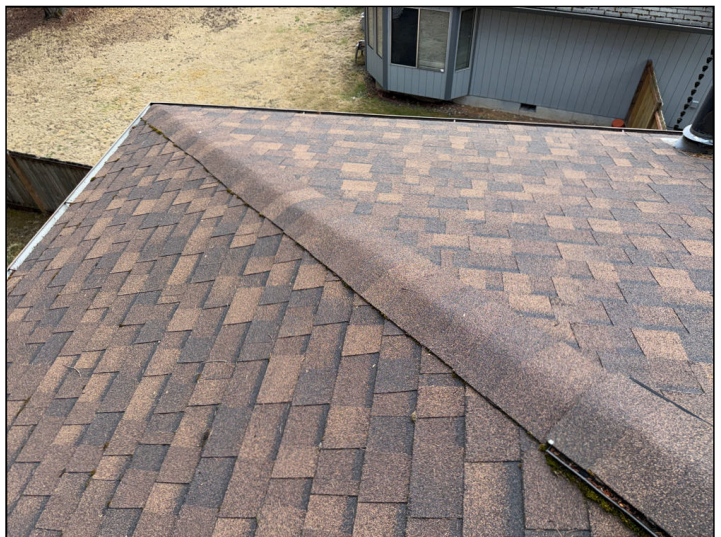
Recommend securing the loose ridge shingle. Due to the ridge vent longer roof nails will be needed.

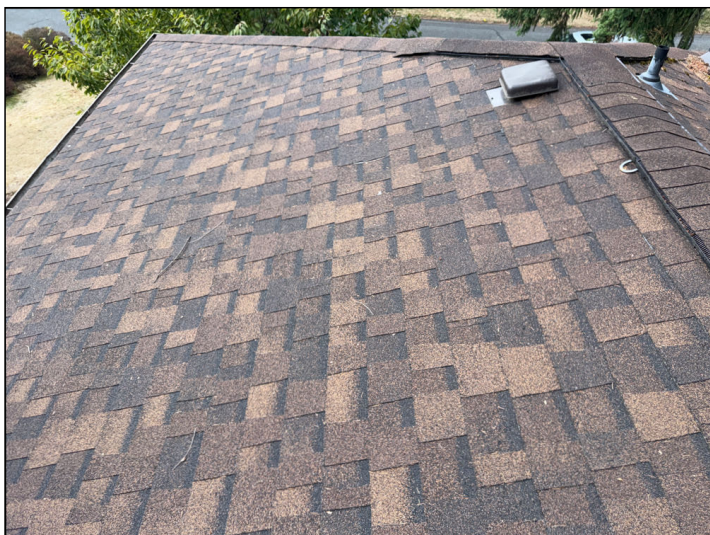
**Roof – No Major Concerns**

Areas that are visible without debris. No major safety or functional concerns were observed with the roof covering at the time of the inspection. Routine maintenance and periodic monitoring are recommended.

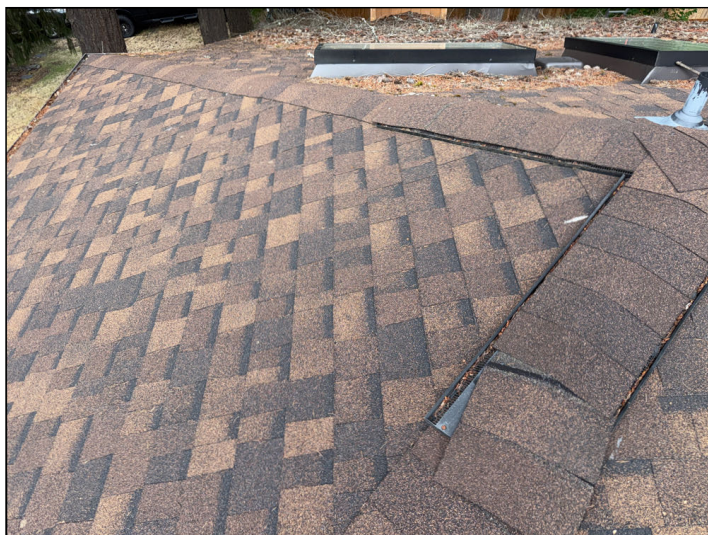
Roof – No Major Concerns

Areas that are visible without debris. No major safety or functional concerns were observed with the roof covering at the time of the inspection. Routine maintenance and periodic monitoring are recommended.

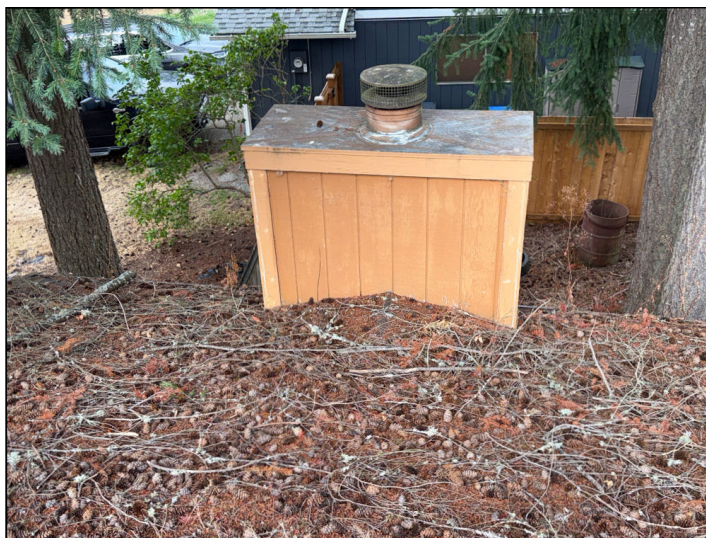
No major system safety or function concerns noted at time of inspection.

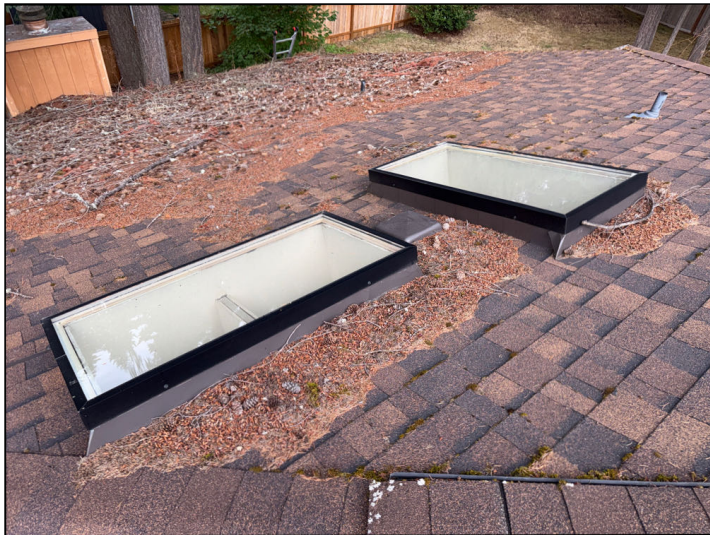
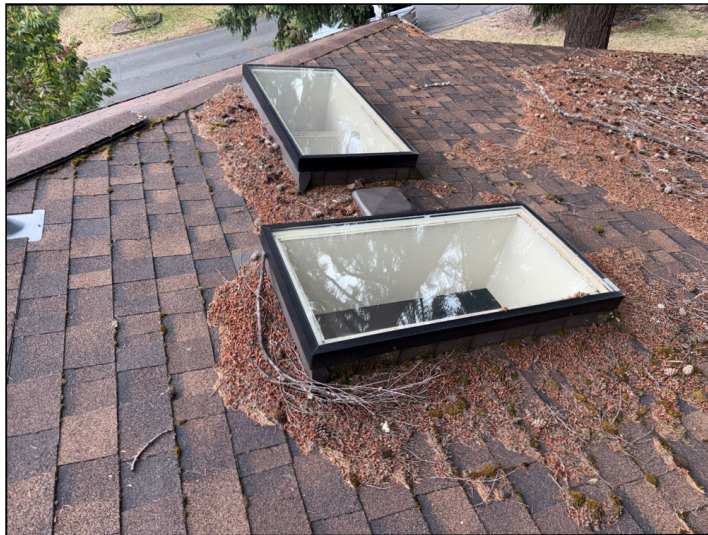
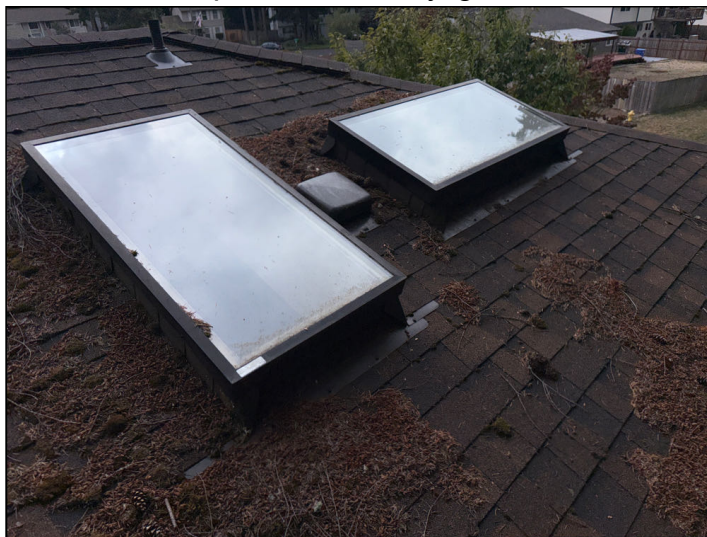
No signs of present or past leaking around the skylight were discovered at time of inspection.

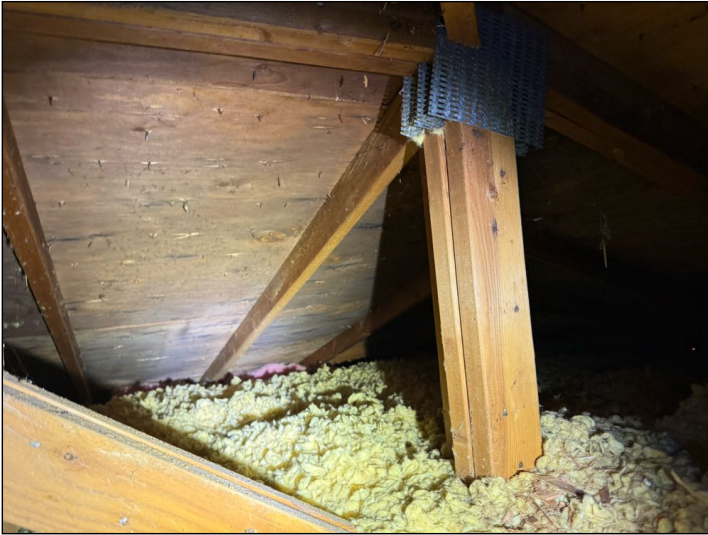
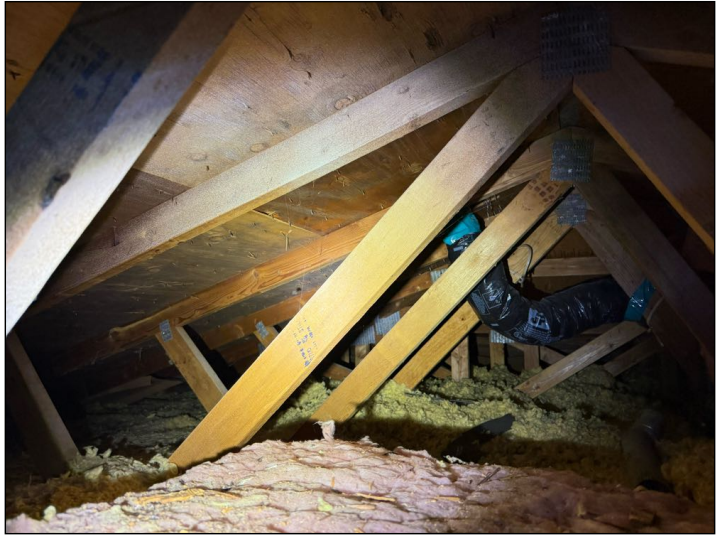
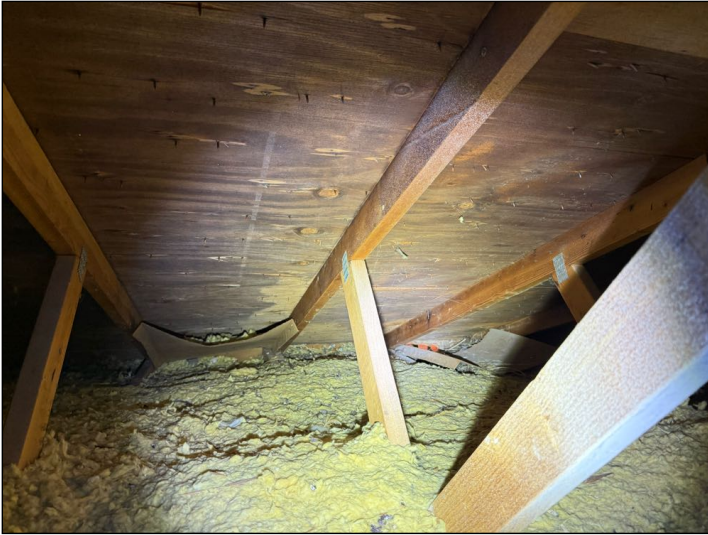
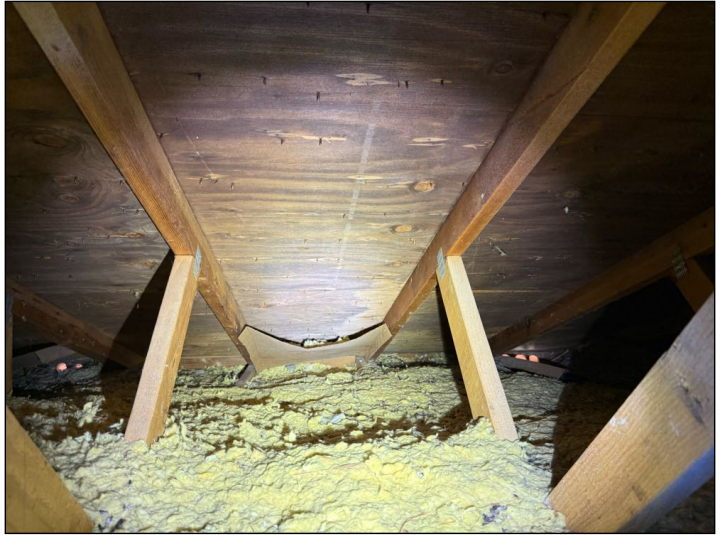
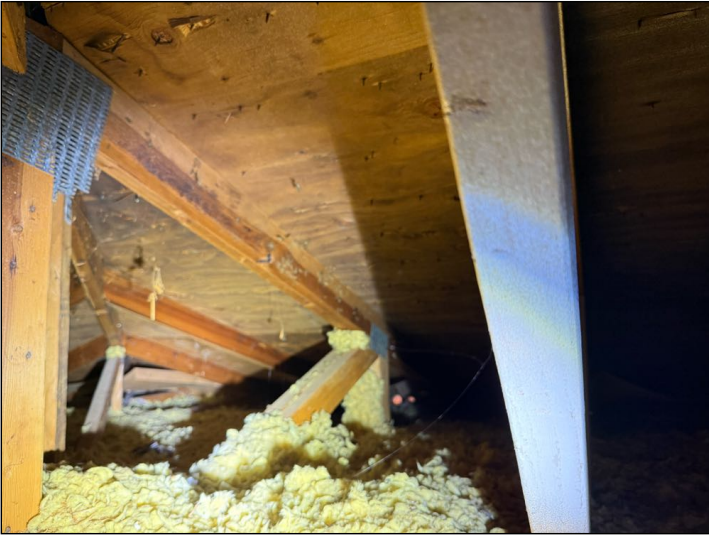
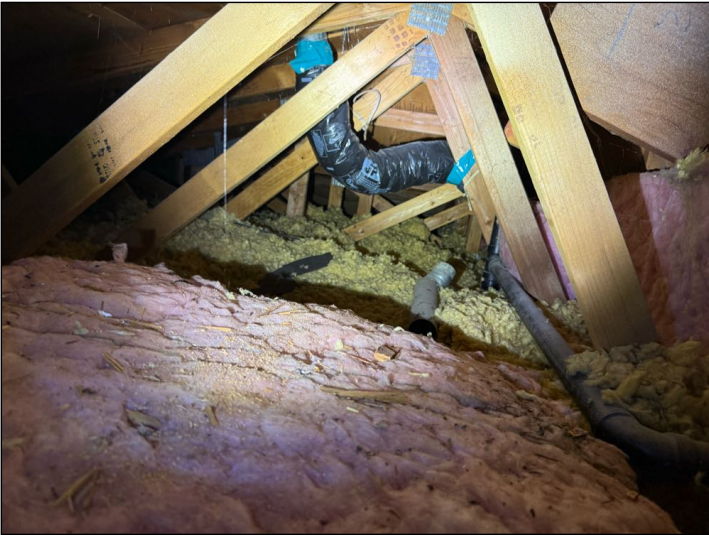
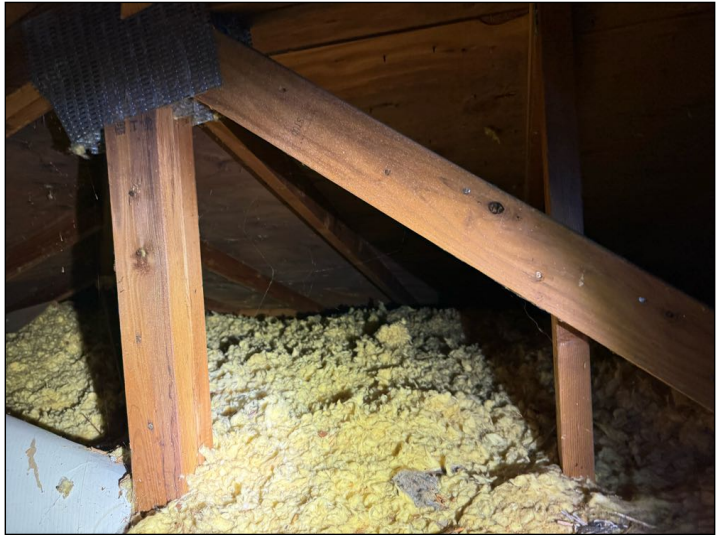
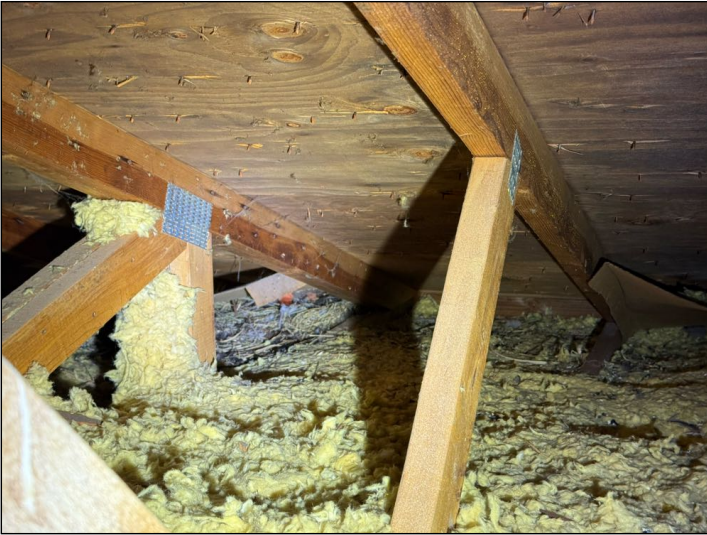
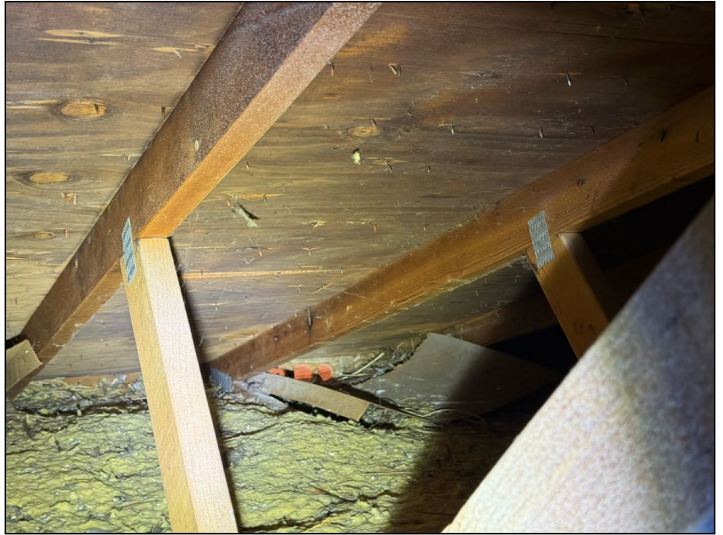
Insulation level in the attic is typical for homes this age. Recommend adding insulation for better home heating performance.

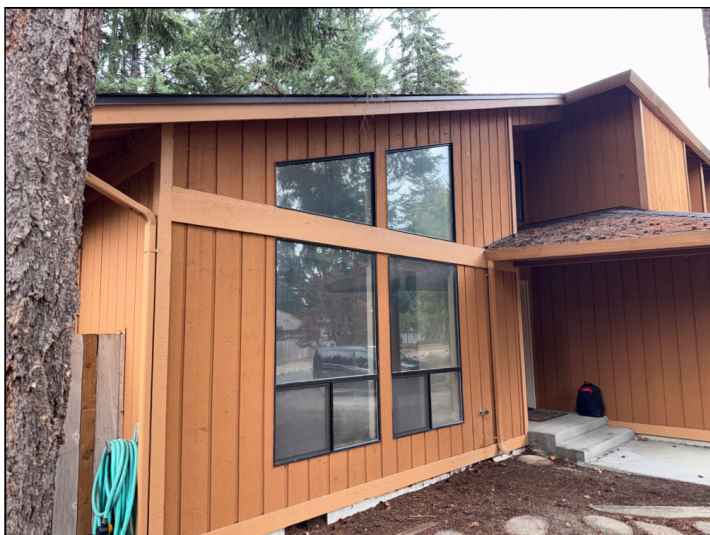
- Some of the channel siding at the front (west) elevation is cupping and pulling away from the home. Recommend securing and painting the affected siding as needed. Replace any boards that cannot be properly repaired.
- Moisture damage and wood rot were noted at the siding on the east elevation near the leaking hose bib. Recommend repairing the leak and replacing all damaged siding and underlying materials as needed.

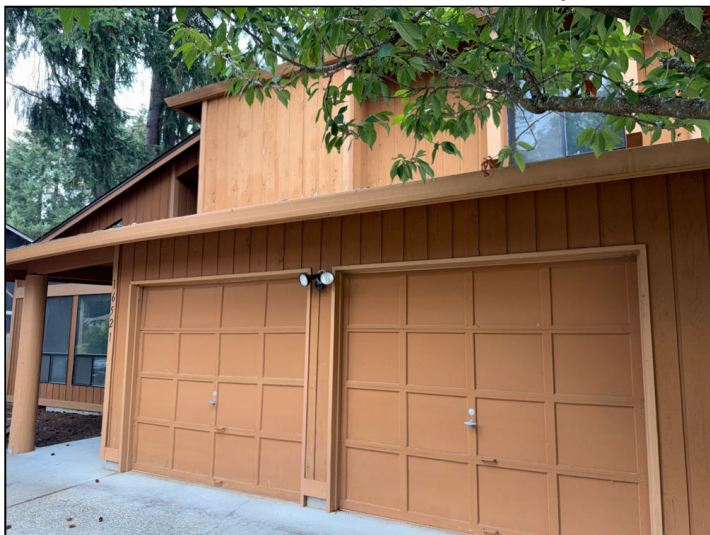
General Condition

Cedar siding was observed at the home. Cedar siding typically requires periodic maintenance such as painting or staining to help protect the wood from moisture and weather exposure.

Some of the channel siding at the front (west) elevation is cupping and pulling away from the home. Recommend securing and painting the affected siding as needed. Replace any boards that cannot be properly repaired.

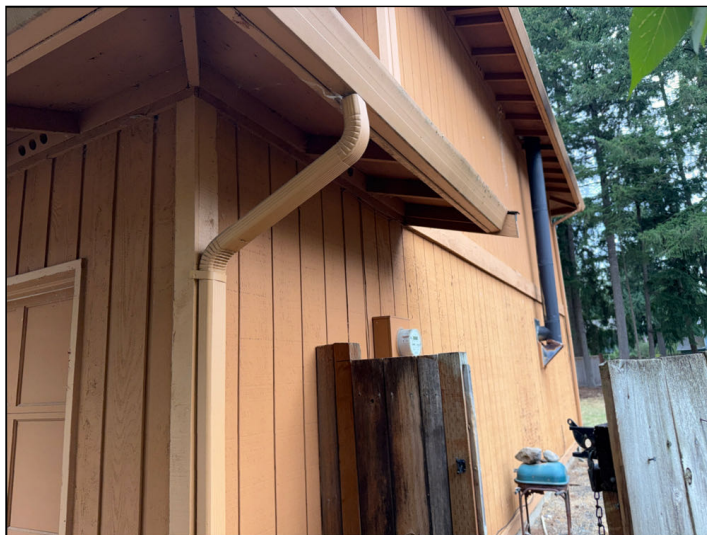
General Condition

Cedar siding was observed at the home. Cedar siding typically requires periodic maintenance such as painting or staining to help protect the wood from moisture and weather exposure.

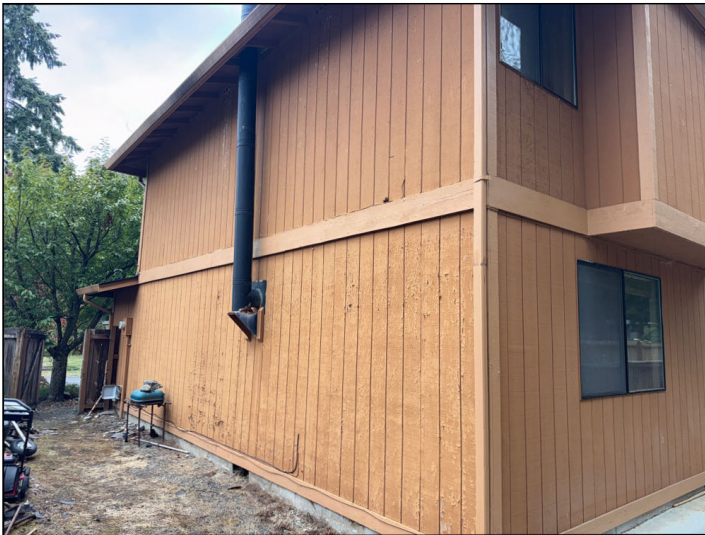
General Condition

T1-11 wood panel siding was observed at the home. This type of siding requires periodic maintenance such as painting or sealing to help protect the wood from moisture exposure.

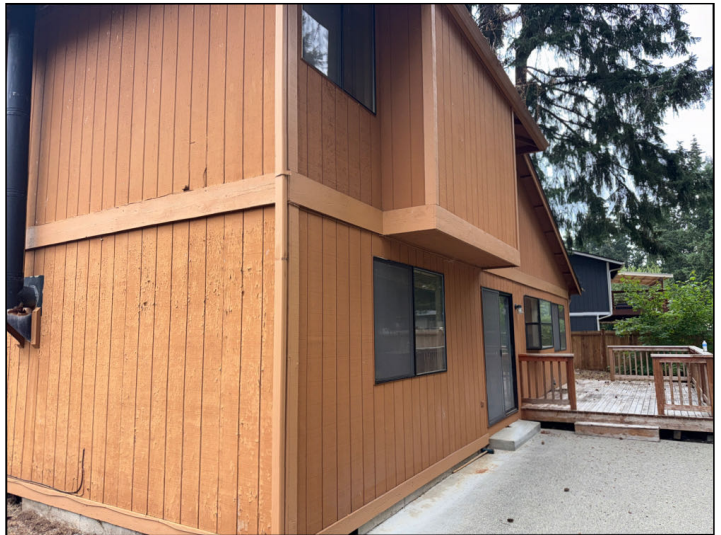
General Condition

T1-11 wood panel siding was observed at the home. This type of siding requires periodic maintenance such as painting or sealing to help protect the wood from moisture exposure.

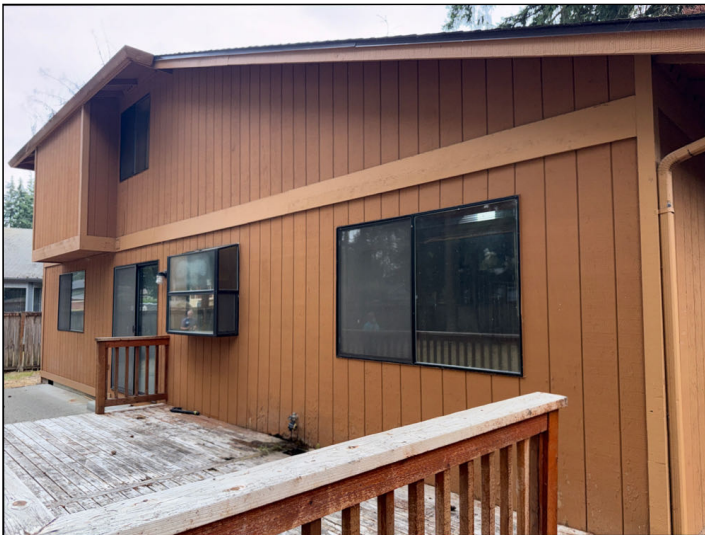
T1-11 wood panel siding was observed at the home. This type of siding requires periodic maintenance such as painting or sealing to help protect the wood from moisture exposure.

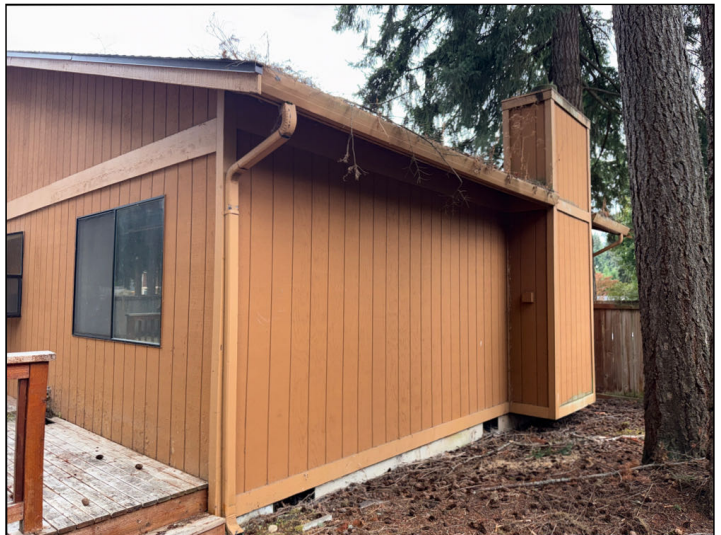
T1-11 wood panel siding was observed at the home. This type of siding requires periodic maintenance such as painting or sealing to help protect the wood from moisture exposure.

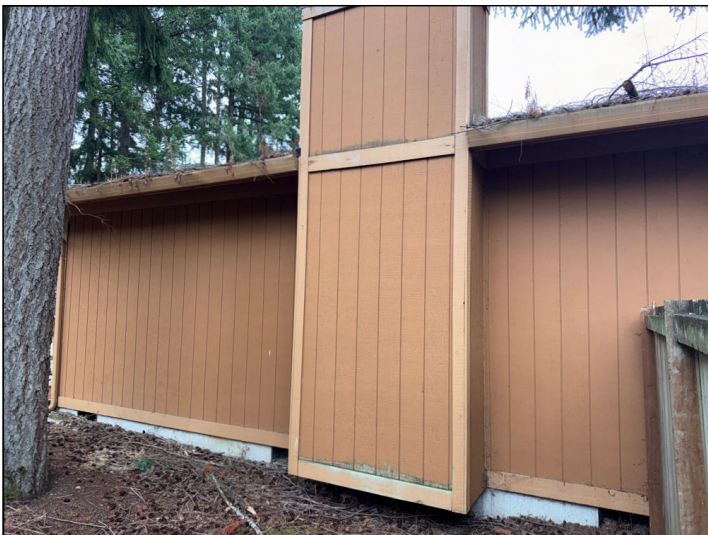
T1-11 wood panel siding was observed at the home. This type of siding requires periodic maintenance such as painting or sealing to help protect the wood from moisture exposure.

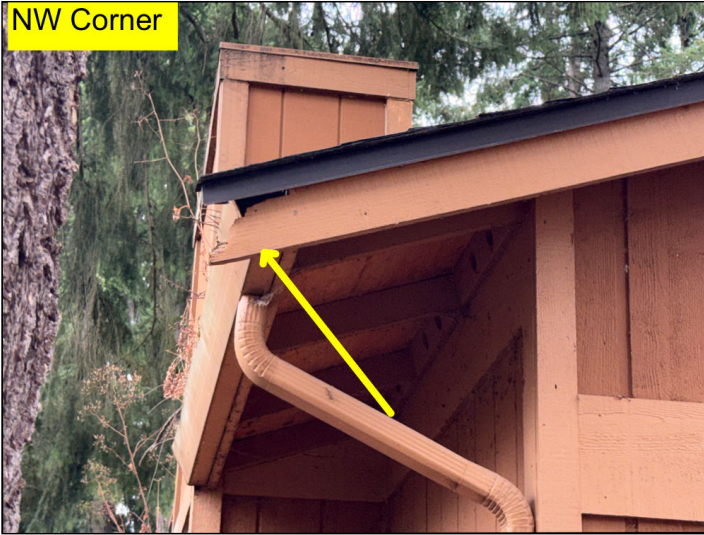
NW Corner

Moisture damage, wood rot, observed.  
Recommend review for repair as necessary.

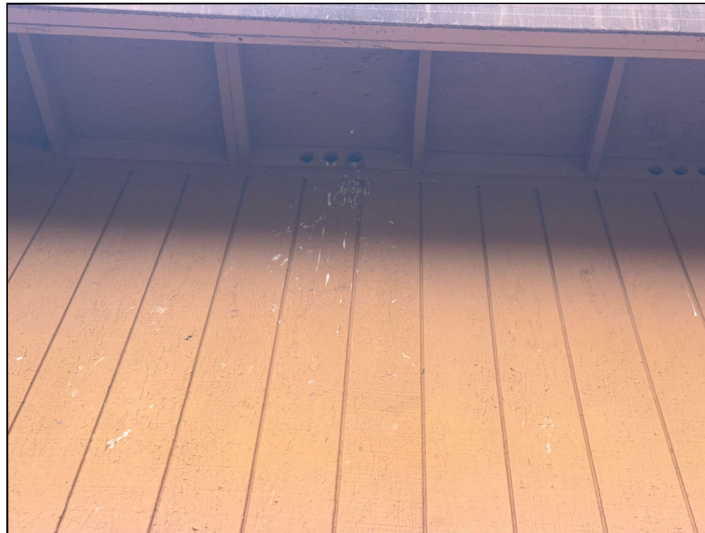
Missing vent screen noted on the south side of the home.

Missing vent screen noted on the south side.

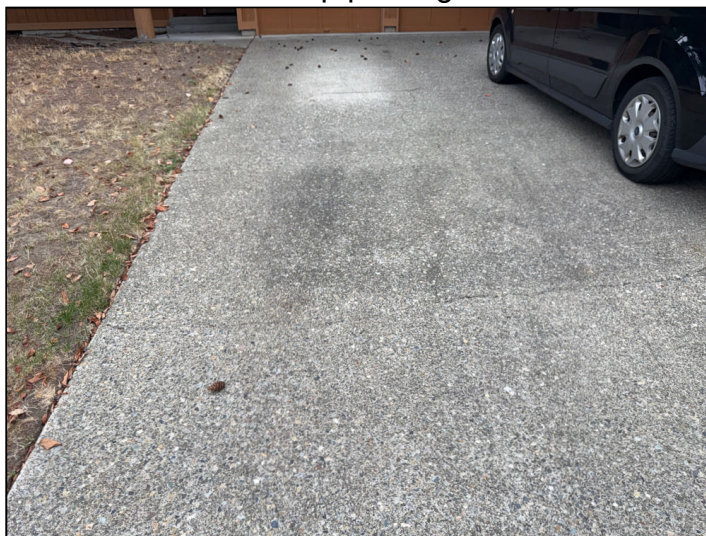
Typical cracking was observed at the concrete driveway surfaces. Minor cracking is common in concrete due to normal settlement and seasonal expansion and contraction from freeze–thaw cycles. Continued deterioration may occur over time as moisture enters the cracks and expands during freezing conditions. Recommend sealing the cracks and maintaining the surface as needed to help prolong the life of the concrete.

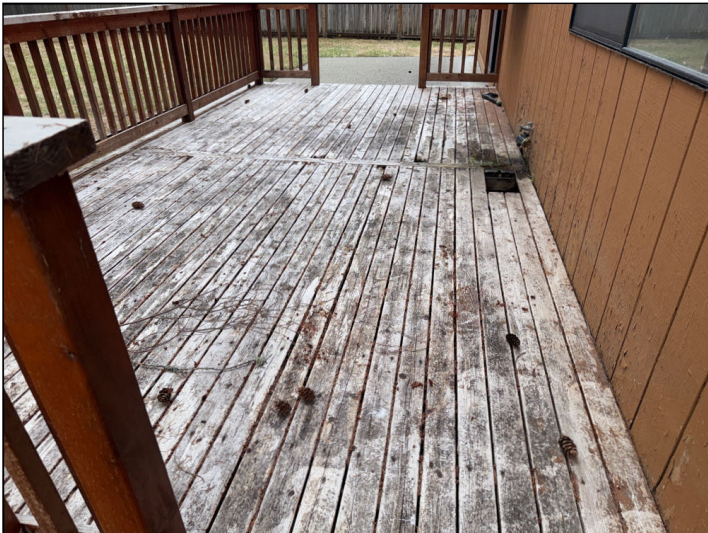
The wood deck is in poor condition and should be budgeted for replacement.

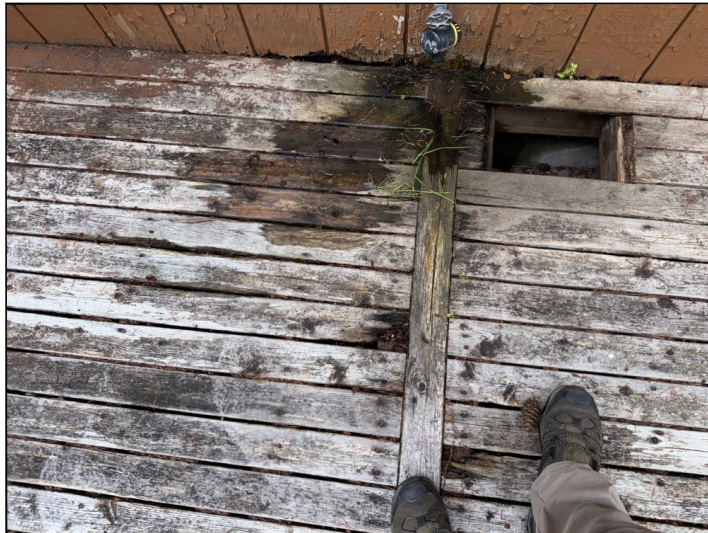
Some boards at the deck were rotting/deteriorating. Recommend replacing damaged boards as needed.

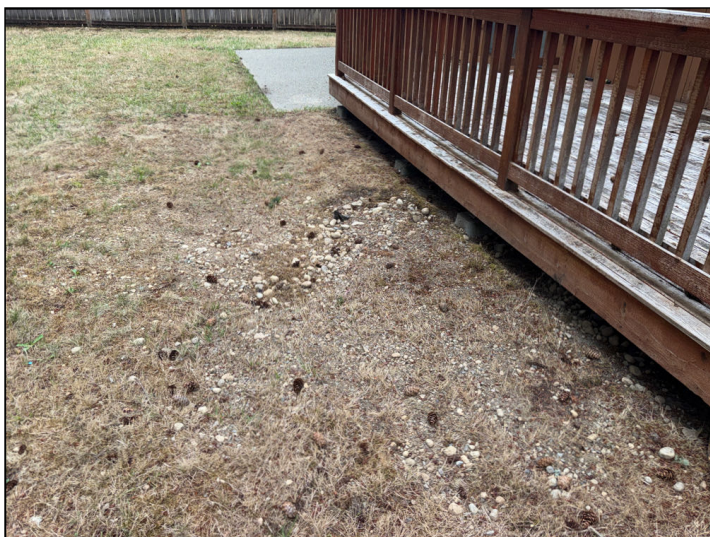
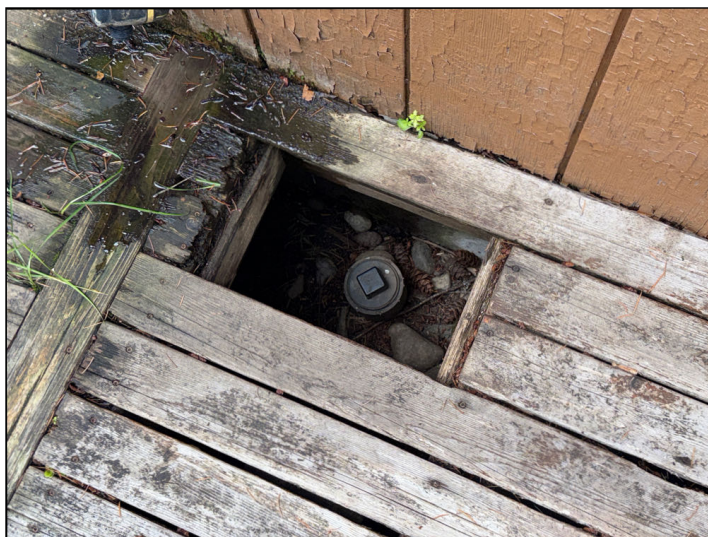
Septic clean out and tanks were noted on the east exterior side of the home.

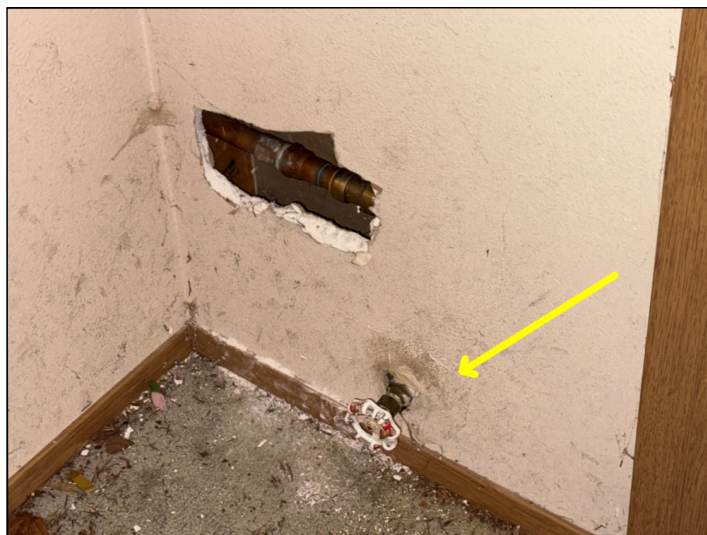
Main water shutoff noted in the front hall closet.

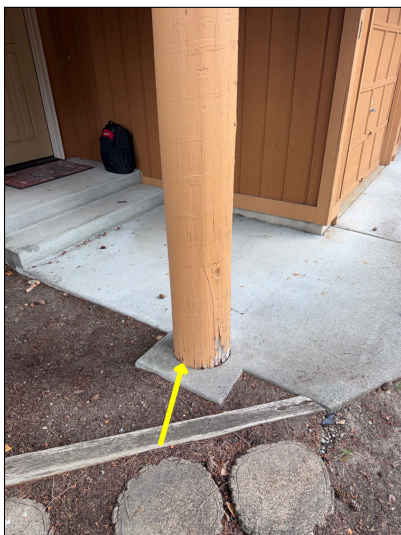
The front porch support post has visible wood rot and has settled to the point that it is no longer in contact with the roof structure. Recommend replacement of the damaged post and releveling and properly securing the roof structure as needed by a qualified contractor.
