Update

Project Update: Status and Next steps

## Project Overview

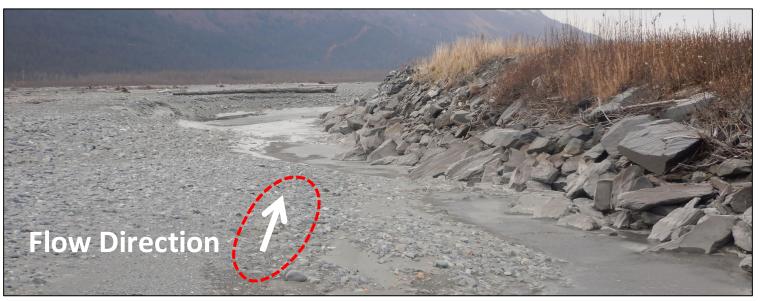
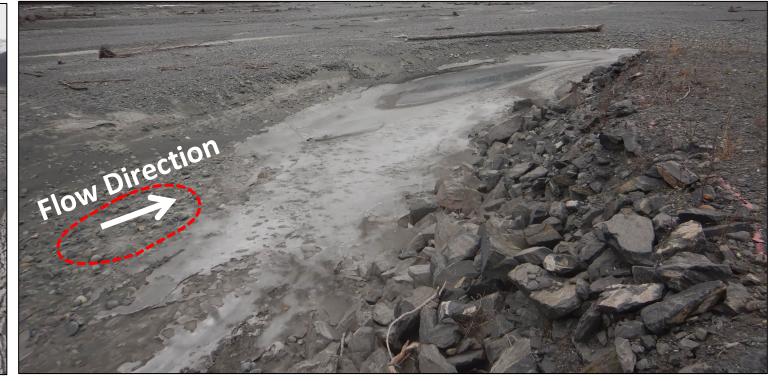
#### Scour Hole

• Example: Tip of Groin 2

• Dimensions of scour hole:

• Depth: 8+ feet

• Width: 40 feet

• Length: 93 feet

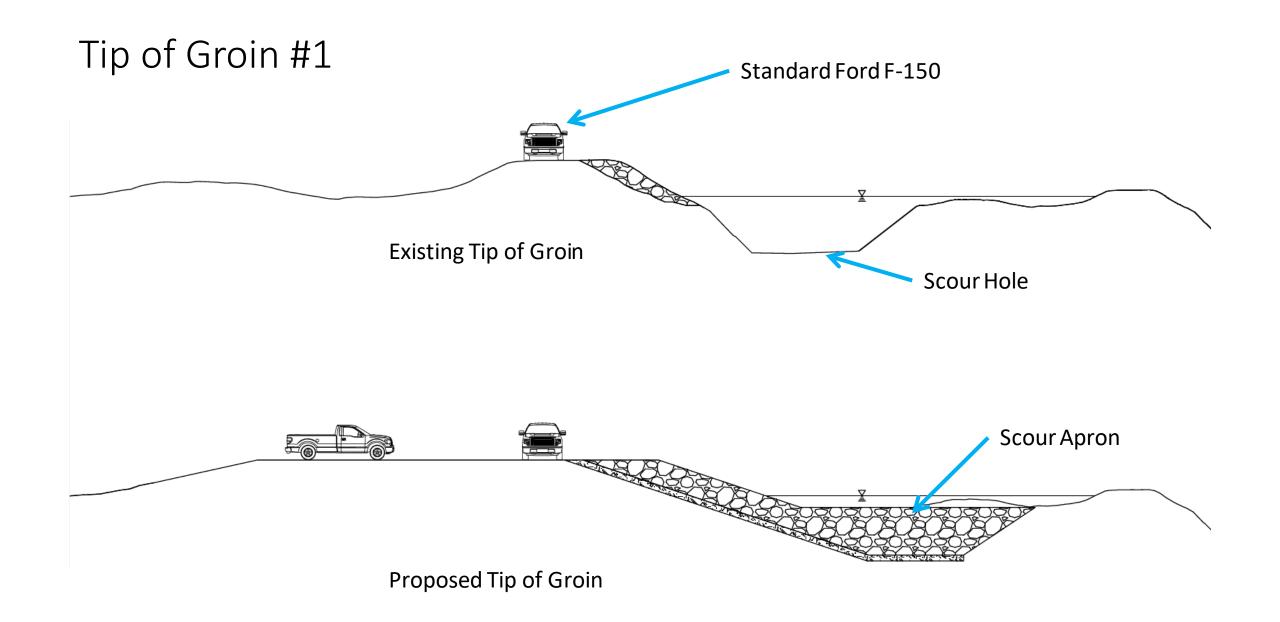
### Tip of Groin #1

- Maintenance on Groin 1, 2 &4
- Refacing of rock armor
  - Remove existing rock
  - Reestablish 3H:1V riverside slope
  - Place rock that is appropriately sized
- Scour Mitigation
  - Construct toe for the groins
  - Severe scour and rock loss seen at tips of Groin 1 and Groin 2
    - Scour apron and 'round head' tip designed using USACE design standards
