# SIGNET HOME INSPECTIONS, LLC

## COMPREHENSIVE PROPERTY INSPECTION REPORT

13668 Auburn Rd., Grass Valley , CA 95949

Date of Inspection: 11/27/2024 Time: 1:00 PM

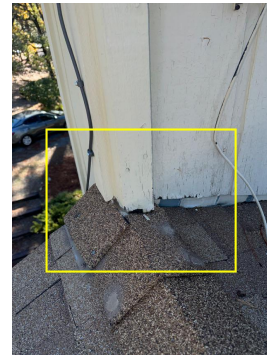
4.1. Chimney enclosure siding and/or trim noted as sitting on roof deck. It is recommended that siding be held up at least 1 inch from roof decking to avoid water saturation during rain and subsequent deterioration over time.

Enclosure trim to **roof contact**

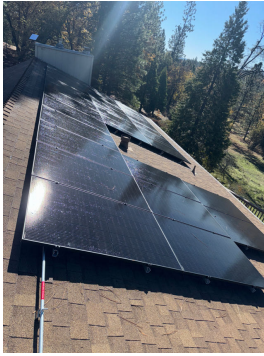
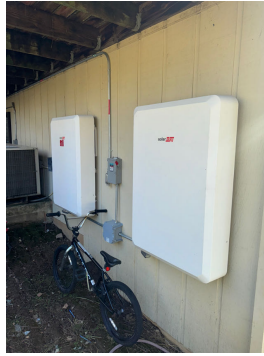
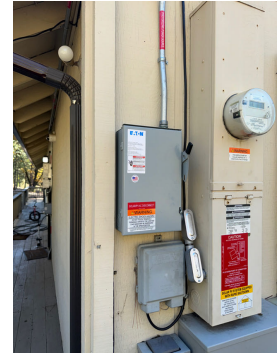
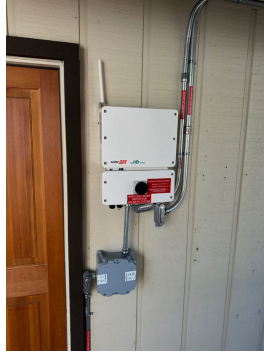
8.1. Based on a solar photovoltaic panel visual examination only, no apparent problems or concerns were noted at time of inspection. Since testing the functionality of the system is beyond the scope of this inspection, it is recommended the buyer seek operation guidance from the seller and if necessary, that a qualified solar technician check the system for serviceability.

Solar system not inspected

Solar array system not inspected

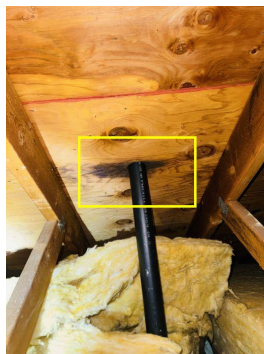
4.1. NOTE: Evidence of past attic leaks noted but dry at time of inspection. Due to the age of this home, leak staining is not uncommon as these leaks could have occurred at any time in the past and been subsequently repaired. Recommend checking with seller for further details.

Attic leak stain

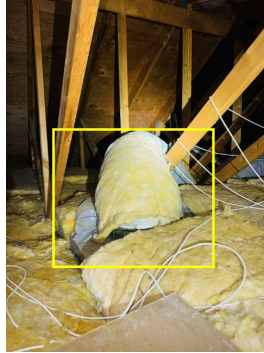
6.1. The vapor barrier on some ducting was noted as torn or missing. Recommend repair as needed.

Torn vapor barrier on ductwork

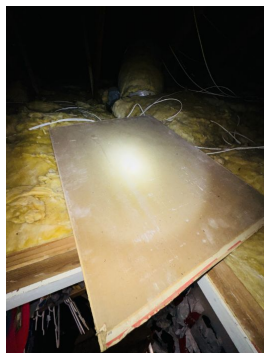
9.1. The attic access hatch was noted as not insulated which will result in some energy loss through convection. Recommend insulating attic access hatch cover with a batt of fiberglass insulation to reduce energy expenses.

Uninsulated attic hatch

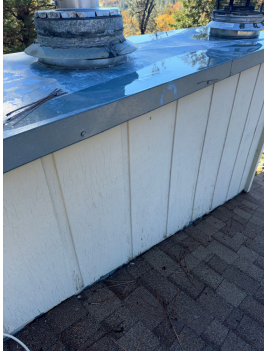
Deficient paint on chimney

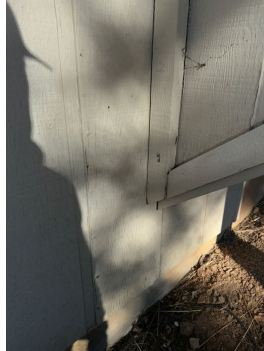
Deficient paint on siding

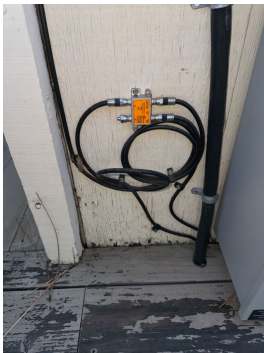
Deficient paint on siding

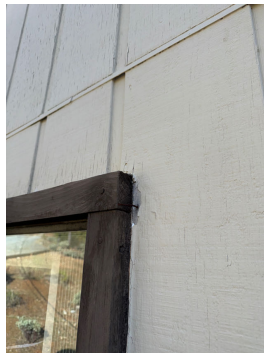
Deficient paint on siding

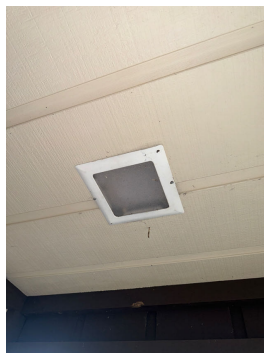
6.1. Light switch, fixture or bulb noted as inoperable. Change bulb(s) and re-check and if necessary, consult a qualified contractor for further options.

Light fixture inoperable

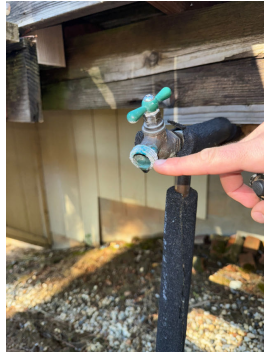
8.1. One or more water hose bibbs noted to be leaking. Recommend repair or replacement as needed.

Leaking left side hose bibb

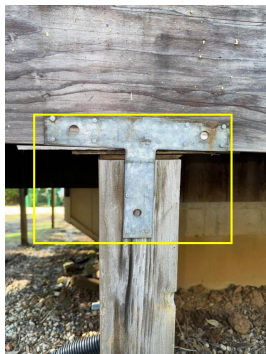
Questionable deck construction

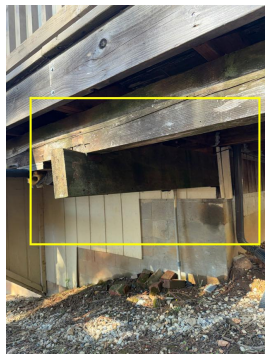
Questionable deck construction, sagging cantilevered beam

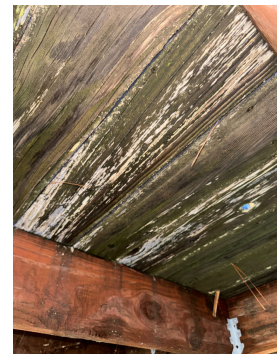
Fungal growth under decking

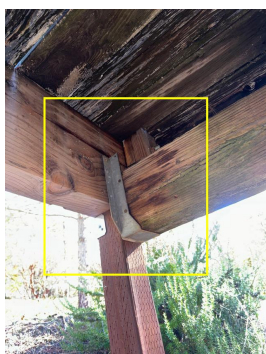
Questionable deck construction

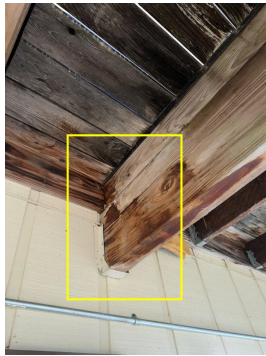
Questionable deck construction

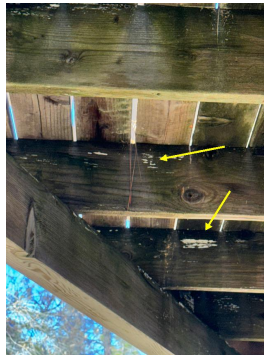
Fungal growth on underside of deck

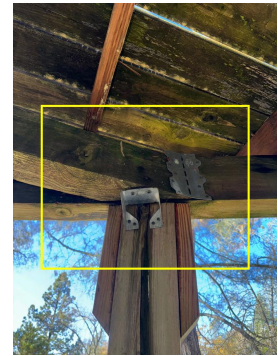
Questionable deck construction

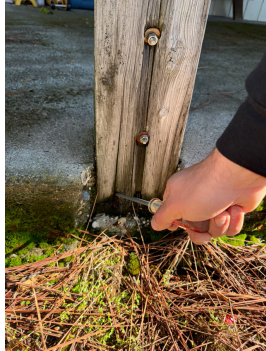
Decayed deck post

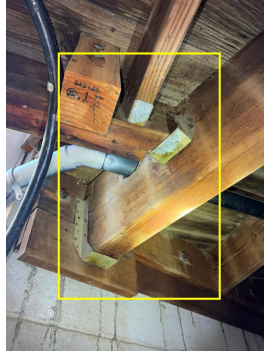
Questionable deck construction

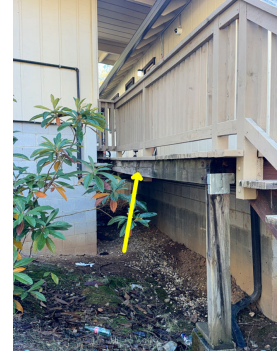
Sagging deck beam

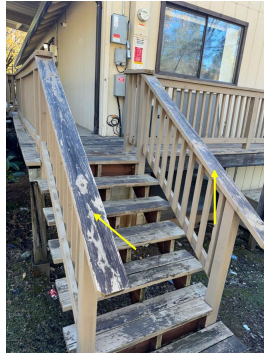
Handrails not graspable

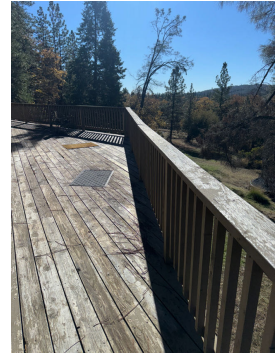
Railing height under 42"

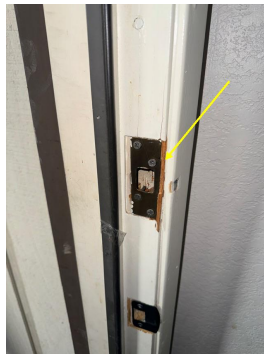
2.1. Damage to door jamb and/or threshold noted. Recommend repairs as needed.

Damaged door jamb

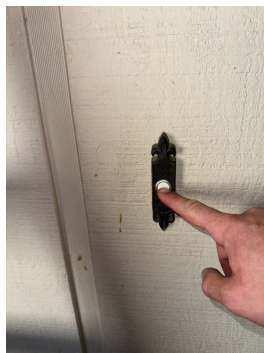
3.1. The doorbell did not operate when tested. Recommend checking the door bell button, chime & transformer & replace or repair as needed.

Inoperable door bell

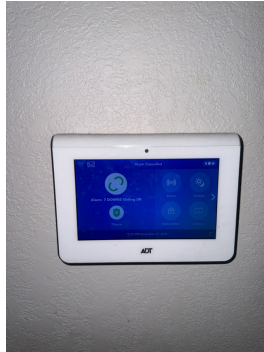
6.1. NOTE: A security system was noted with wall sensors, ceiling alarms and a control panel. Since testing this system is beyond the scope of this inspection, it is recommended the buyer seek operation guidance from the seller and if necessary, that a qualified professional check the system for serviceability.

Security system not inspected

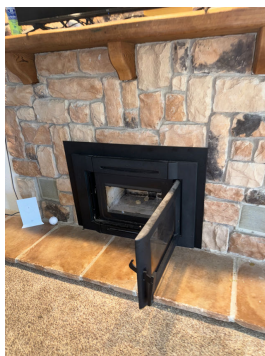
12.2. Fireplace hearth, wall or mantel deficiency noted. Recommend repairs as needed.

Fireplace detail

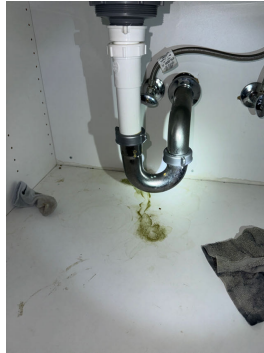
14.1. NOTE: Older style metal traps noted and buyer is cautioned that these traps will eventually leak due to corrosion. Recommend upgrading to **ABS**.

14.2. NOTE: Evidence of past leaks noted around drain lines but dry at time of inspection. Due to the age of this home, leak staining is not uncommon as these leaks could have occurred at any time in the past and been subsequently repaired. Recommend checking with seller for further details.

Metal sink trap with evidence of leaking

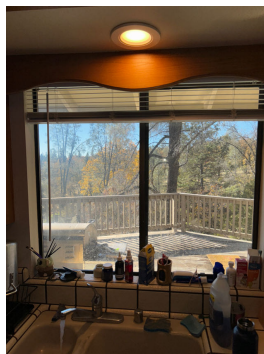
3.2. Fog and/or condensation or the resulting stains were noted in double-pane window(s) which is an indication of a failed seal. Recommend review for repair or replacement as necessary.

Failed window seal

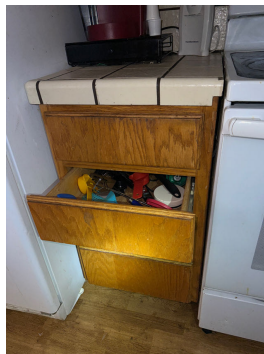
Worn cabinets

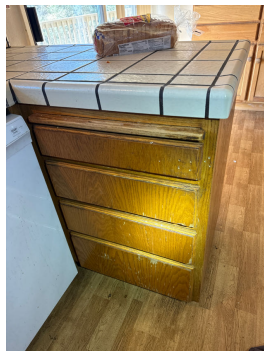
Worn cabinets

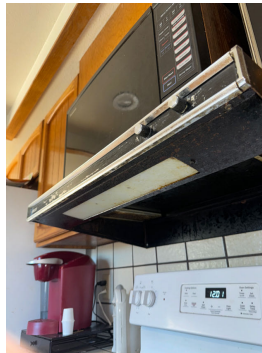
11.1. Fan light fixture or bulb noted as inoperable. Change bulb(s) and re-check and if necessary, consult a qualified contractor for further options.

Light inoperable

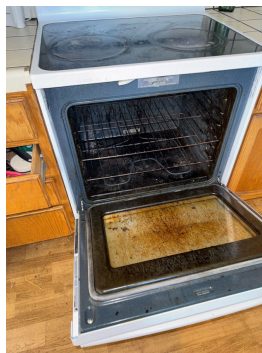
12.2. Oven was noted in need of deep cleaning and it could not be determined whether it could in fact come completely clean.

Oven in need of deep cleaning

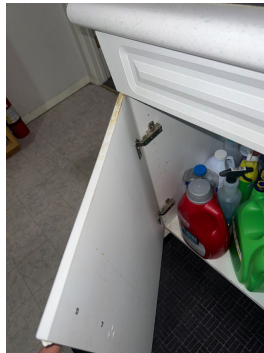
6.1. Loose cabinet door hinge(s) noted. Recommend tightening as needed.

Loose cabinet door hinges

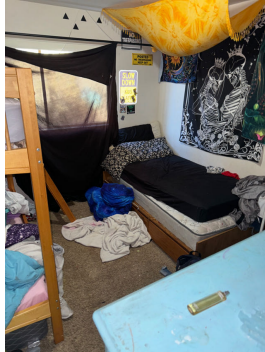
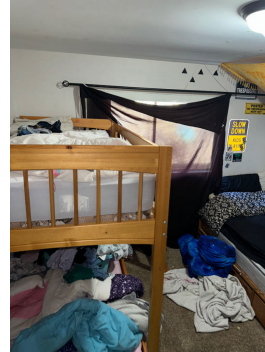
1.1. **NOTE:** Bedrooms were mostly inaccessible due to stored personal items and therefore not fully inspected. Recommend further inspection when the rooms are cleared.

Bedroom inaccessible

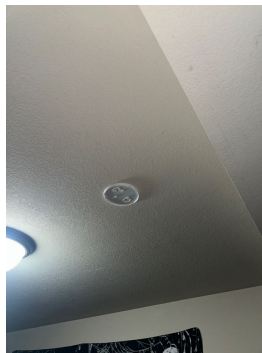
5.1. **No smoke alarm in bedroom** 14 noted which represents a safety hazard. Recommend immediately adding alarm as needed for safety.

Missing downstairs bedroom smoke alarm

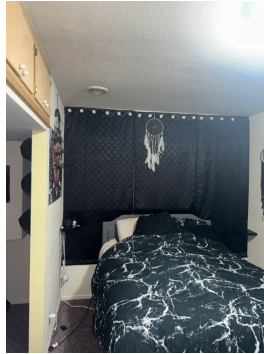
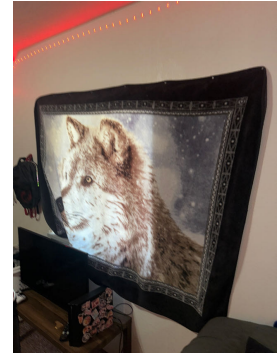
6.1. NOTE: Window(s) noted to be inaccessible and therefore not inspected. Recommend removing obstacle(s) and inspecting as needed.

Blocked window

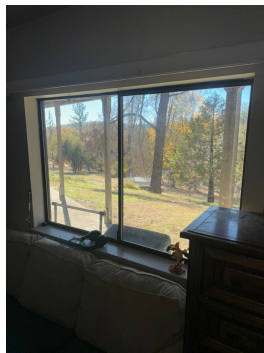
7.1. Screen noted to be missing from window(s). Recommend replacing as needed.

Missing downstairs bedroom screen

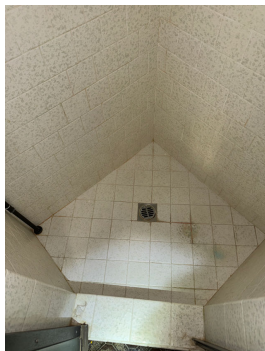
5.4. Staining noted on shower surround and it is not known if it can be removed. Recommend a shower wall cleaner for starters.

Stained and discolored shower pan

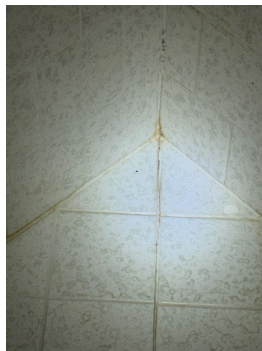
5.2. Tile grout noted as cracking or missing in areas. Recommend repairing as needed.

Cracked grout

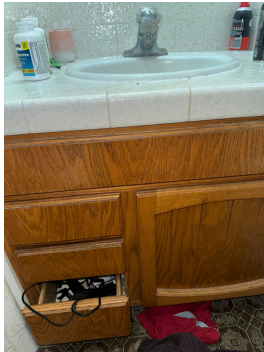
9.1. Worn finish noted on some cabinet areas. Consider refinishing as needed.

Worn cabinets

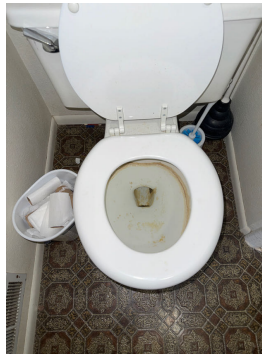
10.1. Staining and/or organic growth observed on the parts of the toilet which could hide certain defects. Recommend a thorough and heavy cleaning and inspection as needed.

Stained toilet fixture

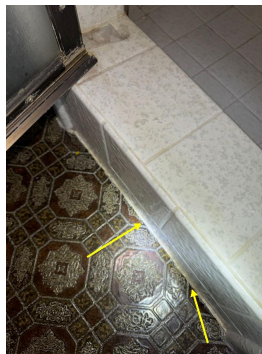
11.1. Deficient floor edge grout or caulking seal noted. Recommend resealing as needed.

Deficient floor edge seal

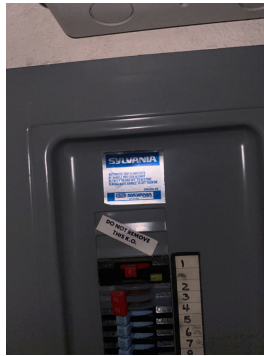
3.2. Noted was a GTE Sylvania Zinsco, Sylvania Zinsco or **Sylvania electrical panel**. Due to the problems associated with some of these service panels, we recommend contacting a qualified electrical contractor for a full safety assessment of the home's electrical system and component repairs or replacement as needed.

GTE Sylvania brand electrical panel

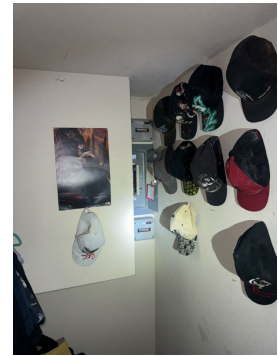
3.1. **NOTE:** Main service panel access was limited and due to the safety issues of this GTE Sylvania/Zinsco panel, the panel was not opened. Recommend further review and panel replacement as deemed necessary by a qualified electrician.

Inaccessible main service panel

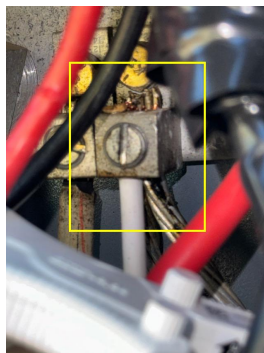
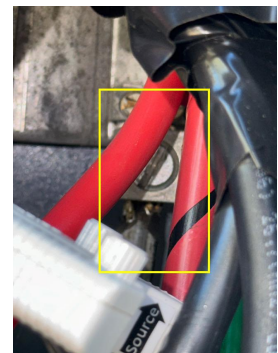
5.1. Wiring feed in the main breaker box was double tapped under lugs which may cause a poor connection, wires to loosen and possible arcing. Recommend a qualified electrician for review and repairs as needed.

Double tapped wire feed

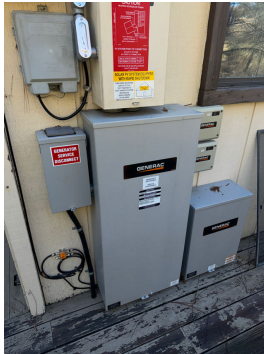
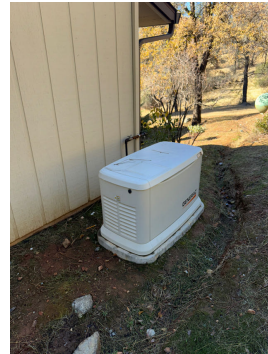
7.1. NOTE: Auxiliary generator and/or switch box noted but not inspected. Recommend confirming serviceability and if necessary a full evaluation by a qualified electrician.

Auxiliary generator system not inspected

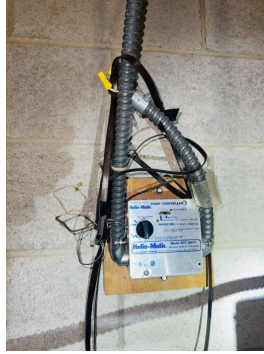
11.1. NOTE: An unknown pump system was noted with an electrical panel near the pressure tank. Since testing this system is beyond the scope of this inspection, it is recommended the buyer seek operation guidance from the seller and that a qualified professional check the system for serviceability.

Pump system not inspected

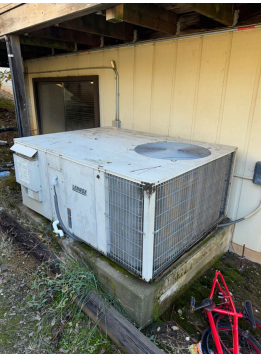
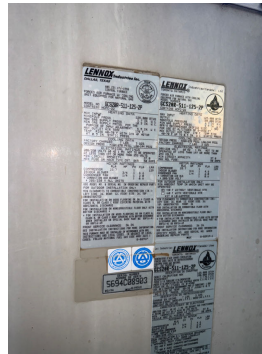
1.3. **NOTE:** This age of this appliance exceeds the normal expected service life for an HVAC system. Recommend preparing for the eventuality of replacement.

Packaged HVAC unit detail

Packaged HVAC unit label detail

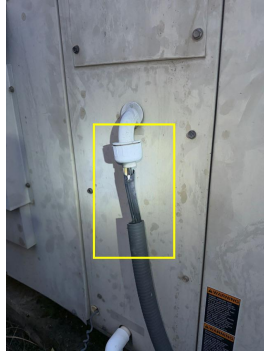
5.1. Conduit noted to be disconnected at cabinet or breaker box exposing live electrical wires to the elements. Recommend repairs by a qualified electrician.

Loose conduit with exposed wiring

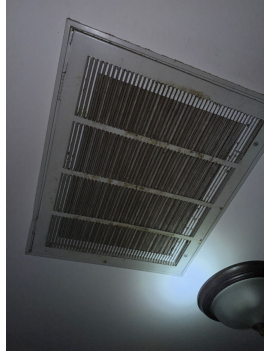
10.1. Dirty HVAC return air filter(s) noted. Recommend changing as needed for efficient HVAC operation.

Dirty HVAC filter

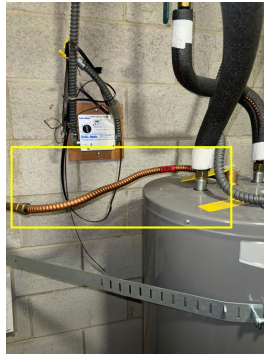
4.2. Flexible copper piping noted to be used in **TPRV discharge tube** which is not a permitted according to UPC (Uniform Plumbing Code). Recommend a qualified plumber install hard-drawn copper piping instead.

Flexible copper TPR discharge tube

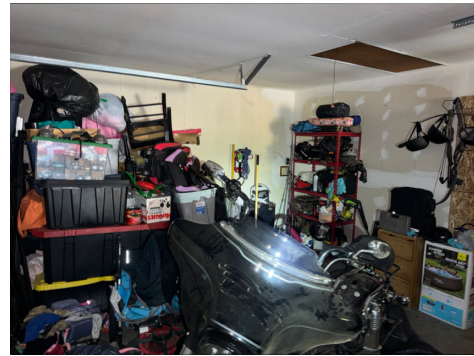
12.1. NOTE: Most areas of the walls were not accessible for inspection due to personal items. Recommend inspecting these areas when clear.

Blocked walls

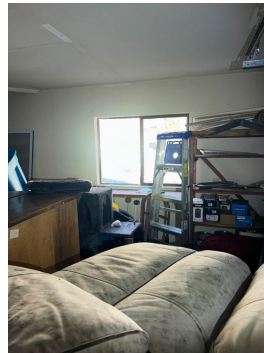
13.1. NOTE: Window(s) noted to be inaccessible and therefore not inspected. Recommend removing obstacle(s) and inspecting as needed.

Blocked window

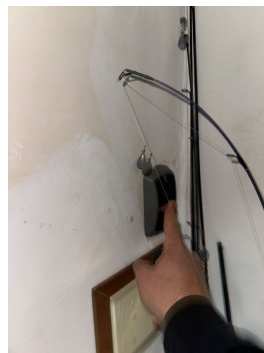
15.1. Vehicle door opener was inoperable when tested using the wall button. Recommend checking with seller for details and consulting with a qualified contractor for review and repairs as needed.

Vehicle door opener inoperable

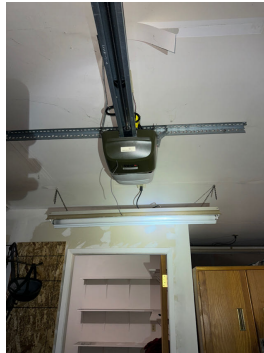
19.2. Light switch, fixture or bulb noted as inoperable. Change bulb(s) and re-check and if necessary, consult a qualified contractor for further options.

Light fixture inoperable

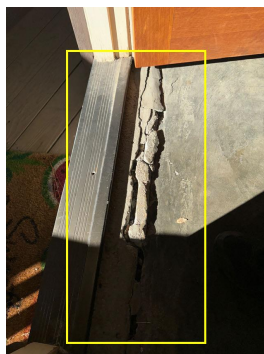
21.1. Large crack(s) noted in concrete slab foundation/floor. Recommend sealing, continued monitoring and consulting a qualified contractor for remediation options should conditions dramatically change.

Large cracking

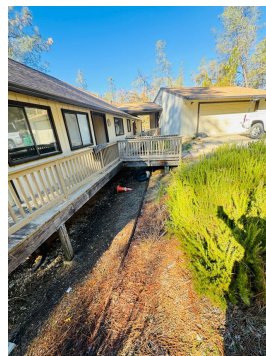
2.2. There are areas of negative grading towards the house and it is not known if a **drainage system** exists to take rain water away from the foundation. Recommend checking with seller on the presence of a drainage system and if necessary, consider adding additional backfill and/or drain lines to create the proper slope or drainage to take rain water away from house.

Negative grade toward house

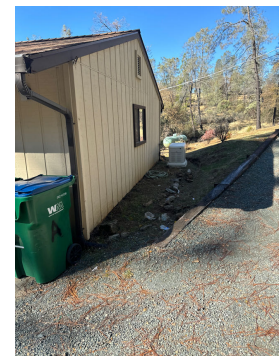
Negative grade toward garage

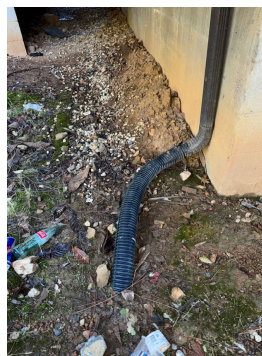
3.2. NOTE: A lot drainage system was noted but not inspected. Recommend checking with seller on serviceability.

Drainage system not inspected
