# SIGNET HOME INSPECTIONS, LLC

## COMPREHENSIVE PROPERTY INSPECTION REPORT

12875 Rattlesnake Rd., Grass Valley, CA 95945

Date of Inspection: 11/27/2024 Time: 9:00 AM

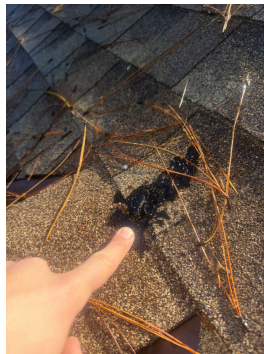
1.2. Damaged shingle(s) noted on roof. Recommend a qualified roofing contractor repair or replace as needed.

Damaged shingle, patched with mastic

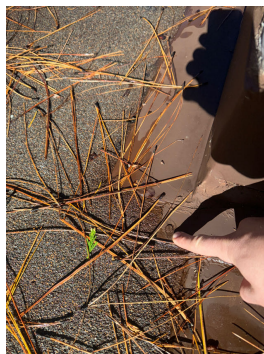
2.1. Exposed and unsealed flashing nails noted. Recommend checking all exposed flashing nails and sealing as needed.

Unsealed flashing nail

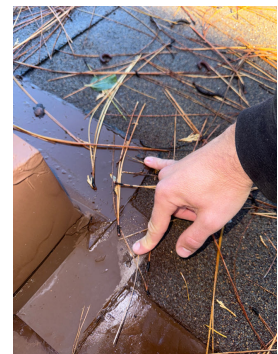
Unsealed flashing nails

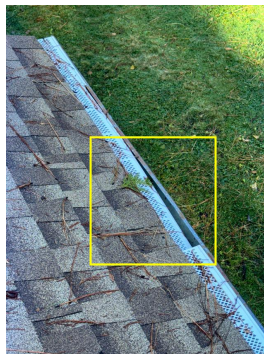
6.3. Some screened gutter tops noted as out of place. Recommend repairs as needed.

Damaged/out of place gutter screen

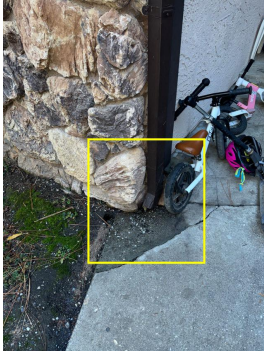
7.1. **Deficient downspout termination** noted at or near the structure foundation. Recommend drain pipe(s) to divert roof water away from the foundation.

Downspout terminates at foundation

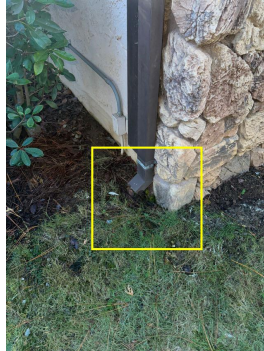
Downspout terminates at foundation

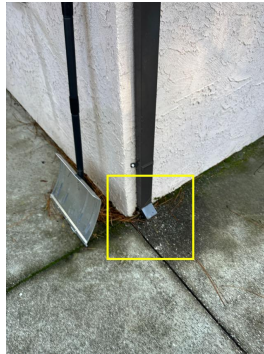
Downspout terminates at foundation

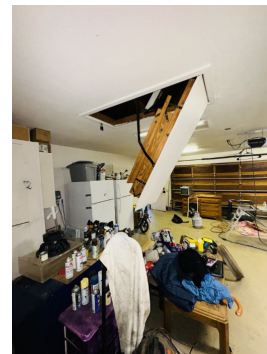
2.2. NOTE: Pull down ladder attic access in the garage was blocked by personal items and the attic area was therefore not entered and inspected. Recommend further inspection when the attic is accessible.

Blocked attic access hatch

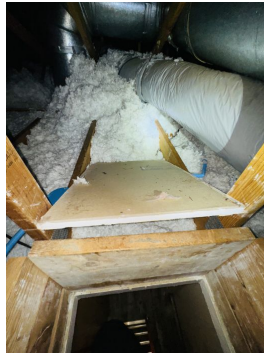
9.1. The attic access hatch was noted as not insulated which will result in some energy loss through convection. Recommend insulating attic access hatch cover with a batt of fiberglass insulation to reduce energy expenses.

Uninsulated attic access hatch

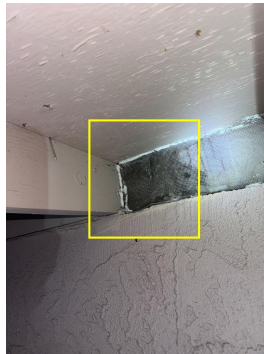
10.1. Bathroom exhaust fan ducting appears to terminate in attic at soffit vent. It is always recommended that ducting be routed to exterior or at minimum to the gable-end or ridge vent to minimize excessive moisture and possible mold development.

Exhaust duct terminates at soffit vent

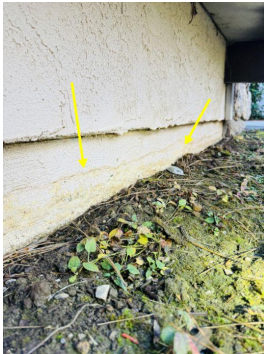
2.1. NOTE: Minor shrinkage/settlement cracking and **cold joints** from multiple concrete pours or additions, noted at exterior perimeter. These are relatively common conditions and are normally no reason for concern. Recommend sealing and contacting a qualified contractor should condition worsen or if water intrusion occurs.

Foundation wall cold joint

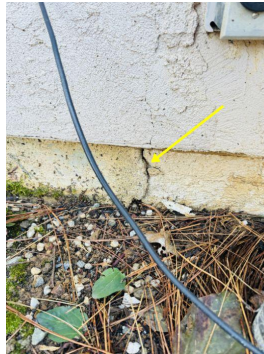
Back left foundation wall cold joint

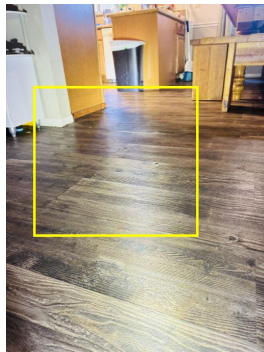
3.1. Anomalies were noted in floor covering(s) which could indicate concrete slab deficiencies. Recommend further review and repairs if needed by a qualified contractor.

Anomalies in floor material

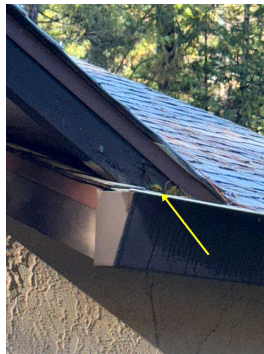
2.2. Barge rafter **roof contact** noted. It is recommended that all wood building materials be held up at least 1 inch from roof decking to avoid water saturation during rain and subsequent deterioration over time.

Barge rafter to roof contact, left side

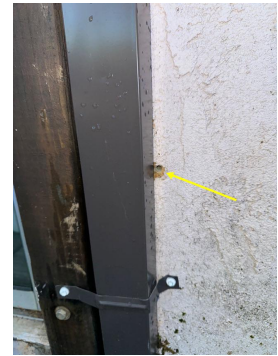
Back left stucco holes

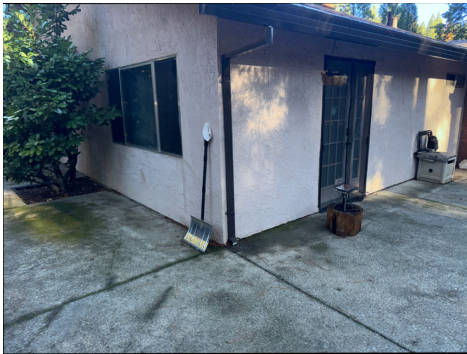
Stucco to patio contact

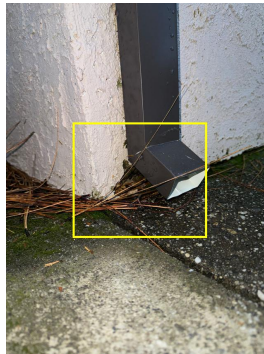
Back right corner stucco damage

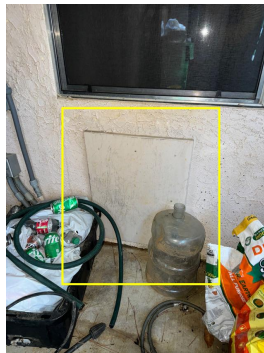
Right side patched stucco with plywood

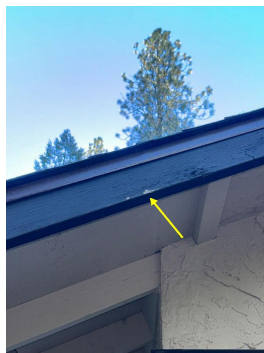
Deficient paint and/or caulk

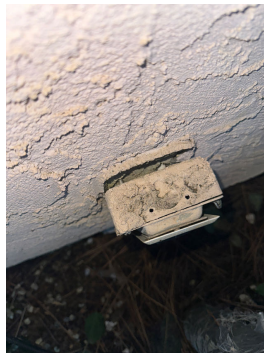
Back left corner elecrcial box loose on wall

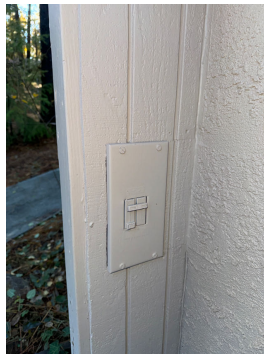
Missing waterproof box for panel

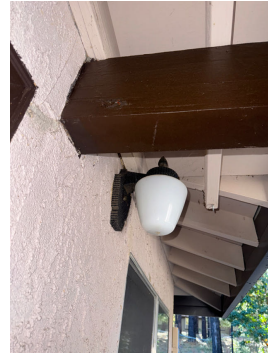
Light fixture inoperable

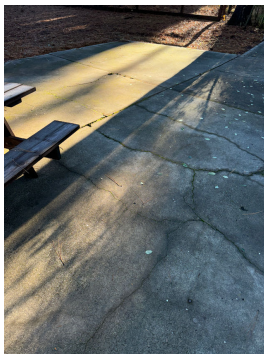
10.1. Heavy concrete cracking and displacement noted which represents a trip hazard. Recommend consulting a qualified concrete contractor for repair options.

Patio cracking

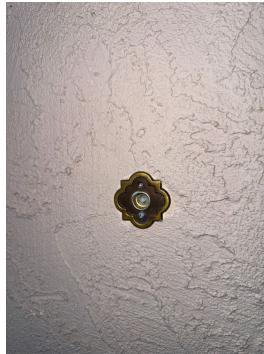
2.1. The exterior doorbell push button was noted as damaged. Recommend replacing as needed.

Damaged door bell button

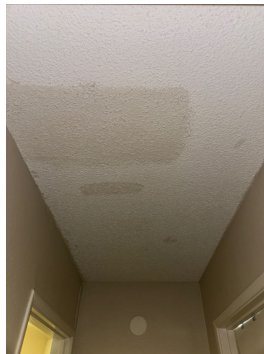
3.1. **Popcorn texturing** noted on ceiling which presents a possible asbestos hazard. Recommend leaving undisturbed until having done additional research and preparation for removal if desired.

Popcorn ceiling texturing

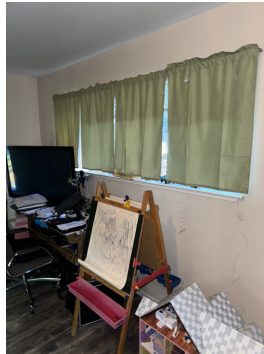
Blocked windows

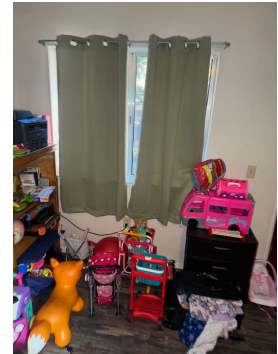
Blocked windows

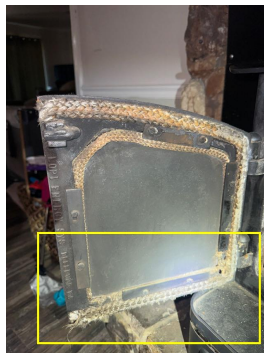
8.2. Wood stove door gasket was noted as deficient or missing which can allow CO gases into the living space. Recommend replacement as needed.

Damaged door rope gasket

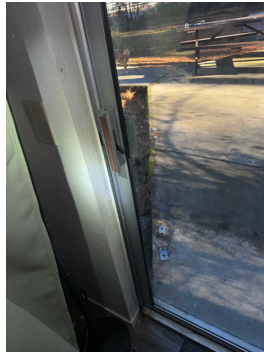
9.1. Sliding glass door is damaged and does not operate correctly. Recommend repairs as needed.

Door not operating correctly

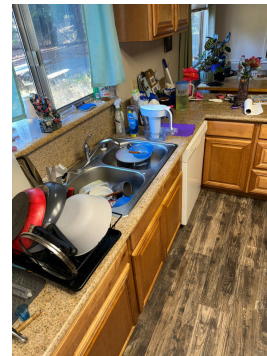
Blocked counters

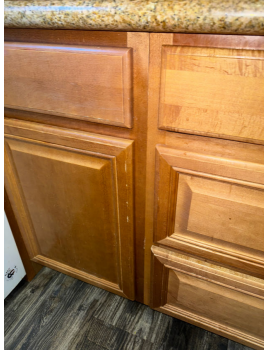
7.2. Worn finish noted on some cabinet areas. Consider refinishing as needed.

Worn cabinet finish

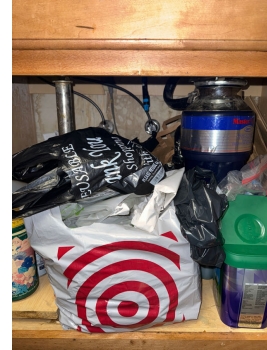
7.1. NOTE: Cabinet(s) noted with personal items blocking access and therefore inside cabinet, plumbing and other under-cabinet appliances may not be completely inspected.

Blocked cabinet

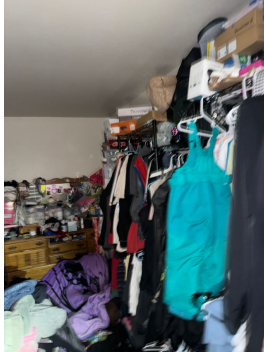
1.1. **NOTE:** Due to large amounts of personal items, bedroom 6 could not be fully inspected. Recommend further inspection when the items are cleared.

Room 6 not accessible

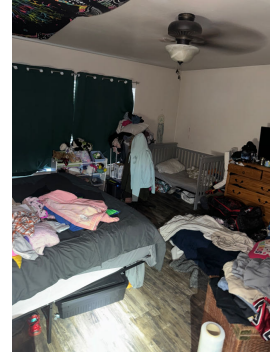
Room 6 not accessible

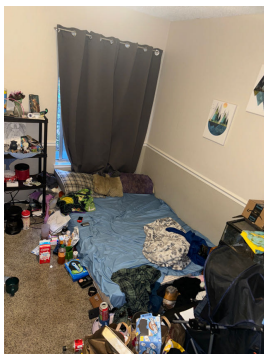
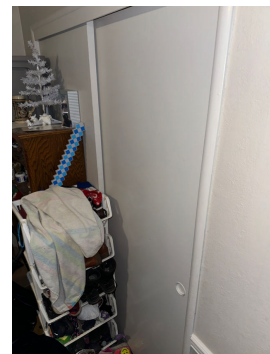
2.1. **NOTE:** Due to large amounts of personal items, bedroom 7 could not be fully inspected. Recommend further inspection when the items are cleared.

Bedroom 7 inaccessible

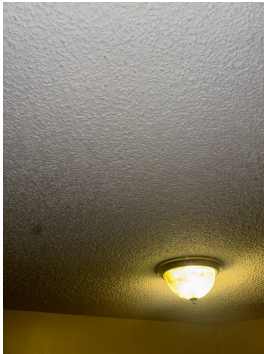
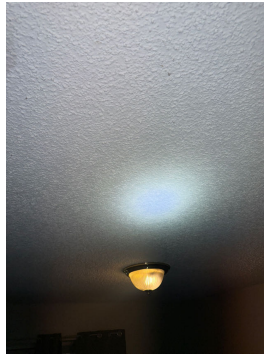
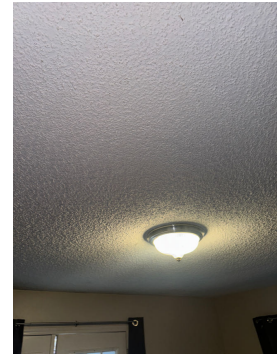
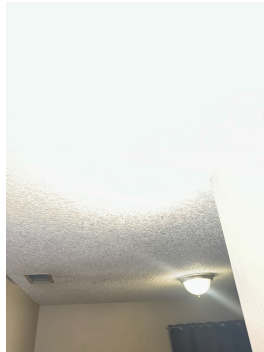
5.1. Popcorn texturing noted on ceiling which presents a possible asbestos hazard. Recommend leaving undisturbed until having done additional research and preparation for removal if desired.

Room 9 popcorn ceiling texturing

Room 8 popcorn ceiling texturing

Bedroom 10 popcorn ceiling texturing

Bedroom 7 popcorn ceiling texturing

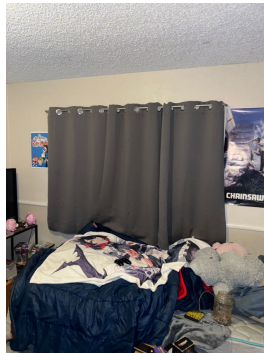
7.1. NOTE: Window(s) noted to be inaccessible and therefore not inspected. Recommend removing obstacle(s) and inspecting as needed.

Room 9 blocked window

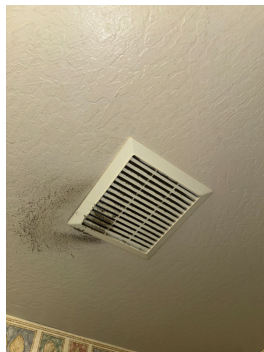
4.1. The exhaust fan vent openings appeared clogged which makes it work harder and less effective. Recommend cleaning as needed.

Clogged bathroom 1 exhaust vent

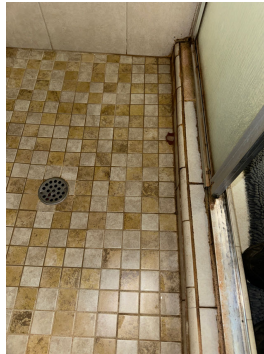
5.3. Staining noted on shower surround and it is not known if it can be removed. Recommend a shower wall cleaner for starters.

Bathroom 2 shower pan stain/discoloration

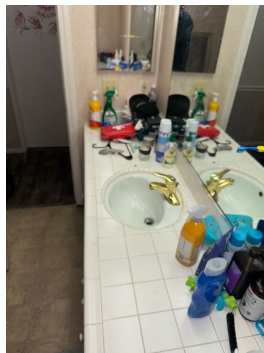
10.1. NOTE: Counter surfaces were partially blocked with personal items and therefore not fully inspected. Recommend clearing and inspecting as needed.

Bathroom 1 blocked counters

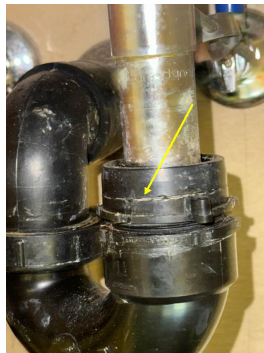
12.1. Bathroom 2 damaged drain pipe noted, leaving the drain at risk of leaking. Recommend a qualified plumber for review and repairs as needed.

Bathroom 2 damaged drain pipe

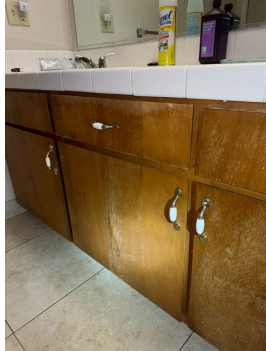
13.2. Worn finish noted on some cabinet areas. Consider refinishing as needed.

Worn bathroom 2 cabinet finish

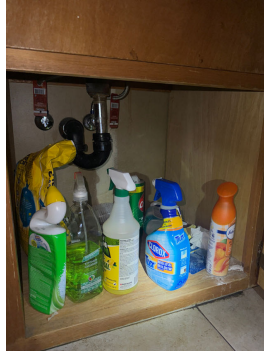
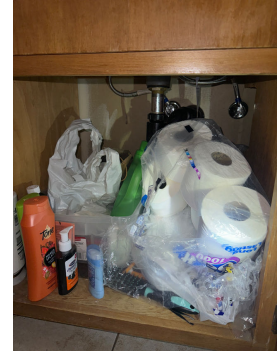
13.1. NOTE: Cabinet(s) noted with personal items blocking access and therefore inside cabinet, plumbing and other under-cabinet appliances may not be completely inspected.

Blocked bathroom 2 cabinet

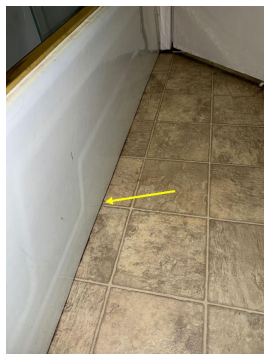
16.1. Deficient floor edge grout or caulking seal noted. Recommend resealing as needed.

Deficient bathroom 1 floor edge seal

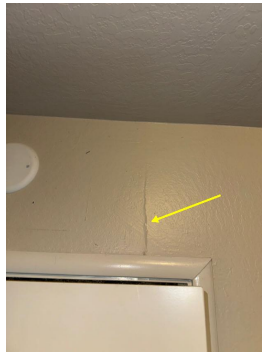
- 1.1. **Sheetrock crack(s)** noted which normally represents a cosmetic issue as opposed to a structural problem. Consider patching with a flexible caulking to reduce or eliminate eyesore.

Sheetrock crack

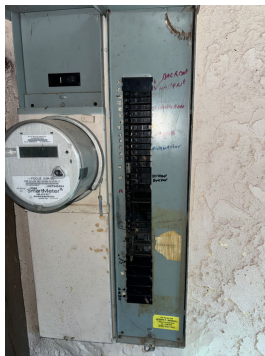
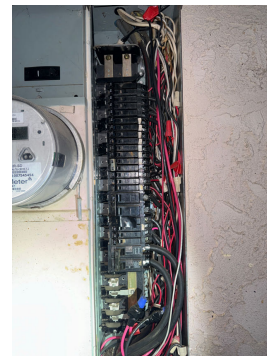
3.1. Panel labeling is absent or confusing. Consider relabeling with easy to understand and accurate circuit labels.

Main service panel detail

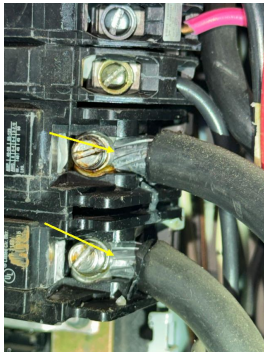
7.1. Stranded aluminum wiring ends connected to breaker are noted without proper **anti-oxidant paste**. Recommend adding to avoid oxidation.

Missing anti oxidant paste

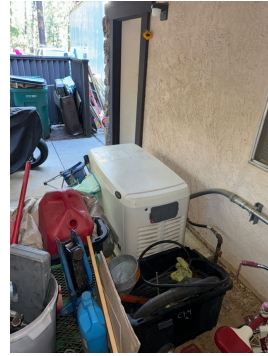
9.1. NOTE: Auxiliary generator and/or switch box noted but not inspected. Recommend confirming serviceability and if necessary a full evaluation by a qualified electrician.

Auxiliary generator system not inspected

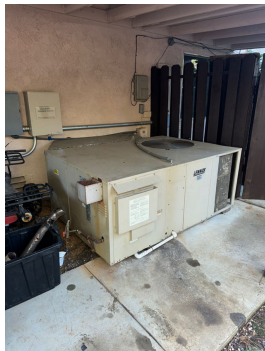
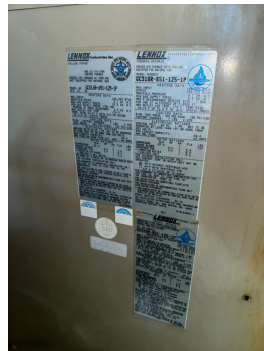
1.2. **NOTE:** This age of this appliance exceeds the normal expected service life for an HVAC system. Recommend preparing for the eventuality of replacement.

Packaged HVAC unit detail

Packaged HVAC unit label detail

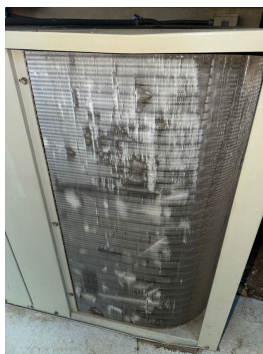
2.1. Condenser coil aluminum cooling fins were noted to be damaged. Recommend a qualified HVAC contractor for repairs as needed or DIY option of using a fin comb to straighten damaged fins.

Damaged/bent cooling fins

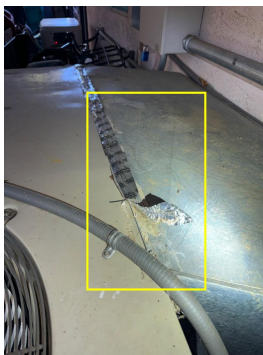
6.1. Deficient plenum seal noted which may allow moisture and pest intrusion. Recommend sealing as needed.

Deficient plenum seal

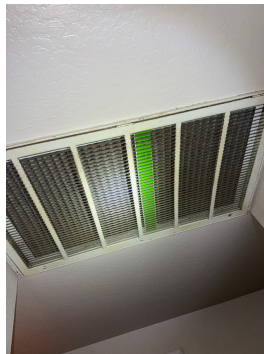
10.1. Dirty HVAC return air filter(s) noted. Recommend changing as needed for efficient HVAC operation.

Dirty HVAC filter

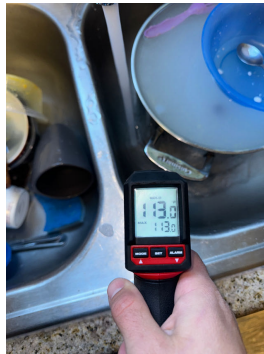
2.1. **Water temperature** is 113° as measured at the kitchen sink.

Water temperature noted at 113° F

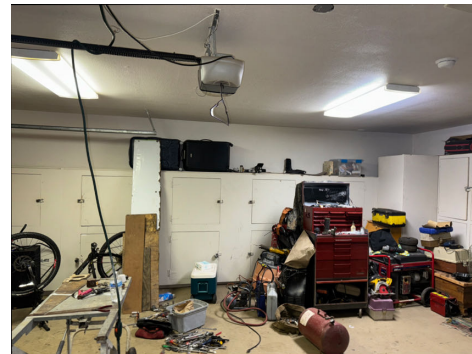
Blocked walls

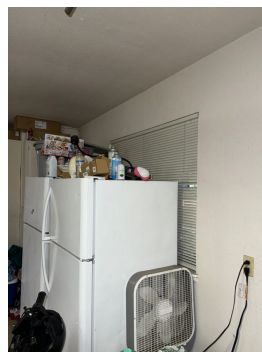
3.1. NOTE: Window(s) noted to be inaccessible and therefore not inspected. Recommend removing obstacle(s) and inspecting as needed.

Blocked window

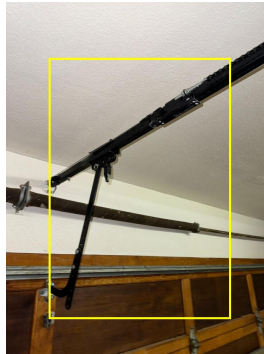
8.1. The vehicle door was disconnected from the opener with reasons unknown and the opener was therefore not tested. Recommend checking with seller for details and if necessary, consulting with a qualified contractor for review.

Disconnected vehicle door opener

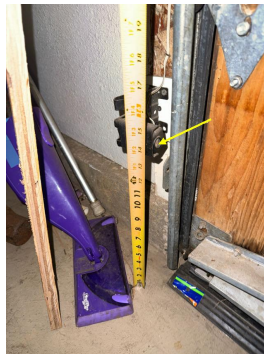
9.2. Photo-electric sensor noted installed over the maximum 6" from floor on one or more doors. The current mounting height of these sensors could allow a small child to lay beneath them and still not break the beam which is a serious safety hazard. Recommend re-installing between 4 and 6 inches above floor.

Photo electric sensor over 6" from ground

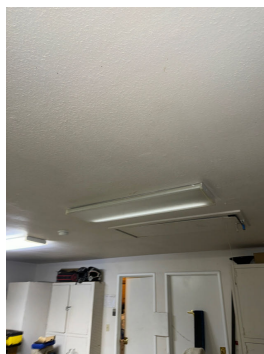
10.2. Light switch, fixture or bulb noted as inoperable. Change bulb(s) and re-check and if necessary, consult a qualified contractor for further options.

Light fixture inoperable

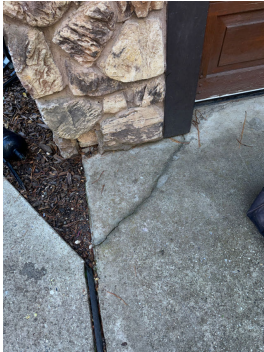
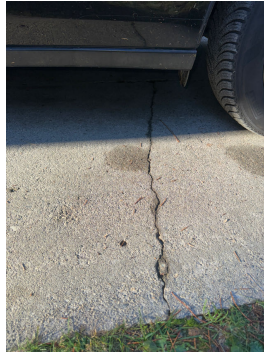
1.1. Heavy driveway and/or walkway cracking noted. Recommend consulting a qualified concrete contractor for repair options.

Driveway crack

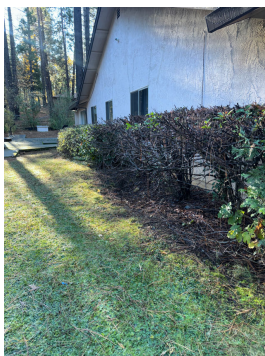
2.2. There are areas of negative grading towards the house and it is not known if a **drainage system** exists to take rain water away from the foundation. Recommend checking with seller on the presence of a drainage system and if necessary, consider adding additional backfill and/or drain lines to create the proper slope or drainage to take rain water away from house.

Negative grade toward house

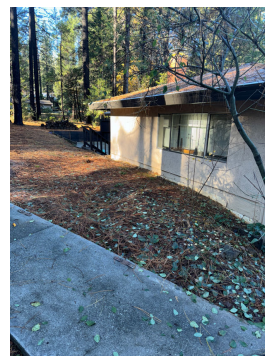
Negative grade toward house

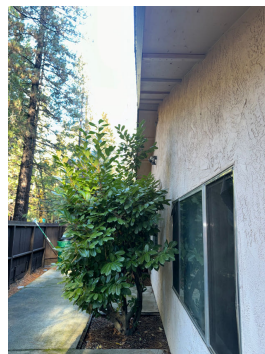
4.1. **vegetation against house** was noted in areas. Recommend trimming so no plant to exterior cladding exists.

Vegetation against house

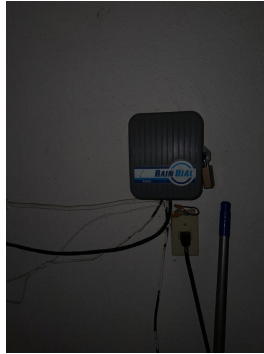
6.1. NOTE: An outdoor irrigation system was noted with sprinkler valves and a control panel. Since testing this system is beyond the scope of this inspection, it is recommended the buyer seek operation guidance from the seller and that a qualified landscaping professional check the system for serviceability.

Irrigation system not inspected

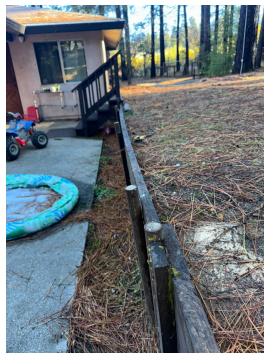
7.1. Retaining wall noted to be leaning out. Recommend checking with seller for further details on age, any drainage system present and plan on repair or replacement in the foreseeable future.

Leaning retaining wall
