# SIGNET HOME INSPECTIONS, LLC

## COMPREHENSIVE PROPERTY INSPECTION REPORT

11855 Slow Poke Ln., Grass Valley, CA 95945

Date of Inspection: 12/2/2024 Time: 1:00 PM

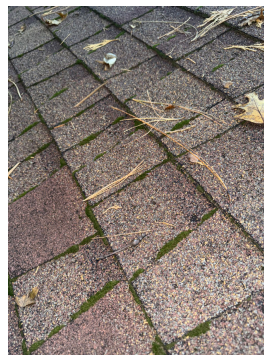
1.3. **Moss on composition** roof noted which can lead to the premature failure of the roof and subsequent leaks. Recommend treating moss during its growing season (wet months) with a moss killer.

Moss on roof

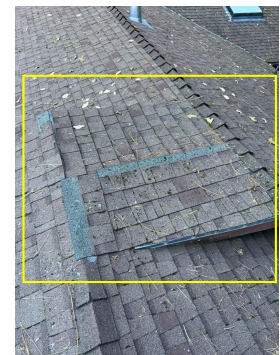
1.5. Unprofessional roofing work observed at one or more locations which leaves the roof at risk of leaking and subsequent moisture damage. Recommend a qualified roof contractor for review and repairs as needed.

Unprofessional roof installation

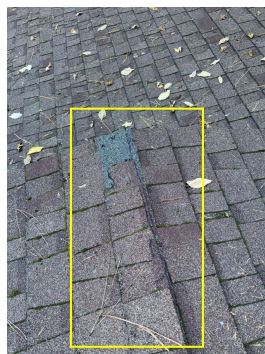
Unprofessional roof installation and/or damage

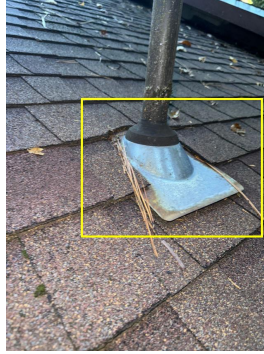
2.1. Flashing noted to be lifting up in one or more areas. Recommend securing down with stainless steel roofing screws with sealing washers as needed to avoid wind-driven rain intrusion.

2.2. Rusted flashing noted. Recommend either replacing or prepping and painting with a rust-resistant paint as needed.

Lifting and rusted flashing

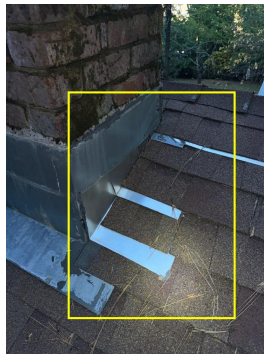
2.4. Questionable chimney flashing noted. Recommend further review by a qualified roofing contractor and repairs if needed.

Questionable chimney flashing

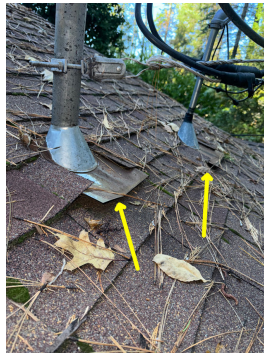
Rusted and lifting flashing

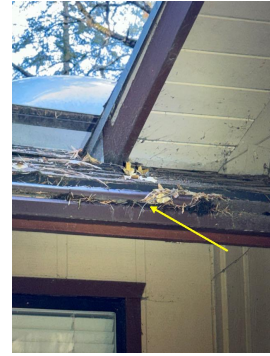
Clogged leafless style gutter guard

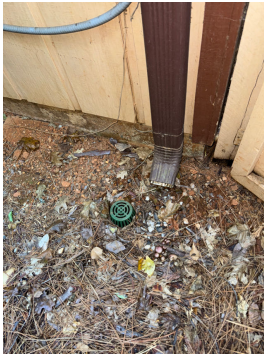
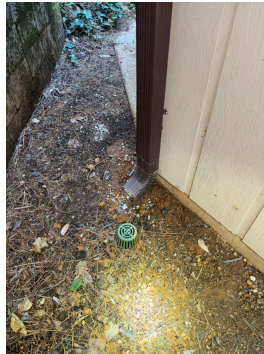
8.1. **Deficient downspout termination** noted at or near the structure foundation. Recommend drain pipe(s) to divert roof water away from the foundation.

Downspout terminates at foundation with **drainage system**

Downspout terminates at foundation with drainage system

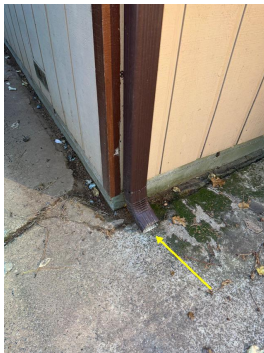
Downspout terminates at foundation

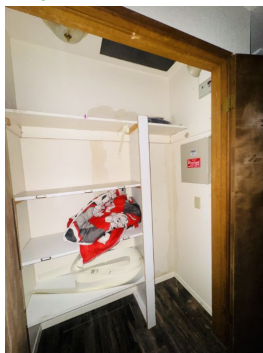
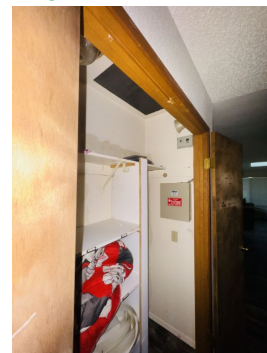
2.2. NOTE: Due to shelving unit, the entryway area closet attic access was inaccessible and this portion of the attic was therefore not inspected. Recommend gaining access as necessary and having this attic area inspected as needed.

Blocked closet attic access

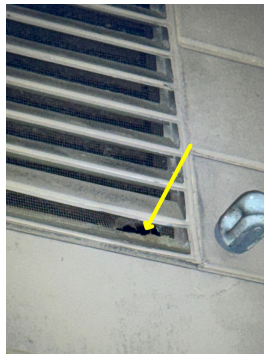
5.1. Vent screen(s) noted to be damaged or missing. Recommend complete visual inspection and repairing or replacing screens as necessary.

Damaged front left gable end vent screen

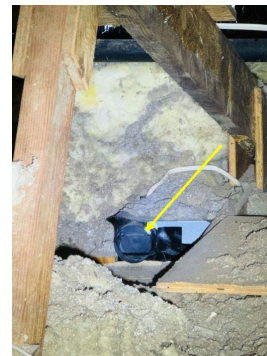
Exhaust vent terminates in attic

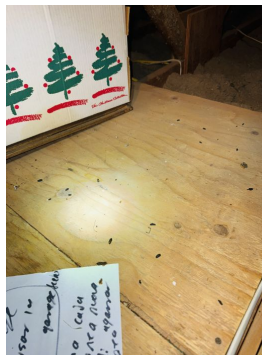
10.1. Evidence of rodent infestation was noted in attic. Consider the services of a pest control specialist for eradication.

Rodent droppings in attic

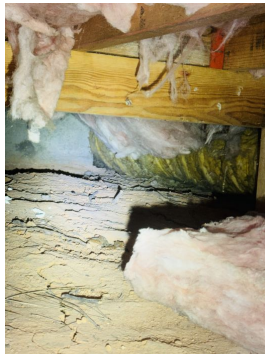
2.1. NOTE: Due to the low height of construction of this home and the installation of rigid ductwork in the crawl space area, most areas could not be accessed or inspected. If necessary, recommend a qualified specialist for further review and inspection.

No access due to ducting

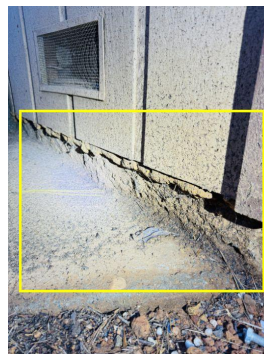
Back left foundation wall spalling/deterioration

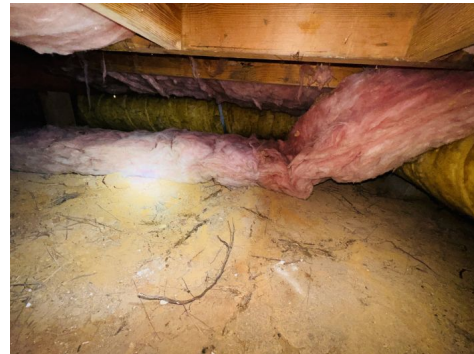
Disturbed insulation

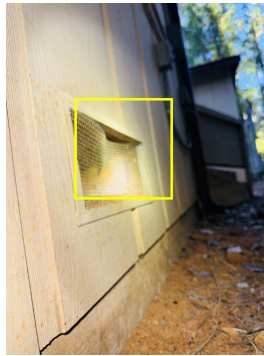
12.1. Vent screens are damaged or missing. Recommend repairing or replacing as necessary.

Damaged left side vent screen

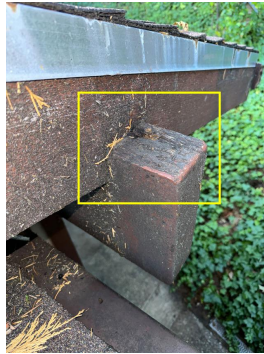
Decayed back side beam end

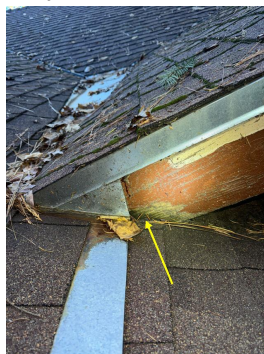
Barge rafter to roof deck contact

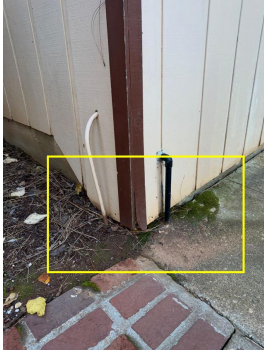
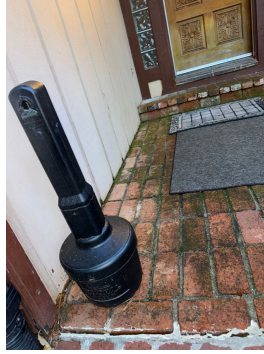
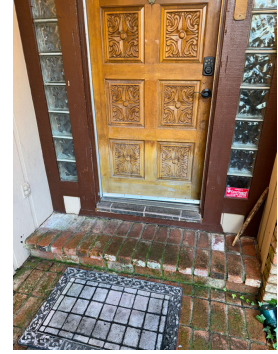
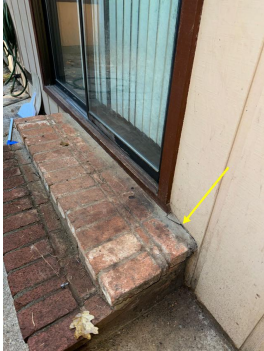
3.3. Siding to ground contact noted which will eventually cause moisture damage and degradation. Recommend flashing, correcting so siding is a minimum of 6 to 8 inches above ground or consulting with a qualified contractor for

Front side siding to ground contact and decay

Front siding to ground contact

Back side siding to ground contact

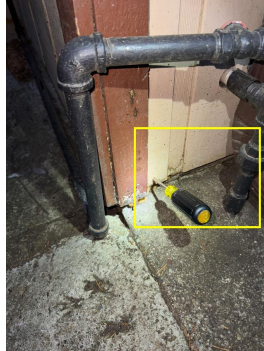
Back side siding decay

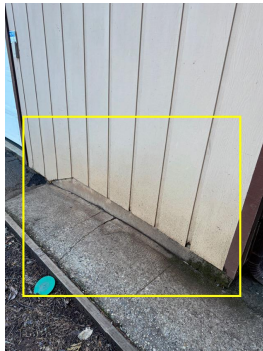
Back right side siding wood decay

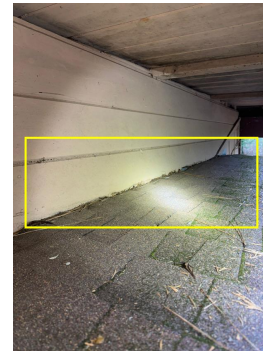
Siding to roof contact and wood decay

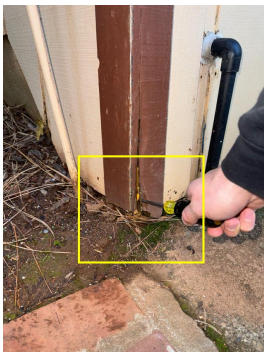
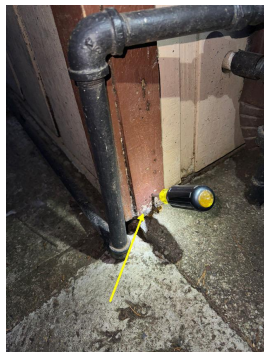
4.1. Some exterior trim wood decay was noted. Refer to pest report for more detail and consider consulting a qualified contractor for remediation options.

Front side trim to ground contact and decay

Back side trim decay

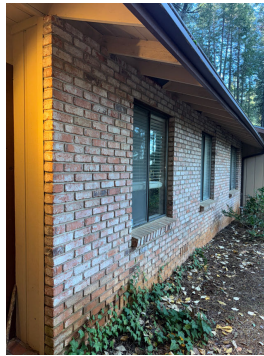
5.2. Masonry veneer noted attached to exterior wood framed wall without any visible weep holes for drainage as recommended by the **IRC** which would prevent moisture the ability to exit should a leak occur. Since adding this feature is not a cost-effective option after the fact, at minimum we recommend an annual check-up to ensure no moisture intrusion is possible.

Masonry veneer without drain plane

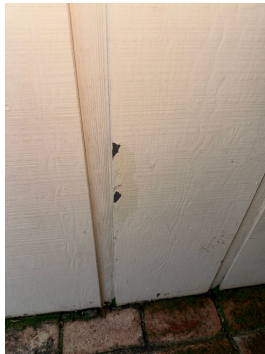
6.1. Deficient paint and poorly sealed **exterior cladding** junctions noted in places. Recommend painting and caulking as needed to avoid moisture intrusion and its related negative effects.

Deficient paint

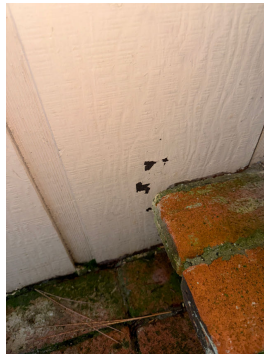
Deficient paint

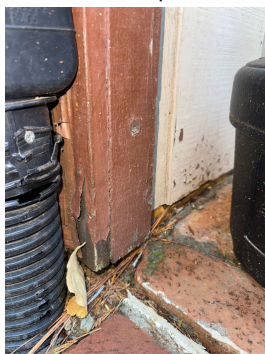
Deficient paint

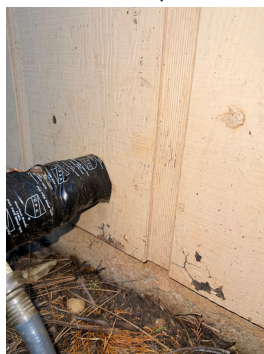
Deficient paint

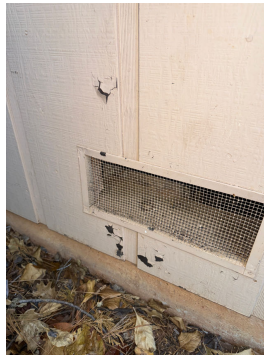
Deficient paint

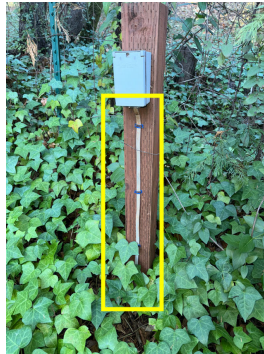
7.1. Non-metallic sheathed electrical cable noted on the outside which is not rated for exterior use. Recommend consulting a qualified electrician for remediation option.

Exposed romex at back side outlet

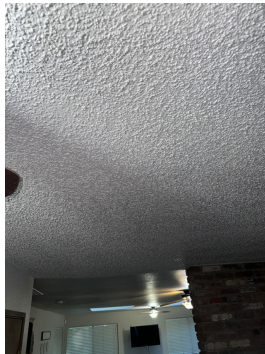
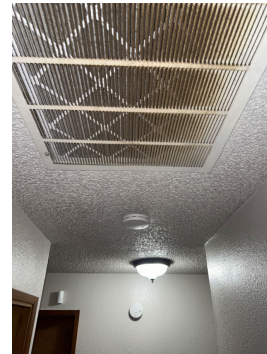
3.1. **Popcorn texturing** noted on ceiling which presents a possible asbestos hazard. Recommend leaving undisturbed until having done additional research and preparation for removal if desired.

Popcorn ceiling texturing

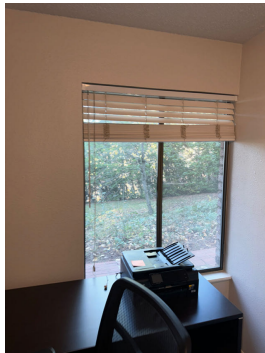
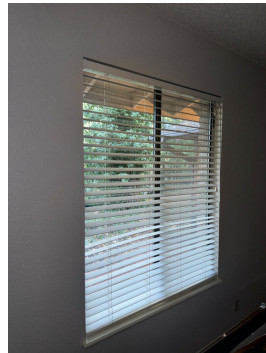
7.2. Window(s) noted to be difficult to open for reasons unknown. Recommend cleaning and lubricating friction points or consulting a qualified window repair contractor for remediation options.

Office window difficult to operate

Entryway window difficult to open

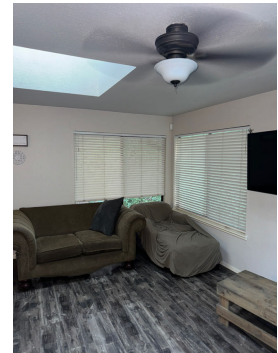
7.1. NOTE: Window(s) noted to be inaccessible and therefore not inspected. Recommend removing obstacle(s) and inspecting as needed.

Blocked window(s)

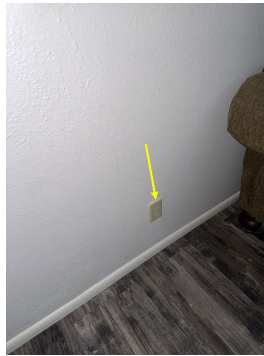
11.2. One or more wall outlet(s) noted to be loose inside box which could loosen wires and cause arcing. Recommend a qualified electrician check for loose wires and tighten as needed.

Loose living room outlet

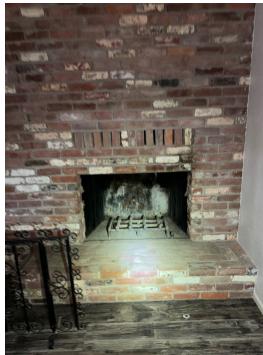
12.2. Rust/corrosion noted inside fireplace likely due to a missing rain cap (See "Roof > Rain Cap/Spark Arrestor"). This is making the **damper** difficult to operate. Recommend a qualified professional for further review and repairs/remediation as needed.

Fireplace detail

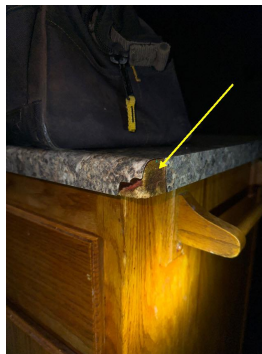
4.1. [Laminate counter surface damage noted. Recommend patching or replacing as needed.](#)

Damaged laminate counter top

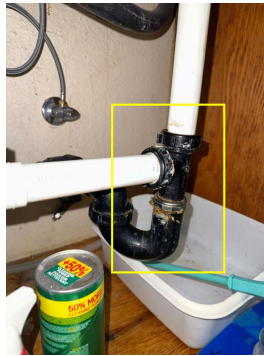
6.1. **NOTE:** Evidence of past leaks noted around drain lines but dry at time of inspection. Due to the age of this home, leak staining is not uncommon as these leaks could have occurred at any time in the past and been subsequently repaired. Recommend checking with seller for further details.

Evidence of past drain line leak

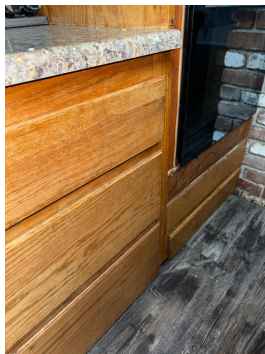
8.2. Worn finish noted on some cabinet areas. Consider refinishing as needed.

Worn cabinets

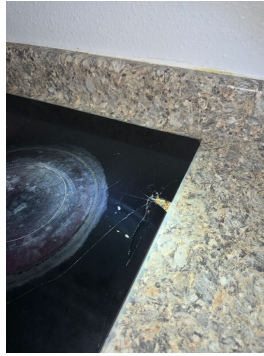
12.1. Cracked/shattered glass cooktop was noted. Recommend a qualified contractor for replacement as needed.

Cracked cooktop

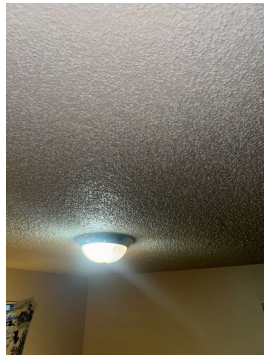
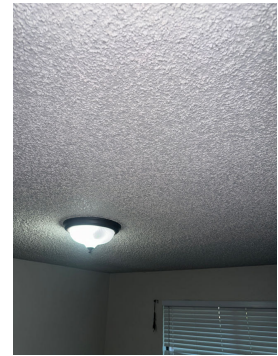
3.1. Popcorn texturing noted on ceiling which presents a possible asbestos hazard. Recommend leaving undisturbed until having done additional research and preparation for removal if desired.

Room 3 popcorn ceiling texturing

Room 1 popcorn ceiling texturing

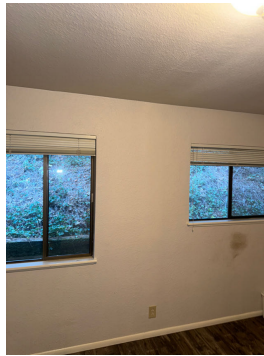
5.2. Fog and/or condensation or the resulting stains were noted in double-pane window(s) which is an indication of a failed seal. Recommend review for repair or replacement as necessary.

Room 4 possible failed seals

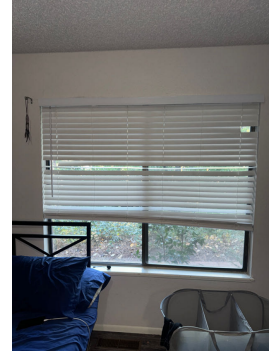
5.3. Window(s) noted to be difficult to open for reasons unknown. Recommend cleaning and lubricating friction points or consulting a qualified window repair contractor for remediation options.

Room 1 window difficult to open

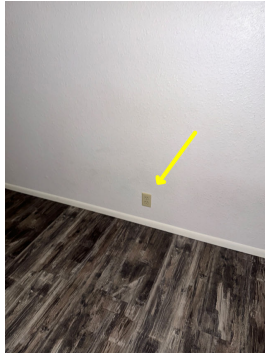
9.2. One or more wall outlet(s) noted to be loose inside box which could loosen wires and cause arching. Recommend a qualified electrician check for loose wires and tighten as needed.

Room 2 loose outlet

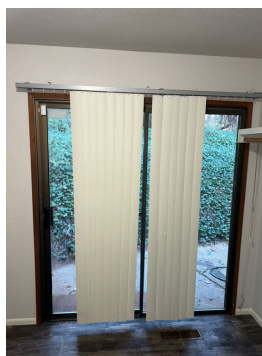
12.1. Screen door was noted to be missing. Recommend replacement as needed.

Room 5 missing sliding screen door

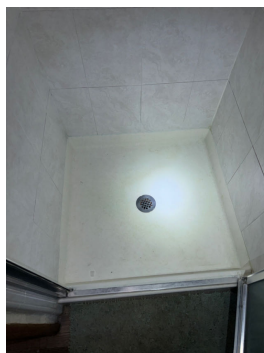
7.2. Staining noted on shower surround and it is not known if it can be removed. Recommend a shower wall cleaner for starters.

Bathroom 2 stained shower pan

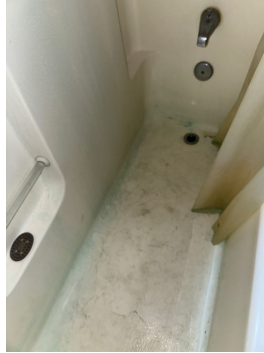
9.1. Worn and/or stained tub finish noted and it is not known if it can be restored to its original condition.

Bathroom 1 stained bathtub

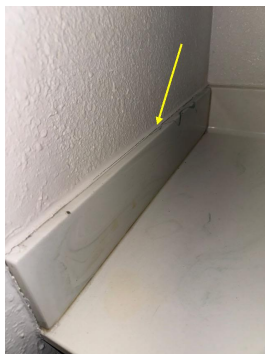
11.1. Deficient counter seam caulking noted. Recommend recaulking as needed.

Bathroom 1 deficient counter caulk

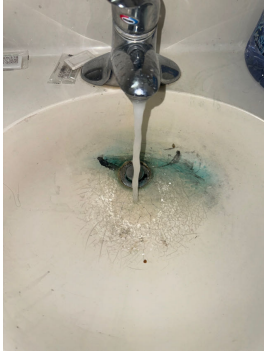
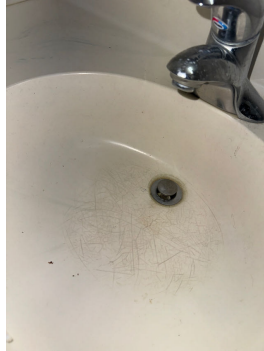
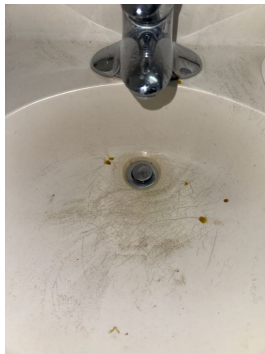
12.2. Sink surface crack(s) and/or chips noted. Recommend repairs as needed.

Bathroom 1 cracked and stained sink surface

Bathroom 1 cracked sink surface

Bathroom 2 cracked sink surface

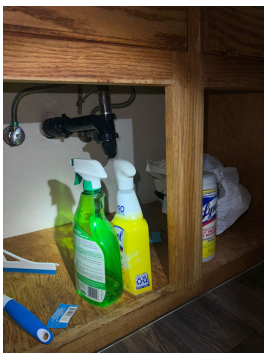
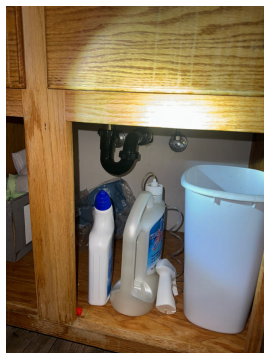
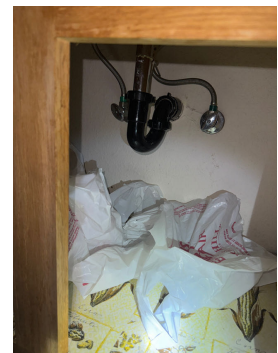
14.1. NOTE: Cabinet(s) noted with personal items blocking access and therefore inside cabinet, plumbing and other under-cabinet appliances may not be completely inspected.

Bathroom 1 blocked sink cabinet

Bathroom 2 blocked sink cabinet

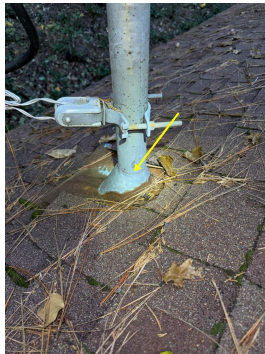
1.2. Cracked or missing seal noted between electrical service drop masthead and roof flashing. Recommend resealing as needed to avoid moisture intrusion.

Missing cable feed masthead seal

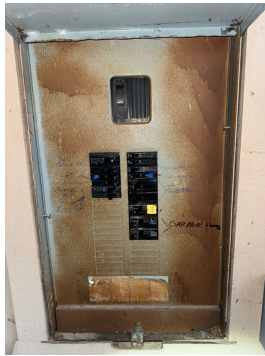
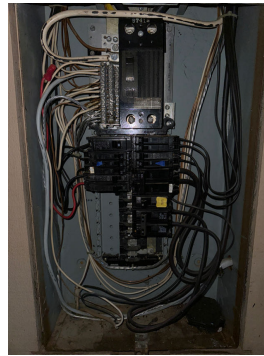
3.2. Cable clamp has come loose/out of place inside main service panel, leaving wiring penetrating through sharp panel box opening. Recommend a qualified electrician re-position cable clamp to protect wiring from sharp edges.

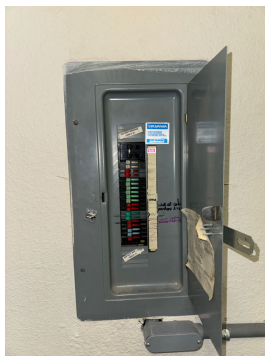
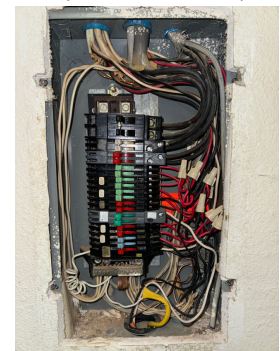
4.4. Sub panel 1 and cover are not flush, leaving a gap which leaves exposed wiring. Recommend a qualified electrician for review and repairs as needed for safety.

4.5. Sub panel 2 bonding jumper appears to be connected between neutral and grounding bus bars which is not appropriate for a sub panel. Recommend further review and repair by a qualified electrician.

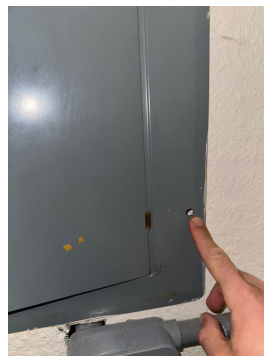
Missing panel cover screw

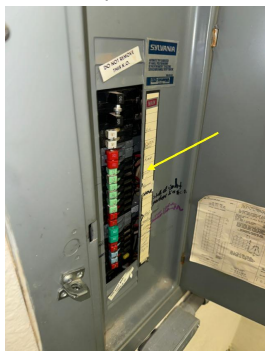
Panel cover not flush against breakers

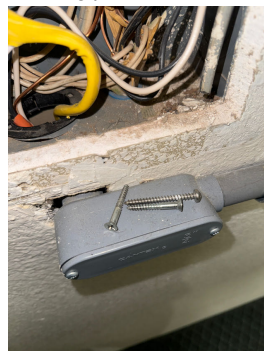
Sharp pointed panel cover screws

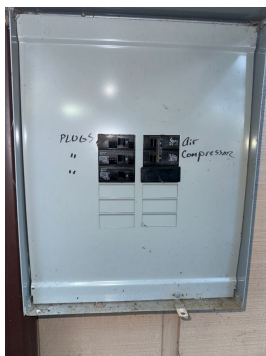
Sub panel detail

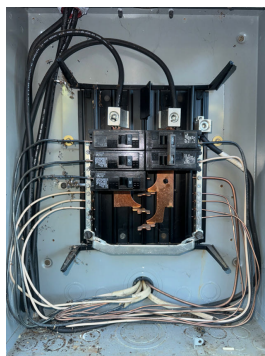
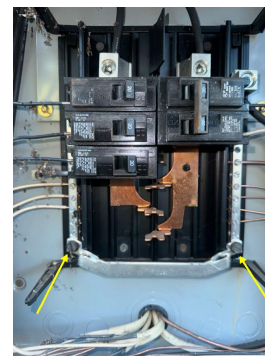
Sub panel 2 ground and neutral bus bars connected

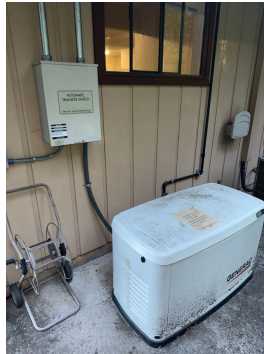
8.1. NOTE: Auxiliary generator and/or switch box noted but not inspected. Recommend confirming serviceability and if necessary a full evaluation by a qualified electrician.

Auxiliary generator system not inspected

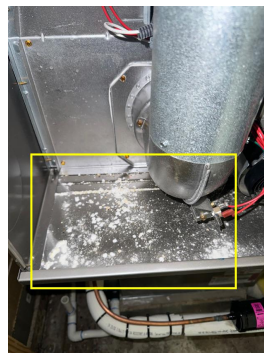
10.1. White powdery residue, rust and/or corrosion was noted inside furnace cabinet which may be an indication of incomplete or improper combustion. Recommend consulting with a qualified HVAC contractor for review and remediation options.

White powder/corrosion inside furnace cabinet

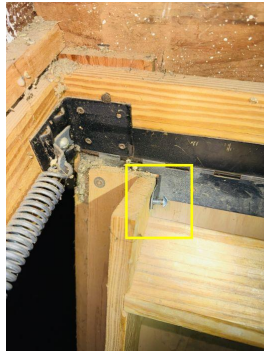
1.1. Loose fastener noted for the attic pull down ladder. Recommend checking all fastening for ladder and securing for safety.

Loose pull down ladder fastener

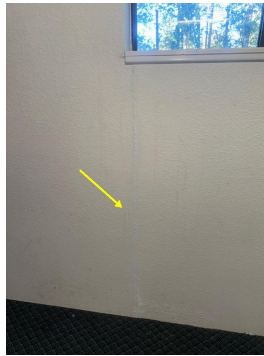
3.1. Sheetrock crack(s) noted which normally represents a cosmetic issue as opposed to a structural problem. Consider patching with a flexible caulking to reduce or eliminate eyesore.

Sheetrock crack

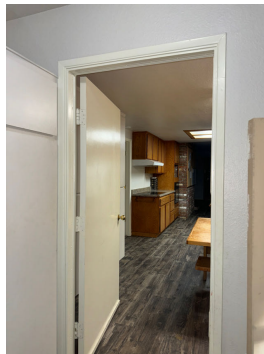
6.1. The automatic closure device does not close the garage to house fire separation door properly. This could allow a fire to enter the home. Recommend adjusting or replacing the hinges to allow for proper closure of the door.

Deficient self closing device on fire door

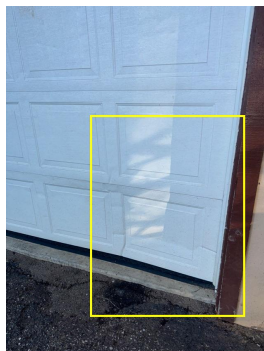
7.1. Vehicle door damage noted but did not appear to affect serviceability.

Damaged vehicle door

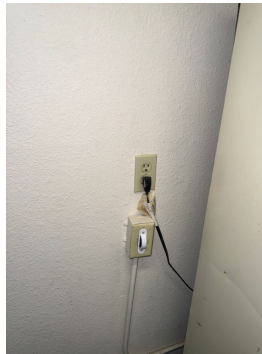
10.2. One or more wall outlet(s) noted to be loose inside box which could loosen wires and cause arcing. Recommend a qualified electrician check for loose wires and tighten as needed.

Loose outlet

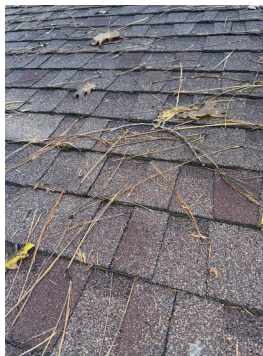
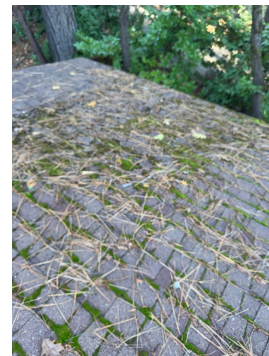
2.2. Moss on composition roof noted which can lead to the premature failure of the roof and subsequent leaks. Recommend treating moss during its growing season (wet months) with a moss killer.

Moss on roof

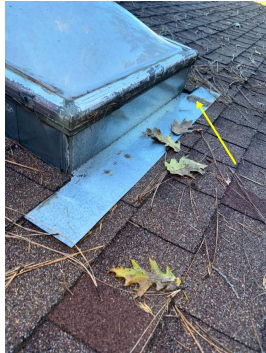
3.2. Rusted flashing noted. Recommend clearing debris and checking for integrity if necessary, and either replacing or prepping and painting with a rust-resistant paint as needed.

Rusted skylight flashing

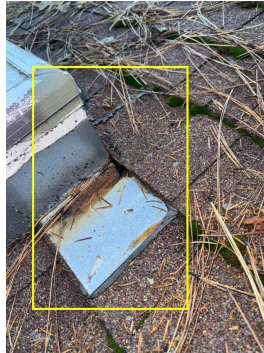
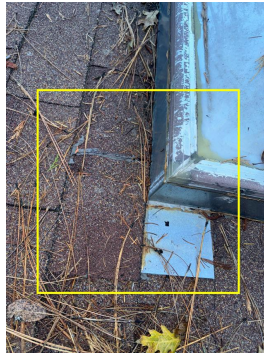
3.3. Since proper flashing does not require additional waterproofing and based on the build-up of mastic or caulking on

various flashing pieces, serviceable flashing may be lacking in these areas. Recommend checking with seller for details on any leaks and consulting with a qualified contractor for further review and repair as needed. Since these types of sealants will only last a few years at best, if nothing is done we recommend monitoring for future leaks.

Mastic sealant around skylight flashing

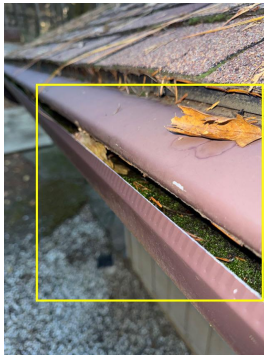
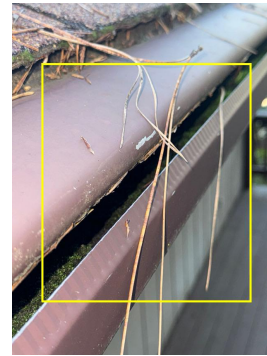
5.2. Leafless gutters clogged with organic materials were noted. Recommend cleaning to avoid overflow and foundation edge saturation.

Leafless style gutter guard clogged

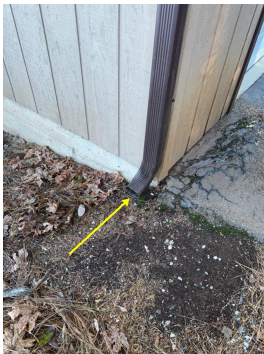
6.1. Deficient downspout termination noted at or near the structure foundation. Recommend drain pipe(s) to divert roof water away from the foundation.

Downspout terminates at foundation

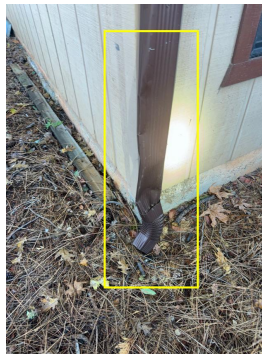
6.2. Damaged downspout(s) noted. Recommend repairs as needed.

Downspout terminates at foundation and is damaged

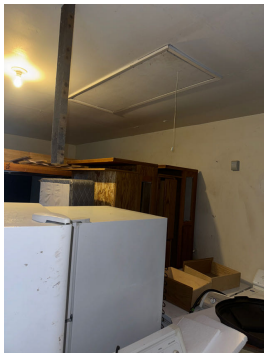
7.1. NOTE: Due to obstructions or space considerations, attic area was not accessible and therefore not inspected. Recommend measures necessary to allow for attic inspection.

Blocked attic pull down ladder

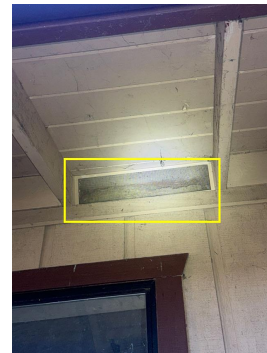
7.2. Soffit vent screen(s) noted to be blocked with insulation. Recommend clearing as needed and consider installing attic baffle vents to correct problem without losing ceiling R-value.

Soffit vent blocked with insulation

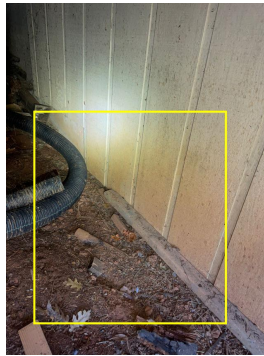
10.1. Siding to ground contact noted which will eventually cause wood decay. Recommend correcting so siding is a minimum of 6 to 8 inches above ground.

Siding to ground contact

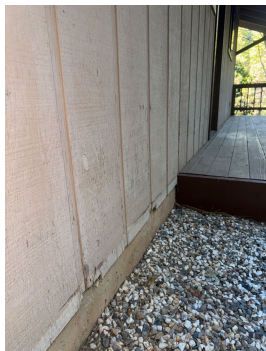
12.1. Deficient paint and poorly sealed exterior cladding junctions noted in places. Recommend painting and caulking as needed to avoid moisture intrusion and its related negative effects.

Deficient paint

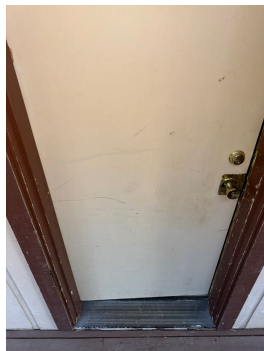
Deficient paint

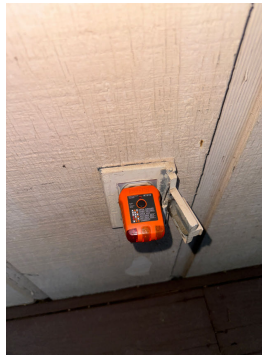
13.1. No power to outlet(s) noted. Recommend checking with seller for further details and if necessary, contacting a qualified electrician for repairs as needed.

No power to outlet

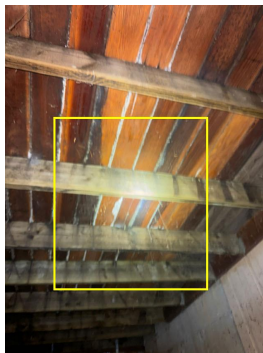
15.3. **Wood destroying fungus** noted on wood support structure which will continue to deteriorate over time. Refer to pest report for more detail and consider treating as needed to avoid further deterioration.

Fungal growth under deck

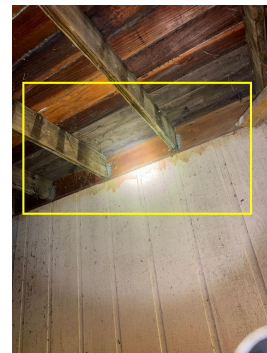
15.1. Deck **ledger board** flashing appears to be lacking. Recommend consulting with a qualified contractor for remediation options.

15.2. Less than ideal attachment of ledger board noted with nails used instead of lag or through bolts. Although the ledger board appeared sound, this form of ledger attachment will loosen over time and could present a safety issue down the road. Recommend monitoring and if conditions change, consulting with a qualified contractor for remediation options.

Ledger installed with nails and lacking flashing

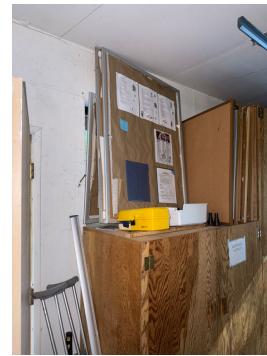
18.1. NOTE: Window(s) noted to be inaccessible and therefore not inspected. Recommend removing obstacle(s) and inspecting as needed.

Blocked window

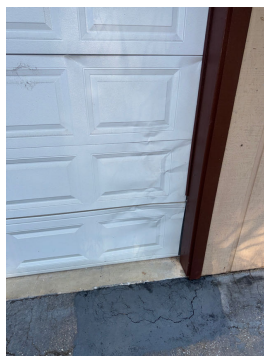
19.1. Vehicle door damage noted which appeared to effect serviceability. Recommend repair or replacement as needed.

Vehicle door damage

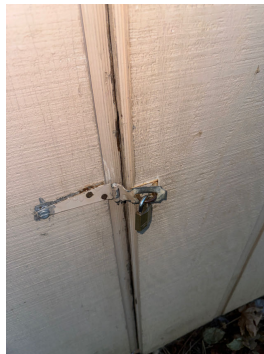
26.1. NOTE: The back right side crawlspace access door was locked with a padlock and the inspector did not have a key to open this door. The crawlspace/foundation area was therefore not accessed or inspected. Recommend further inspection when access is gained.

Locked crawlspace access door

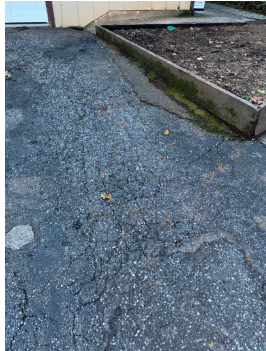
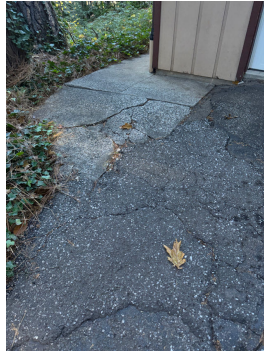
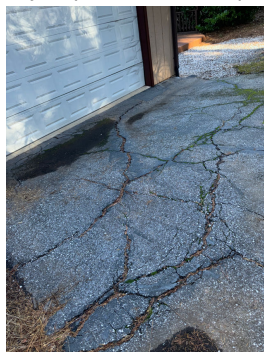
1.1. Heavy driveway and/or walkway cracking and displacement noted which represents a trip hazard. Recommend consulting a qualified concrete contractor for repair options.

Heavy driveway cracking

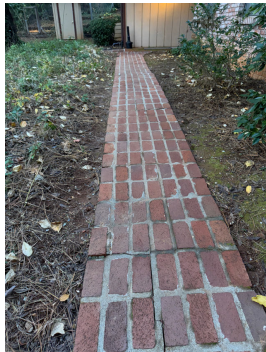
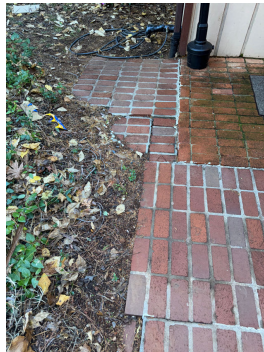
Walkway displacement and trip hazard

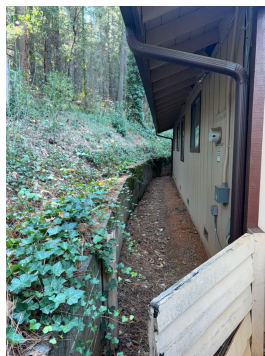
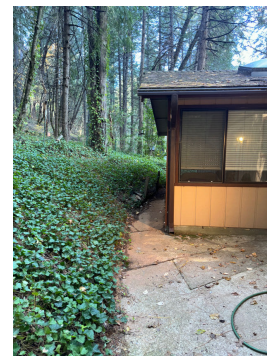
2.2. There are areas of negative grading towards the house and it is not known if a drainage system exists to take rain water away from the foundation. Recommend checking with seller on the presence of a drainage system and if

Negative grade toward house

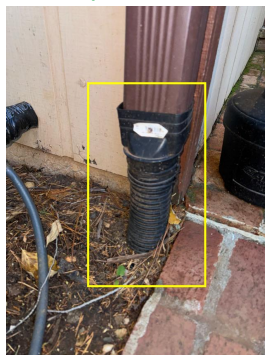
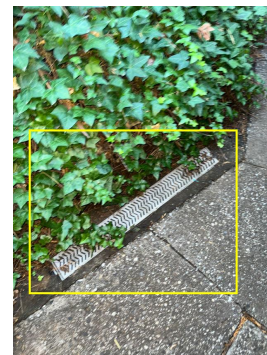
3.2. NOTE: A lot drainage system was noted but not inspected. Recommend checking with seller on serviceability.

Drainage system not inspected
