American Marine Surveyors
Quality. respect. professionalism

Marine Survey Report For

2018 Grady White Canyon 271 FS

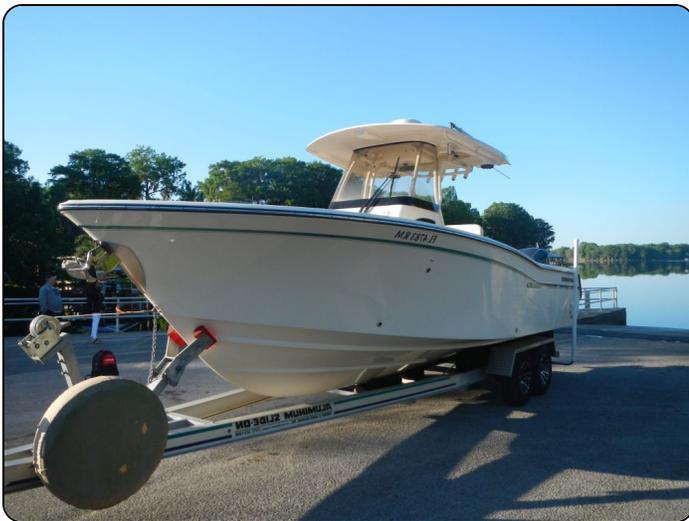
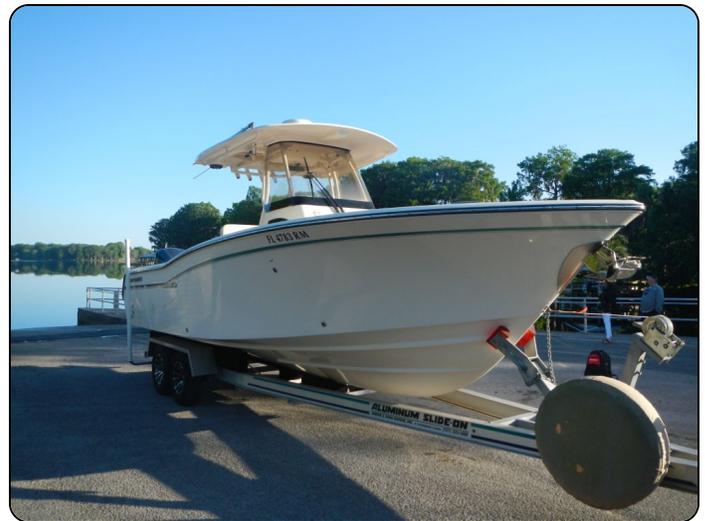
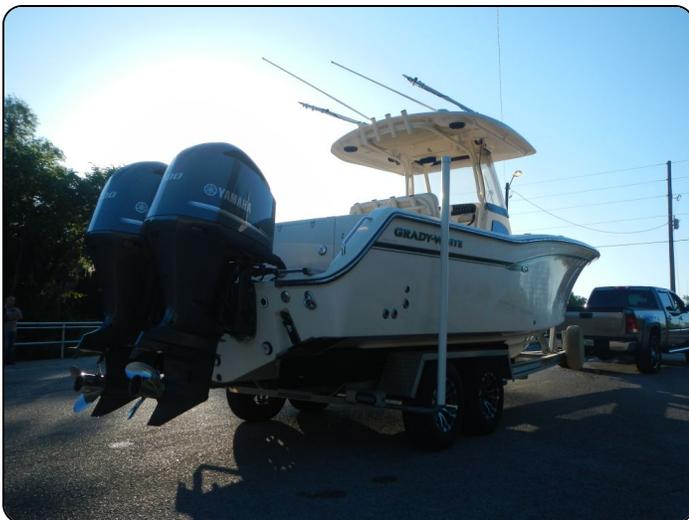
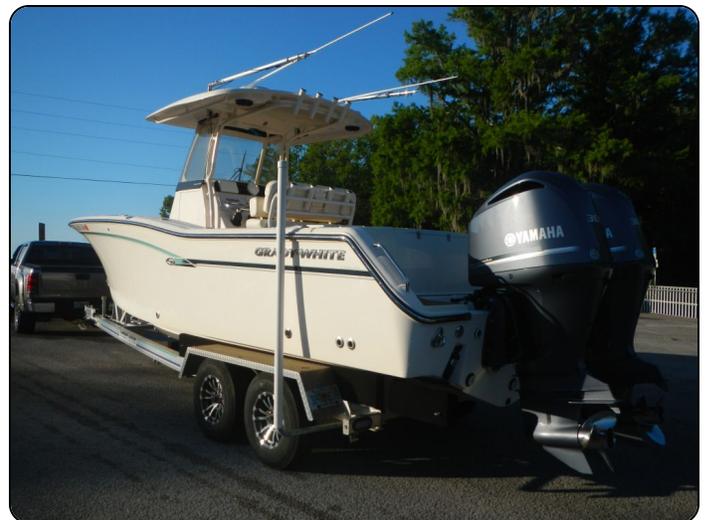
Blisters are an unknown factor on all boats and if not currently present, there is no guarantee that they will not appear in the future. Blisters have a tendency to dry out over winter storage unless severe or large. Blisters (if any) best appear after the vessel has been in the water for an entire season. In addition, the symptomatic evidence of blistering can be obscured by bottom coatings, a dry storage period during which blisters spontaneously depressurize, bottom laminate sanding, and other conditions or actions. Recommend full inspection for blisters immediately after haul-out and power wash. Surveyor has no firsthand knowledge of the history of bottom maintenance, blistering, repairs or prophylactic coatings on this vessel. No blistering sighted on the below waterline hull.

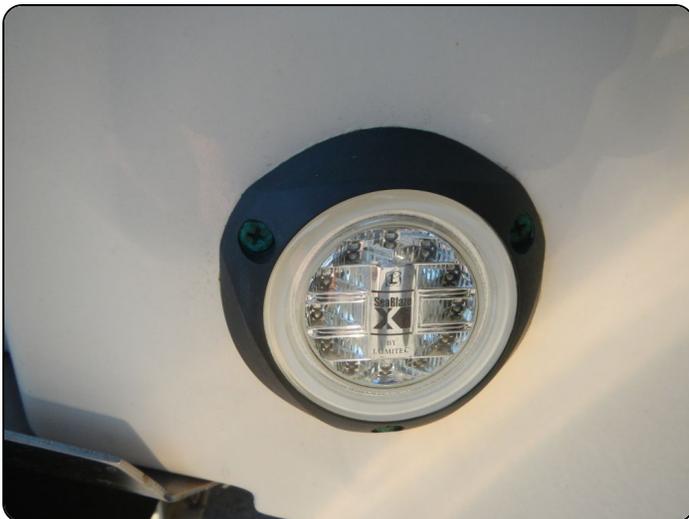
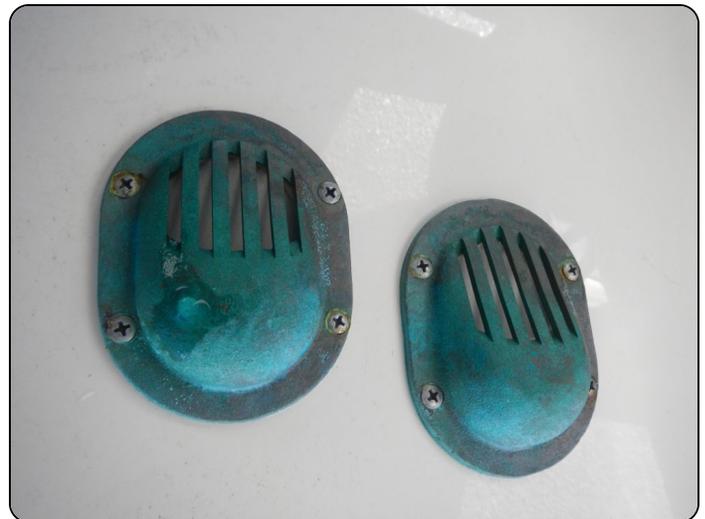
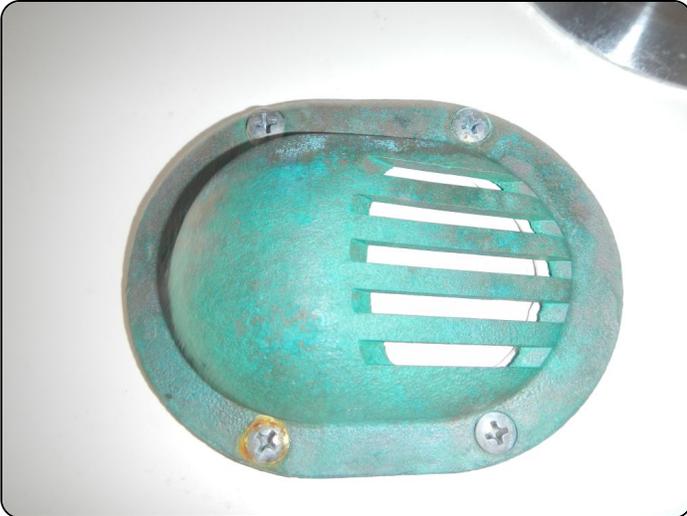
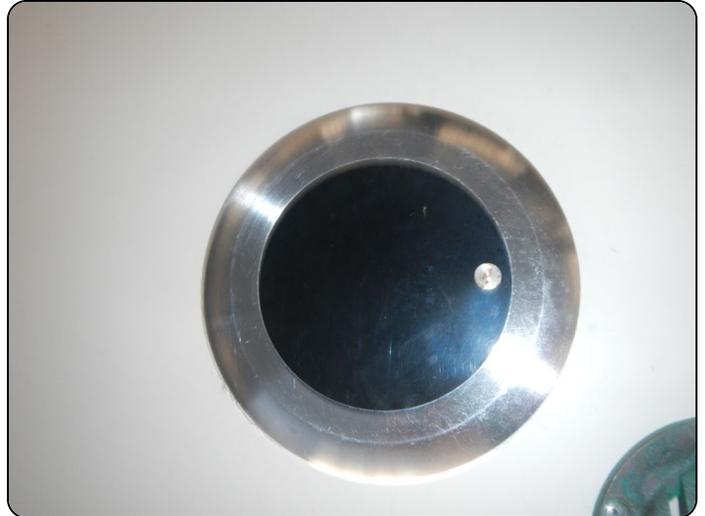
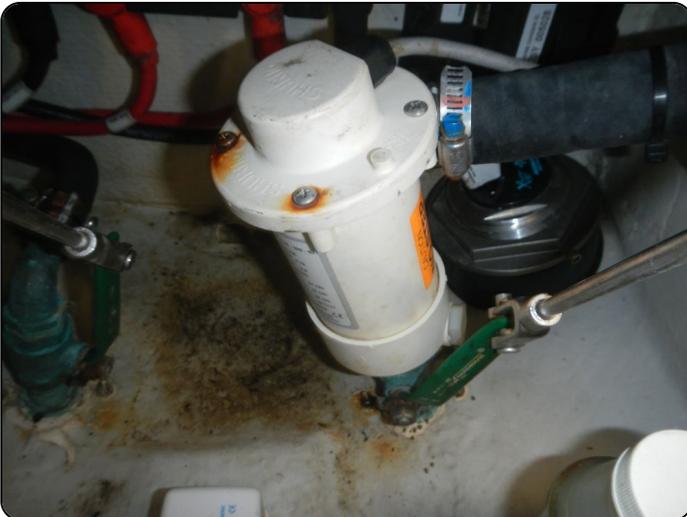
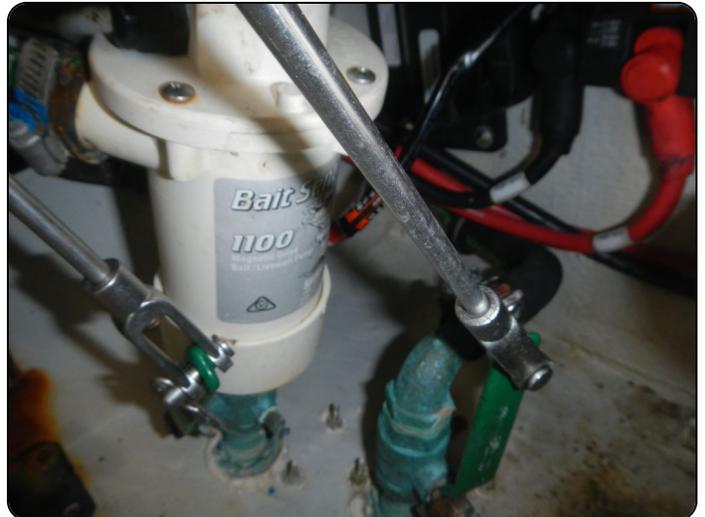
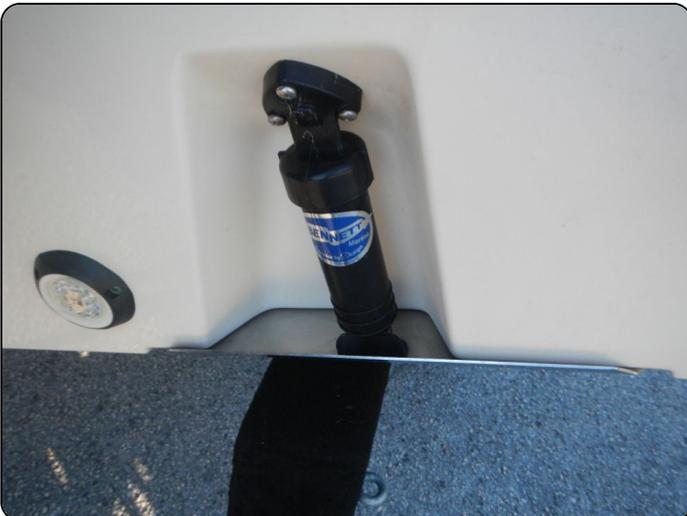
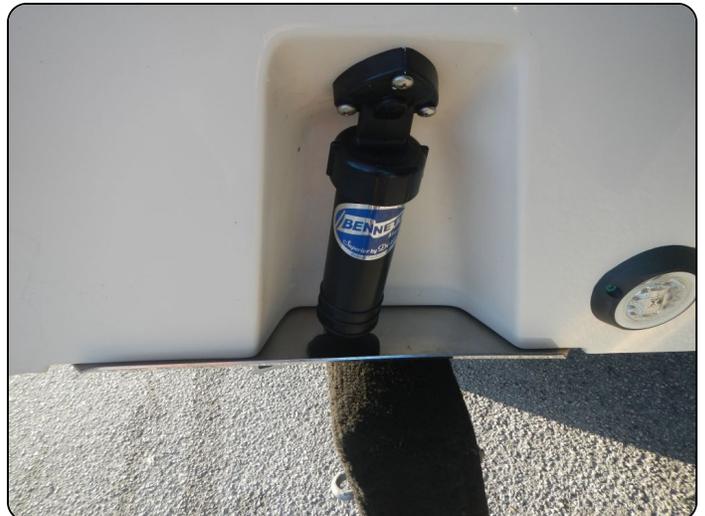
Bronze sea cocks with mounting flanges. Valves were tested and some found to be inoperable. See Findings & Recommendations.

In apparent serviceable condition except as noted in the Findings & Recommendations.

This company suggests the sea cock/ sea valves be serviced according to the manufactures recommendations as a preventative measure upon purchasing a used vessel and thereafter as recommended by the sea cock/ sea valve manufacturer or more frequently as a part of the vessel's regular maintenance program. We also strongly recommend that if the vessel is left unattended that all below waterline sea valves be closed with the exception of scuppers, bilge pump discharge, or other valves that are required to be in the open position to prevent flooding of the vessel during inclement weather. This provides an extra measure of safety for the vessel as well as the added benefit of familiarizing the crew with safety valve locations and to exercise the valves to prevent seizure.

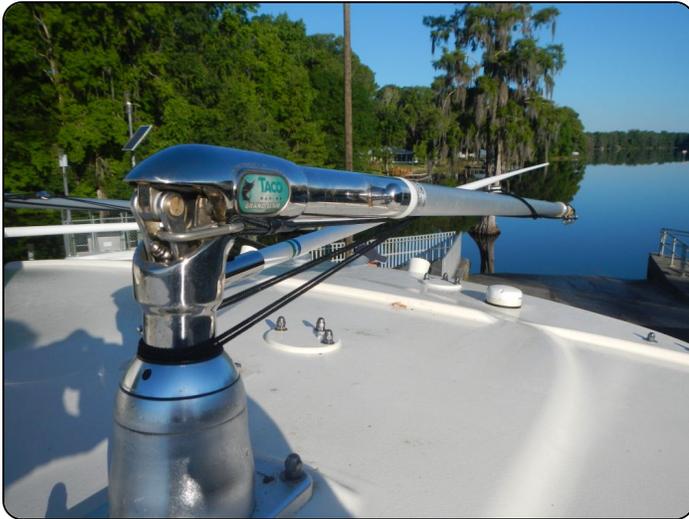
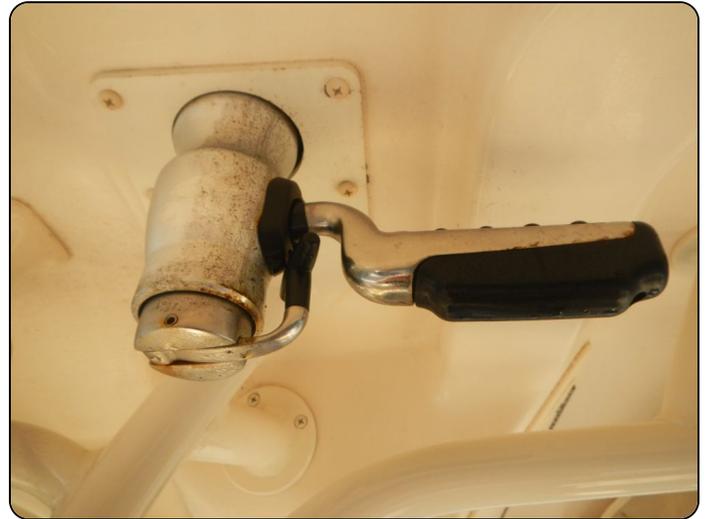
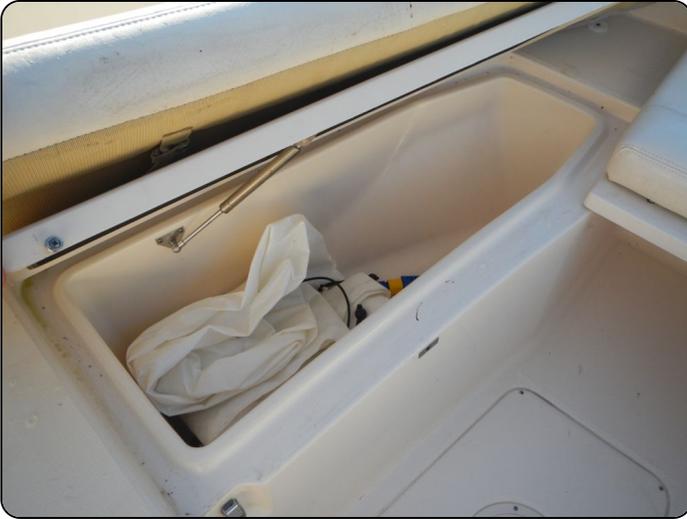
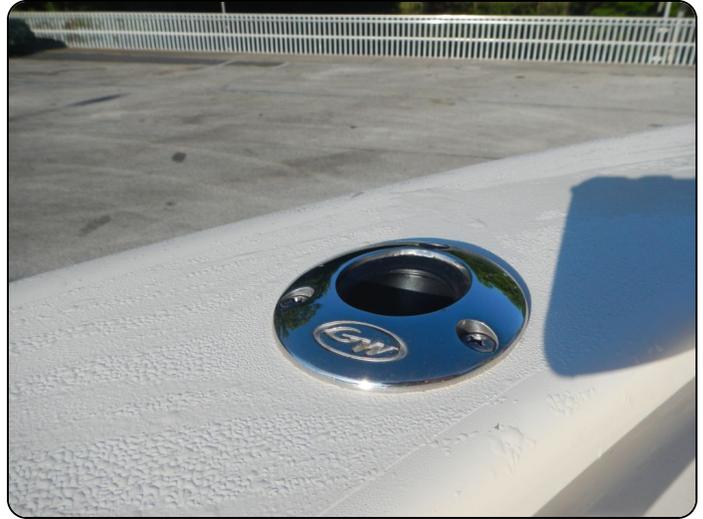
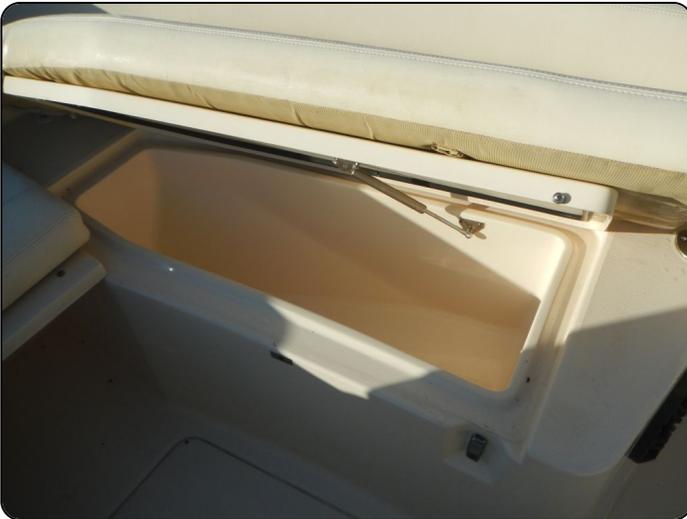
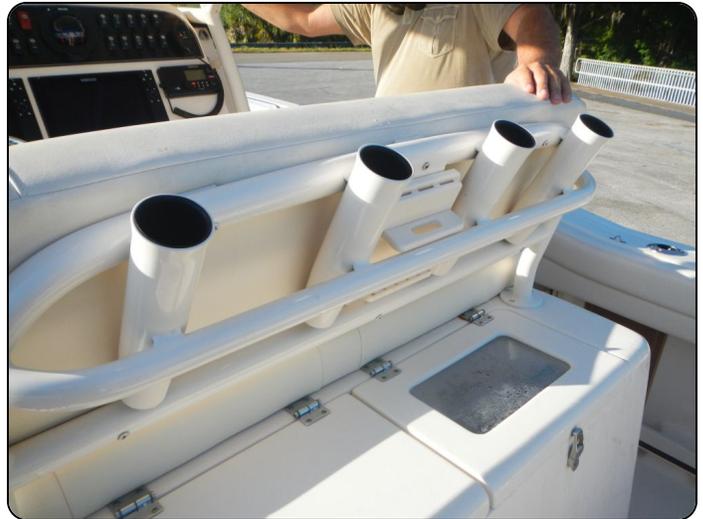
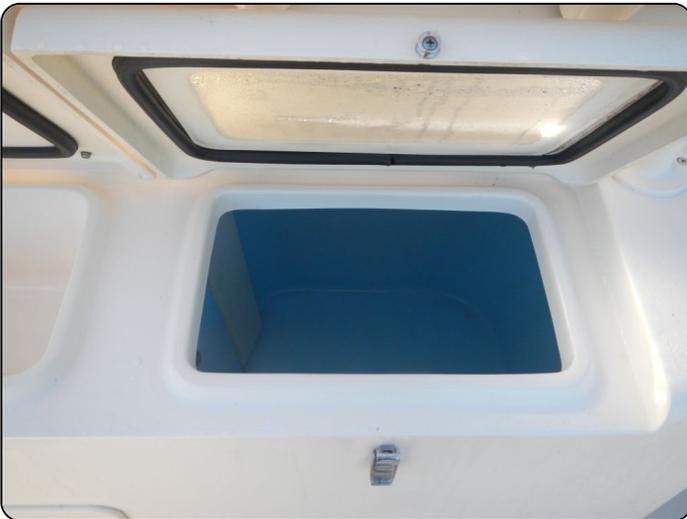
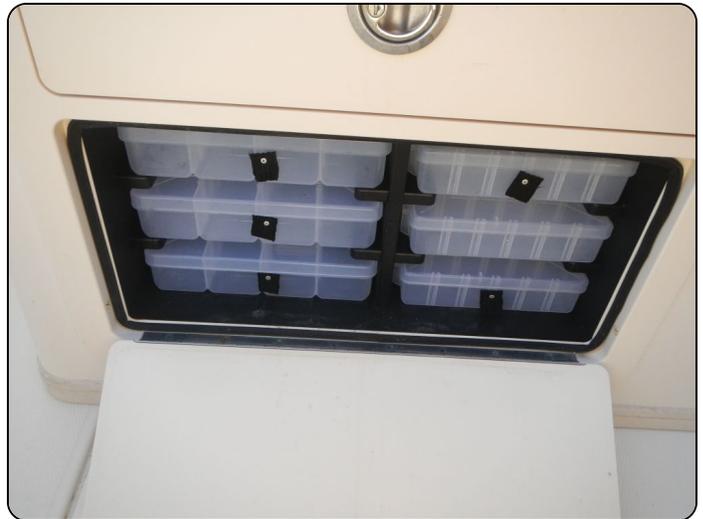
Insulated fish/storage boxes under the deck; cockpit rod storage; 42-gallon main livewell and additional livewell of unknown capacity; gunwale rod holders; raw-water washdown and Taco outriggers(not deployed). All equipment was functional and showed minimal wear and tear.

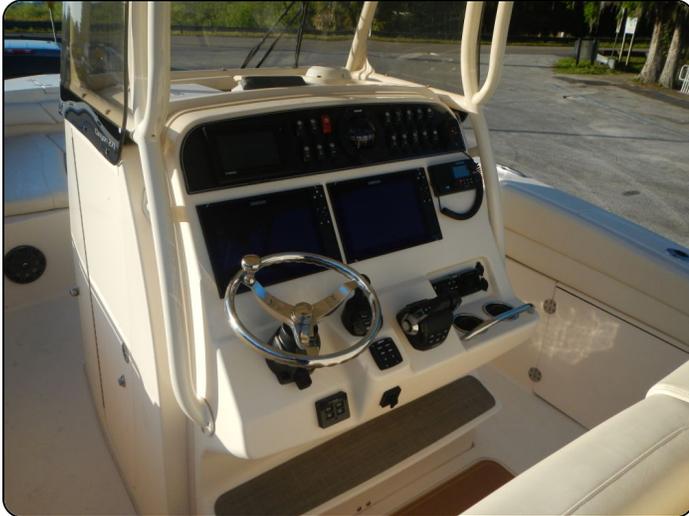
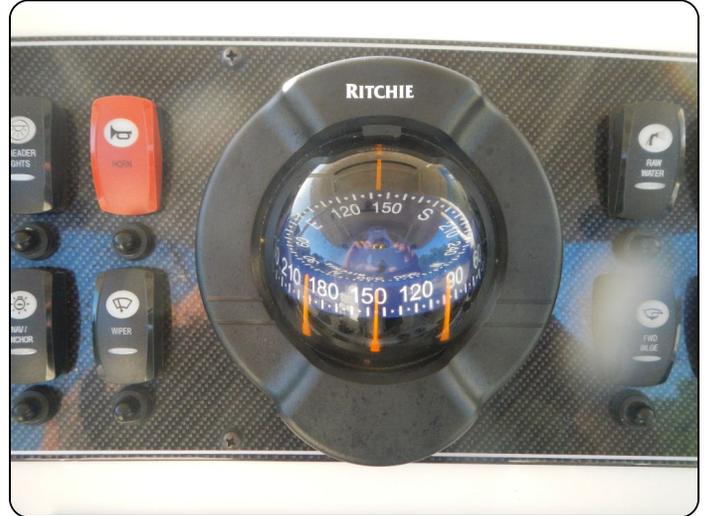
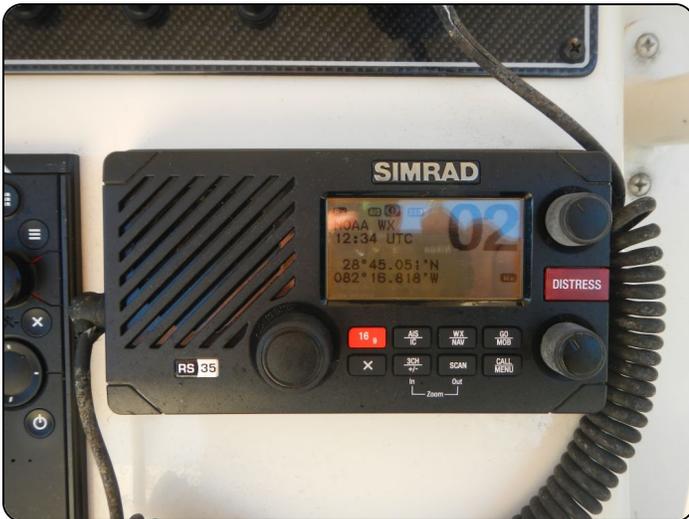
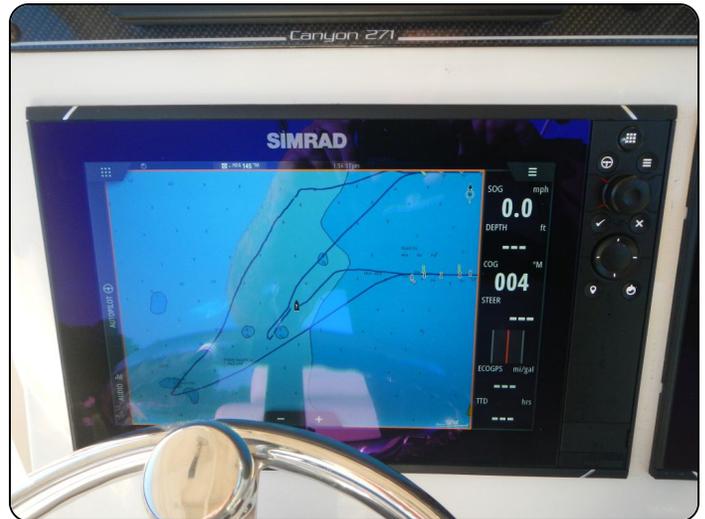
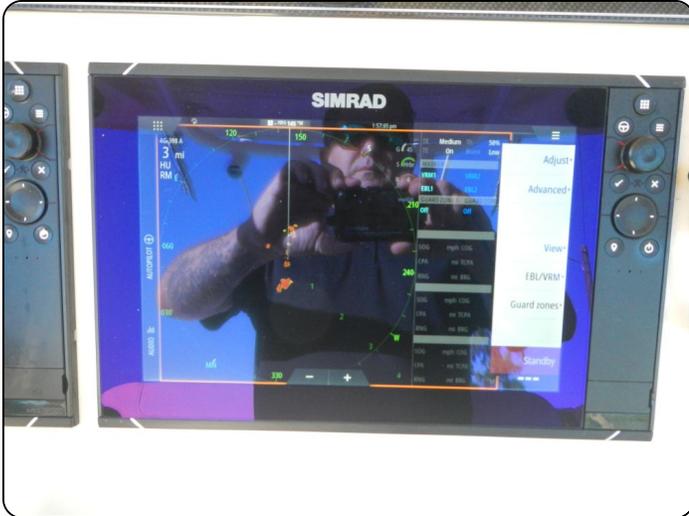
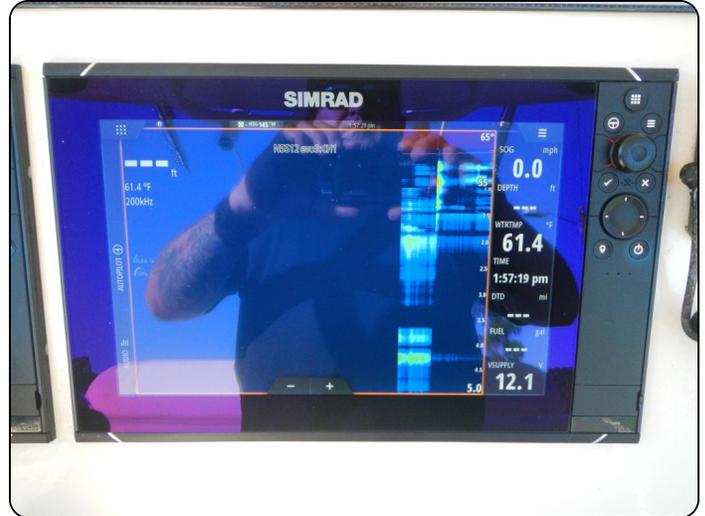
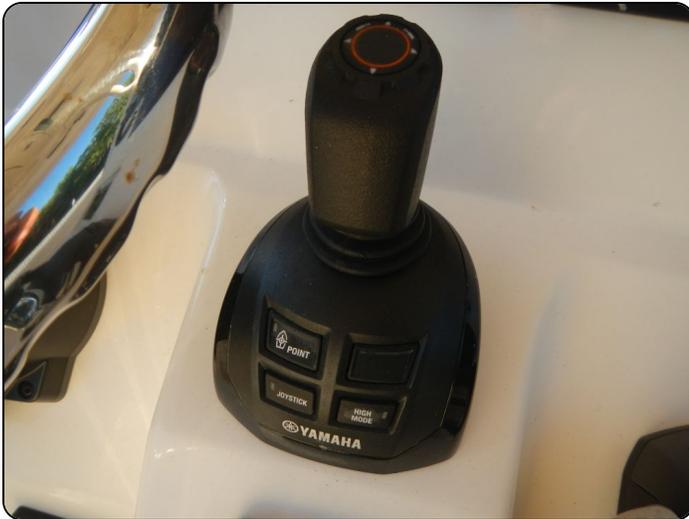
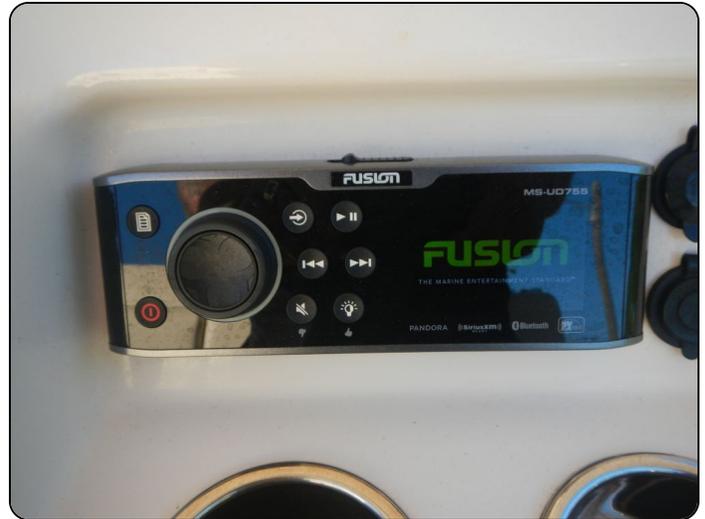
Electronics mounted on cockpit bulkhead. A 4" Ritchie compass in serviceable condition. The accuracy of the compass was not verified. A SIMRAD VHF radio, powered up and received transmission using the weather service. A Garmin Hybrid Touch chart plotter with navigational charts, sonar and radar that powered up and appears to function properly. A Yamaha autohelm system integrated into the Yamaha joystick system including setpoint that was proven operational during the trial run.

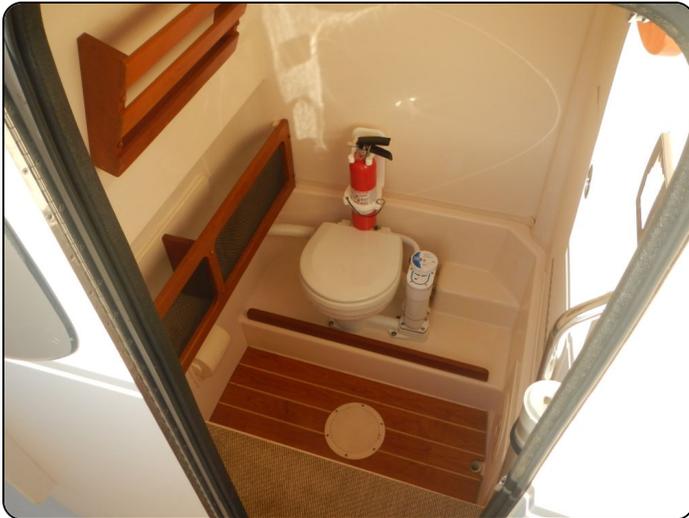
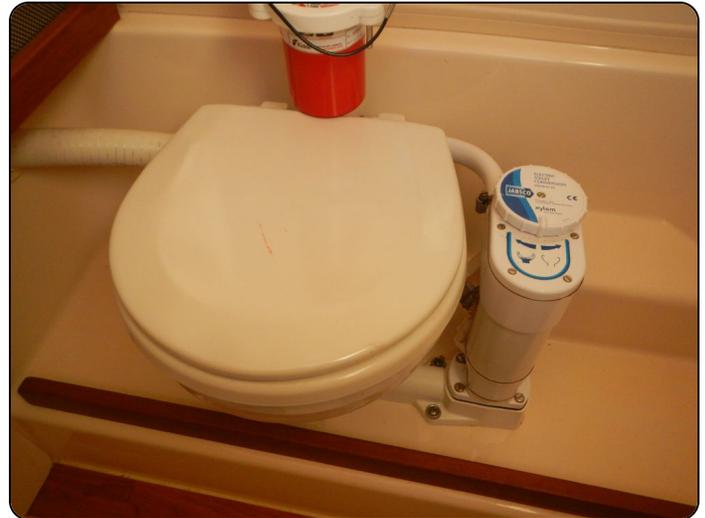
Interior Cabin

(1) water closet formed with pre-molded FRP liner module with gelcoat and exterior surfaces. A Jabsco brand marine head (Toilet) that operates on a maceration flush system piped with reinforced hoses and secured with hose clamps. The installed equipment operated normally and presented low wear and tear.

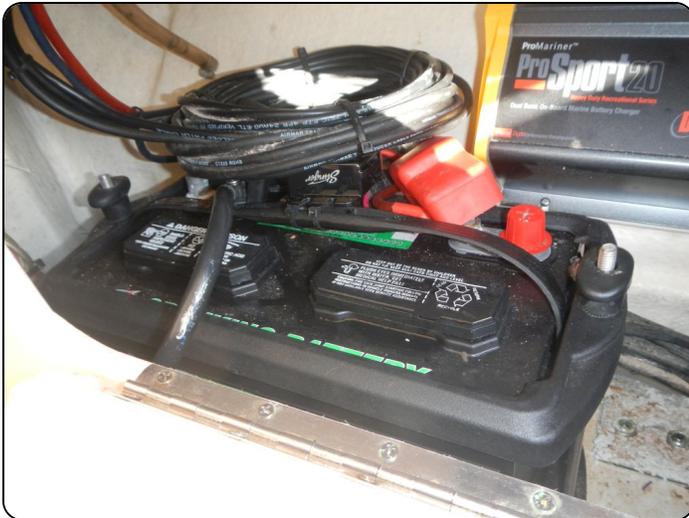
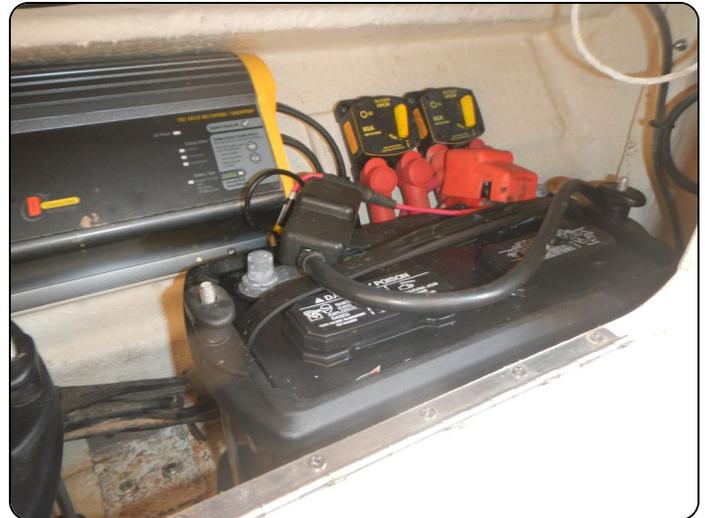
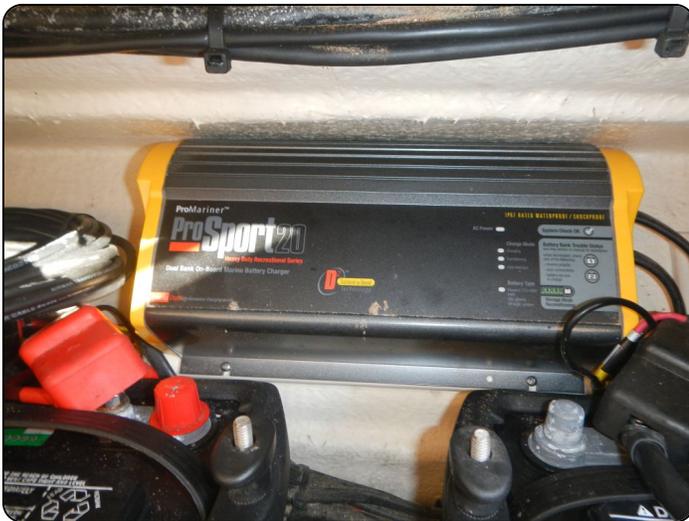
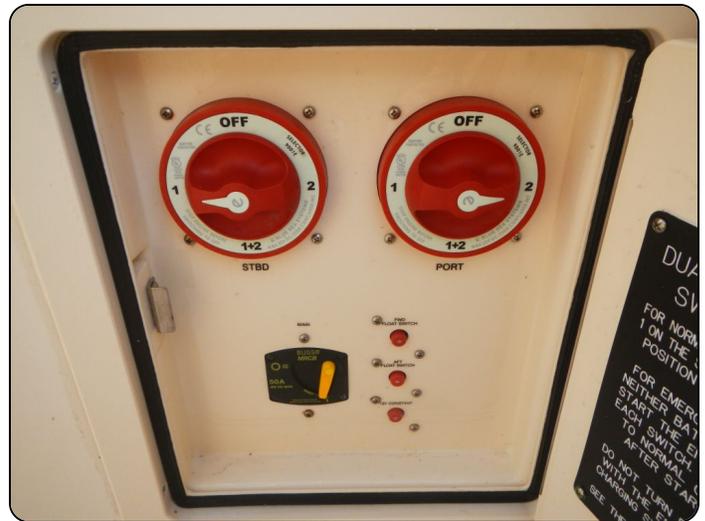
The vessel was equipped with a single 12Vdc system consisting of (2) battery banks. (2) Group 31 12Vdc wet cell lead acid batteries are located in the center console compartment and are secured with clamps. The bank of (2) batteries provide power to all 12 V systems to include the house electrical, windlass and equipment and act as the engine start batteries. (2) Blue Sea Systems rotary switches are located in a locker inside the aft quarter port side gunwale by the transom. Where visible the vessel was wired with multi-stranded copper conductors with plastic-type insulation. Much of the wire did not appear to have been modified from its factory installation. Furthermore, where observed, no indications of overheating conductor insulation was observed.

The terminals where splices could be seen consisted of ring terminals, terminal plugs, spade and blade terminals, fork terminals, common butt splices, and waterproof butt splices. Battery charging was accomplished by 12 Vdc unknown amperage alternators on each engine and by the ProSport 20A dual bank battery charger. All panels were clearly marked for voltage. Overcurrent protection of the system was provided by a variety of in-line fuses of different types, push-button thermal reset breakers and circuit breakers.

Check all battery dates prior to purchase to determine any batteries that are older than 3 years, It is recommended any battery over 3 years be replaced. Batteries are not load tested as a part of the survey and often battery dates are not visible. Verify this information prior to closing.

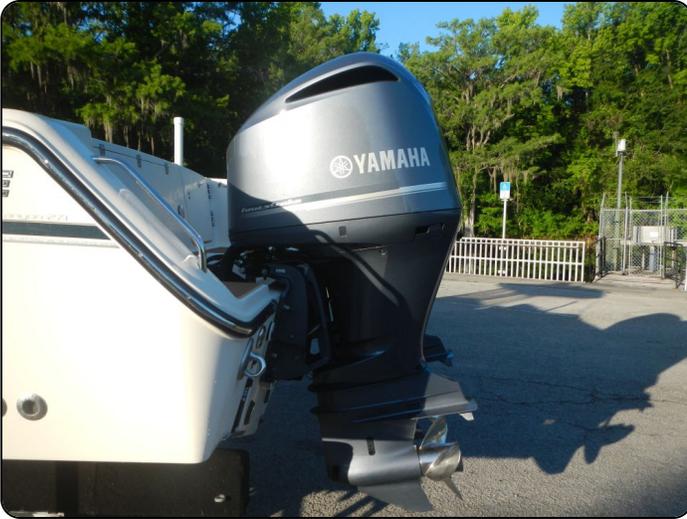
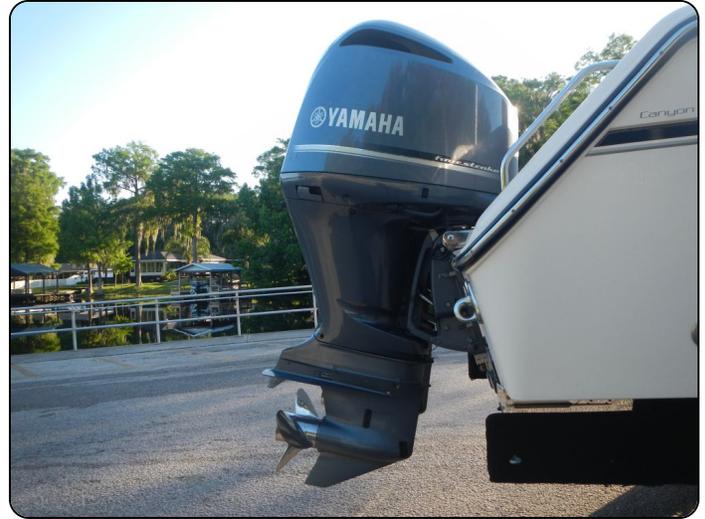
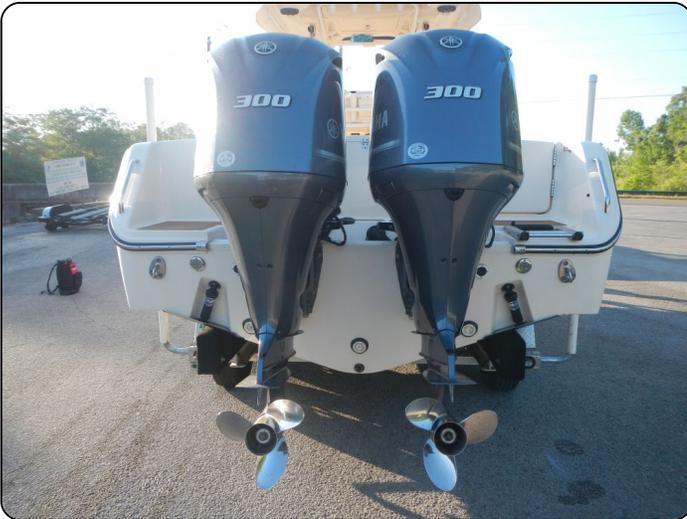
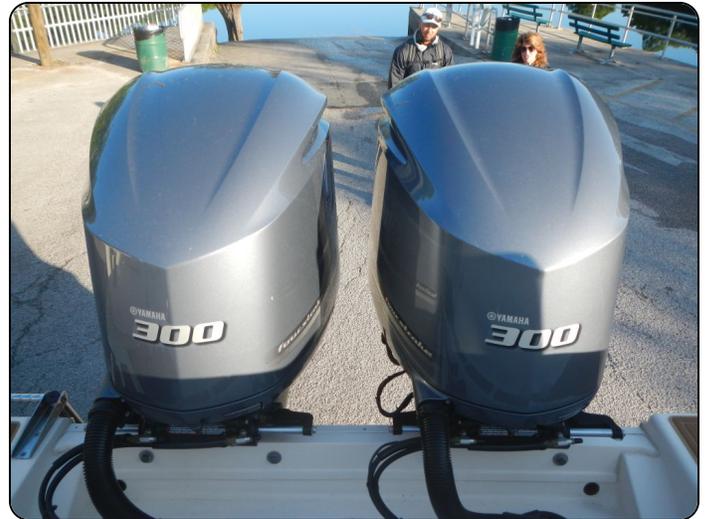
FINDING B-4

(2) Yamaha 300 HP four-stroke outboards. The engine mounts were secure. Both tilt and trim functions were operational when tested. Engine fluid levels were full and no metal shavings or emulsified oil sighted in the upper unit. The cowlings were in good condition with no visible scratches or broken sides. The props were stainless steel three-bladed props with no visible damage and both skegs were in good condition. See Findings & Recommendations.

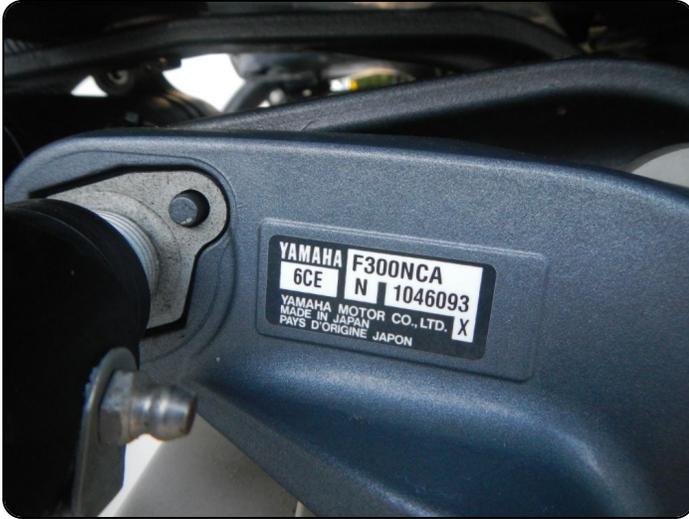
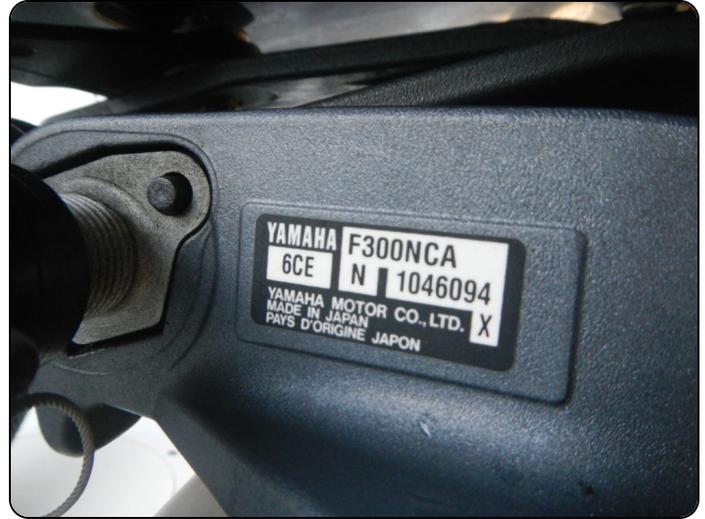
Port Engine: 1046093 Starboard Engine: 1046094
