American Marine Surveyors

Marine Survey Report For

2022 Freeman 47'

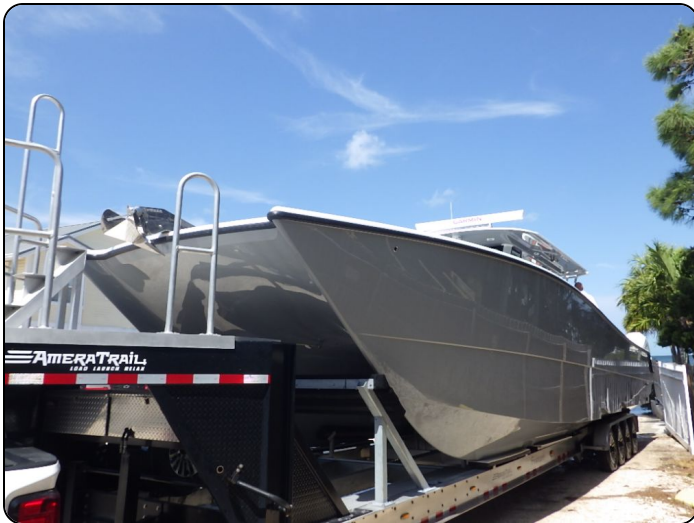
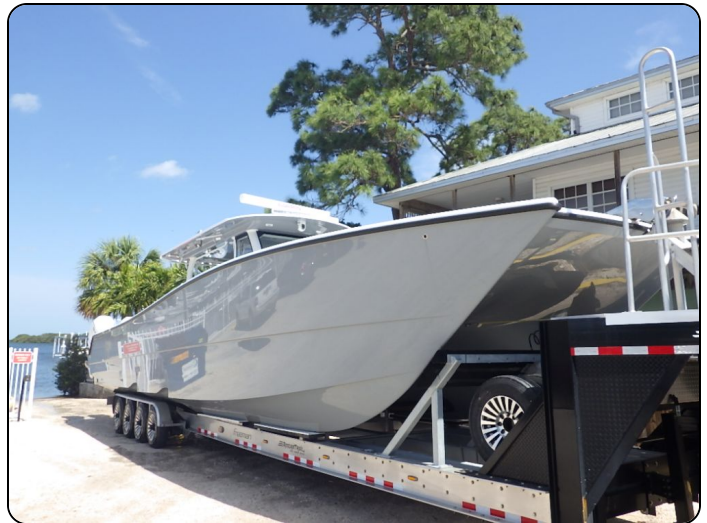
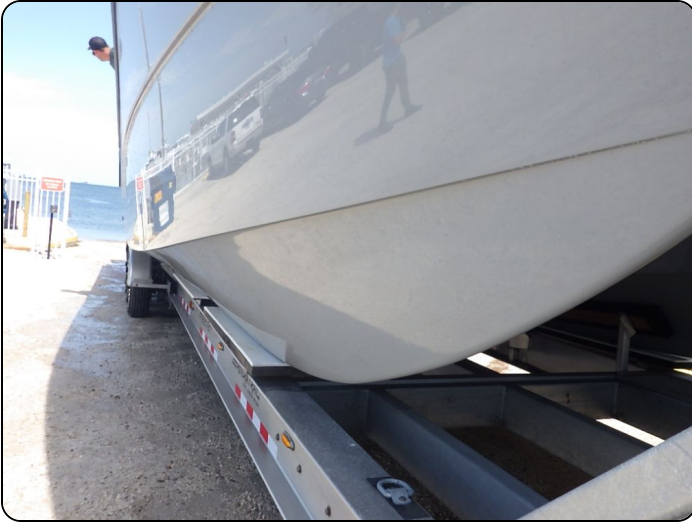
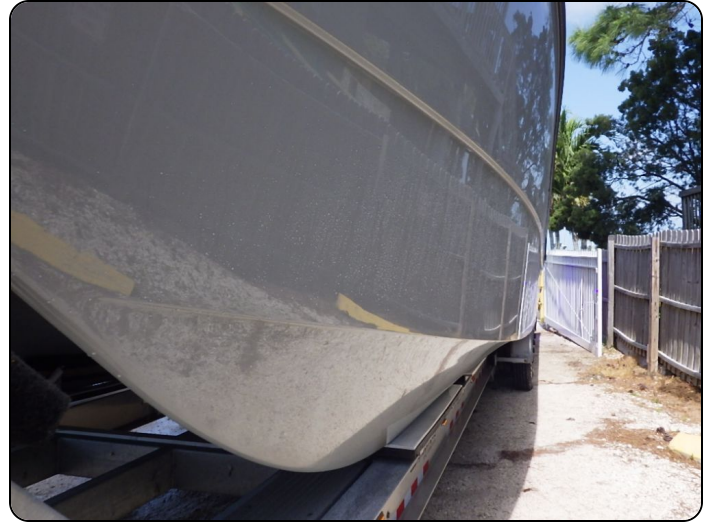
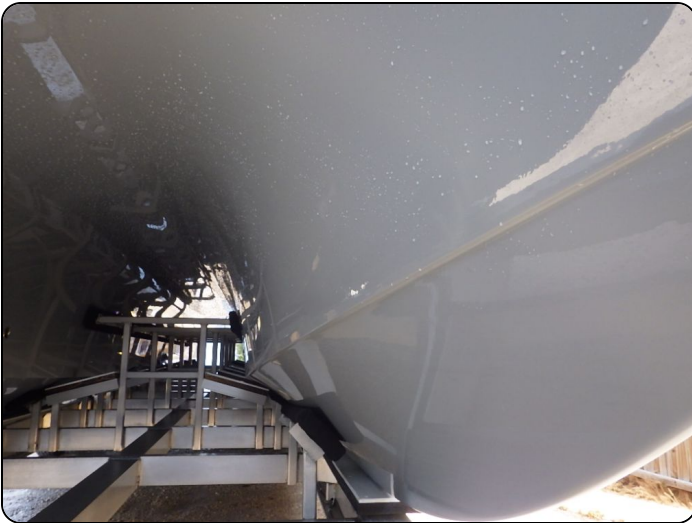
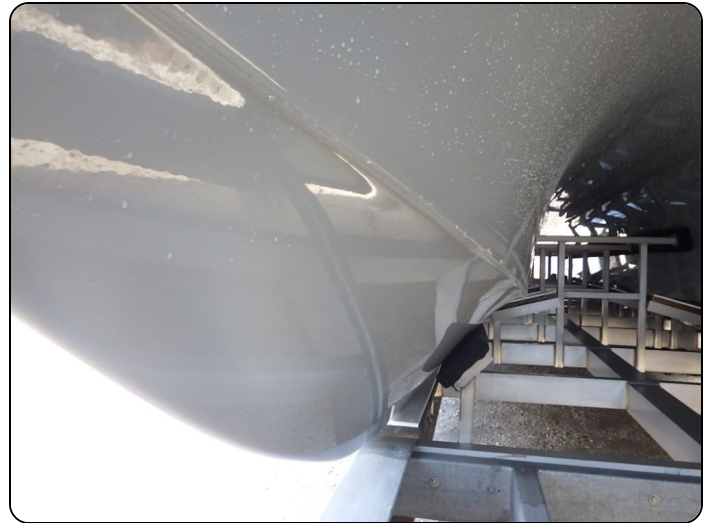
Blisters are an unknown factor on all boats and if not currently present, there is no guarantee that they will not appear in the future. Blisters have a tendency to dry out over winter storage unless severe or large. Blisters (if any) best appear after the vessel has been in the water for an entire season. In addition, the symptomatic evidence of blistering can be obscured by bottom coatings, a dry storage period during which blisters spontaneously depressurize, bottom laminate sanding, and other conditions or actions. Recommend full inspection for blisters immediately after haul-out and power wash. Surveyor has no firsthand knowledge of the history of bottom maintenance, blistering, repairs or prophylactic coatings on this vessel. No blistering sighted on the below waterline hull. No blistering sighted on the below waterline hull.

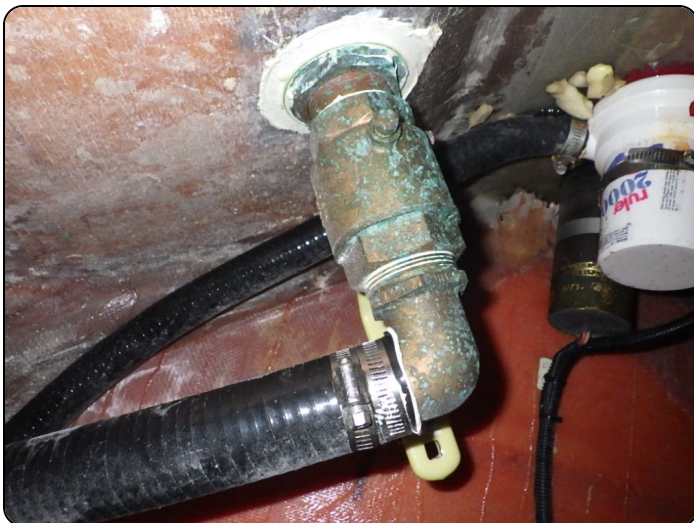
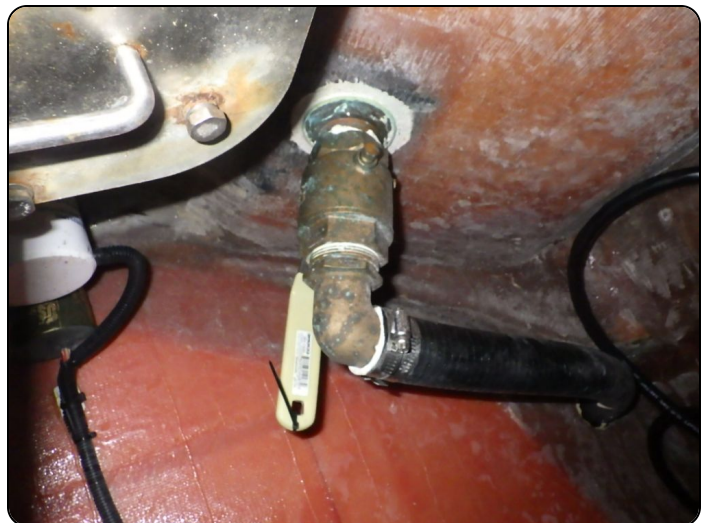
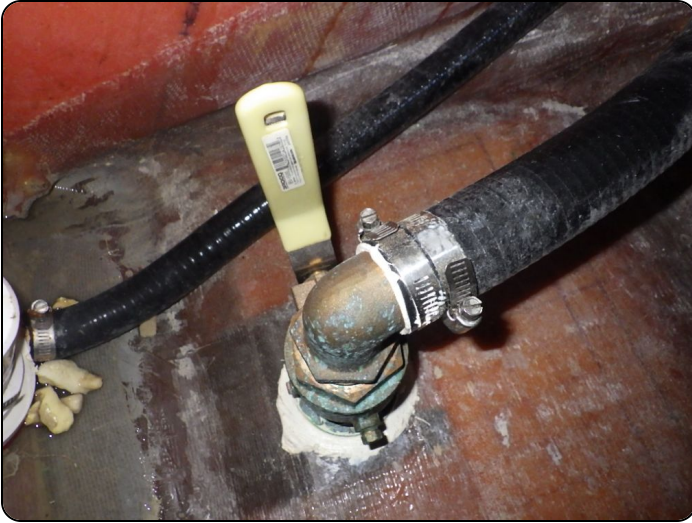
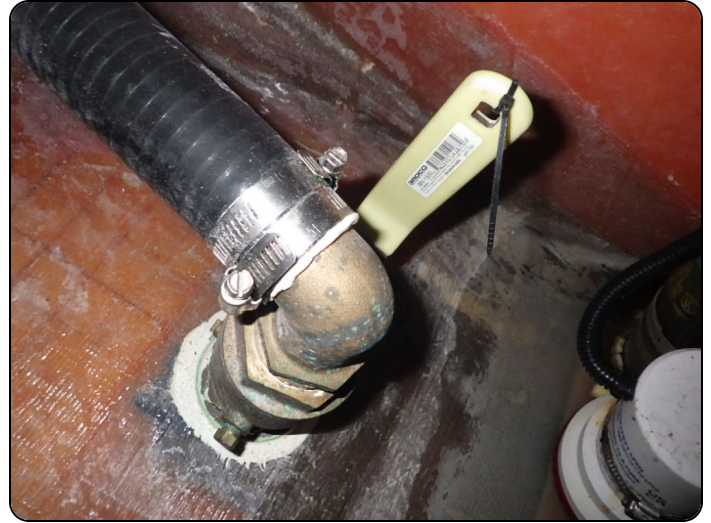
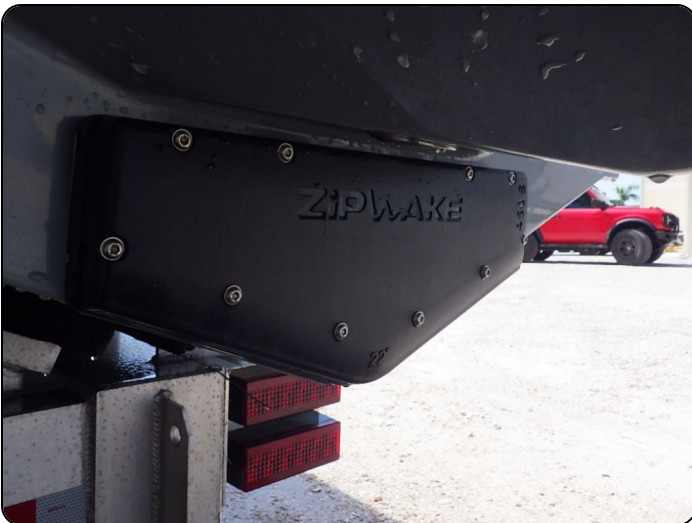
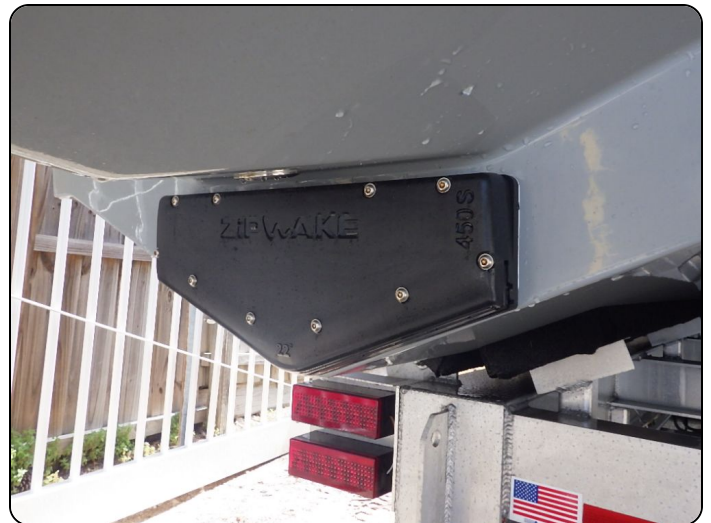
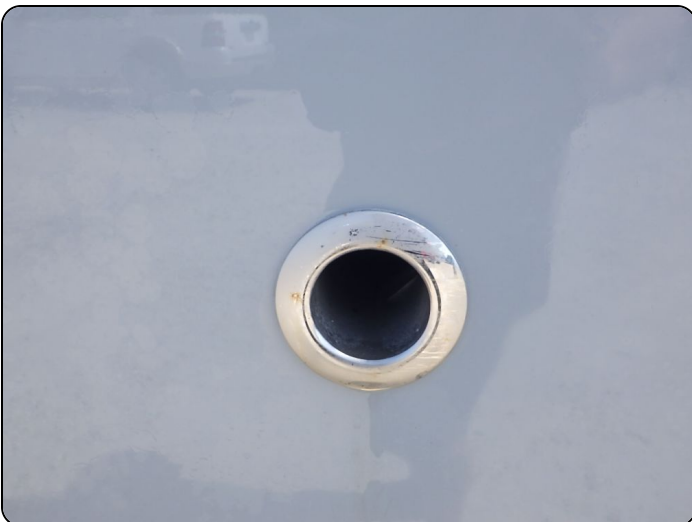
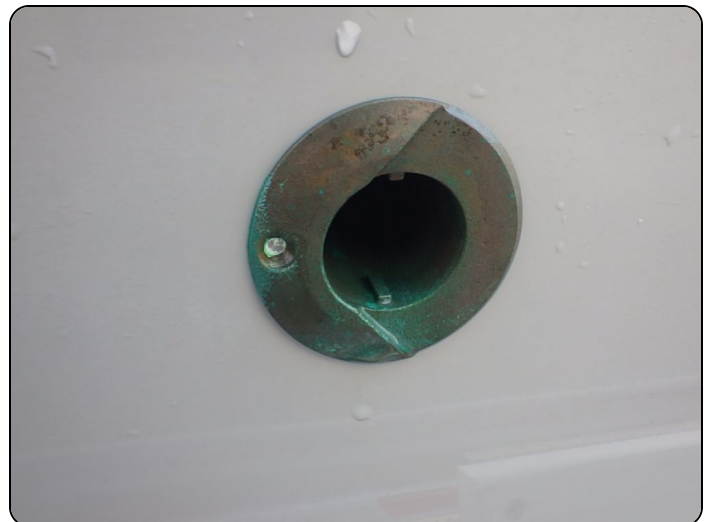
Bronze sea cocks with mounting flanges. Valves were tested and some found to be inoperable. See Findings & Recommendations.

(6) LED underwater lights, operational unless otherwise noted. See Findings & Recommendations

In apparent serviceable condition except as noted in the Findings & Recommendations.

This company suggests the sea cock/ sea valves be serviced according to the manufactures recommendations as a preventative measure upon purchasing a used vessel and thereafter as recommended by the sea cock/ sea valve manufacturer or more frequently as a part of the vessel's regular maintenance program. We also strongly recommend that if the vessel is left unattended that all below waterline sea valves be closed with the exception of scuppers, bilge pump discharge, or other valves that are required to be in the open position to prevent flooding of the vessel during inclement weather. This provides an extra measure of safety for the vessel as well as the added benefit of familiarizing the crew with safety valve locations and to exercise the valves to prevent seizure.

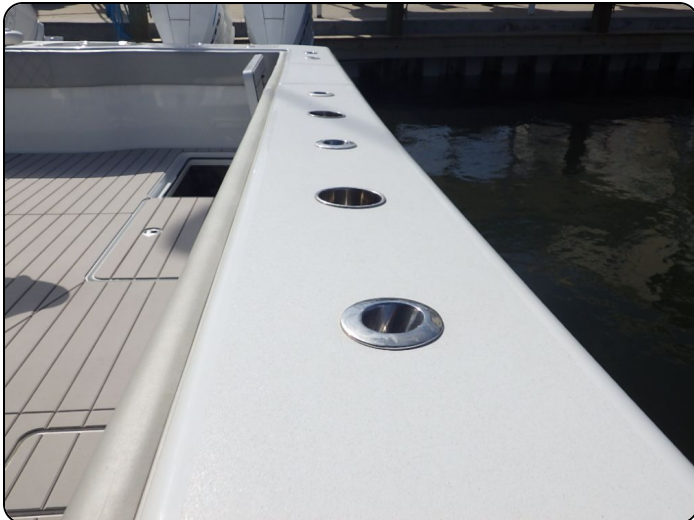
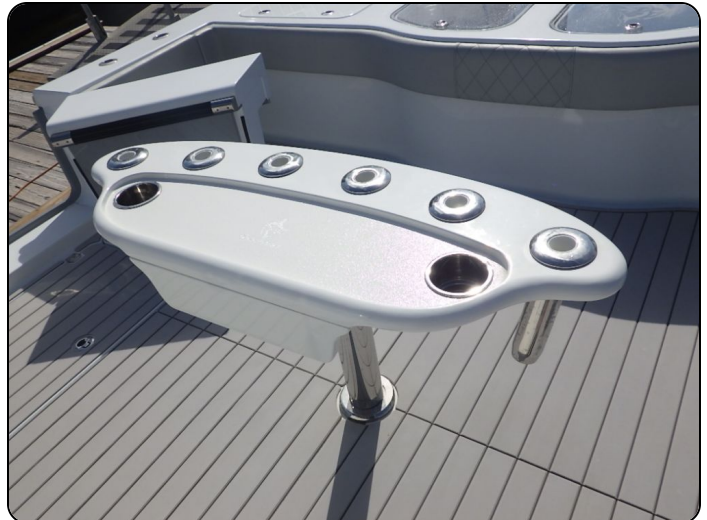
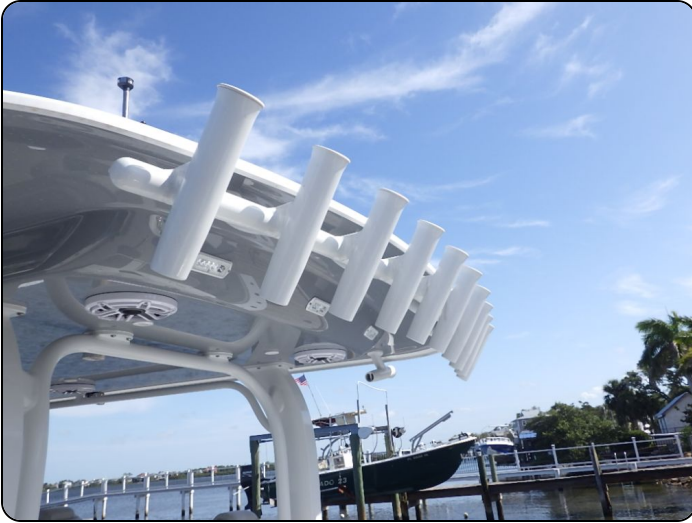
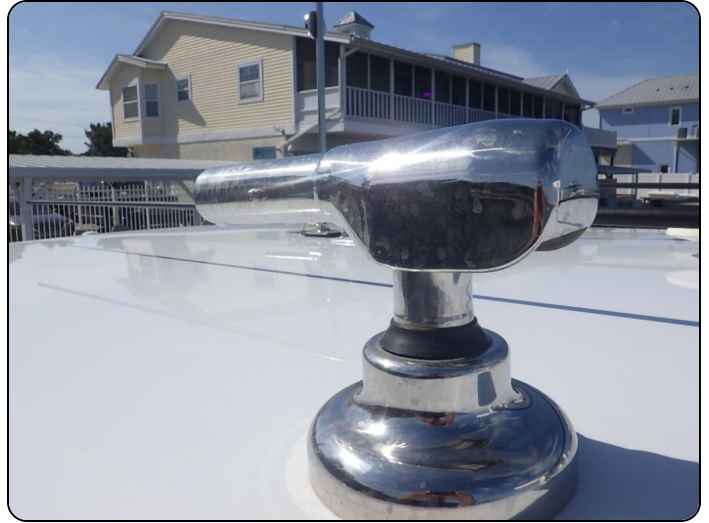
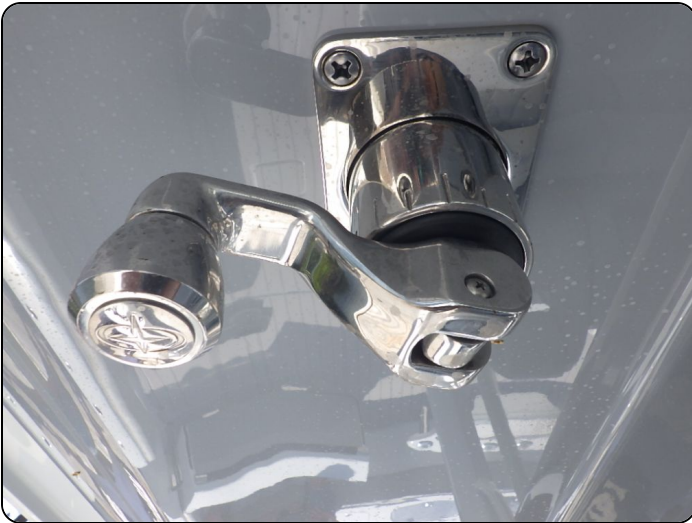
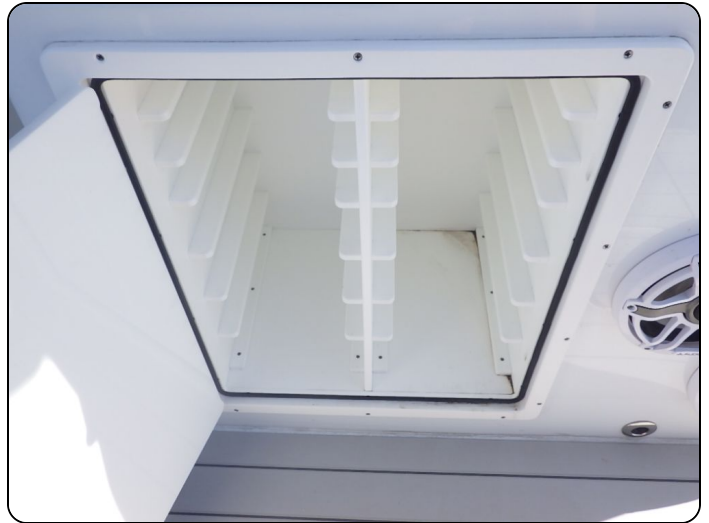
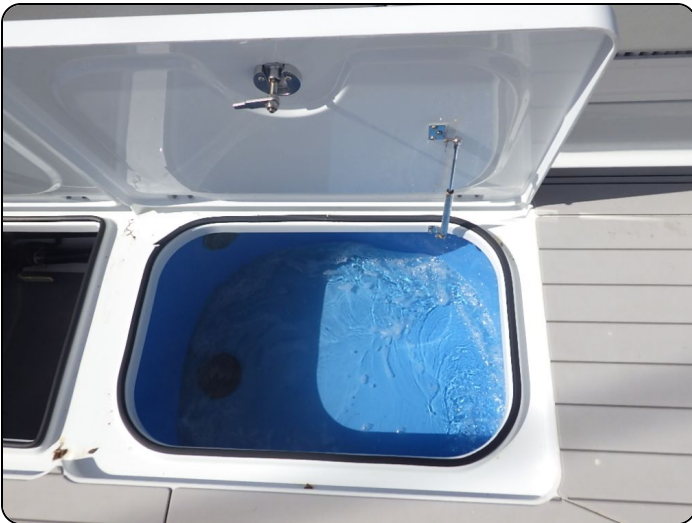
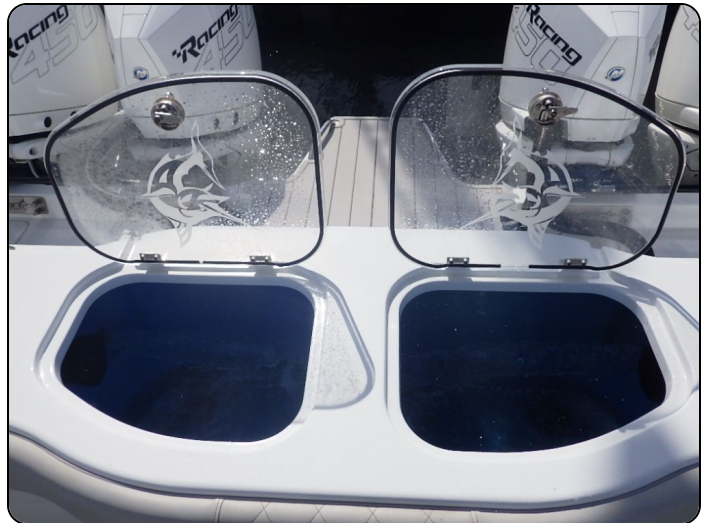
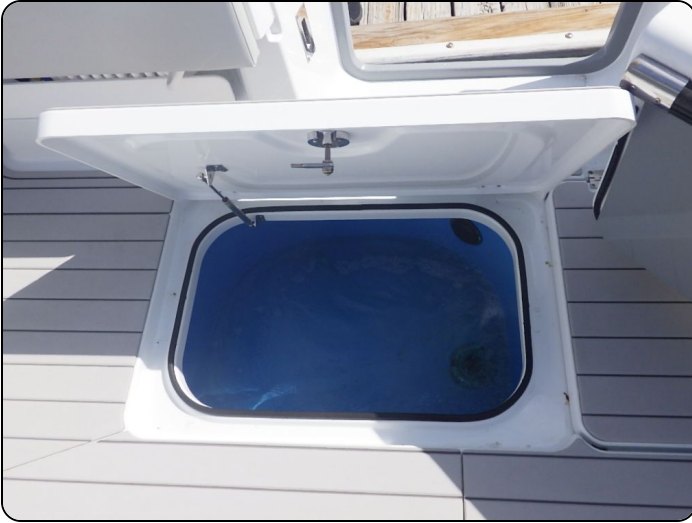
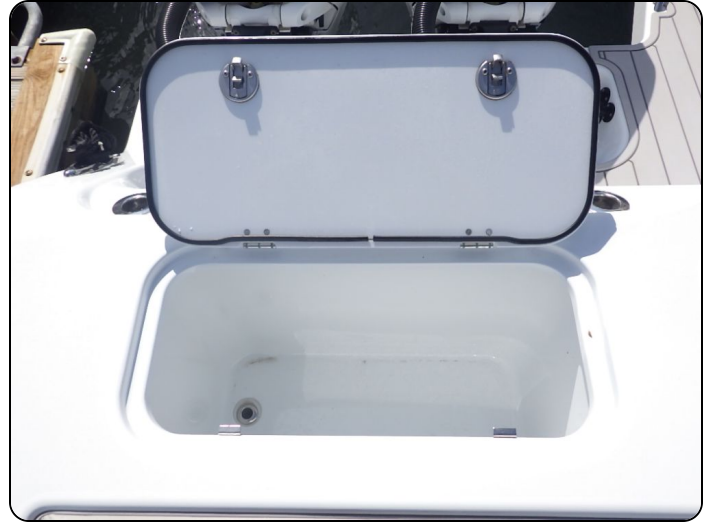
Insulated fish/storage and boxes under the fore and aft deck; cockpit rod storage; Cabinet tackle box storage Rocket launcher rod holders on the Hard Top; (4) livewells, (2) Under the aft deck port and starboard and (2) in the transom; gunwale rod holders; fresh and raw-water washdown and unknown brand outriggers(not deployed, and poles not included). All equipment was functional and showed minimal wear and tear.

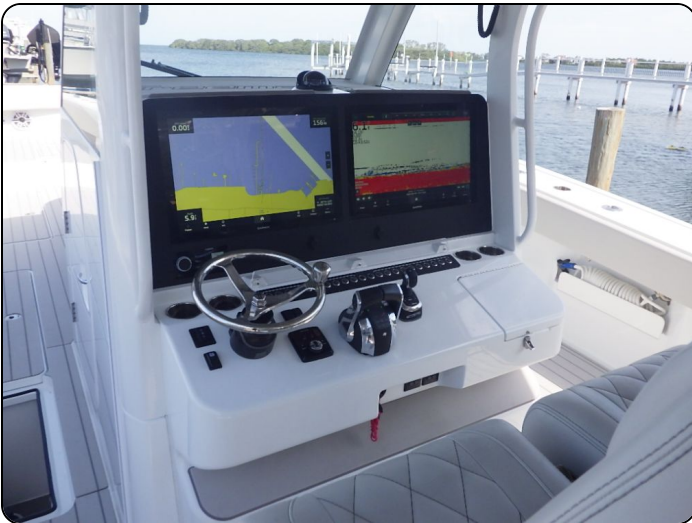
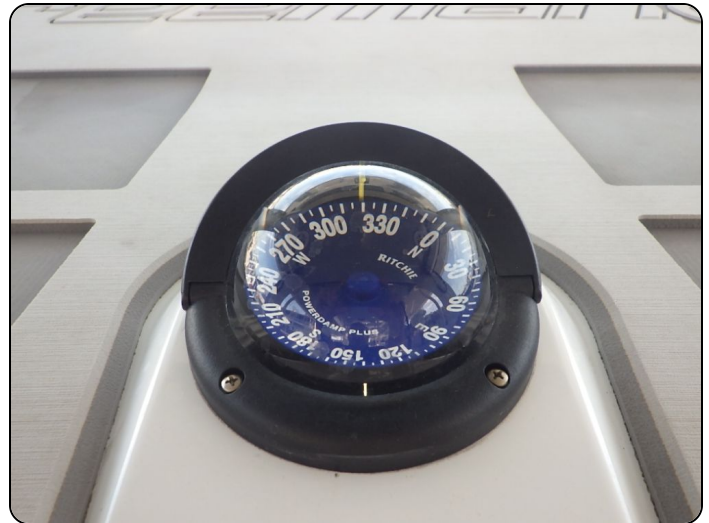
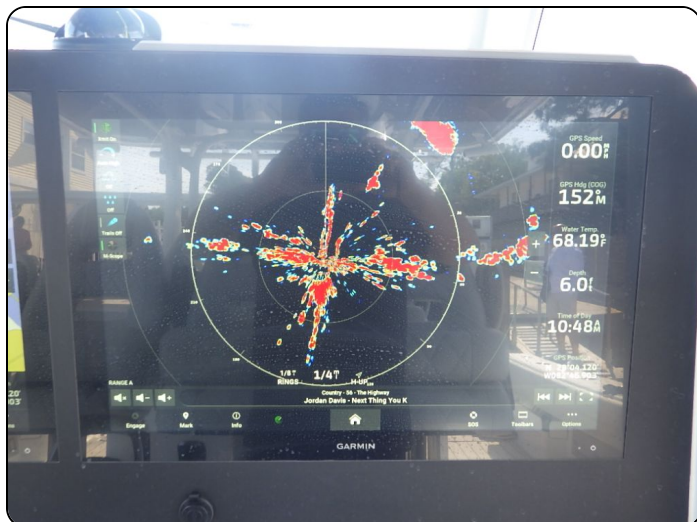
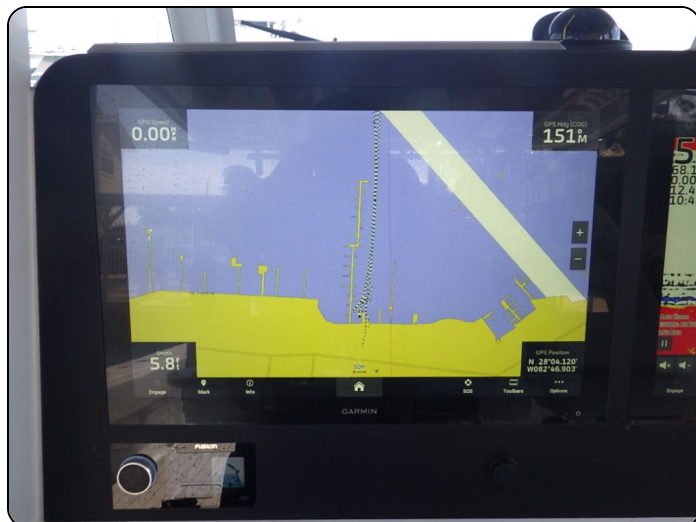
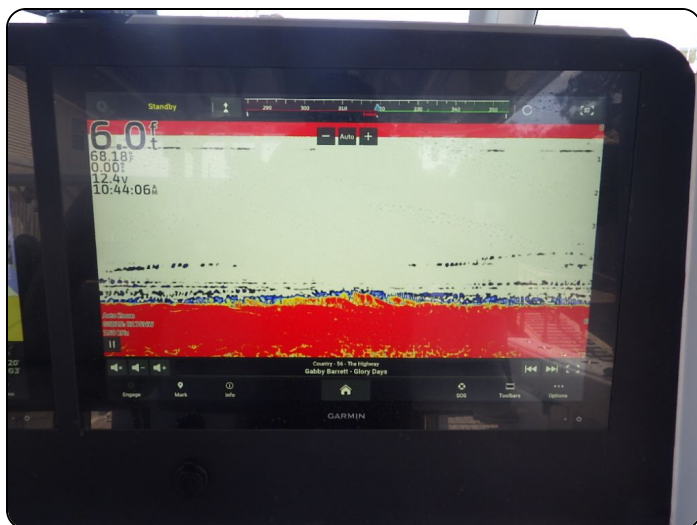
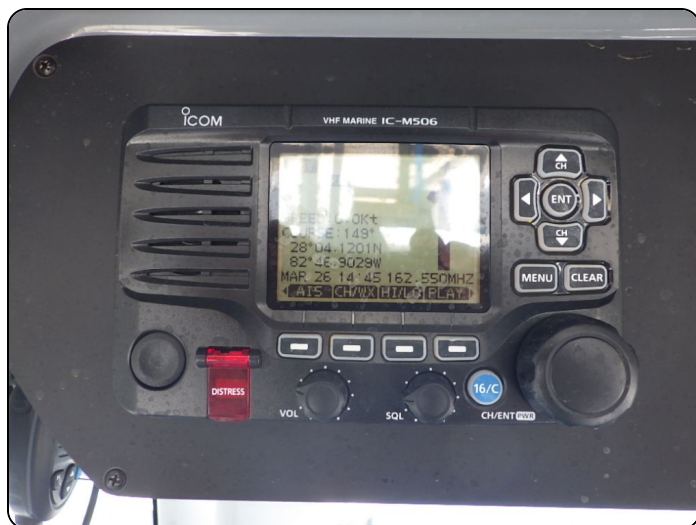
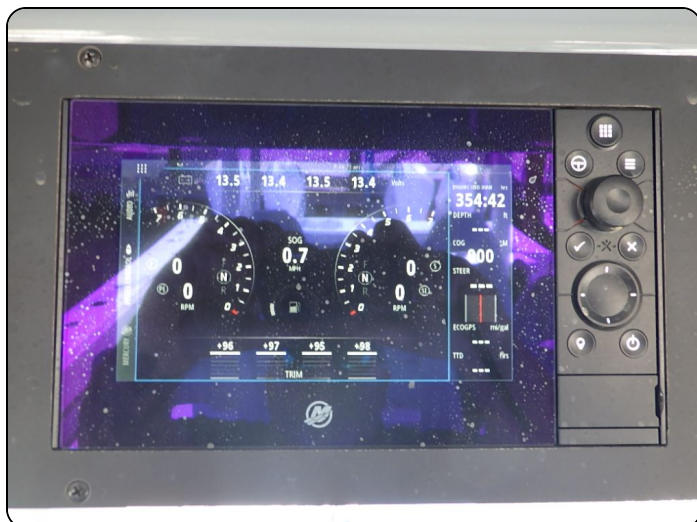
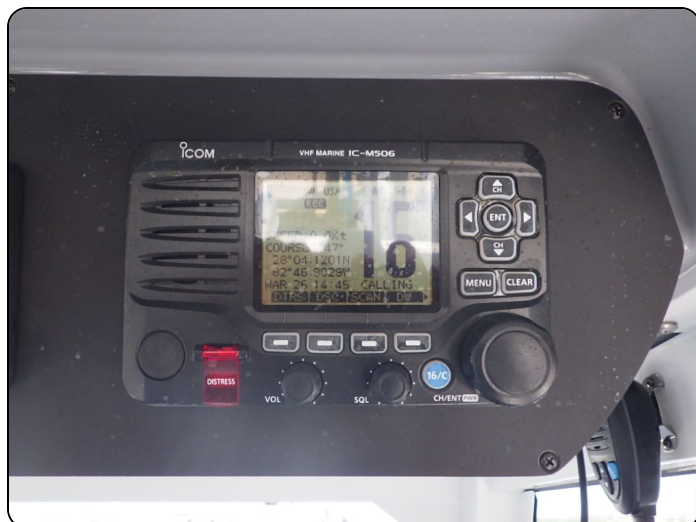
Electronics mounted on cockpit bulkhead. A 4" Ritchie compass in serviceable condition. The accuracy of the compass was not verified. Twin ICOM IC M506 VHF radios that powered up and received transmission using the weather service. Dual Garmin Touch screen chart plotters with navigational charts, radar, sonar, engine information and FLIR that powered up and appears to function properly.

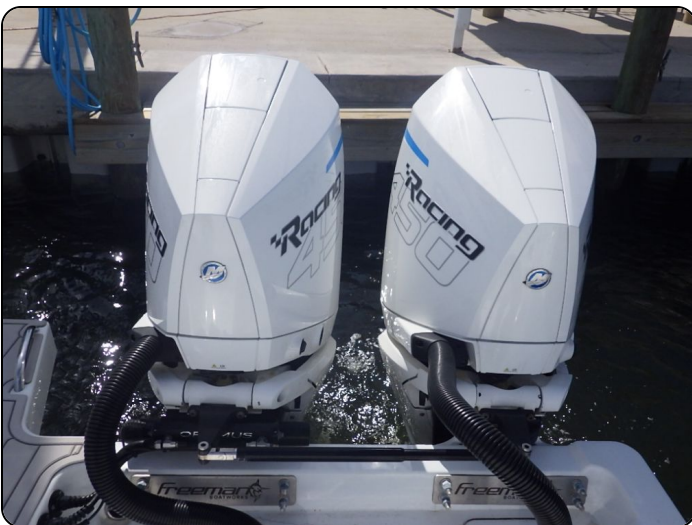
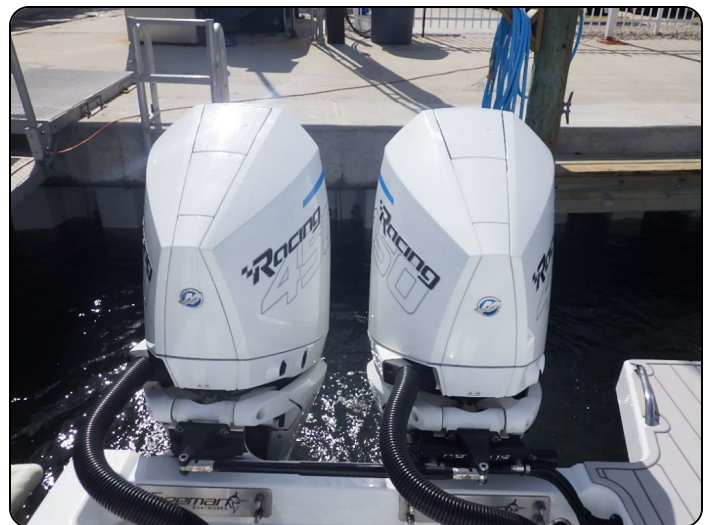
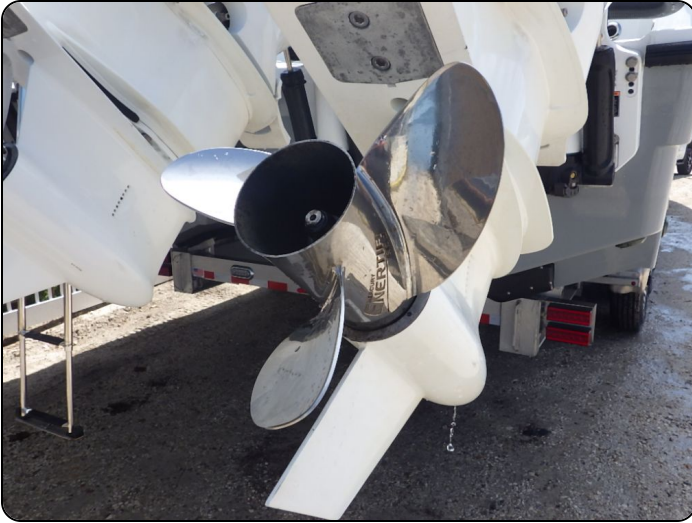
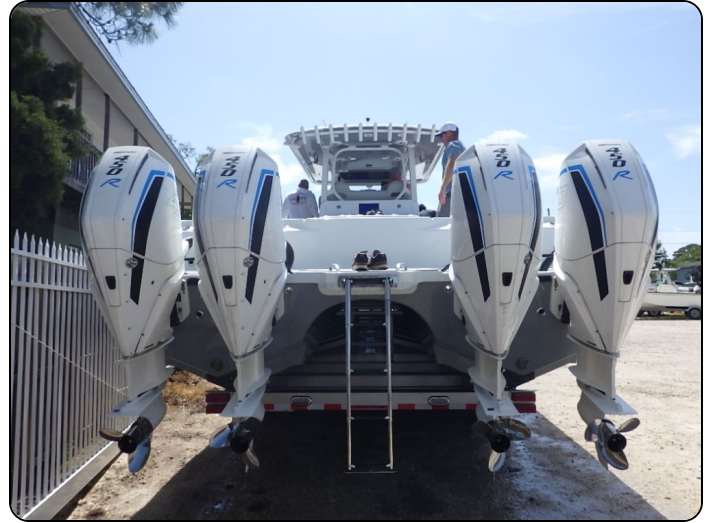
**FINDING B-3****SERIAL #**

(4) Mercury 450R High performance four-stroke outboards. The engine mounts were secure. Both tilt and trim functions were operational when tested with one exception. The cowlings were in good condition with no visible scratches or broken sides. The props were stainless steel three-bladed props with no visible damage and both skegs were in good condition. See Findings & Recommendations.

Port Engine: Not Sighted
Port Center: 1E088214
Starboard Center: 1E088226
Starboard Engine: 1E088225
See Findings and recommendations.

The serial number sticker for the port engine is missing.
