KUHN FAMILY
HOME INSPECTIONS

INSPECTION REPORT
123 Main St
NoWhereVille NJ 00000

INSPECTED BY
Ryan Kuhn
Kuhn Family
Home
Inspections LLC
#24GI00152800

1/1/2023

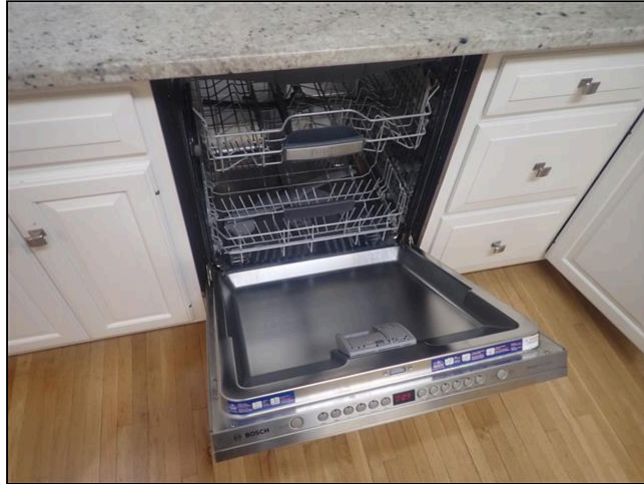
7.3 Item 1 (Picture)

7.3 The dishwasher operated through one full cycle; however, neither the operation of all cycles or modes nor its cleaning ability was determined.
