Master Plan Design Review

Facility Condition Assessment

RE: Nissan Stadium Concept Estimate and Schedule Analysis
(based on Facility Condition Assessment and Gensler Concept Drawings)

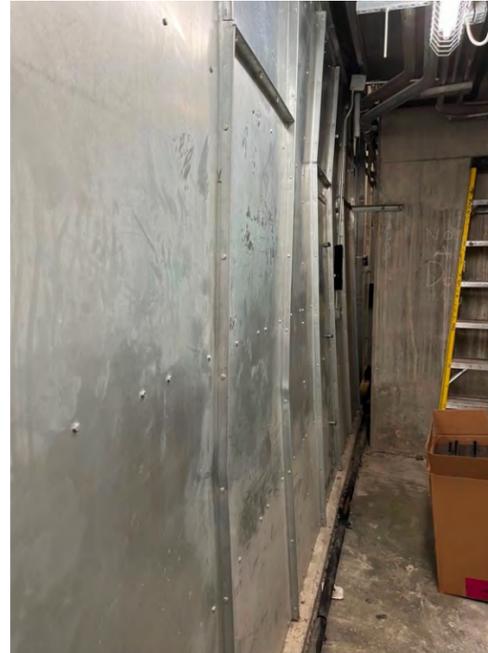
Buckled return air plenum AHU 3B1

Continue with routine maintenance, consider replacing all cooling coils starting with critical areas first. Review 3B1's return air mixing box for any airflow leakage losses.

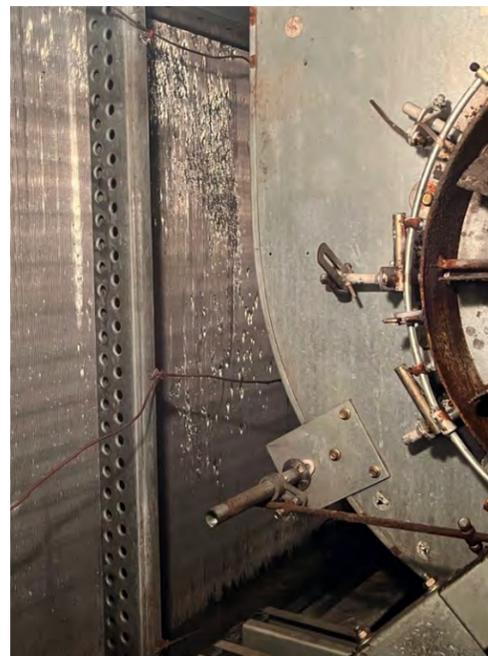
Fin damage of cooling coil on service level AHU

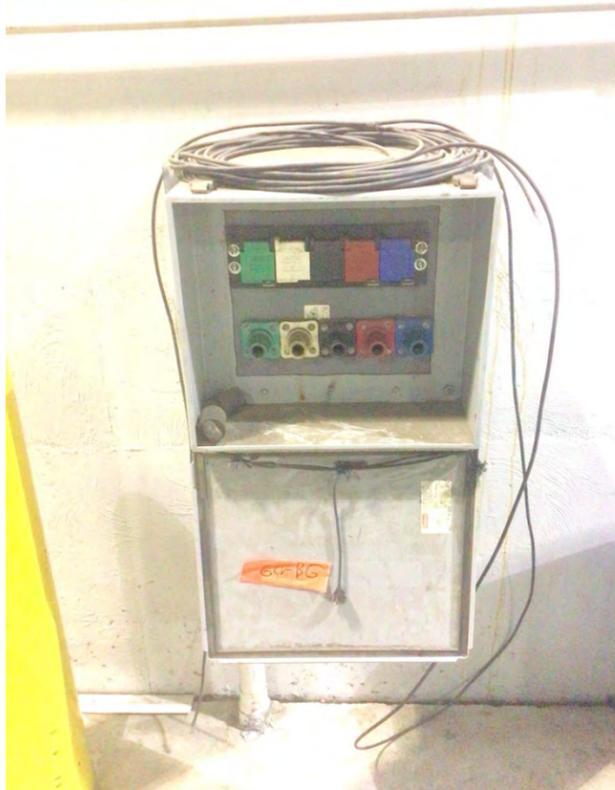
Broadcast truck and tour bus power is located in the loading dock area. There are currently two 208Y/120V 200A Cam-Lok and one 208Y/120V 400A Posi-Lok connection that are served

from a show power distribution board located on the service level. Currently this power is adequate for most events.

Existing show power panel

The equipment appears to be in adequate condition to continue to function properly for the next five years.

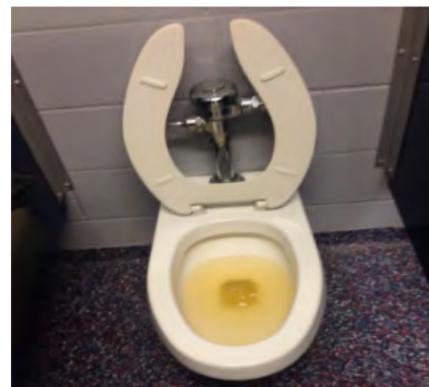
Corroded water within water closet bowl

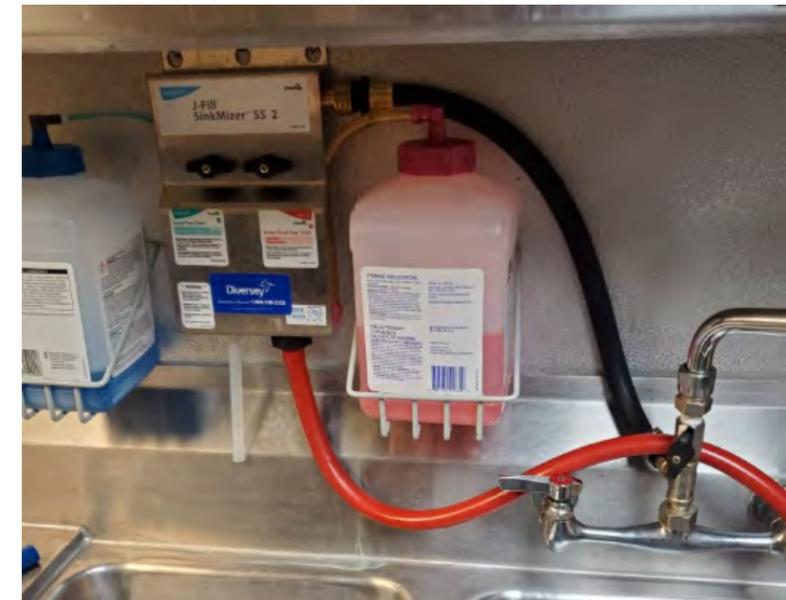
The domestic water lines serving the chemical dispensers are directly connected and no backflow mitigation is provided. In order to prevent chemical infiltration within the potable domestic water system backflow preventers need to be provided.

Domestic water tap serving chemical dispenser without backflow preventer

- Drain down the domestic water system in the area(s) where the work is being performed.
- Demolish sections of piping where the shutoff valves will be installed.
- Install the backflow prevention devices along the wall in an accessible location.

- Flush the domestic water systems once the new backflow preventers are installed and complete testing procedures.

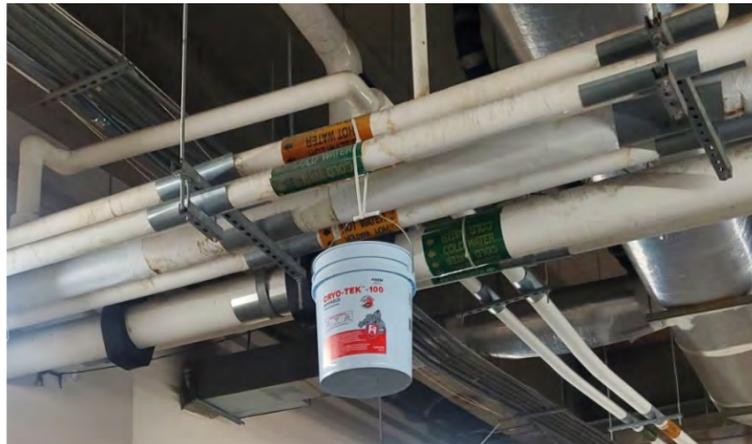
Lack of shutoff valves on domestic water branches

- Drain down the domestic water systems in the area(s) where the work is being performed.
- Demolish sections of piping where the shutoff valves will be installed.
- Install approximately 420 shut off valves throughout the stadium to provide adequate controllability of the domestic water systems.
- Flush the domestic water systems once the new shutoff valves are installed.

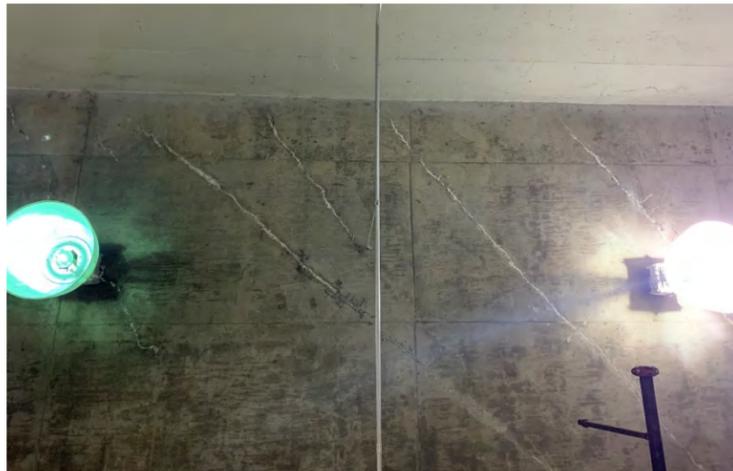
The elevated main concourse slab above the loading dock was observed to have cracking along the underside as viewed from the loading dock below near the north foundation wall northwest of the dock levelers. Additionally, several calthemite stalactites were observed originating from the cracks. This is an indication that the cracks permeate through the slab to the top surface to a sufficient extent to allow water to permeate through the full depth of the crack.

Cracking in slab above loading dock

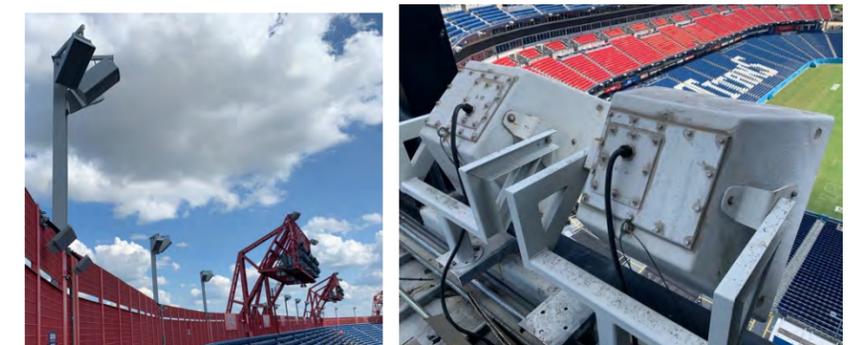
During the site assessment speakers performed well and coverage in the areas assessed aligned to similar system types. Although coverage is adequate, the system does not provide the full-range impact more accustomed of modern PA systems and is best suited for speech reproduction over music.

Typical eating zone speaker conditions

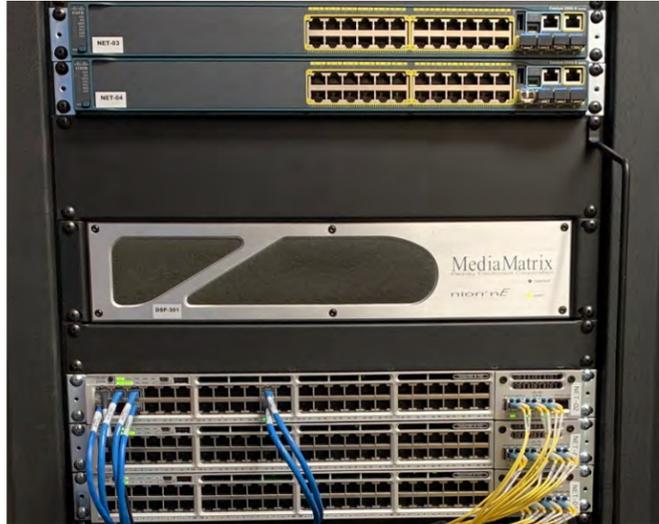
Core network switches and DSP processor location

As noted in the high-risk section; the DSP system is at the end of its normal useful life with no direct replacements available from the manufacture and very long lead times on equivalent equipment from alternative manufactures.

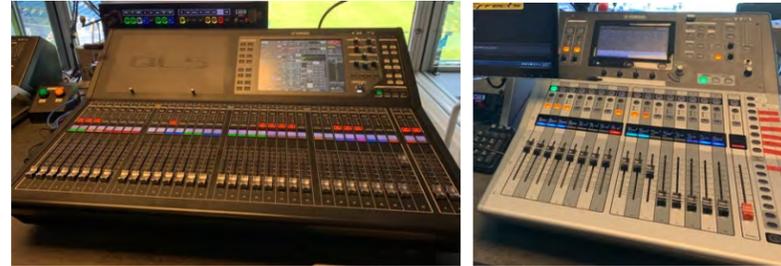
Audio consoles located in audio control room

The use of an outboard console in addition to a primary console is the result of the primary console reaching its input channel limitations. This stop gap solution meets the needs of the current operators and is not a concern.

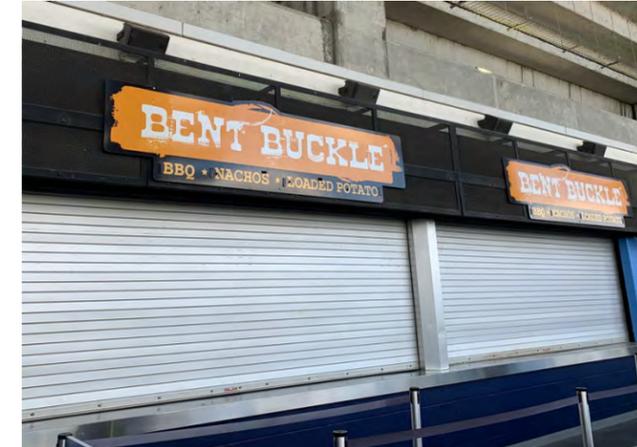
There are two notable conditions as the concourses are both exterior open air and interior. The exterior concourses contain distributed One Systems loudspeakers over each concession stand and ceiling speakers in the restrooms. This accounts for about 50% of coverage throughout the exterior concourses.

Typical concourse speaker coverage

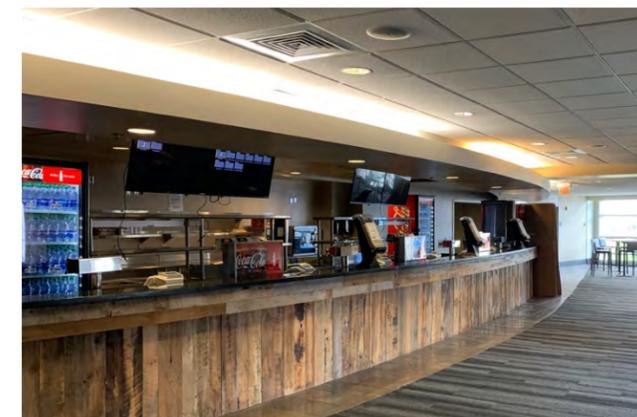
Throughout the interior concourse areas, coverage is located in the ceilings over each concession stand and in ceilings of the restrooms. This accounts for about 40% of coverage throughout the exterior concourses.

Typical concourse speaker coverage

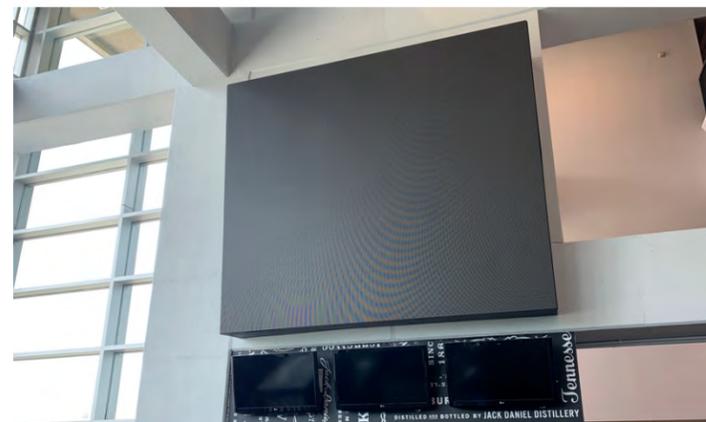
Video presentation is facilitated on the 4:3 aspect ratio LED screens utilizing a local HDMI input. All content contains letterboxing unless reformatted to be natively displayed on the LED screens. When not used for video presentation, a local cable set top box feeds a processor where additional graphics are added prior to routing the signal to the screen to mitigate the impact of the letterboxing. The LED screens and their associated processing are nearing the end of their expected 10–12-year life cycle.

Wesley Mortgage Club LED display

Audio and video connectivity in each space is sparse and has largely been abandoned and supplemented within each of the supporting audio and video equipment racks. Additional supplemental equipment is recommended to be procured to bolster the clubs functionality and reduce reliance on current stopgap measures.

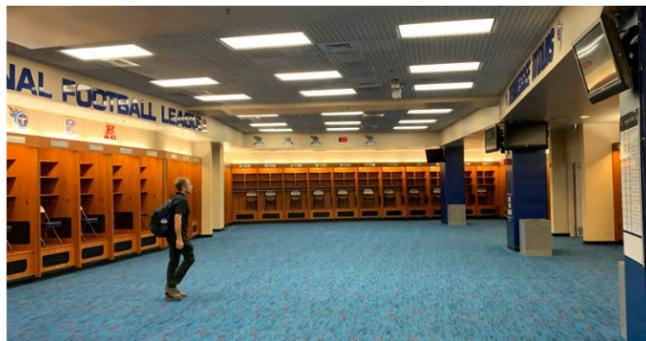
Titans locker room

This operational experience of these amenities is adequate for current use cases but is behind the times when compared to similar facilities technology within back of house and player spaces.

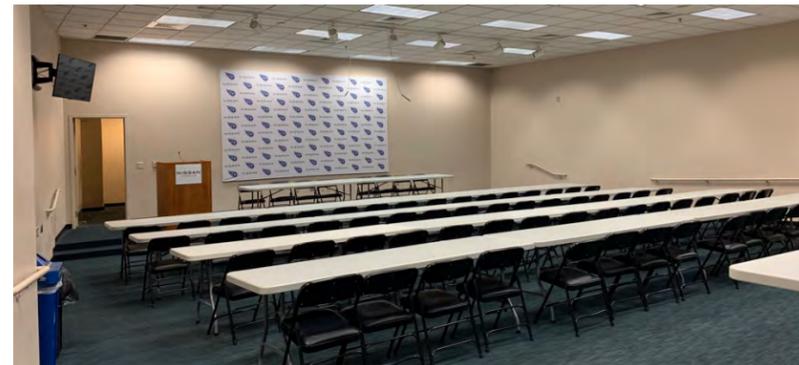
Many of the systems within the space are original. Due to the age of these systems, the space is not aligned with what is deployed at more modern stadiums as it relates to interconnectivity to the truck dock and in-house production rooms, studio lighting for the platform, and in room sound reinforcement.

Interview room

Operators rely on temporary cabling to be deployed per event to support interviews. The room is lacking local automated controls for AV devices, and the sound operator is located in an adjoining closet without working lights or a view to the interview platform.

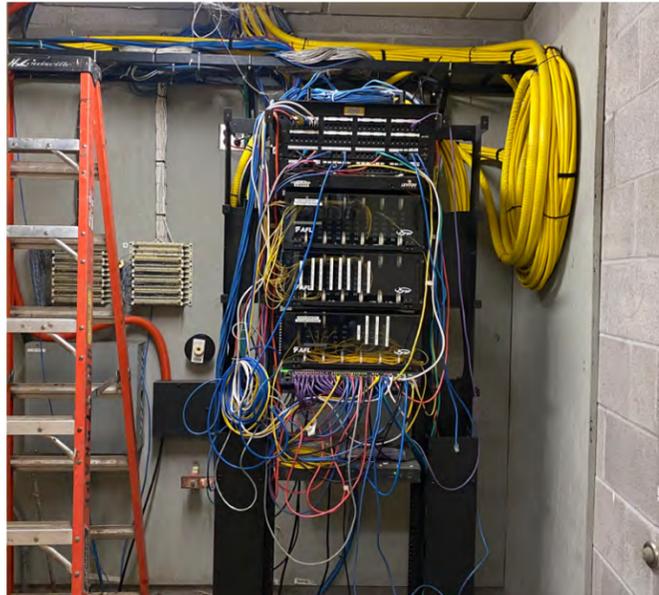
Typical IDF with no UPS, no HVAC and open ceiling tiles

The existing structured cabling, telecom rooms, and pathways are limited throughout the facility. Most rooms are full but should be appropriate for the facility needs for the next four to five years. A rack mounted UPS should be added to all telecom rooms to provide power to all network switches. Clean power from UPS will extend the life of the existing network switches.

Portable AC units should be added to any telecom room that cannot maintain a temperature of 75 degrees or lower. Cooler rooms will extend the life of the existing network switches.

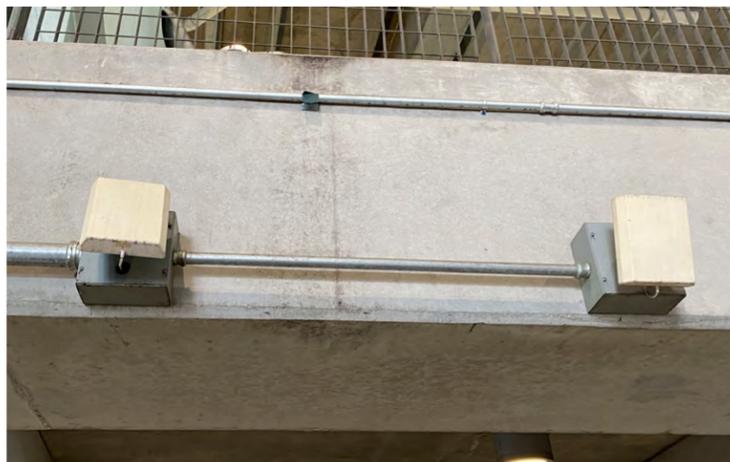
Existing DAS system is old but functional. The existing system is acceptable for the next five years.

Existing DAS antennas with carrier responsible for upgrades

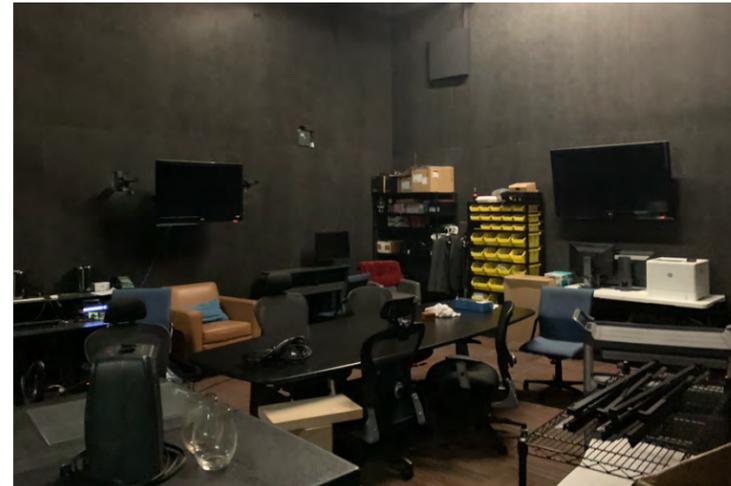
Potential space for IT storage

Existing video production studio green room space should be converted to IT storage (after training facility upgrade is completed), so that stored equipment can be moved out of current office.

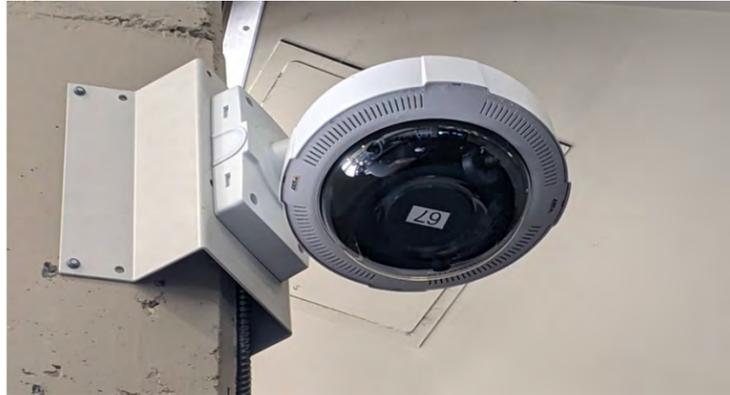
Security camera with corner mounted multi-imager

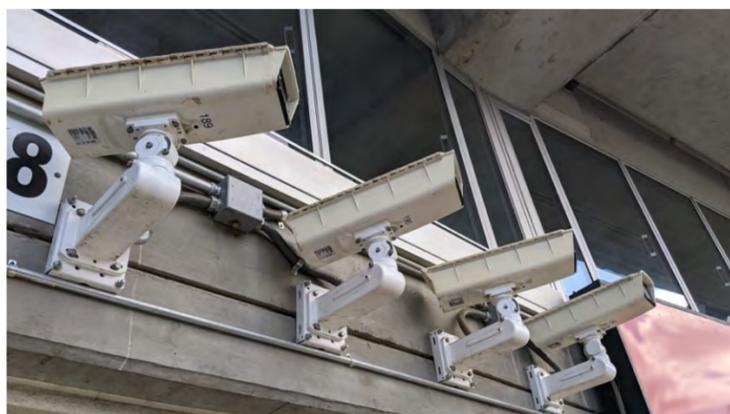
Long range bowl security cameras

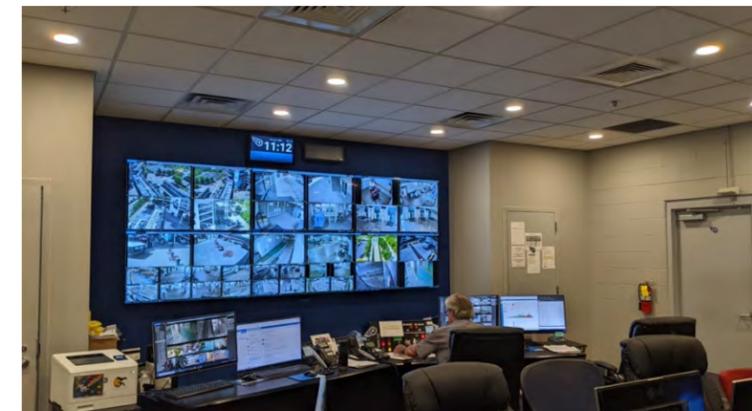
Main security control room with video wall and individual workstations

The security control suite currently meets the operational needs of the security team. However, when the security team needs to change the source to one of the displays, the process requires physical disconnection of the common sources and a significant delay upon source change. It should also be noted that the typical lifecycle for a similar video wall would be 7-8 years. This system should be updated and replaced within the next two years to maintain optimal functionality.

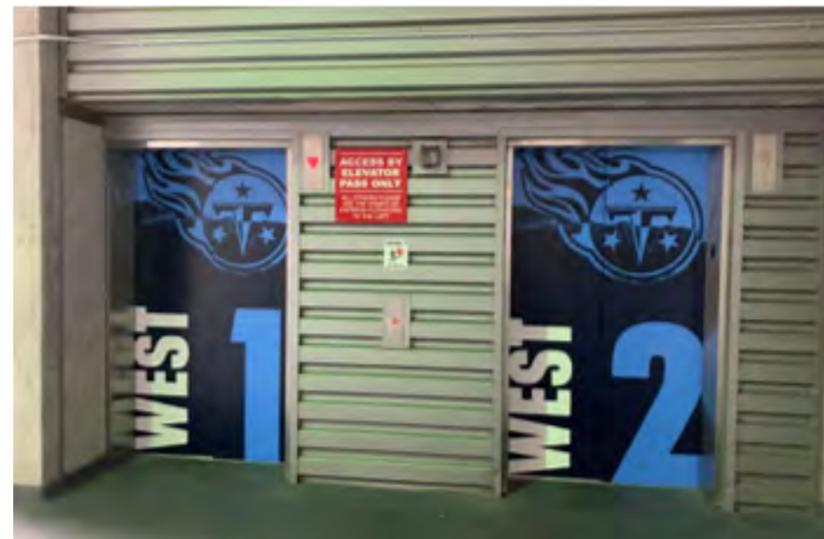
Elevators #1 and #2 top landing (7th floor) open to the outdoors

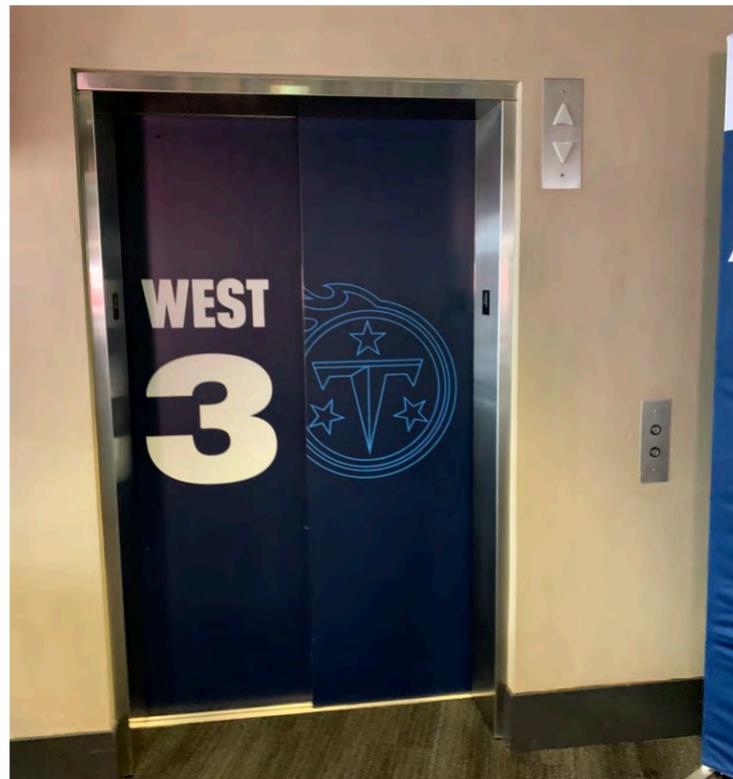
Elevator West #3 entrance with directional arrows and hall button fixture

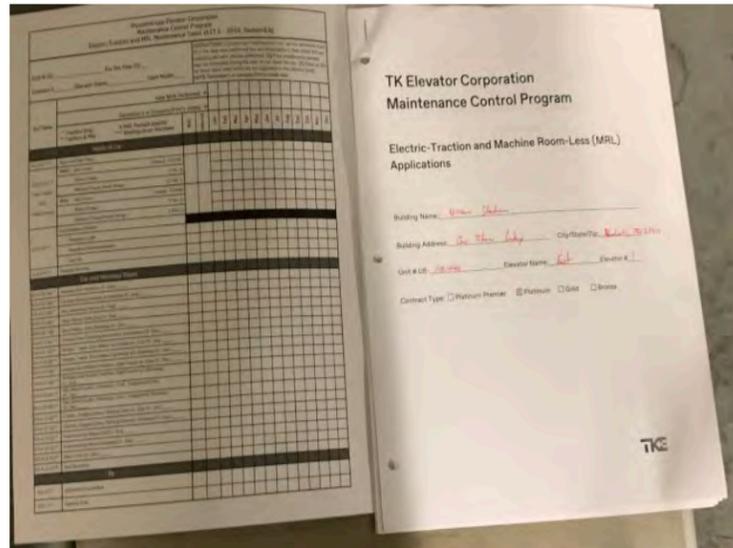
posted on the controller door. The written maintenance control program (MCP) documents were not up to date on any elevator on site.

Written maintenance control plans (MCP) were not current on any elevator on site

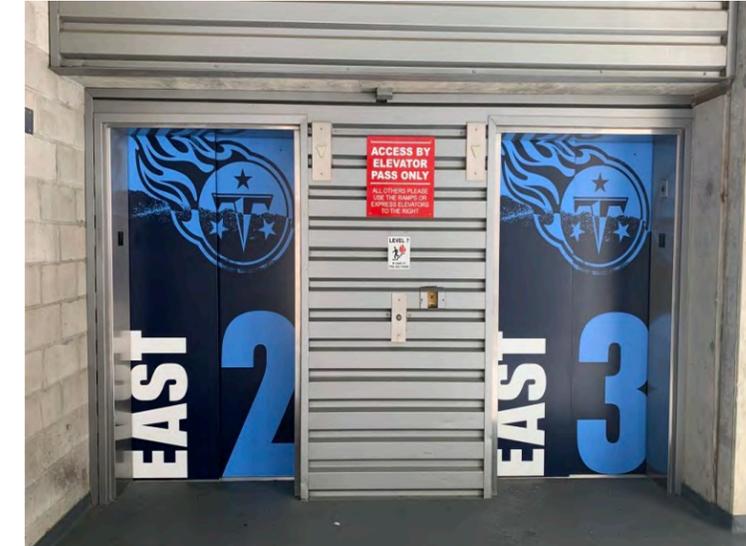
Elevators #7 & #8 top floor entrance is numbered as East #2 & #3 and the entrance is open to the outdoors

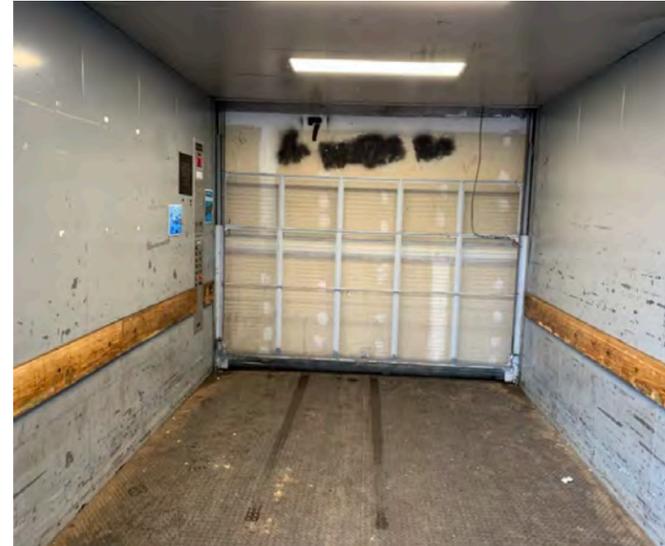
The automatic simplex freight elevator is located on the westside of the stadium. It has a 12,000 lbs. capacity and operates at 100 fpm with seven stops, two front openings floor designation, 1 & 2 and five rear openings designated floors 3 through 7. The elevator was modernized in 2017 with a new Smartrise controller and new AC drive, updated Courion controller, cartop motor control system, proximity gate detectors and Courion Model G power freight doors. The original 1998 Hollister Whitney 63-OH geared traction machine was retained and a new AC, 40 HP motor was installed.

Freight elevator #4 cab enclosure

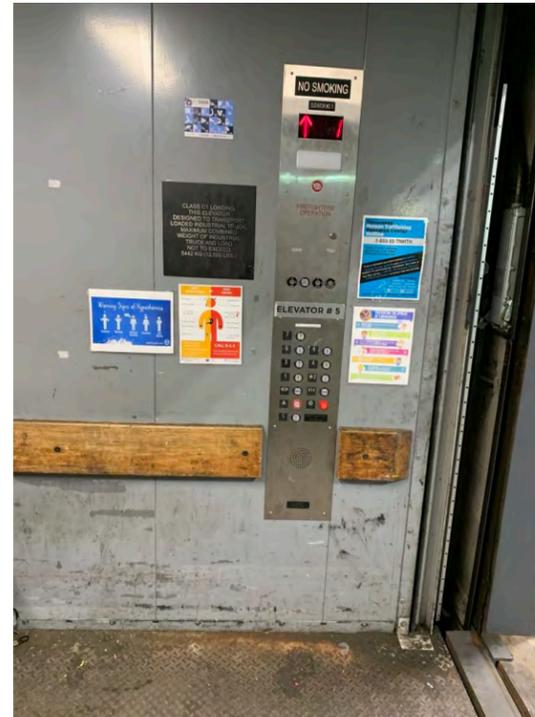
The fixtures were upgraded during the modernization. All push button fixtures are standard plastic style buttons that are susceptible to vandalism and discoloration.

Freight elevator #5 modernized car operating panel and fixtures

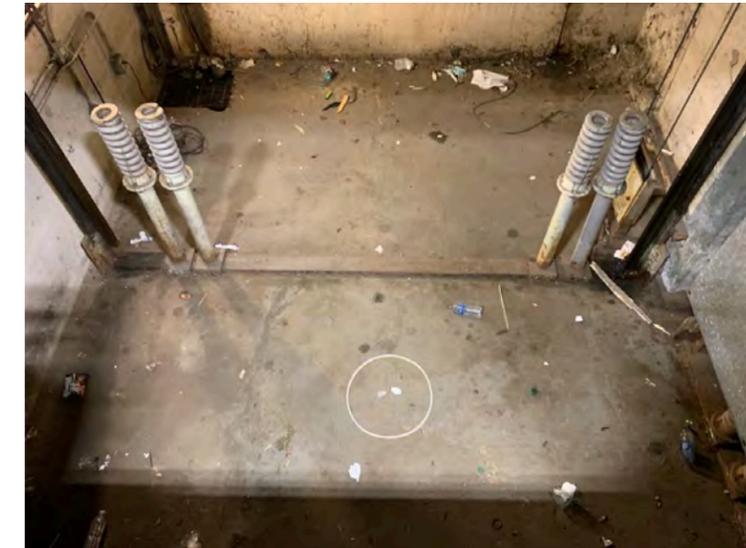
The pit had debris on the floor and needs to be cleaned. There was no water in the pit at the time of the inspection.

Elevator pit had some debris on the floor and was dry

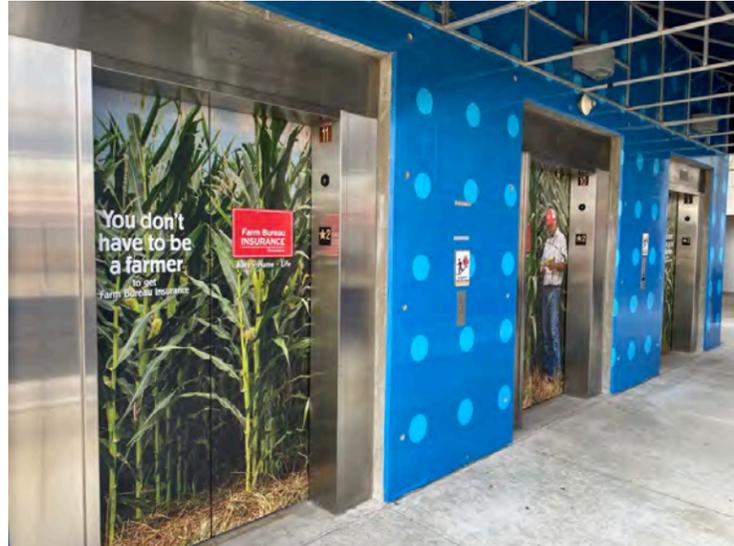
Typical main entrance for the bank of express elevators

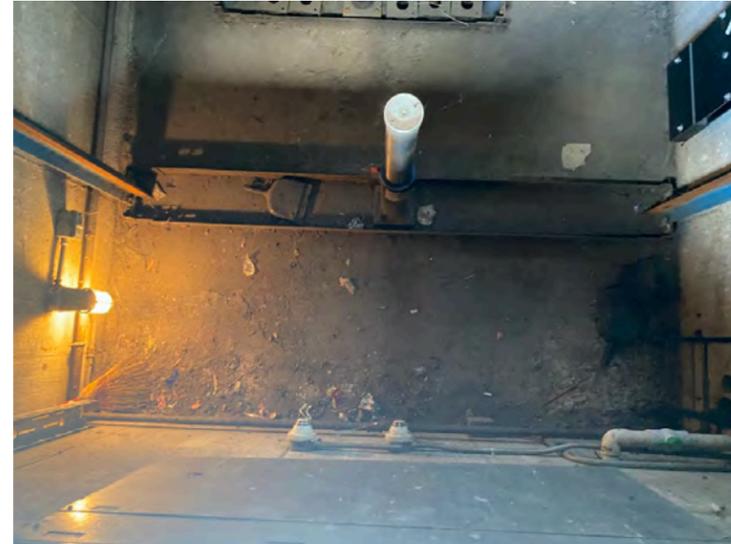
Equipment is good quality and in fair condition. The pits have trash and debris on the floor and need cleaning. The area has a sump pump, smoke and heat detectors installed. The pits are missing identification numbers and need to be installed to meet code. The equipment is showing signs of rusting and needs cleaning and should be painted.

Pits have trash and debris and need additional cleaning

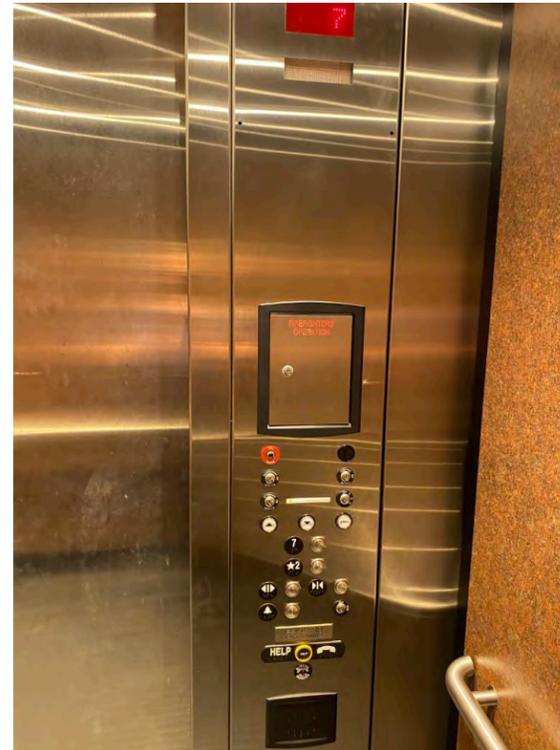
All push button fixtures were standard ThyssenKrupp metal style buttons. Due to the exposure to the outdoor elements, it will be necessary to replace buttons as they become damaged and or inoperable. The cab interiors were in good condition, but the stainless-steel door panels need cleaning.

Typical car operating panel and fixtures for these elevators

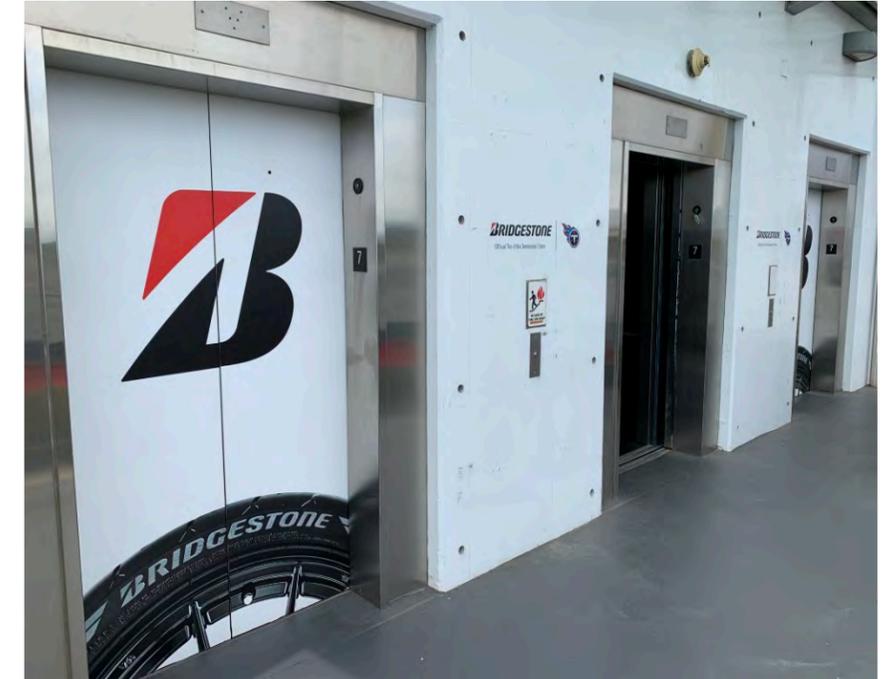
All push button fixtures were standard ThyssenKrupp metal style buttons. Due to the exposure to the outdoor elements, it will be necessary to replace buttons as they become damaged and or inoperable. The cab interiors were in good condition, but the stainless-steel door panels need cleaning.

Express elevators at outdoor top landing 7th floor entrance

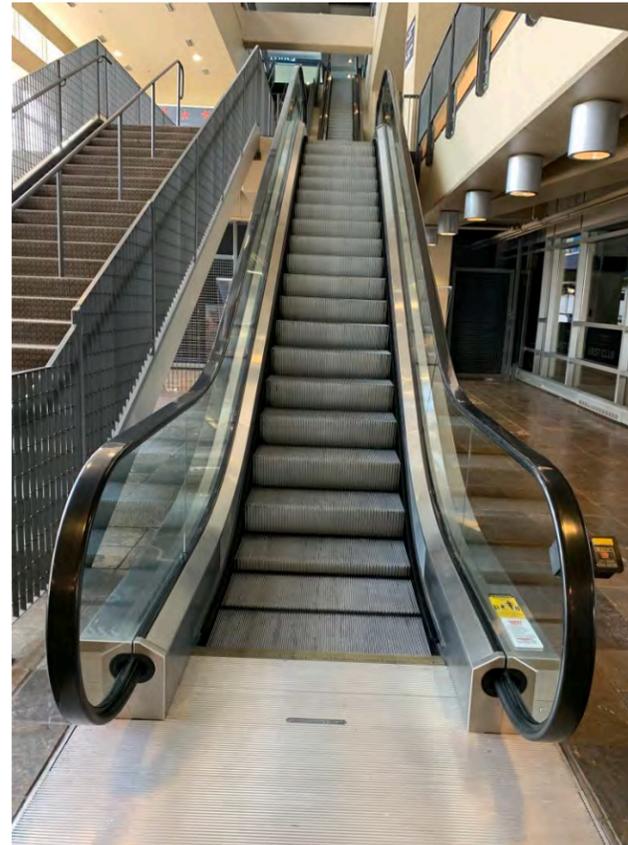
The Montgomery/KONE E-5000-236 F model/smart controller was operating at the designed speed of 100-fpm. The escalator was originally installed in 1998. Handrails and steps were tracking at the same speed, and no damaged steps were visible on the day of our evaluation. The mechanic is applying lubricant manually and the chain is well lubricated. The units have not had a clean down and condition report recently, which is imperative to determining the remaining useful life.

The escalator is used on a limited basis and is in good overall condition with the maintenance rated as average. A detailed listing of all such items has been formulated and included further on in this report.

Escalator landings, balustrades, and steps are in good condition

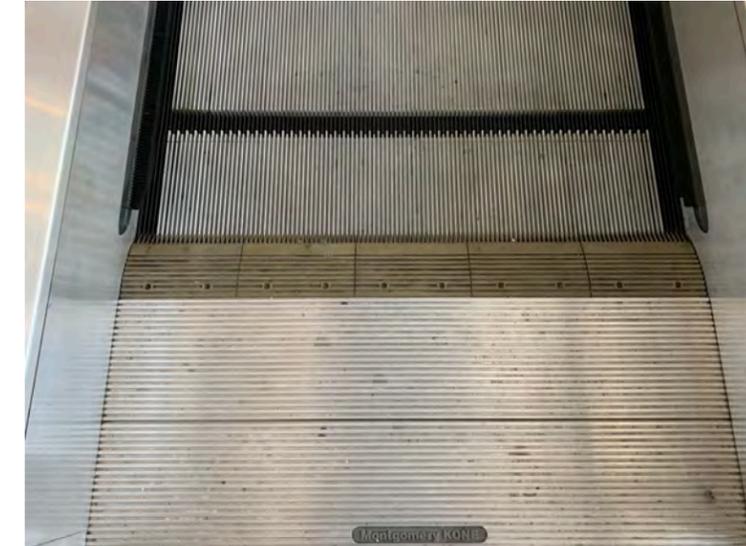
There is trash and debris that has accumulated in the upper well, and no brake torque data or annually testing information was available on site.

Comb plates on all units have faded and are non-contrasting in color

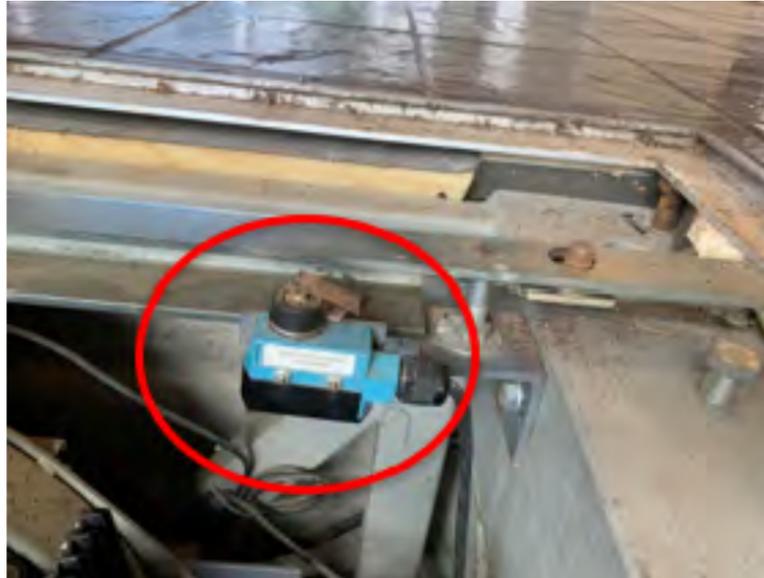
Dust and debris have collected on the lower end areas and the microswitch were not operational on all units at the time of our assessment. TKE has since corrected the issue.

Microswitches inoperable due to metal shim depressing the plungers

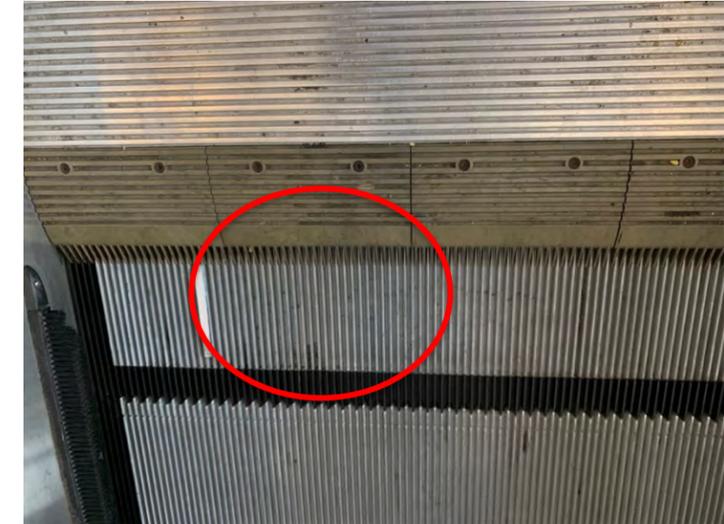
There is trash and debris that has accumulated in the upper well, and no brake torque data or annually testing information was available on site.

Upper landing comb plates gap to steps in excess of 5mm and plates have faded color and are non-contrasting which is required by code
