CAPITAL RESERVE STUDY

CATEGORY 2: UPDATE WITH ON-SITE REVIEW

LEISURE KNOLL AT MANCHESTER HOMEOWNERS ASSOCIATION

Prepared: November 2016

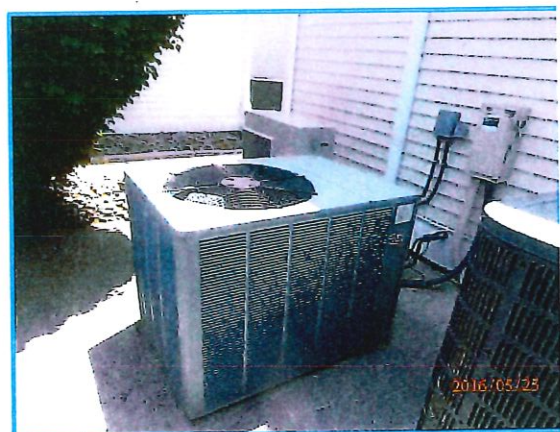
A/C Condenser

Heating throughout the recreational buildings is provided by separate gas-fired boilers in each building. Boilers of this type must be maintained on a regular basis to ensure they reach their full estimated useful life. Heat from the boilers is forced throughout the buildings utilizing blower units. Cooling of the community buildings is accomplished with exterior air conditioning condensers.

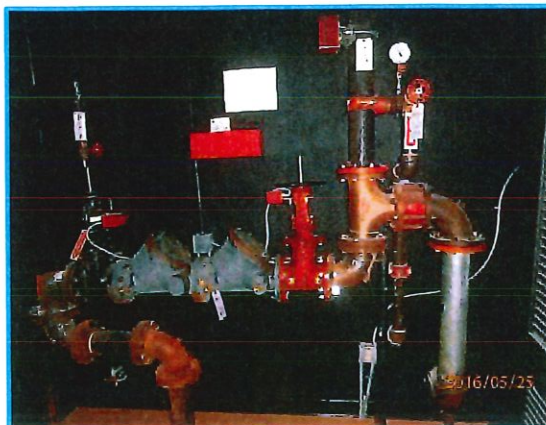
Fire Suppression Equipment

Timberland Hall and the Performing Arts Center are provided with fire suppression systems. Components of these systems include the fire control panel, fire pump, jockey pump, panel relay, and the sprinkler heads. These systems must be periodically maintained and inspected by qualified personnel.

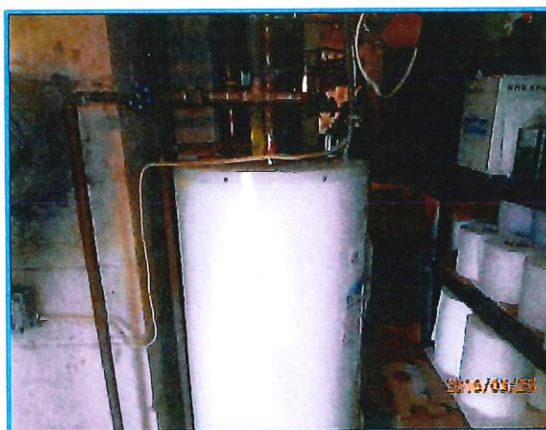
Water Heater

Hot water is supplied to the community buildings with electric water heaters, which possess a typical useful life of ten (10) years.
