# AMERISPEC<sup>®</sup> INSPECTION SERVICES

Doc #:	41619	Inspector:	Todd Newman
Date:	4/15/2019		
Dwelling Address:	3010 Gateway Ct Louisville KY 40219		
Client Name:	Norm Woods		
Client's Agent:	Martha McGough	Real Estate Company:	United Real Estate

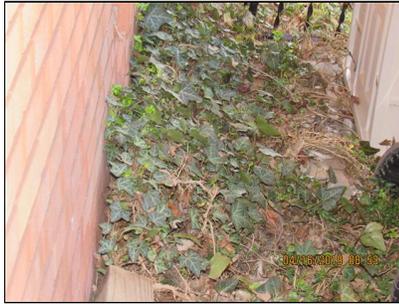
1.2 Item 2(Picture)

(1) Extensive vegetation and overgrowth observed at various locations. This can promote moisture damage and wood deterioration to the siding and structure which is not always visible to the inspector. Suggest trimming/removal of vegetation to prevent damage to the home. This was a limited review of this area. Damage/deterioration can only be viewed after removal of vegetation/overgrowth.

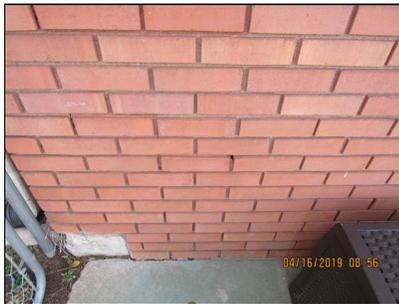
1.2 Item 4(Picture)

(2) Damaged/deteriorated mortar observed at various locations; suggest tuck pointing as necessary to prevent further damage.

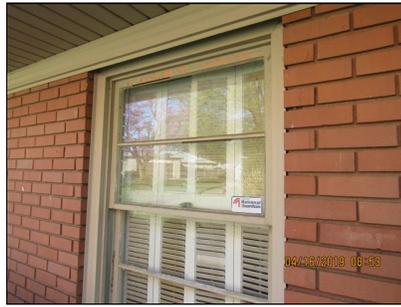
1.4 Item 2(Picture)

Peeling paint observed at right side; suggest scraping and painting as necessary as part of normal maintenance.

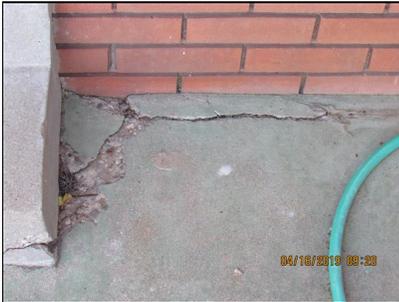
1.13 Item 1(Picture)

Common cracks observed, primarily a cosmetic concern. We suggest sealing all cracks in concrete surfaces to prevent water penetration as a routine maintenance effort.

This patio has also settled over time and may need to be monitored for further movement as the surface slopes away from the home slightly.

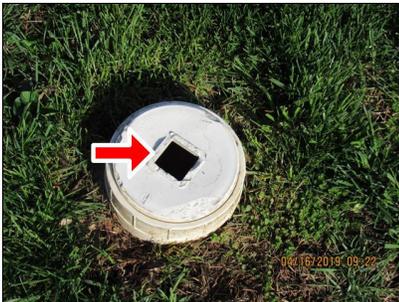
1.14 Item 1(Picture)

**Possible septic clean out area for local utility observed. This cover is broken in the center and will need replacement as possible sewer gases can release odors or hazardous gases into the air. We are unable to confirm if this system is an actual live line at the time of inspection as septic lines are outside the scope of a home inspection due to being a utility company issue and underground.**

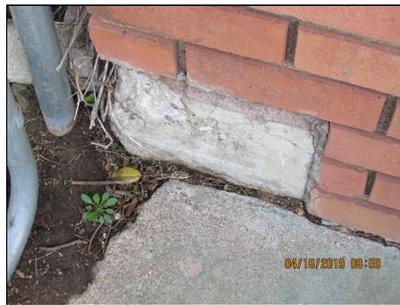
2.1 Item 2(Picture)

Cement parking is flaking/deteriorated at various locations. Recommend review for repair as necessary.

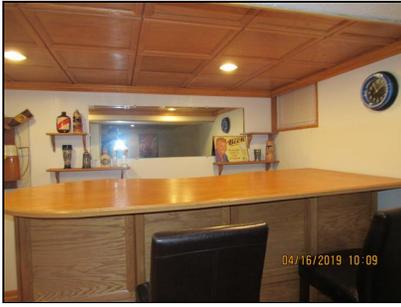
2.4 Item 1(Picture)

Limited review as a portion of the basement was finished.

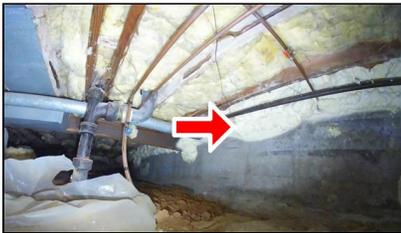
2.6 Item 1(Picture)

Limited review as a portion of the basement was finished.

Limited review as spray foam is covering key areas to inspect along sill plate and joist supports. Unable to inspect proper anchoring of the sill plate which fastens the home to the foundation.

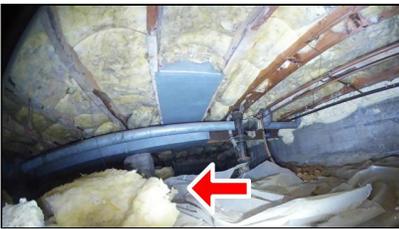
2.11 Item 1(Picture)

Loose insulation observed in the crawlspace, suggest securing as necessary.

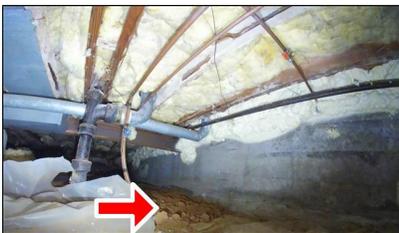
2.12 Item 1(Picture)

Gaps observed. Recommend review for repairs/replacement as needed.

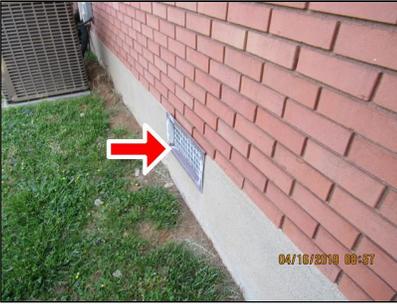
2.13 Item 1(Picture)

Ventilation openings due to spray foam are blocked in the crawlspace, suggest removing obstructions to provide for proper ventilation.

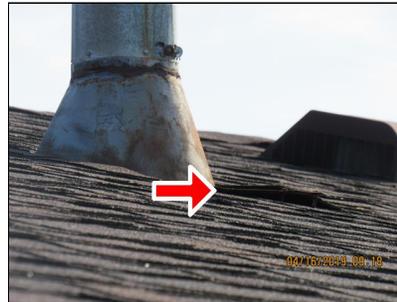
3.0 Item 2(Picture)

(1) Popping nails observed near furnace vent. Nails should be secured as part of a routine maintenance effort to prevent roof damage.

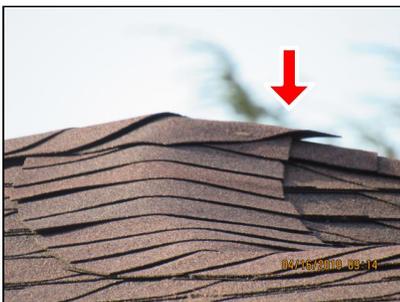
3.0 Item 3(Picture)

(2) Ridge cap shingle has lifted. This may be torn in high winds. Repair/replace as needed to prevent water entry into the attic space.

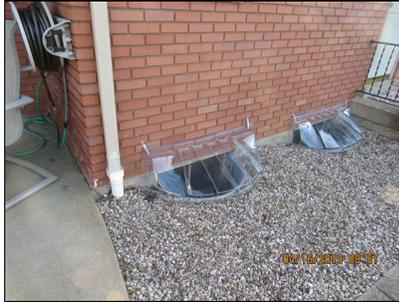
3.2 Item 2(Picture)

(3) The downspouts are loose and need securing to the wall at most areas of the home. Recommend securing to avoid movement and potential damage.

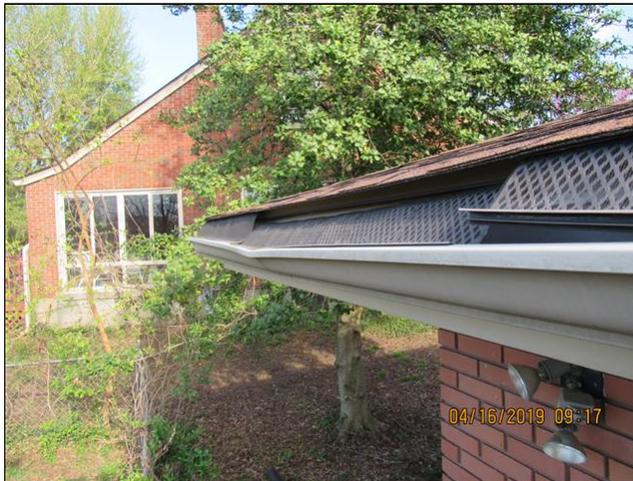
3.2 Item 5(Picture)

(5) Damage observed at left corner (facing rear). Recommend review for repair or replacement as necessary.

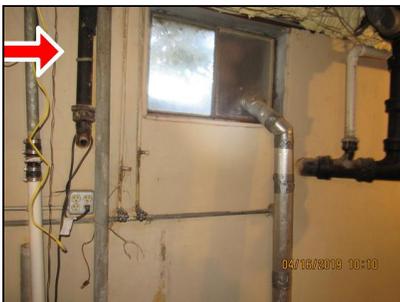
4.1 Item 1(Picture)

(1) Poorly supported piping observed in the basement. This line may rattle when the sump pump is used. Recommend installing additional supports as necessary, review by a licensed plumber for repair or replacement, as necessary.

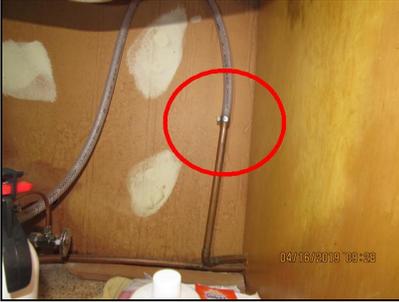
5.9 Item 1(Picture)

Drainage was serviceable at the time of inspection although this connection may be prone to leaking. Recommend monitoring over time or review by a licensed plumber for replacement as needed..

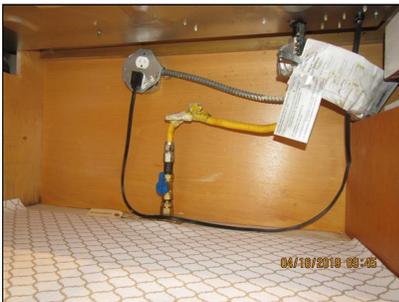
5.12 Item 1(Picture)

Odors of natural gas were observed under the cook top while testing the burners. It is possible gas may be leaking under the cook top area into the cabinet. A qualified appliance contractor is needed for further review and to perform necessary repairs/corrections to ensure safety.

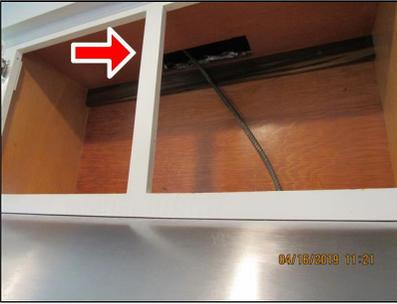
5.13 Item 1(Picture)

Past venting observed in cabinet above the range hood. This appears to open to the attic space. Recommend closing this area to keep insulation and pest from possibly entering cabinet area.

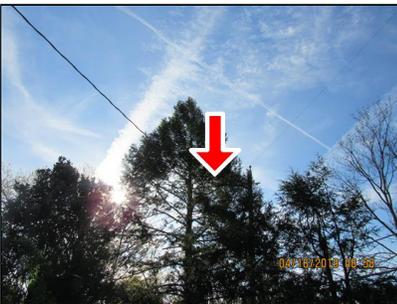
12.0 Item 1(Picture)

Service entrance is overhead. The utility company wires coming into the service mast are sagging and strung through trees. Client is advised to contact the utility company prior to closing to correct the condition or verify its safety.

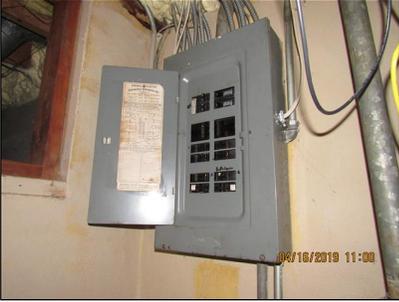
12.2 Item 1(Picture)

(2) More than 6 disconnects required to shut off all power to home in the main electrical panel. This contrary to standard practice. Upgrading panel may be needed to correct. Recommend review by licensed electrician for corrections as needed.

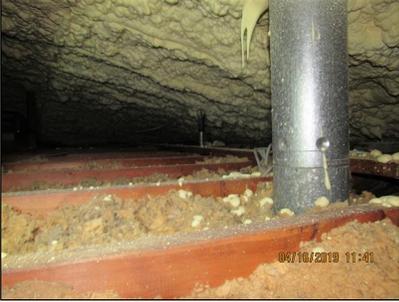
15.2 Item 1(Picture)

Limited inspection due to spray foam insulation added to sheathing members. We are unable to verify stability, condition or integrity of this system.

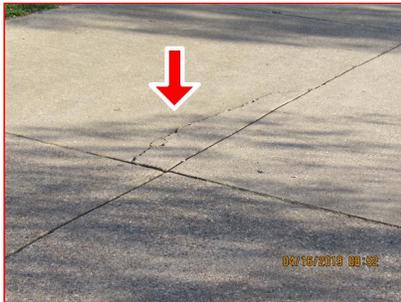
1.0 Item 1(Picture)

Common cracks observed, primarily a cosmetic concern. We suggest sealing all cracks in concrete/asphalt/brick surfaces to prevent water penetration as a routine maintenance effort.

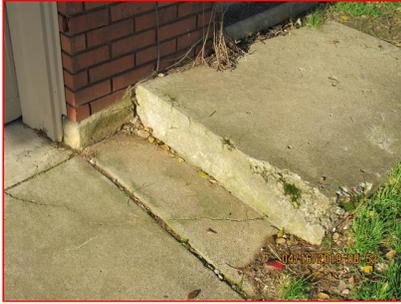
1.1 Item 1(Picture)

Common cracks observed, primarily a cosmetic concern. We suggest sealing all cracks in concrete/asphalt/brick surfaces to prevent water penetration as a routine maintenance effort.

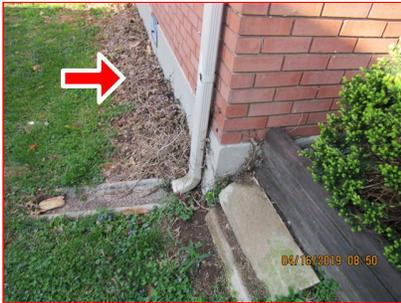
1.2 Item 1(Picture)

(1) Extensive vegetation and overgrowth observed at various locations. This can promote moisture damage and wood deterioration to the siding and structure which is not always visible to the inspector. Suggest trimming/removal of vegetation to prevent damage to the home. This was a limited review of this area. Damage/deterioration can only be viewed after removal of vegetation/overgrowth.

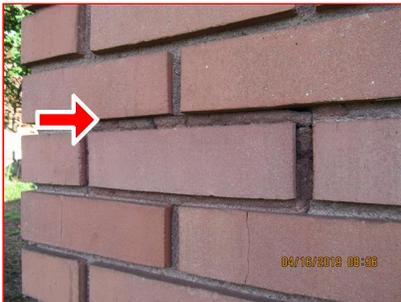
1.2 Item 3(Picture)

(2) Damaged/deteriorated mortar observed at various locations; suggest tuck pointing as necessary to prevent further damage.

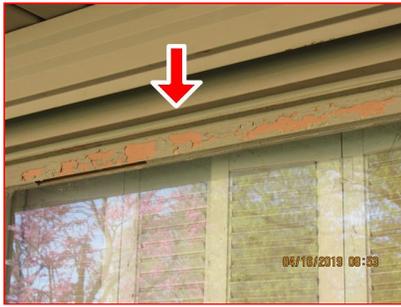
1.4 Item 1(Picture)

Peeling paint observed at right side; suggest scraping and painting as necessary as part of normal maintenance.

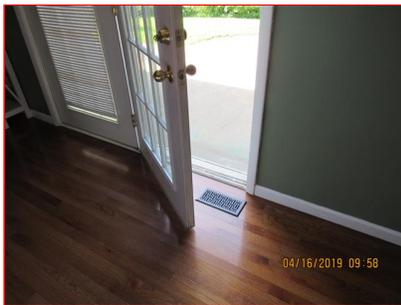
1.5 Item 1(Picture)

Rear entry door doesn't lock well without adjusting door. Recommend adjustments as needed.

- This door is reliant on a key for opening instead of a dead bolt handle. This could be a potential safety hazard in the event of a fire and the key is missing. This room has no other means of egress by windows except for this doorway.

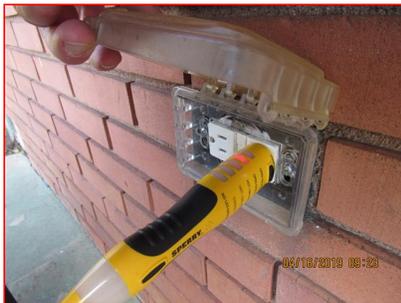
1.7 Item 1(Picture)

(1) Ungrounded three prong receptacles observed at rear of home. It is recommended that these types of receptacles be grounded, replaced with two prong receptacles, or protected on a GFCI circuits as applicable. Suggest review by licensed electrical contractor for repairs/replacements as needed to ensure safety.

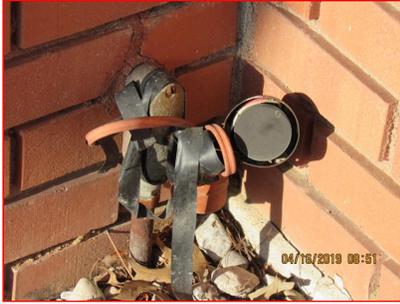
1.7 Item 2(Picture)

(2) Exposed electrical wiring observed at front of home. This is a safety concern if used where it could be subject to "Physical Damage". Exposed electrical wires are normally encased in conduit to ensure safety. Client should consult with a licensed electrician prior to closing for repairs/replacement as needed to ensure safety.

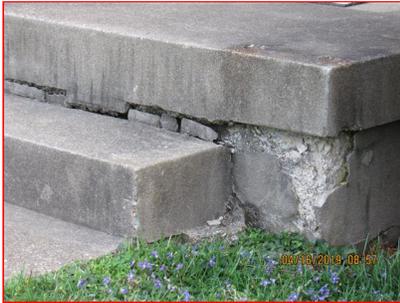
1.12 Item 1(Picture)

Cement deterioration and chipping present at back steps. Recommend review by a qualified professional for repair or replacement as necessary.

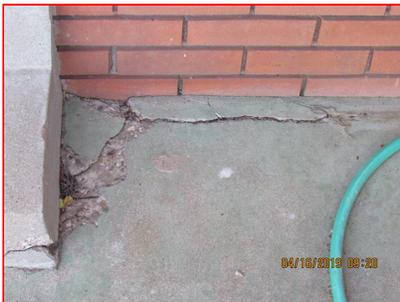
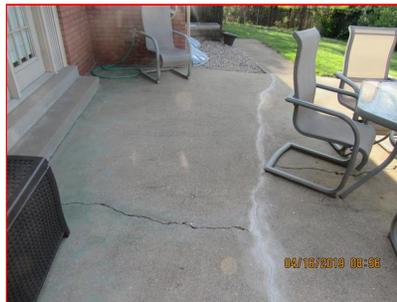
Common cracks observed, primarily a cosmetic concern. We suggest sealing all cracks in concrete surfaces to prevent water penetration as a routine maintenance effort.

This patio has also settled over time and may need to be monitored for further movement as the surface slopes away from the home slightly.

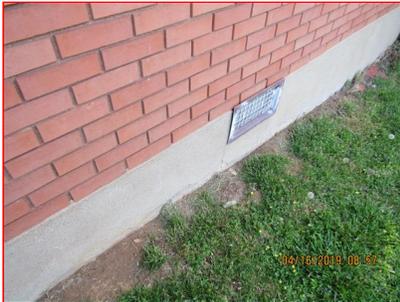
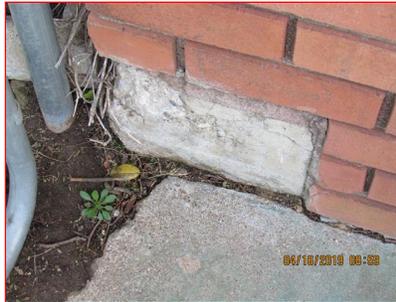
Cement parging is flaking/deteriorated at various locations. Recommend review for repair as necessary.

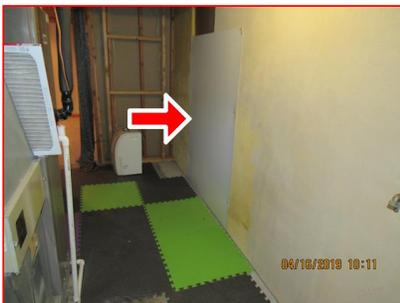
2.3 Item 1(Picture)

Structural wall re-enforcements or patching work observed in the basement, unable to determine effectiveness of repairs, suggest consult sellers or a structural engineer for additional information, prior to close.

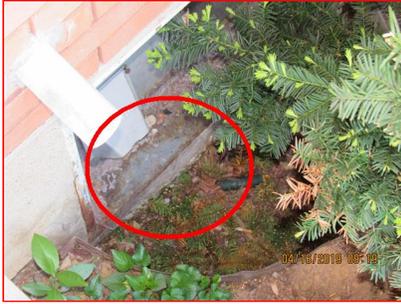
2.9 Item 1(Picture)

Peeling paint observed; suggest scraping and painting as necessary as part of normal maintenance to avoid more rust decay.

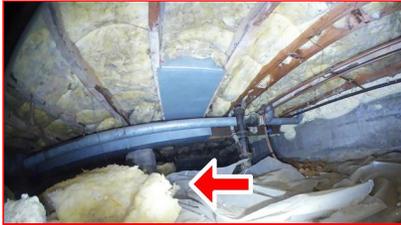
2.11 Item 1(Picture)

Loose insulation observed in the crawlspace, suggest securing as necessary.

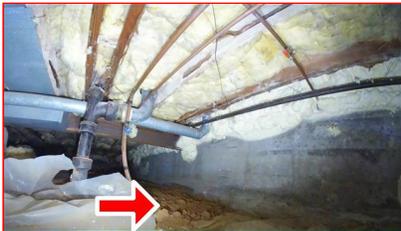
2.12 Item 1(Picture)

Gaps observed. Recommend review for repairs/replacement as needed.

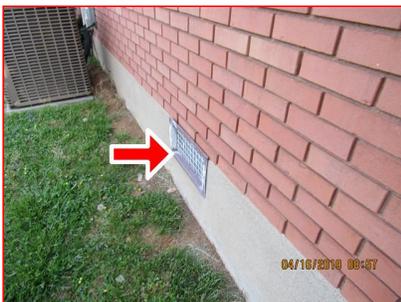
2.13 Item 1(Picture)

Ventilation openings due to spray foam are blocked in the crawlspace, suggest removing obstructions to provide for proper ventilation.

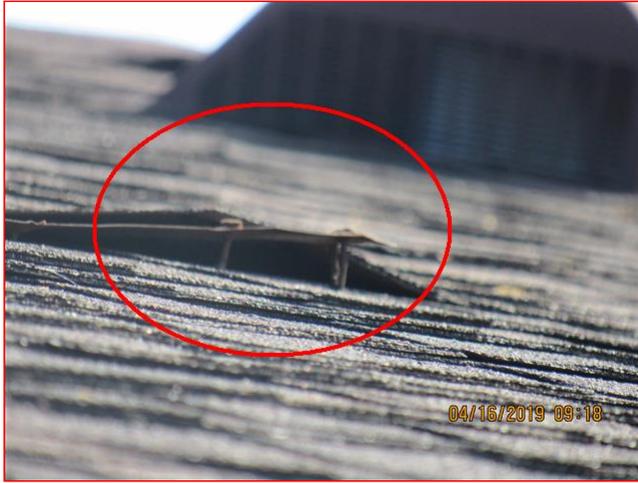
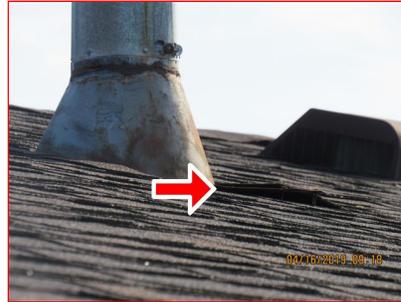
(1) Popping nails observed near furnace vent. Nails should be secured as part of a routine maintenance effort to prevent roof damage.

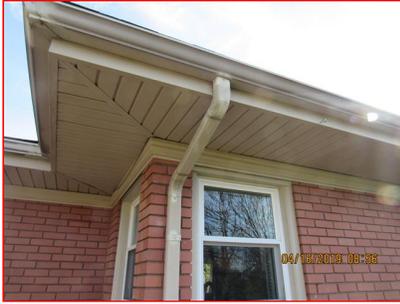
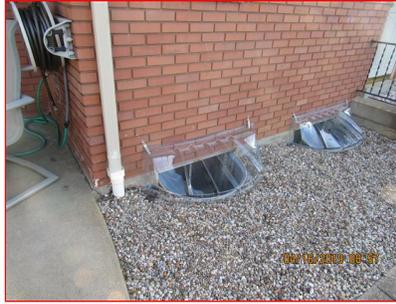
(3) The downspouts are loose and need securing to the wall at most areas of the home. Recommend securing to avoid movement and potential damage.

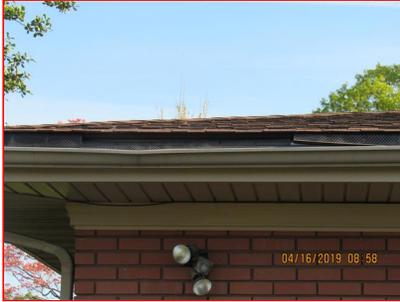
3.2 Item 3(Picture)

(4) Gutters are improperly pitched at rear of home, gutters should be re-aligned to slope towards downspouts for proper drainage.

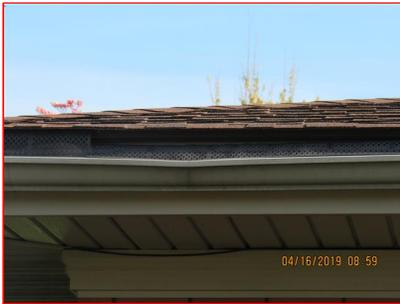
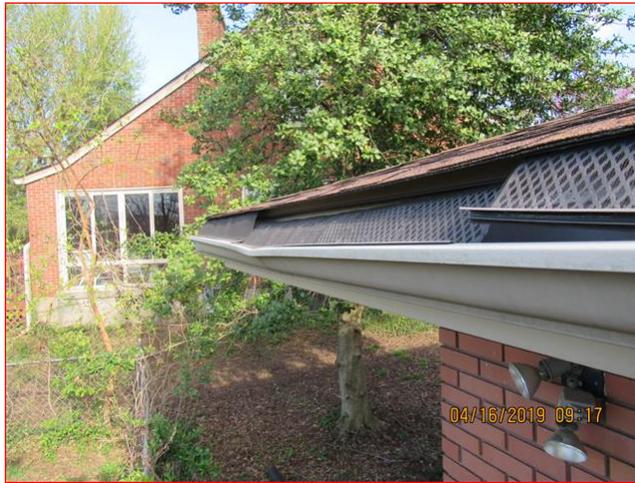
(5) Damage observed at left corner (facing rear). Recommend review for repair or replacement as necessary.

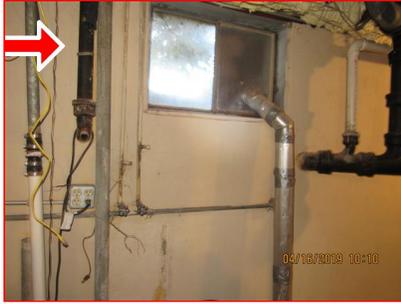
4.1 Item 1(Picture)

(1) Poorly supported piping observed in the basement. This line may rattle when the sump pump is used. Recommend installing additional supports as necessary, review by a licensed plumber for repair or replacement, as necessary.

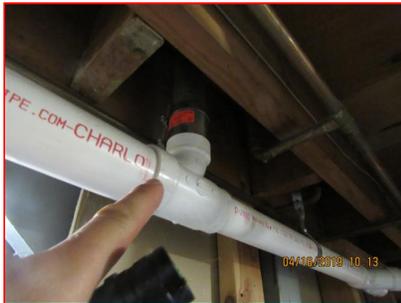
4.1 Item 2(Picture)

(2) Poorly supported drain piping observed in the basement. Recommend installing additional pipe hangers as necessary, review by a licensed plumber for repair or replacement, as necessary.

(3) Fernco/Rubber piping installed as a connector. These may leak over time due to collapsing or sagging. No leaks were detected at the time of inspection, although it is advised to monitor and replace as needed with correct fittings.

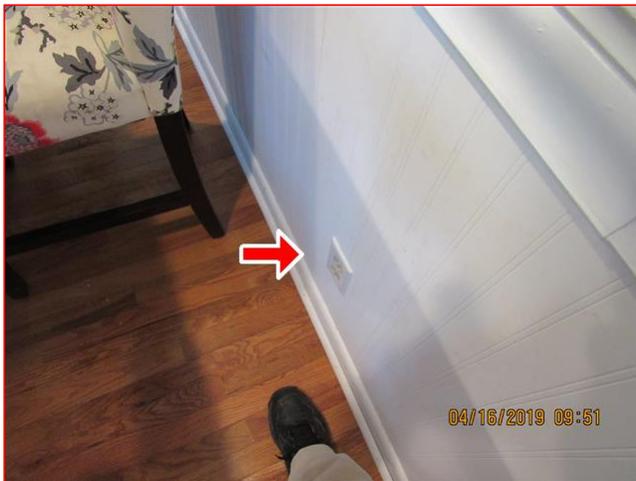
5.6 Item 1(Picture)

The top outlet plug is loose from use where an appliance will not stay plugged in possibly. Suggest replacing.

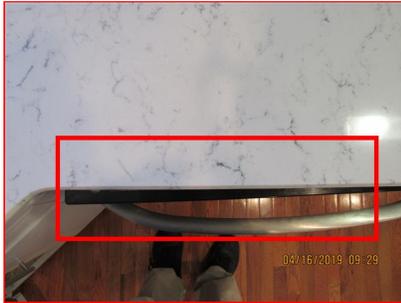
5.11 Item 1(Picture)

The dishwasher needs adjustment as it isn't properly aligned with the countertop. Recommend repair or adjusting as necessary.

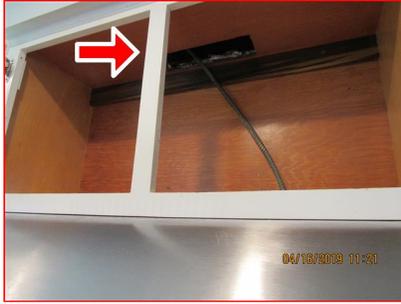
5.13 Item 1(Picture)

Past venting observed in cabinet above the range hood. This appears to open to the attic space. Recommend closing this area to keep insulation and pest from possibly entering cabinet area.

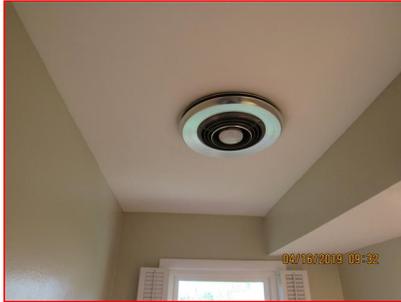
6.8 Item 1(Picture)

Fans located in the hall bathroom may be improperly venting into attic. Due to spray foam in attic, this unable to completely verify. Recommend extending the fans' exhaust to the exterior of attic to prevent damage/deterioration in the attic from moisture/condensation.

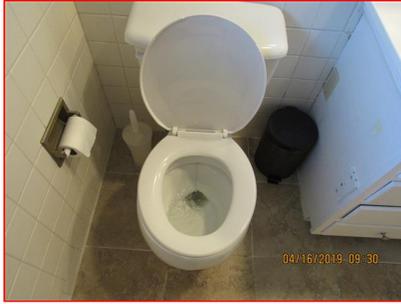
6.12 Item 1(Picture)

The toilet does not flush properly in the hall bathroom. Recommend review by a licensed plumber for repair or replacement, as necessary.

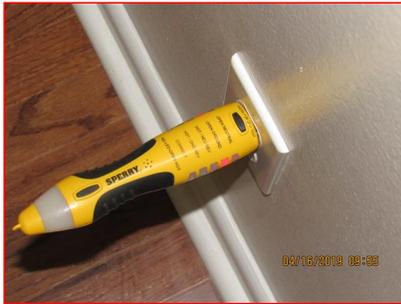
7.7 Item 1(Picture)

Ungrounded three prong receptacles observed in the living room. It is recommended that these type receptacles be grounded, replaced with two prong receptacles, or protected on a GFCI receptacle as applicable. Suggest review by licensed electrical contractor for repairs/replacements as needed to ensure safety.

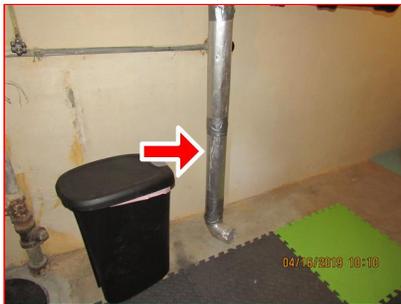
8.10 Item 1(Picture)

The dryer vent piping is duct taped and may not be properly functional. Recommend review for repair as needed.

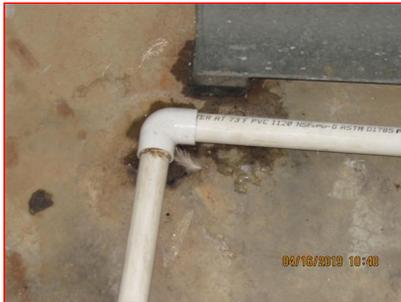
9.0 Item 1(Picture)

(2) Condensate line is leaking and should be replaced or repaired as needed.

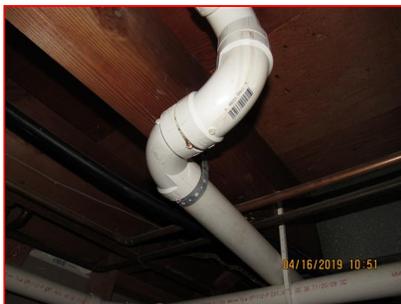
9.2 Item 1(Picture)

Exhaust vent pipe for furnace is leaking condensate. Suggest maintenance/ repairs to ensure leak free conditions.

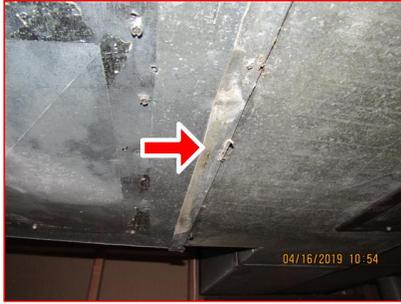
9.5 Item 1(Picture)

(1) The ductwork is not insulated. This may not have been required when home was built. Recommend review by a licensed heating contractor for corrections as necessary.

(2) Possible asbestos materials observed. The materials were torn, ripped, or damaged at the time of inspection. This is a possible safety hazard. Suggest further review by a licensed asbestos testing lab be performed prior to closing for repairs/replacement needed to ensure safety.

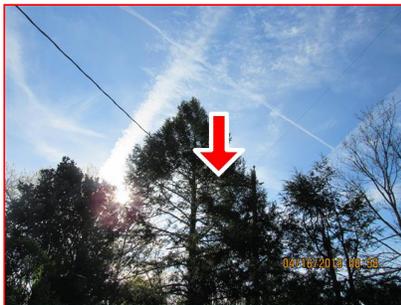
12.0 Item 1(Picture)

Service entrance is overhead. The utility company wires coming into the service mast are sagging and strung through trees. Client is advised to contact the utility company prior to closing to correct the condition or verify its safety.

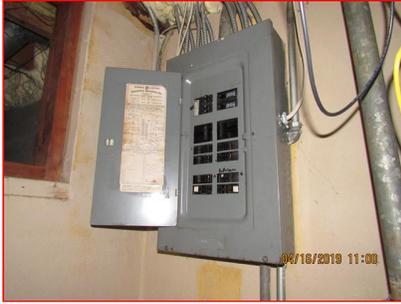
12.2 Item 1(Picture)

- No Futures are available for expansion in the electrical panel. If additions are added an additional panel may be required.

(2) More than 6 disconnects required to shut off all power to home in the main electrical panel. This contrary to standard practice. Upgrading panel may be needed to correct. Recommend review by licensed electrician for corrections as needed.

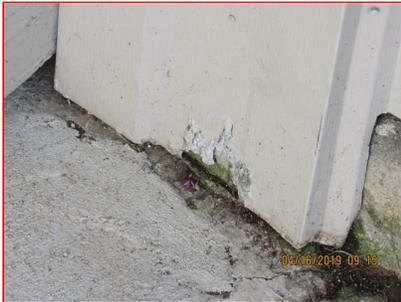
13.0 Item 1(Picture)

(1) Same as Exterior.

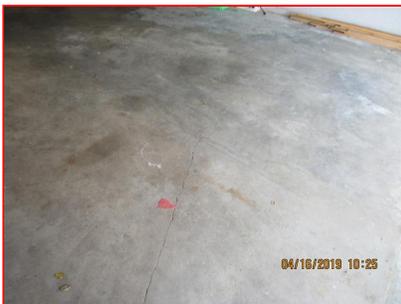
13.2 Item 1(Picture)

Common cracks observed, primarily a cosmetic concern. We suggest sealing all cracks in concrete/asphalt/brick surfaces to prevent water penetration as a routine maintenance effort.

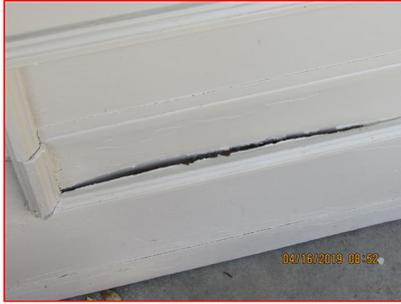
13.3 Item 1(Picture)

The door panel of the garage door is warping. We recommend repair as necessary to help assure long term serviceability.

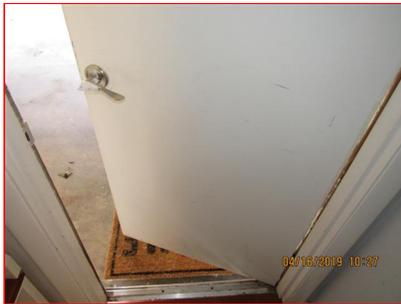
13.5 Item 1(Picture)

The occupant door from inside garage to inside the home is not a fire rated door. This means that should a fire occur in garage, the occupant door does not afford protection until fireman arrive. This door should be replaced with a fire rated door.

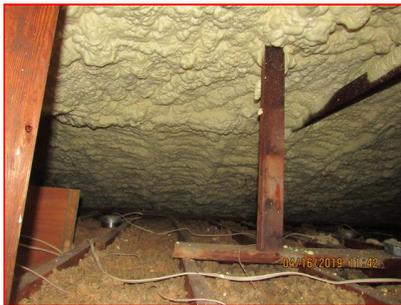
15.1 Item 1(Picture)

Limited inspection due to spray foam insulation added to framing members. We are unable to verify stability, condition or integrity of this system.

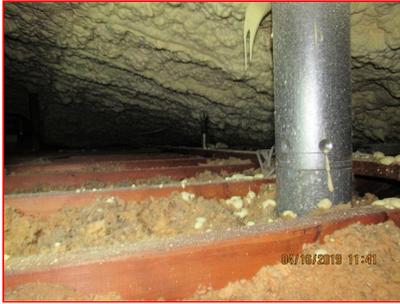
15.2 Item 1(Picture)

Limited inspection due to spray foam insulation added to sheathing members. We are unable to verify stability, condition or integrity of this system.

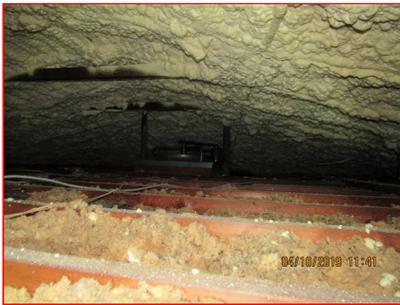
15.4 Item 1(Picture)

- Unable to verify proper attic ventilation by spray foam or if the seller intended to seal the attic space with it. There is a draft in the attic that can not be detected to its location. If vents were to be added, generally, vents should be installed at a minimum ratio of 1 square foot of ventilation per 300 square feet of attic space balanced between the lower and upper thirds of the attic space. This can help to reduce interior temperatures and preserve the life of the roofing materials.
